## **QIKIQ15 BAFFIN REGION DEW LINE SITE MONITORING**

# **2016 FOX-4 Monitoring Report**

**Report Number:** 1530908-2000-R6-V3

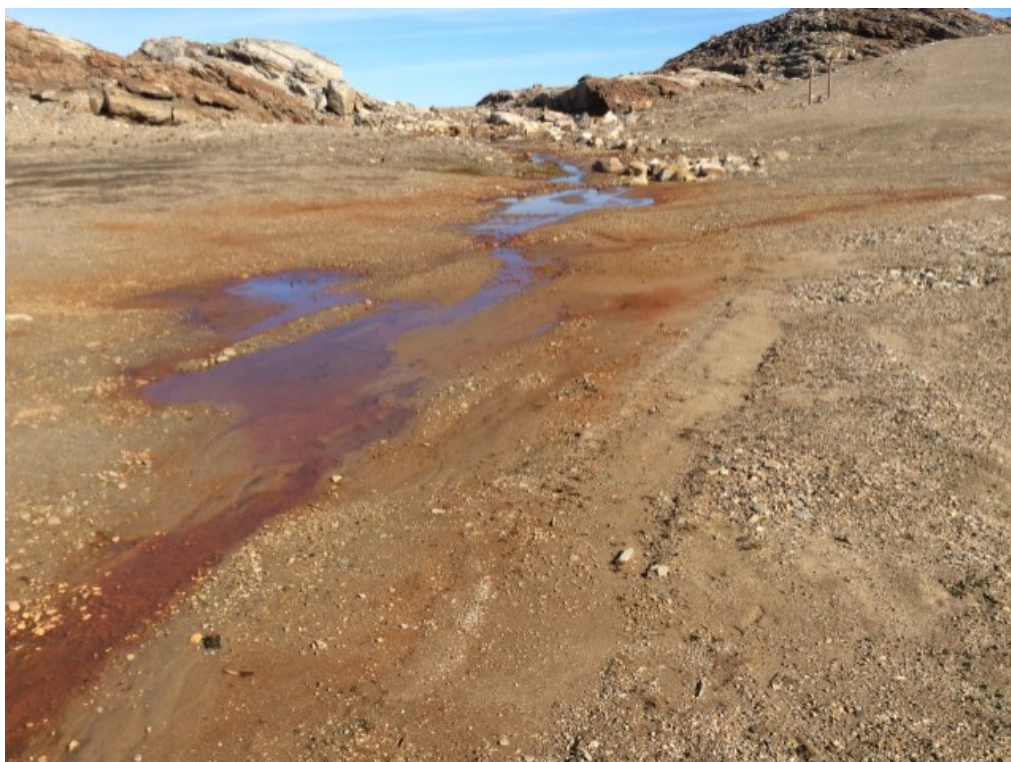
Photo 128: FOX-4 – Station Area Landfill – Northwest toe facing east – Feature B – Ponded water with orange staining (Acceptable) (ATT137\_Photo137.jpg)

It is recommended that soil samples from closer to the ponded water/staining area be collected during the next monitoring event. It is further recommended, considering the inability to collect groundwater samples from the wells (because they are filled with bentonite clay), that consideration be given to collection of water samples from either the ponded surface water, or a shallow hand dug excavation. In addition, an attempt should be made to flush these wells during the next sampling program.

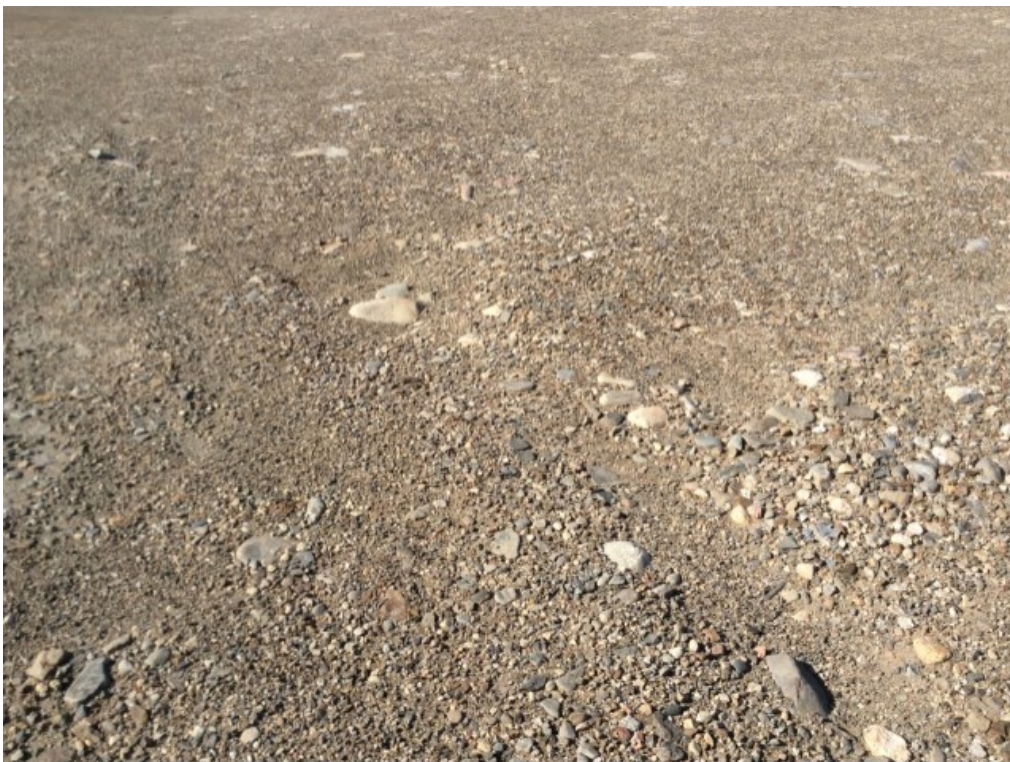
Photo 134: FOX-4 – Station Area Landfill – Central crest surface facing southwest – Feature G – Previously observed minor settlement (<0.1 m deep) may just be rough grading (Acceptable) (ATT133\_Photo133.jpg)

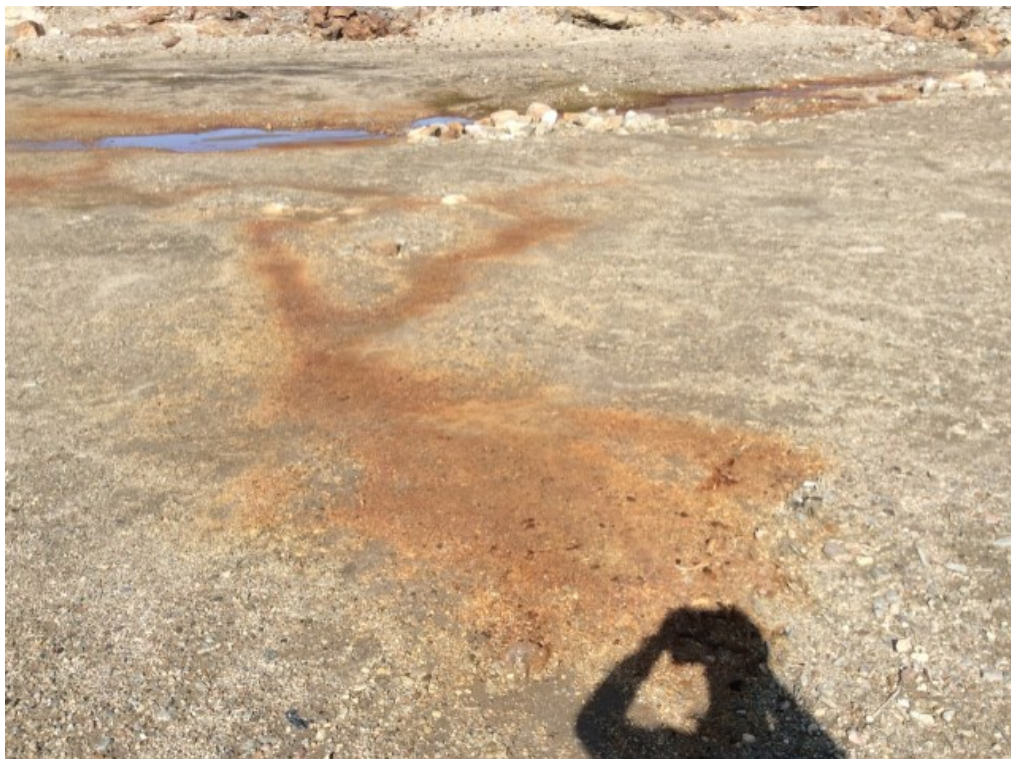
Photo 135: FOX-4 – Station Area Landfill – West toe facing north – Feature L – Orange staining (Acceptable) (ATT136\_Photo136.jpg)

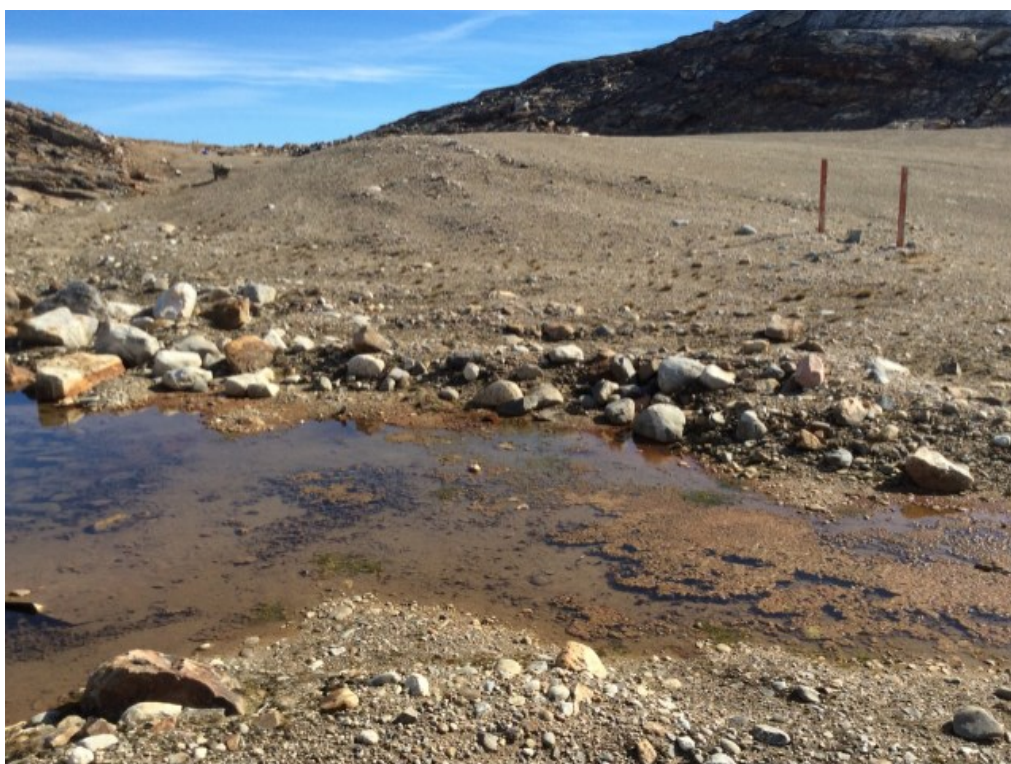
Photo 136: FOX-4 – Station Area Landfill – Northwest toe facing southeast towards landfill – Feature B – Ponded water with orange staining (Acceptable) (ATT135\_Photo135.jpg)

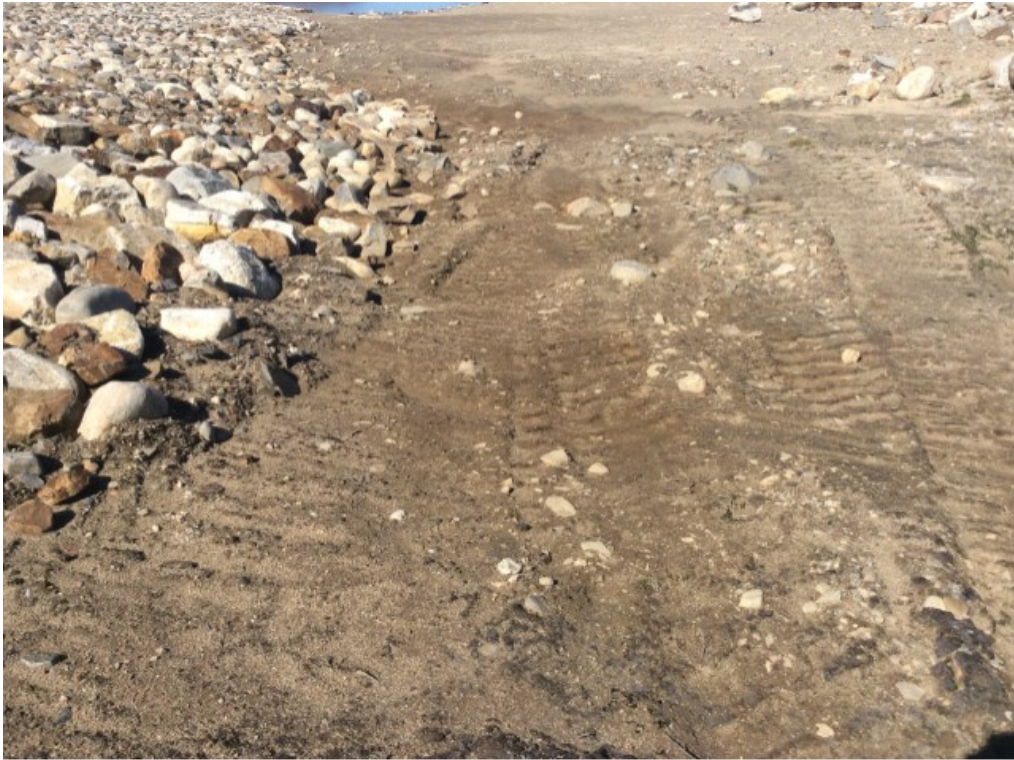
Photo 161: FOX-4 – Pallet Line Landfill – Previously observed ponded water (Feature A) not observed in 2016 – East end facing southwest (ATT95\_Photo95.jpg)

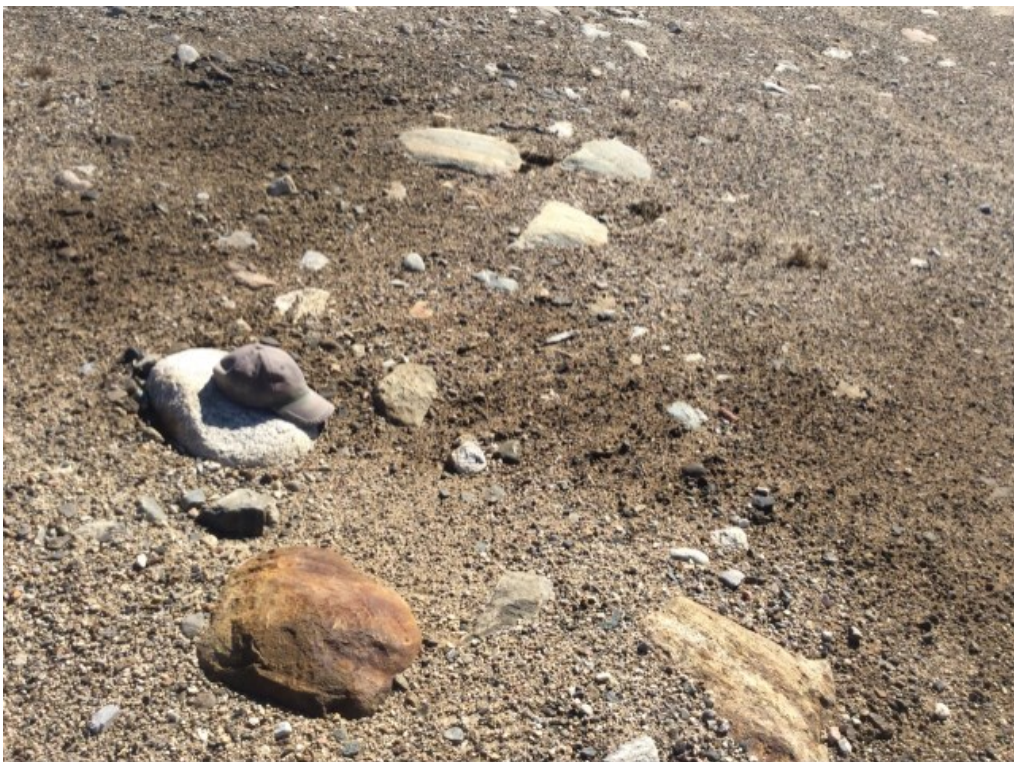
Photo 162: FOX-4 – Pallet Line Landfill – Crest surface of landfill facing north – Feature B – Minor dark (potential hydrocarbon) staining not related to landfill performance (Acceptable) (ATT94\_Photo94.jpg)

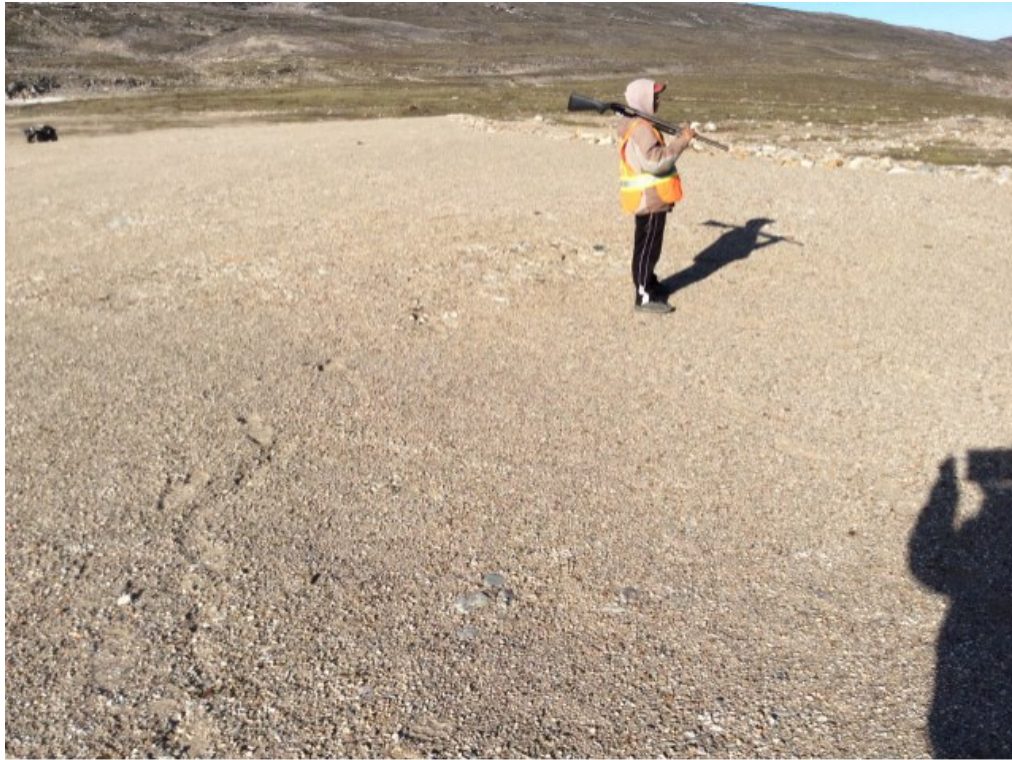
Photo 185: FOX-4 – Tanner Bay Landfill – Crest surface facing northeast – Feature A – Minor settlement area with weathered crack (Acceptable) (ATT159\_Photo159.jpg)

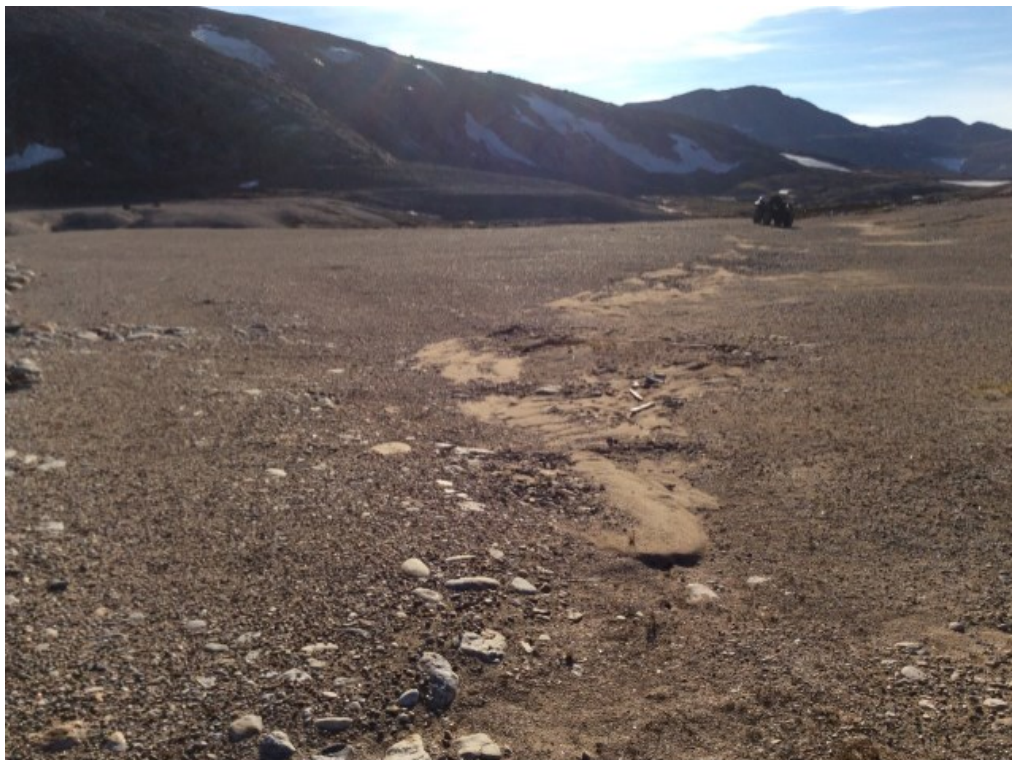
Photo 186: FOX-4 – Tanner Bay Landfill – Northeast corner facing west – Feature B – Minor erosion (Acceptable) (ATT160\_Photo160.jpg)
