Figure 1  
Station Area  
Geomorphology and Surficial Geology  
Borrow Areas and Landfills

Figure 2  
Station Area  
Site Plan

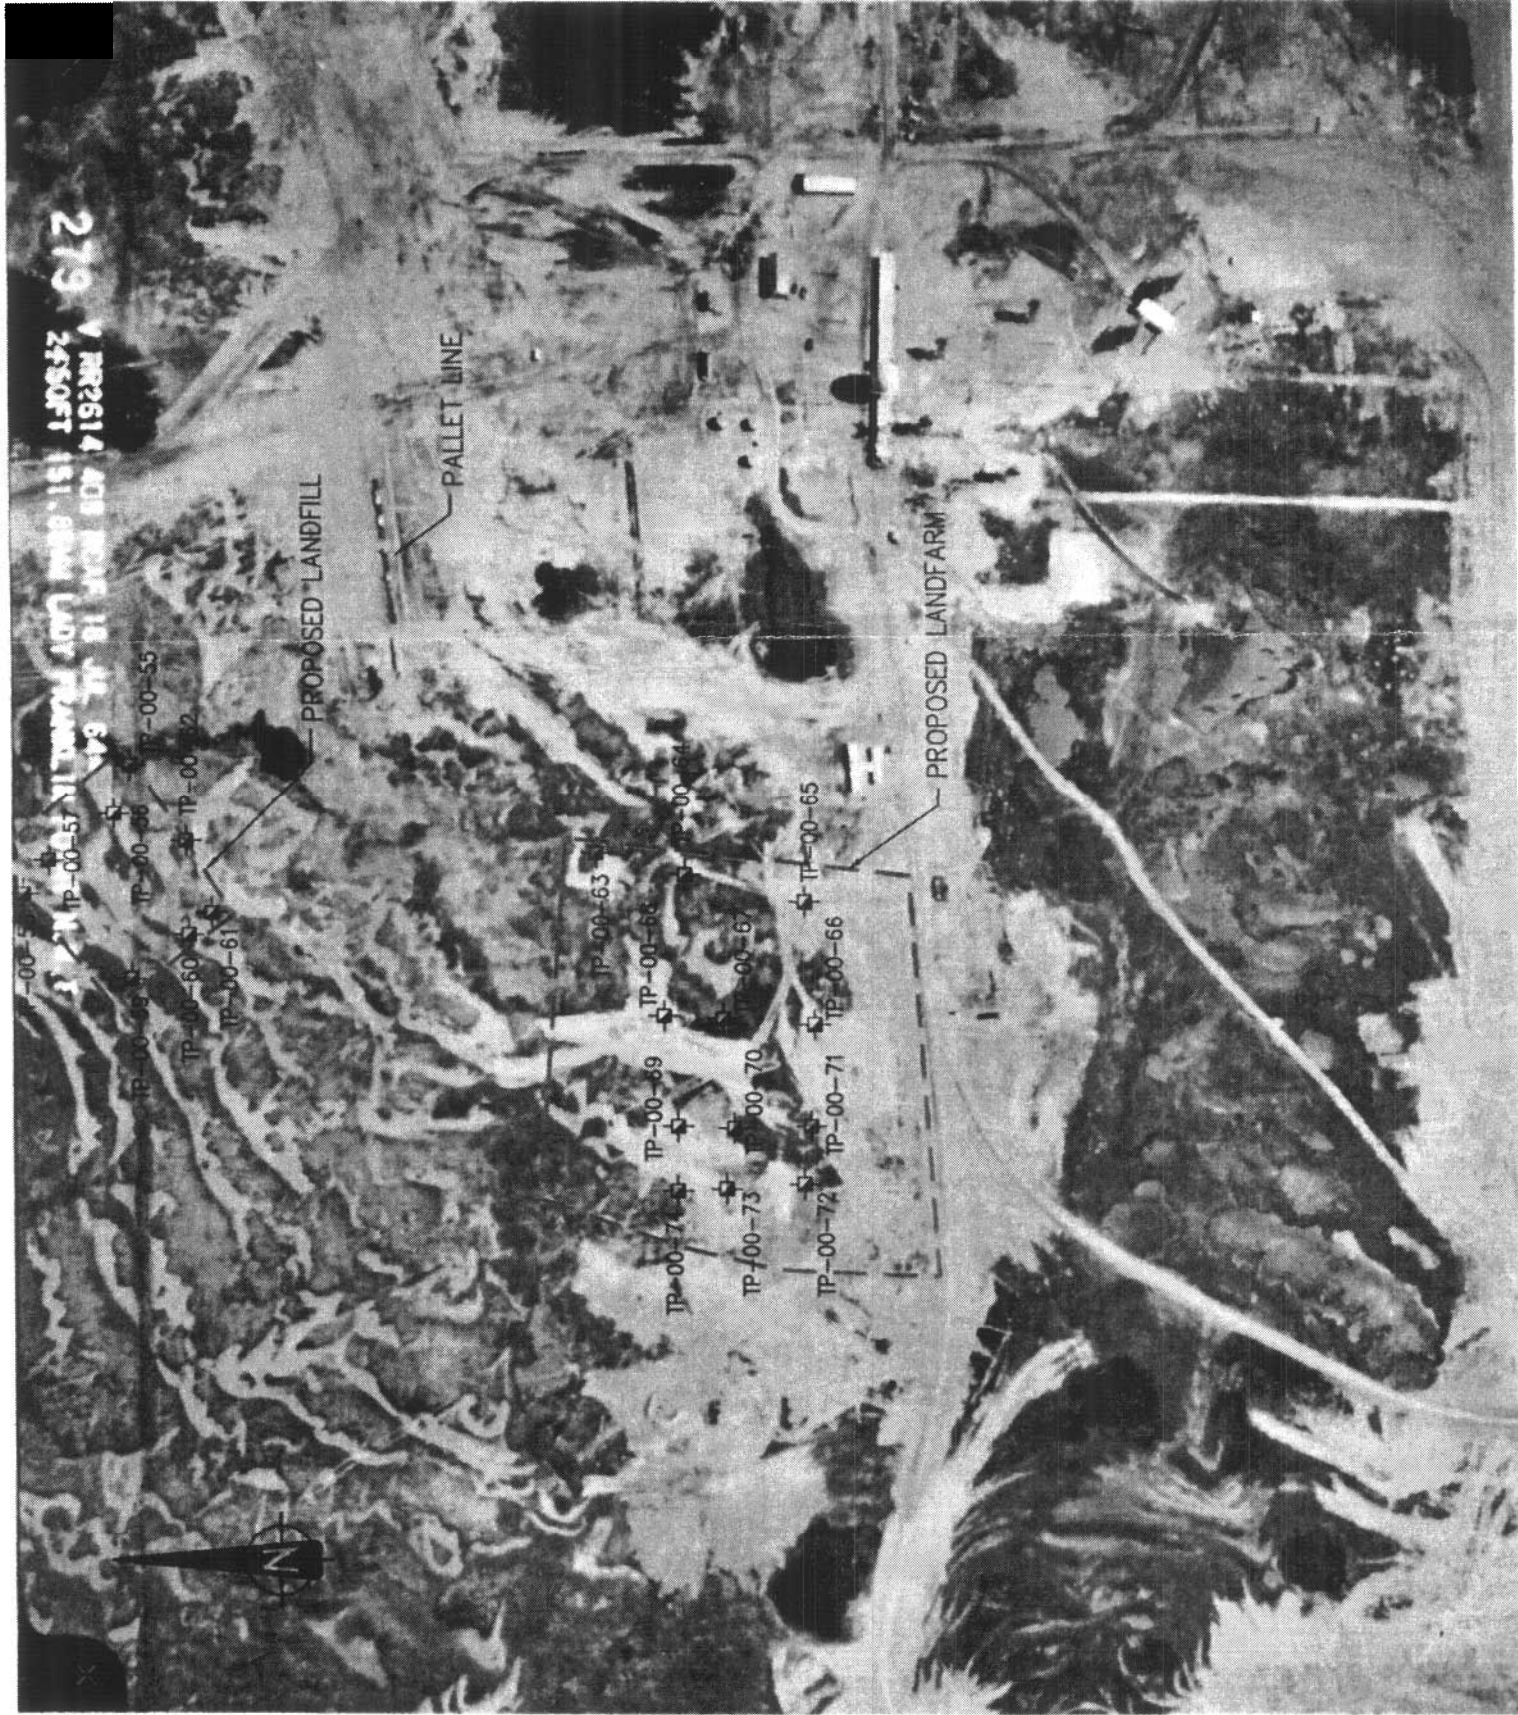
BASE DRAWING: 1964 AERIAL PHOTOGRAPH RR2614-408, GOVERNMENT OF CANADA,  
DEPARTMENT OF ENERGY, MINES AND RESOURCES
