The Collection of Landfill Monitoring Data at the PIN-3 Lady Franklin Point Site

Prepared for
Defence Construction Canada

Submitted by
Gartner Lee Limited

Re: GLL 70-516 – FINAL Report for the 2007 Collection of Landfill Monitoring Data at the PIN-3 Dew Line Site, Lady Franklin Point, Nunavut

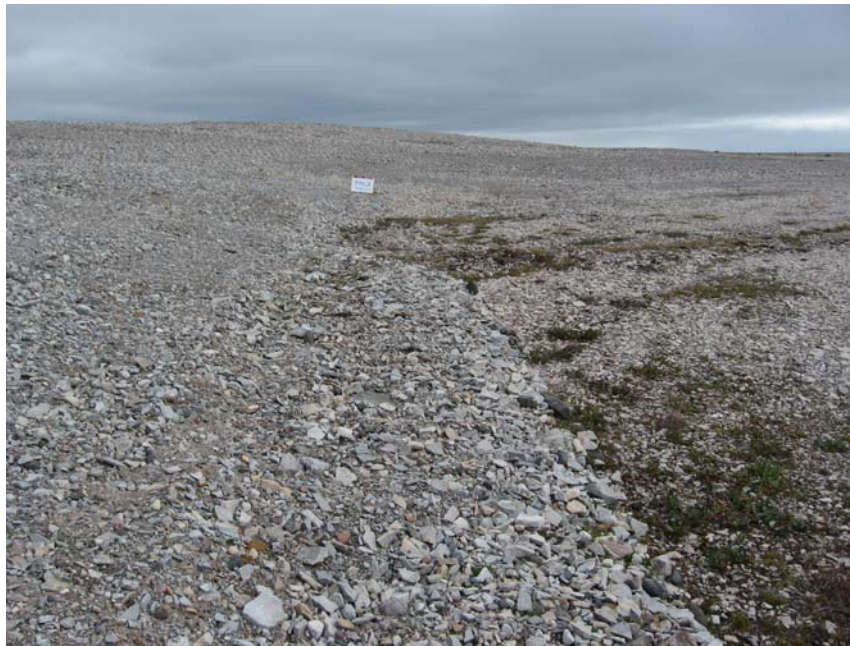
Photograph 18. NWS Landfill (West Cell): Looking to SE corner from midpoint of south side of the western cell. No staining or ponding. Note organics along perimeter. White board for scale (61cm by 46cm).↑

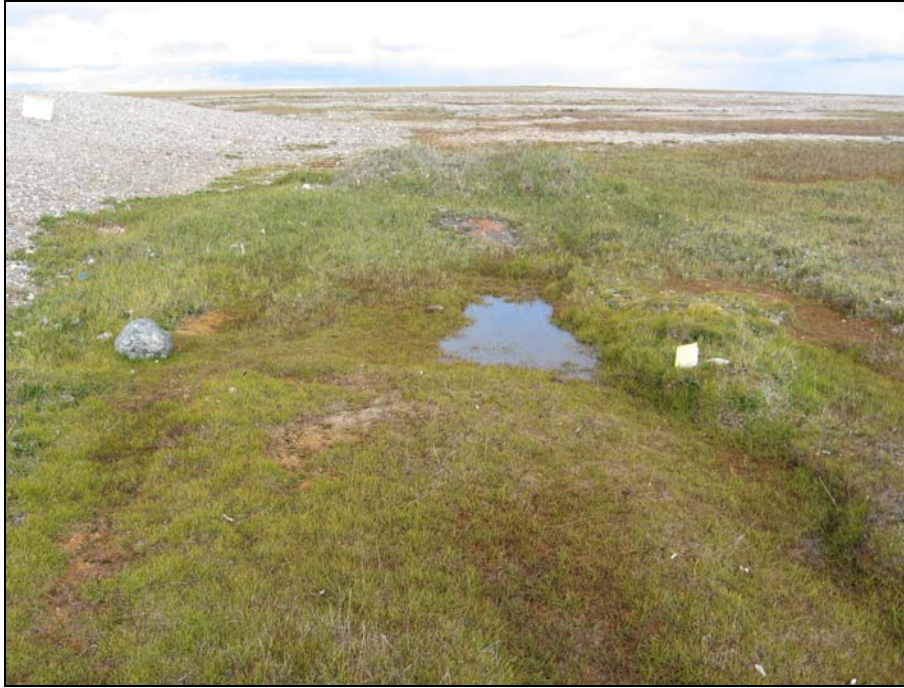
Photograph 3. South Landfill East Cell: Close up of ponded water in depression. Minor/negligible staining. Approx. 3m x 1m areal extent.↑

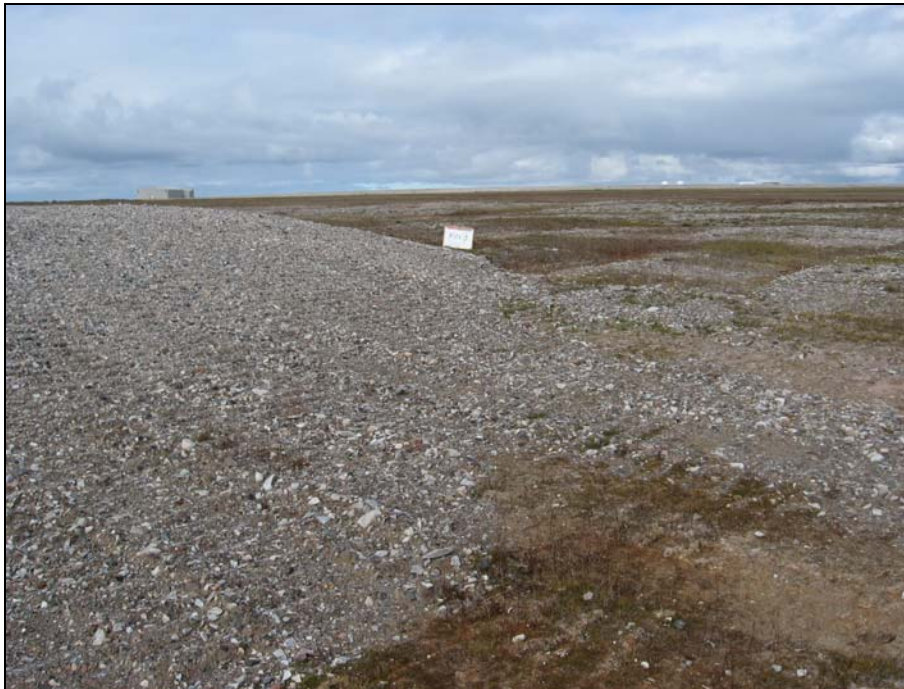
Photograph 4. South Landfill East Cell: Looking NW to NE corner of landfill. Whiteboard situated in area of previous seepage/staining (tags 12991 and 12990 indicate previous sampling).↑

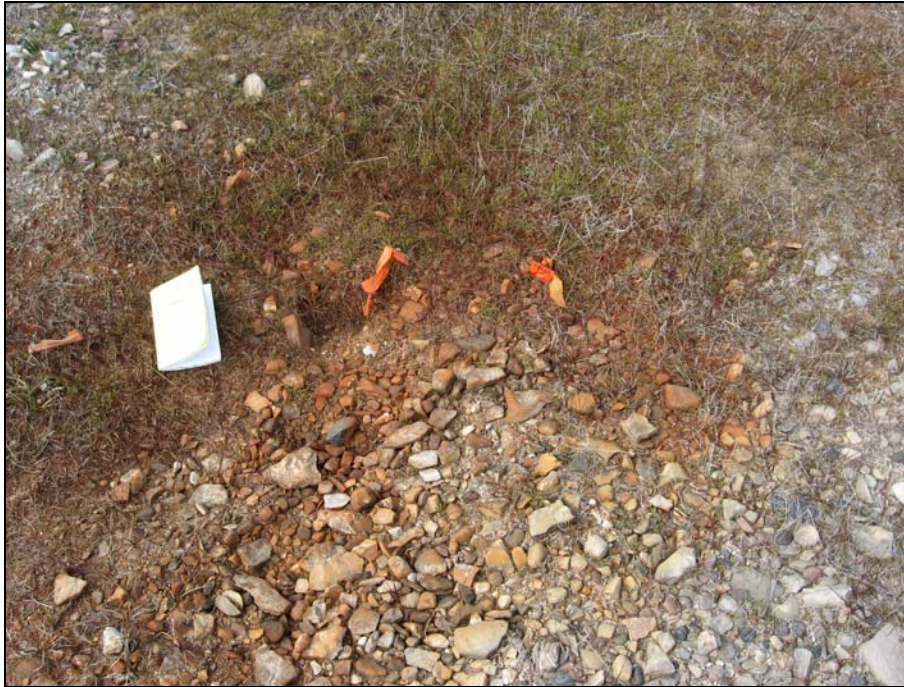
Photograph 5. South Landfill East Cell: Close up of staining and pins named above.↑

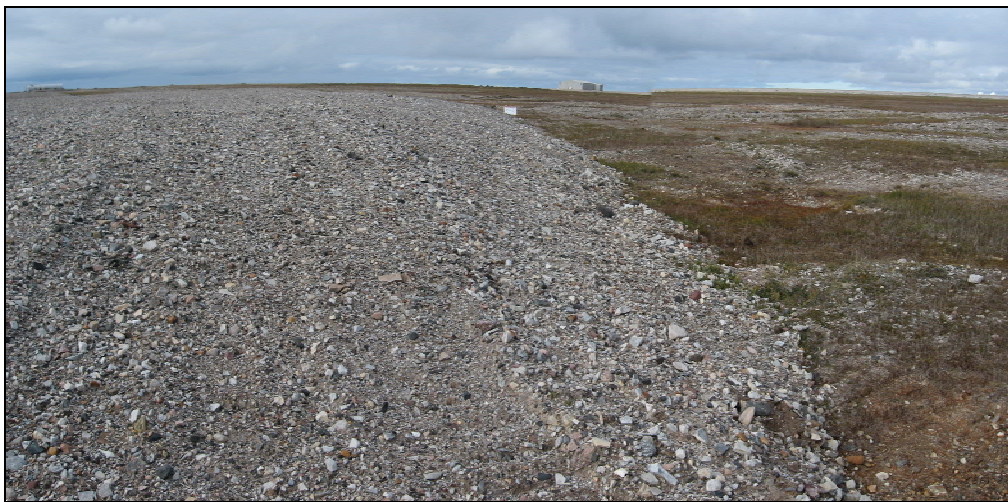
Photograph 6. South Landfill East Cell: Looking NW along NE edge of landfill. Entire downslope toe is dry. No signs of instability.↑

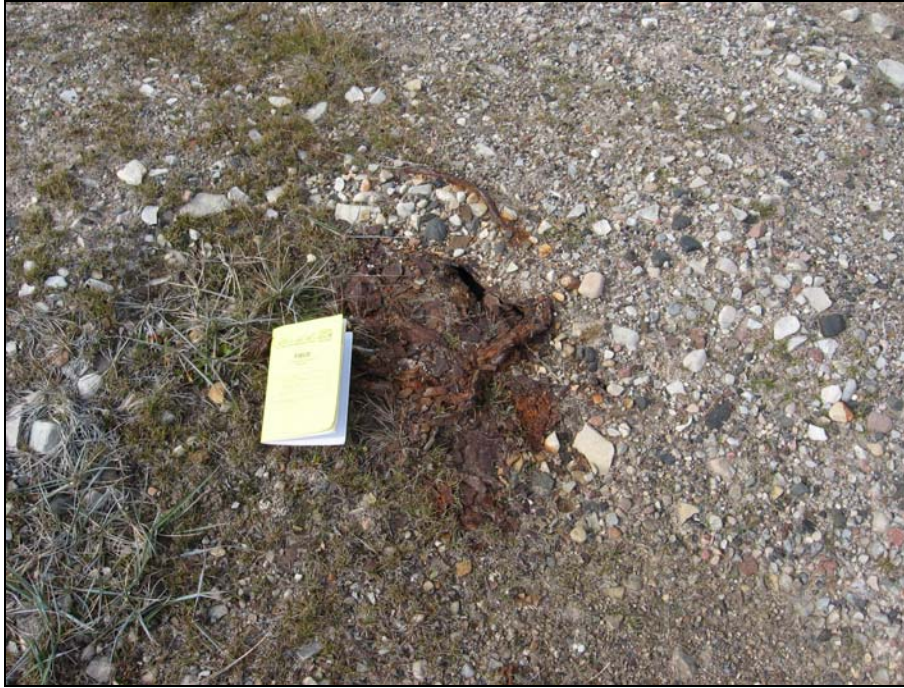
Photograph 7. South Landfill East Cell: Close up of rusty barrel exposed at surface.↑

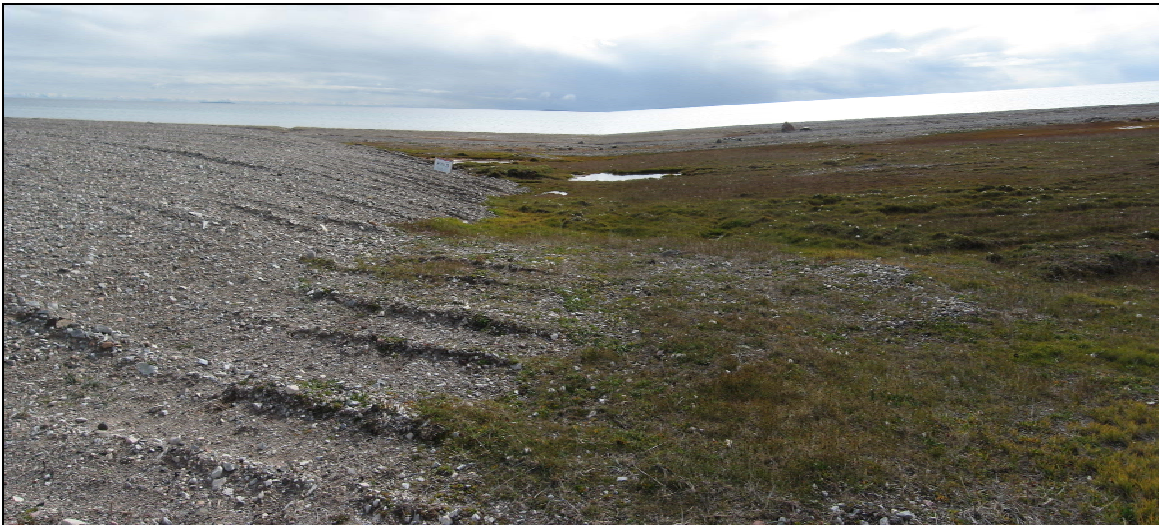
Photograph 10. South Landfill East Cell: Looking S along west side the landfill cell to standing water in displaced peat/muskeg. Pond appears smaller than last year. Orange staining around most ponded water.↑

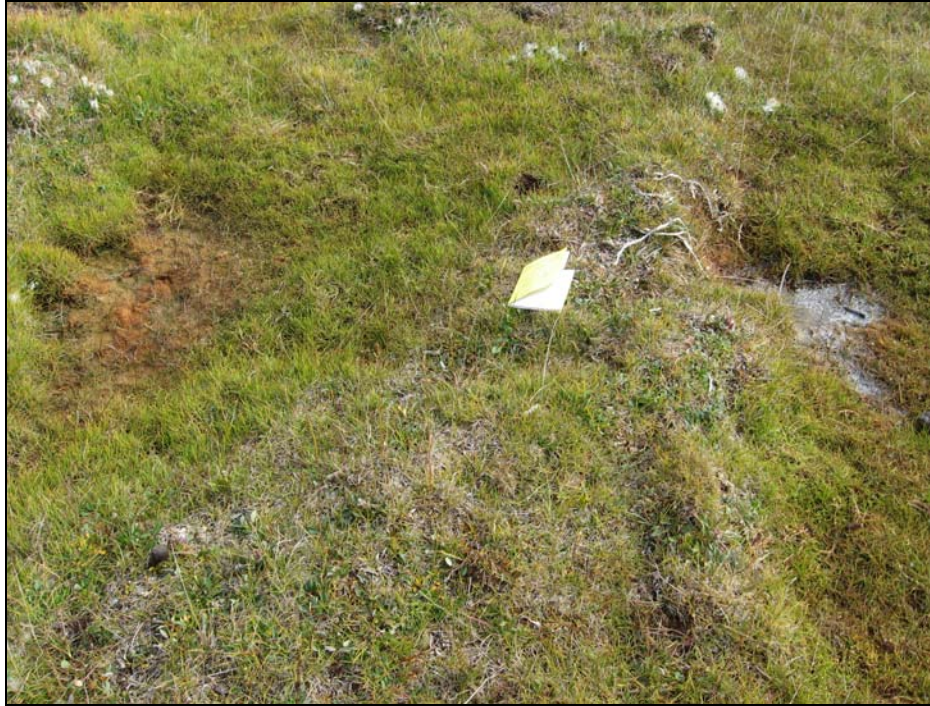
Photograph 11. South Landfill East Cell: Close up of typical staining and ponding along western perimeter of the landfill cell.↑

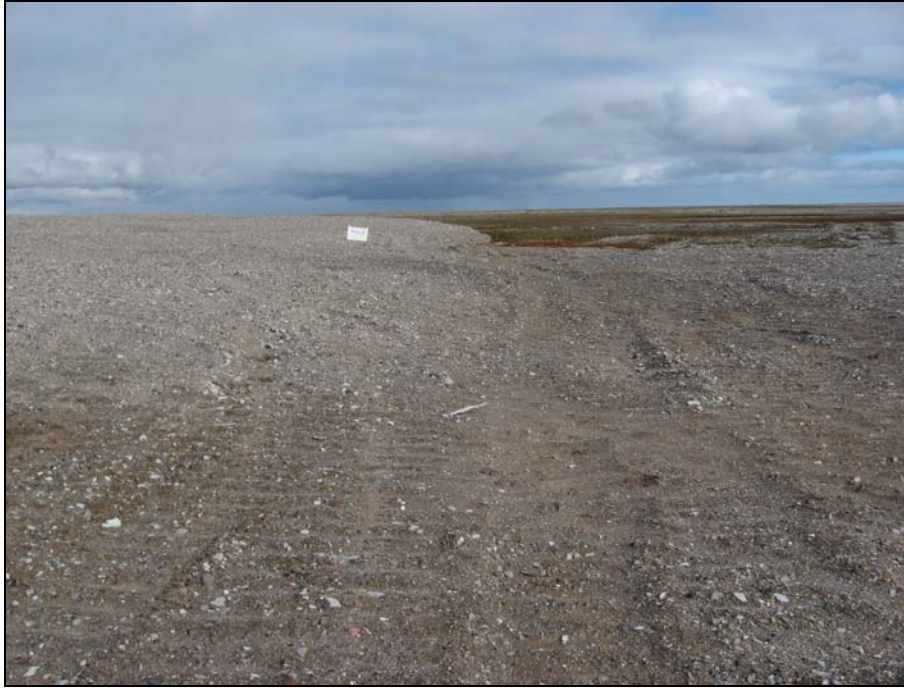
Photograph 15. South Landfill East Cell: Looking East along south side of landfill cell from 8m SW of the SW corner. White board adjacent to staining/ponding at SE corner of the landfill cell.↑

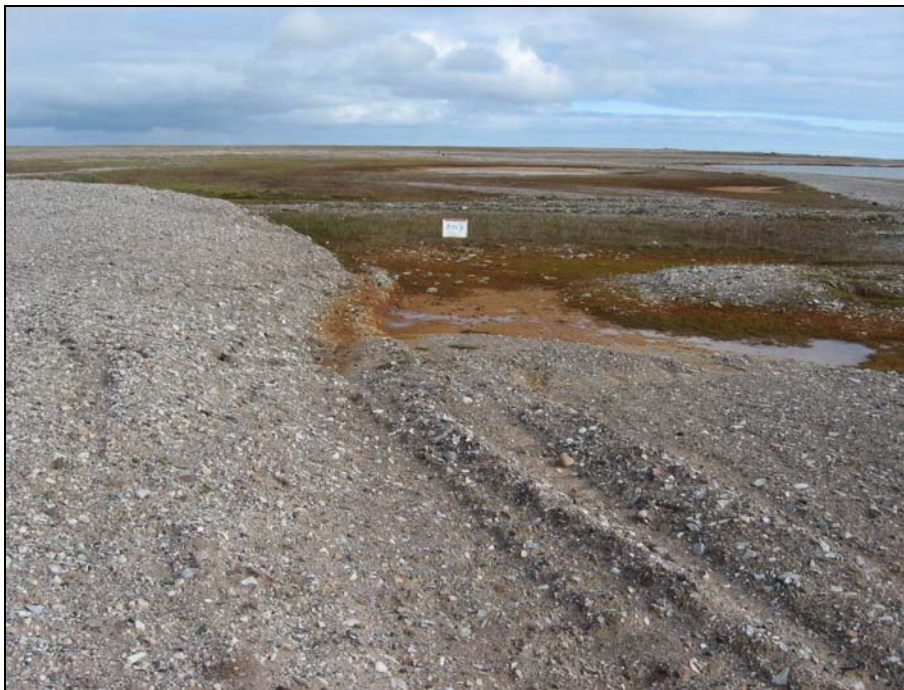
Photograph 16. South Landfill East Cell: Looking east to the SE corner of landfill. Extensive staining and indications of ongoing seepage.↑

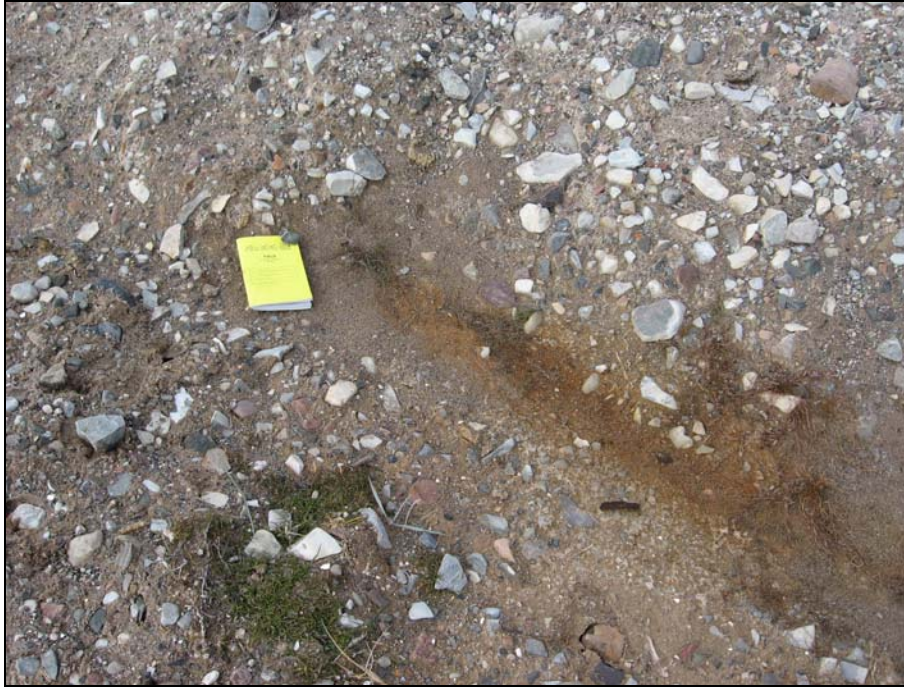
Photograph 17. South Landfill East Cell: Staining/seepage along the SE portion of the landfill cell. Seepage appears to come to surface adjacent to the field book.↑

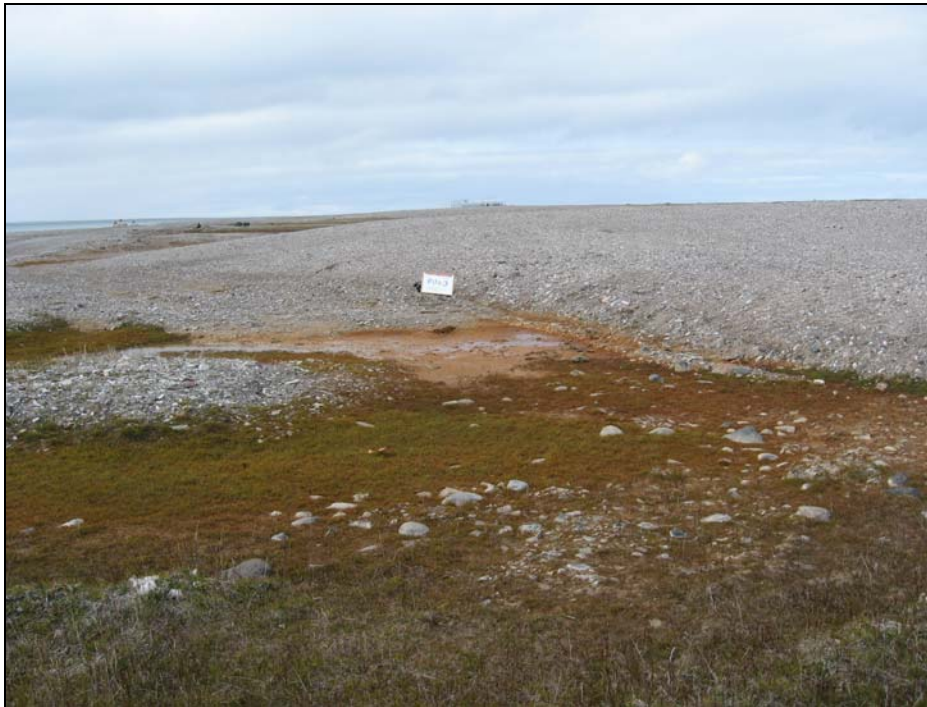
Photograph 18. South Landfill East Cell: Looking NW towards seepage area and staining along the SE corner of the landfill cell. Whiteboard for scale (61cm by 46cm).↑

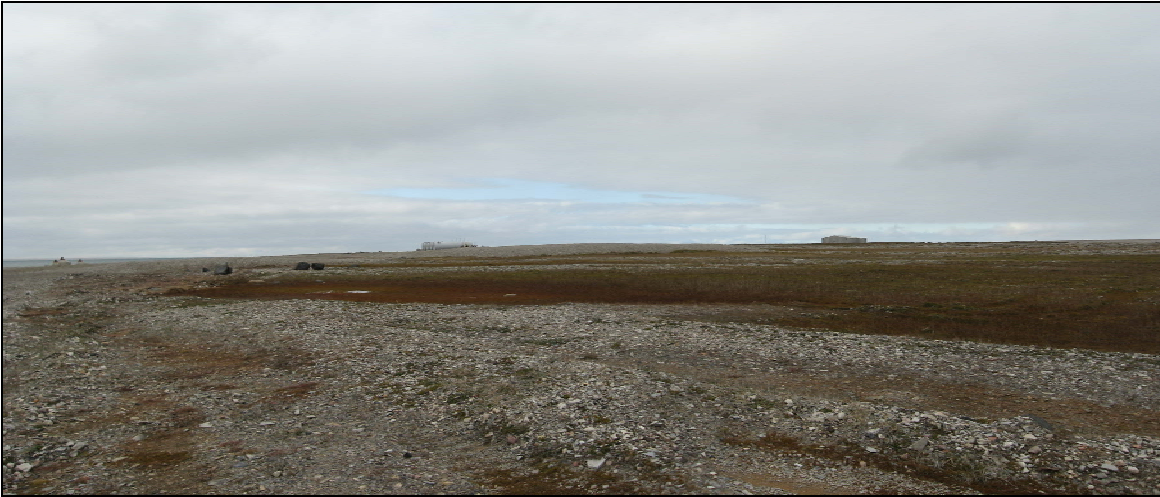
Photograph 19. South Landfill East Cell: Panoramic looking NNE over the upper surface of the landfill cover. Granular cover appears stable.↑

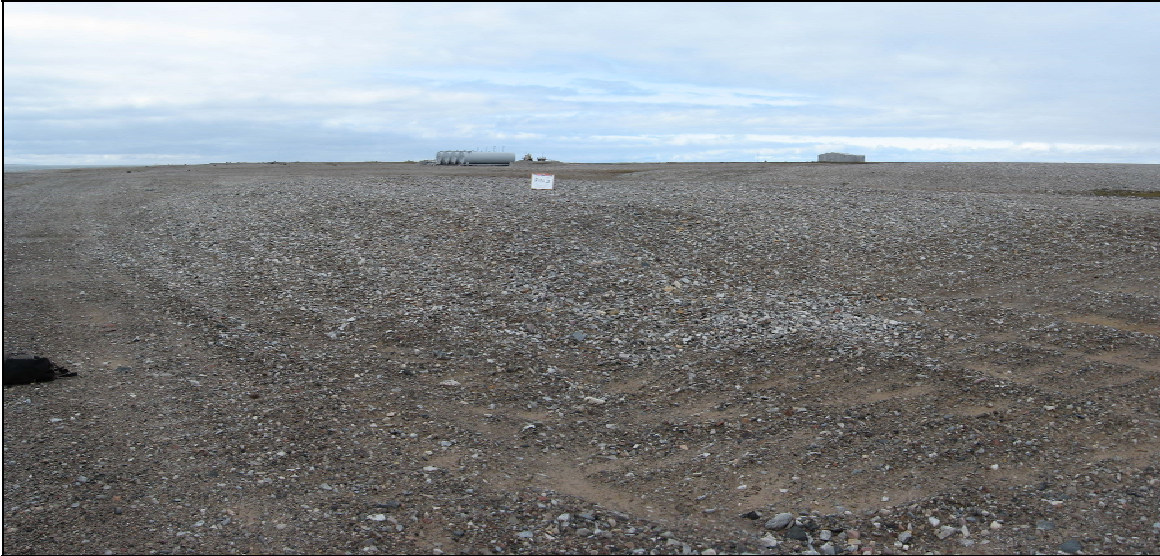
Photograph 21. South Landfill West Cell: Looking NW to the smaller southern lobe of the west cell. No indications of instability or degraded performance.↑

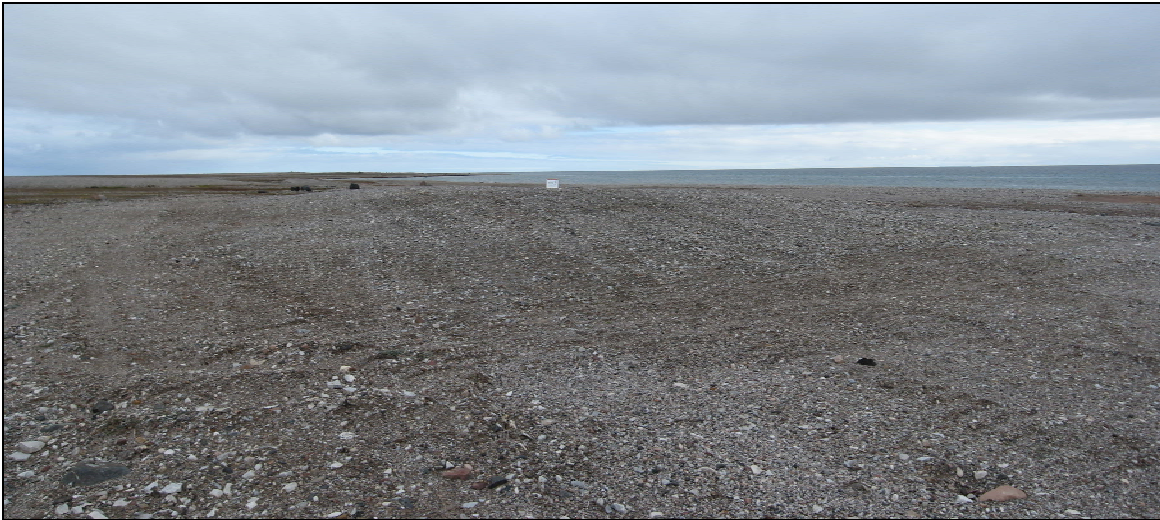
Photograph 22. South Landfill West Cell: Looking SE to the smaller south lobe of the West Cell. No problems noted.↑

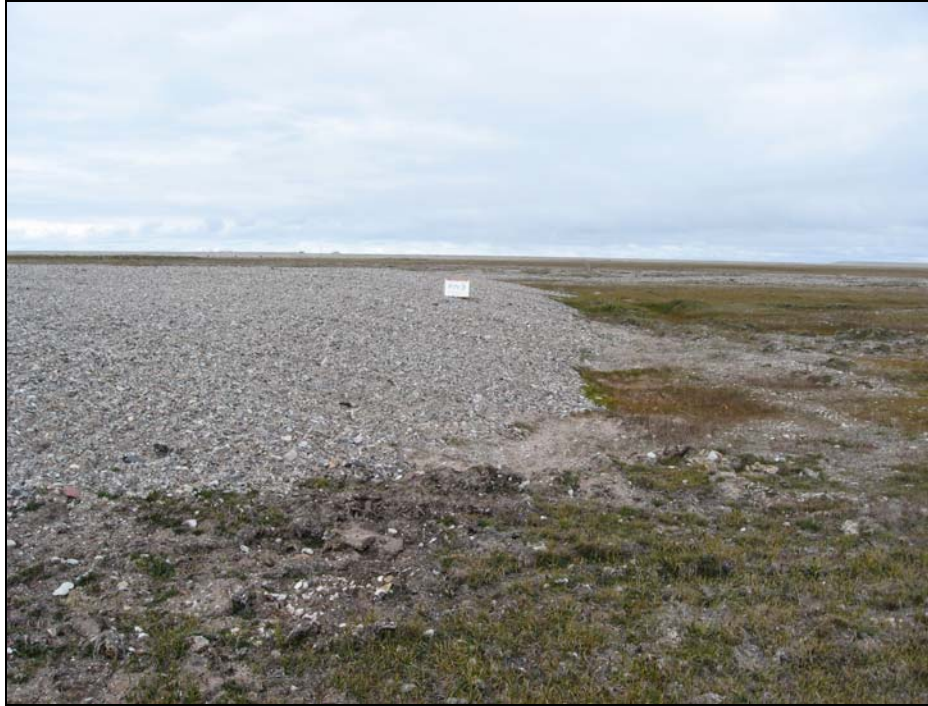
Photograph 23. South Landfill West Cell: Looking N along east side of the larger (northern) lobe of the West Cell. Displaced organics and some minor ponding, Staining along eastern toe.↑

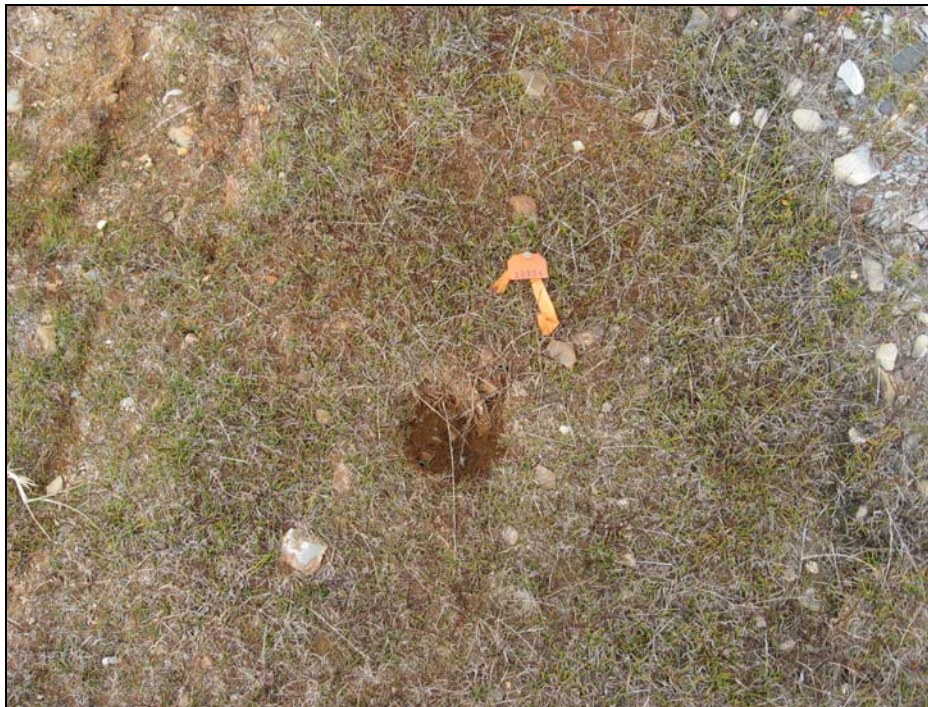
Photograph 24. South Landfill West Cell: Close up of staining adjacent to the southeast corner of the larger (northern) West Cell (Pin 12954 indicates sample previously collected). Now dry.↑

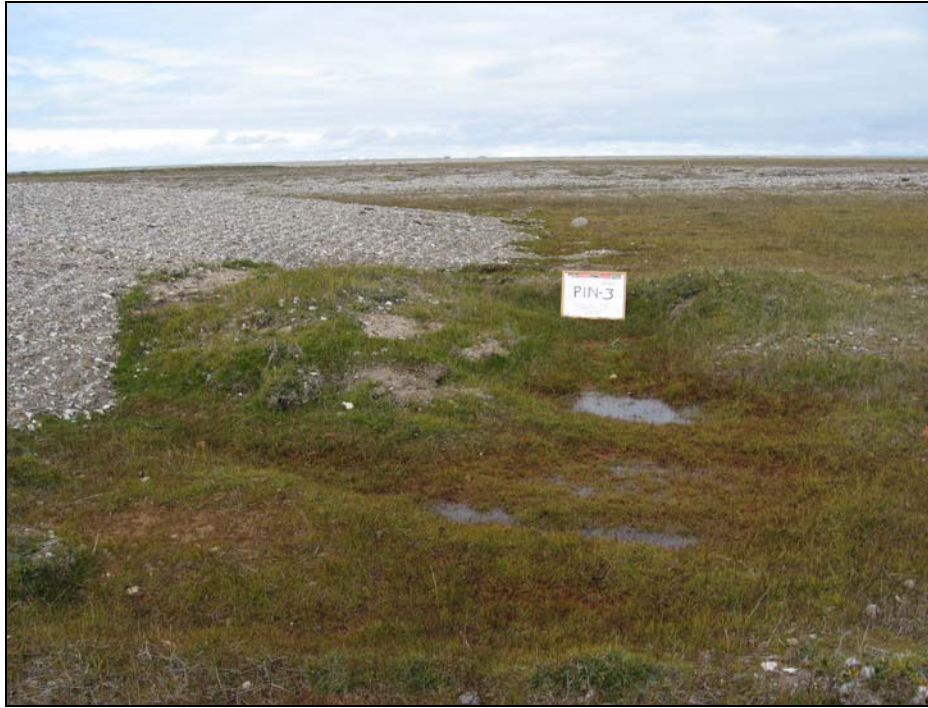
Photograph 25. South Landfill West Cell: Ponded water and staining along eastern edge of the West Cell. Pin 12958 and sample hole are located next to ponded water. Whiteboard for scale (61cm by 46cm).↑

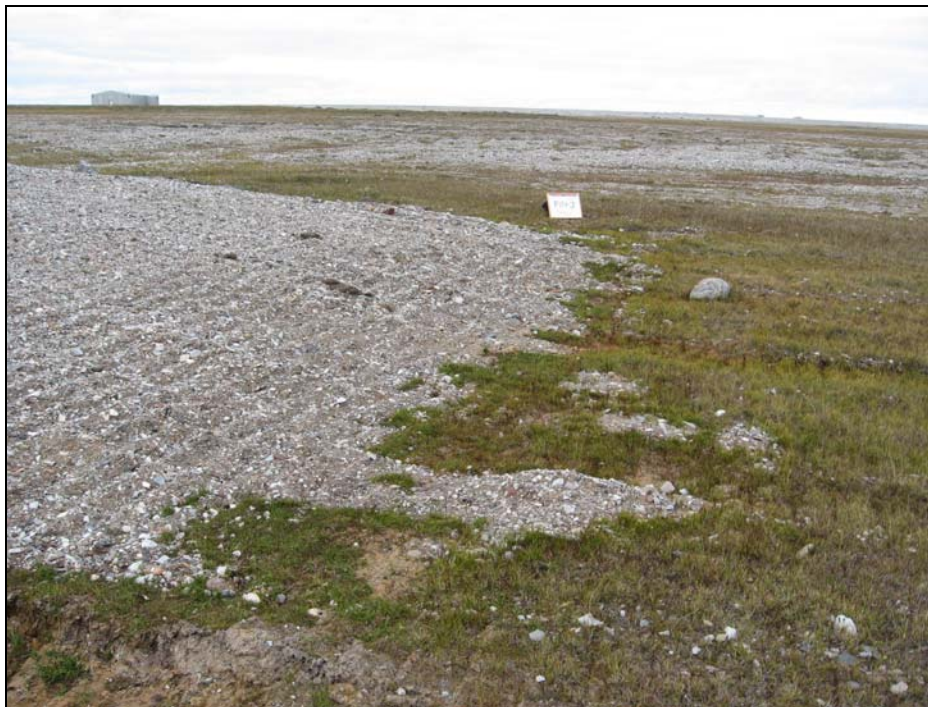
Photograph 26. South Landfill West Cell: Looking N to NE corner of larger northern lobe. Minor displacement of organics in vehicle ruts.↑

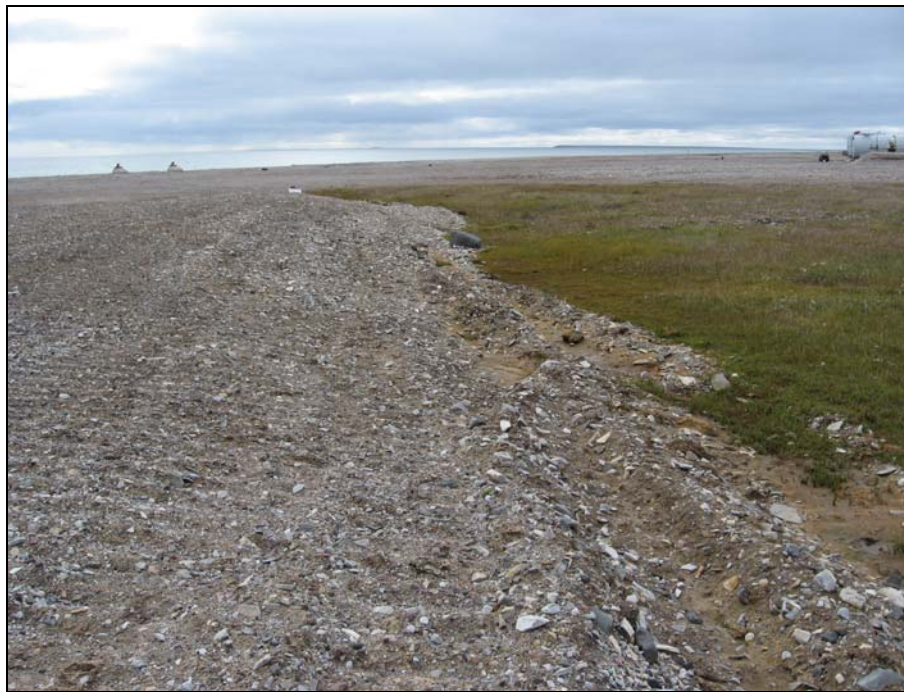
Photograph 28. South Landfill West Cell: Looking WSW along north edge of landfill cell. Heavy rutting, minor staining, indicative of periodic ponding. ↑

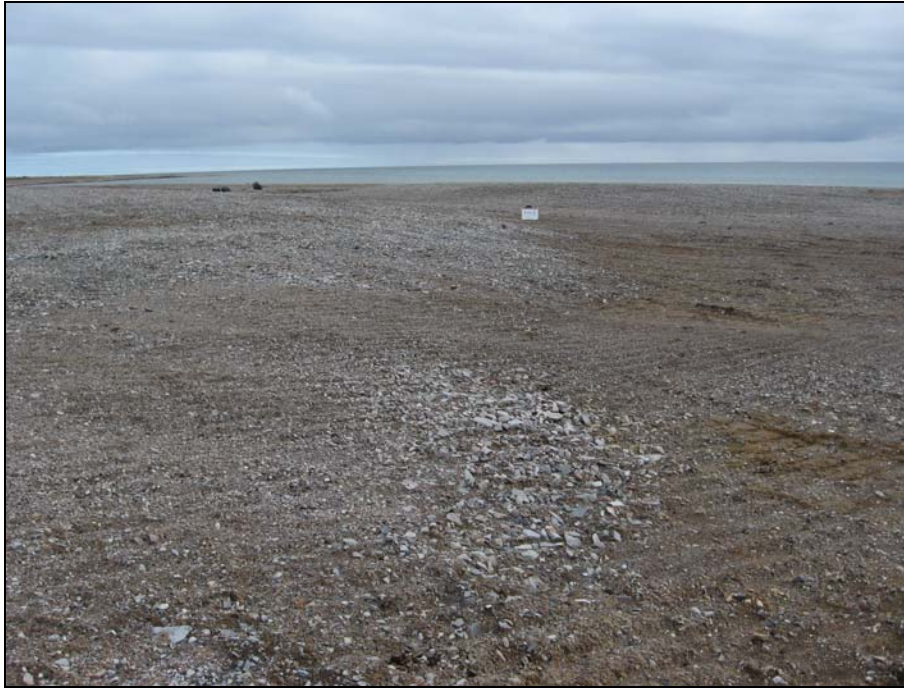
Photograph 29. South Landfill West Cell: Looking S along west sided of landfill cell. The granular cover appears stable. South lobe of the West Cell is visible in the in distance.↑

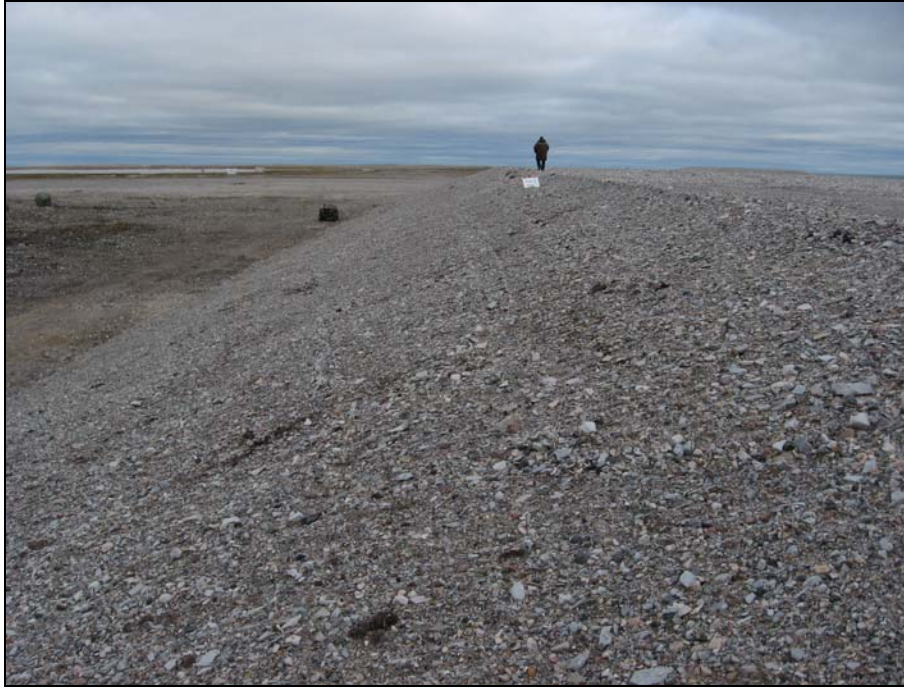
Photograph 3. Non-Hazardous Waste Landfill: Looking east from midslope NW corner. Slope appears stable with no indications of degraded performance.↑

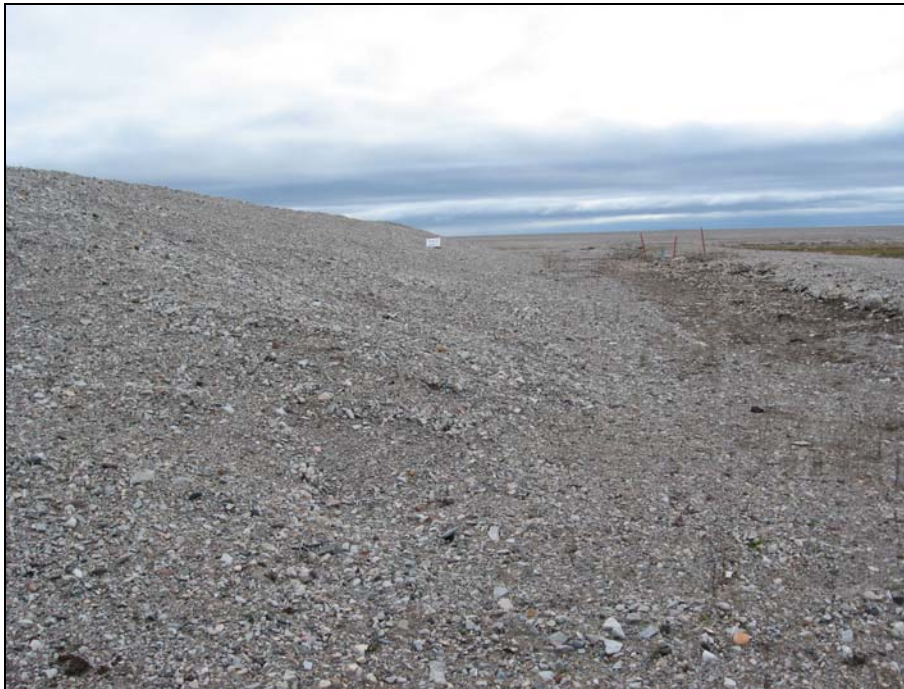
Photograph 6. Non-Hazardous Waste Landfill: Looking S along downslope toe of NW corner. Stable slope, minor irregularities in finish. The granular fill appears to be self armouring.↑

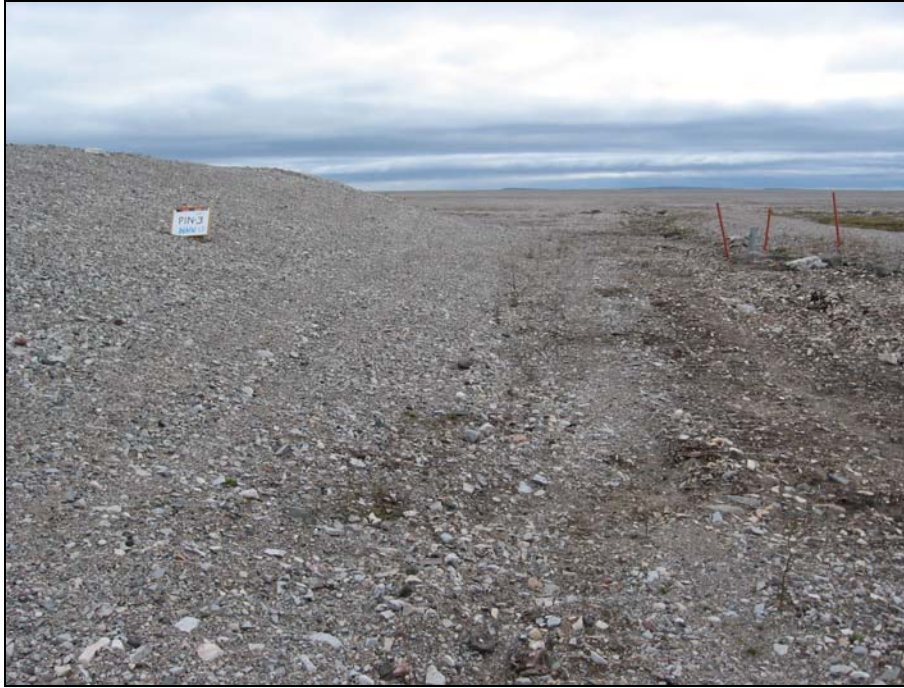
Photograph 7. Non-Hazardous Waste Landfill: Looking S along downslope toe mid-way along west side. MW-15 in the distance. Toe area is damp (organics present) but there is no clear evidence of seepage.↑

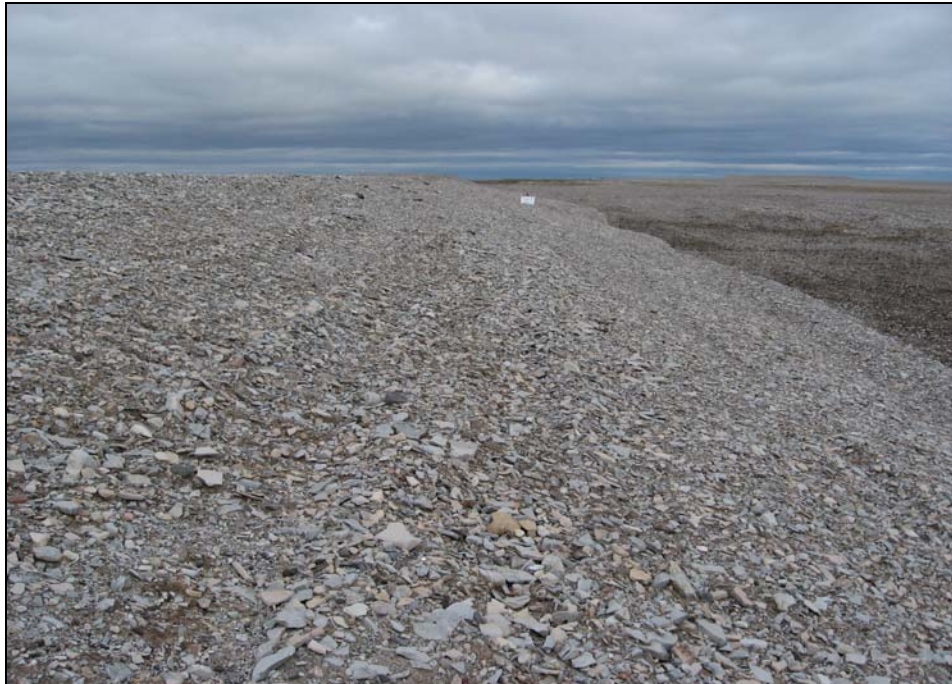
Photograph 10. Non-Hazardous Waste Landfill: South slope looking East to the SE corner from mid-slope, mid-way to corner. The slope has a slightly irregular finish and steepens (still gentle) downslope of whiteboard towards the toe of slope. Slope appears stable with no indications of degraded performance.↑

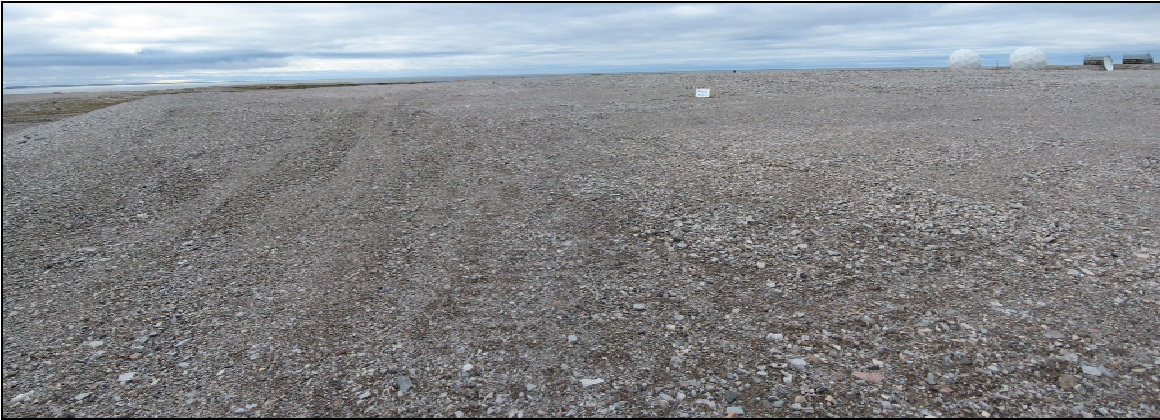
Photograph 12. Non-Hazardous Waste Landfill: Looking NE to toe of slope/access road interface from centre crest east slope. Slope abuts onto organic layer (darker area). No indications of instability.↑

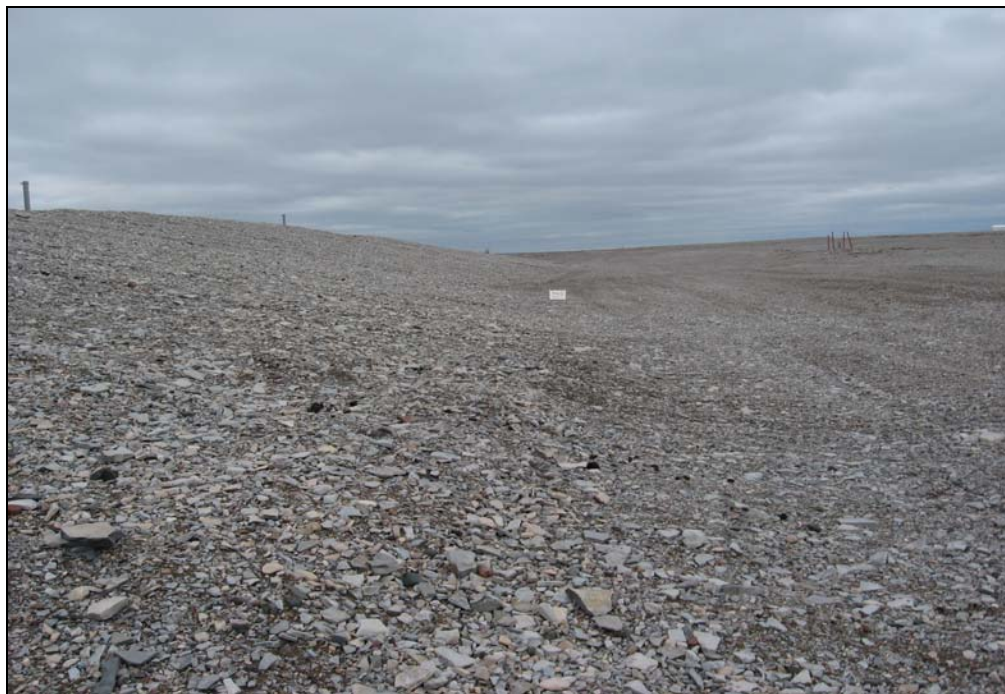
Photograph 2. Tier II Landfill: Looking west from NE corner along downslope north toe. Slope appears stable with no signs of cracking; however, inconsistent finished grade (undulations and vehicle ruts) makes it difficult to differentiate differential settlement from poor finish at the time of construction.↑

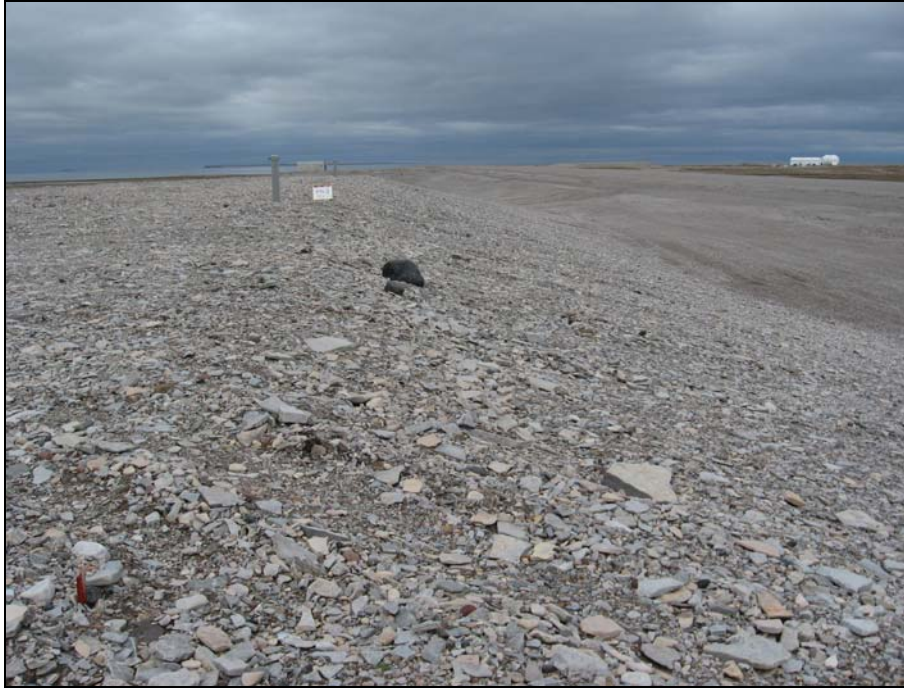
Photograph 3. Tier II Landfill: Looking west along crest from NE corner to VT-6. There is a 0.5m deep depression about 4m x 6m wide centred 4m NE of VT-6. Appears consistent with poor construction finish (i.e., not post construction settlement) but will need to be monitored.↑

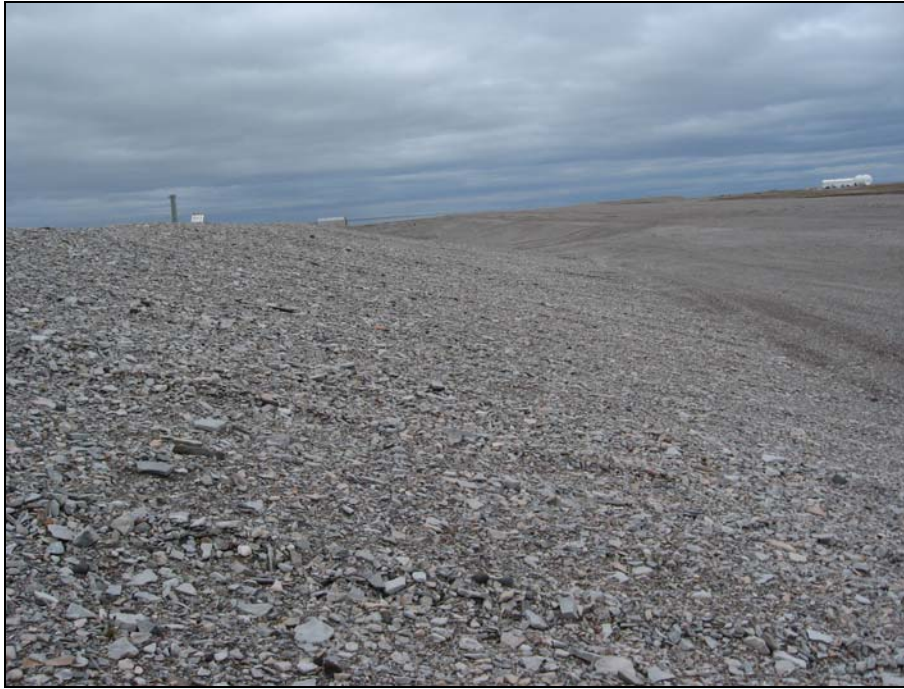
Photograph 5. Tier II Landfill: Looking west from mid-slope about 8m downslope of VT-6 looking to VT-5. Zone of depression noted downslope of VT-5.↑

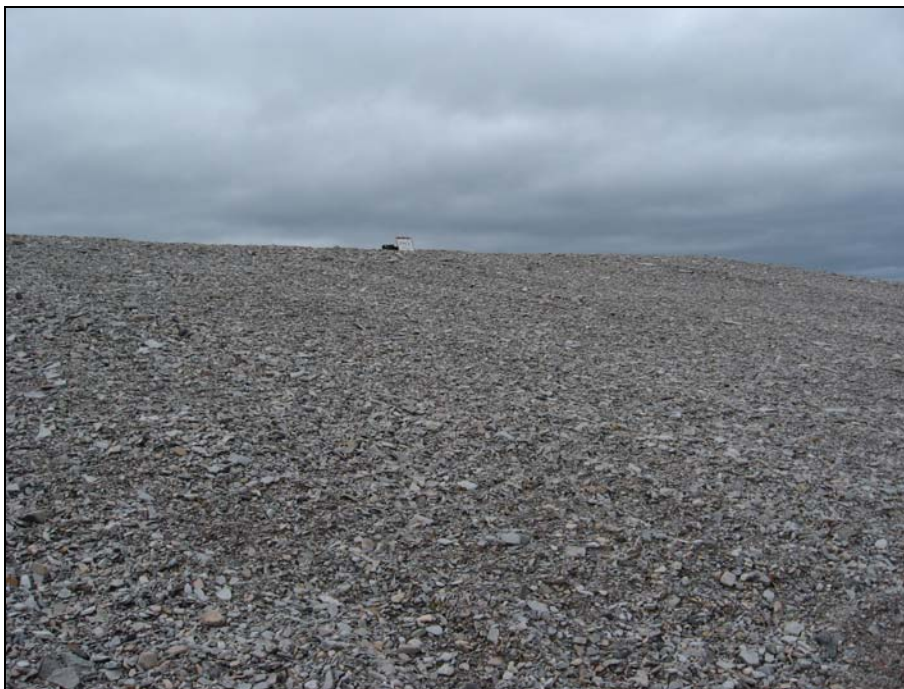
Photograph 6. Tier II Landfill: Looking SW from toe of slope towards area of depression adjacent to VT-5 along the upper slope.↑

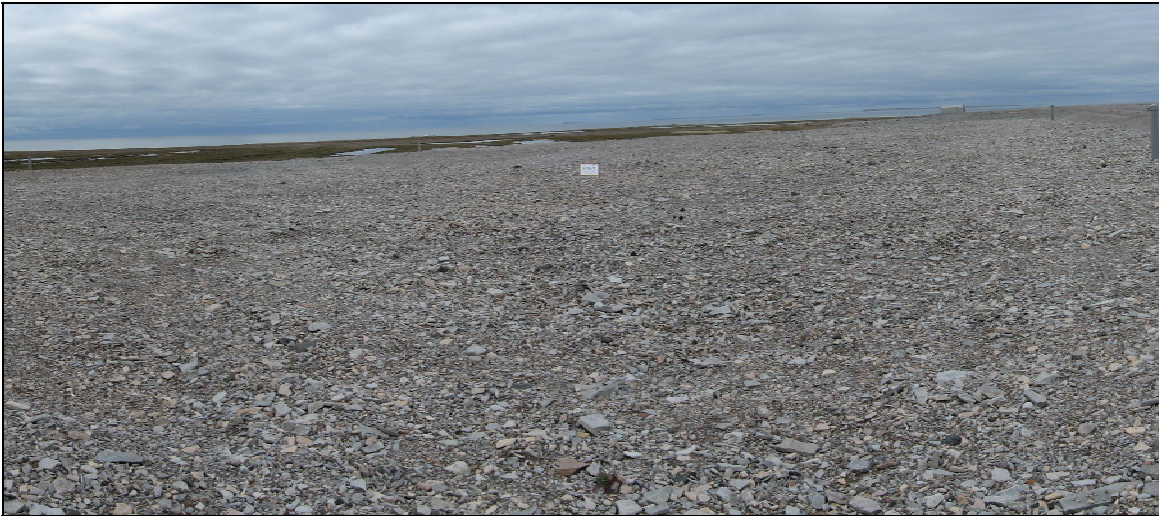
Photograph 22. Tier II Landfill: Panoramic of the top of the landfill viewed from the NE corner. There are no obvious indications of problematic conditions (e.g., significant differential settlement or slope movement). The seemingly irregular construction finish makes it difficult to observe minor changes.↑

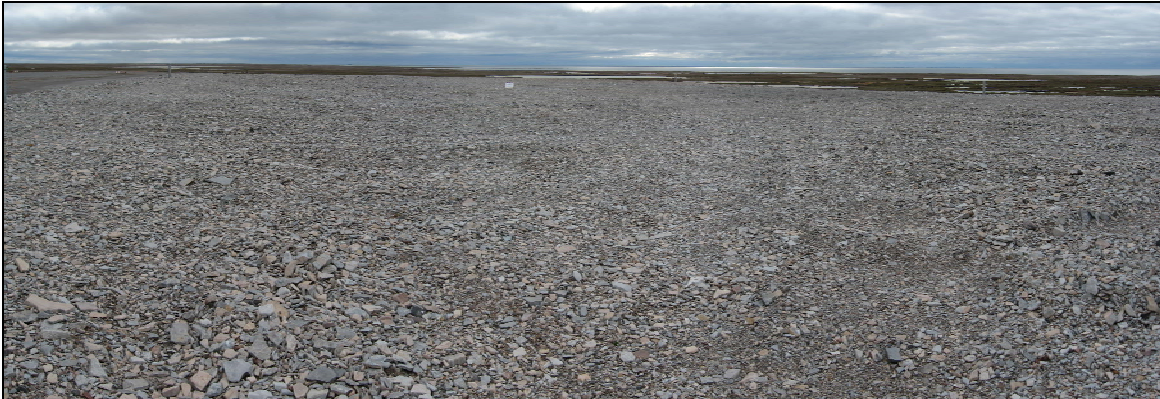
Photograph 23. Tier II Landfill: Panoramic view of top of Tier II landfill looking SE from near the NW corner. Note general undulation and inconsitent construction finish.↑
