**Abandonment and Restoration
Plan, Cambridge Bay Airport
Apron Land Treatment Unit,
Version 3**

Final Report

February 17, 2021

File No: 110220512

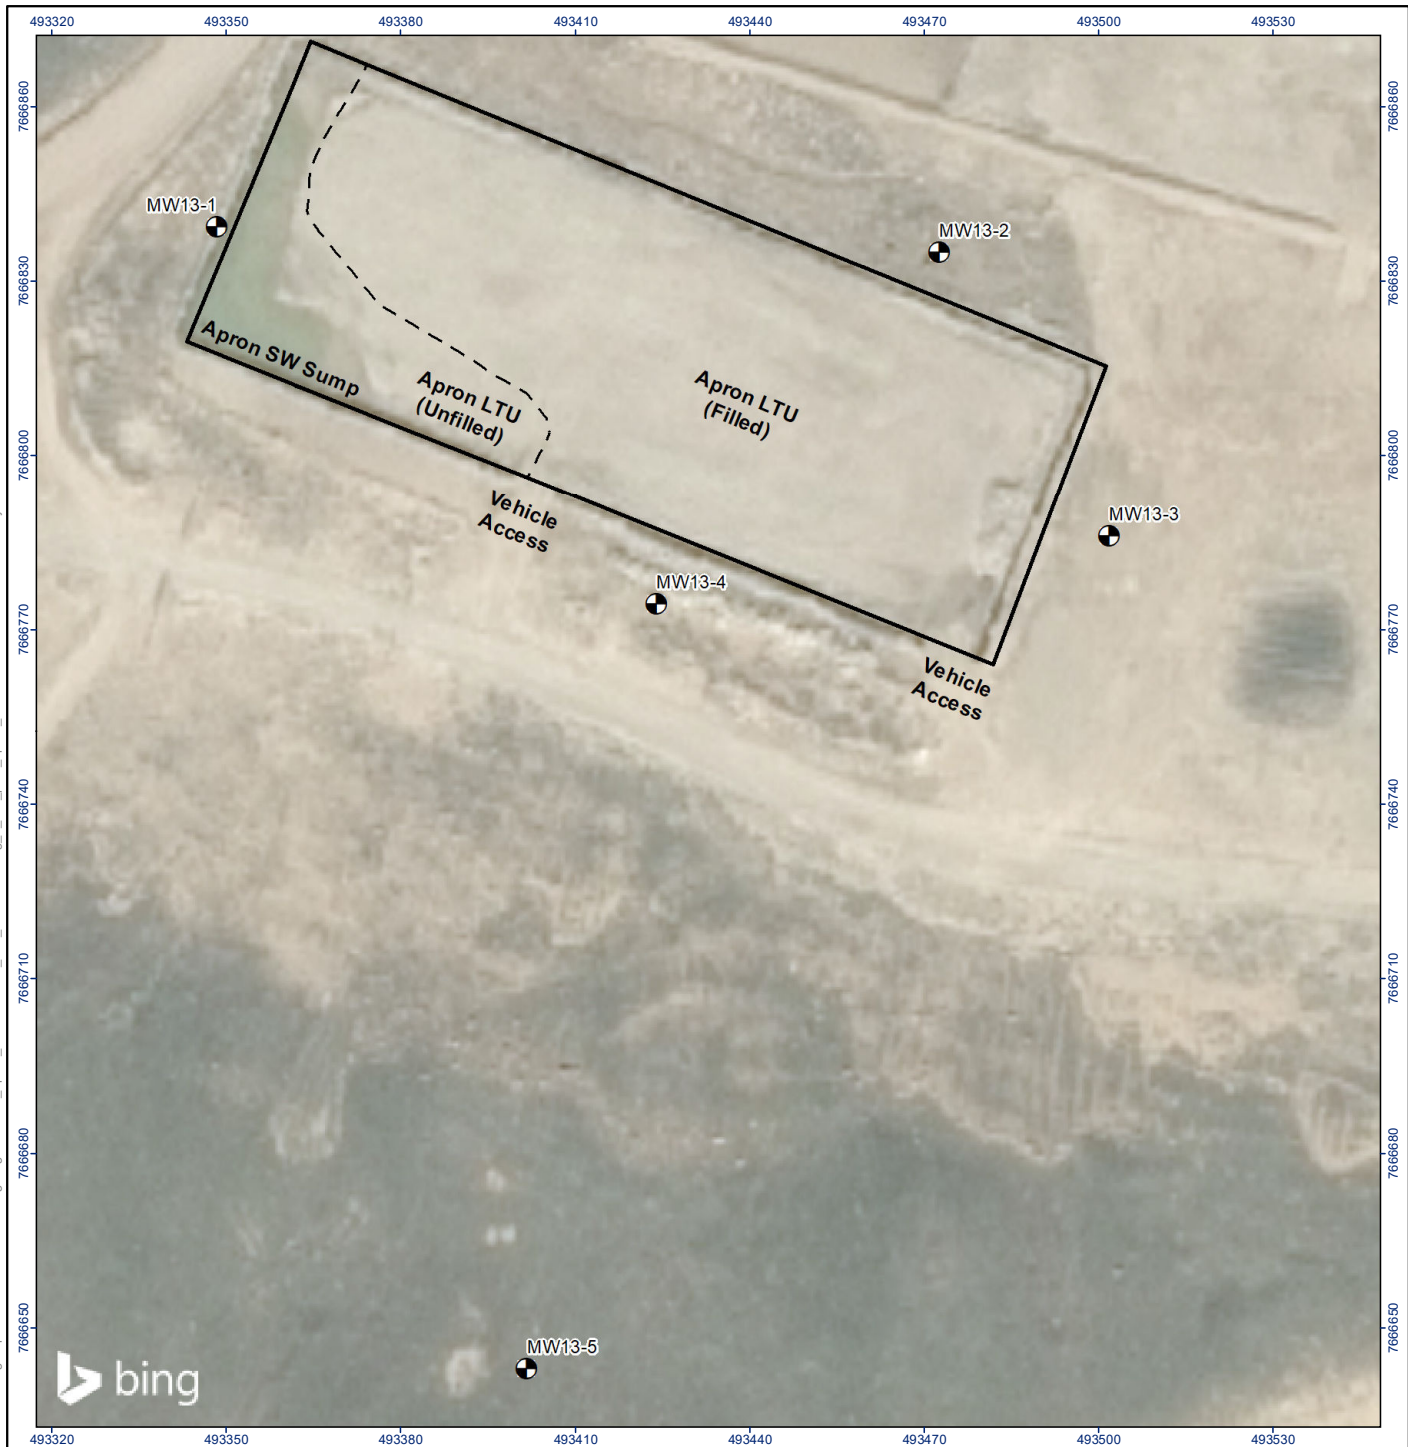
Site Plan of Apron LTU

The Apron LTU is located southwest of the northwest end of the CBA runway (Figure 2). The LTU is located in a developed area of the CBA which is restricted from public use. As the location of the Apron LTU is within the restricted area of the commercial/industrial property, the Apron LTU is not expected to impact the community, sensitive ecological areas or public and private water supplies. The area surrounding the airport is generally flat lying close to the roadside, with topography then sloping steeply towards the shoreline and West Arm of Cambridge Bay which is approximately 180 meters (m) south of the CBA.

The base of the Apron LTU was graded and covered with a 60-mil high-density polyethylene (HDPE) geomembrane liner to promote drainage of runoff and leachate towards the single sump location in the southwest corner and prevent infiltration of the contaminants from the soil into the groundwater. The liner was covered and compacted with a layer of granular material approximately 0.25 m thick. A berm, approximately 0.5 m above ground surface was constructed around the Apron LTU. Petroleum hydrocarbon (PHC) impacted soil was excavated from the Apron area and relocated to the Apron LTU in 2013. The impacted soil placed from the Apron excavation and residual material from the FTA LTU excavation has been spread uniformly across the Apron LTU liner at a depth of approximately 0.5 m. The as-built drawings of the Apron LTU are attached (Figure 4). At the time of construction, nine groundwater monitoring wells were installed surrounding the Apron LTU. Since 2014, landfarming activities including tilling, sump dewatering and recirculation, and soil sampling have been completed annually at the Apron LTU.

To address these impacts, a remedial action plan (RAP) was developed for the impacted soil at the Apron area that led to a recommendation for the construction of an on-site engineered land treatment unit (LTU). A permit was obtained from the Nunavut Water Board (NWB) in 2012, which allowed for the construction of the Apron LTU on the northwest corner of the CBA. In 2013, the Apron LTU was constructed and petroleum hydrocarbon impacted soil was excavated from the Apron area and placed in the LTU. The location of the Apron excavation area and the Apron LTU are shown in Figure 1 (attached). The Apron LTU covers an area of approximately 55 m by 143 m and contains approximately 4,000 m³ of soil. A site plan is attached as Figure 2.

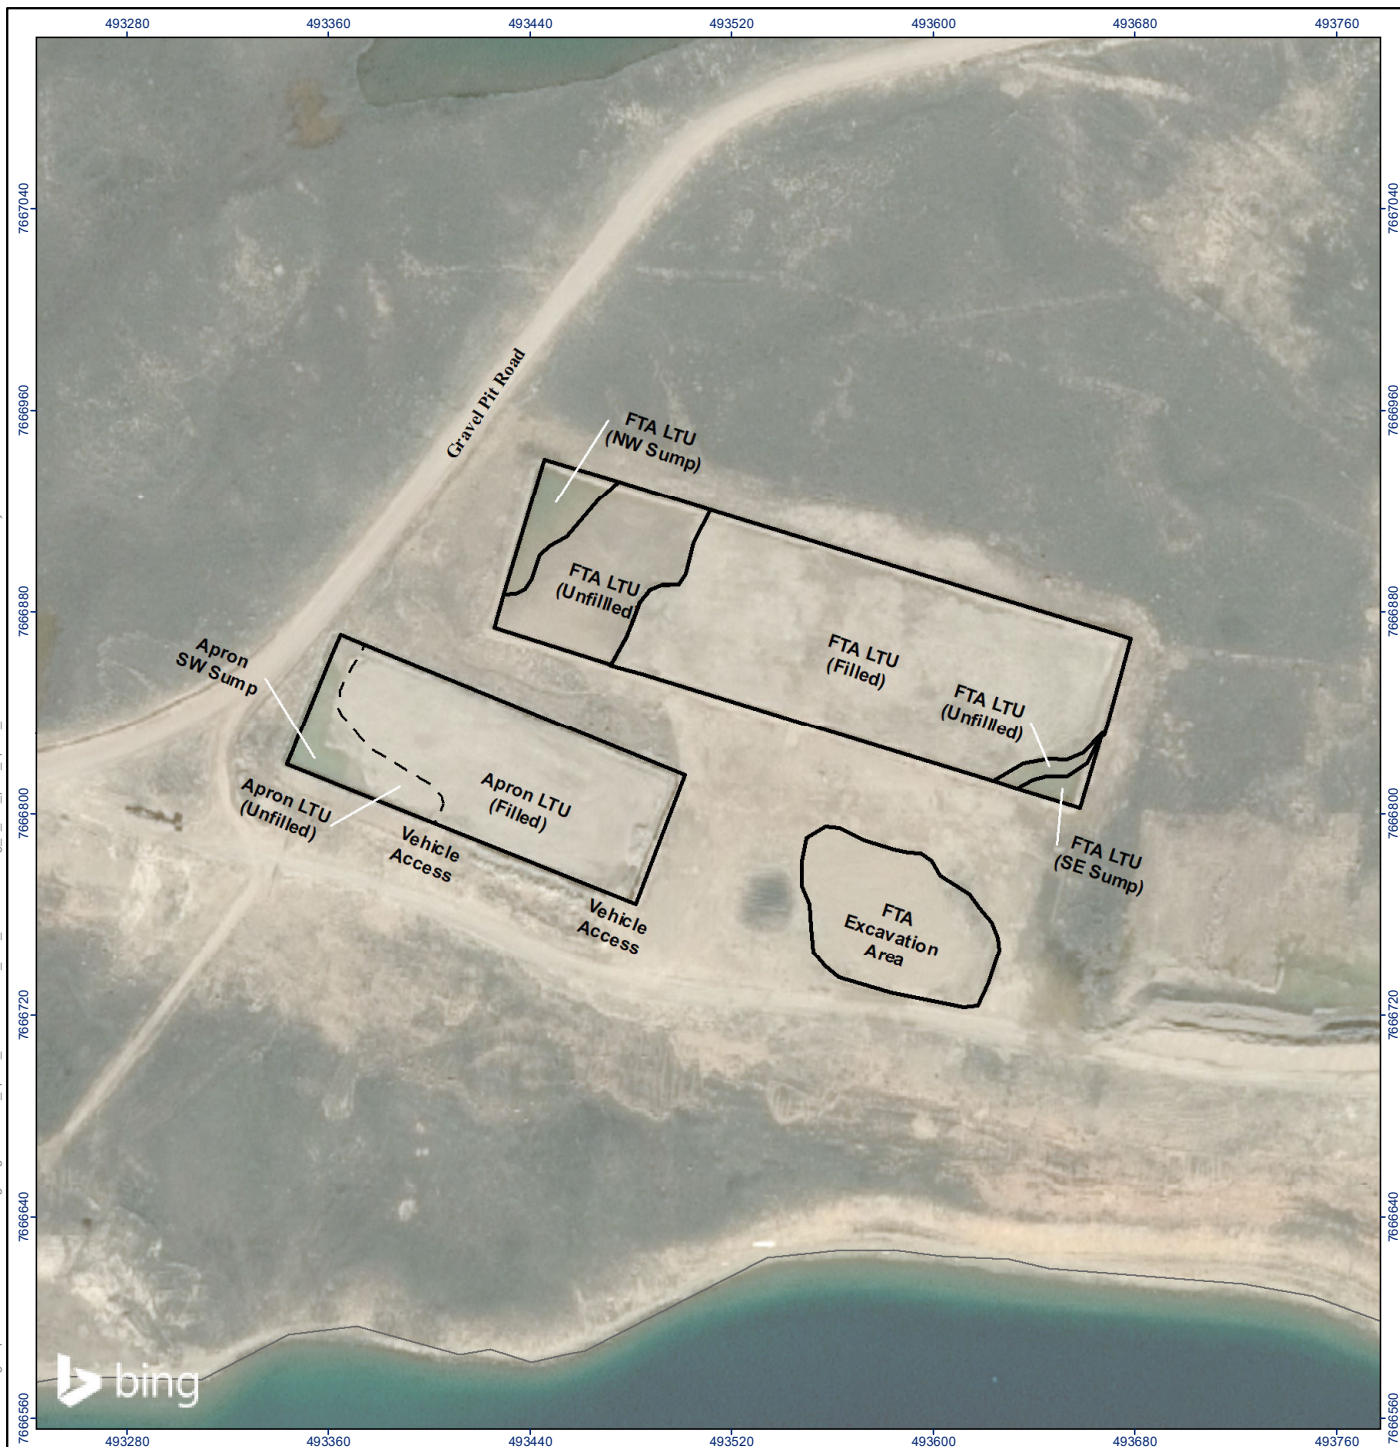
An additional LTU, the adjacent fire training area (FTA) LTU, was constructed in 2014 upgradient of the Apron LTU to receive impacted soils from the FTA excavation area (Figure 3). During the construction of the FTA LTU, a drum cache was discovered within the FTA LTU footprint. Approximately 560 m³ of impacted soil, originating from the FTA LTU excavation area, was stockpiled on the Apron LTU while the FTA LTU was being constructed. The drum cache material was spread out and mixed in with the existing Apron LTU soil in August 2015. In 2016, TC sampled soil and sump water from the Apron LTU for PFAS parameters. Following the identification of PFAS compounds in the Apron LTU soil and sump water, it was

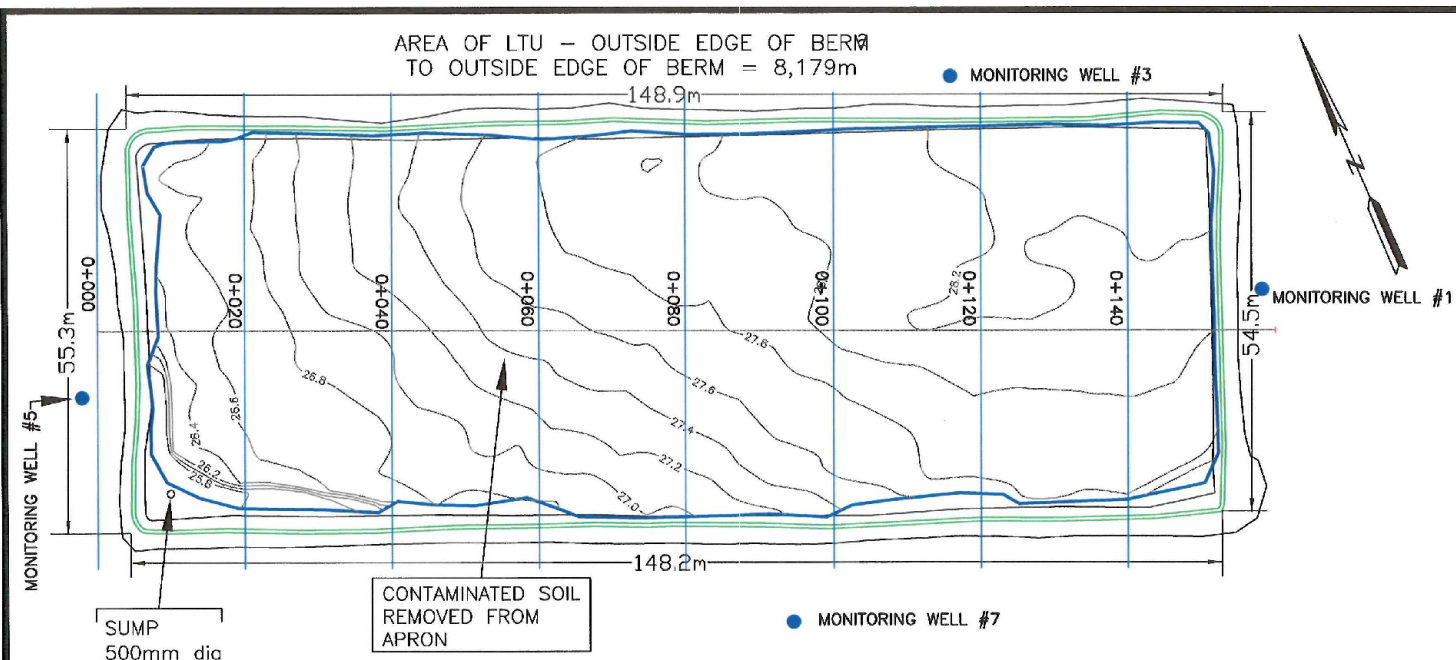
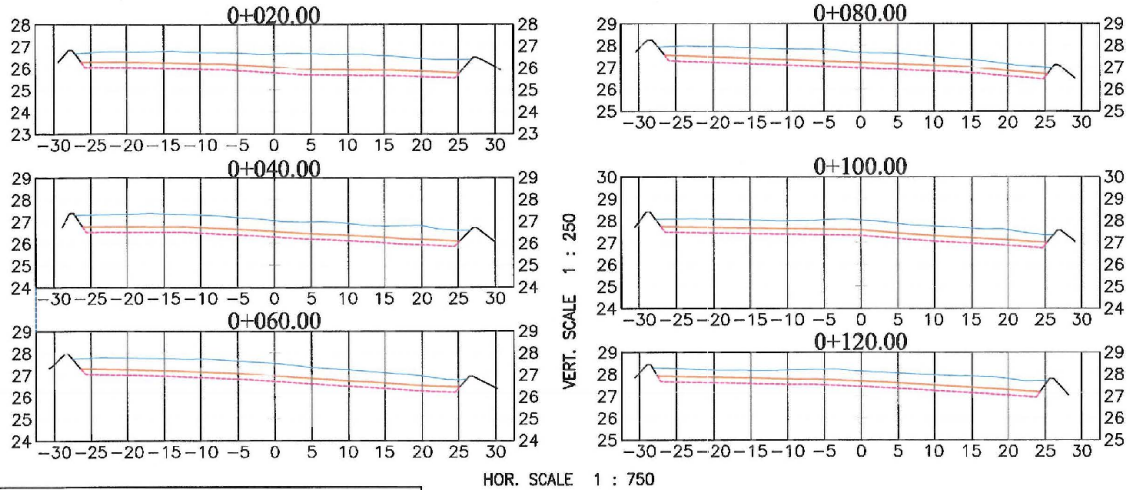
ASBUILT OF
LTU
CAMBRIDGE BAY AIRPORT
CAMBRIDGE BAY, NU

2. Drawing Source: Ollerhead and Associates Ltd., Pr. No. 13-86-NP, Certified on Nov. 21, 2013.
