Project Number: CAM-2 (3.6)

Re: 2005 Annual Report: Water Use License #NWB5GLA0308

UMA Engineering Ltd. is pleased to submit this annual report as per the requirements of Part B.1 of water use license NWB5GLA0308. The report was prepared on behalf of Defence Construction Canada and the Department of National Defence.

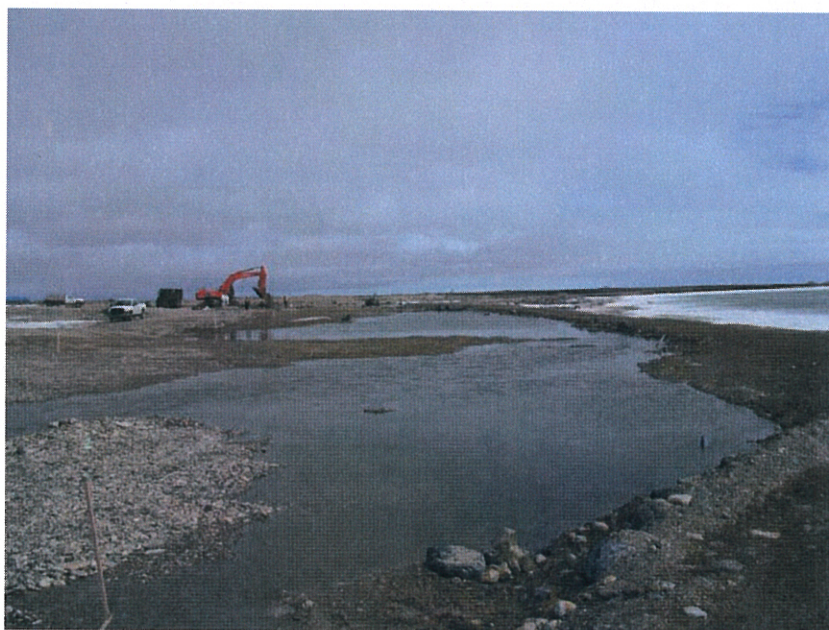
Photograph 1: Excavation work at the Airstrip Landfill. Note the water ponded in the excavation behind the berm and the proximity of the excavation to the ocean. Photograph taken June 27, facing east.

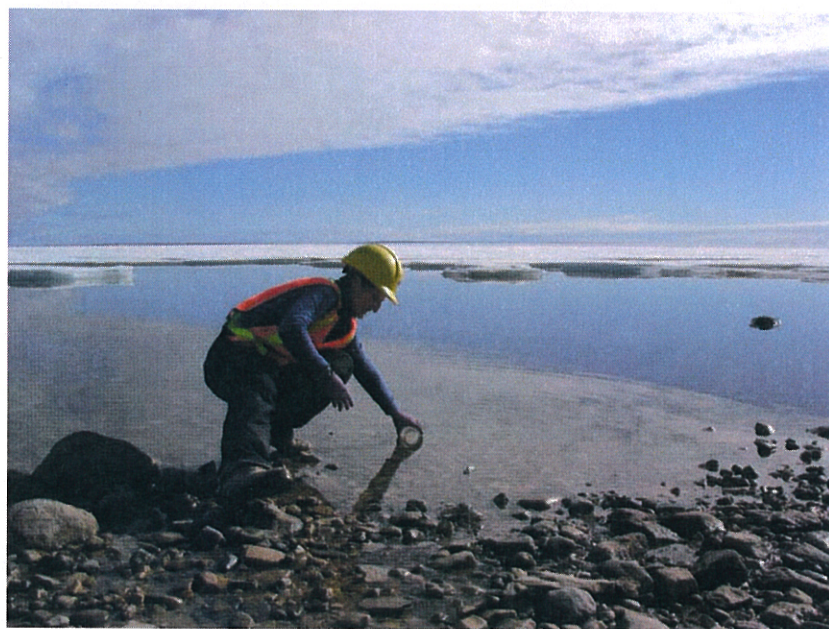
Photograph 2: Collecting an ocean water sample at the outlet of the discharge stream. Photograph taken July 3, facing south.

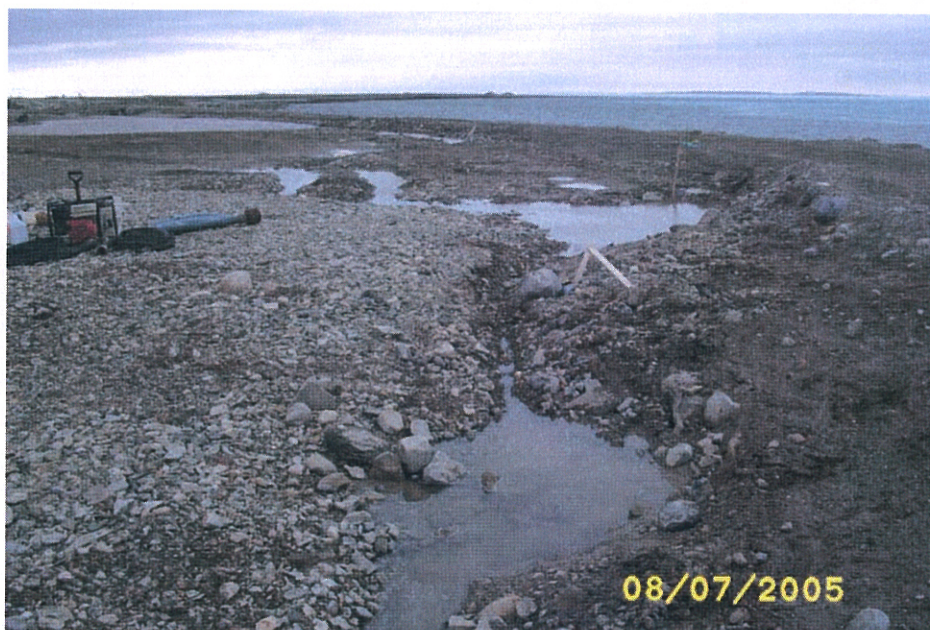
Photograph 3: The discharge stream after pumping and discharge of water in the pond. The pond is visible in the background. The ocean can be seen to the right of the berm. Photograph taken July 8, facing east.

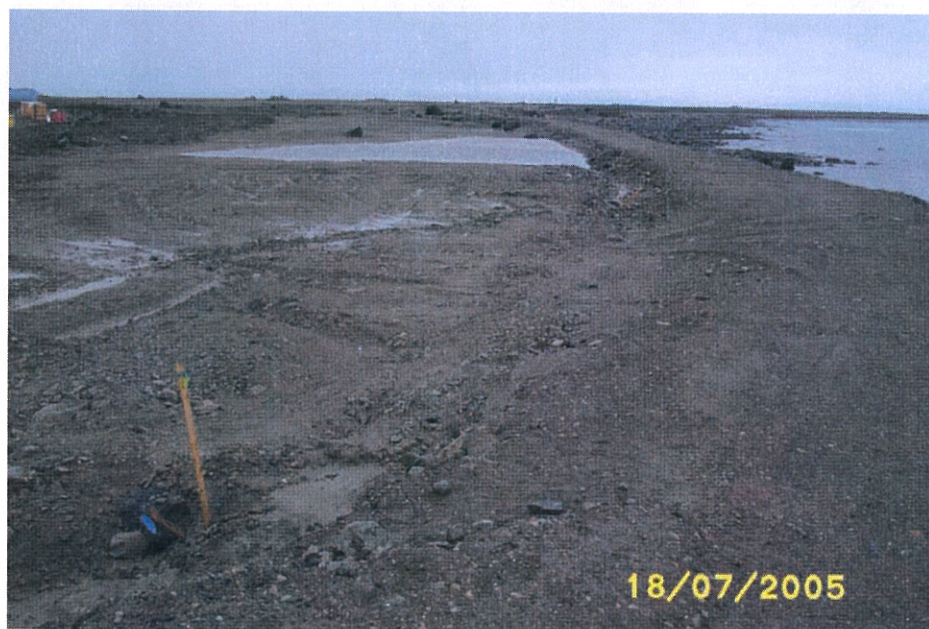
Photograph 4: The excavation after pumping. Note that the discharge stream is now dry. Photograph taken July 18, facing east.

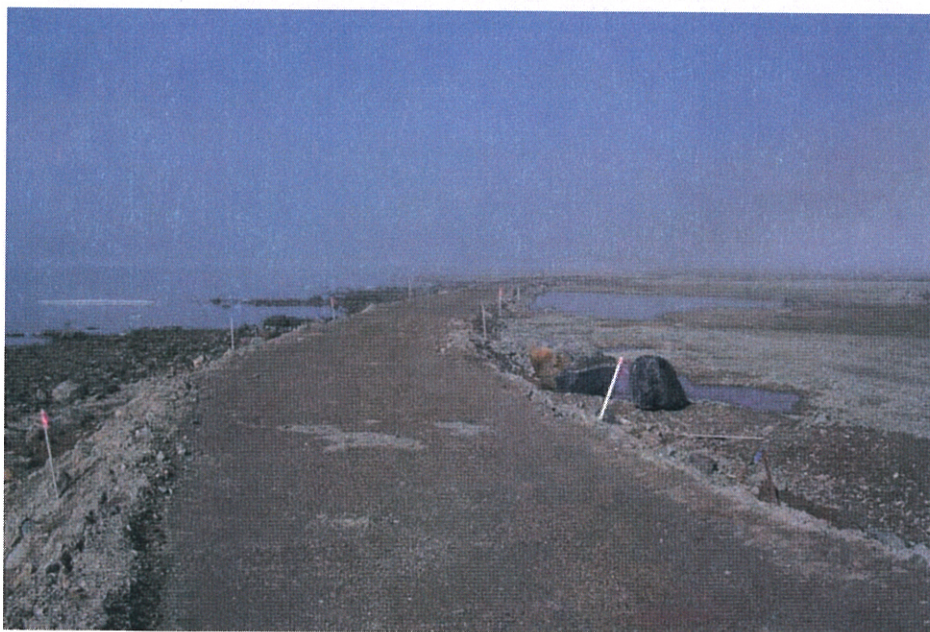
Photograph 5: View of the berm at the airstrip landfill excavation. Photograph taken July 28, facing west.

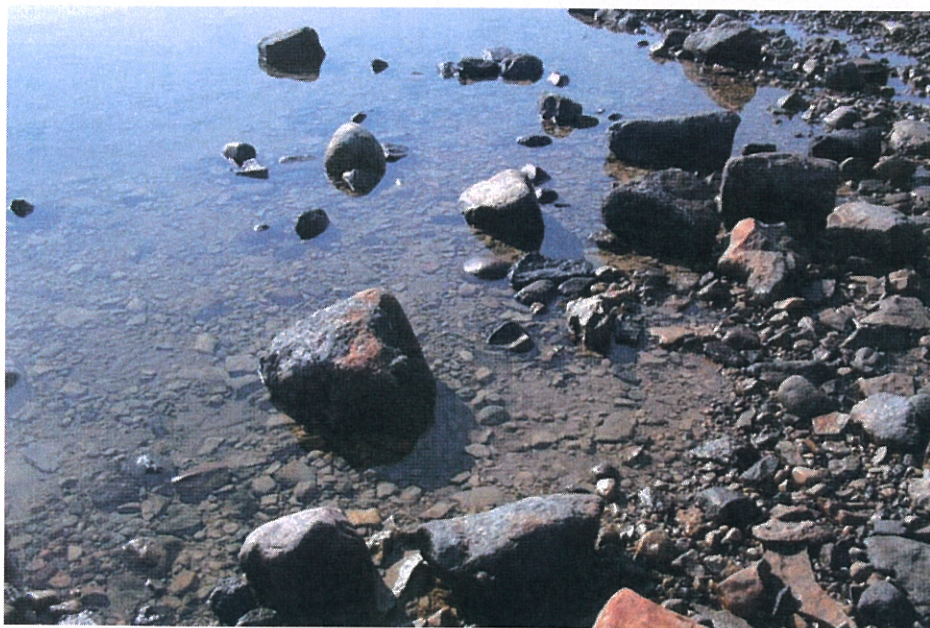
Photograph 6: View of ocean water after removal of the berm at the Airstrip Landfill. There is no visual evidence of TSS. Photograph taken Aug. 18, facing southwest.

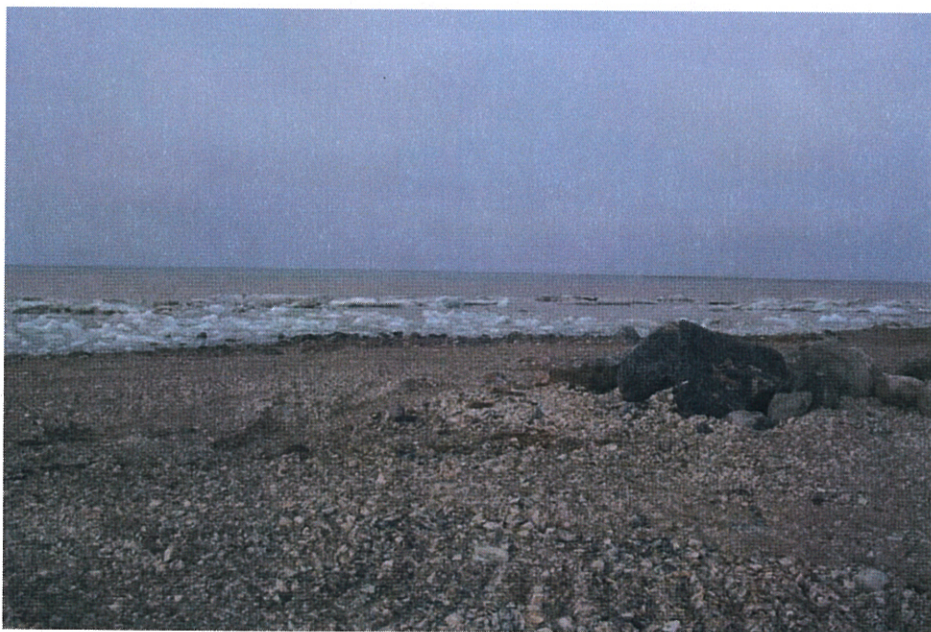
Photograph 7: Visual evidence of TSS in the ocean after a storm. Note the brown sediment plume extending approximately 100m from the shoreline. Photograph taken Aug. 29, facing southwest.

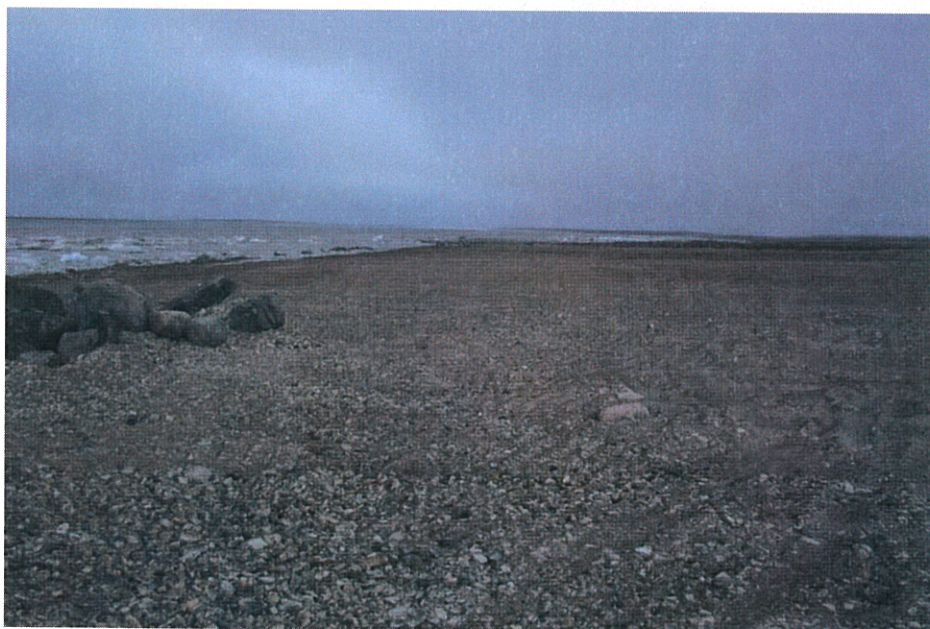
Photograph 8: The Airstrip Landfill after completion of excavation and backfilling. TSS after a storm event can be observed in the ocean at the time of this photo. Photograph taken Aug. 29, facing southwest.
