1. INTRODUCTION AND BACKGROUND

This report summarizes the cleanup activities that were accomplished at FOX-MAIN, Nunavut during the months of August and September of 2002. FOX-MAIN is a former Distant Early Warning (DEW) Line site situated near the community of Hall Beach, Nunavut and is currently operated by the Department of National Defence (DND) as a North Warning System Logistical Support Site. The beach refuel area at FOX-MAIN was classified as a due diligence issue in need of immediate attention due to the potential for a release of hydrocarbons into the marine environment.

The following report summarizes the work accomplished at FOX-Main in 2002 that was contracted to Mosher Engineering Ltd. of Halifax, Nova Scotia. The goal of the work was to remediate the beach refuel area of FOX-MAIN in accordance with the plans and specifications. The goal was successfully achieved and the details of this work are presented below.

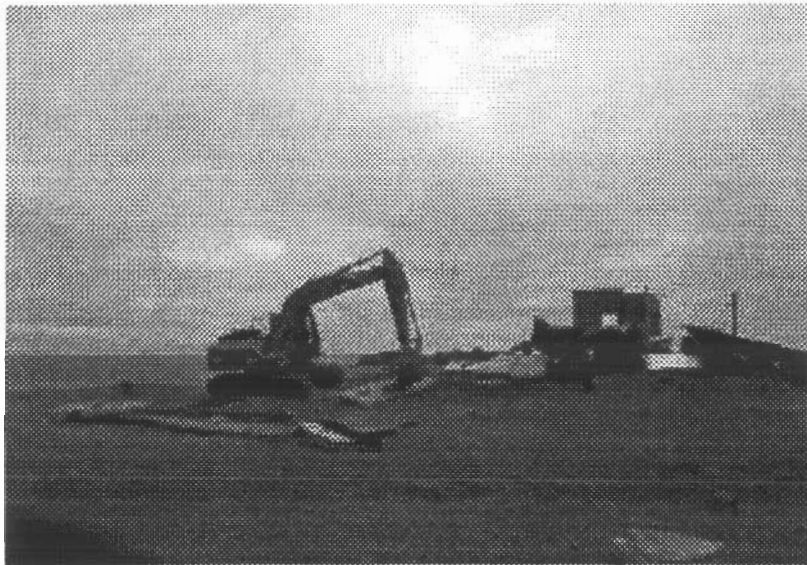
Photograph 1: Beachmaster's shed demolition

Three abandoned power poles, and various pieces of surface debris, ranging from random pieces of wood and plastic to a metal barge, metal pallets and metal storage bins were removed and stored in the existing retrograde storage area. The concrete pads and the existing beachmaster's shed were demolished and the material stored in the retrograde storage area.

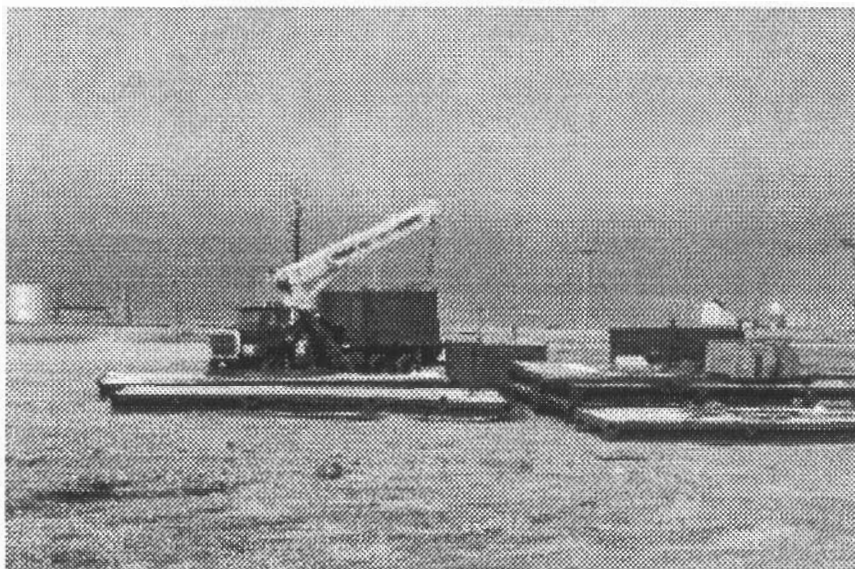
Photograph 2: Debris Removal

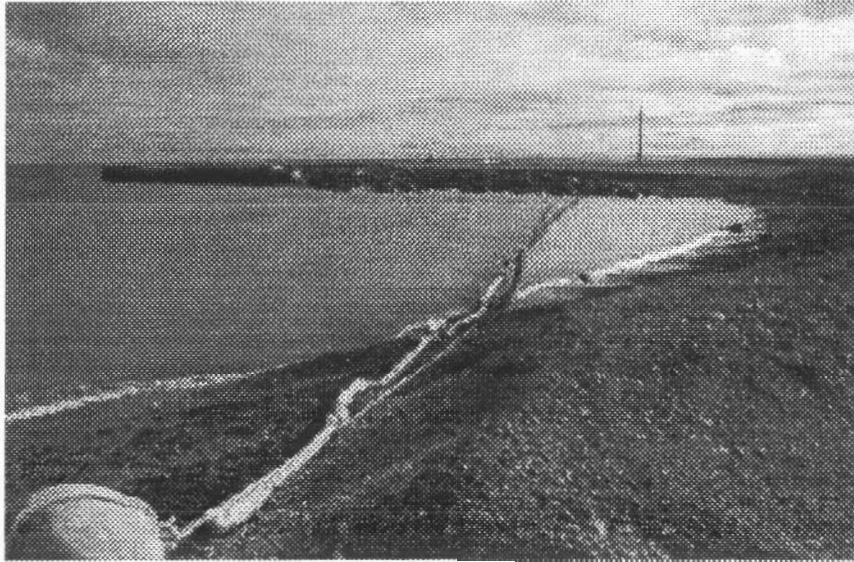
Picture 3: Sorbent Booms and Silt Curtain

During the work at the beach refuel area, sixty five meters of absorbent booms and sixty five meters of a two meter high silt curtain were installed in the water north east of the work area, stretching from the pier across to the beach. A temporary 0.5 m high berm was constructed above the high tide

mark along the shoreline and following the shoreline's contour. See Photos 3 and 4 in Appendix B.

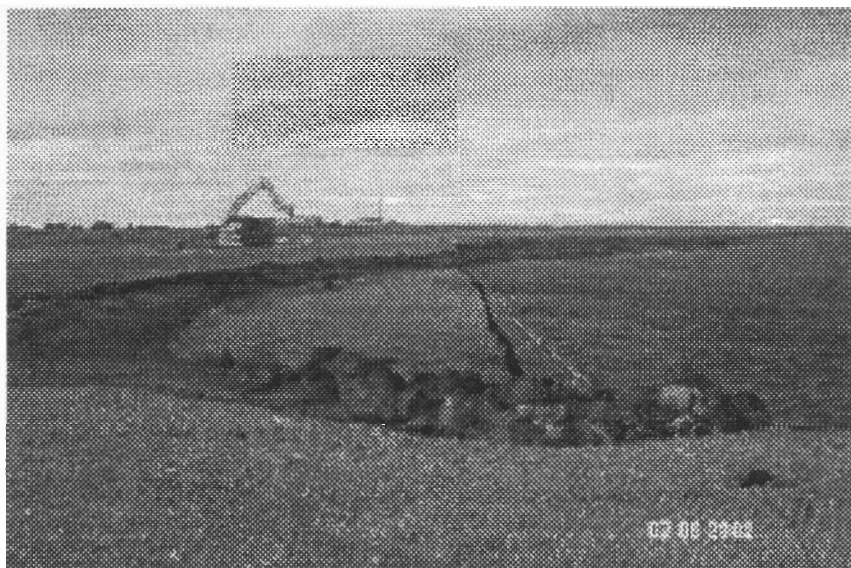
Photograph 4: Sorbent Booms and Silt Curtain

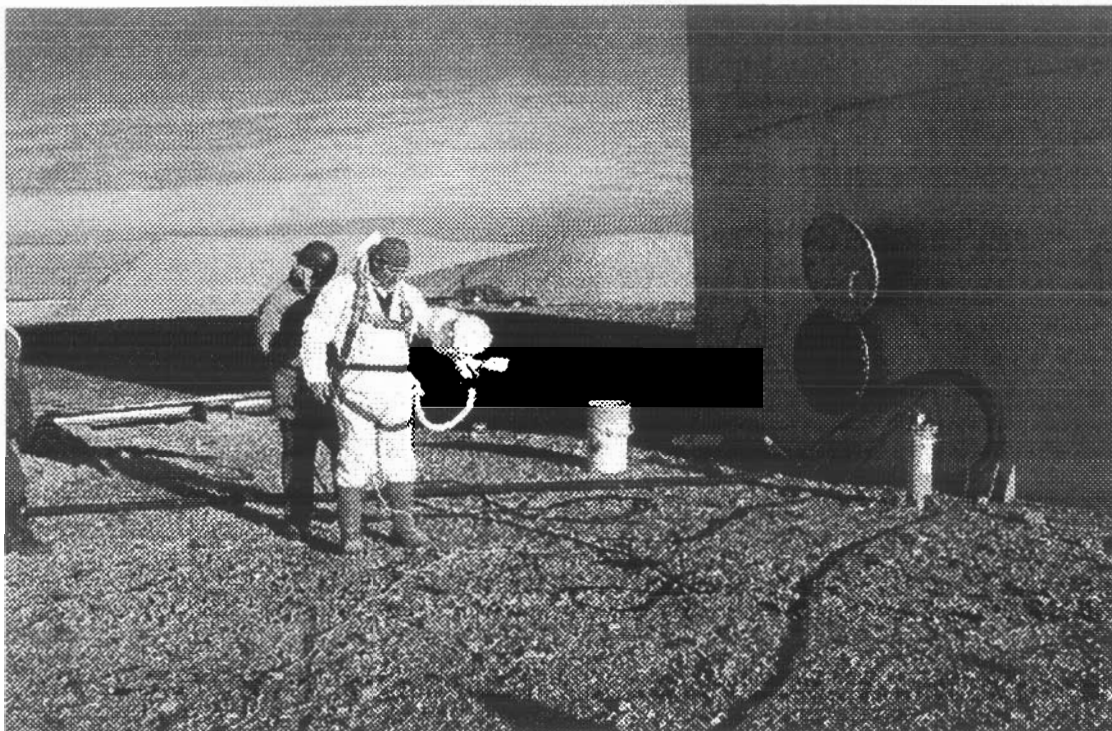
Photograph 5: Tank Cleaning

Tank W22G was cleaned and was used to store the water that resulted from the dewatering of ponded contaminated areas during the excavation. The sludge removed from Tank W22G due to the cleaning has been stored in tank W22F.

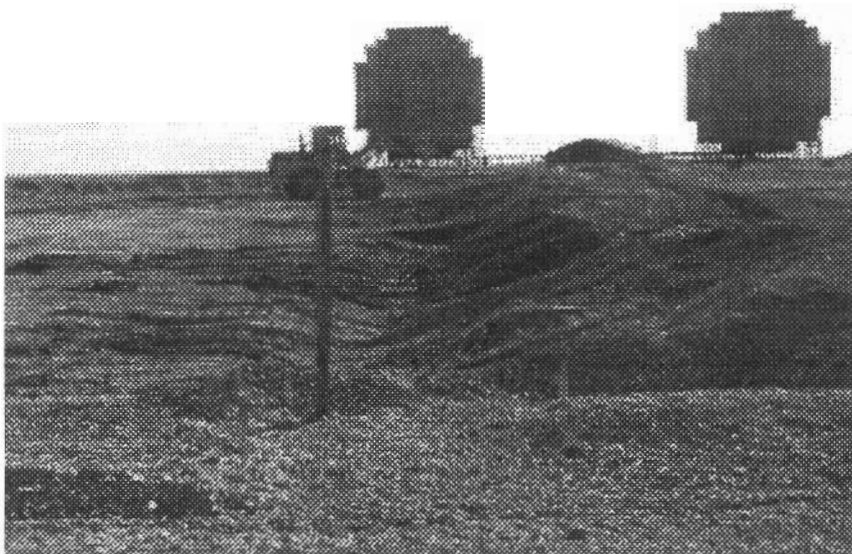
Photograph 6: Hydrocarbon Secure Storage Area ditch digging

A 21 642 m² area of land north of the communications area was leveled off to provide a uniform surface for use as a secure storage area for the Hydrocarbon Type B contaminated soil. It is approximately square in shape and is enclosed on all sides by a 0.6m deep ditch with a slope of 1:3 and is surrounded by a one meter high perimeter berm with 1:3 side slopes and a 2 meter width at the top.

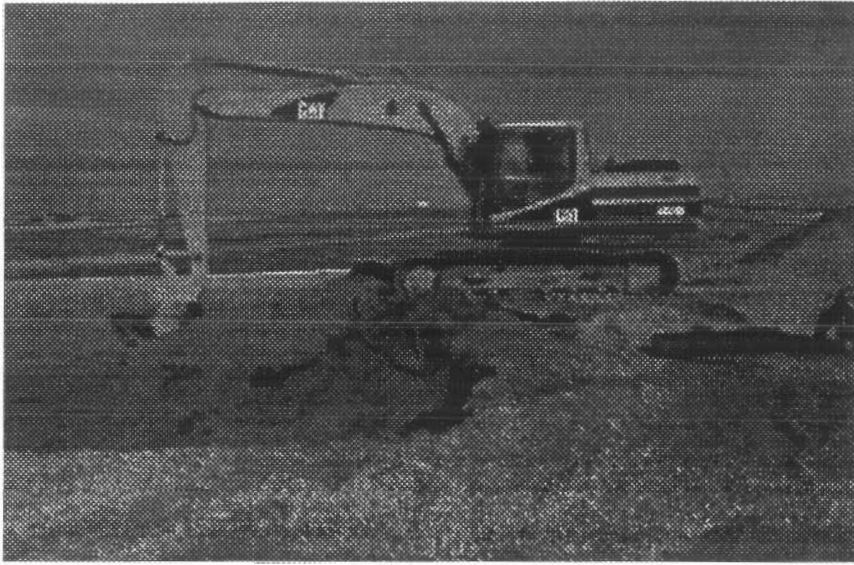
Photograph 7: Soil Excavation

The Hydrocarbon Type B Contaminated soil was excavated to the depths noted in the plans and specifications. The Hydrocarbon Type B was excavated to the limits noted in the drawings and specifications except for the area on the eastern edge, which is below the high tide mark. This section was excavated up to the temporary berm. It was also decided with SGE Acres that the Hydrocarbon Type B would only be excavated to within one meter on all sides of the existing refuel lines to ensure no damage to the lines.

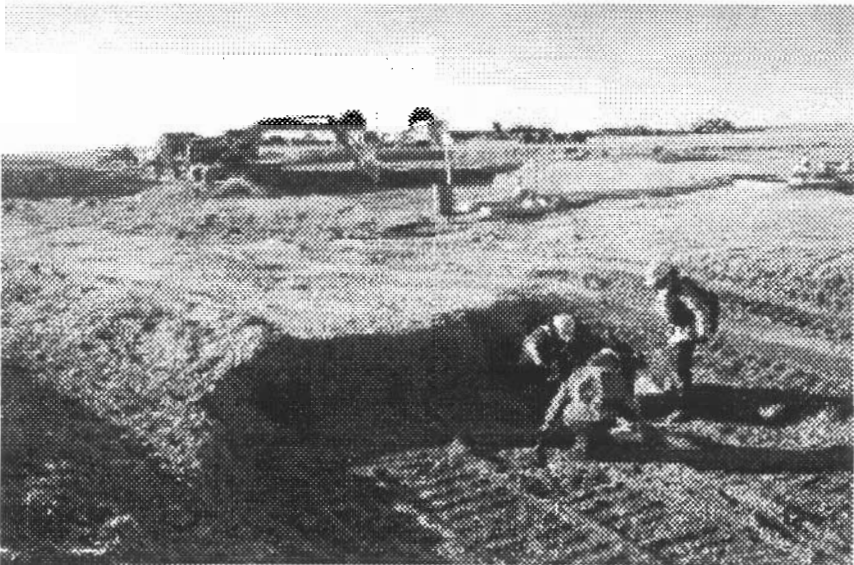
Photograph 8: Confirmatory testing

Confirmatory testing of the limits of all excavated areas was completed by the ESG prior to backfilling with borrow material to confirm that the contaminated soil has been removed. Additional areas discovered at the site that were not excavated this season will be delineated by the ESG. This work will be performed during the full site cleanup of the FOX-M Site.

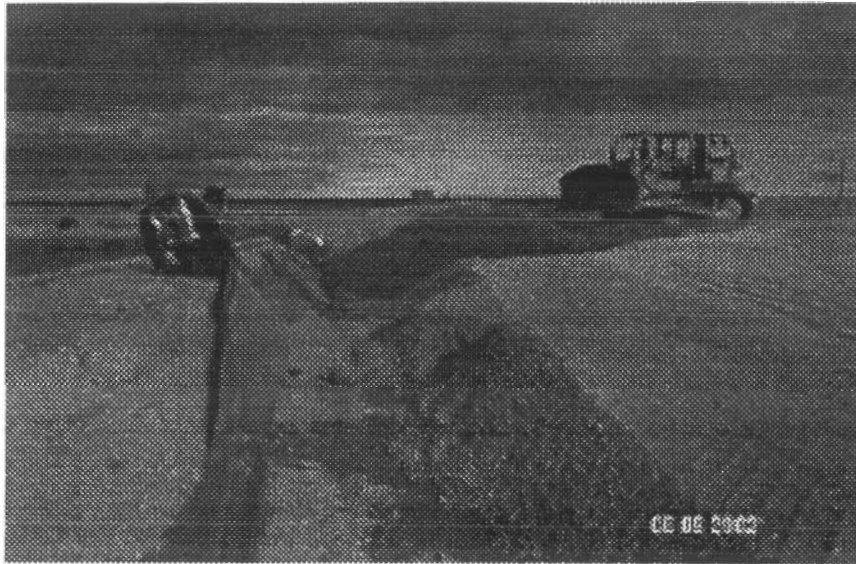
Photograph 9: Installation of Geomembrane around refuel lines

Before backfilling, the PVC Arctic Liner Geomembrane was installed on both sides of the refuel lines to separate the hydrocarbon contaminated soil that was not excavated from the clean backfill material.

The PVC Arctic Liner Geomembrane was also installed along the eastern limits of the excavation before backfilling as per the onsite agreement between Wade Cumins, Enforcement Officer, Northern Division, Environmental Protection Branch, Environment Canada, and Nick Monteiro, Associate Project Manager, DEW Line Cleanup, Defence Construction Canada, on September 10, 2002. Refer to the attached as-built and Photo 9 and 10 for the locations of the geomembrane installation.

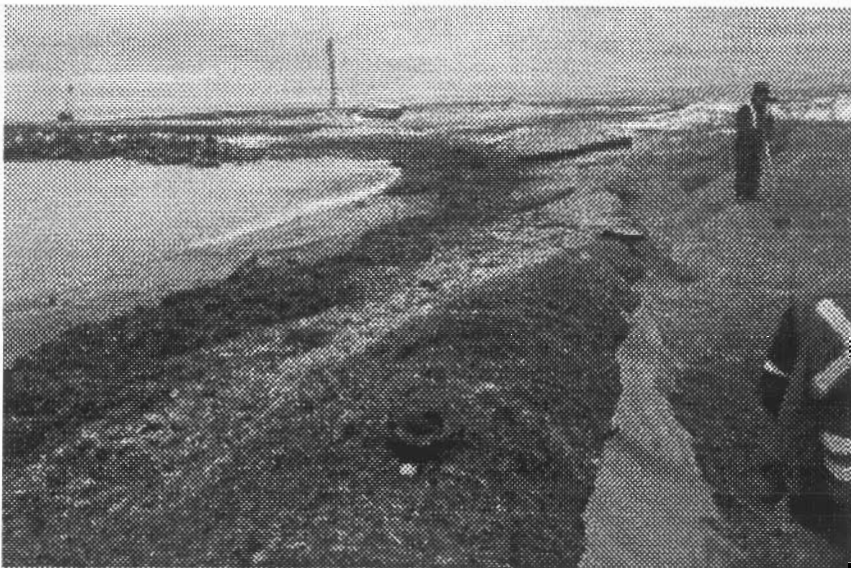
Photograph 10: Installation of geomembrane, east side of excavation

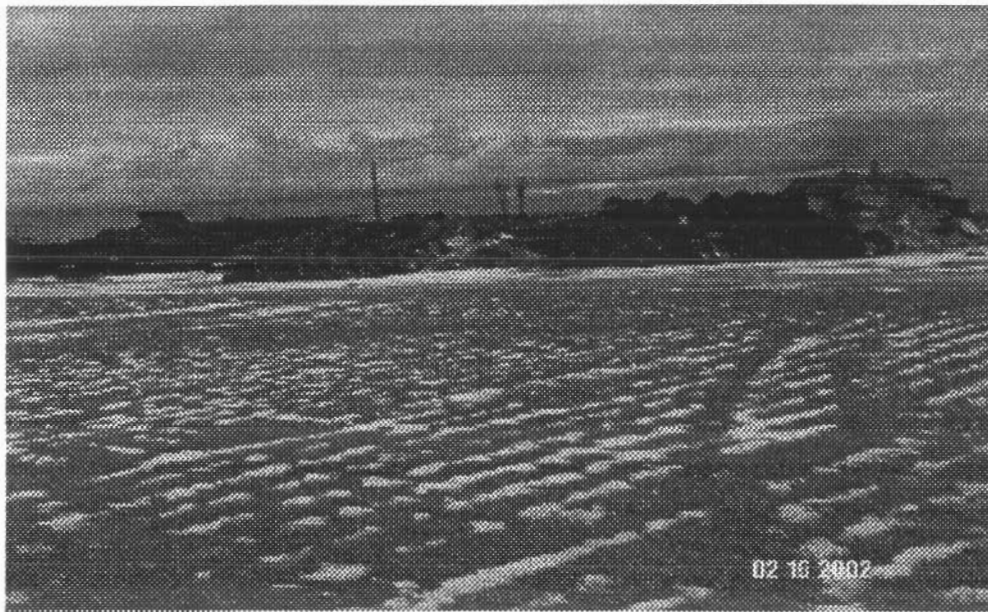
Photo 11: Debris

There were two locations within the original specified excavation area that had buried debris. The specified buried debris at the northwest consisted of crushed empty metal barrels. The previously unknown buried debris located at the southwest area, which was discovered during the excavation, consisted of pieces of wood, piping, bottles and metal. All of the debris was sorted and removed to the retrograde storage area for temporary storage as no hazardous materials were found.

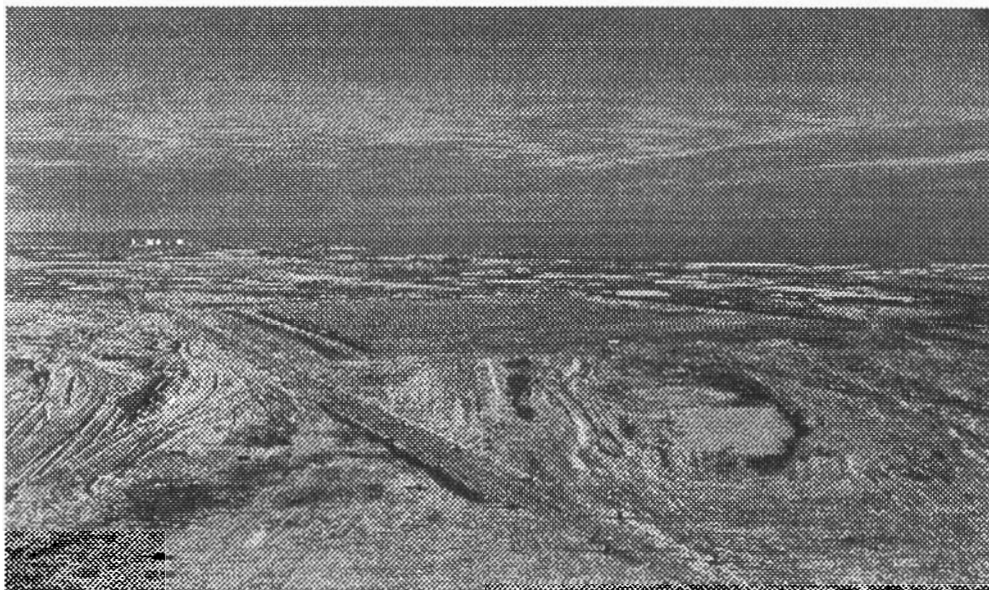
Photo 12: Hydrocarbon Secure Storage Area, aerial view

In total, approximately 6 897 m³ of Hydrocarbon Type B Contaminated Soil was transported to the hydrocarbon secure storage area. Within the secure storage area it was then spread out in a single layer to a thickness of approximately 0.4 m.

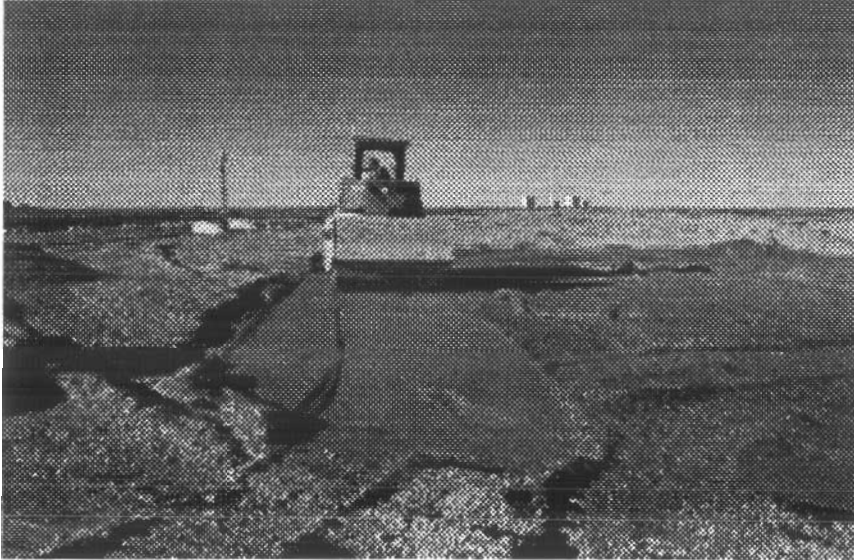
Picture 13: Compaction

The entire excavation was backfilled with borrow material taken from the areas shown on the plans and specifications. The area was regraded to match the original elevations.

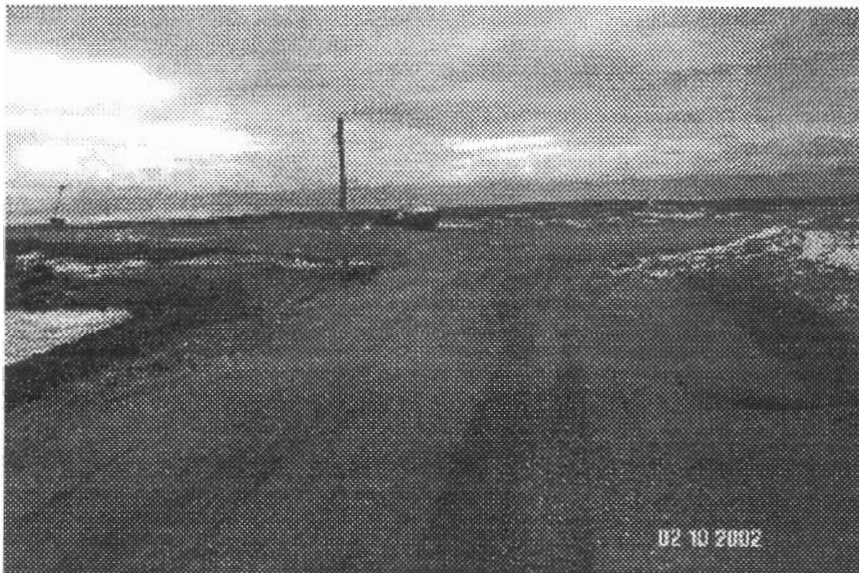
Picture 14: Final grade
