Re: Water Use License 1BR-HAL0308, 2007 Annual Report

Project Name: FOX-M, Hall Beach DEW Line Clean Up

2007 CLOSE-OUT INSPECTION
OVERALL SITE PLAN

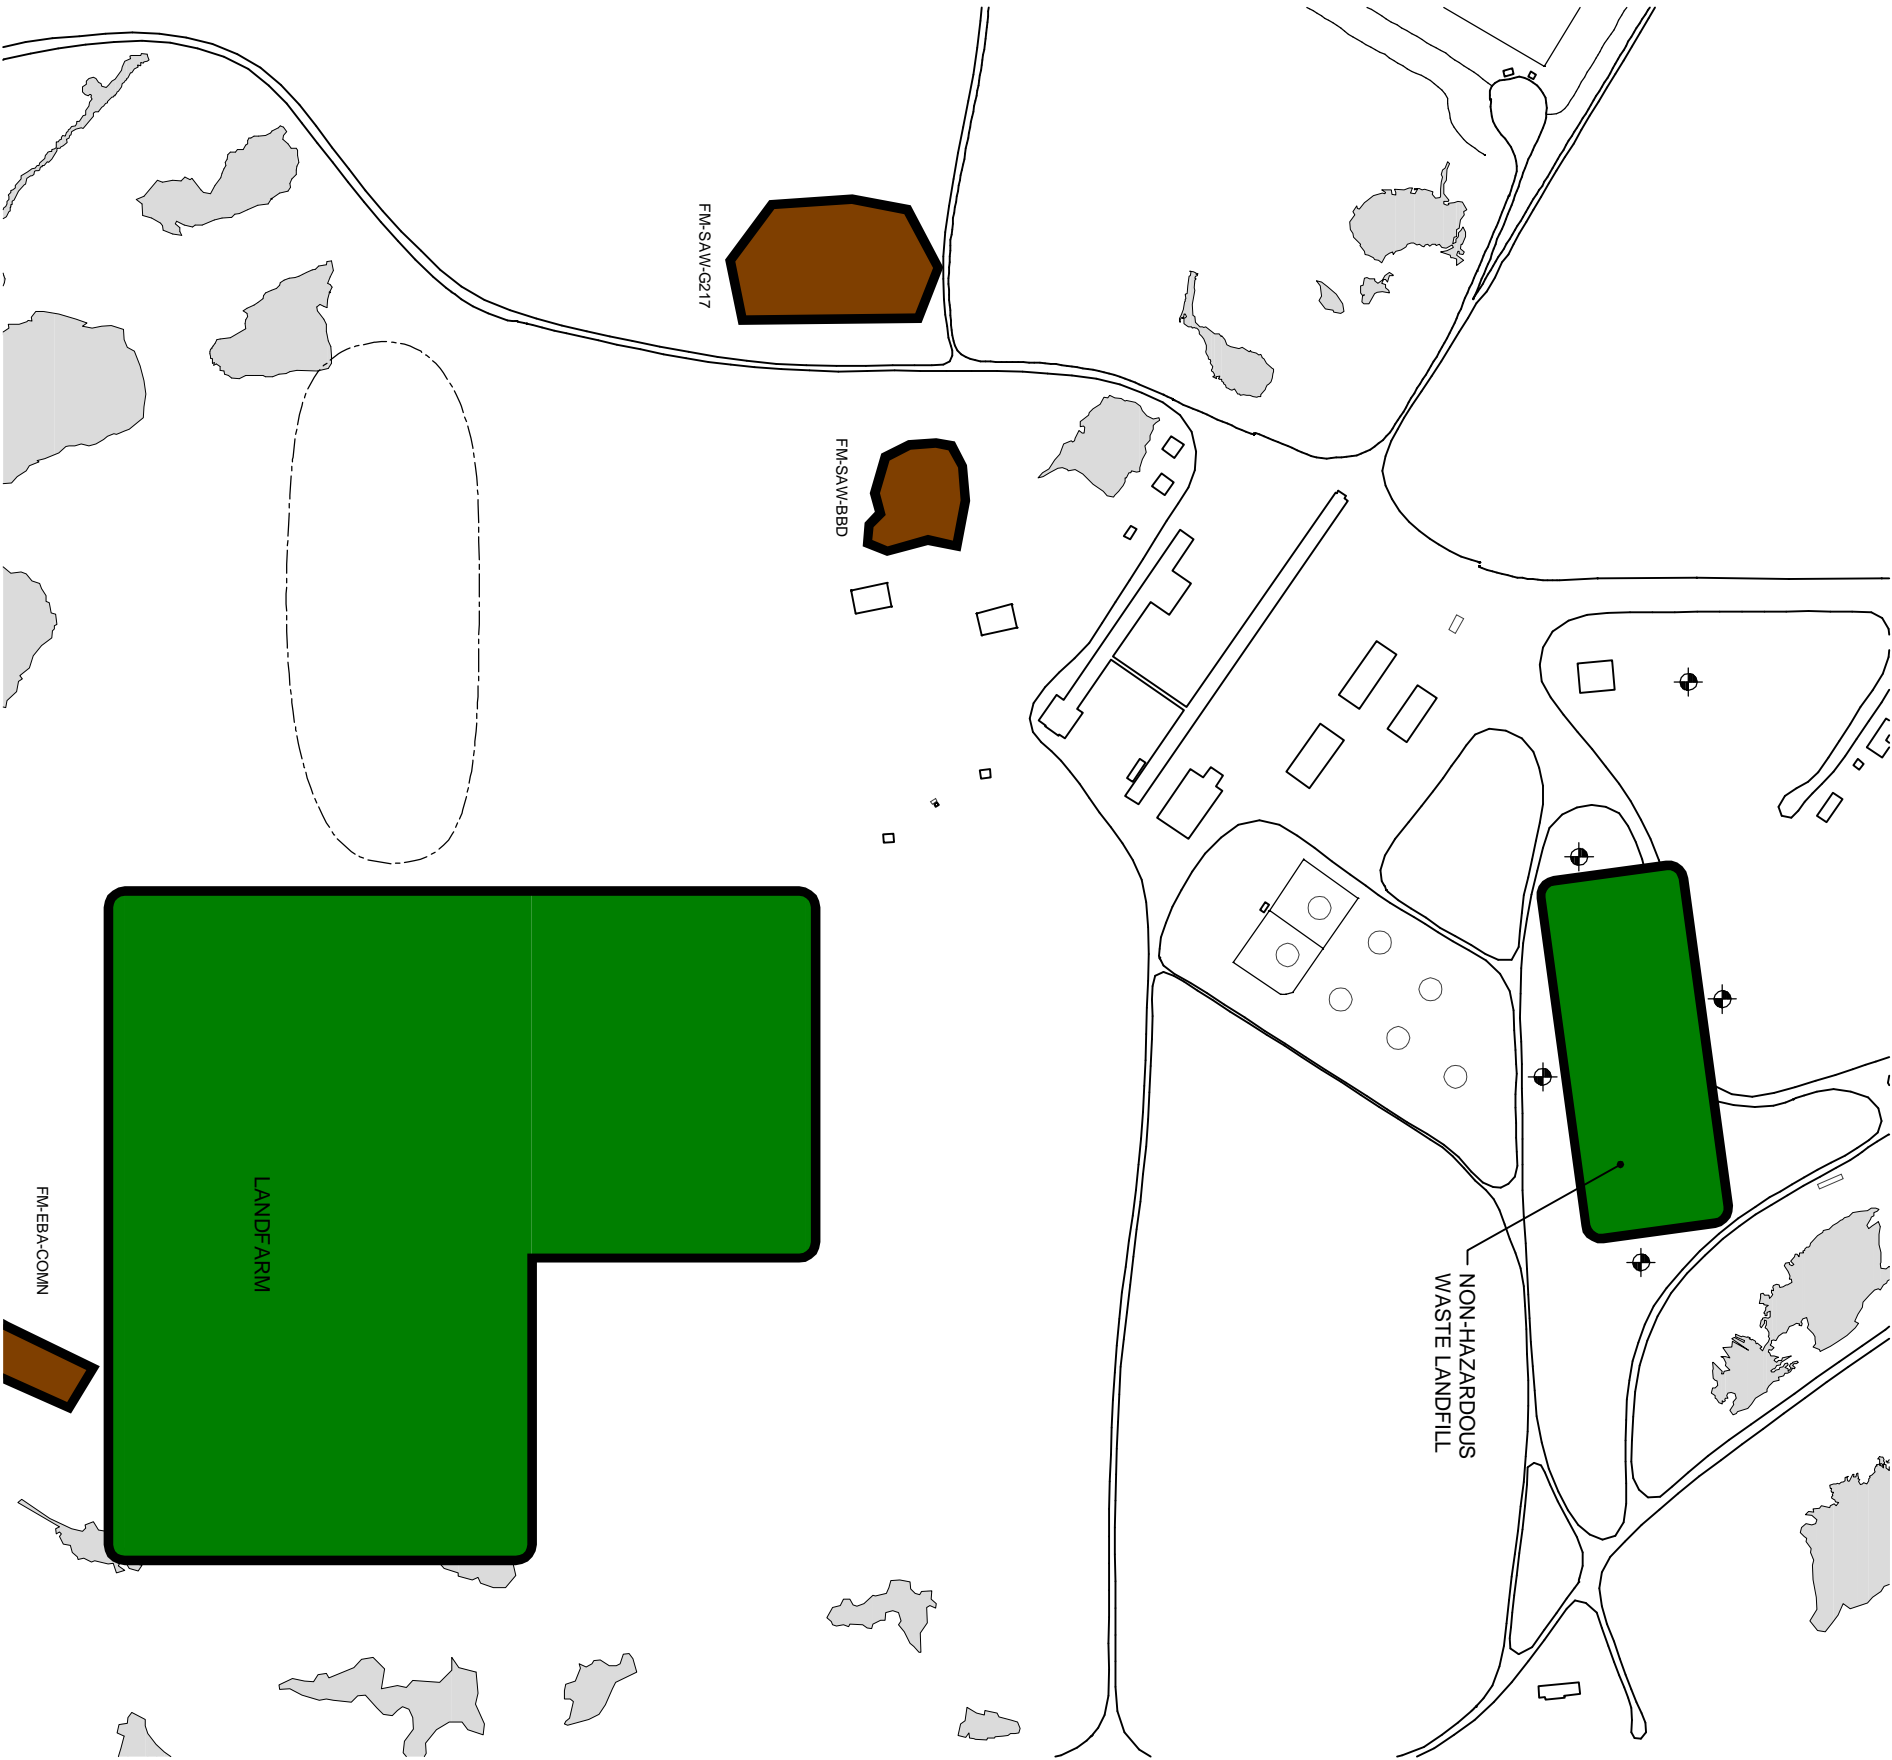
2007 CLOSE-OUT INSPECTION INSTRUMENTATION PLAN 2

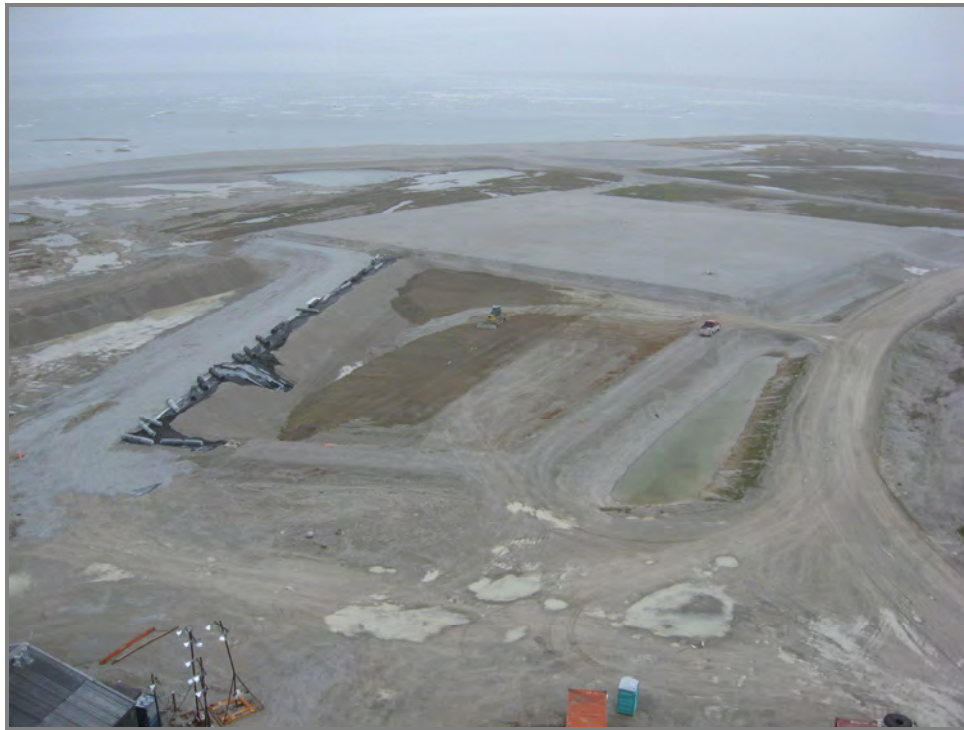
Picture #1 - Tier II Disposal Facility, During Construction, Viewing South – July 25, 2007

Tier II Soil Disposal Facility: The Tier II Soil Disposal Facility at FOX-M consists of two cells. Cell 1 was completed and closed in 2006. The construction of Cell 2 began in 2006, and was completed and closed in 2007, including placement and compaction of a granular fill cover. A total of 32,170 m³ of Tier II impacted soils were placed in this facility.

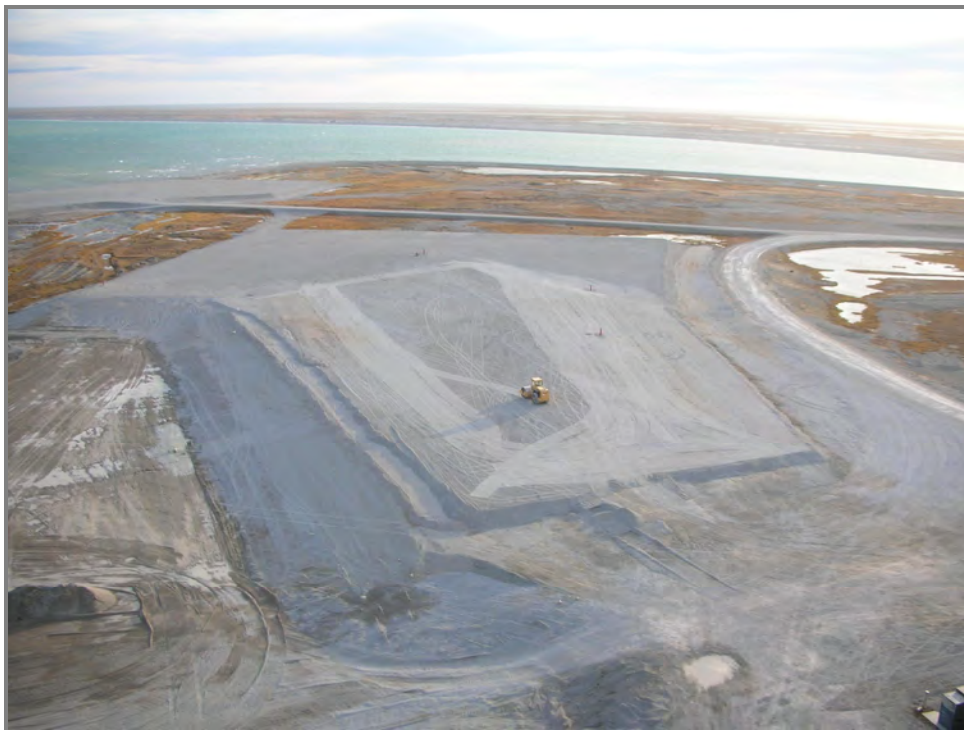
Picture #2 - Completed Tier II Disposal Facility, Viewing South – August 9, 2007

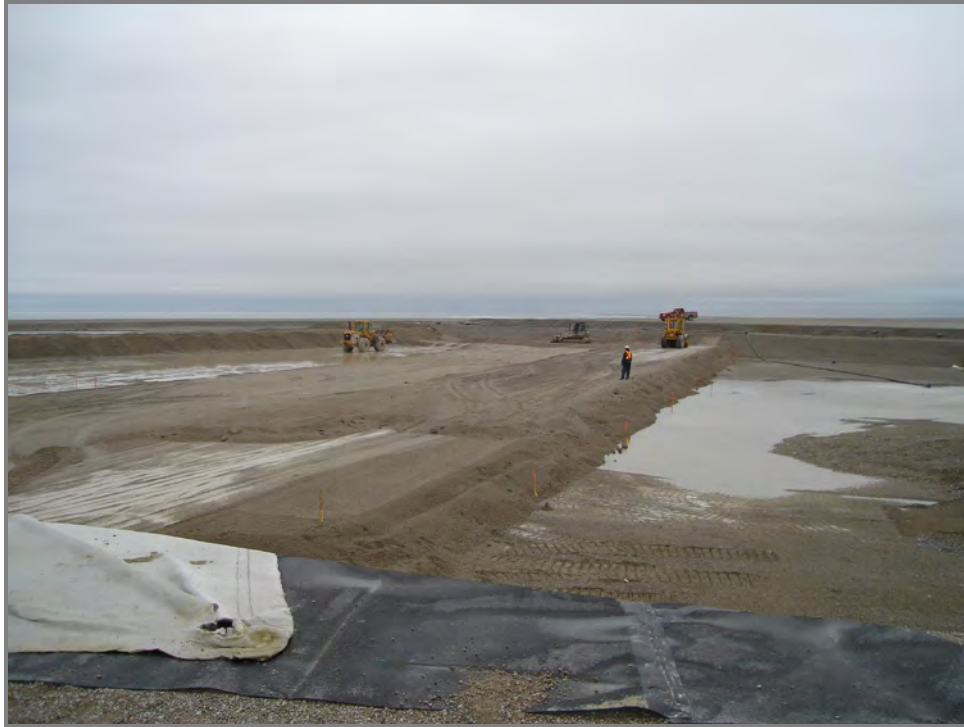
Picture #3 - Construction of Intermediate Berm of Tier II Facility, Viewing South – July 5, 2007

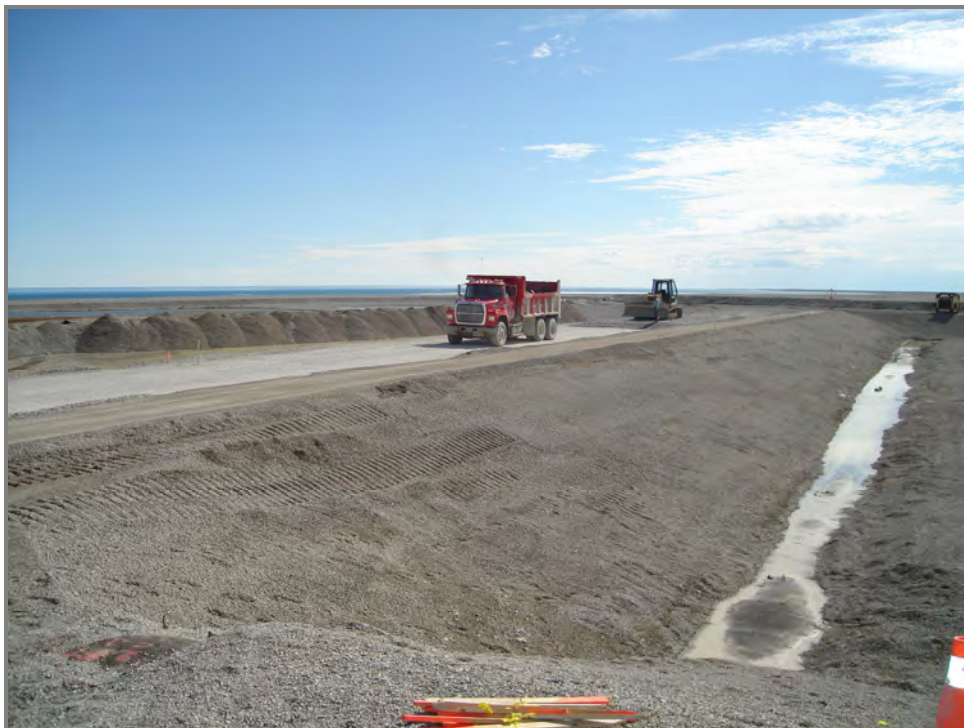
Picture #4 - Construction of Intermediate Berm of Tier II Facility, Viewing South – July 11, 2007

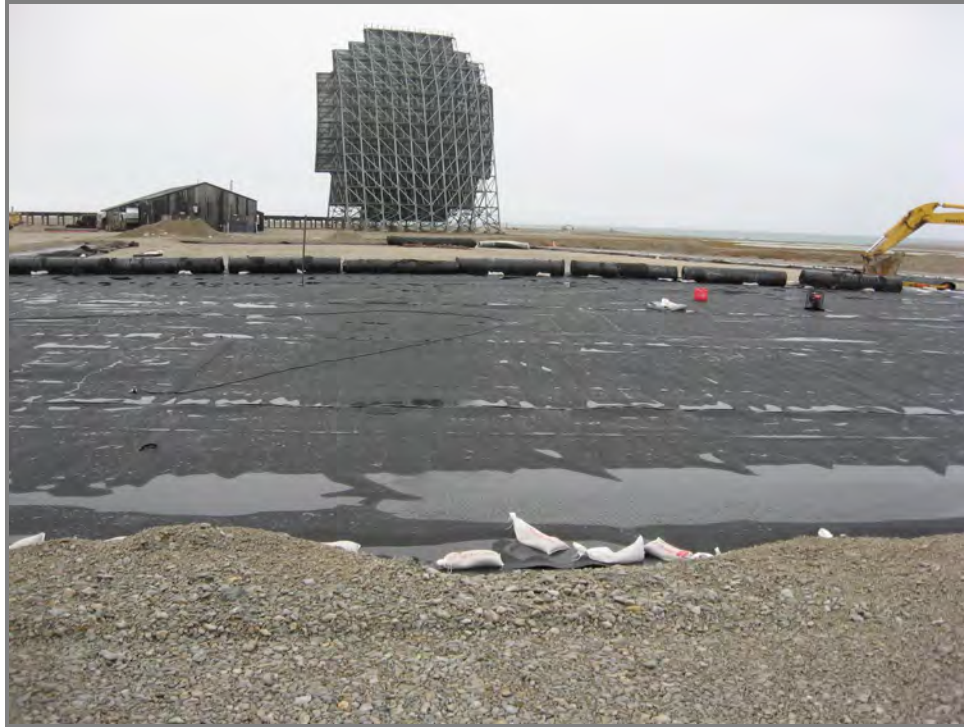
Picture #5 - Installation of Cover Liner of Tier II Disposal Facility, Viewing North – August 25, 2007

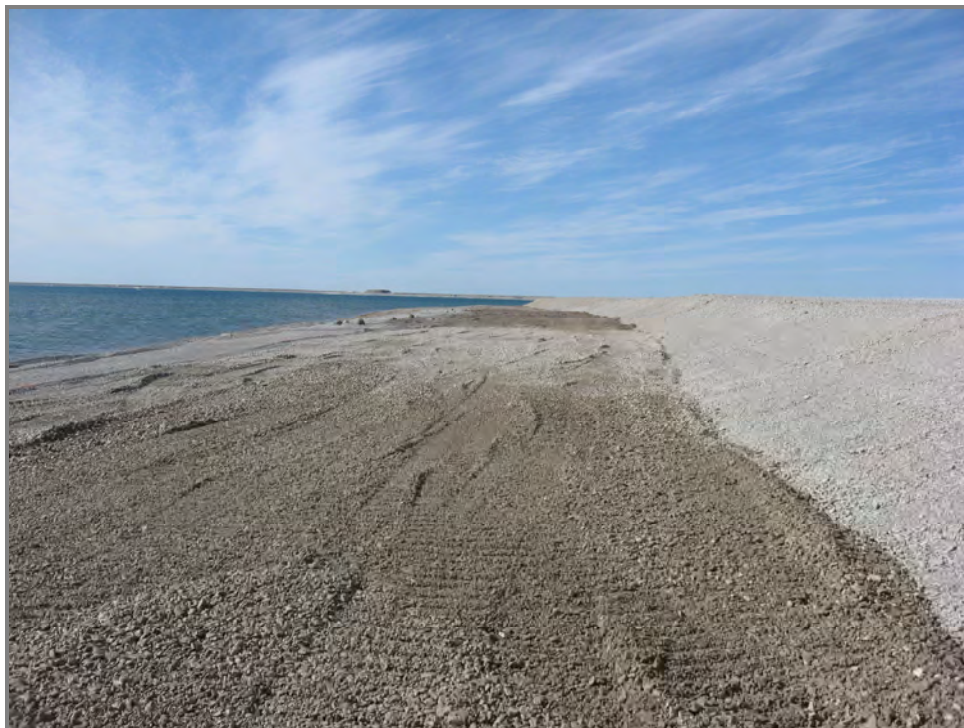
Picture #6 - Placement of Granular Fill to Promote Positive Drainage at the East Beach Landfill, Viewing West – July 12, 2007

East Beach Landfill Remediation: Most of the work associated with the remediation of the East Beach Landfill was completed in 2006. The work that was completed in 2007 included the placement and compaction of granular materials along the edge of the south lobe to keep surface water away from the landfill toe.

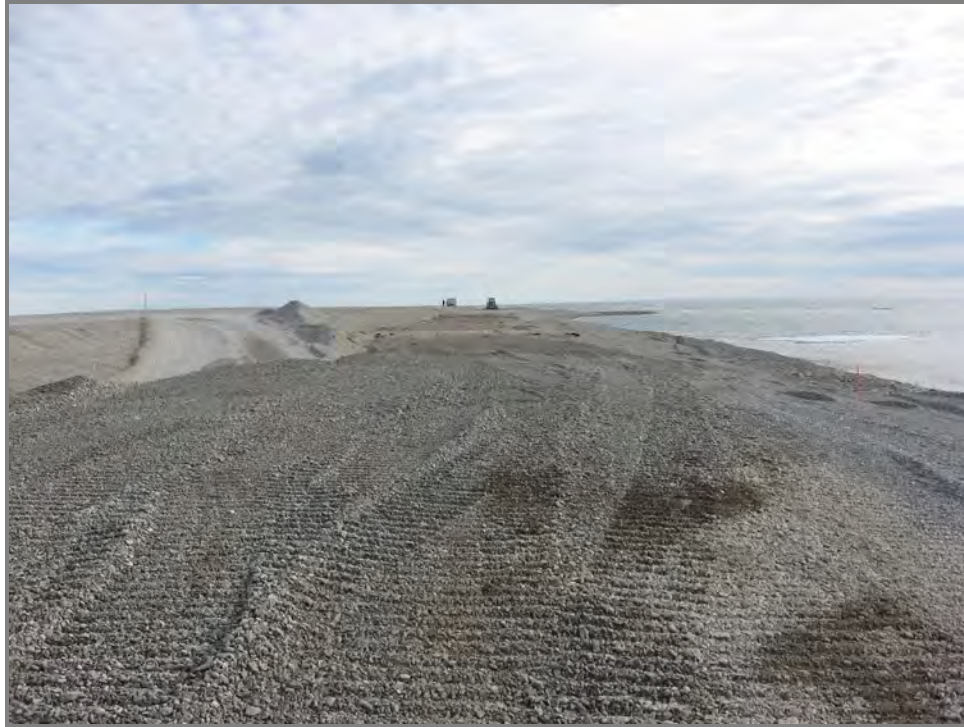
Picture #7 - Placement of Type 3 Granular Fill to Promote Positive Drainage at the East Beach Landfill, Viewing East – July 13, 2007

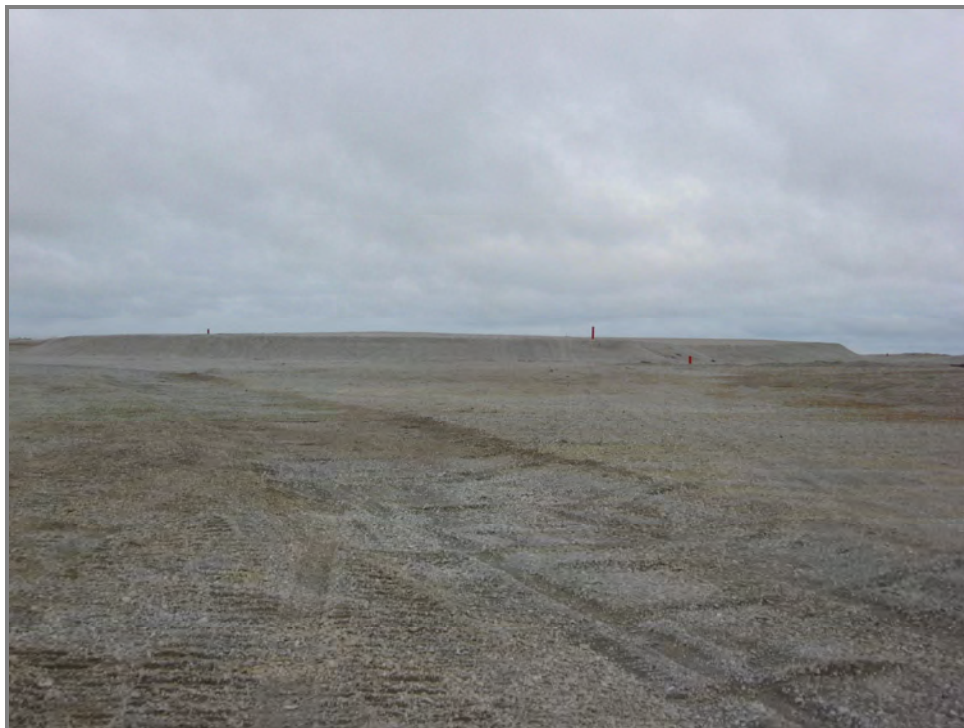
Picture #8 - Completed Swale Between East Beach Landfill North and South Lobes, Viewing South West – September 11, 2007

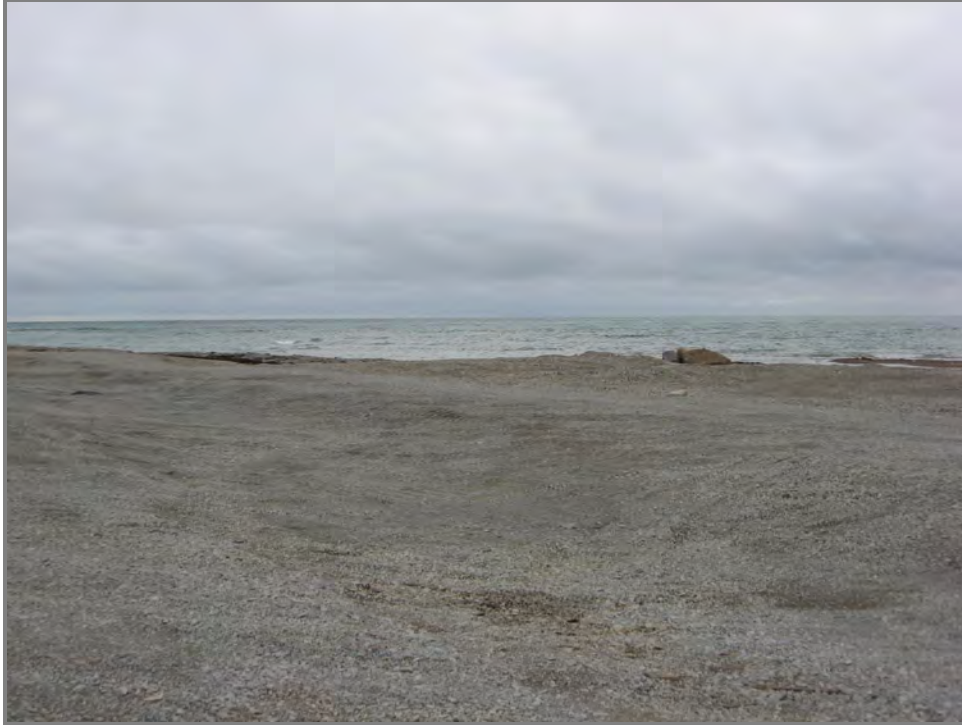
Picture #9 - Completed Swale Between East beach Landfill North and South Lobes, Viewing South – September 11, 2007

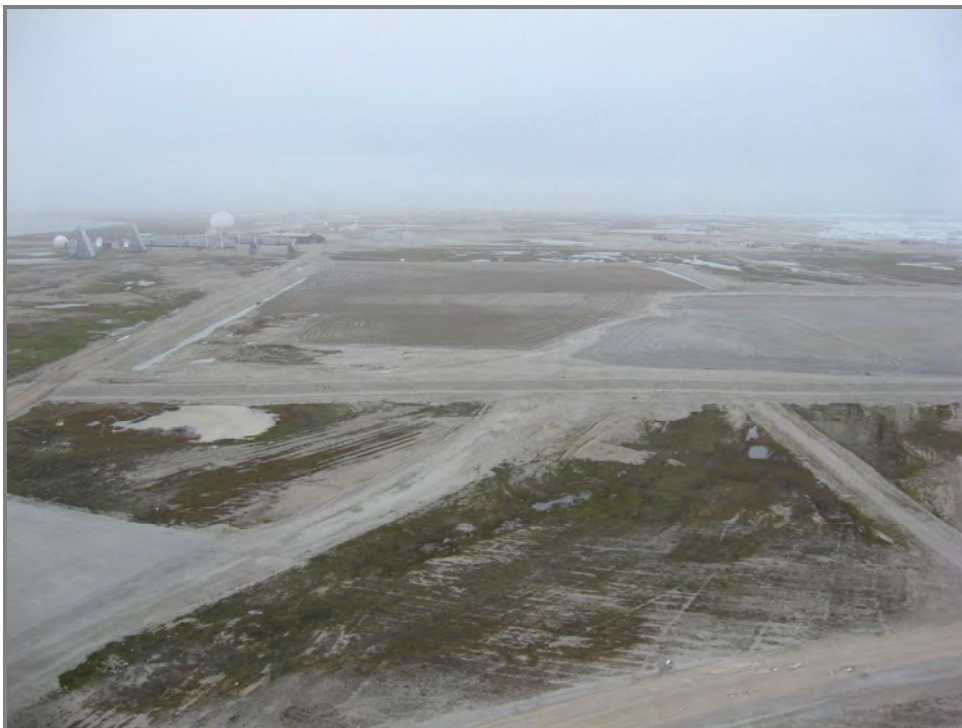
Picture # 10 - Hydrocarbon Contaminated Soil Landfarm, Viewing North – July 25, 2007

Landfarm: The landfarm was decommissioned in 2007, which included removal of the liner (placed in the Non-Haz Landfill), leveling of the perimeter berms, grading of the area for positive drainage, and decommissioning of the monitoring wells. A total volume of 20,800 m³ of hydrocarbon impacted soils was treated in the landfarm.

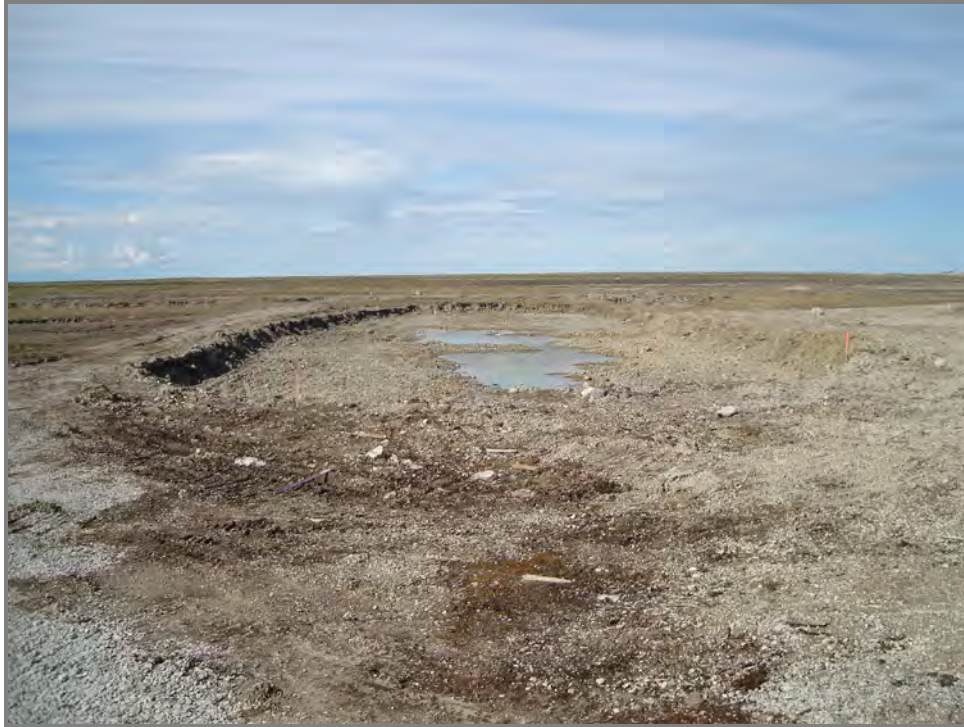
Picture #11 - West Communications Area Excavation, Viewing North West – July 11, 2007

West Communication Area: Five areas of excavation were completed, backfilled and graded to promote positive drainage.

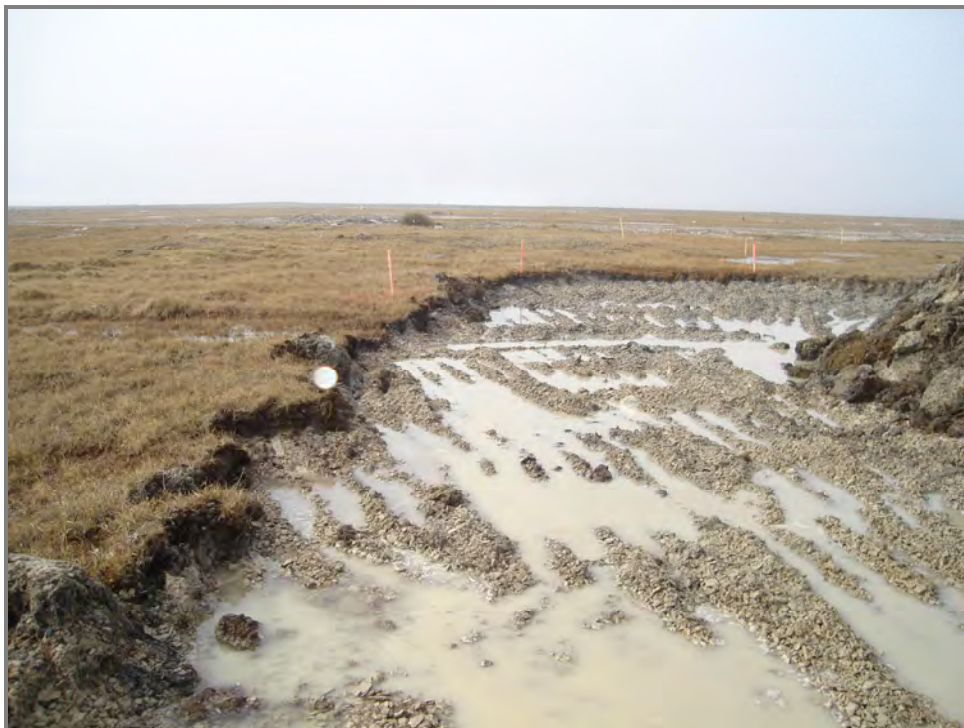
Picture #12 - West Communications Area Excavation FM-WCA-CO3, Viewing West – July 11, 2007

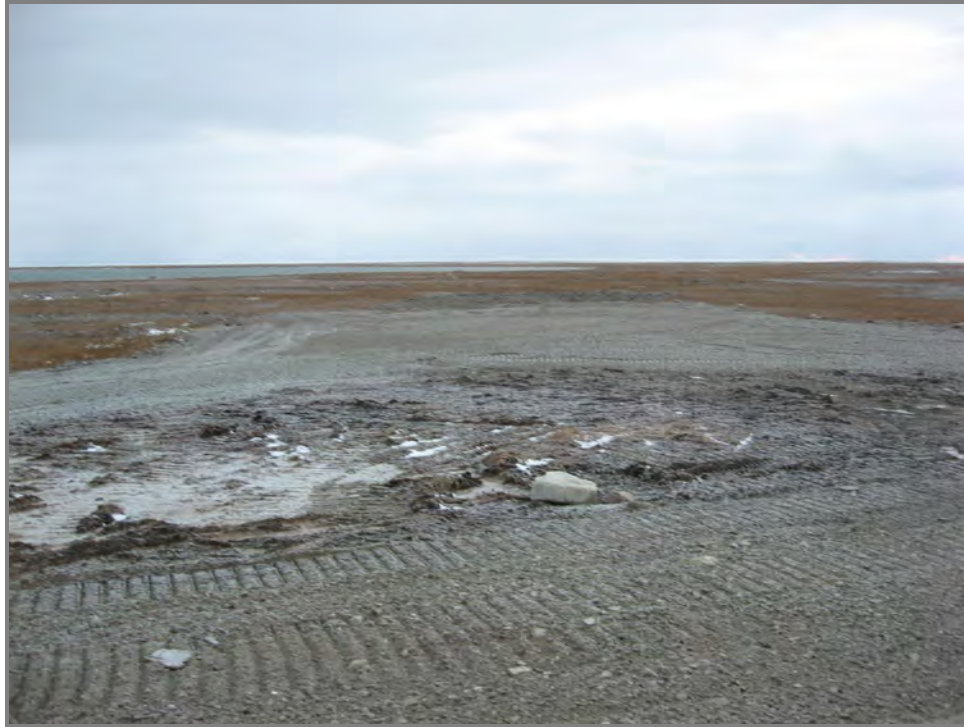
Picture #13 – Backfilled West Communications Excavation FM-WCA-CO3, Viewing North West – September 9, 2007

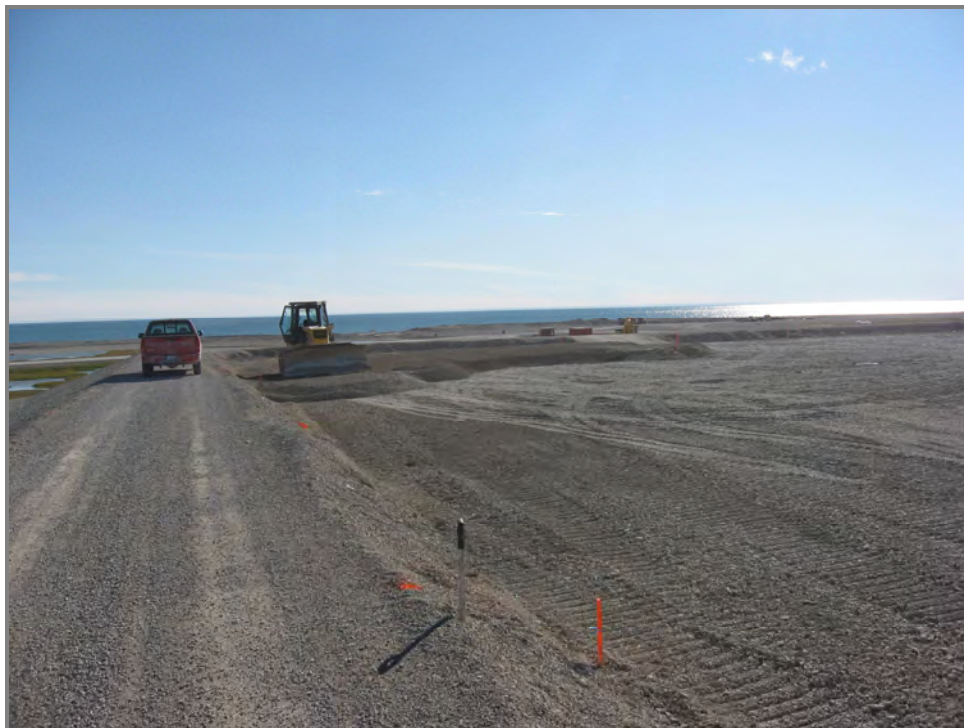
Picture #14 - Construction of Final Cover Layer of NHW Landfill, Viewing East – August 6, 2007

Non-Hazardous Waste Landfill: The Non-Hazardous Waste Landfill was completed and capped in 2007. A total volume of 19,700 m³ of compacted material is in this landfill.

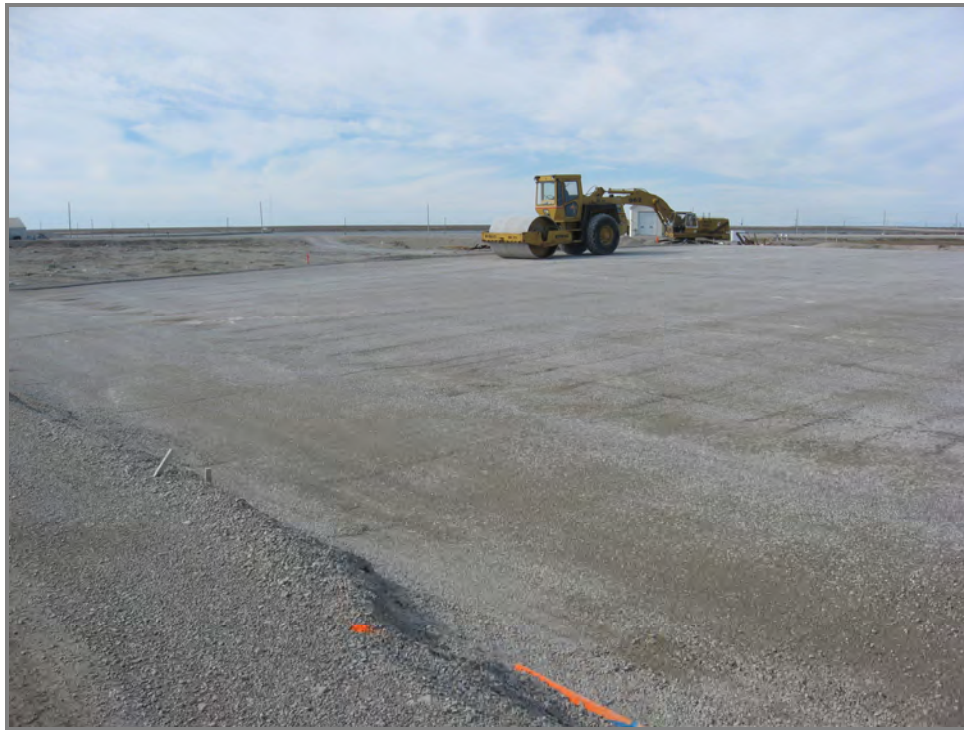
Picture #15 - Construction of Final Cover Layer of NHW Landfill, Viewing North West – August 8, 2007

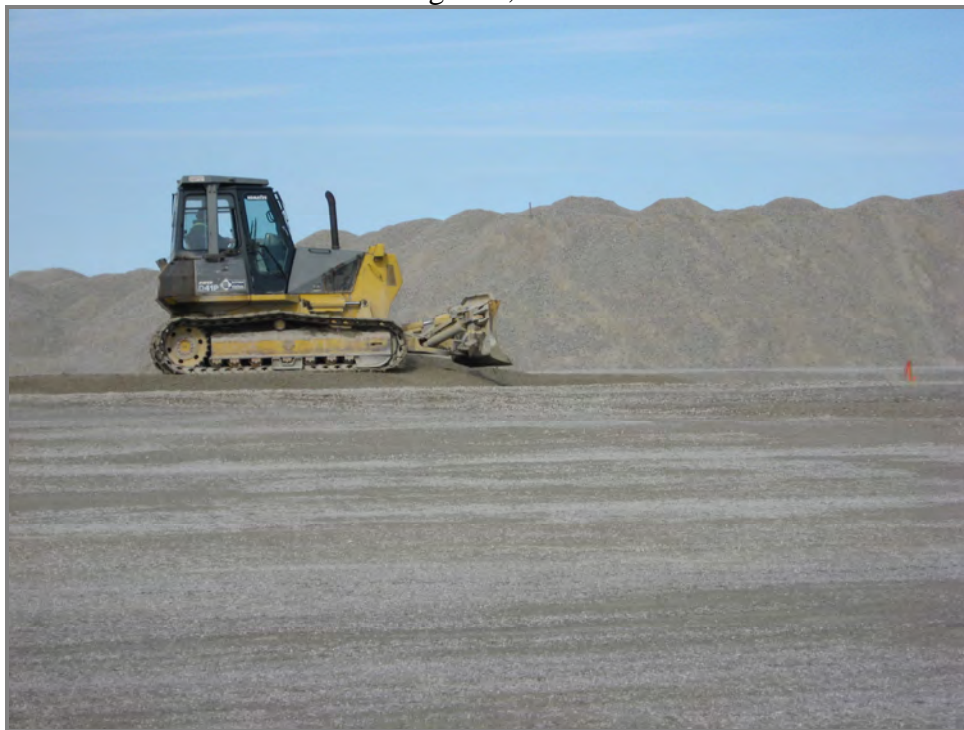
Picture # 16 - Construction of Final Cover Layer of NHW Landfill, Viewing North East – August 8, 2007
