Site Investigation Report: Per- and Polyfluoroalkyl Substances (PFAS) Presence /Absence Study at Iqaluit Airport

Iqaluit, NU

Date: March, 2020

Project #: 60615382

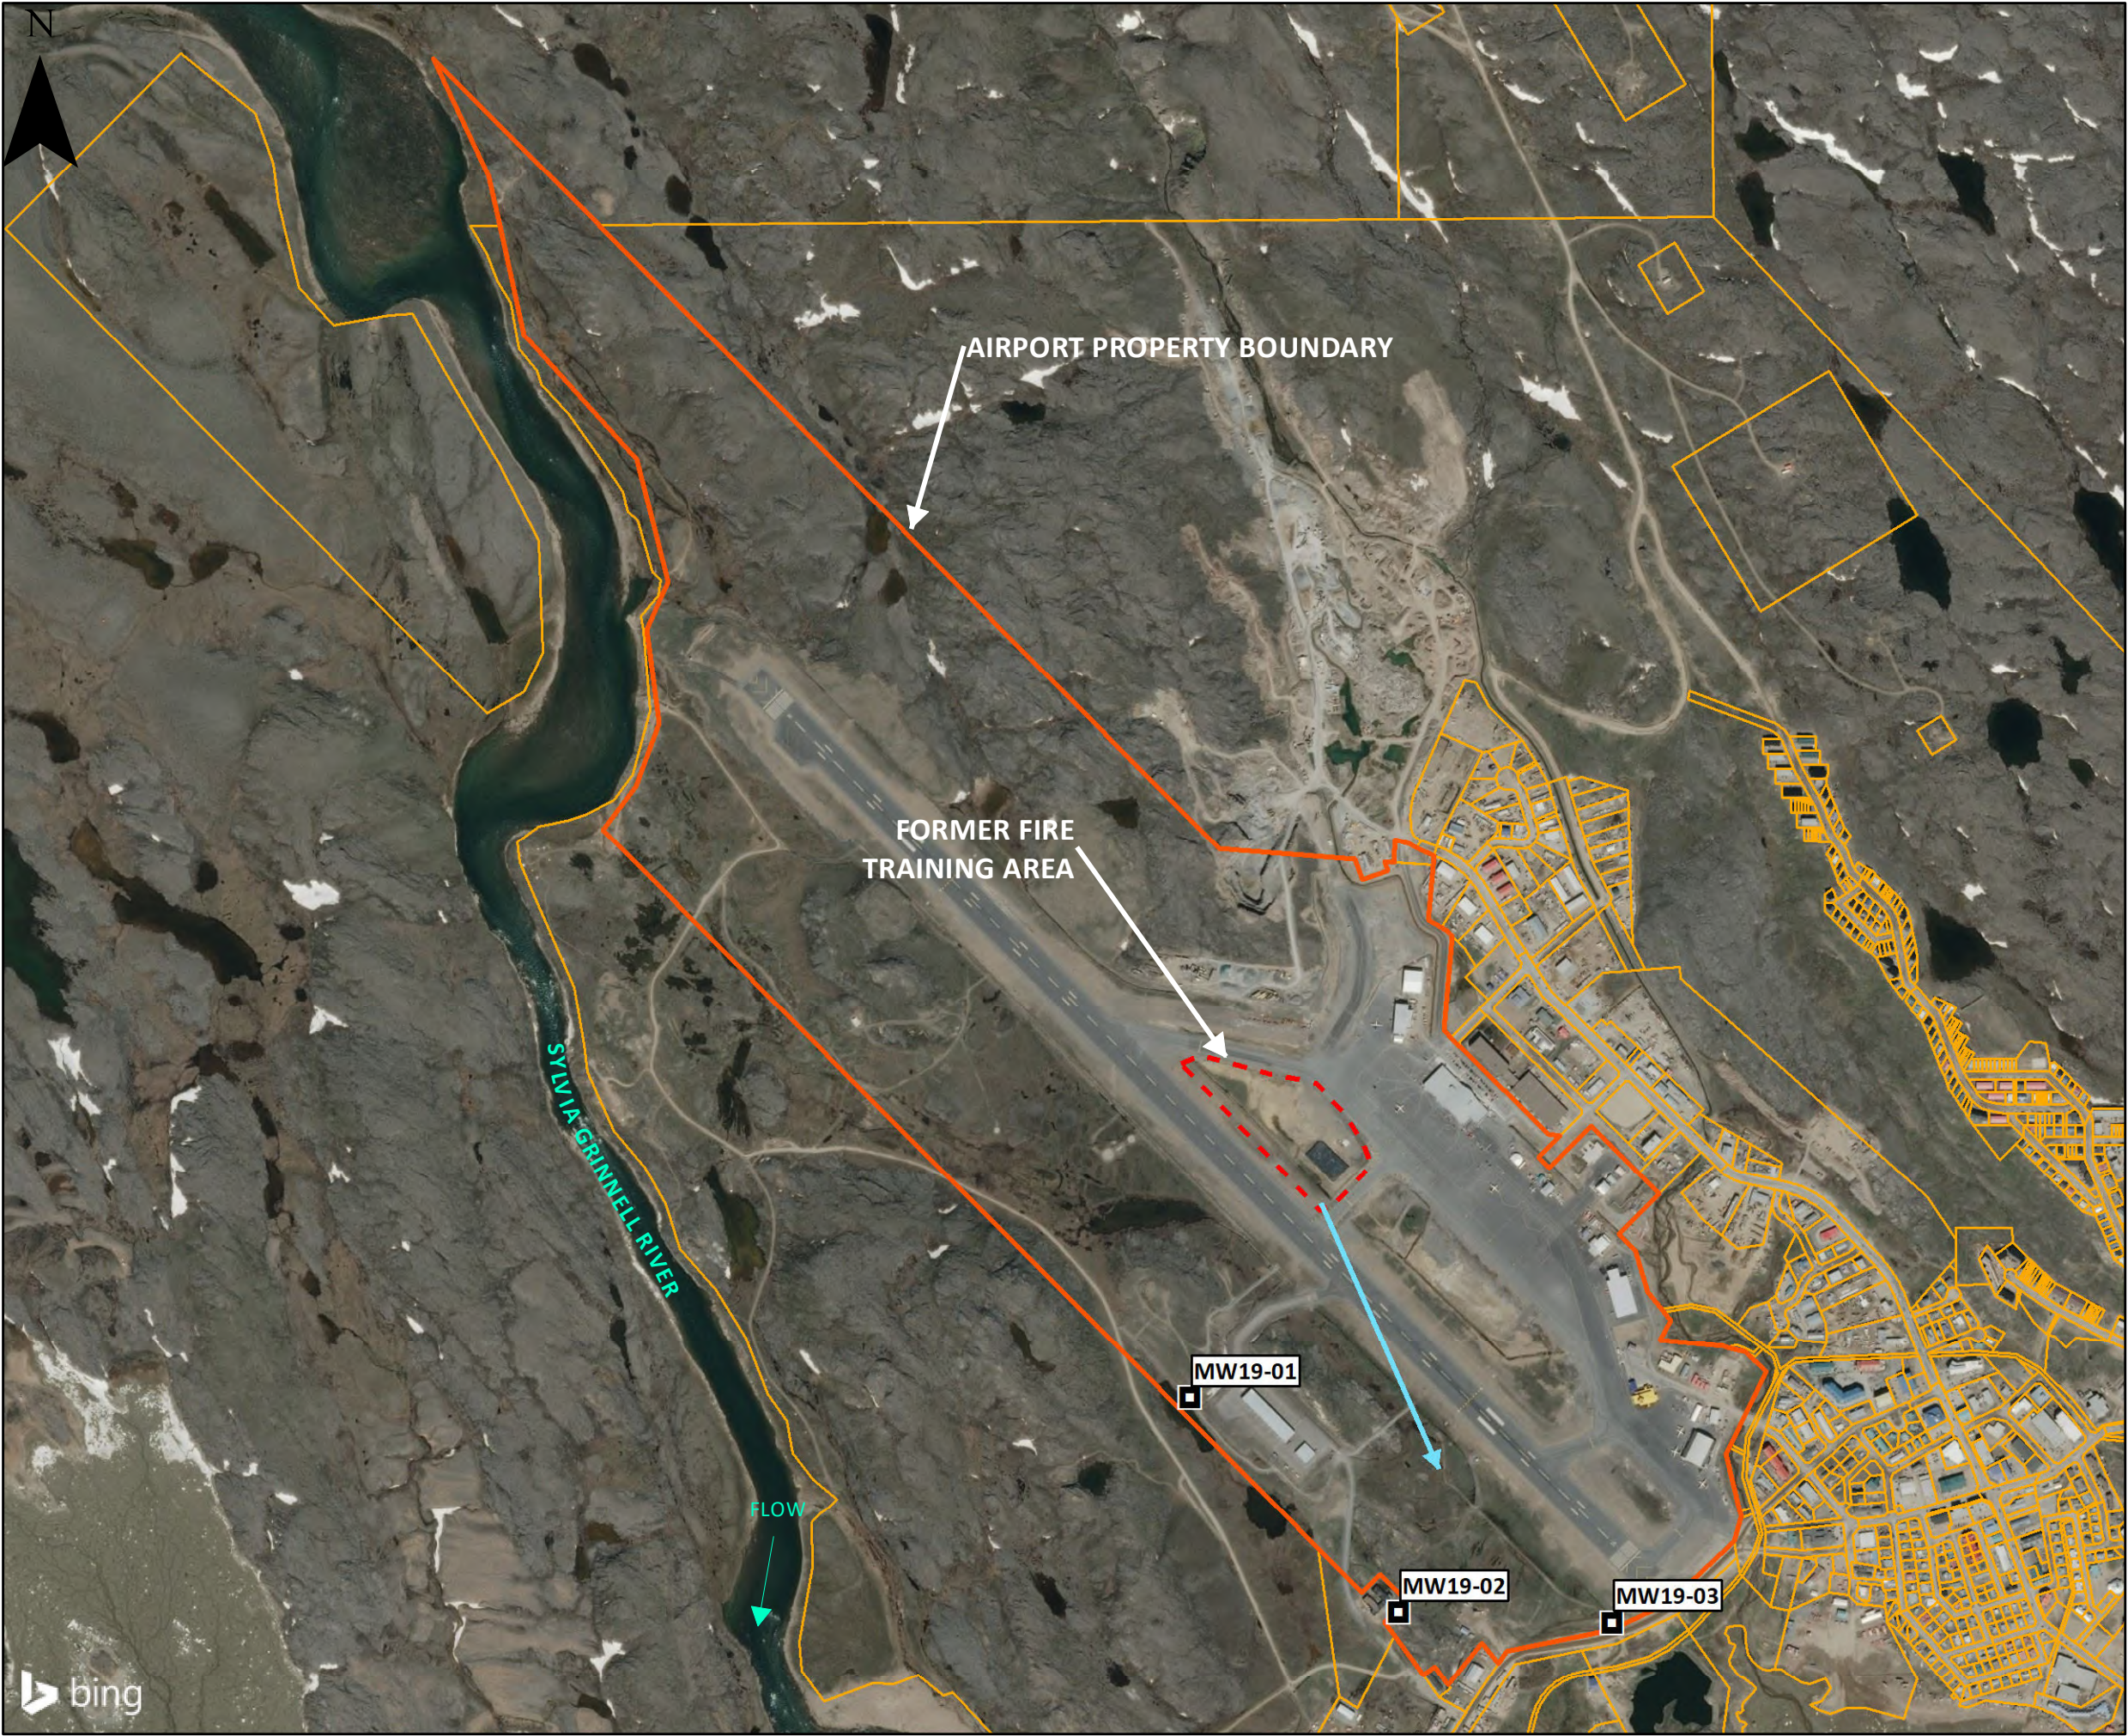
Figure 2

- Legend**
- Monitoring Well Location
 - Assumed Groundwater Flow Direction
 - Iqaluit Airport Boundary
 - Land Parcel Boundary
 - Former Fire Training Area

MW ID	X-Coordinate	Y-Coordinate
MW19-01	7069390.973	521883.3952
MW19-02	7068934.92	522323.8995
MW19-03	7068912.125	522775.9659

The FTA was approximately 1350 m² in size, unlined, and located in the northwestern section of the airport, west of the main apron and between the terminal tarmac and runway (**Figure 2**). The nearest downgradient property boundary is approximately 1.1 km southeast of the former FTA. The FTA Site has been previously remediated for hydrocarbons. A soil and groundwater investigation was conducted in the former FTA in 1997 (EBA, 1997) to delineate the extent of hydrocarbon impacted soil and groundwater, and the follow-up supplemental site investigation and environmental baseline study re-audit were conducted in 1999 (GeoEnv, 1999, Dillon 1999). Remedial activities including soil excavation and development of two lined land treatment units (LTUs) were conducted in 2000 (Transport Canada, 2001). Approximately 2,790 cubic meters (m³) of impacted soils were excavated in the FTA and landfarmed in LTUs onsite. The excavated area was backfilled with clean material. Monitoring wells were historically installed in the FTA area up to the depth of approximately 2 mbgs (intersect permafrost). Historical site maps, borehole logs, and groundwater elevation maps are also provided in **Appendix A**.
