#### PHASE III ENVIRONMENTAL SITE ASSESSMENT

#### **IQALUIT AIRPORT, AREAS OF ENVIRONMENTAL CONCERN**

**FINAL REPORT**

June 26, 2014

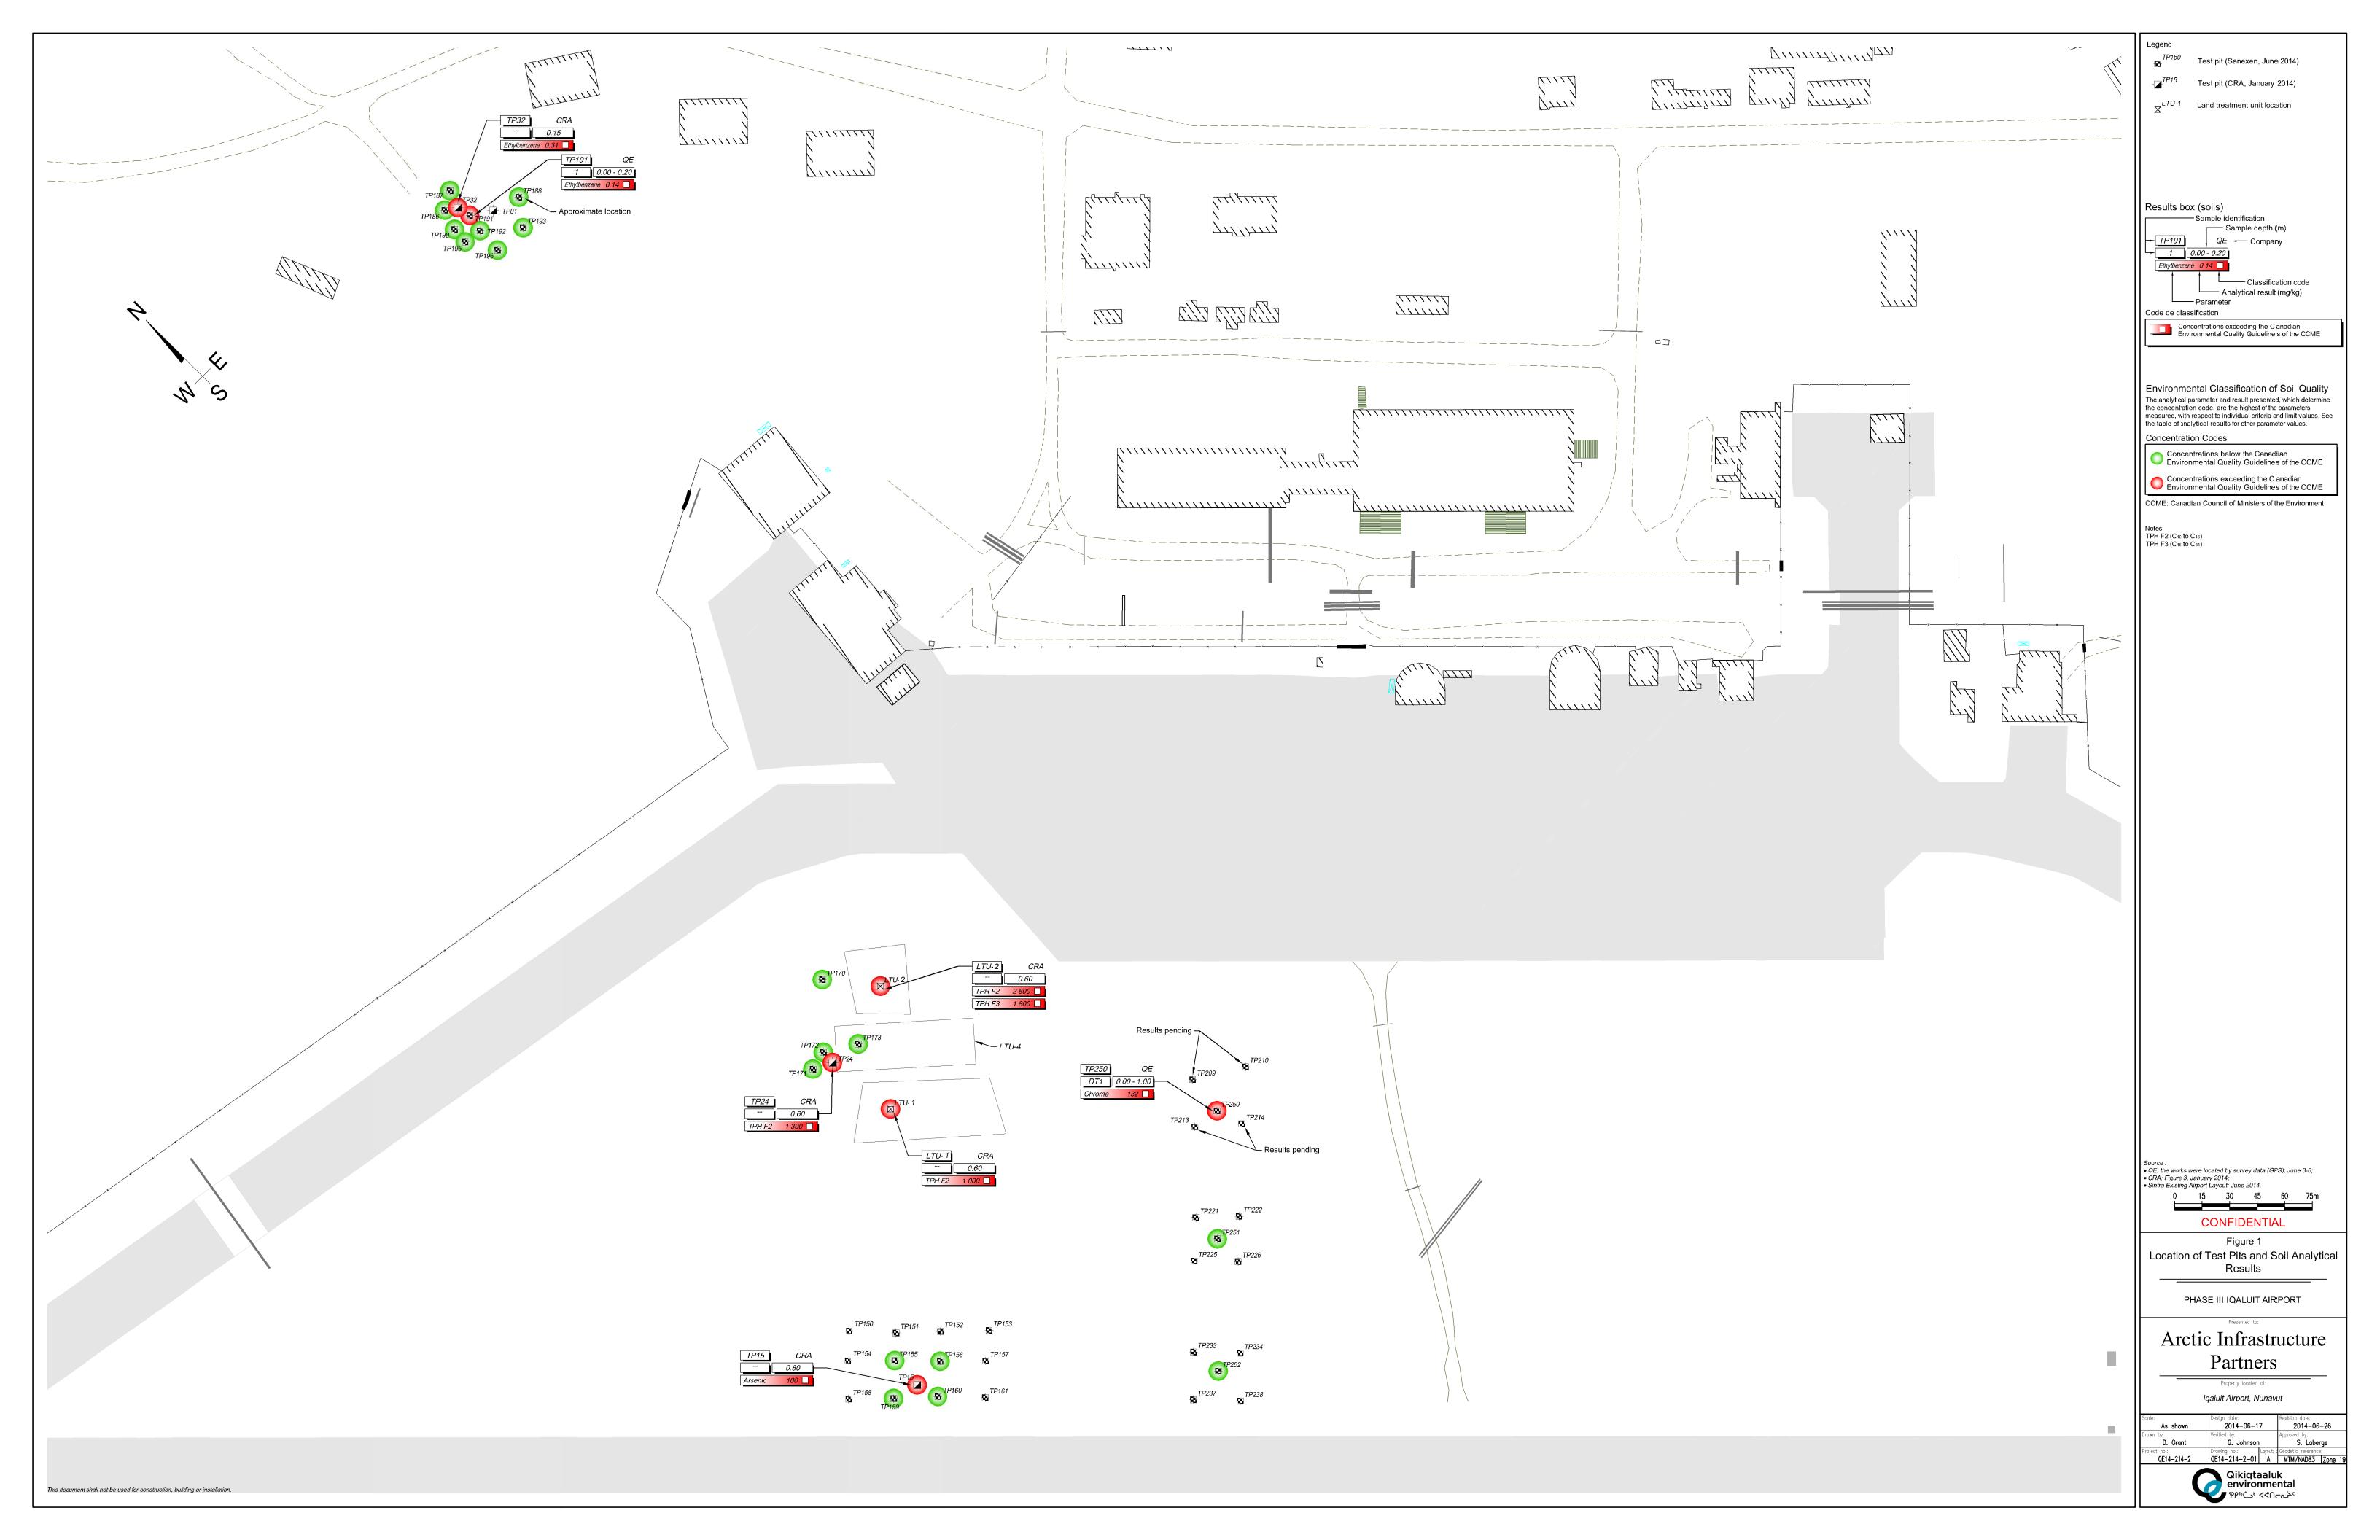
It should be noted that several test pits were relocated during the fieldwork due to logistical constraints on-Site. Figure 1 in Appendix B illustrates the final location of all test pits.

The Phase III ESA fieldwork included the excavation of 40 test pits as shown in Figure 1 of Appendix B.

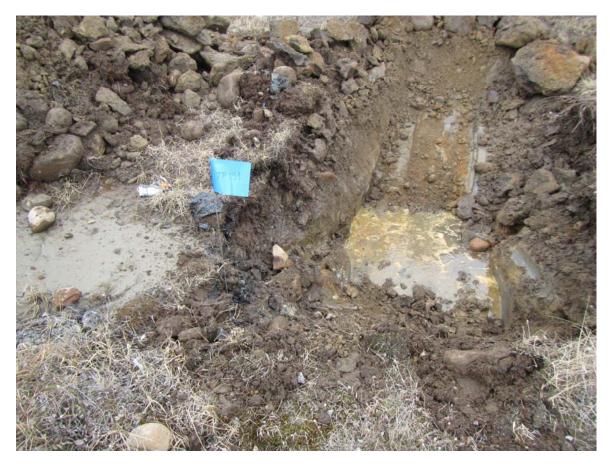
Photo 9: TE 191

The analytical results of the samples submitted to the laboratory showed that soils in the Drum Cache 1 area are impacted by ethylbenzene at concentrations above the Government of Nunavut's industrial criteria in the top 0.2 m at TE-191. This contamination is associated with the tar that leaked out of the drums that were stockpiled in this area.

At the drum cache, all areas where tar is found in contact with the ground should be excavated to a depth of 20 cm. The walls and the bottom of the excavations should also be tested to ensure that no contamination remains. The volume of impacted soils above the industrial criteria in the Drum Cache 1 Area is estimated at maximum of 170 m³ (853 m² by 0.2 m deep). There are many constraints related to the use of this material as backfill. The primary reason is due to the high volatility of this type of contaminant, thus, they will need to be disposed of off-site.

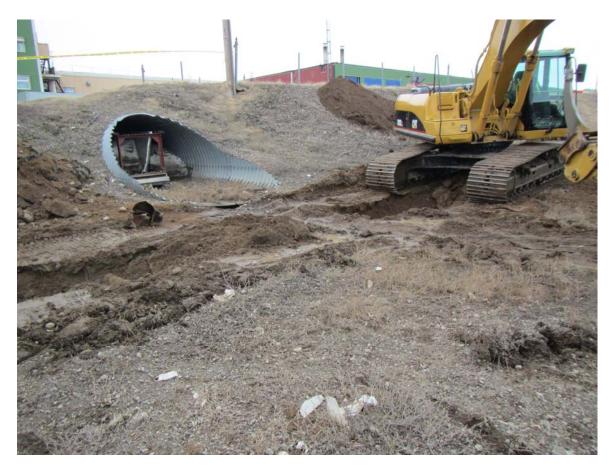
Photo 21: End of FOSSE 5 and Start of FOSSE 6

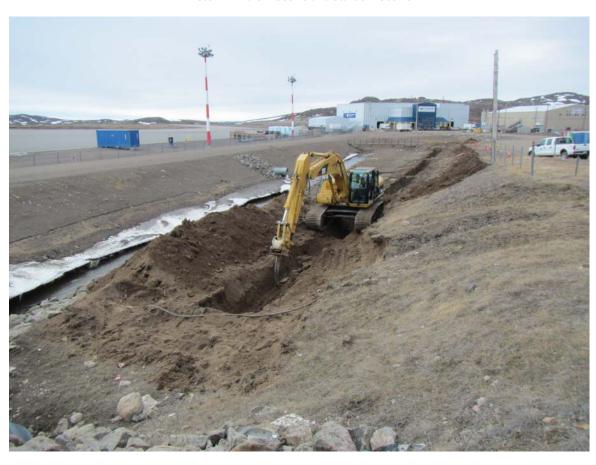
Photo 22: Excavation of FOSSE 6

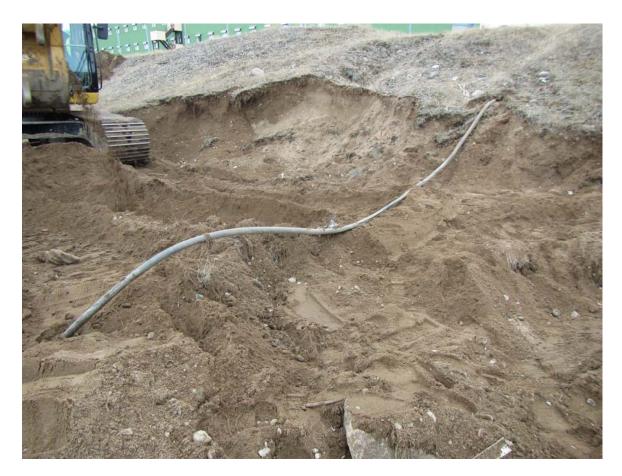
One communications cable was found, buried approximately 6" below the ground surface, during the excavation of the trenches beside the drainage ditch. This communications cable was lightly impacted by the excavator. QE attempted to determine whom the communications cable belonged to and if it is still active. At the time of publishing this report, no owner of the cable had been found. This tends to suggest that this cable is no longer in use.

**Photo 23: Communications Cable Found**
