## PHASE III ENVIRONMENTAL SITE ASSESSMENT

### IQALUIT AIRPORT, AREAS OF ENVIRONMENTAL CONCERN

**FINAL REPORT**

June 26, 2014

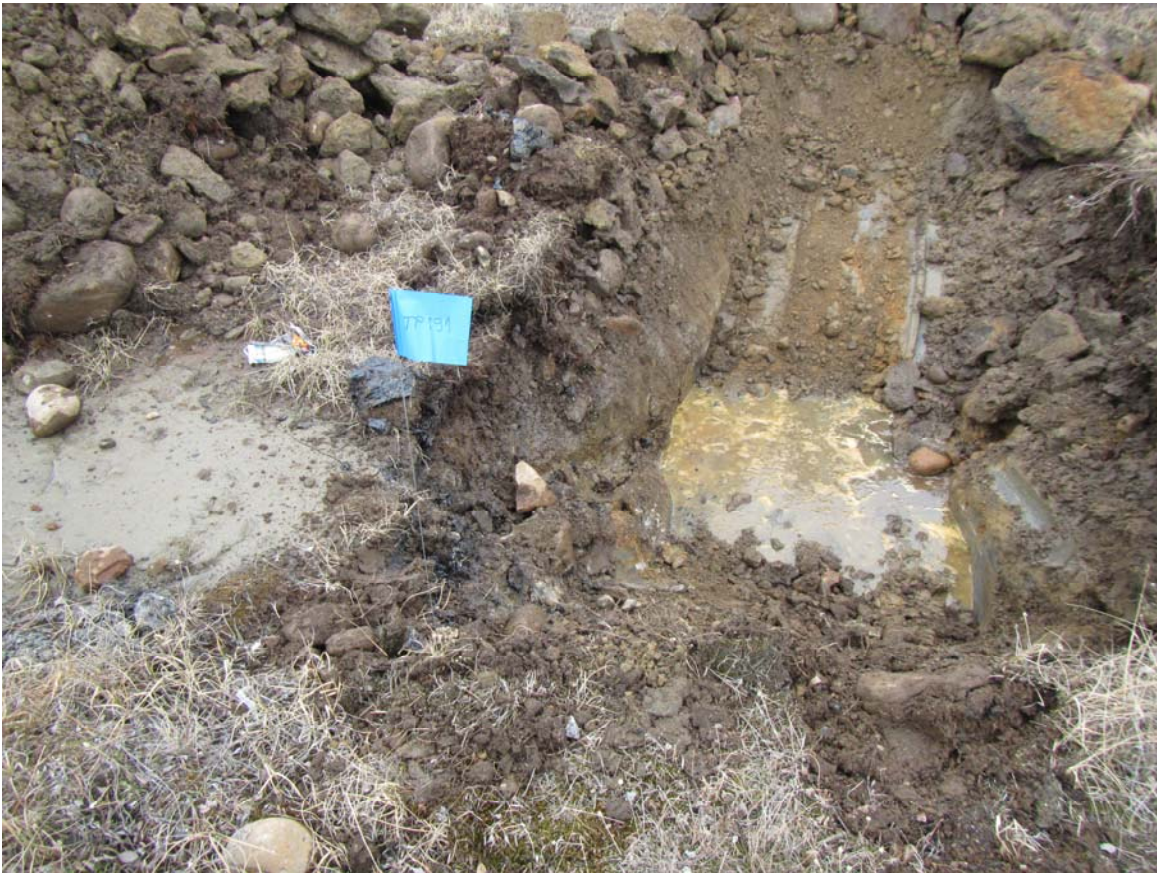
Photo 9: TE 191

The analytical results of the samples submitted to the laboratory showed that soils in the Drum Cache 1 area are impacted by ethylbenzene at concentrations above the Government of Nunavut's industrial criteria in the top 0.2 m at TE-191. This contamination is associated with the tar that leaked out of the drums that were stockpiled in this area.

At the drum cache, all areas where tar is found in contact with the ground should be excavated to a depth of 20 cm. The walls and the bottom of the excavations should also be tested to ensure that no contamination remains. The volume of impacted soils above the industrial criteria in the Drum Cache 1 Area is estimated at maximum of 170 m<sup>3</sup> (853 m<sup>2</sup> by 0.2 m deep). There are many constraints related to the use of this material as backfill. The primary reason is due to the high volatility of this type of contaminant, thus, they will need to be disposed of off-site.

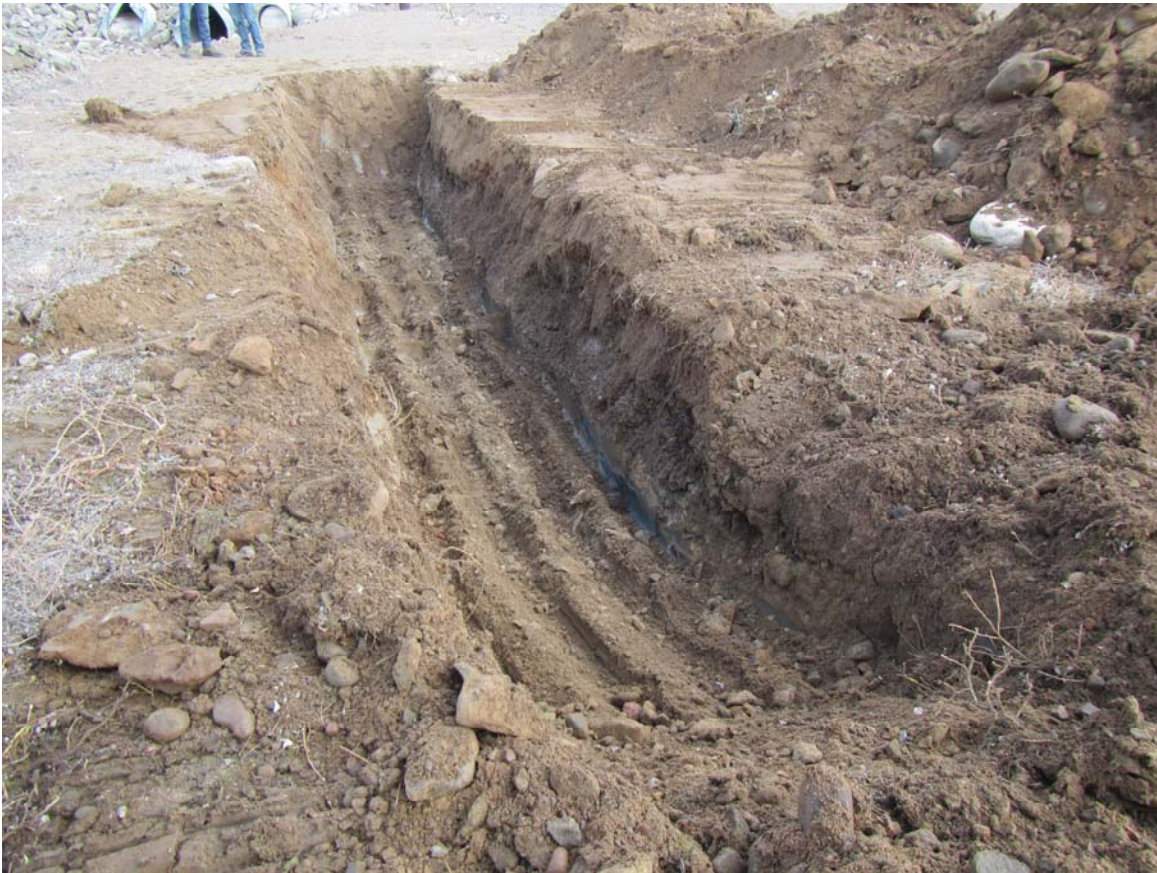
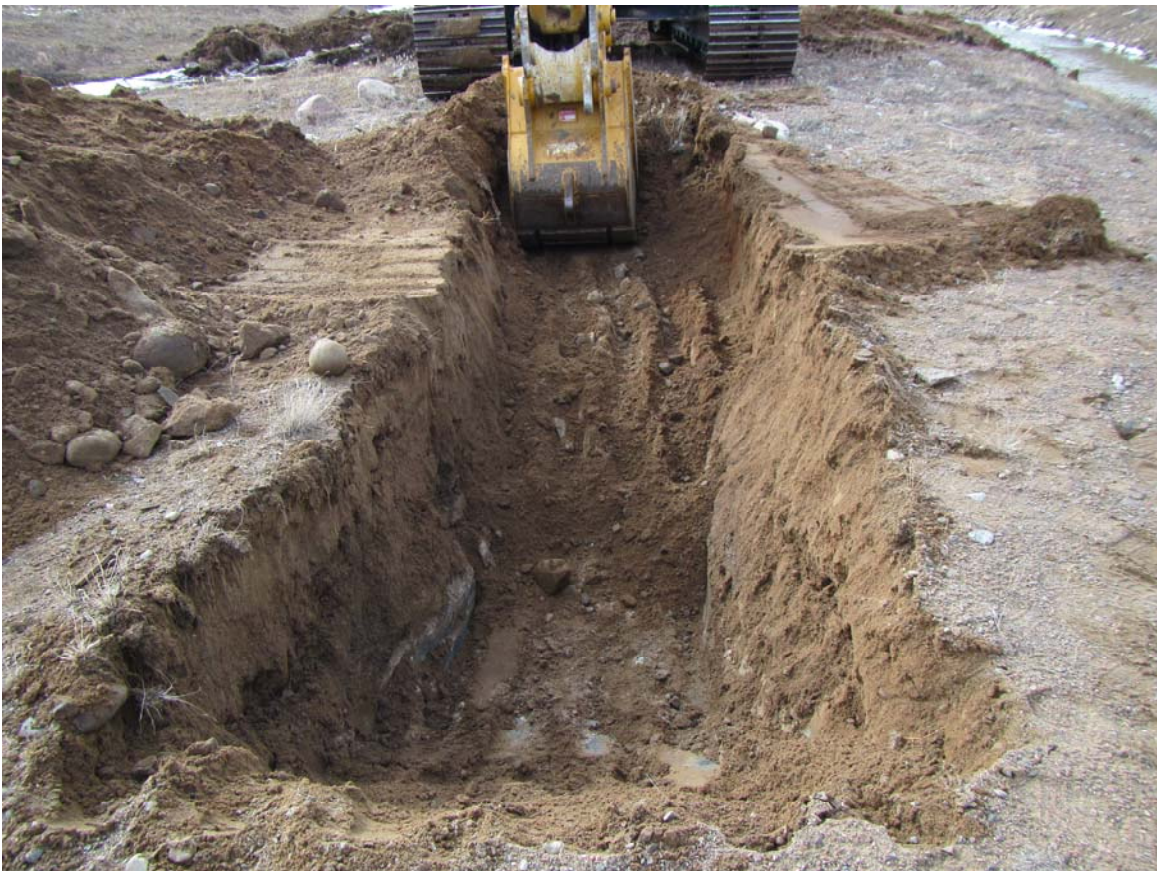
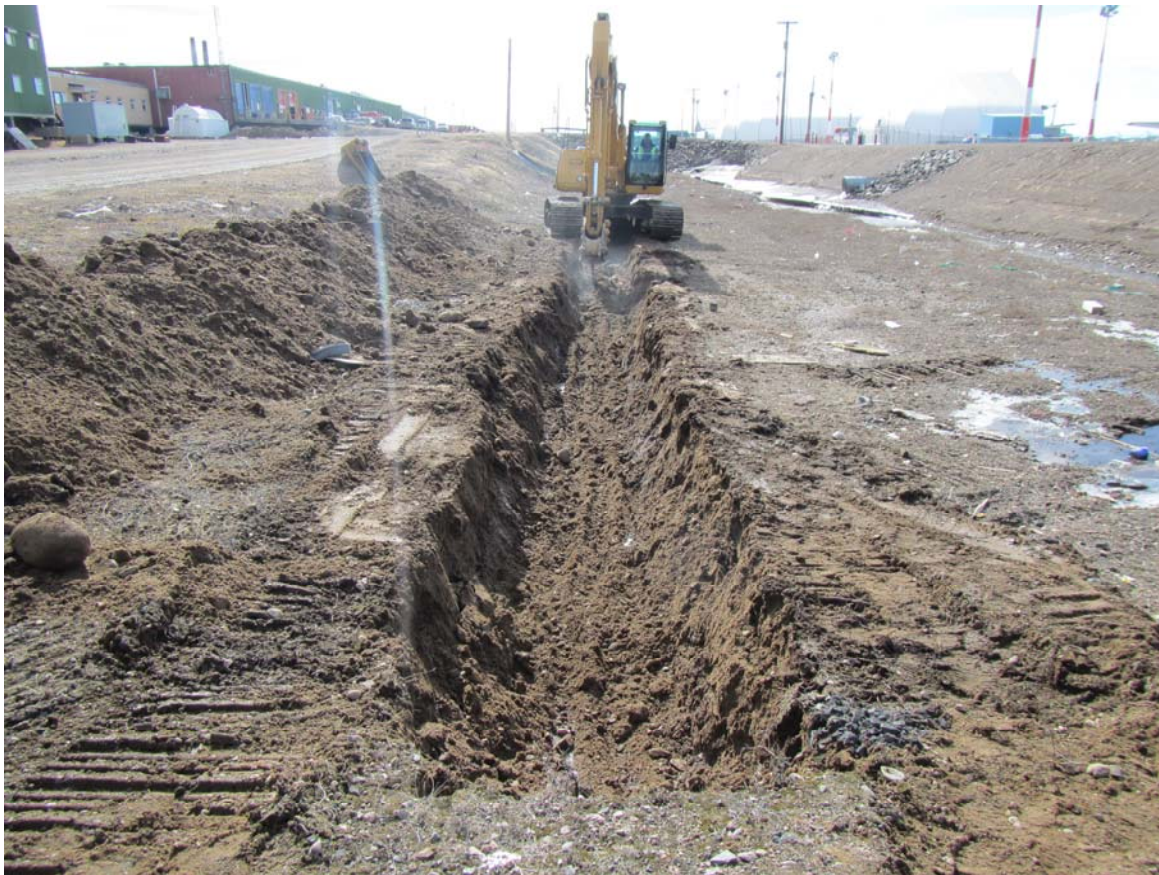
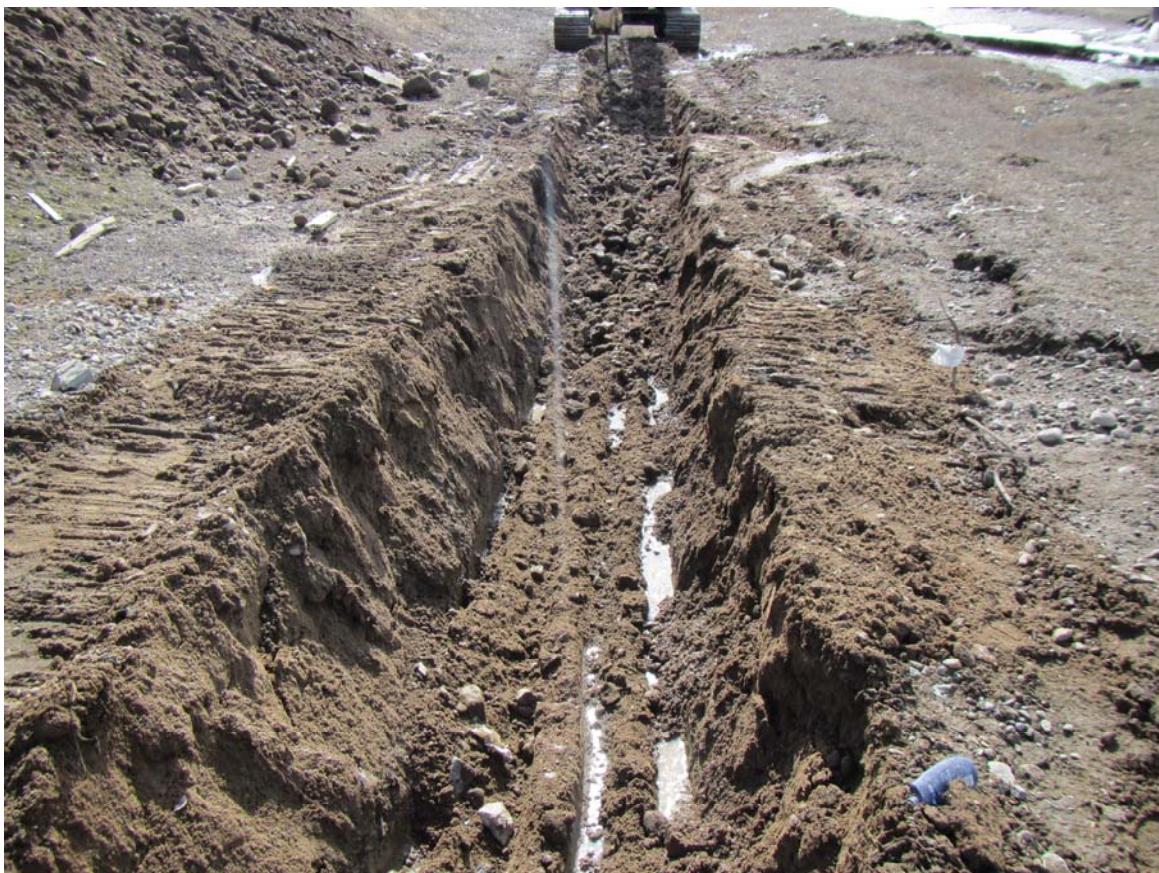
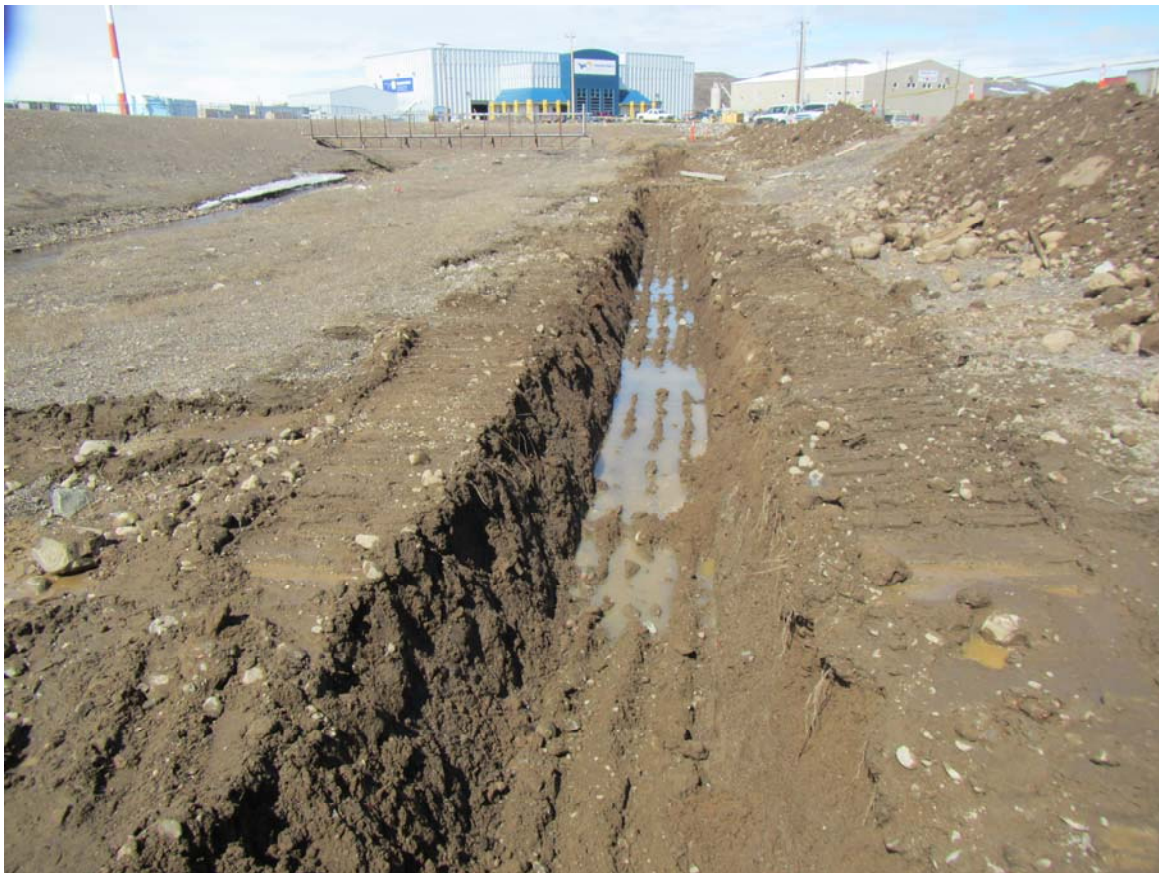
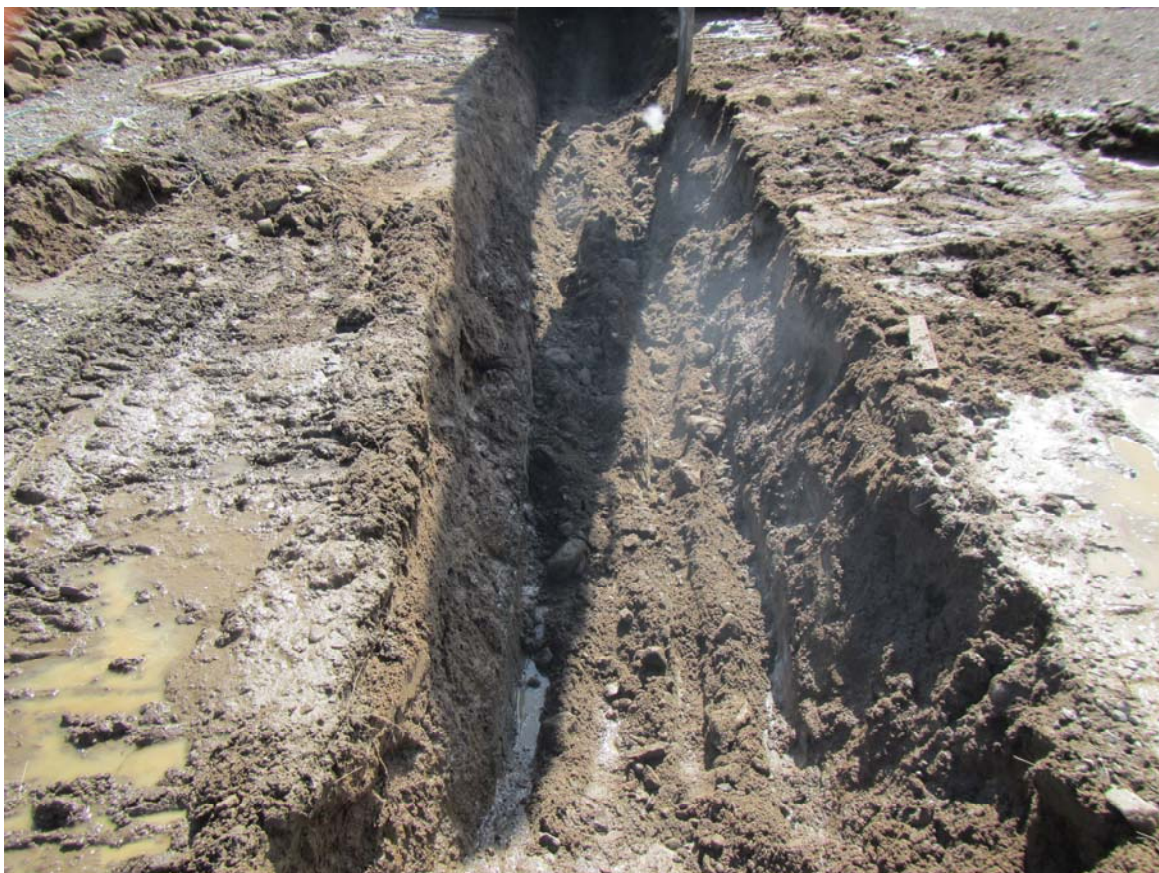
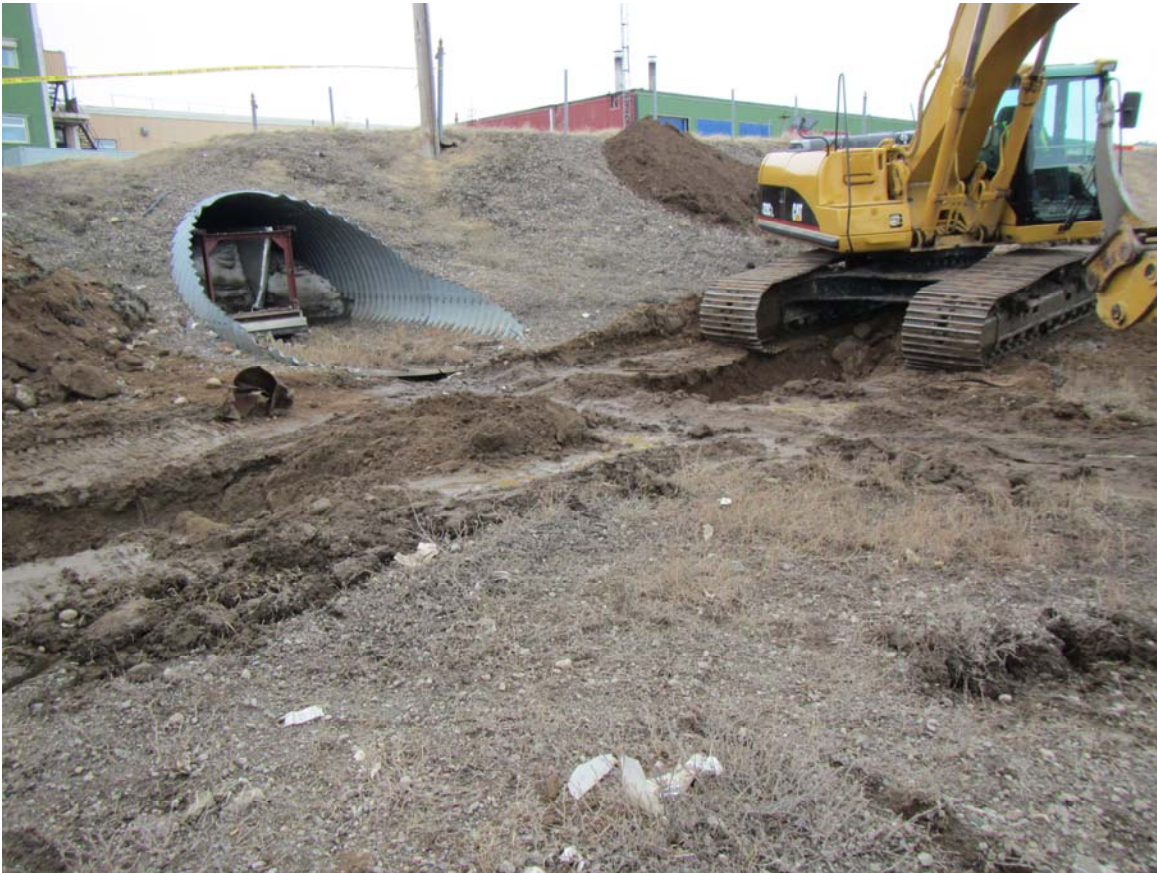
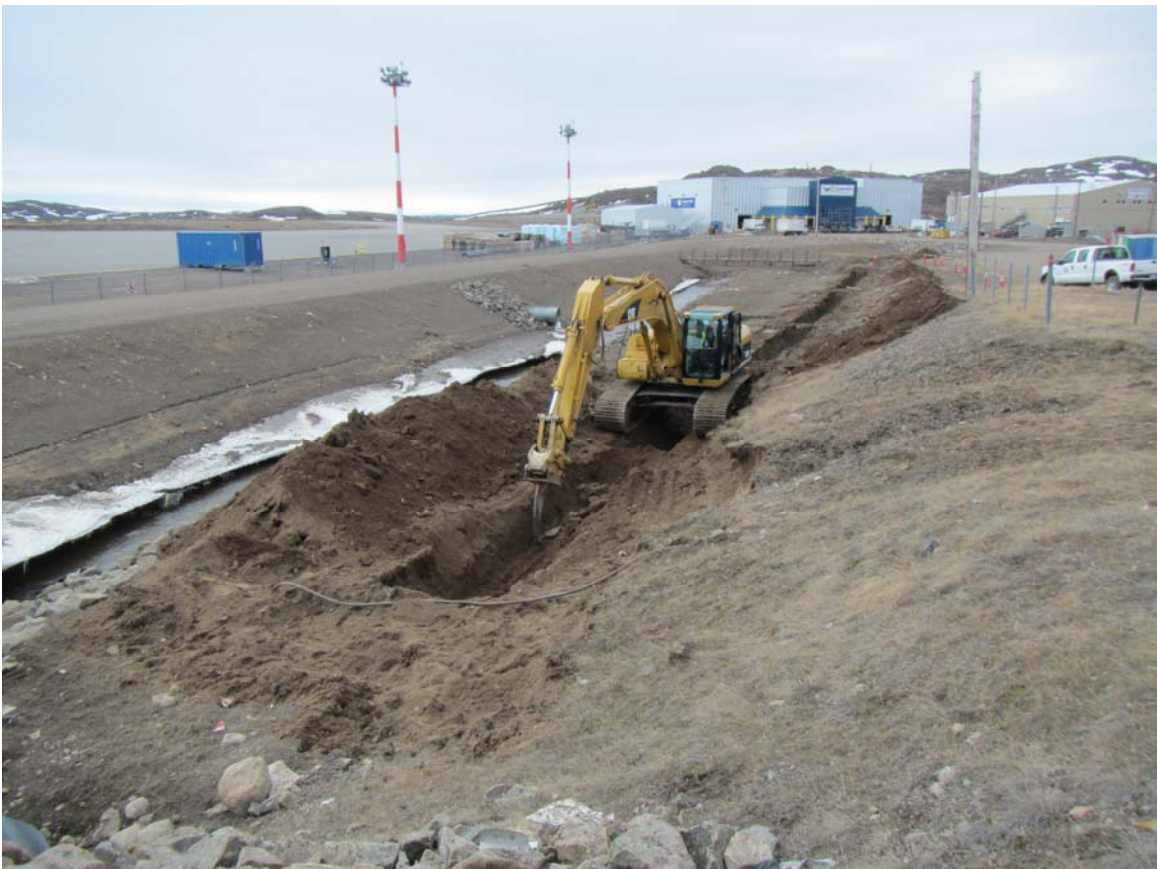
The trenches were dug down to a depth of 1 m. Frozen soil was encountered at approximately 0.5 to 0.75 m. The level of the bottom of the trenches was situated at approximately the same height as the surface level of the water flowing in the ditch. Once the trenches were dug, the water was mostly seeping in from the northeast side of the trench later in the day. There were also signs of water infiltration from the northwest side of the trench, but this appeared to originating primarily from melting soil.

It is difficult to determine the source of the contamination of the groundwater where CRA discovered PAH contamination. However, the results show that the water is contaminated and an AANDC water resource officer should be contacted to determine how to proceed. The water in the temporary diversion channel should be handled during the installation of the culverts. QE recommends that the temporary diversion channel be lined with an impermeable material to prevent the redirected water from coming into contact with the contaminated water found in the soils in this area.

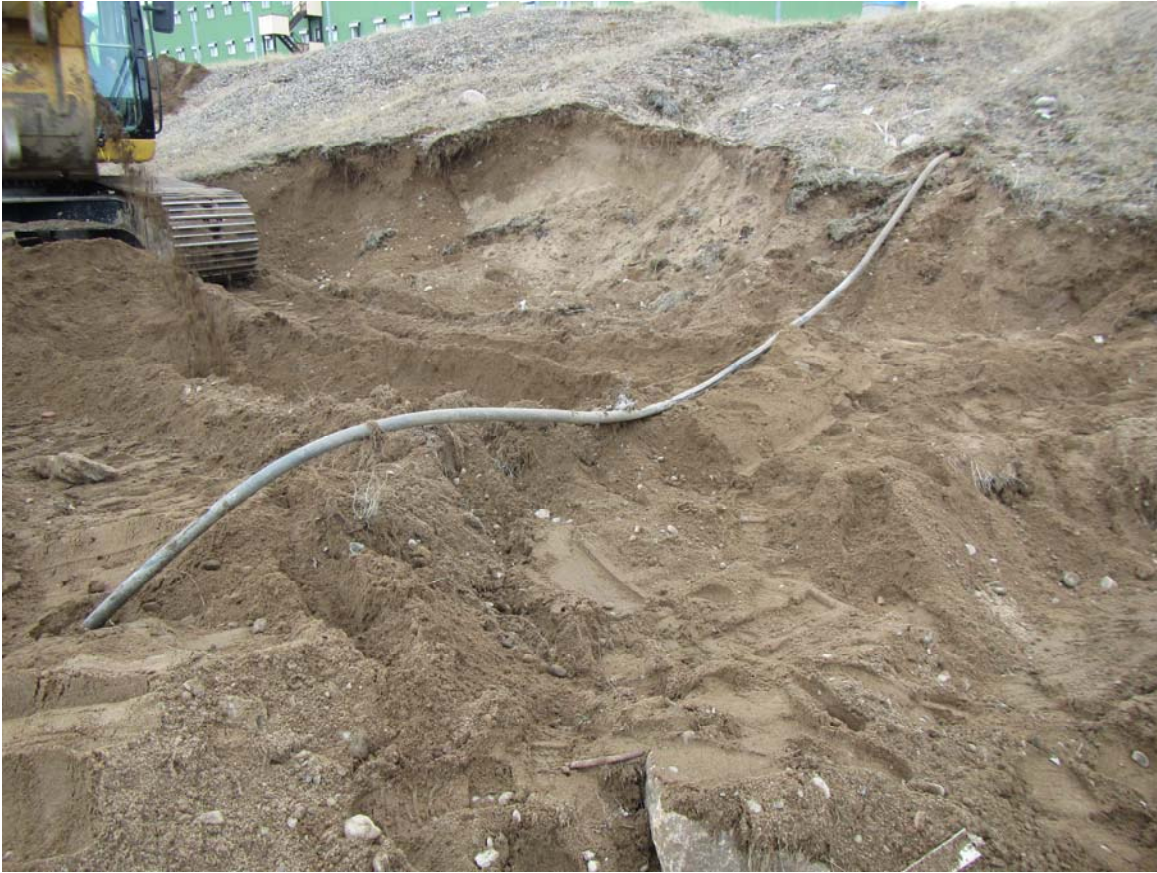
Photo 23: Communications Cable Found

One communications cable was found, buried approximately 6" below the ground surface, during the excavation of the trenches beside the drainage ditch. This communications cable was lightly impacted by the excavator. QE attempted to determine whom the communications cable belonged to and if it is still active. At the time of publishing this report, no owner of the cable had been found. This tends to suggest that this cable is no longer in use.
