**Project No: Water Use License No.: 1BR-JEN0712**

**Regarding: CAM-1, Jenny Lind Island DEW Line Site**

NWB Annual Report

Project Name: CAM-1, Jenny Lind Island DEW Line Site Clean Up

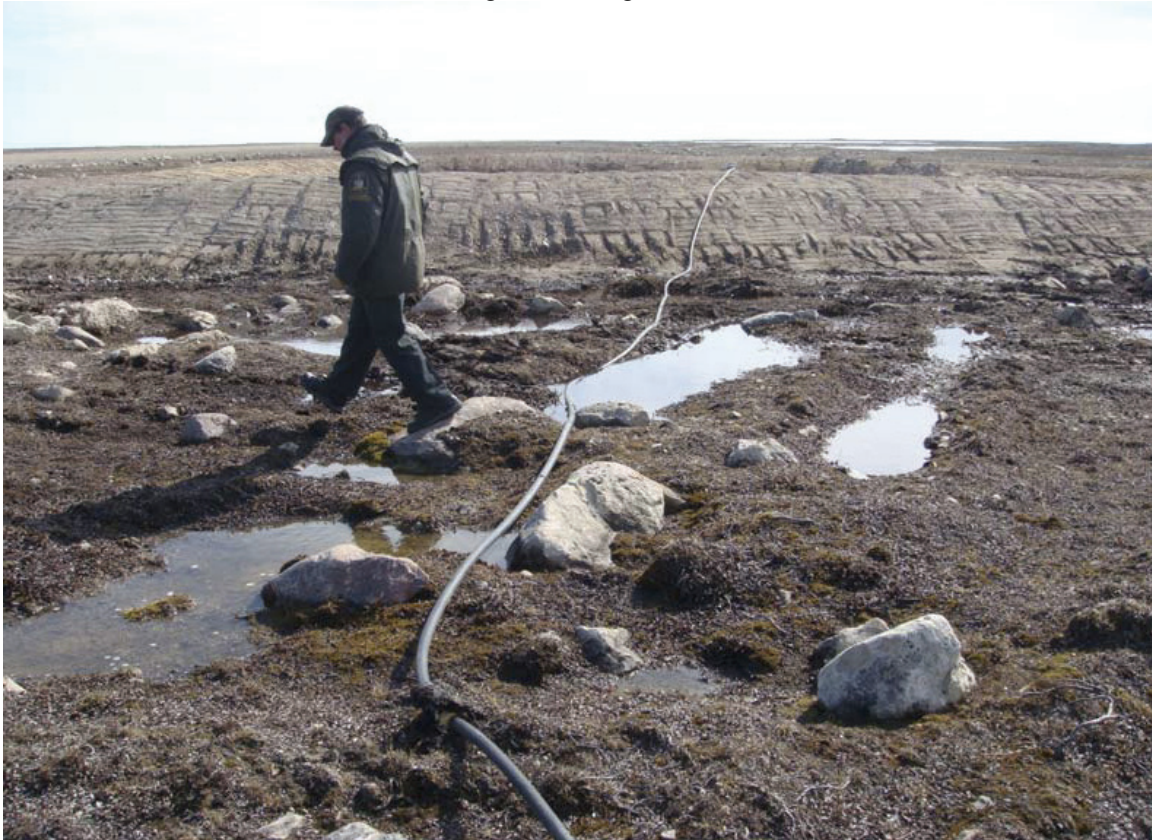
The sample collected from ponding water west of sewage lagoon met discharge criteria. The water was not discharged to land as this was suspected snow melt water and was not interfering with camp activities.

**Photo 1 (DSC00355):** Sample 09-25811 water ponding west of sewage lagoon facing east. Samples were taken to ensure that the water was not leaching from the lagoon

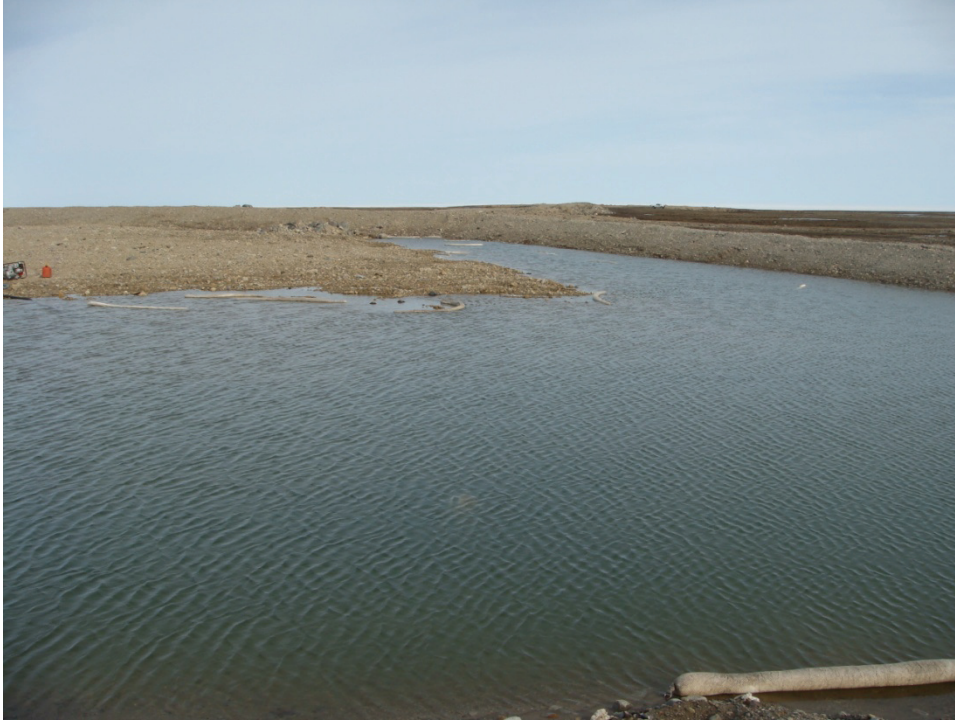
The analytical results for the Land farm met the wastewater discharge criteria. The water has been discharged to land in accordance to the water use license.

**Photo 1 (DSC00252): Sample 09-25725 waste water in landfarm, southwest corner, extending to the eastern corner.**

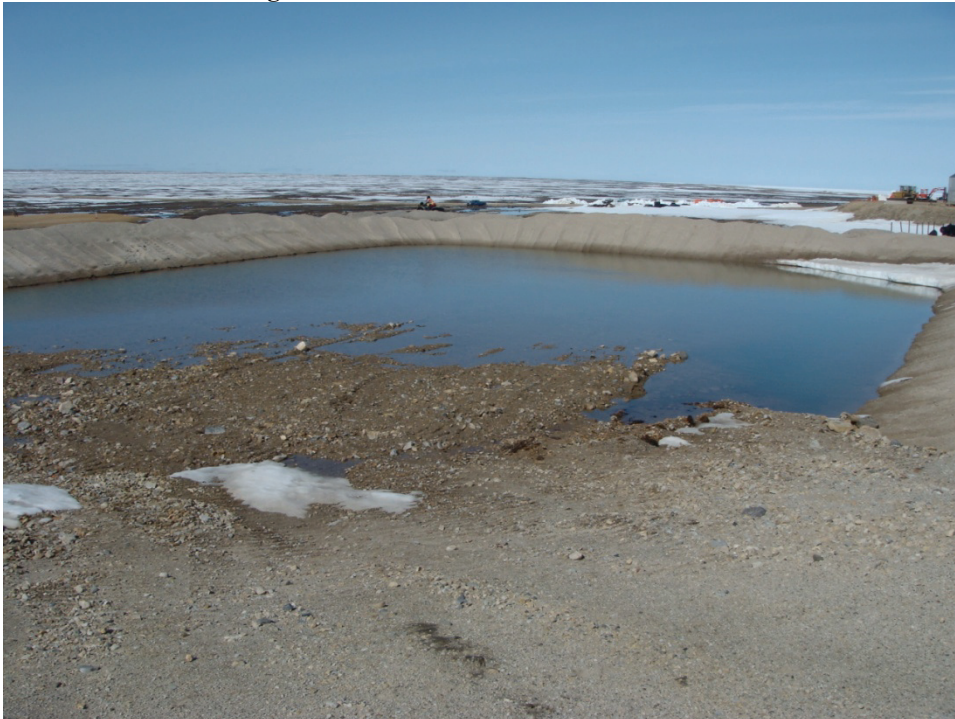
The analytical results for the Tier II Disposal Facility met the wastewater discharge criteria. The water has been discharged to land in accordance to the water use license.

**Photo 2 (DSC00099): Sample 09-25726 tier II facility facing north. Wastewater sample will be collected for the next flight.**

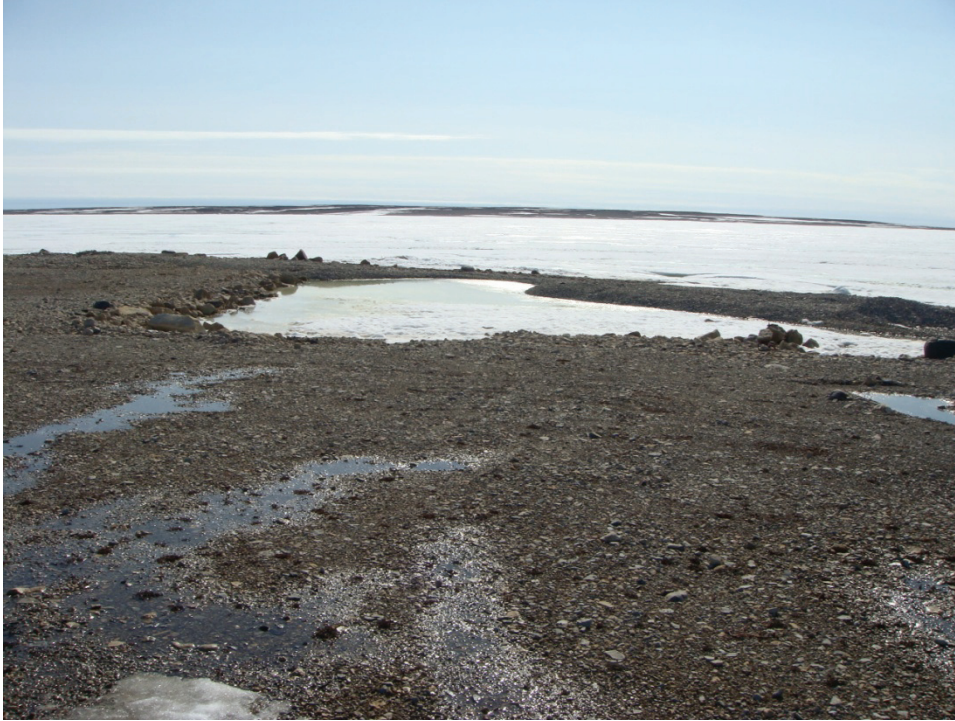
**Photo 3 (DSC00110): Sample 09-25727 west landing debris area facing southwest.**

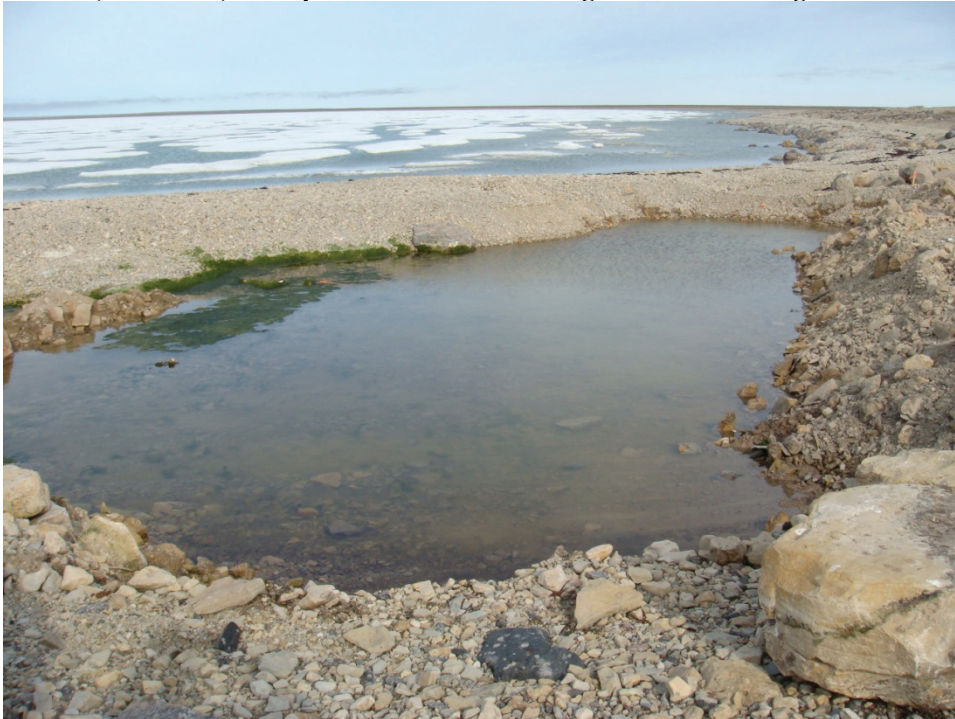
The analytical results for the west landing debris area met the wastewater discharge criteria.  
The water has been discharged to land in accordance to the water use license.

**Photo 4 (DSC00433): Sample 09-26157 west landing debris area facing west.**

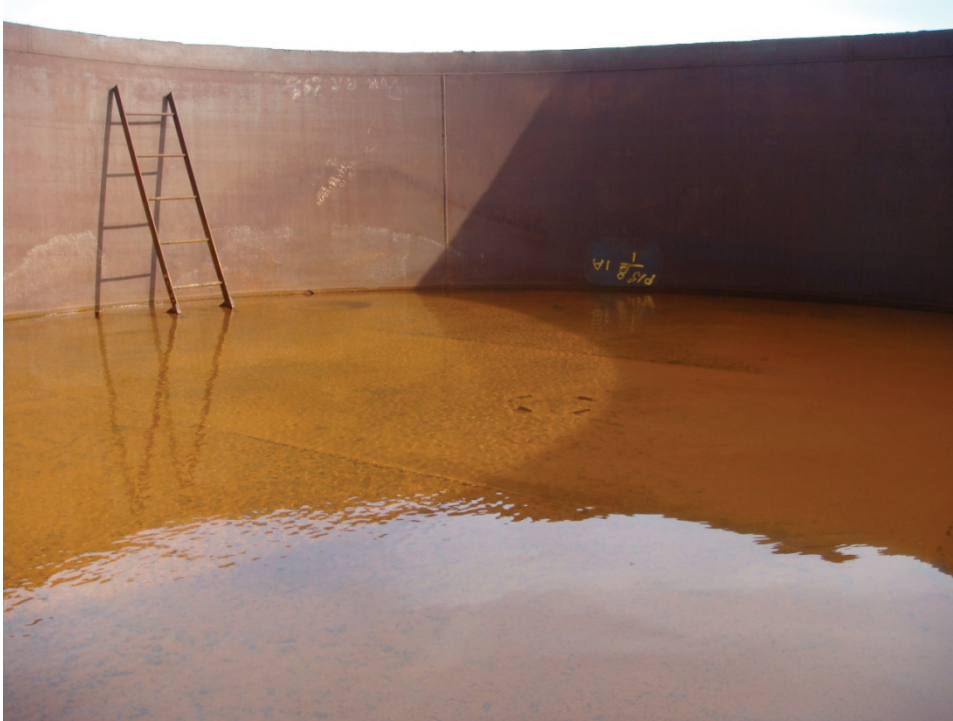
The analytical results for the former POL tank #2 met the wastewater discharge criteria.

**Photo 5 (DSC00231):** Sample 09-25728 empty former POL tank, not used for barrel storage, facing south, view from hole in the side of tank.

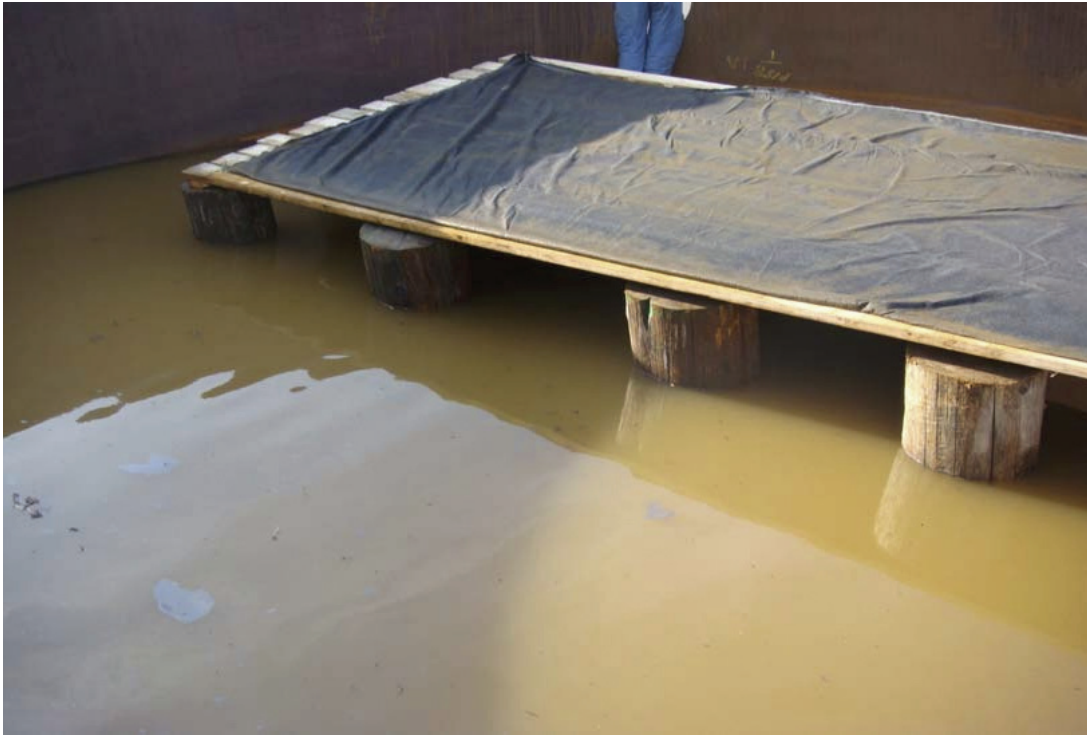
**Photo 9 (DSC00450): Sample 09-26182 former POL filter pack.**

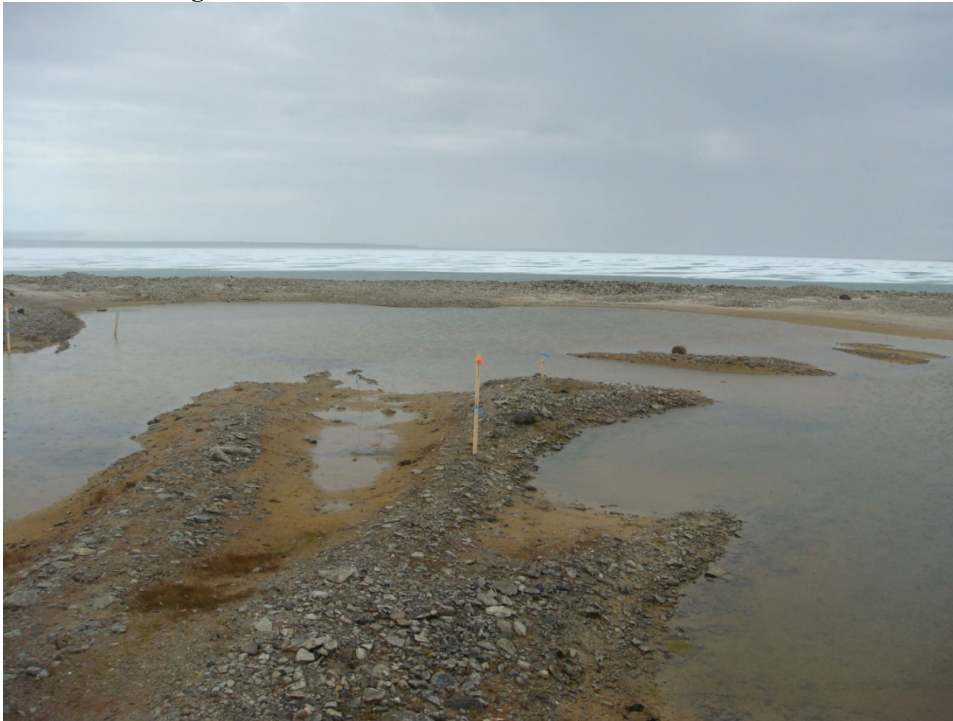
**Photo 10 (DSC00458): Sample 09-26243 north edge of east point debris regrade with sampled wastewater facing northwest.**

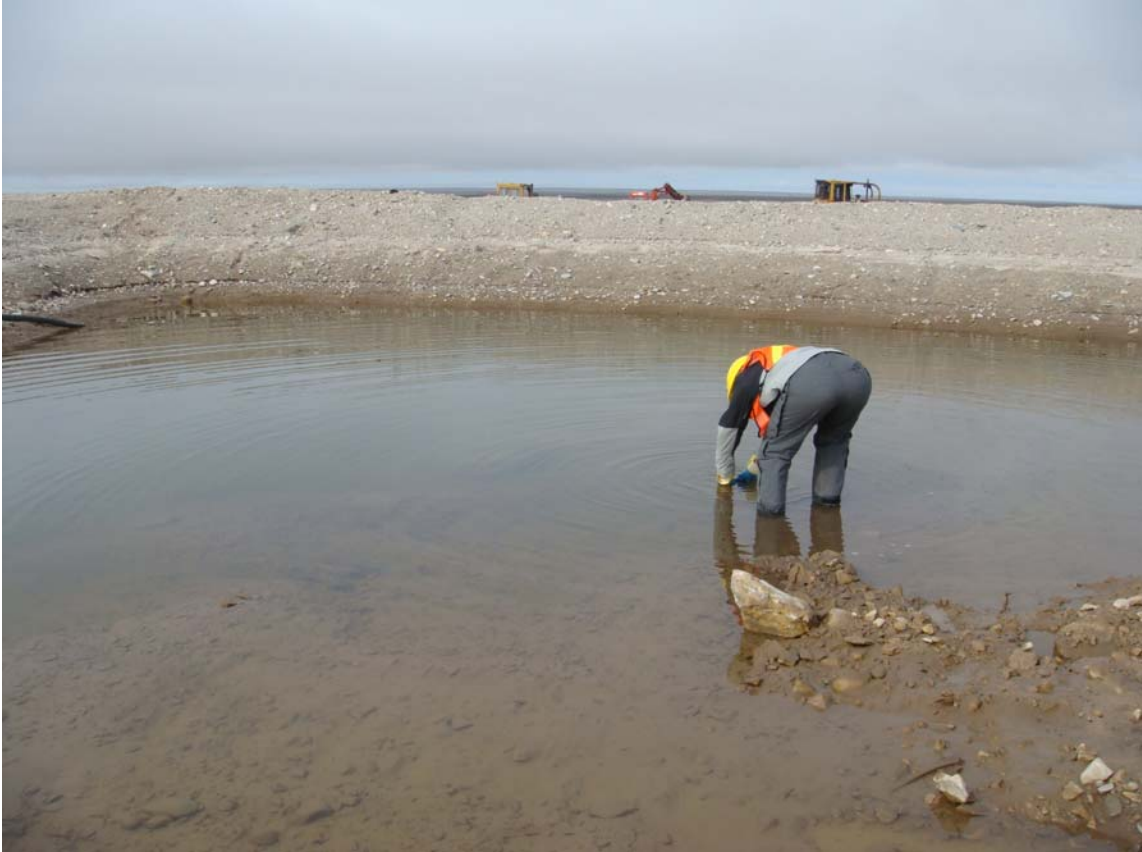
**Photo 1 (DSC00662):** Sample 09-26555 southwest corner inside land farm with sampled waste water facing southwest.
