**GOVERNMENT OF NUNAVUT
DEPARTMENT OF PUBLIC WORKS AND
SERVICES**

**Former Tank Farm Site Remediation
Kugaaruk, Nunavut**

Document No. 0222880801-REP-V0001-01

AUGUST 2008

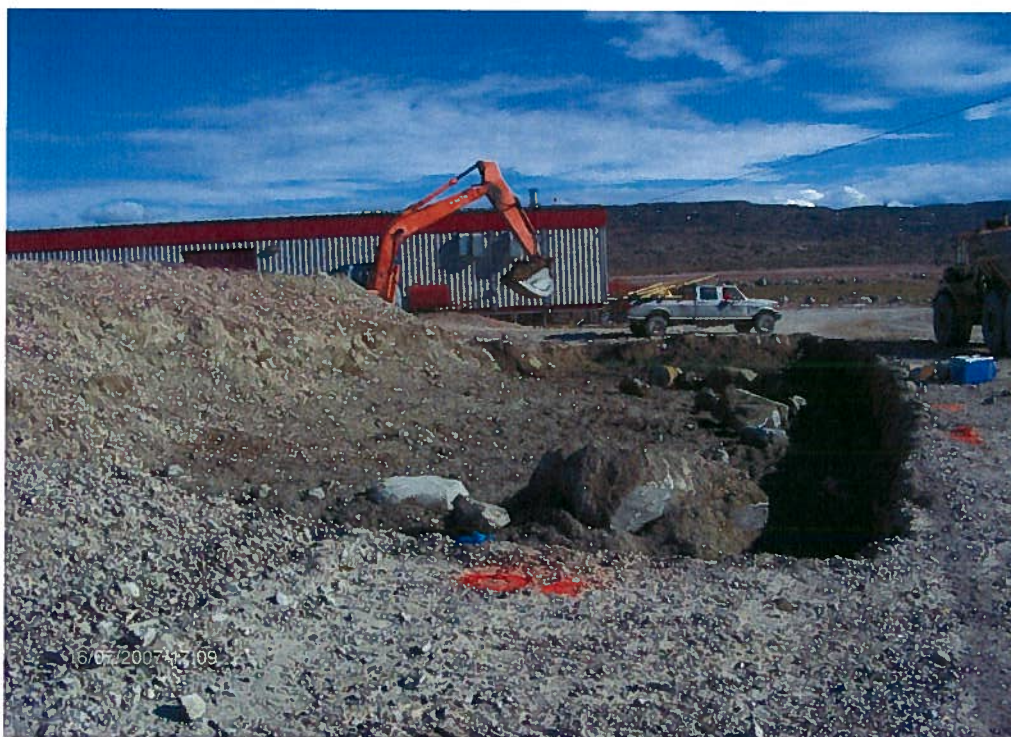
Photo 2: View of the northwestern portion of the Recreation Complex Excavation.

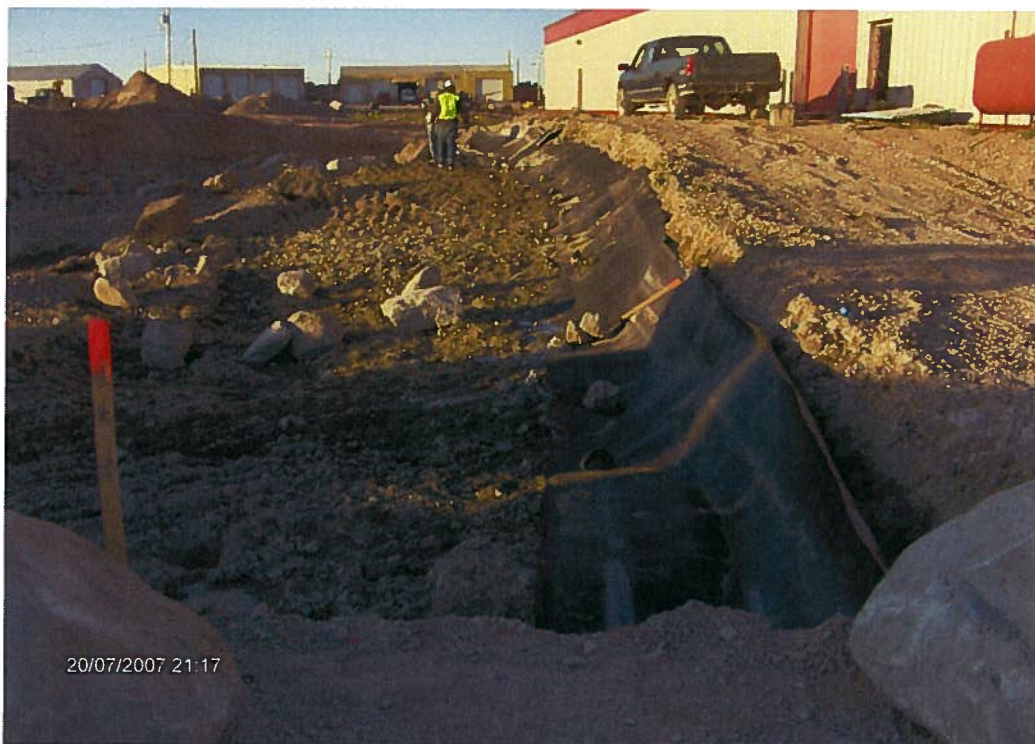
Soil headspace results did not exceed 500 ppm in the final excavation walls, with the exception of the south wall of the Recreation Complex excavation; a hydrocarbon resistant liner was installed in this area of the site. Some base samples within the southwest portion of the Recreation Complex excavation exceeded 500 ppm, where impacts were in the permafrost horizon. There are remaining impacts along the

central south portion of the excavation base. Attempts were made to excavate the impacted permafrost in this area, however it was deemed that undermining the permafrost close to the Recreation Complex could do harm. Samples with the highest soil headspace readings were submitted to the laboratory for petroleum hydrocarbon analyses.

Sample S212 (south base) exceeded the remediation guidelines for PHC F1 and F2; the sample is considered to be representative of impacts that remain in the permafrost horizon at the southwest base of the excavation. All impacts could not be removed at the base of the excavation due to the limitations of the equipment in frozen soils and the close proximity of the recreation complex foundation.

Photo 3: View of the southern portion of the Recreation Complex excavation. Note geomembrane liner along the south wall.

The southern wall of the Recreation Complex Excavation was not extended to ensure that the northern foundation of the Recreation Complex was not disturbed. To prevent possible contaminant migration into the excavated area, a 60 mil Geotechnical HDPE Liner was installed along the western portion of the Recreation Complex excavation's southern wall from base to grade.

The Recreation Complex Excavation could not be advanced further south due to the presence of the Complex, and it is suspected that the soil impacts have migrated under the northwest corner of the Complex. This portion of the building is above grade and appears to have adequate ventilation. No further remedial action is recommended at this time.

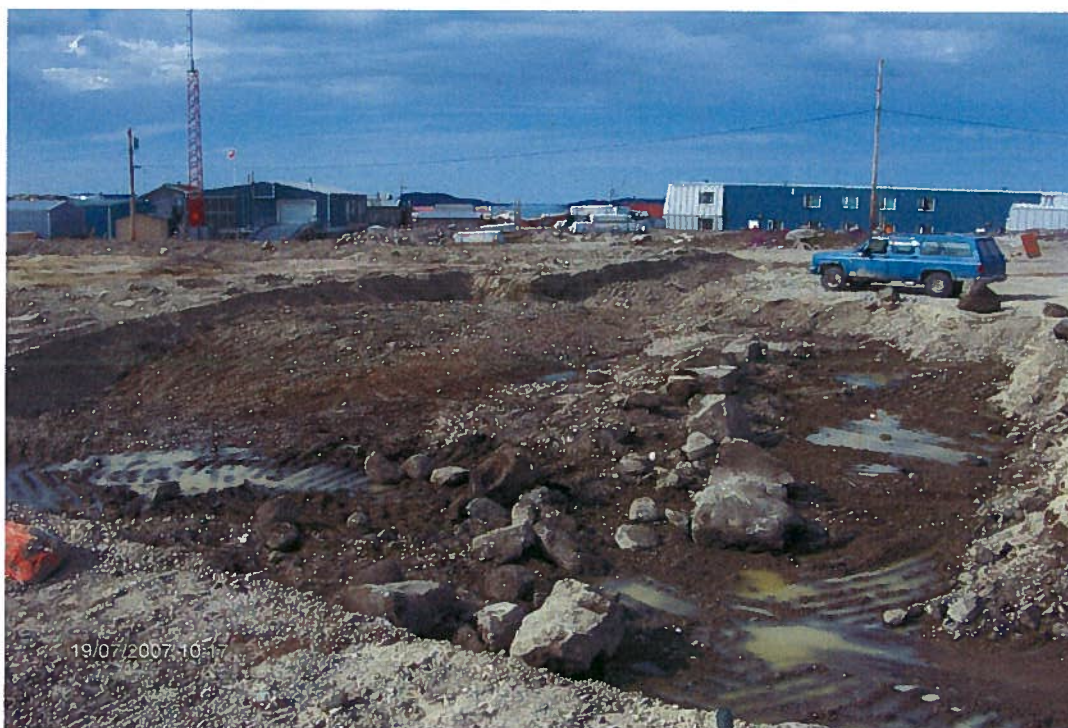
Soil headspace results did not exceed 250 ppm in the final excavation walls. Some base samples within the south and west portions of the Cabinet Excavation exceeded 500 ppm, these impacts were within the permafrost horizon, and were unable to be excavated.

Photo 4: View of the Cabinet excavation. Photo taken facing east.

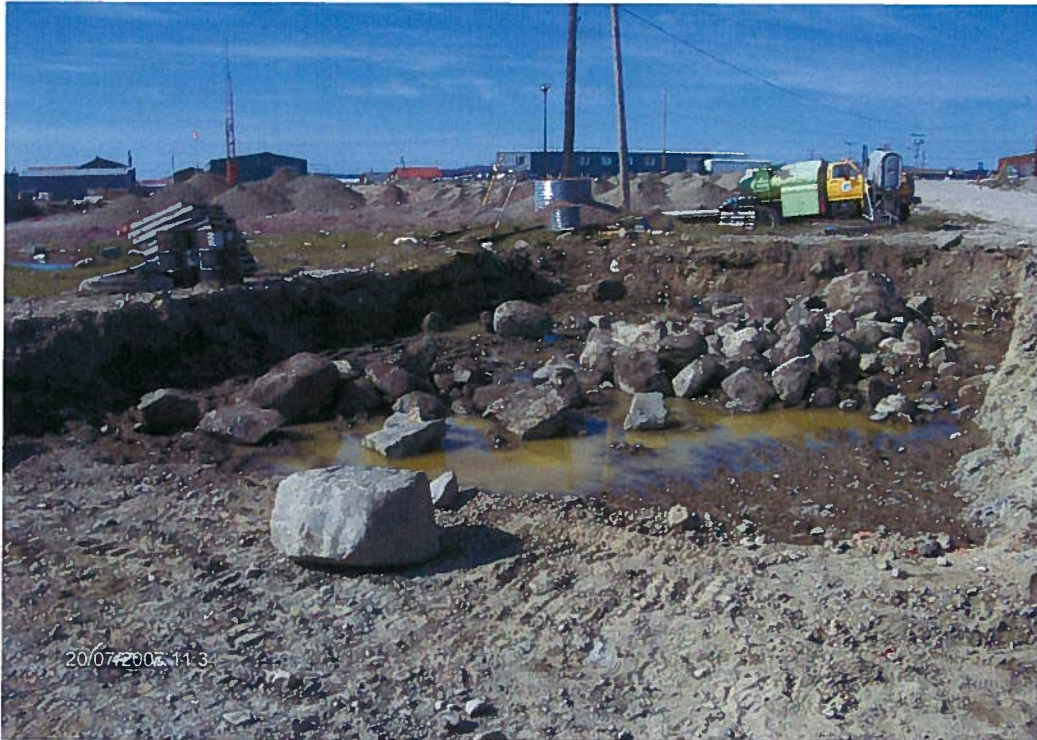
Photo 5: View of the Vertical Tank excavation. Photo taken facing west.

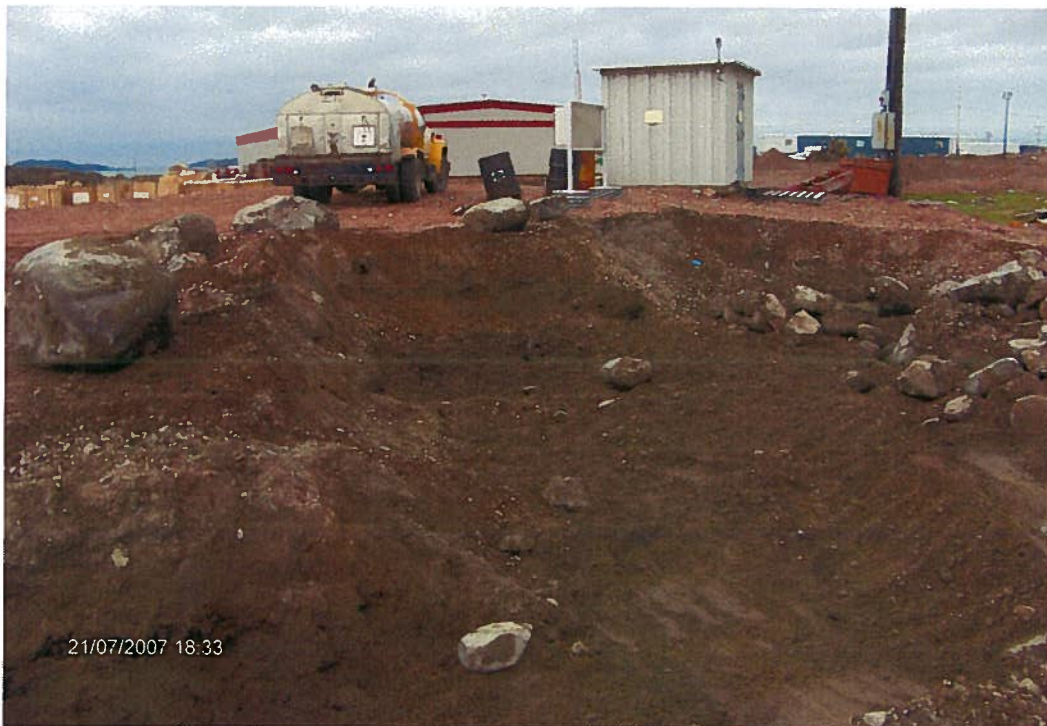
Soil headspace results did not exceed 500 ppm in the final excavation walls. Soil headspace results exceeded 500 ppm periodically for base samples; however, these samples were analysed on-site with the PetroFlag® analyser, and found to be below the applicable guidelines.

Photo 6: View of Fuel Re-Supply excavation. Note fuel re-supply station. Photo taken facing west.

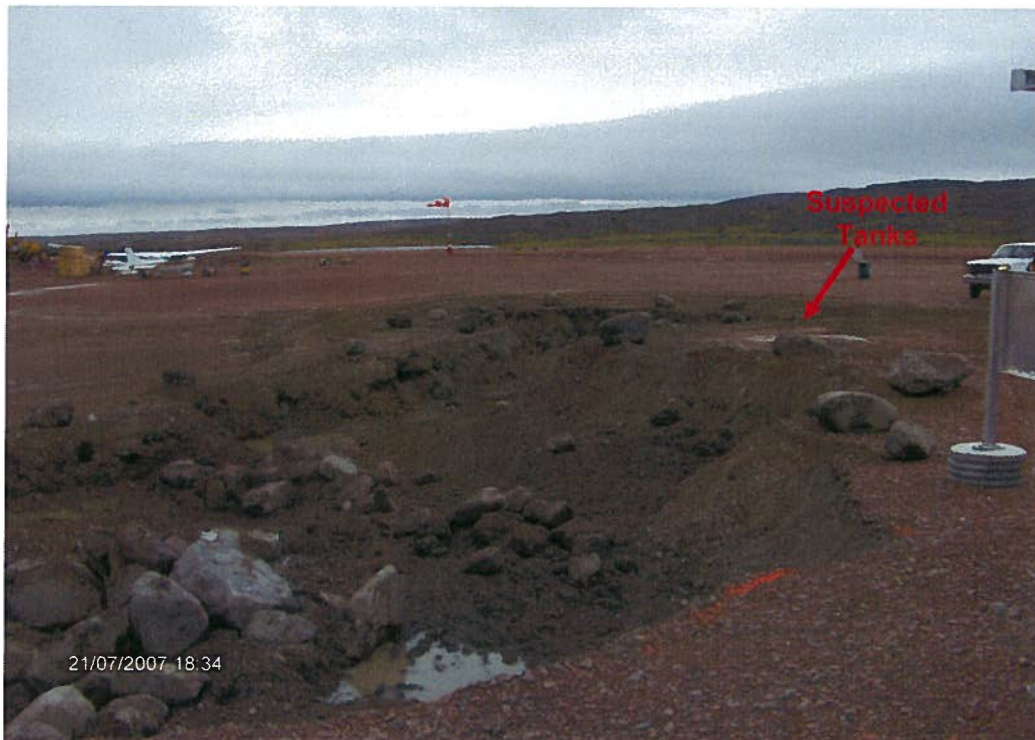
Photo 7: View of Fuel Re-Supply excavation. Photo taken facing east. Note runway in the distance.

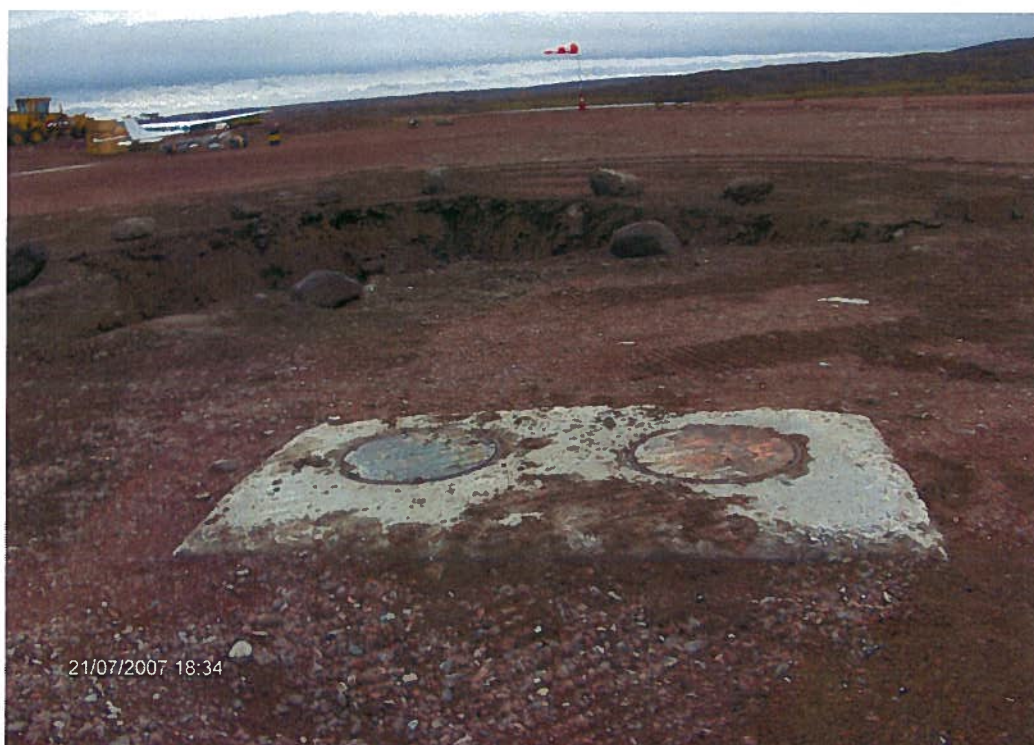
Photo 8: View of underground offloading gas and diesel lines near the fuel re-supply station. Lines run west toward the supply station. Photo taken facing east.

Wardrop recommends that the underground offloading gas and diesel lines near the fuel re-supply building be removed to ensure that the adjacent excavation and clean fill are not impacted due to contaminant migration.

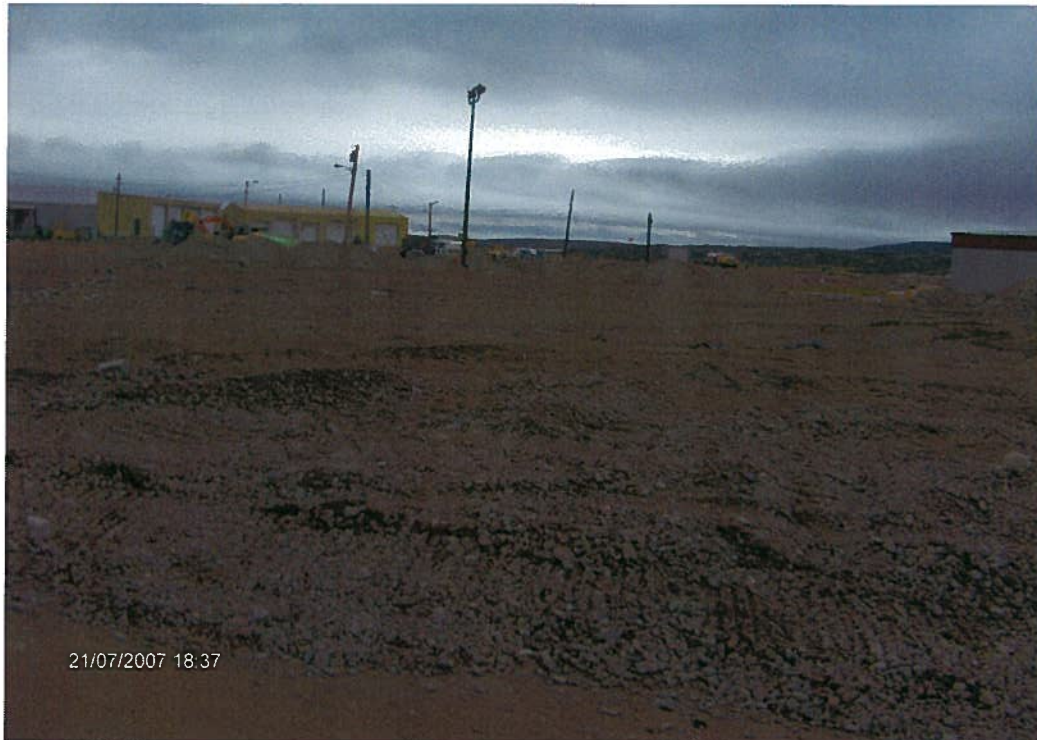
Photo 9: View of backfilling and compacting the Cabinet excavation. Photo taken facing northeast.

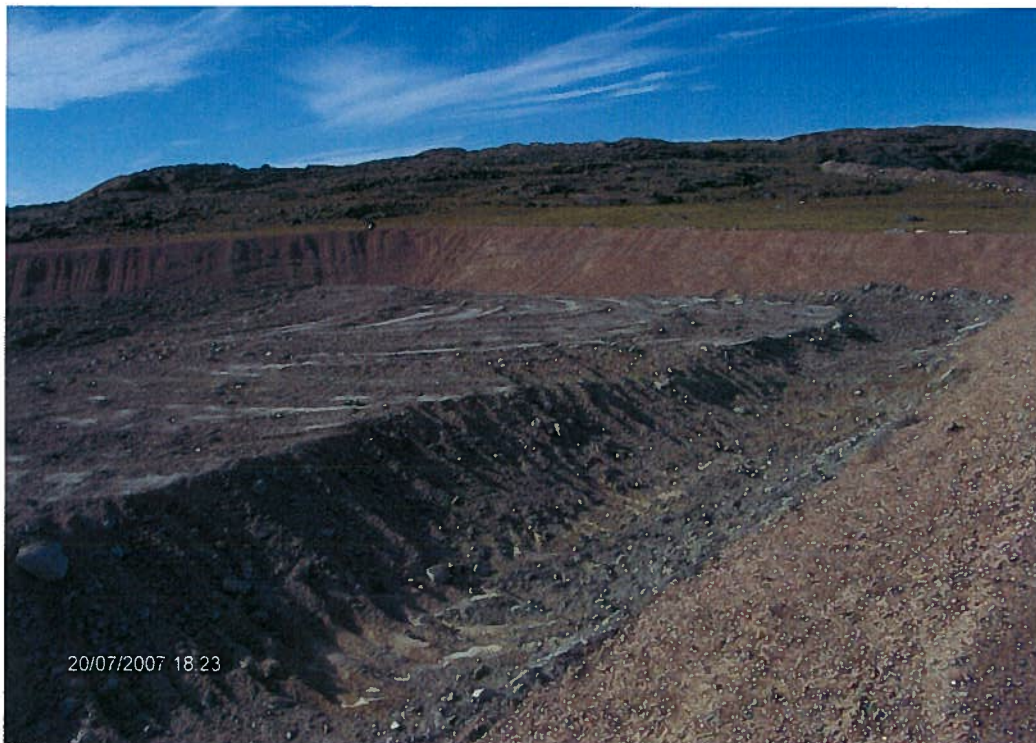
Immediately following the excavation of impacted material, the impacted soils were transported to the Landfarm Facility. A dedicated rubber-tired loader at the Facility spread the soils evenly, and ensured that a one meter perimeter buffer strip was maintained between the toe of the soil and the interior berm. The resulting soil pile was approximately 0.9 m in height. Care was taken to prevent compaction of the soils and damage of the underlying HPDE liner membrane during soil placement.

Photo 10: View of the Landfarm Facility with impacted soils. Note drainage areas along the perimeter of the cell.

Compliance with the Nunavut Water Licence also requires the installation of monitoring wells. Wardrop recommends that five downgradient groundwater monitoring wells be installed to confirm that there is no subsurface migration of contaminants from the Landfarm. Wells will be a standard sandpoint design with the screened section extending from near surface to refusal. Groundwater will be sampled twice per year, and analysed for BTEX and Fraction 1 to Fraction 4 Petroleum Hydrocarbon constituents. A water sample should also be collected from the landfarm sump pit.
