**GOVERNMENT OF NUNAVUT
DEPARTMENT OF COMMUNITY AND
GOVERNMENT SERVICES**

**Kugaaruk Landfarm Facility –
2011 Annual Report**

Document No. 0222880805-REP-V0008-02

DECEMBER 2012

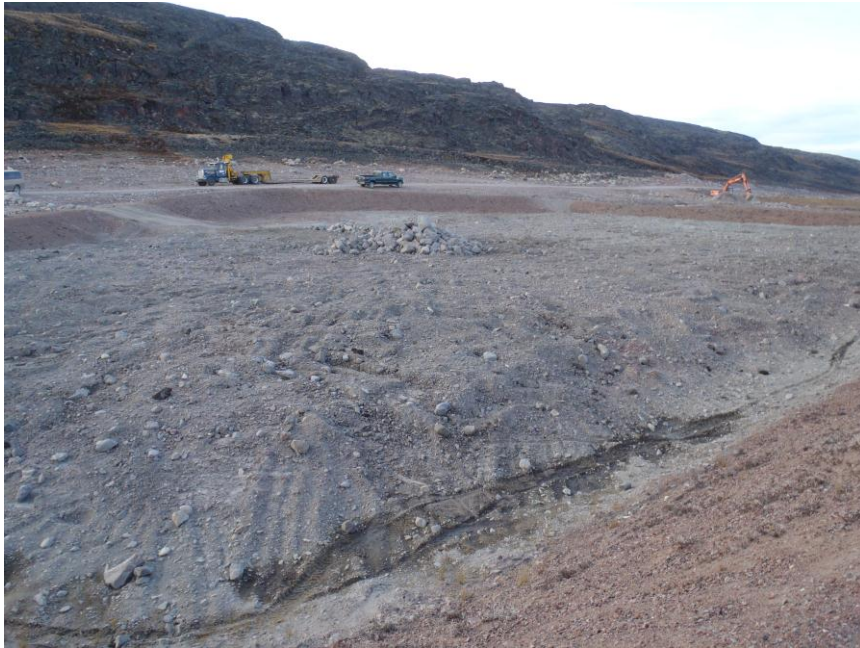
Photo 1: View of the landfarm from the southwest corner – September 2011.

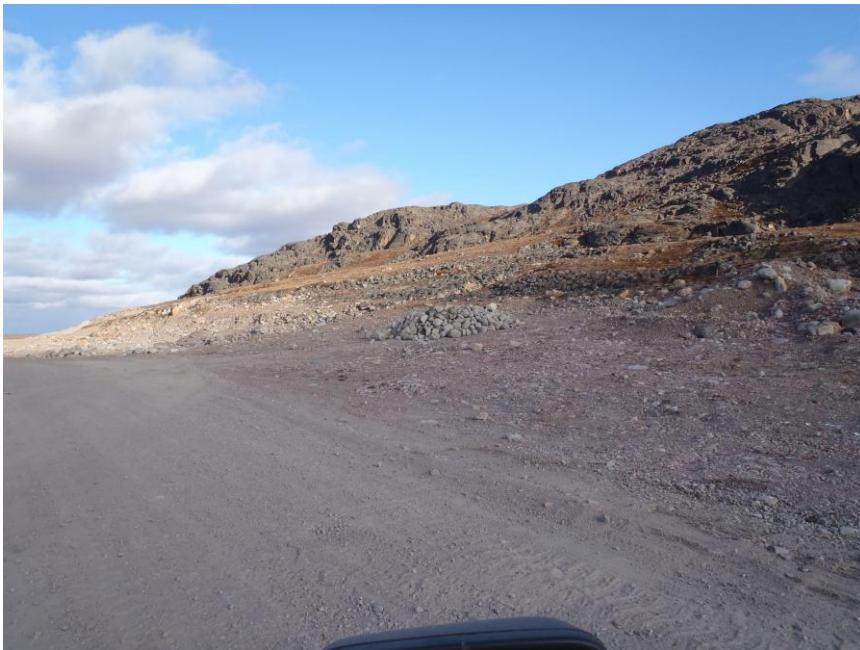
Photo 2: View of the removed boulders piled across public road to the north of the landfarm – September 2011.

During 2011, a number of large rocks were removed from the treatment area. The rocks were examined by TetraTech staff and there was no evidence of visible staining. The rocks were not cleaned prior to removal. The rocks removed were piled in an area adjacent to the landfarm (Photo 2).

The general contractor recommended removal of a number of small boulders from the soil treatment area to improve the soil turning operation. The boulders were first piled on top of the soil treatment layer where they were visually examined by TetraTech during the September, 2011 monitoring program. No visible evidence of hydrocarbon staining was found and the contractor was directed to remove the boulders from the landfarm. The boulders were piled across the public road on the north of the landfarm (Photo 2).

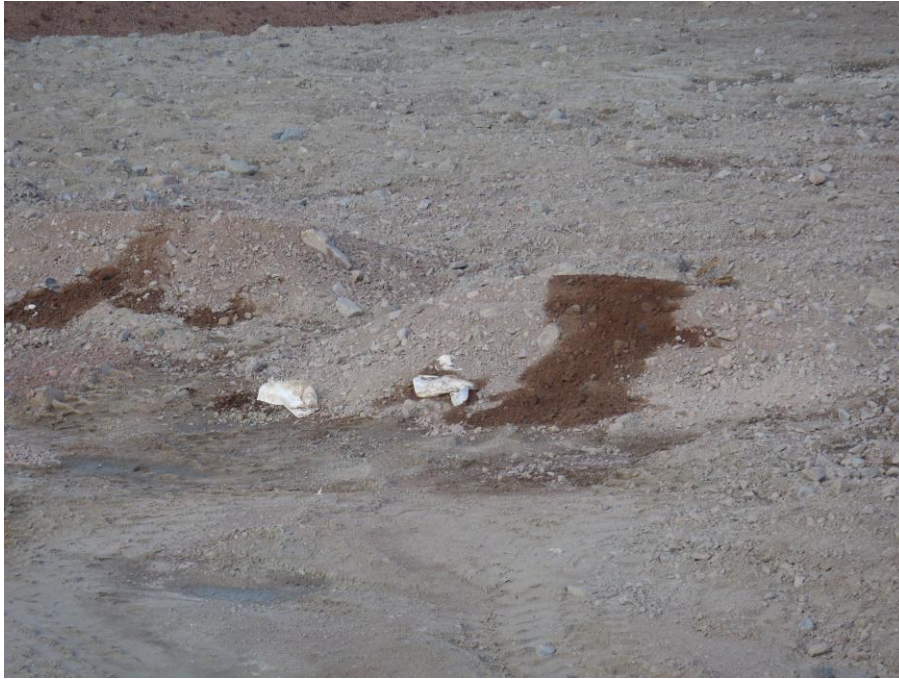
Photo 3: View of the stains on the edge of the treatment pile – September 2011.

Tetra Tech has investigated several possible explanations for the increase in PHC concentrations in the soil samples. During the July site inspection of the facility, it was noted that approximately twenty drums containing diesel fuel-water mixture had been left within the treatment cell at the landfarm. It is not certain whether any of the contents of the drums had been dumped on the soil treatment pile. Some small stains (Photos 3 & 4) were noted on the inside of the treatment cell berm and on the edge of the treatment pile, but that was not considered to be significant enough in itself to account for the increases observed in the 2011 results.

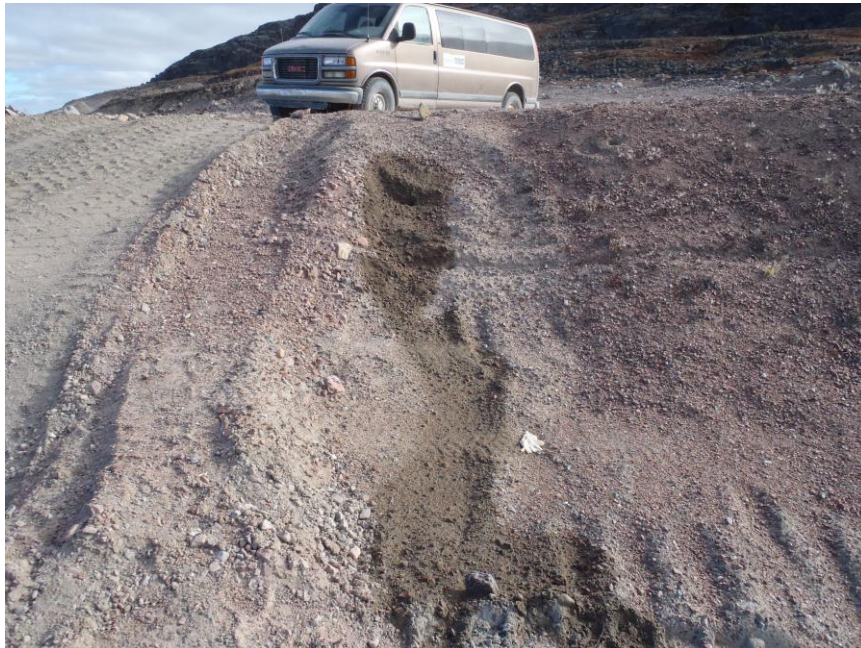
Photo 4: View of the stains on the inside of the treatment cell berm – September 2011.

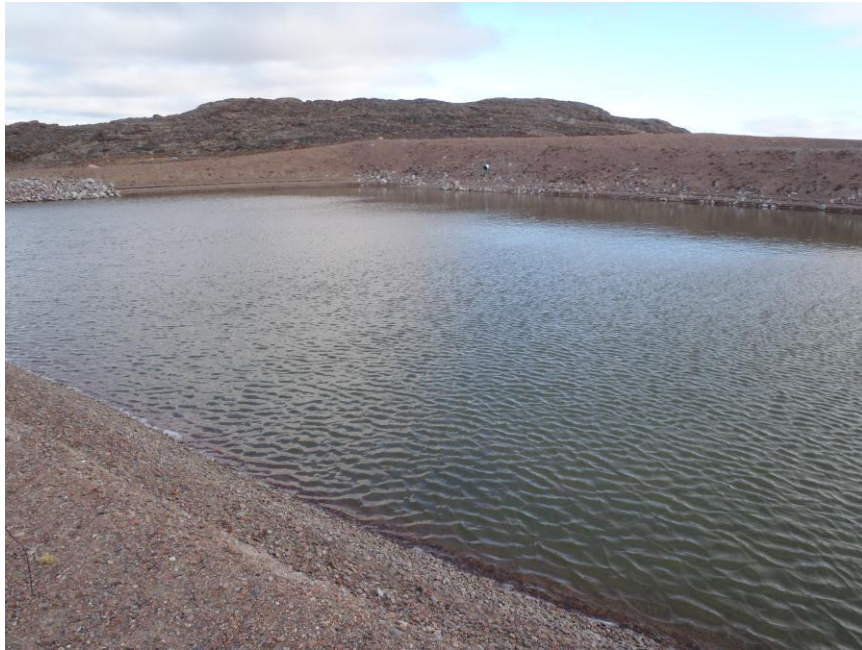
Photo 5: View of the water retention cell prior to discharge – September 2011.

The volume of water discharged from the retention cell was determined by measuring the water depth before the discharge and calculating the volume using the cell dimensions. An adjustment was made for the estimated residual volume left in the bottom of the cell after discharge. There was approximately 1150 cubic meters of water in the cell prior to discharge, and an estimated 100 cubic meters remained after pumping, for a net discharge volume of 1050 cubic meters. Pumping occurred over a 24 hour period, resulting in an estimated flow rate of 700 liters per minute. All water discharge was directed to a splash pad to prevent erosion.

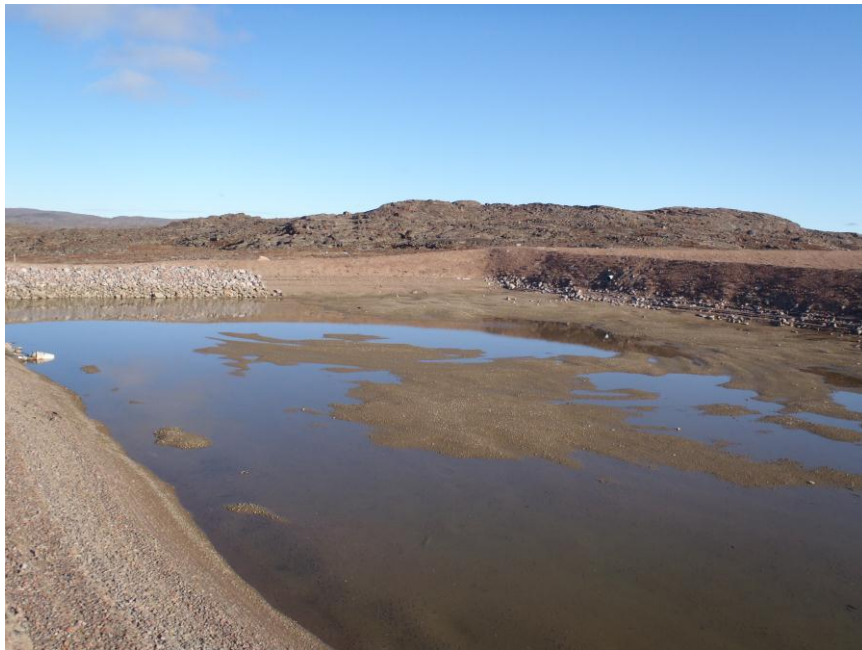
Photo 6: View of the water retention cell after discharge – September 2011.

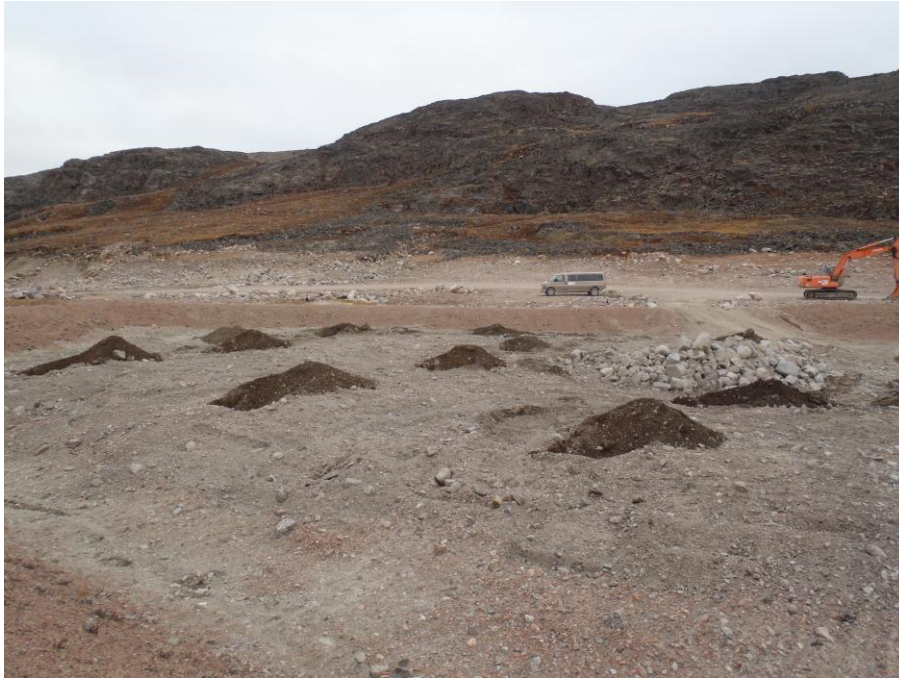
Photo 7: View of the treatment pile sampling locations LF6 to LF4 (left to right) – September 2011.

In the two previous years, soil samples were collected from 30 centimeters below the top of the soil pile in accordance with the procedure which had been established by Tetra Tech. The 2011 program took samples at 60 centimeters below grade. During the soil turning operation, the contractor has been careful not to disturb the layer of granular material directly above the geotextile liner. The increased sampling depth has likely resulted in the composite samples including soil which is below the average turning depth and has not been subject to the same level of bio treatment as the upper soil profile which has been turned and aerated more frequently.

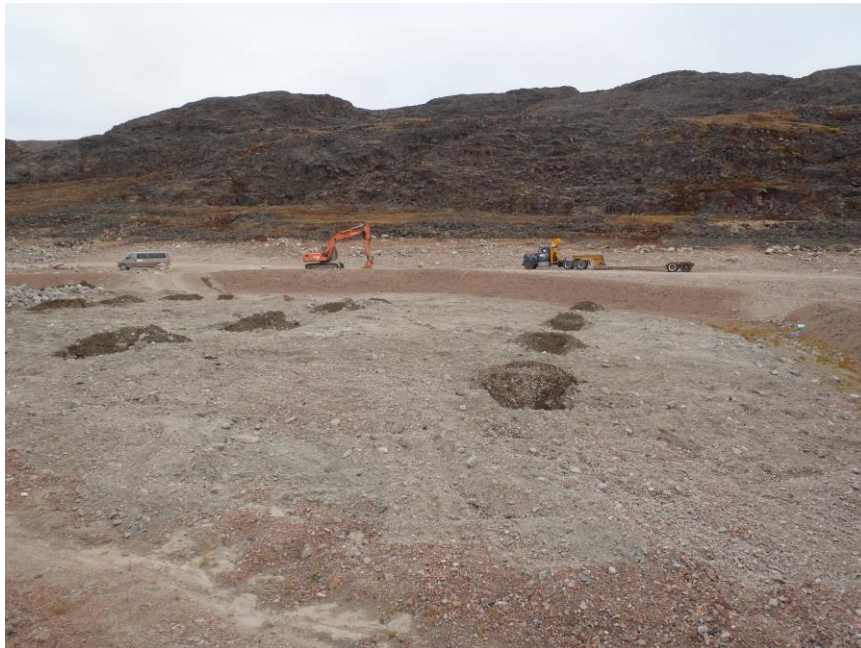
Photo 8: View of the treatment pile sampling locations LF1 to LF3 (right to left) – September 2011.

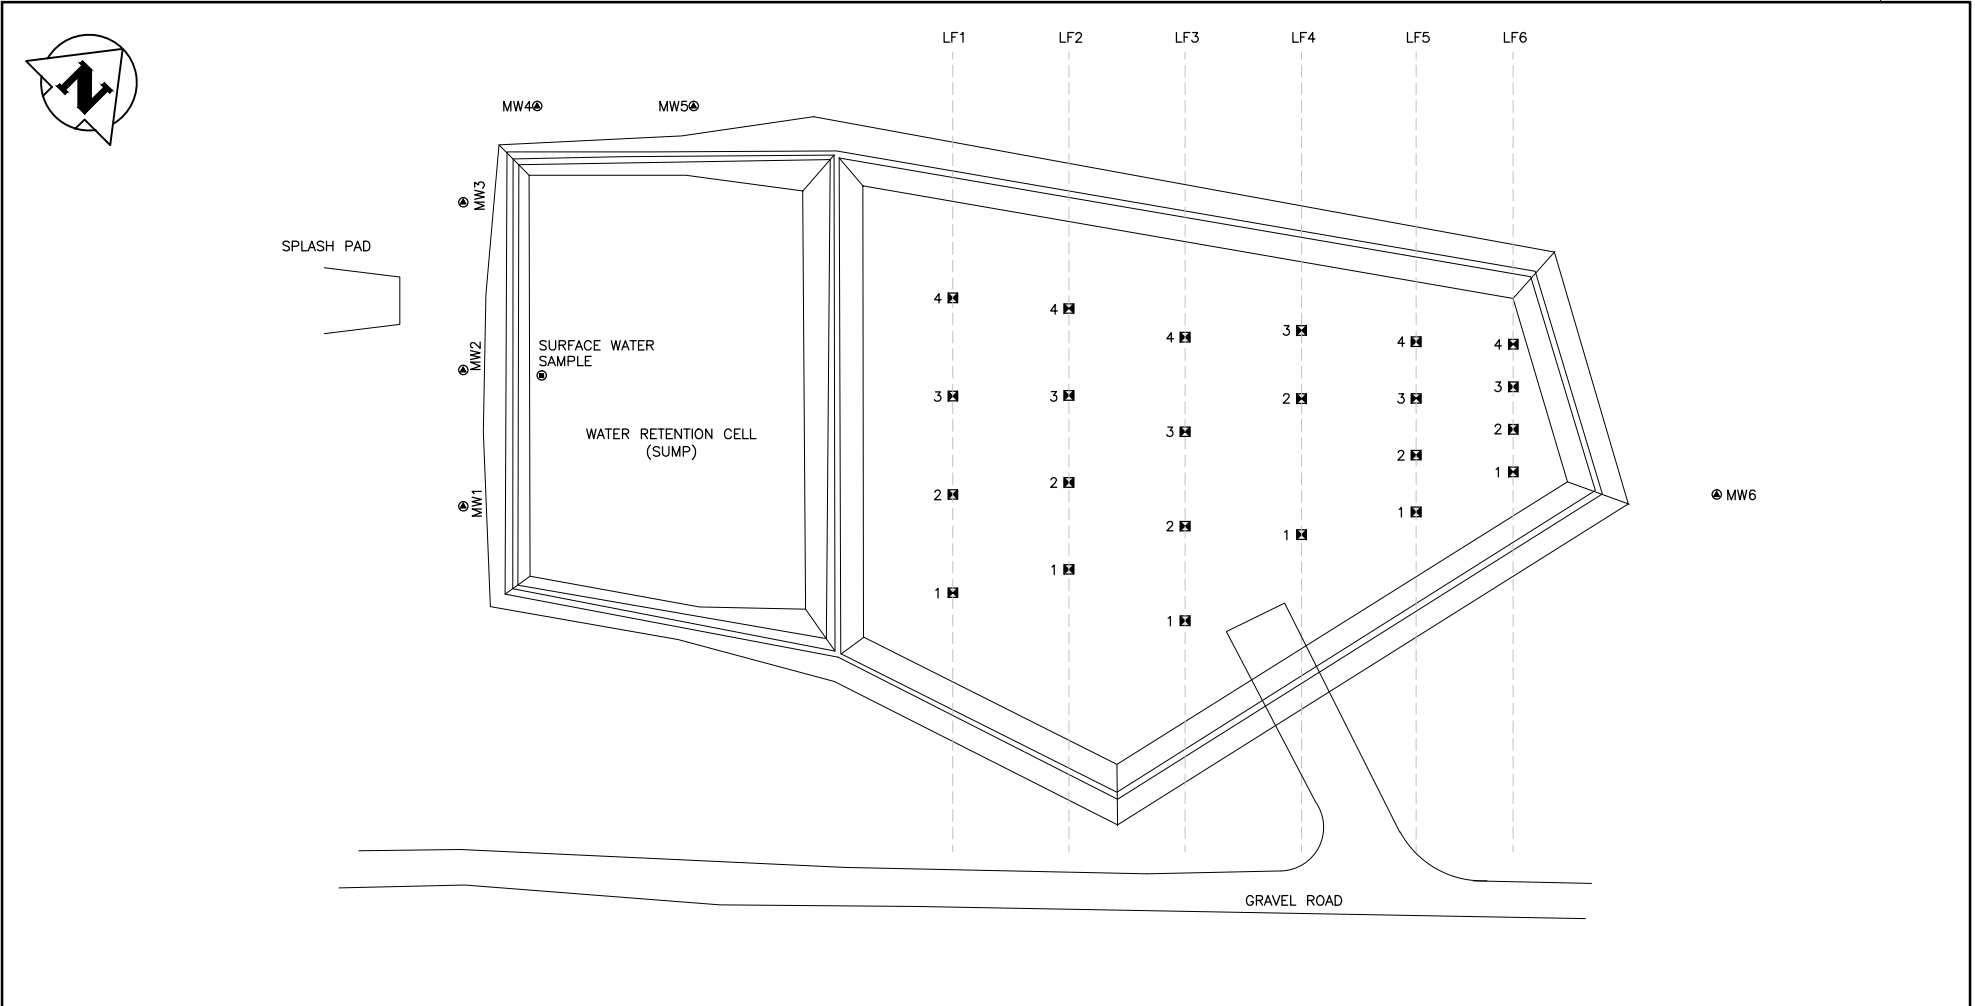
samples were collected from equidistant points along the centreline of the segment. For segments over 50 meters in length, an additional discrete sample was taken for every 10 meters or less. Samples were collected from approximately 0.6 meters below grade. Sample row LF4 was comprised of three discrete samples as a result of the boulder pile limiting access for sampling. The sample locations are shown on Figure 2 (see Appendix C).
