## **ANNUAL REPORT FOR THE KUGAARUK LANDFARM**

**YEAR BEING REPORTED: 2020**

The following information is compiled pursuant to the requirements of Part B, Item 1 of Water License No. 1BR-KRK1929 issued to the Government of Nunavut Department of Community and Government Services.

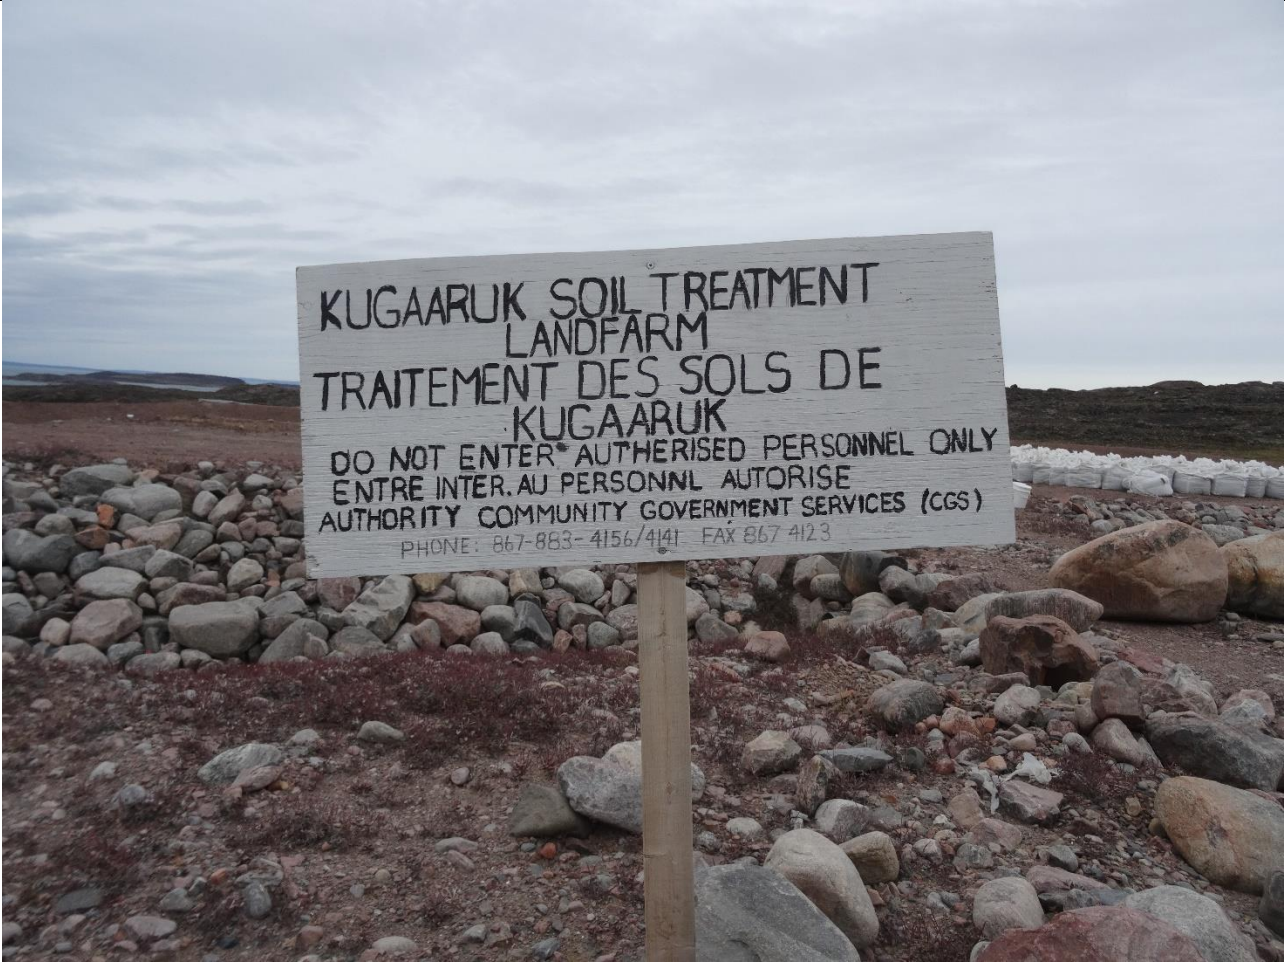
| Date | Camera | Inspector | Authorization |
|---|---|---|---|
| Photo 1 | | | |

| Date | Camera | Inspector | Authorization |
|---|---|---|---|
| Description: Signage Installed at Entrance to Facility as requested during last Inspection – Thank You | | | |

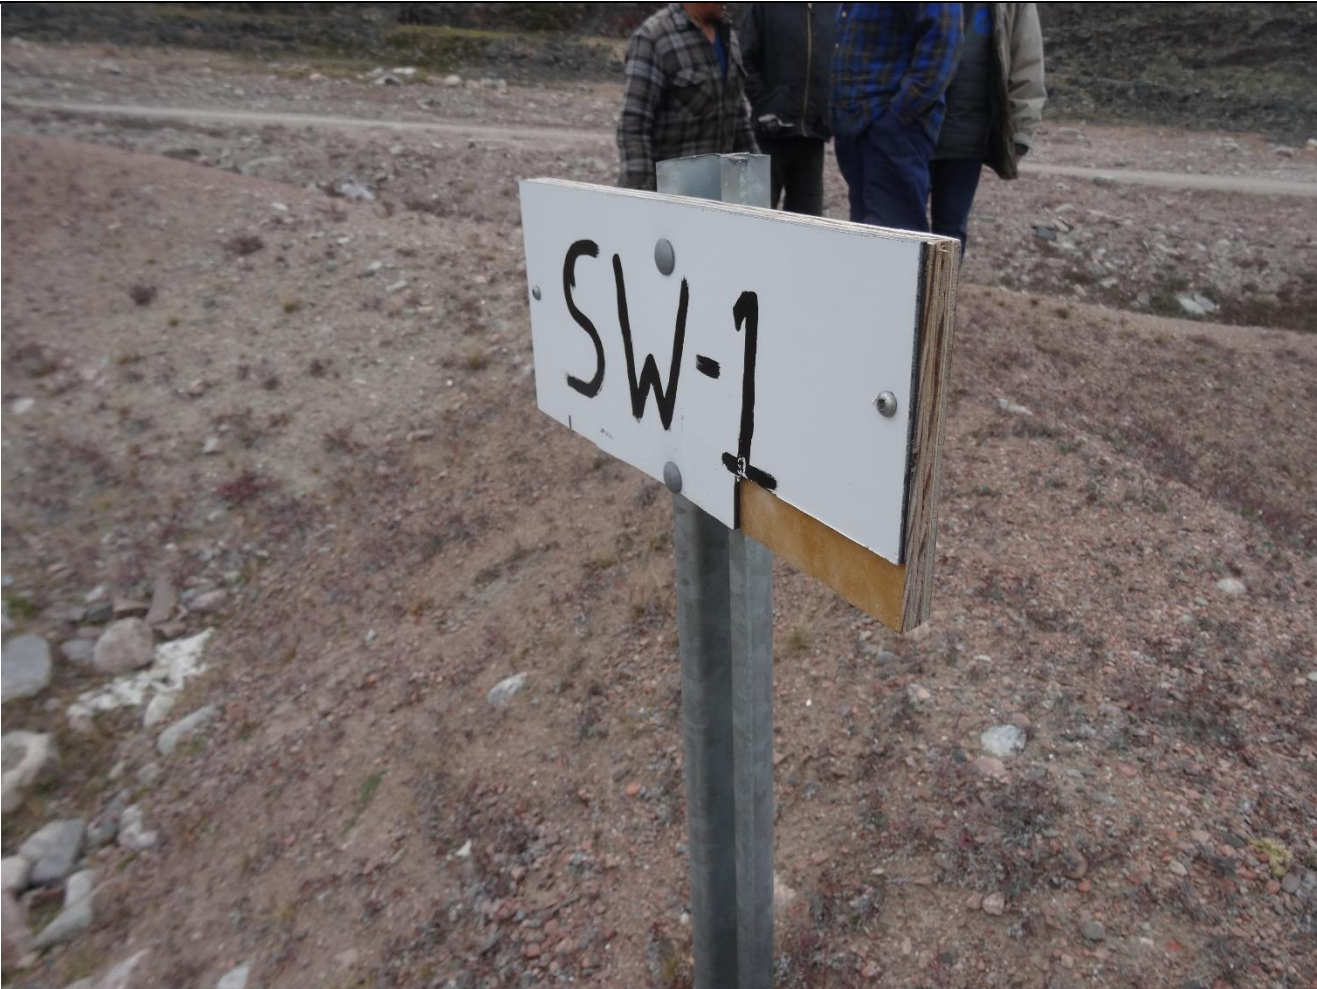
| Date | Camera | Inspector | Authorization |
|---|---|---|---|
| Photo 2 | | | |

| Date | Camera | Inspector | Authorization |
|---|---|---|---|
| Description: Signage Installed at Sample Station SW-1 as requested during last Inspection – Thank you | | | |

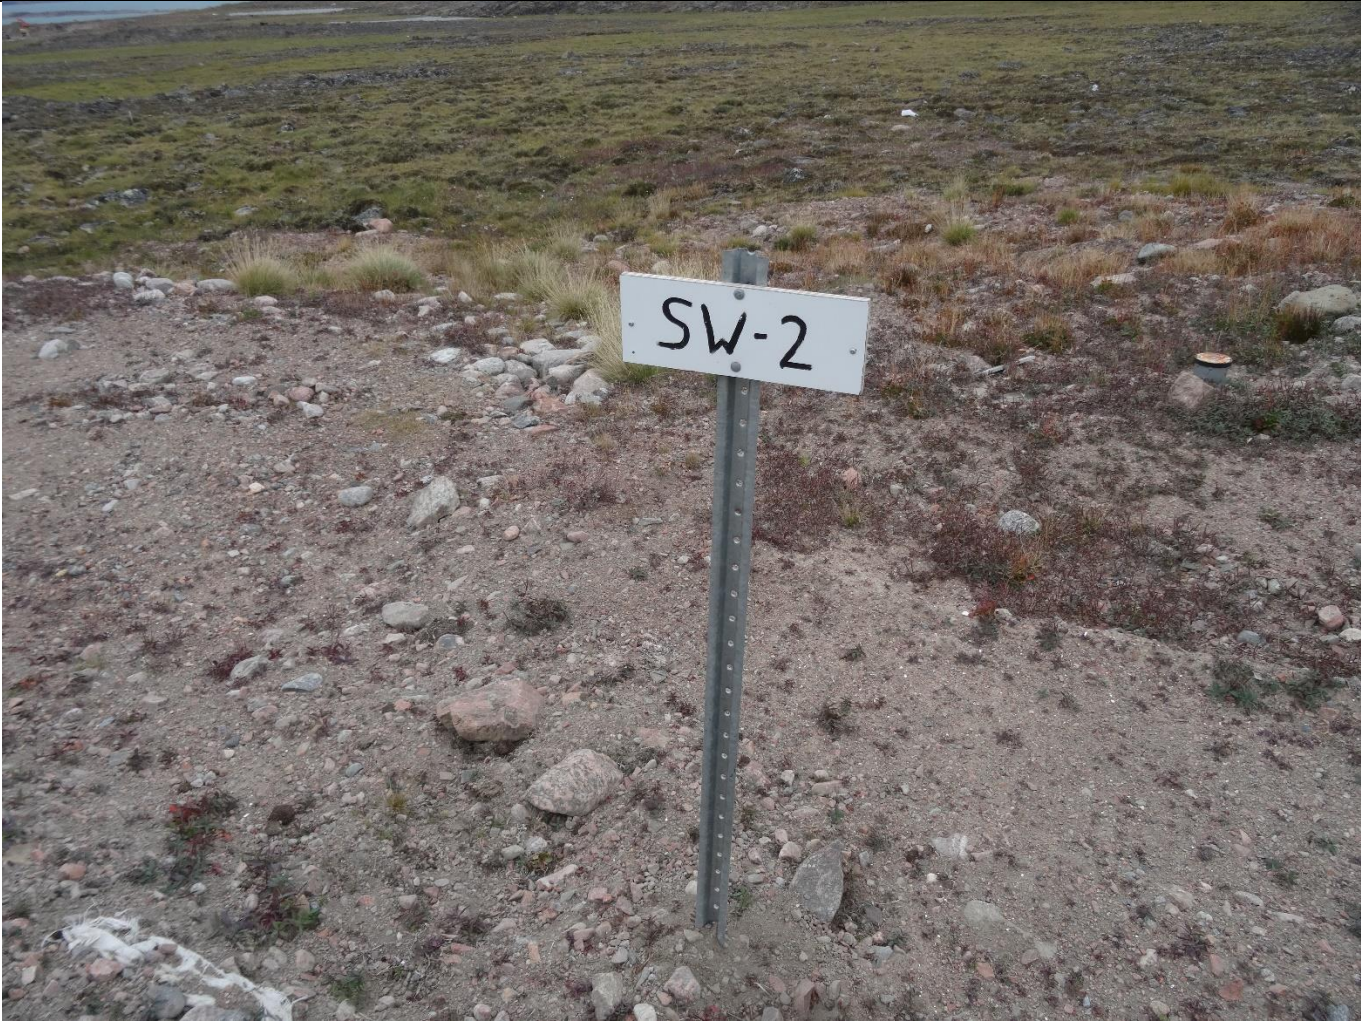
Photo 3

Description: Signage Installed at Sample Station SW-2 as requested during last Inspection – Thank you

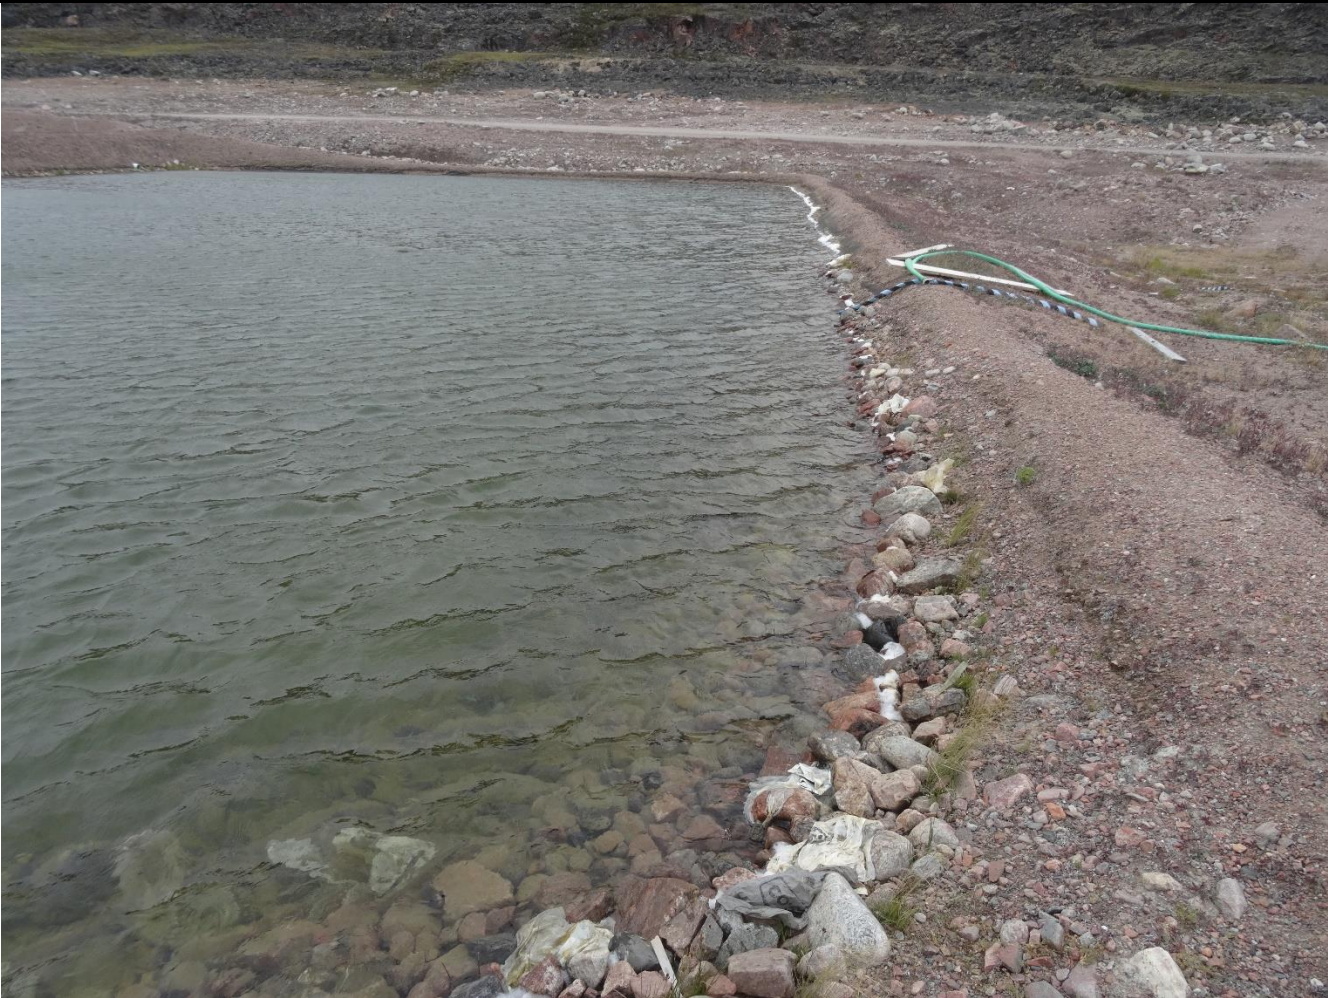
Photo 4

Description: Lower Cell needs to be Sampled then Decanted

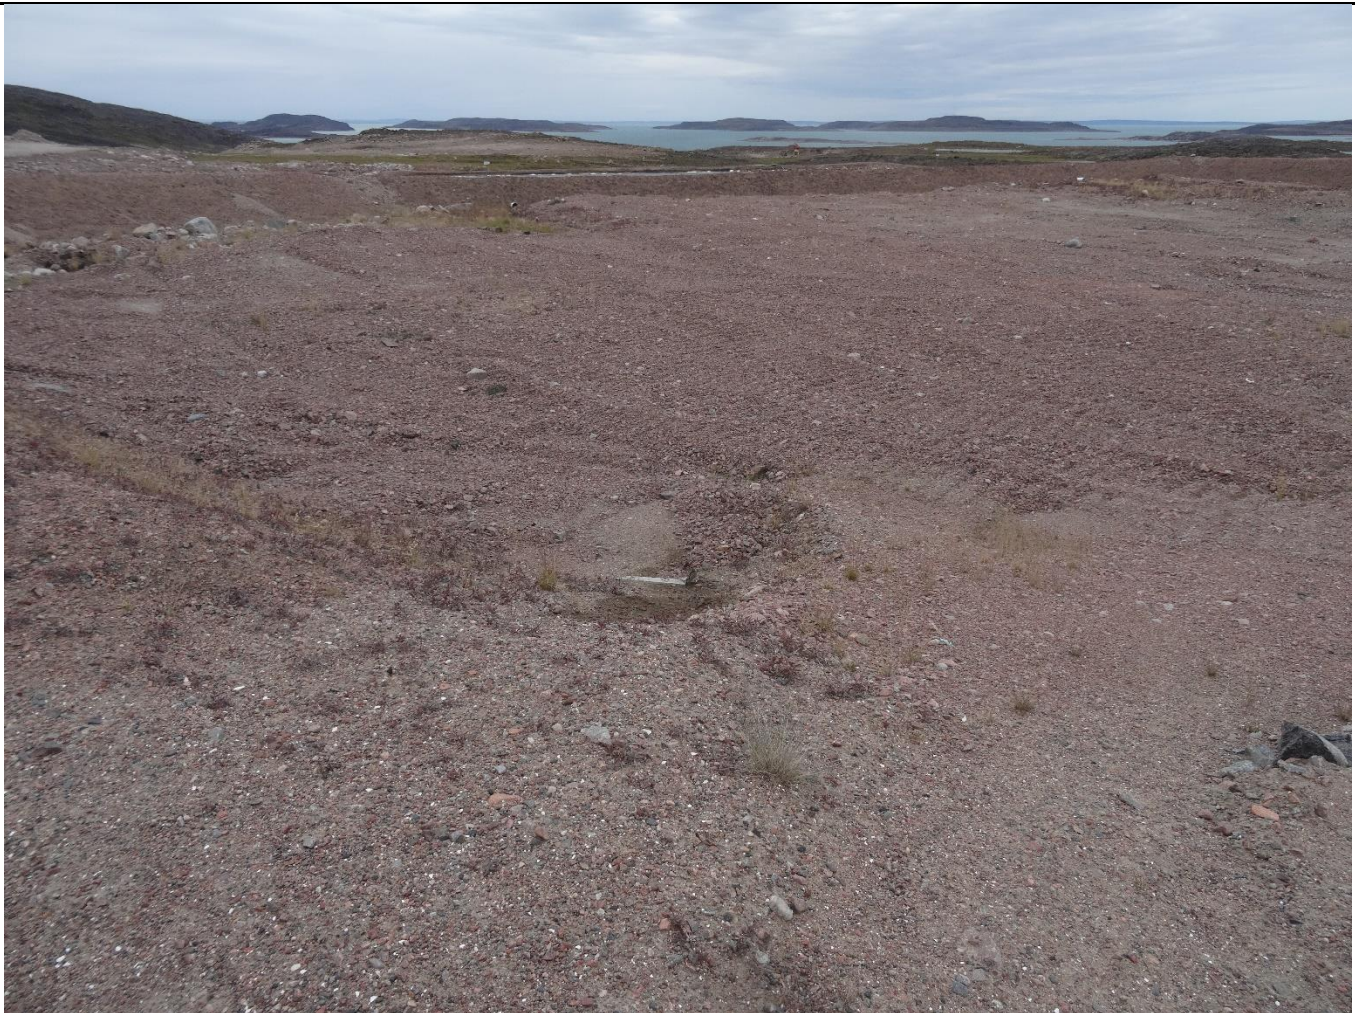
Photo 5

Description: Hamlet Turned the Soil in the Land Farm on behalf of the GN CGS in the Fall of 2019 to Facilitate Remediation – Thank you

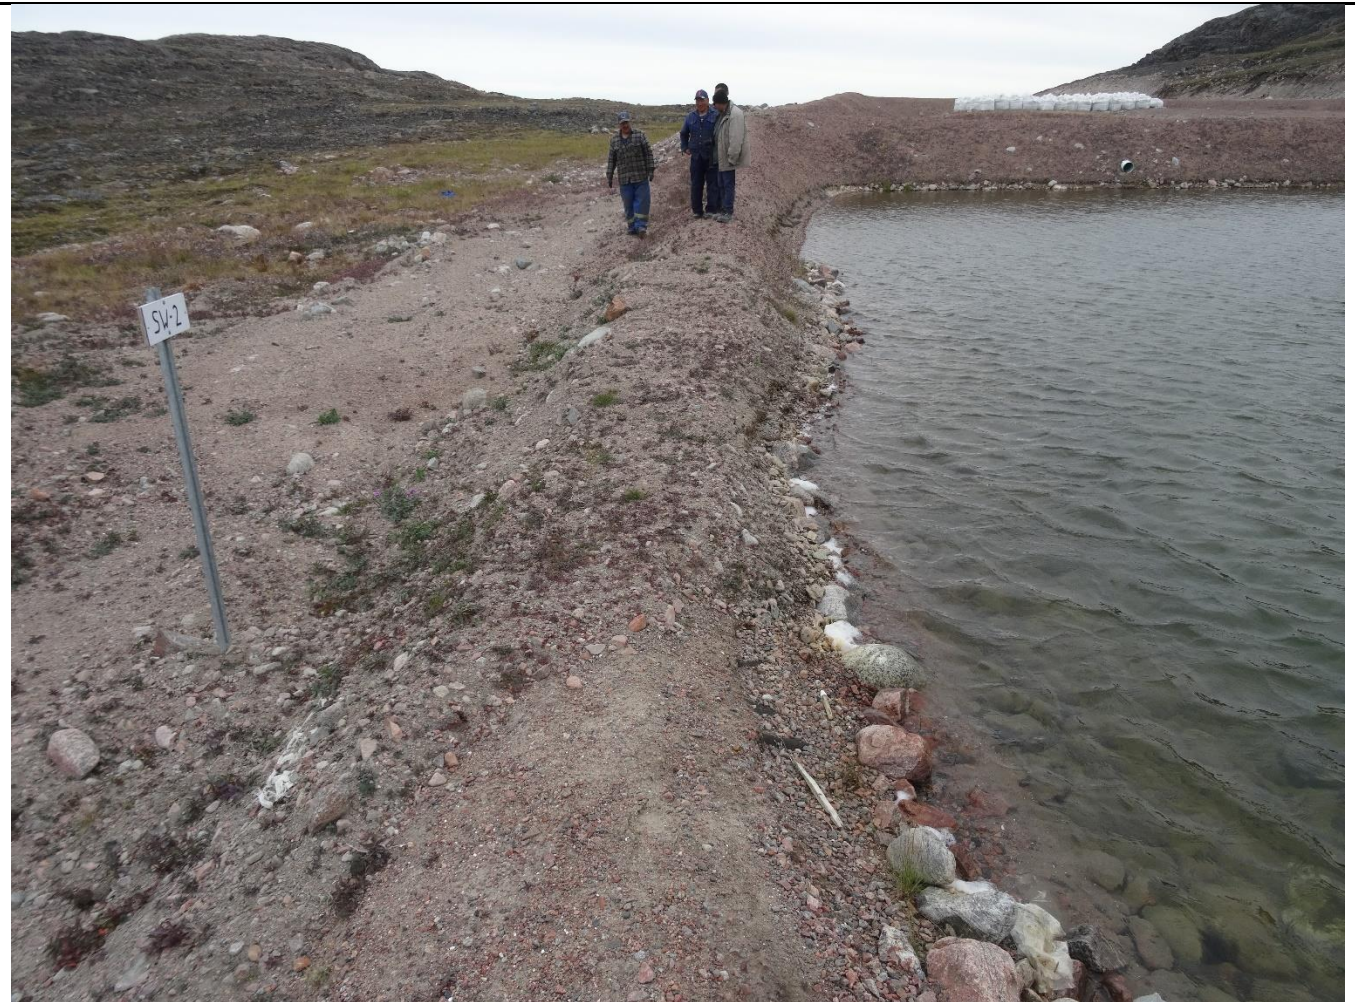
Photo 6

Description: Berm Repair adjacent to Sample Station SW-2 has been completed as requested from last Inspection – Thank you

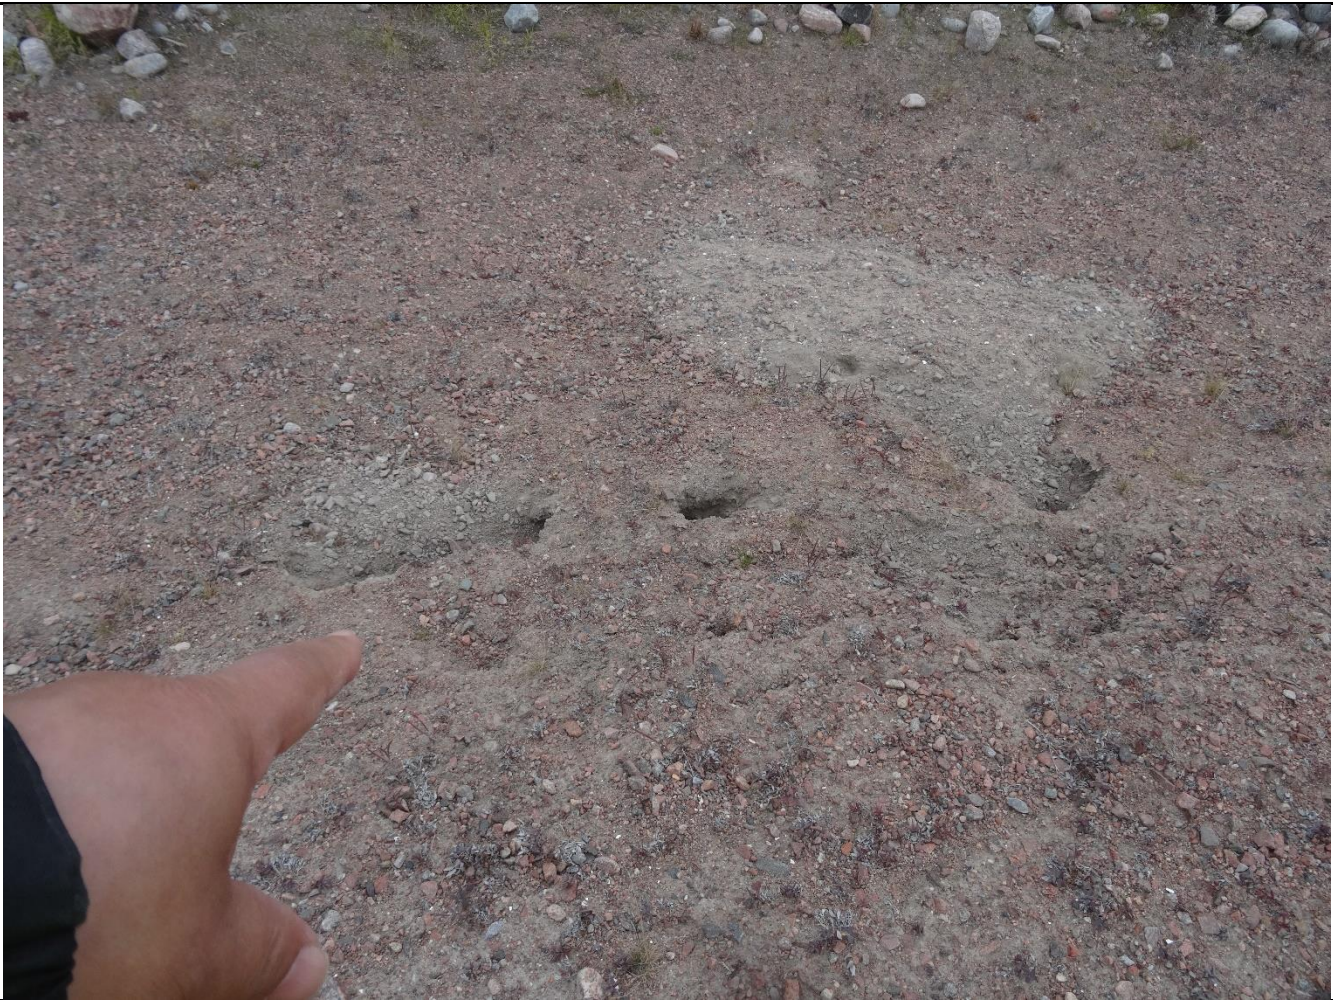
Photo 7

Description: Animal Burrow Holes found in the Berm Perimeter – View 1

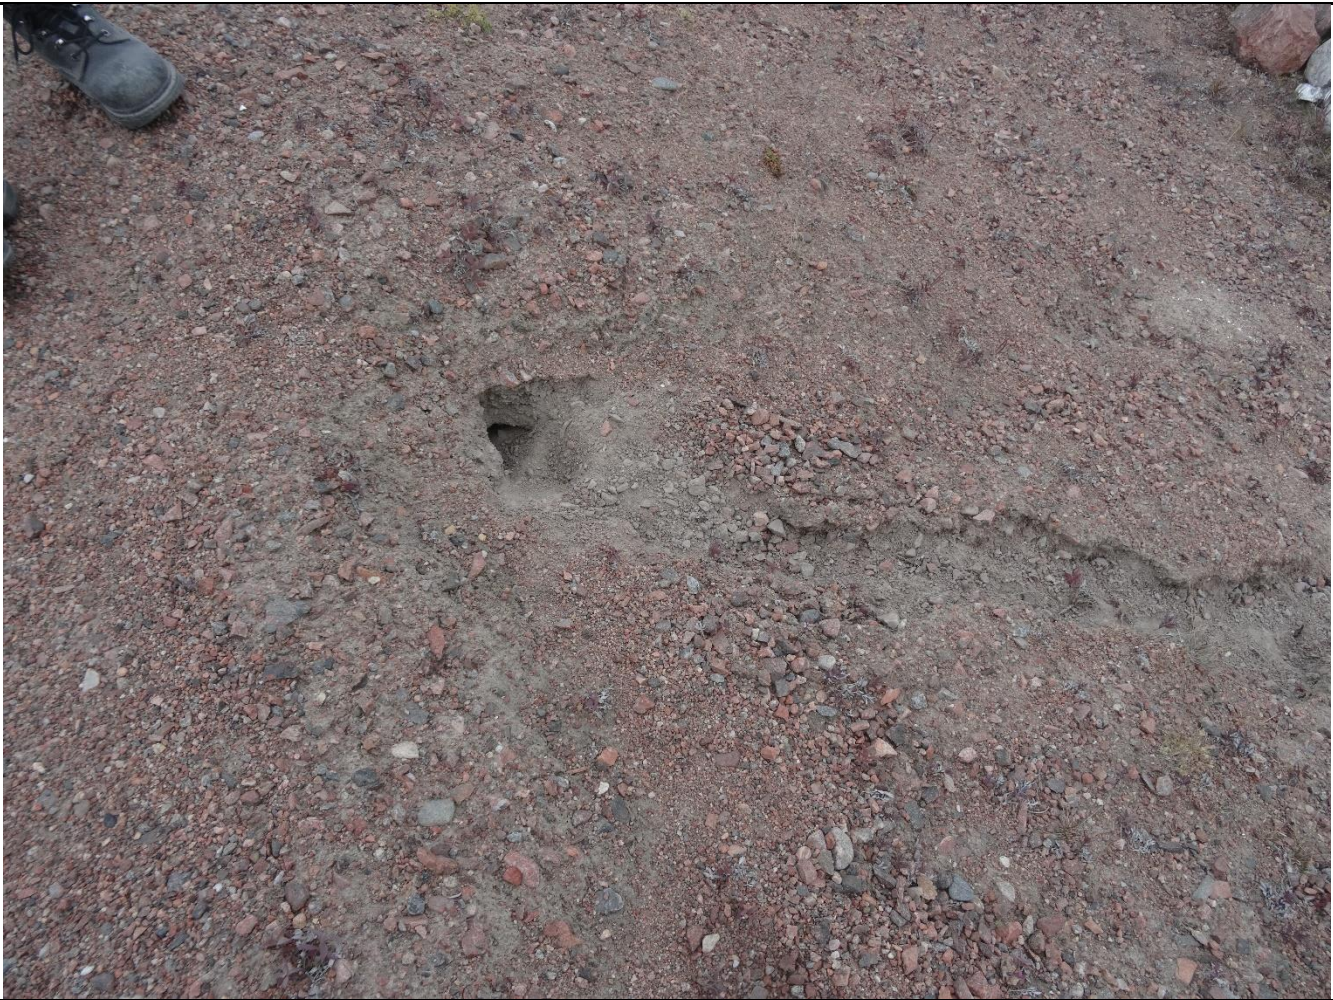
Photo 8

Description: Animal Burrow Holes found in the Berm Perimeter – View 2
