DEW Line Site Longstaff Bluff FOX-2

NTI Technical Representative Report

November, 2005

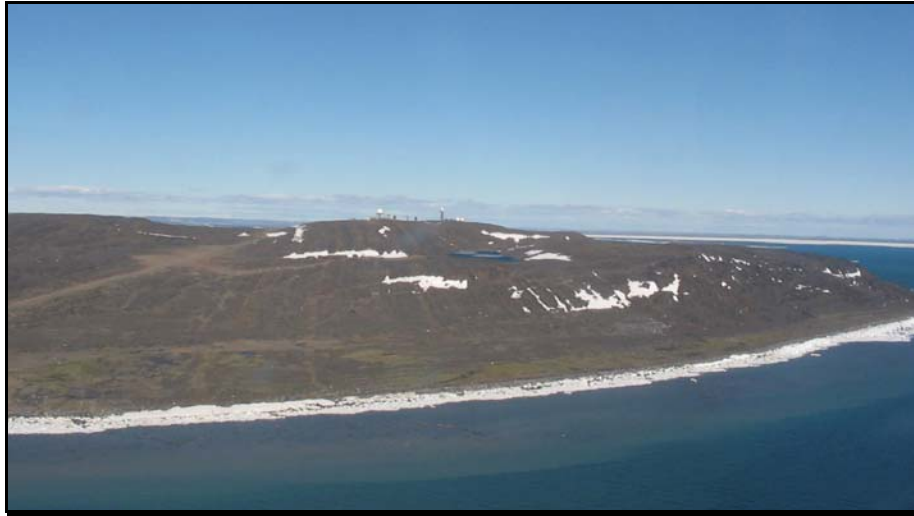
The station is situated on top of Longstaff Bluff at an altitude of 162 m above sea level (refer to Photo 1). The general area in the vicinity of the station is characterized by a series of parallel east-west ridges having an average elevation of 105 m. The station and the airstrip, located at both ends of the site, are separated by almost 10 km. The road that joins both ends of the site is mostly situated along the coast on flat terrain. Vegetation around the site is generally sparse, but denser in the flat low-lying areas along the coast.

Photo1: FOX-2 station atop Longstaff Bluff (looking East)
