Former U.S. Coast Guard Loran Station, Cape Christian, Nunavut Supplemental Environmental Site Assessment, Material Audit and Geotechnical Evaluation (FINAL)

Indian and Northern Affairs Canada Contaminated Sites Program, Nunavut Region P.O. Box 2200 Iqaluit, NU X0A 0H0

Earth Tech Canada Inc. 17203-103<sup>rd</sup> Ave., Edmonton, Alberta, T5S 1J4 (780) 488-6800

January 2007

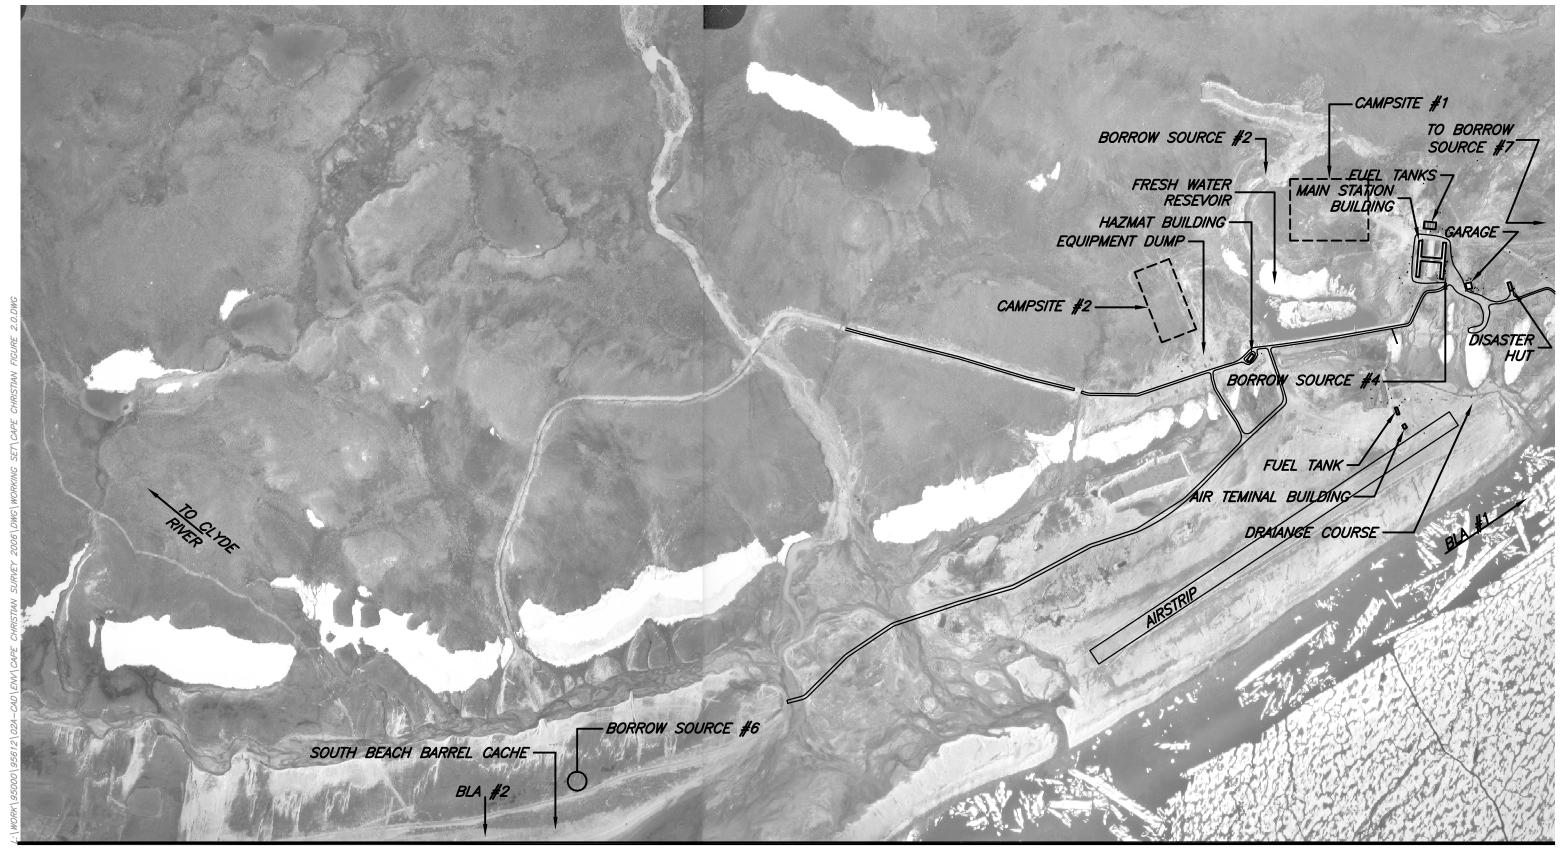
INDIAN AND NORTHERN AFFAIRS CANADA
CAPE CHRISTIAN LORAN STATION
OVERALL SITE PLAN
FIGURE 2.0

NOTE: BLA = BARGE LANDING AREA

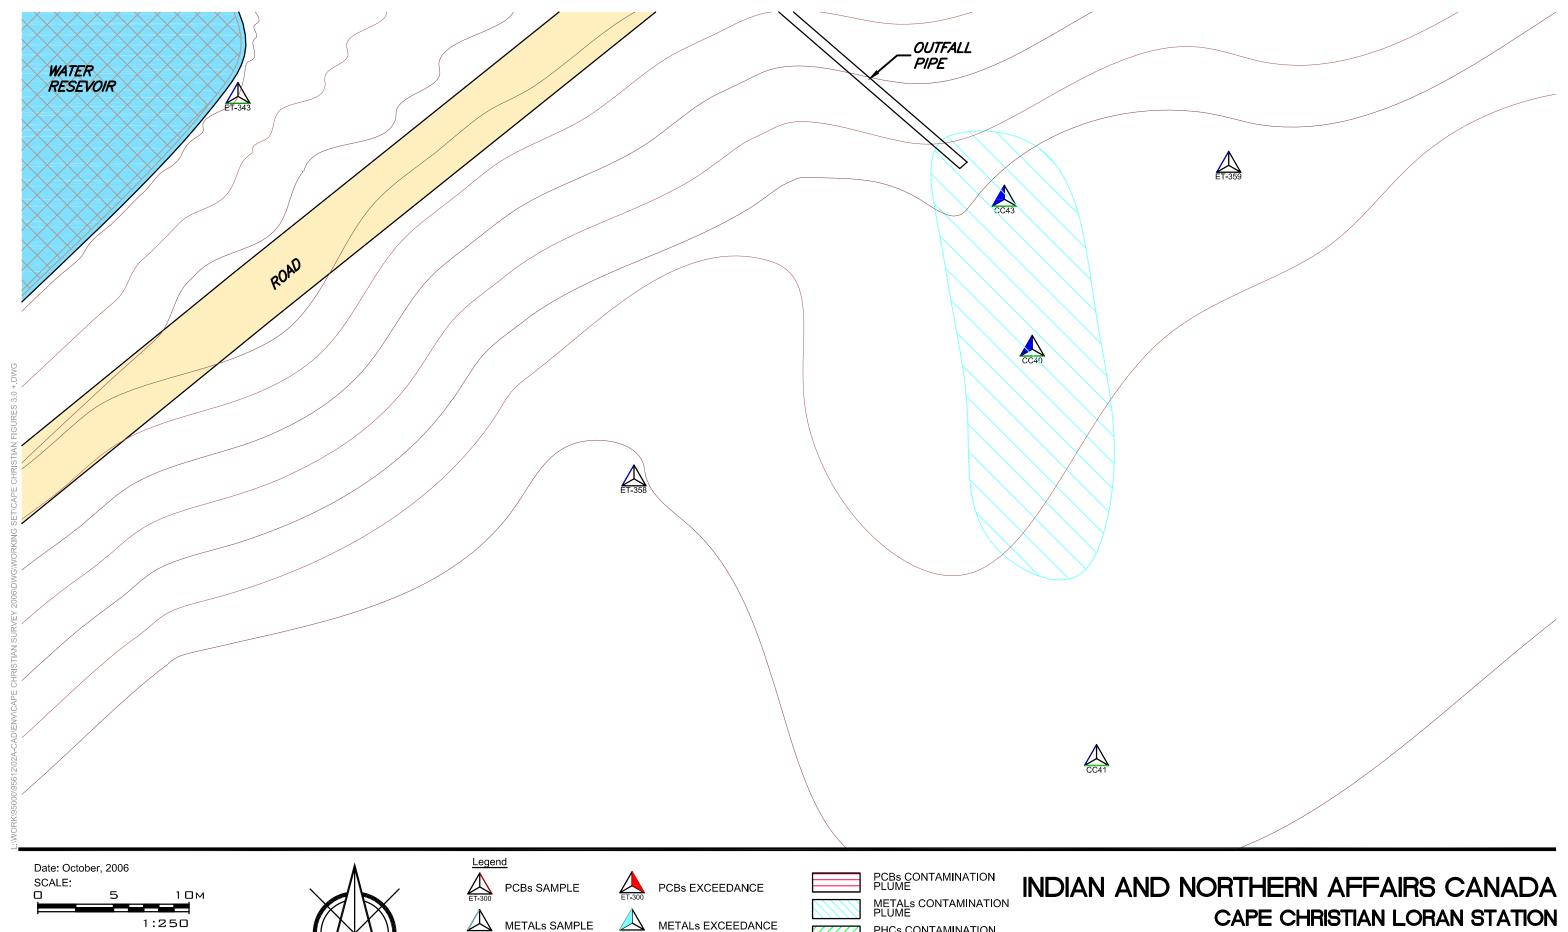
CAPE CHRISTIAN LORAN STATION **OUTFALL AREA** FIGURE 4.1

DRAINAGE COURSE EARTH TECH 2006 SAMPLE CC EARTH TECH 2001 SAMPLE G6543 ESG SAMPLE

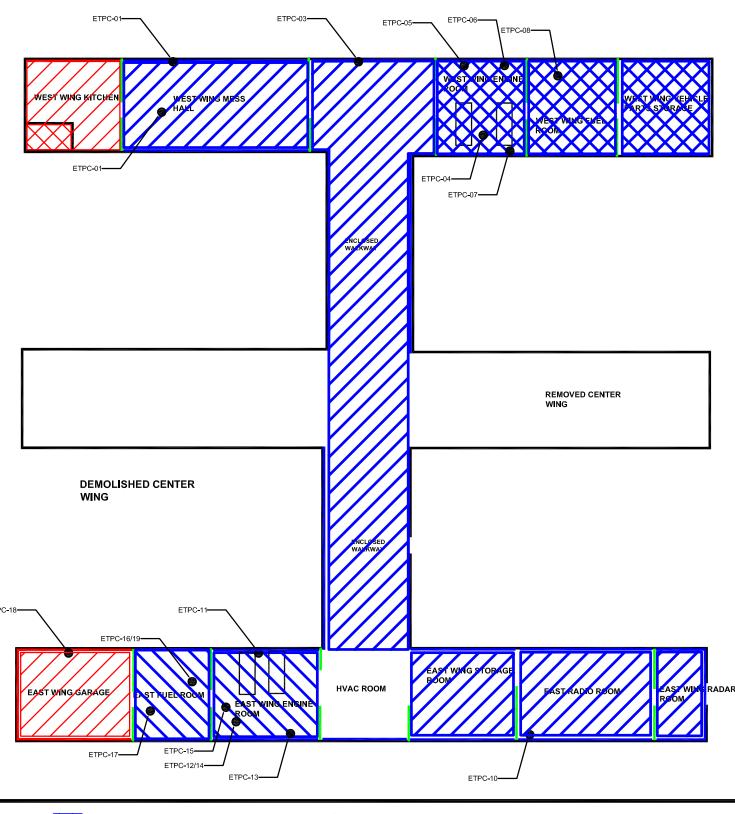
INDIAN AND NORTHERN AFFAIRS CANADA
CAPE CHRISTIAN LORAN STATION
MAIN STATION BUILDING PAINT ASSESSMENT
FIGURE 6.0

Note: asbestos piping throughout building

A detailed lead and PCB paint materials assessment was conducted at the Main Station Building. The results of the paint sampling are shown in **Table 8.1** of **Appendix C**. The lead in paint levels reanged from 392 ppm to 88,100 ppm. The PCB levels in the paint sampled varied from 1 ppm to 67 ppm. The paint sample locations are listed in **Table 8.2** and shown on **Figure 6.0** of **Appendix A**. It should be noted that the majority of the painted surfaces within the main station building contain lead and PCBs in excess of applicable legislation, making the paint hazardous. The overall condition of the paint at the main station building site is poor. One can note in the photos located in **Appendix E** that the paint is generally flaking and weathered throughout the building. The demolished southeast wing of the main station building is assumed to be disposed of on site. Any painted materials discovered during the site clean up must be compared with existing paint sampling data and disposed of accordingly. Discussion as to the estimated method of remediation for hazardous material has not been made due to the many possible methods of accomplishing this (i.e., stripping hazardous paint or leaving it on the substrate to be shipped off site or placed in hazardous materials landfill). It should be noted that the volume of material with a hazardous paint product is based on the assumption that the paint is left in place and the entire subsrate is removed and disposed of.

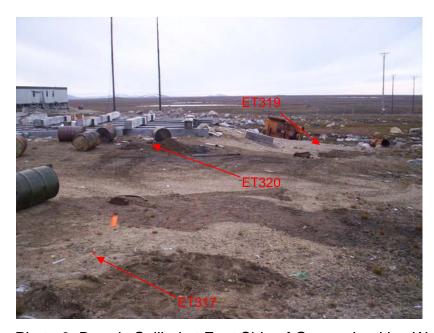
Photo 9: Barrels Spilled at East Side of Garage Looking West

It was noted upon arrival at the Cape Christian site that the previously identified barrels of lubricating oil at the former garage had been recently tipped over. Several of the barrels had been opened and the contents were leaking out creating a large stained area as shown in **Photo 9** of **Appendix C**. It was decided on site that further investigation of this area was required and additional samples were incorporated into the hydrocarbons assessment of the main station garage area. The results are listed in **Tables 2.1, 2.2 and 2.3** of **Appendix C**. Permafrost in the area was encountered at approximately 0.8 m below ground surface. Based on the results of the data, and a maximum depth of contamination of 0.8 m, there is approximately 160 m<sup>3</sup> of PHC contaminated soil at this location.

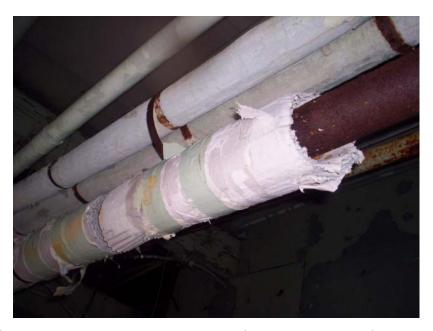
Photo 4: White Pipe Elbow Insulation (40% Asbestos)

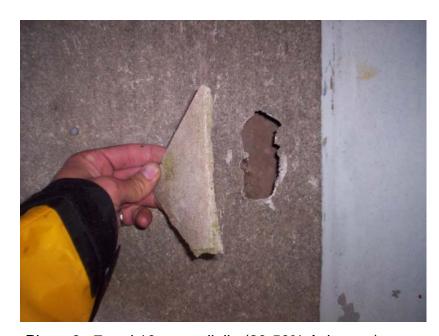
Photo 6: 7 and 10mm wall tile (20-50% Asbestos)

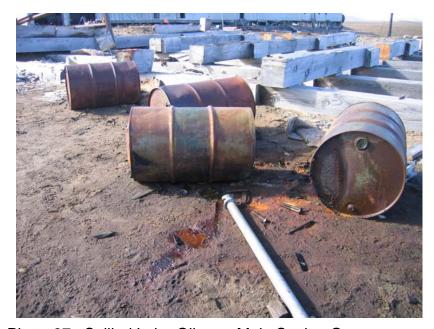
Photo 37: Spilled Lube Oil near Main Station Garage

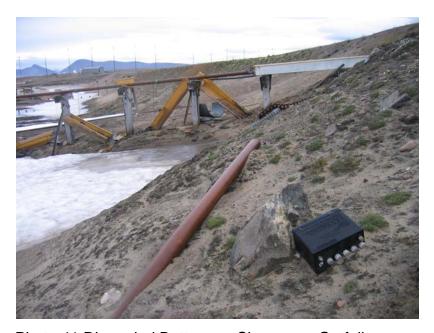
Photo 41:Discarded Battery on Slope near Outfall

Additional general hazardous materials found at the Cape Christian site include various batteries and additional pressurized gas cylinders. Additional batteries were discovered in the equipment dump, outfall area and main station area (**Photos 38, 41 and 42** of **Appendix E**).

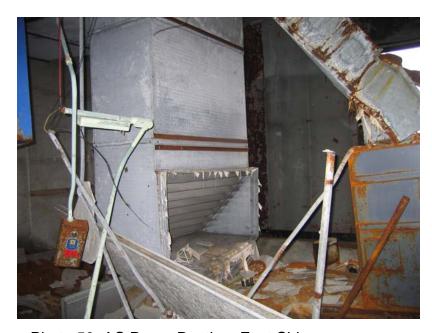
Photo 50: AC Room Ducting, East Side

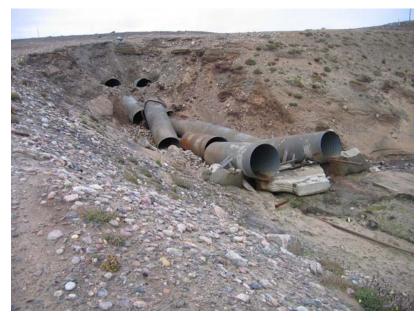
Photo 44: Embankment Culvert Failure at South End of Reservoir Road

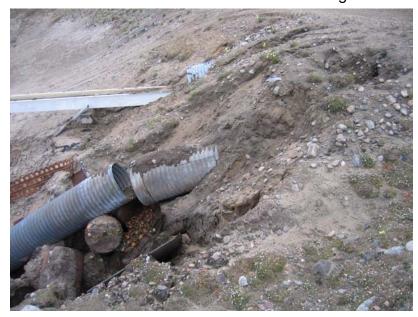
Photo 48: Failed Sections at Culvert Outlet Near Main Station Building

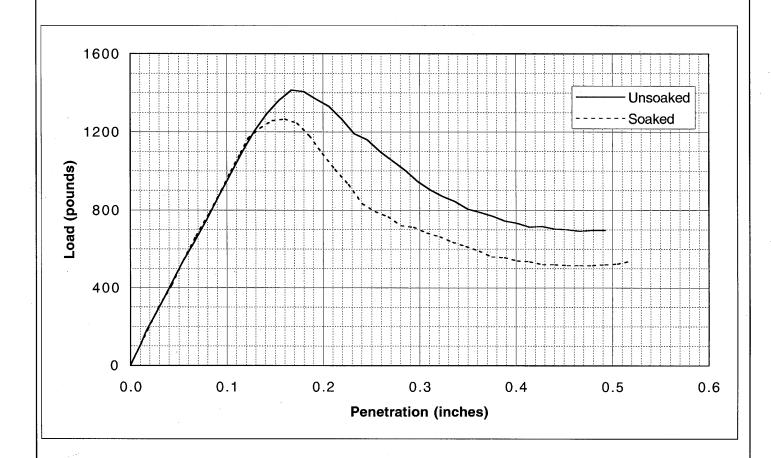
Compacted to 100% of standard proctor

at optimum moisture

CBR Values (%)					
	Unsoaked	Soaked				
0.1"=	31.5	31.8				
0.2"=	29.8	24.1

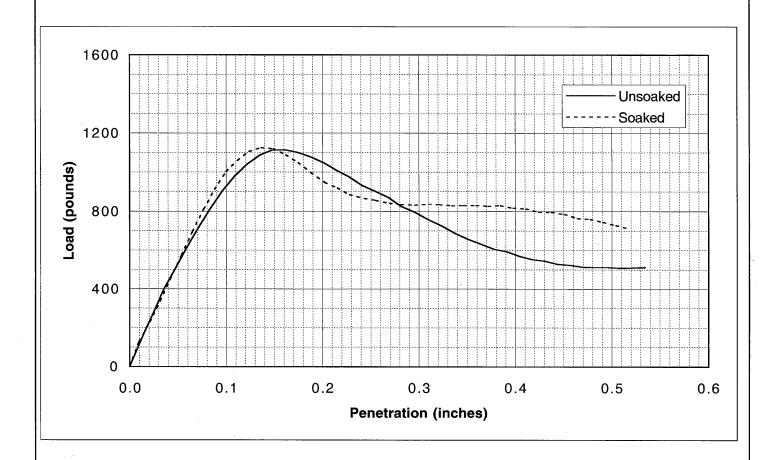
Compacted to 100% of standard proctor

at optimum moisture

CBR Values (%)					
	Unsoaked	Soaked				
0.1"=	30.8	32.8				
0.2"=	23.2	21.4
