## **Long Term Monitoring, 2011 Cape Christian, Nunavut**

### **FINAL REPORT**

Franz Environmental Inc.  
329 Churchill Avenue, Suite 200  
Ottawa, Ontario  
K1Z 5B8  
Tel. (613) 721-0555  
Fax: (613) 721-0029

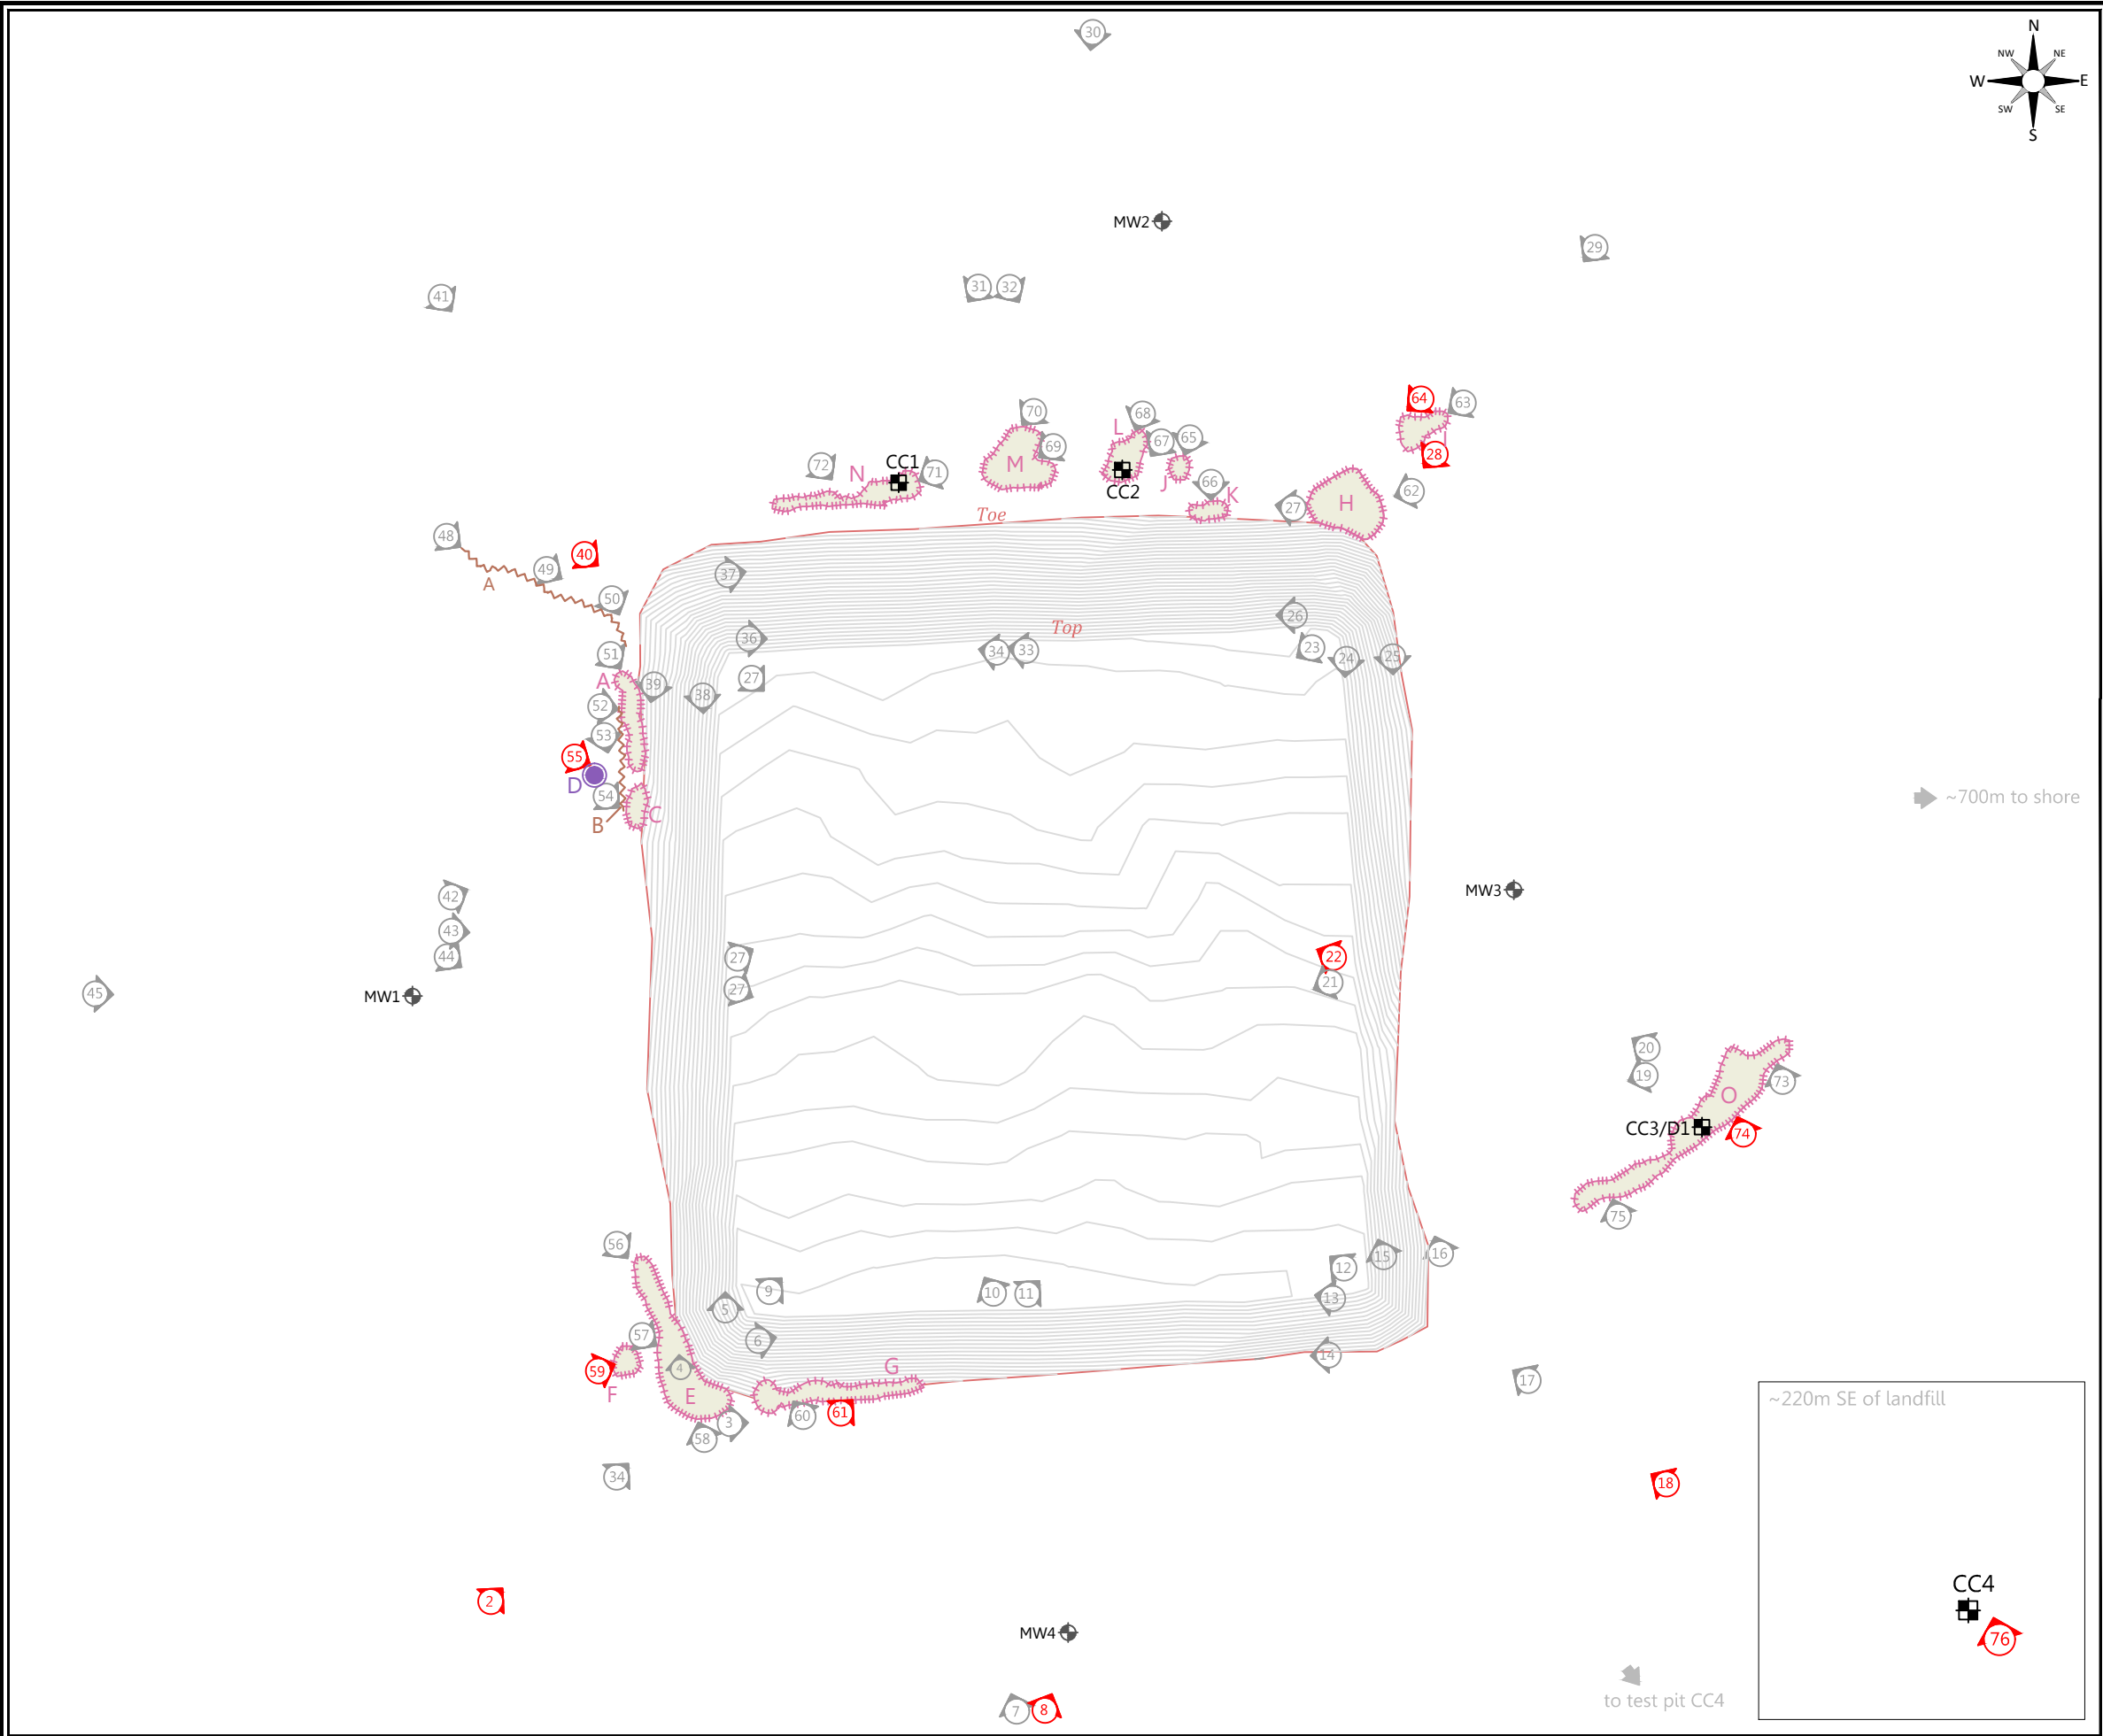
Title: <b>Non-Hazardous Waste Landfill</b>

There were six areas of minor settlement observed at the toe of the landfill (see Features A, C, E, G, H, and K, Figure A-1; Appendix A). Three of these areas (A, G, and K) also had orange staining. Feature E did not contain ponded water, but the soil was fully saturated. These settlement areas do not appear to impact the structure of the landfill, or be a result of other impacts to the landfill structure.

Six areas of ponded water were observed near the NHWL: Two were adjacent to the toe of the NHWL (see Features J and O, Figure A-1; Appendix A and Photographs 65 and 73 to 75; CD-ROM); three of these areas (see Features L, M, and N, Figure A-1; Appendix A and Photographs 67 to 72; CD-ROM) are likely the result of the equipment used to construct the NHWL. Water was pooled in what appear to be tracks left by the heavy equipment; though these three features are not believed to be the result of settlement, they are noted for comparison to future observations. A final area of depression has occurred northeast of NHWL in a drainage area with vegetation. The depression contained ponded water (see Feature I, Figure A-1; Appendix A and Photographs 63 and 64; CD-ROM).

Some minor settlement cracks were observed near the northwest corner of the NHWL (see Feature B, Figure A-1; Appendix A and Photographs 52 to 53; CD-ROM). Two sinkholes were observed near the toe of the NHWL (see Features D and F, Figure A-1; Appendix A and Photographs 55 and 59; CD-ROM). Neither of the sinkholes contained water during the site visit despite the rainy conditions.

The features noted under this heading are currently considered to be of little consequence to the physical integrity of the NHWL. All physical observations indicate that the NHWL is performing as designed and is containing the enclosed waste. Care should be taken during future monitoring events to observe the condition of Feature E at the southwest corner of the NHWL for further evidence of settlement or potential seepage.

Although the overall performance of the landfill is presently considered acceptable, it was noted during the visual inspection that the grading of the landfill cap was poor, inconsistent, and did not appear to maintain a consistent grade. It was also observed that the landfill cap consisted of many different particle sizes (i.e., small cobbles to fines) and that, in many instances, the fines are being eroded away and washed into the voids created by the larger particles. The inconsistent grading and particle size selection has lead to many small undulations on the cap that may trap rain and melt water, potentially increasing the volume of water infiltration into the center of the landfill each year. This potential increase in water infiltration, over time, may cause excessive erosion, possible settlement issues, and potential seepage issues around the landfill perimeter in subsequent years.

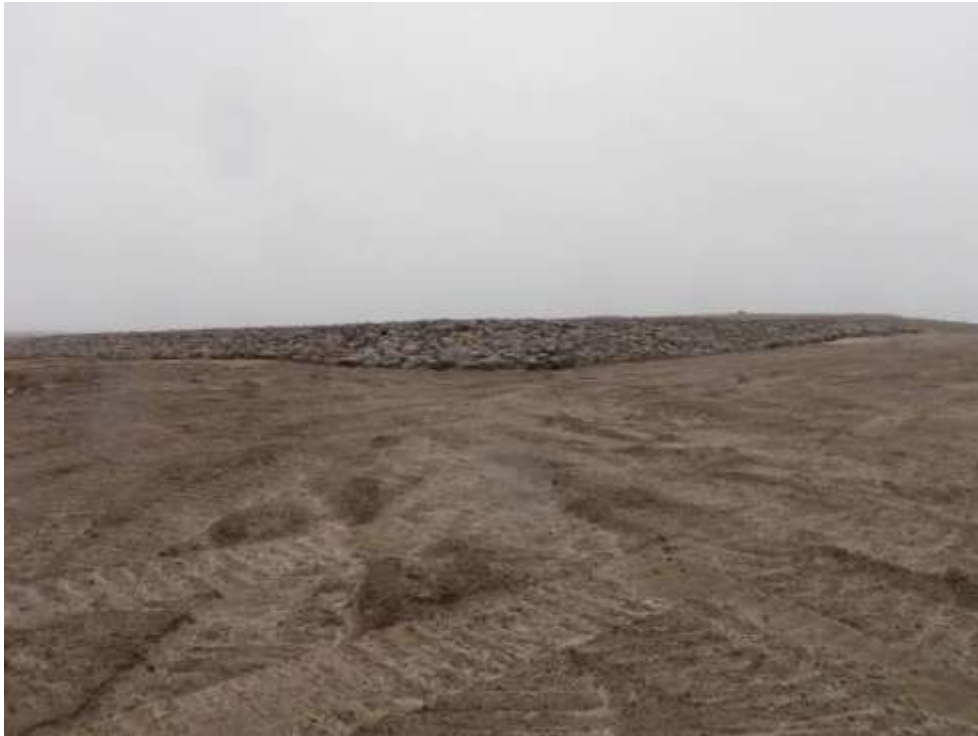
Southwest corner of the NHWL. Viewpoint 2 (Figure A-1; Appendix A). Photograph reference 2 (CD-ROM). Direction photo taken: NE

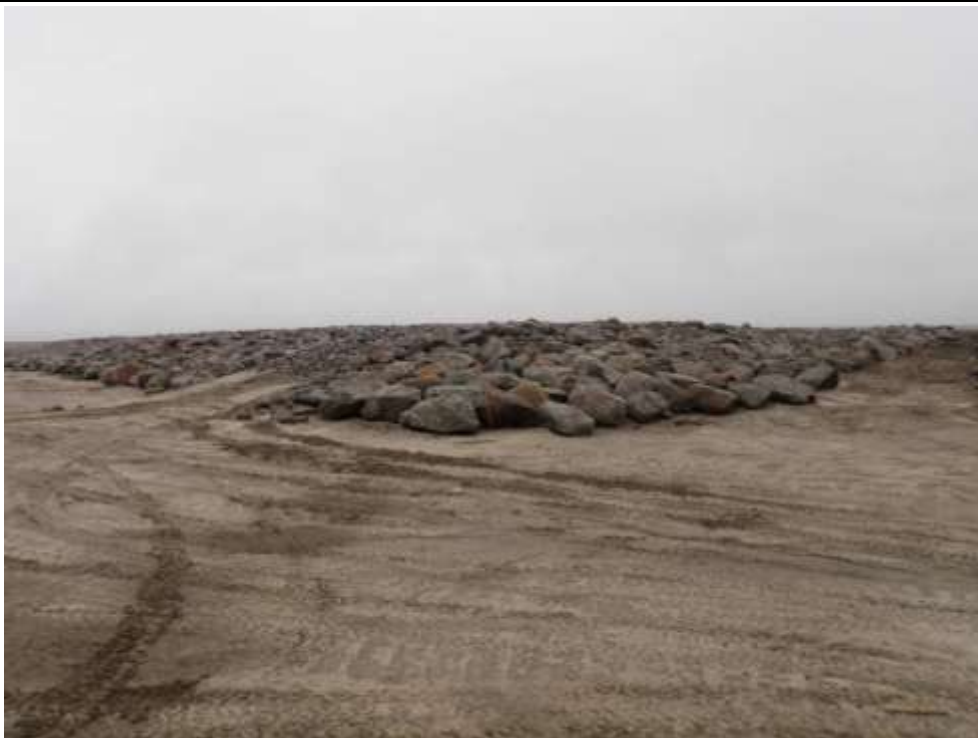
Southeast corner of the NHWL. Viewpoint 17 (Figure A-1; Appendix A). Photograph reference 17 (CD-ROM). Direction photo taken: NW

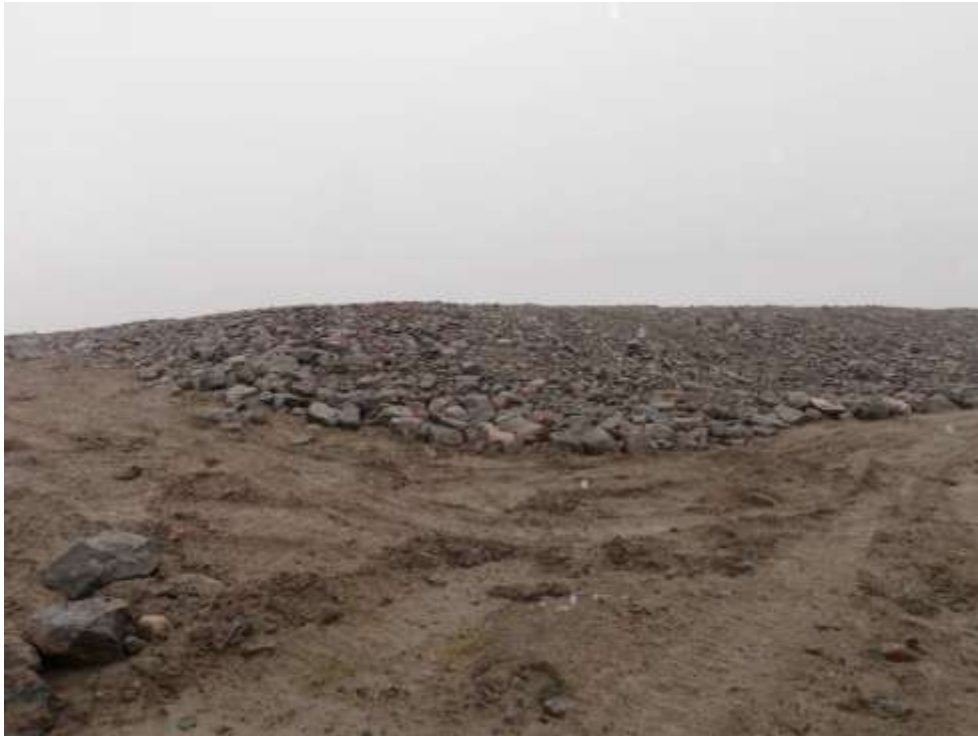
Northeast corner of the NHWL. Viewpoint 28 (Figure A-1; Appendix A). Photograph reference 28 (CD-ROM).  
Direction photo taken: SW

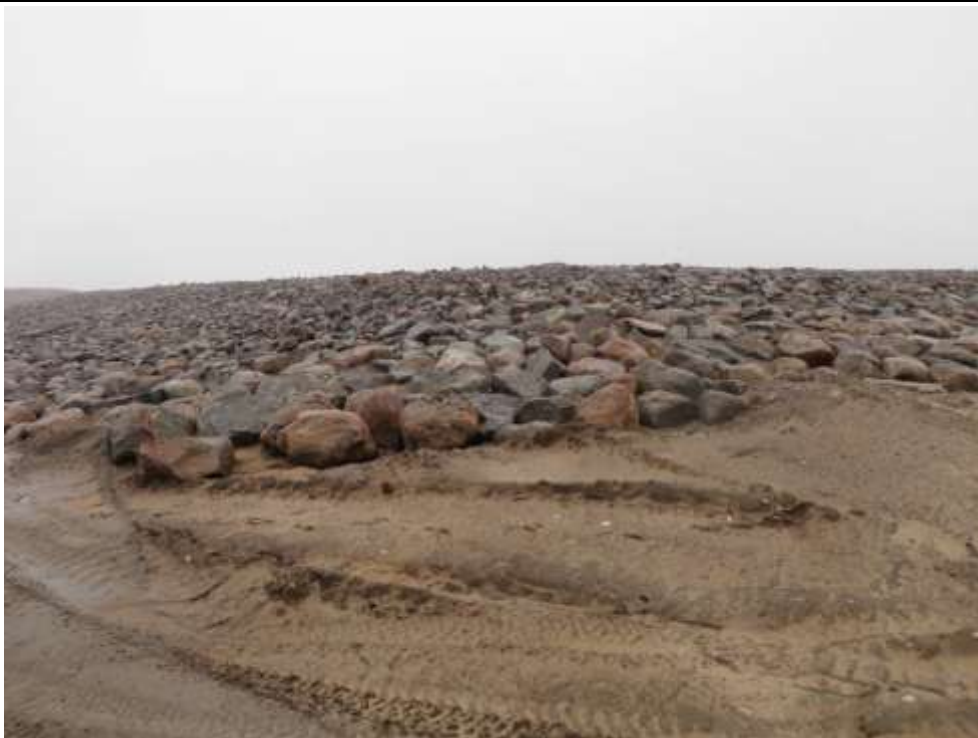
Northwest corner of the NHWL. Viewpoint 40 (Figure A-1; Appendix A). Photograph reference 40 (CD-ROM).  
Direction photo taken: SE

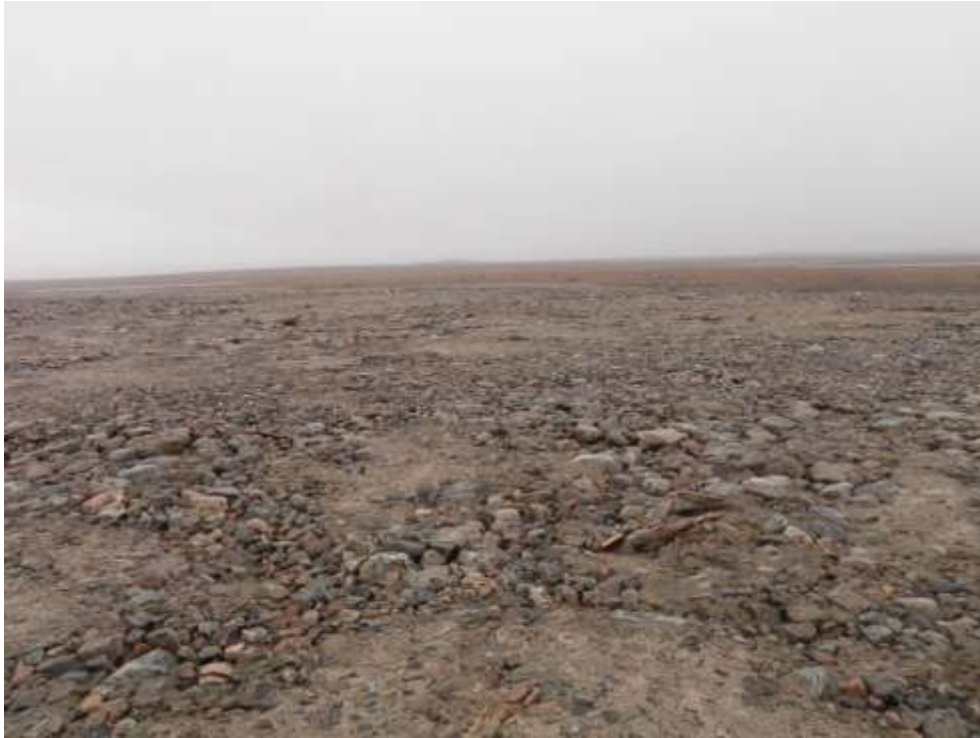
Top of the NHL. Note the undulations of the cap. Viewpoint 22 (Figure A-1; Appendix A). Photograph reference 22 (CD-ROM). Direction photo taken: W

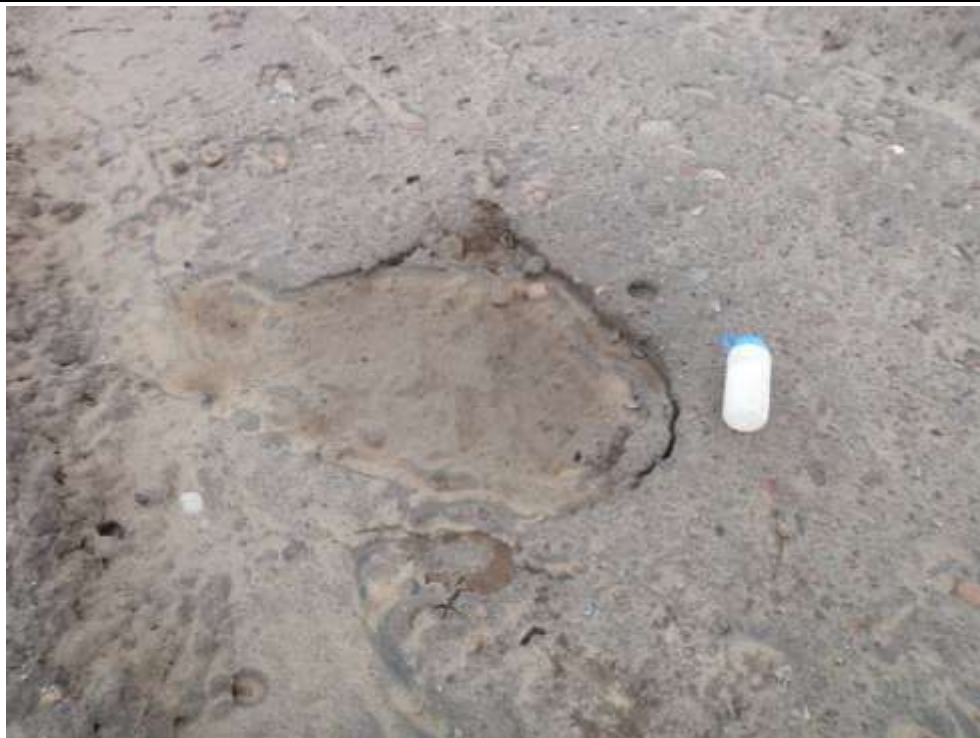
Sinkhole near the northwest corner of the NHL. Viewpoint 55 (Figure A-1; Appendix A). Photograph reference 55 (CD-ROM). Direction photo taken: E

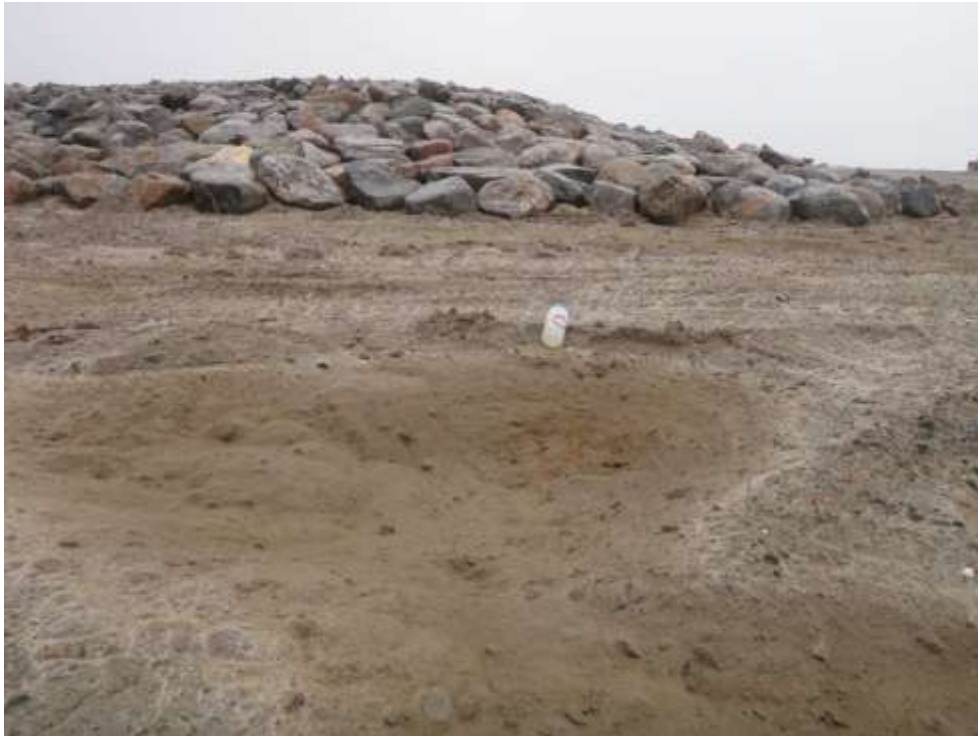
Sinkhole near the southwest corner of the NHL. Viewpoint 59 (Figure A-1; Appendix A). Photograph reference 59 (CD-ROM). Direction photo taken: NE

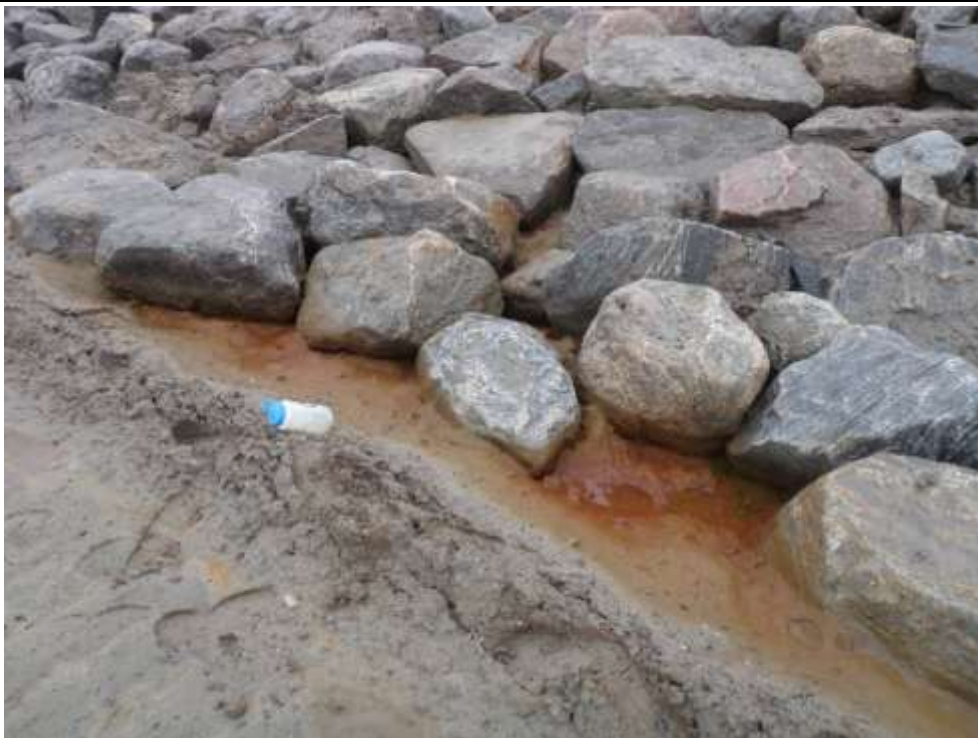
Several areas of orange staining were observed in the area surrounding the landfill (see Photographs 60, 61, and 63 to 75, CD-ROM). Soil was collected from around Features L, N, and O where the staining was observed. Similar orange staining was observed in areas away from the landfill and a soil sample was collected as a reference (see Photograph 76, CD-ROM).

Ponded water with staining along the toe of NHL near the southwest corner. Viewpoint 61 (Figure A-1; Appendix A). Photograph reference 61 (CD-ROM). Direction photo taken: NE

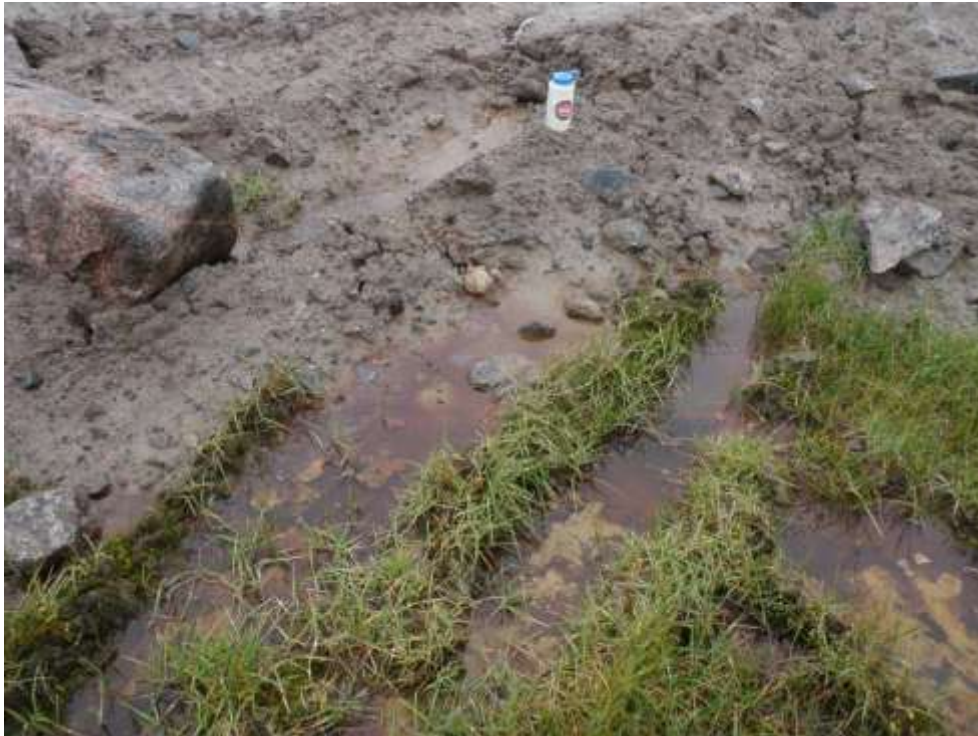
Drainage area with staining and vegetation near the northeast corner of the NHWL. Viewpoint 64 (Figure A-1; Appendix A). Photograph reference 64 (CD-ROM). Direction photo taken: SW

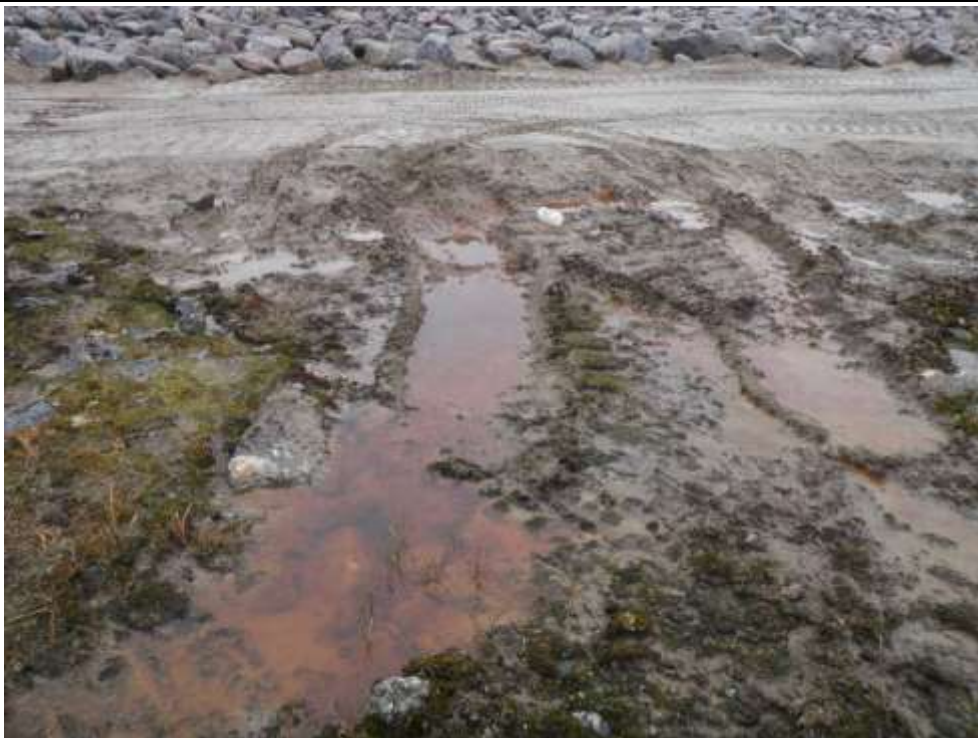
Ponded water with staining near the north side of the NHWL. Soil sample CC2 collected from this area. Viewpoint 68 (Figure A-1; Appendix A). Photograph reference 68 (CD-ROM). Direction photo taken: S

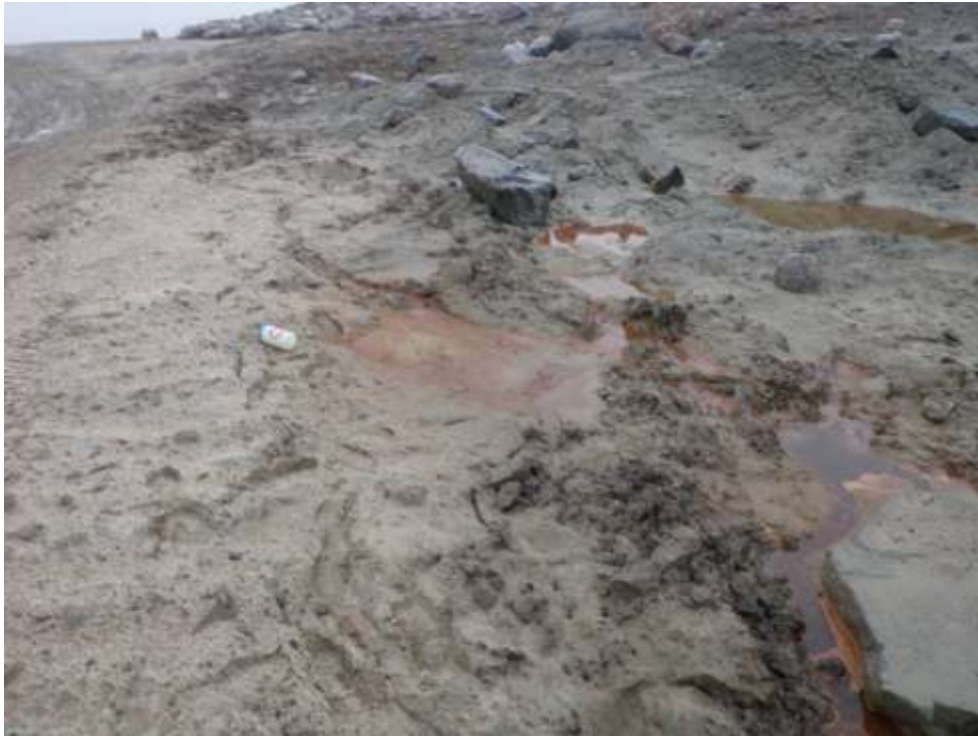
Settlement	O	21 m east of the southeast corner of the NHWL	85.2 m <sup>2</sup>			<1%	Ponded water with staining	Soil sample CC3/D1 collected from this area	73-75

Ponded water with staining near the east side of the NHL. Soil sample CC3/D1 collected from this area. Viewpoint 74 (Figure A-1; Appendix A). Photograph reference 74 (CD-ROM). Direction photo taken: N

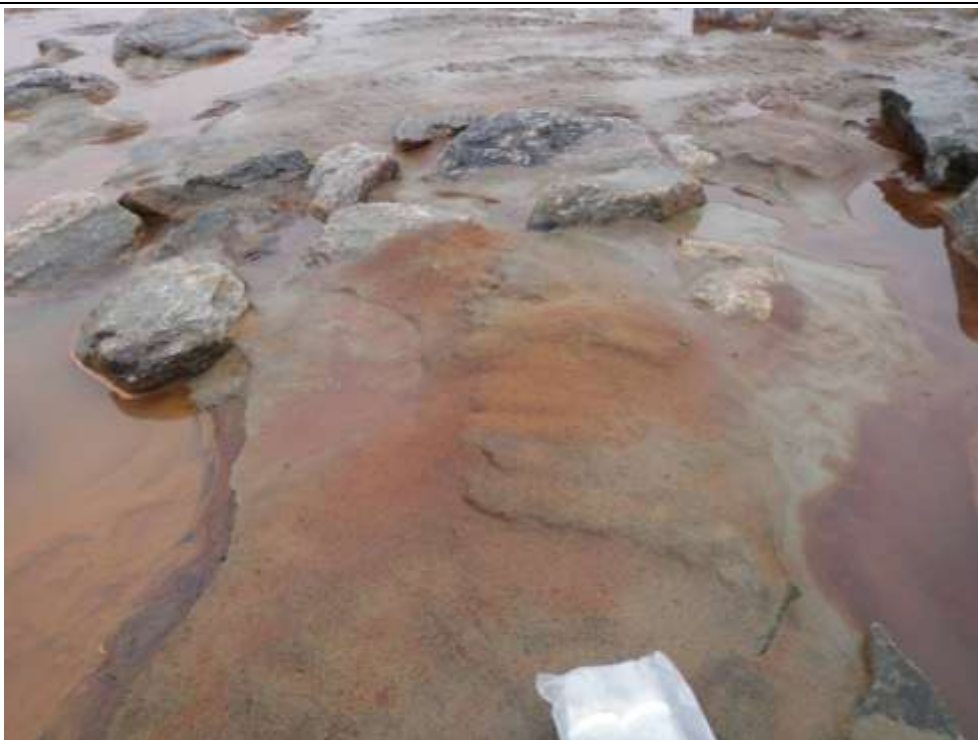
Background soil sampling location. Soil sample CC4 collected from this area. Viewpoint 76 (Figure A-1; Appendix A). Photograph reference 76 (CD-ROM). Direction photo taken: N

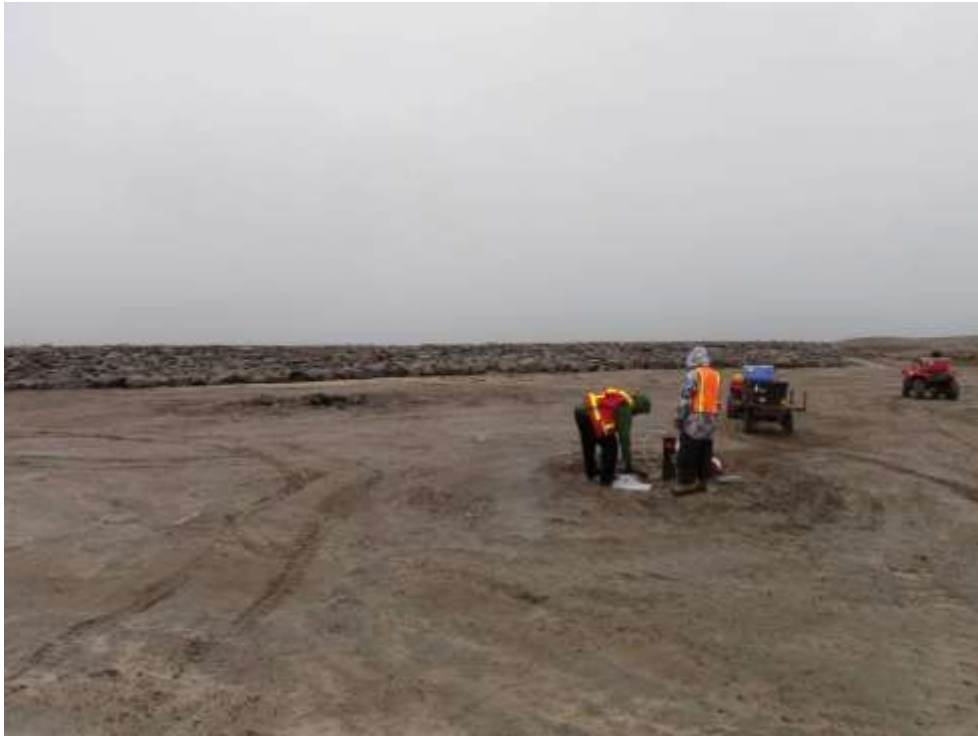
Groundwater sampling at MW-4. Viewpoint 8 (Figure A-1; Appendix A). Photograph reference 8 (CD-ROM).  
Direction photo taken: NE
