## **Long Term Monitoring, 2013, Cape Christian, Nunavut**

### **FINAL REPORT**

Project No. 1697-1301  
January 20, 2014

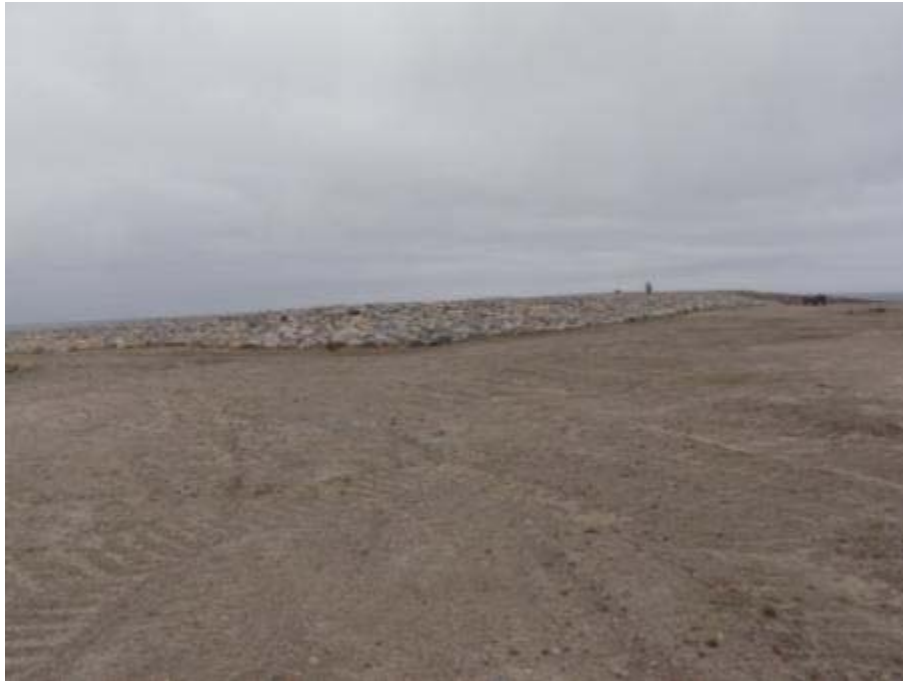
Southwest corner of the NHWL. Viewpoint 2 (Figure A-1; Appendix A). Photograph reference 2 (CD-ROM). Direction photo taken: NE

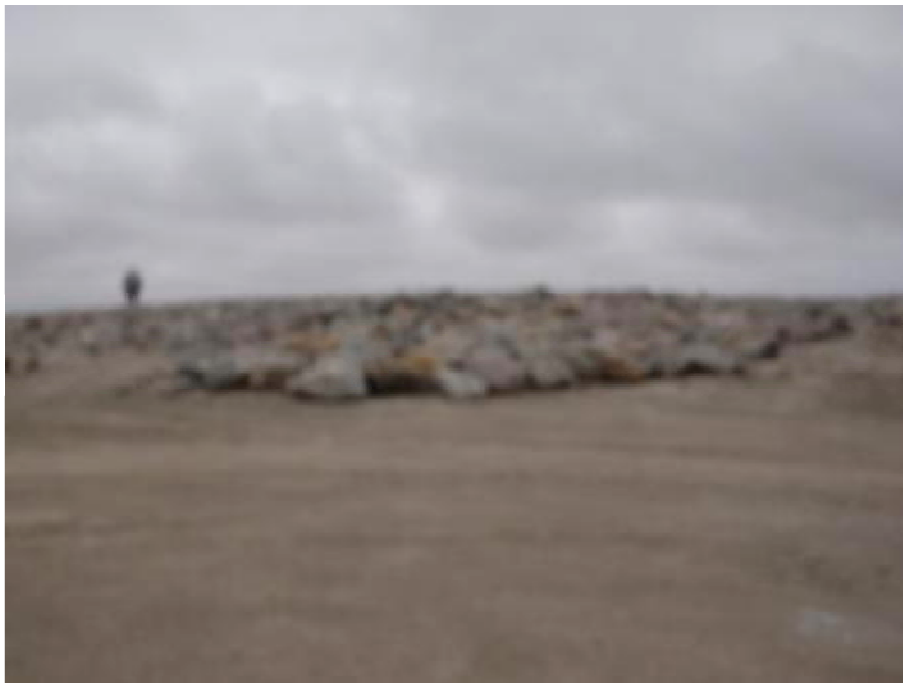
Southeast corner of the NHWL. Viewpoint 17 (Figure A-1; Appendix A). Photograph reference 17 (CD-ROM). Direction photo taken: NW

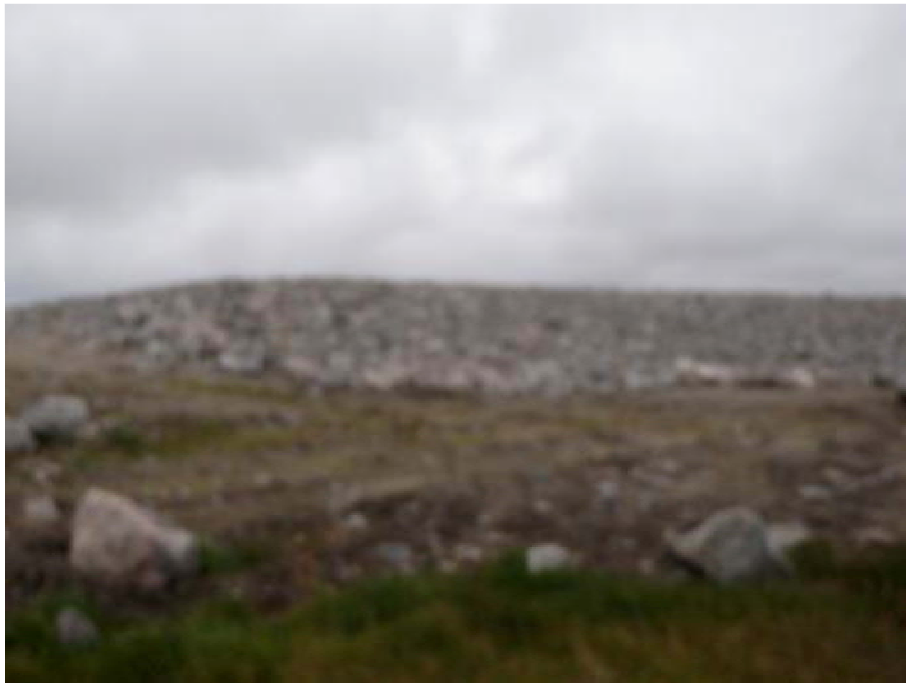
Northeast corner of the NHL. Viewpoint 28 (Figure A-1; Appendix A). Photograph reference 28 (CD-ROM).  
Direction photo taken: SW

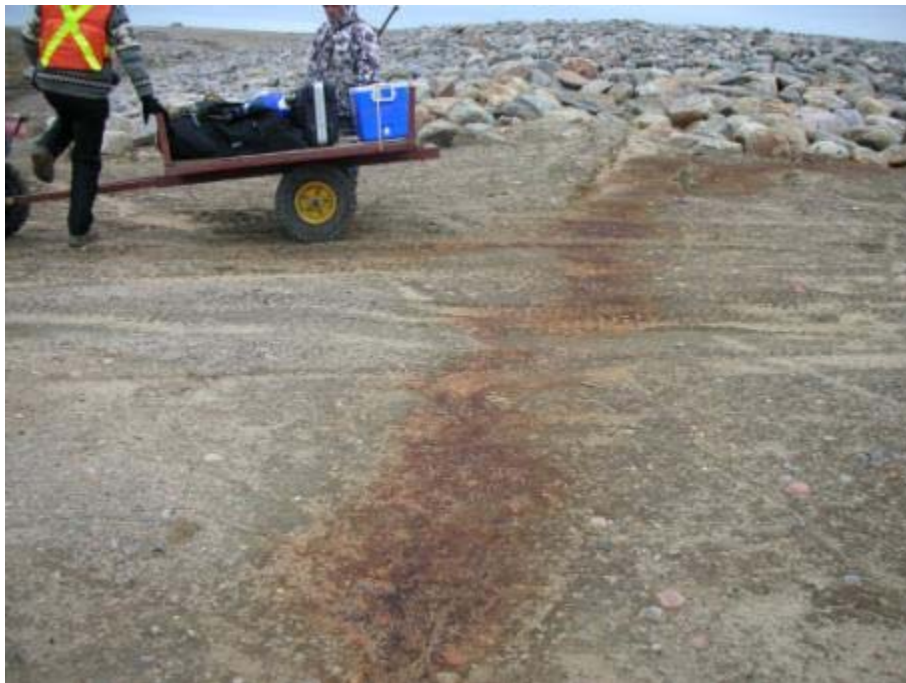
| Sample | Sample Location and Soil Description | Analytical Parameters |
|---|---|---|
| CC-SS3 | Soils collected on west side of NHL at the northwest corner. Possible seepage point. Soils were sand and gravel, brown, moist, stained, slight organic odour, no sheen. | - total metals<br>- PCBs<br>- PHCs F1-F4 and BTEX |

Northwest corner of the NHL. Soil sample CC-SS3 collected from stained area. Viewpoint 40 (Figure A-1; Appendix A). Photograph reference 40 (CD-ROM). Direction photo taken: SE

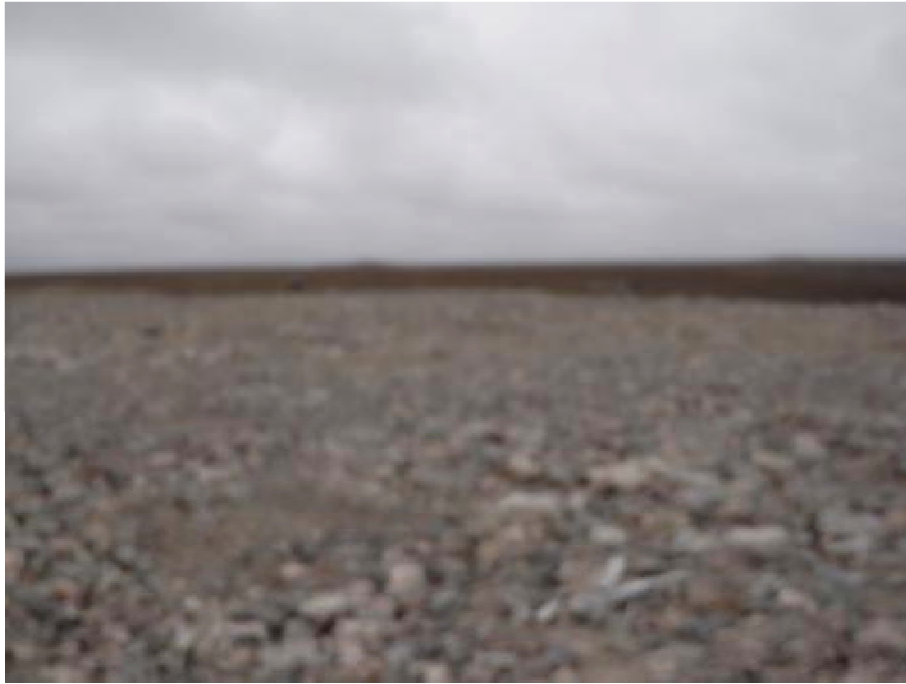
Top of the NHL. Note the undulations of the cap. Viewpoint 22 (Figure A-1; Appendix A). Photograph reference 22 (CD-ROM). Direction photo taken: W

Although the overall performance of the landfill is presently considered acceptable, as it was observed during the Year 1 monitoring event and again in Year 3, the grading of the landfill cap is poor, inconsistent, and does not appear to maintain a consistent grade. It was also observed that the landfill cap consisted of many different particle sizes (i.e., small cobbles to fines). The inconsistent grading and particle size selection has led to many small undulations on the cap. A potential increase in water infiltration, over time, may cause excessive erosion, possible settlement issues, and potential seepage issues around the landfill perimeter in subsequent years.

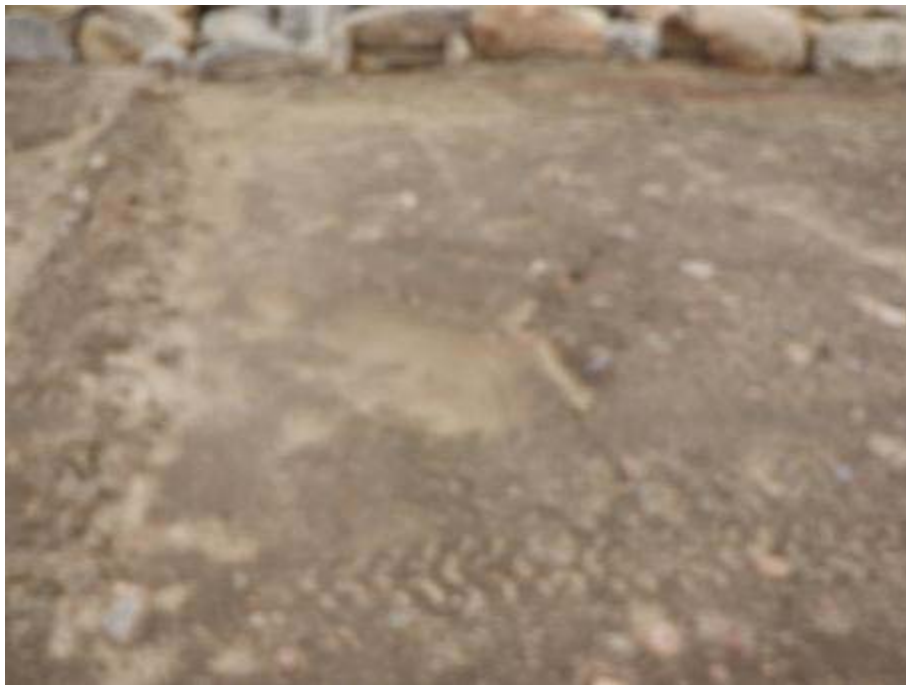
Two sinkholes were still observed near the toe of the NHL (see Features D and F, Figure A-1; Appendix A and Photographs 55 and 59; CD-ROM) during the Year 3 monitoring event. Neither of the sinkholes contained water during the site visit. The size of one of the sinkhole slightly increased.

Sinkhole near the northwest corner of the NHL. Not as pronounced as depicted in 2011. Viewpoint 55 (Figure A-1; Appendix A). Photograph reference 55 (CD-ROM). Direction photo taken: E

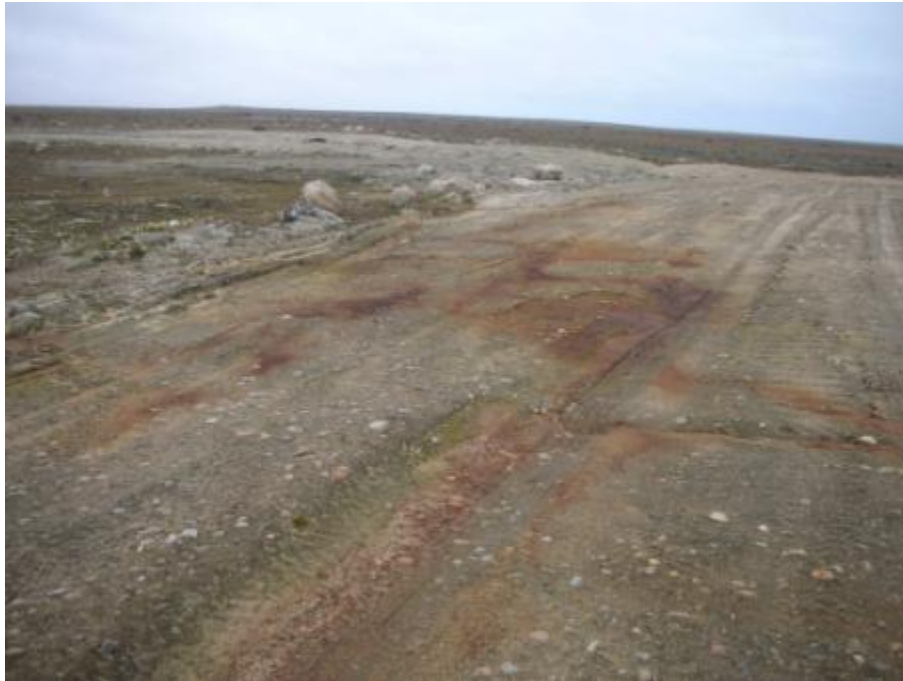
Several areas of orange staining were observed surrounding the landfill. Soil was collected from three (3) locations around Features L, N, and A where the staining was observed. Two new areas of staining were observed on the west side of the landfill (Features P and Q, Photographs 80 and 81). These areas were dry and no ponded water was observed. They are not considered to be seepage points.

| Checklist Item | Feature Letter | Relative Location | Length (m) | Width (m) | Depth (m) | Extent | Description (Change) | Additional Comments | Photo Reference |
|---|---|---|---|---|---|---|---|---|---|
| Staining | P | 10 m west of toe of NHWL | 56.5 m <sup>2</sup> | | | <1% | Soil staining, soils are dry, no ponding of water | New feature in 2013 | 81 |
| Staining | Q | 12 m west of toe of NHWL | 17.6 m <sup>2</sup> | | | <1% | Stained soils, dry, no ponding or seepage | New feature in 2013 | 80 |

Soil staining at Feature Q and P on west side of the NSHL. Viewpoint 81 (Figure A-1; Appendix A). Photograph reference 81 (CD-ROM). Direction photo taken: N

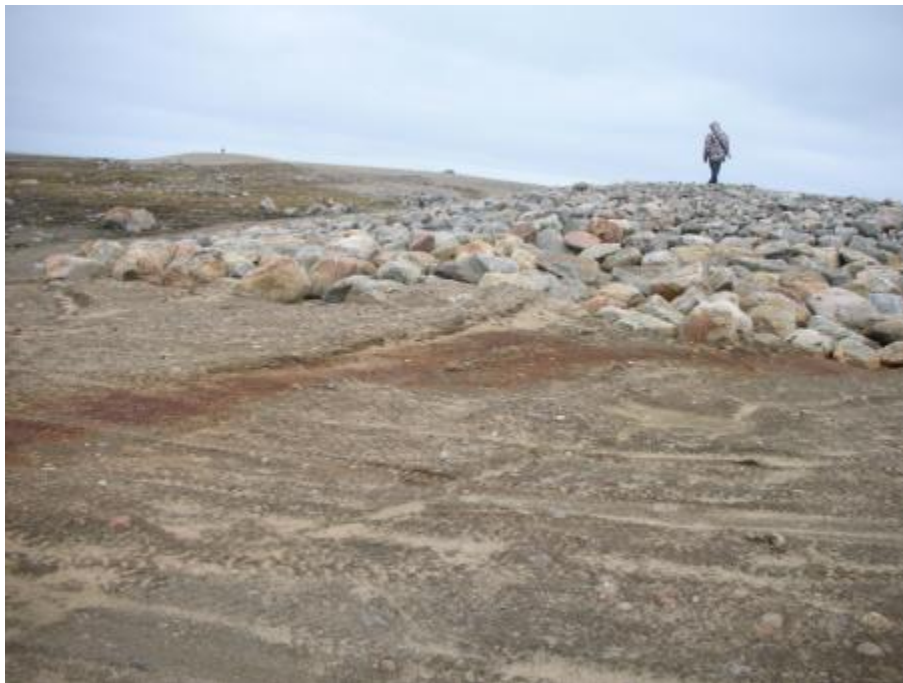
| Checklist Item | Feature Letter | Relative Location | Length (m) | Width (m) | Depth (m) | Extent | Description (Change) | Additional Comments | Photo Reference |
|---|---|---|---|---|---|---|---|---|---|
| Settlement | G | 6 m east of the southwest corner of the NHWL | 35.4 m <sup>3</sup> | | | <1% | Dry, No staining | Dry in 2013, soils not saturated, moss growth | 60-61 |

In 2011, this area was ponded water with staining along the toe of NSHL near the southwest corner. Dry in 2013. Viewpoint 61 (Figure A-1; Appendix A). Photograph reference 61 (CD-ROM). Direction photo taken: NE

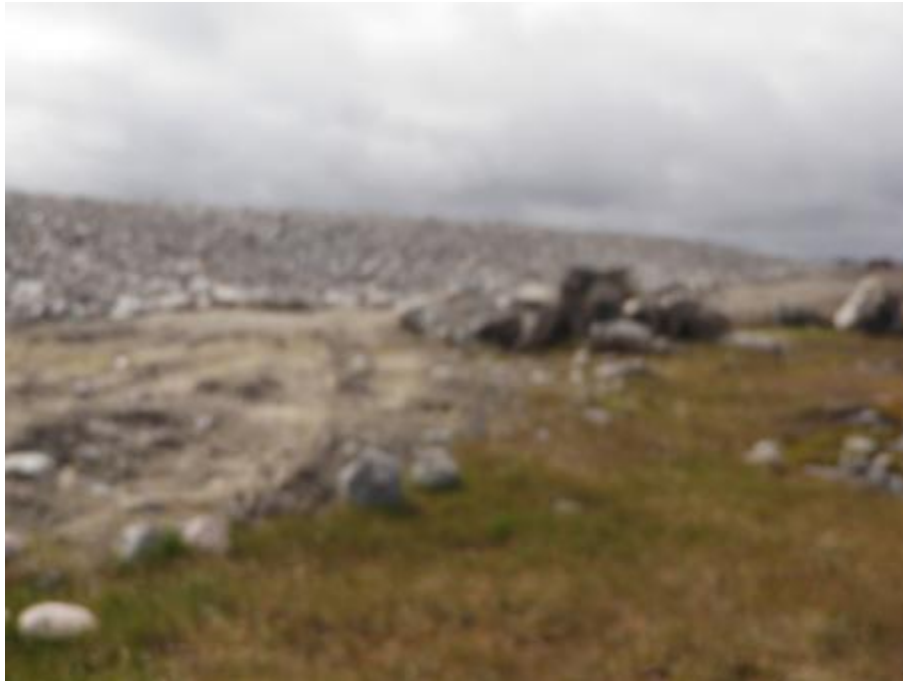
| Checklist Item | Feature Letter | Relative Location | Length (m) | Width (m) | Depth (m) | Extent | Description (Change) | Additional Comments | Photo Reference |
|---|---|---|---|---|---|---|---|---|---|
| Settlement | I | 11 m northeast of the northeast corner of the NHWL | 14.6 m <sup>3</sup> | | | <1% | Saturated soils, No ponding and staining | Was identified as a drainage area with vegetation during the 2011 site visit, area is saturated but not ponded in 2013 | 64 |

Drainage area with staining and vegetation near the northeast corner of the NHL. Area is dry in 2013. Viewpoint 64 (Figure A-1; Appendix A). Photograph reference 64 (CD-ROM). Direction photo taken: SW

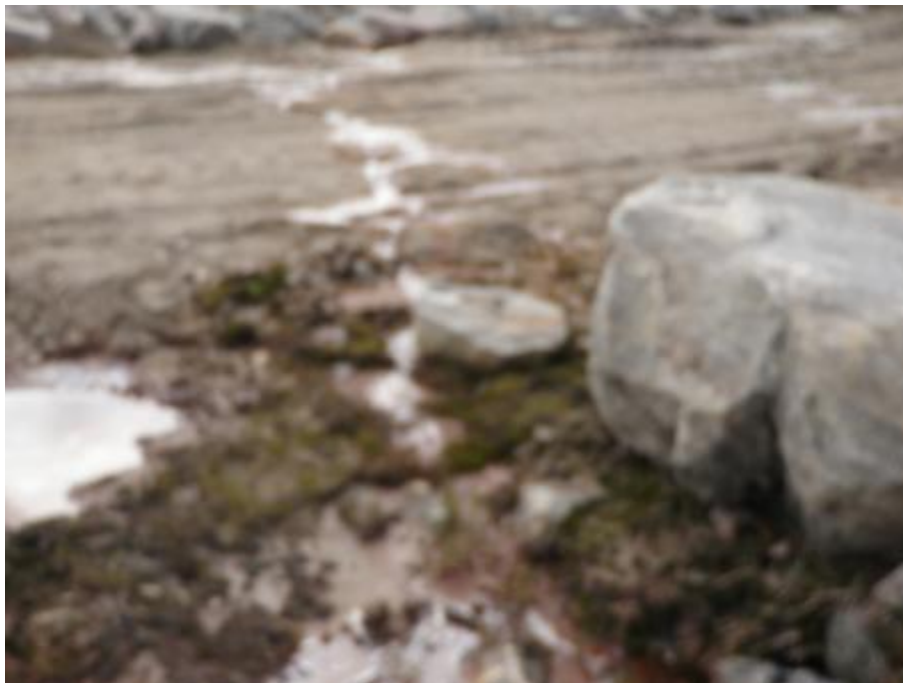
| Sample | Sample Location and Soil Description | Analytical Parameters |
|---|---|---|
| CC-SS1 | Soils collected at north end of NHL near northeast corner, where an erosion channel meets Feature J. Soils were sand, some gravel, brown, heavily stained, no odours | - total metals<br>- PCBs<br>- PHCs F1-F4 and BTEX |

| Checklist Item | Feature Letter | Relative Location | Length (m) | Width (m) | Depth (m) | Extent | Description (Change) | Additional Comments | Photo Reference |
|---|---|---|---|---|---|---|---|---|---|
| Settlement | L | 22 m east of the northeast corner of the NHWL | 18.2 m <sup>2</sup> | | | <1% | Ponded water with staining may be due to equipment tracks | Soil sample CC-SS1 collected from this area | 67-68 |

Ponded water with staining near the north side of the NHL at Feature J. Soil sample CC-SS1 collected from this area. Viewpoint 67 (Figure A-1; Appendix A). Photograph reference 67 (CD-ROM). Direction photo taken: S

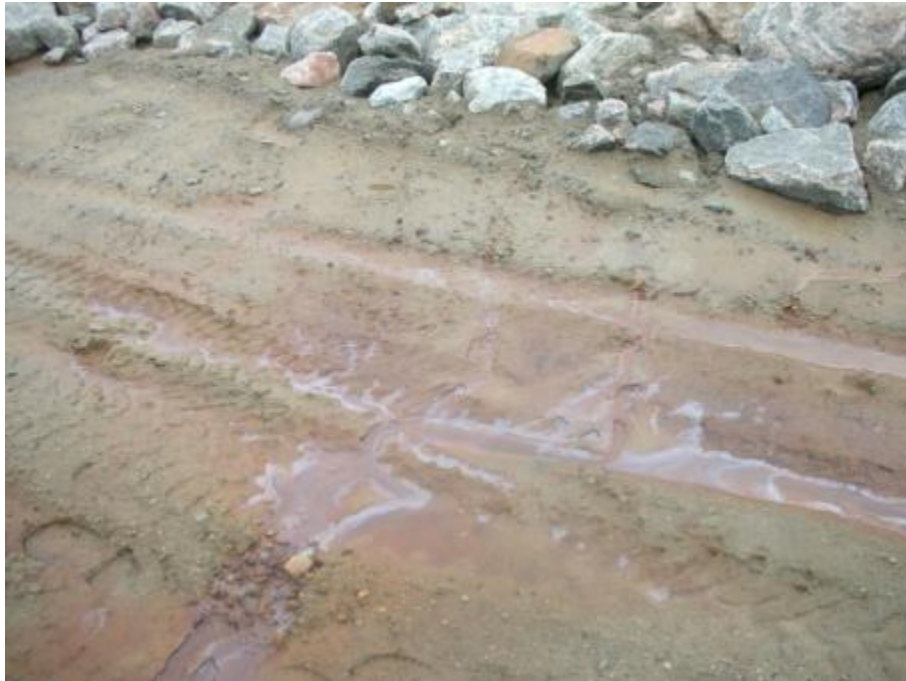
| Sample | Sample Location and Soil Description | Analytical Parameters |
|---|---|---|
| CC-SS2 | Soils collected at north end of NHL near northwest corner where erosion channel meets Feature N. Soils were sand and gravel, brown, heavily stained, sheen, organic odours. DUP1 collected here. | - total metals<br>- PCBs<br>- PHCs F1-F4 and BTEX |

Ponded water was observed in one area near the NHL: Feature N (Figure A-1; Appendix A and Photographs 82 to 84; CD-ROM) is likely the result of the equipment used to construct the NHL. These settlement and ponding areas do not appear to impact the structure of the landfill, or be a result of other impacts to the landfill structure.

| Checklist Item | Feature Letter | Relative Location | Length (m) | Width (m) | Depth (m) | Extent | Description (Change) | Additional Comments | Photo Reference |
|---|---|---|---|---|---|---|---|---|---|
| Settlement | N | 15 m east of the northwest corner of the NHWL | 89 m <sup>2</sup> | | | <1% | Ponded water with staining may be due to equipment tracks, size has increased | Soil sample CC-SS2 collected from this area | 71, 82-84 |

Small erosion channel and staining near the north side of the NHWL. Soil sample CC-SS2/DUP1 collected from this area. Viewpoint 83 (Figure A-1; Appendix A). Photograph reference 83 (CD-ROM). Direction photo taken: SE

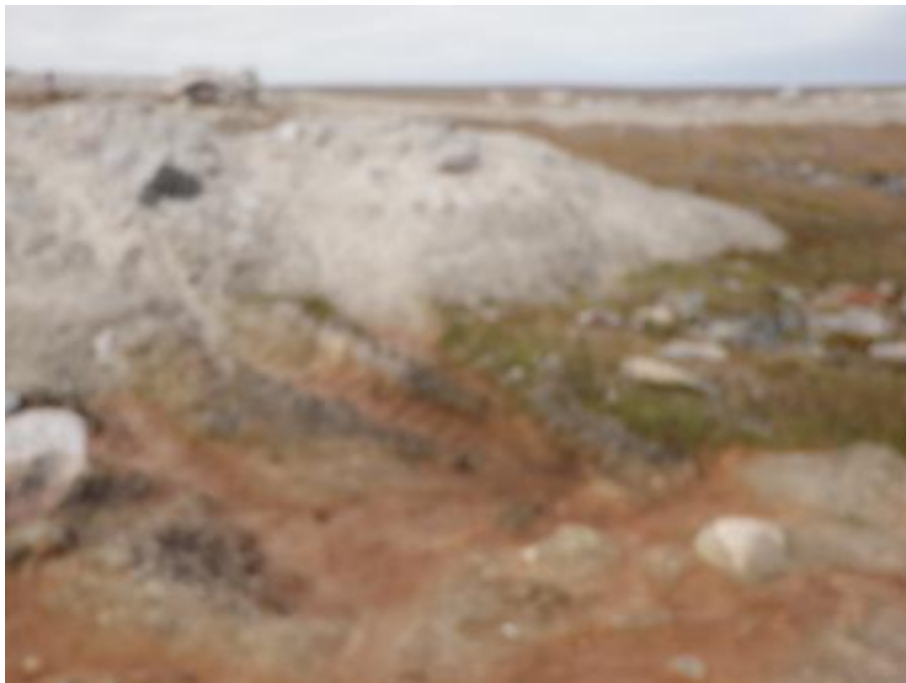
| Sample | Sample Location and Soil Description | Analytical Parameters |
|---|---|---|
| CC-BK | Background soil sample. Soils collected approximately 160 m northwest of NHL. Sample collected in similar stained soils. Soils were sand, brown, moist, no odours. | - total metals<br>- PCBs<br>- PHCs F1-F4 and BTEX |

Background soil sampling location. Soil sample CC-BK collected from this area. Similar stained soils. Viewpoint 74 (Figure A-1; Appendix A). Photograph reference 74 (CD-ROM). Direction photo taken: W
