**RE: Cape Christian Remediation Project: 2009 Annual Report for
Water Licence No: 1BR-LOR0813**

NWB Annual Report

Project Name: Cape Christian Site Remediation Project

Some Select Photos of before and after Remediation

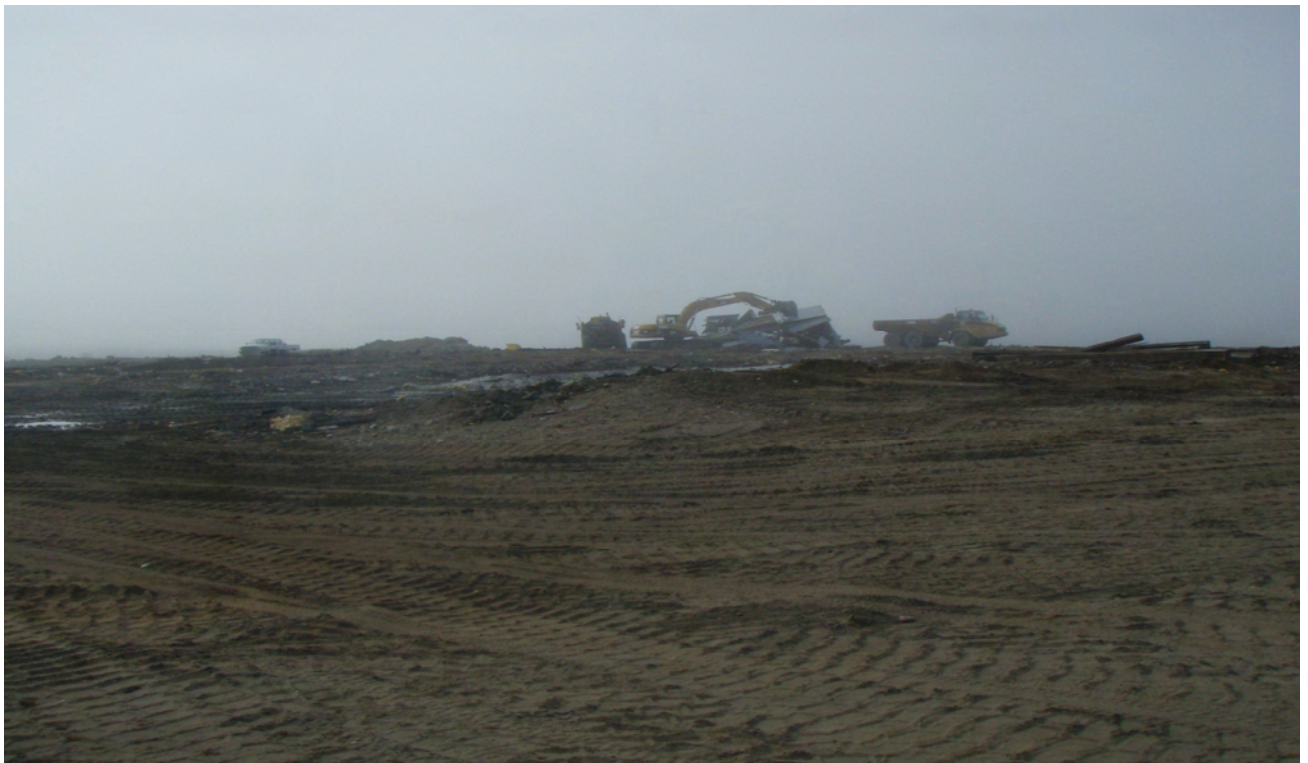
Main Station Area (before
Remediation)

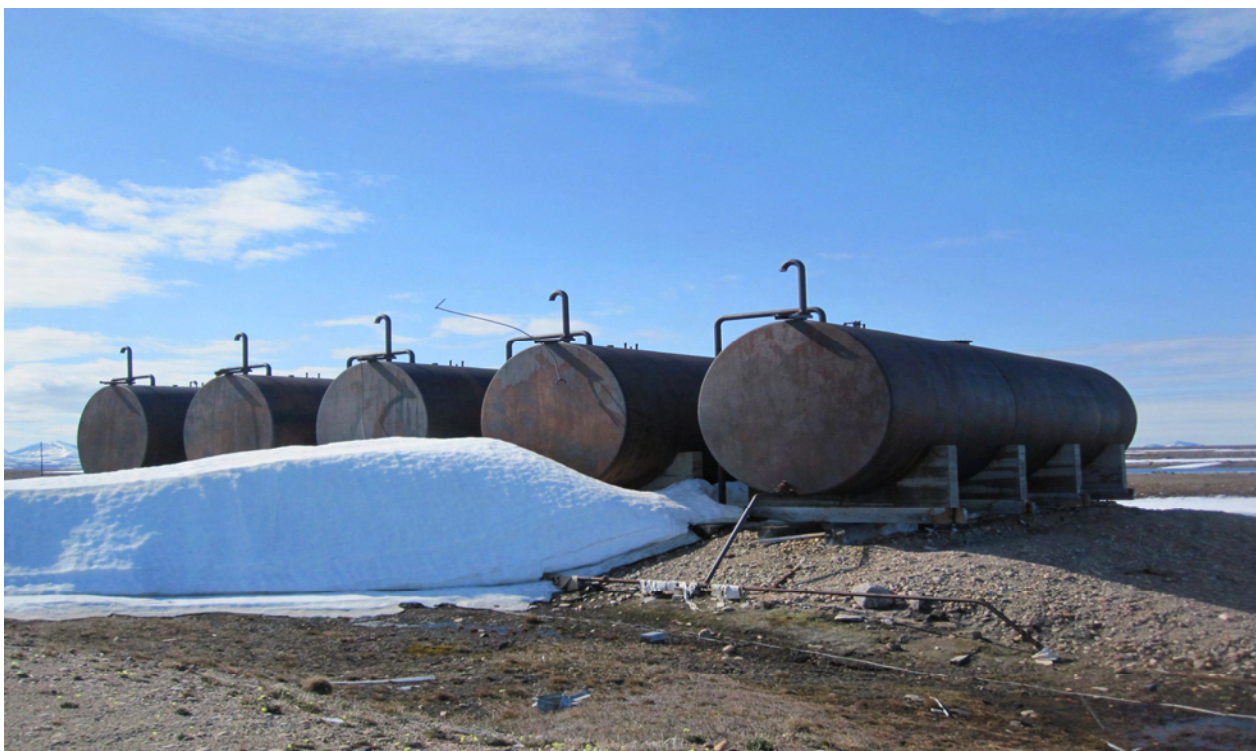
Main Station Area (after Remediation)

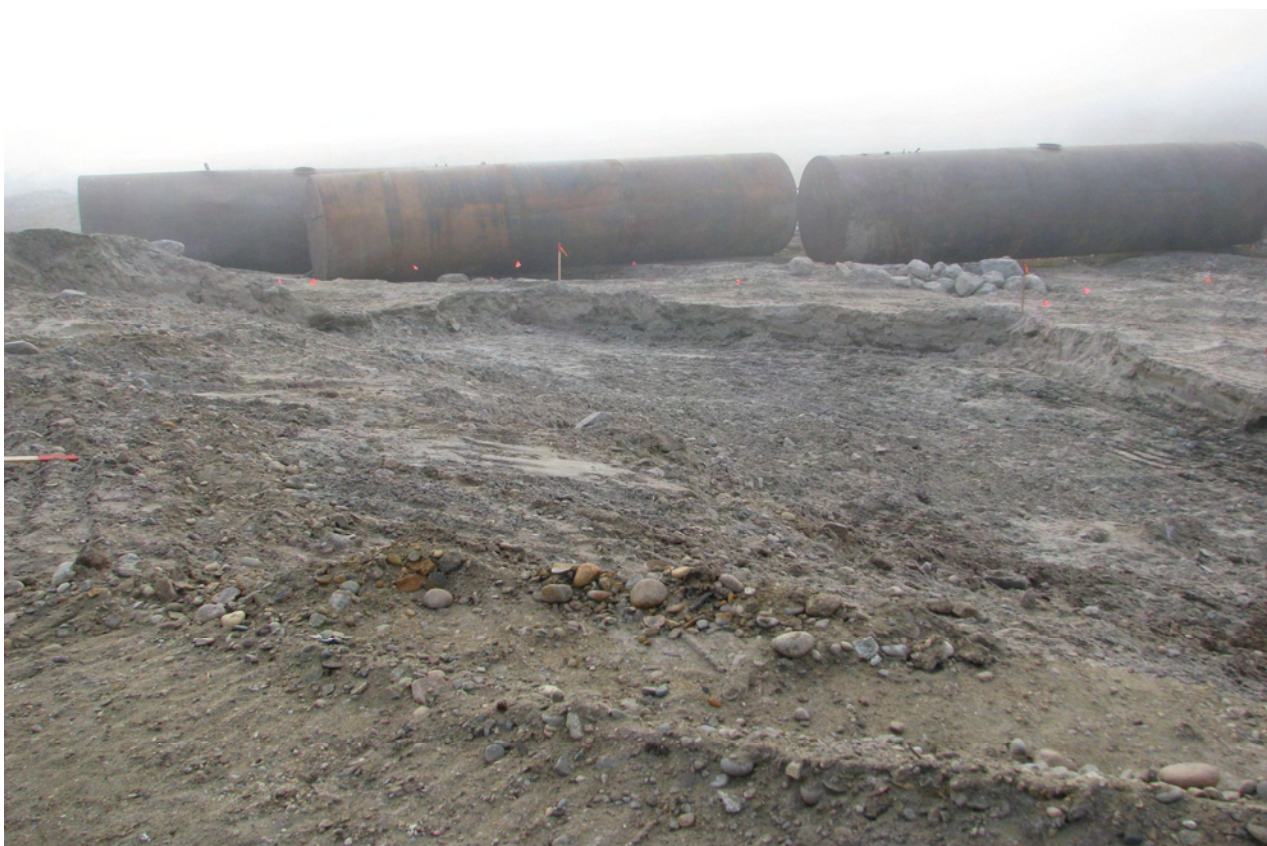
Main Station Area's Aboveground Storage Tanks (ASTs) (before Remediation)

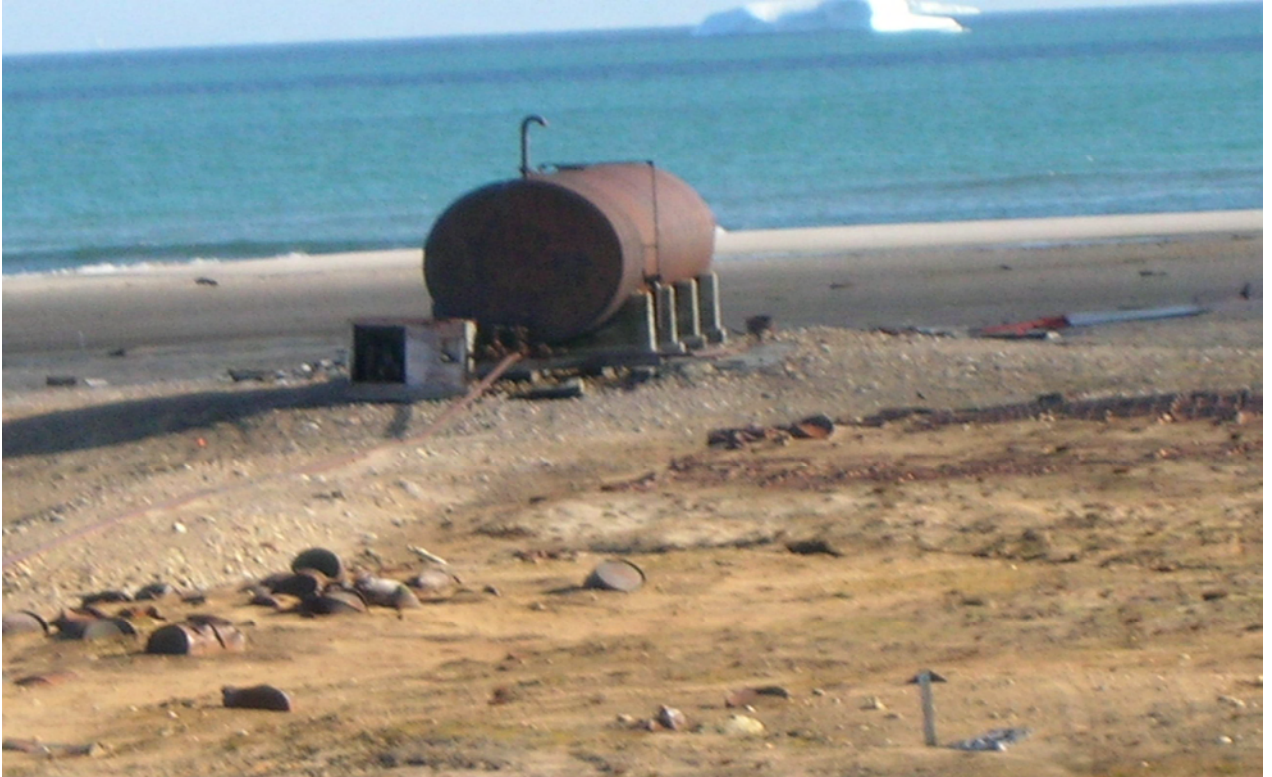
Main Station Area's ASTs (after Decommissioning) – Tanks will be cut and disposed off in Landfill

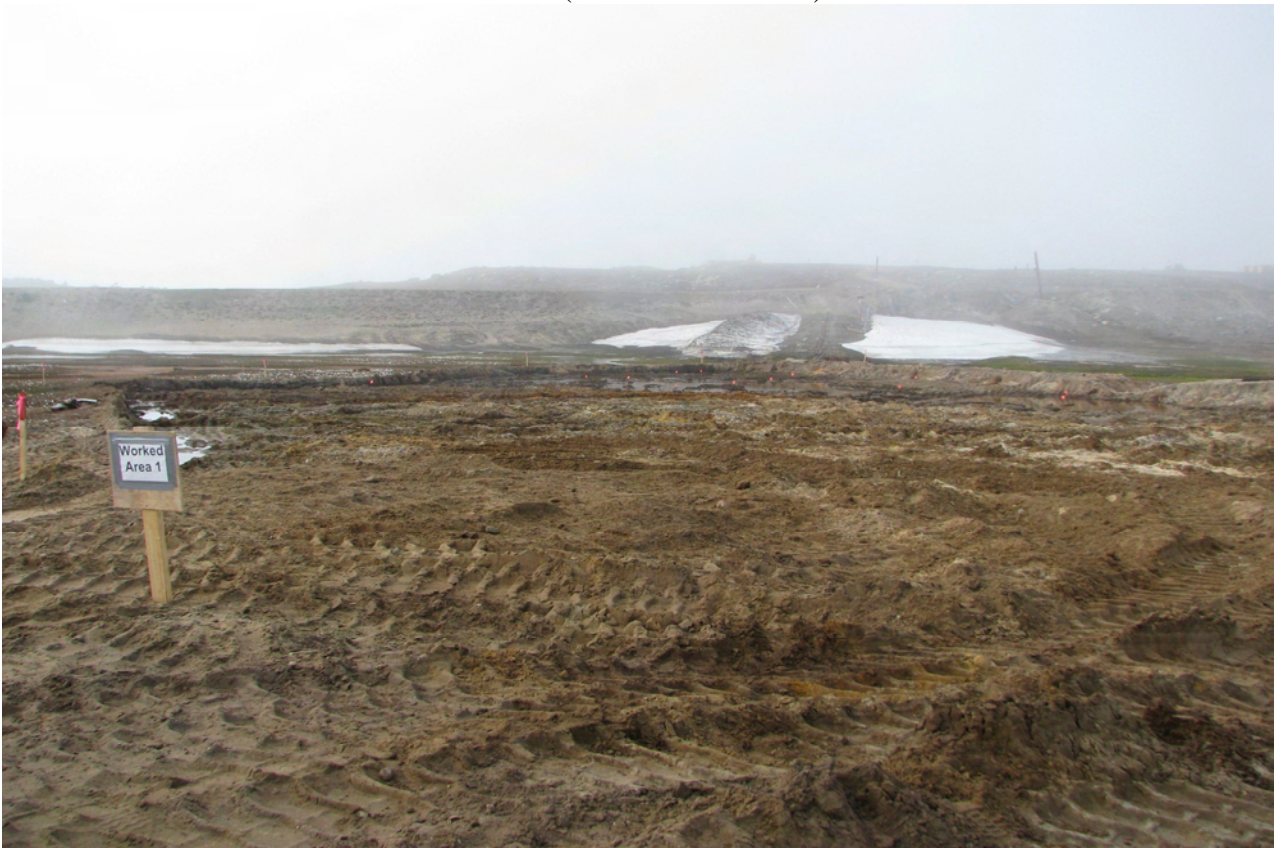
Worked Area # 1 (before remediation)

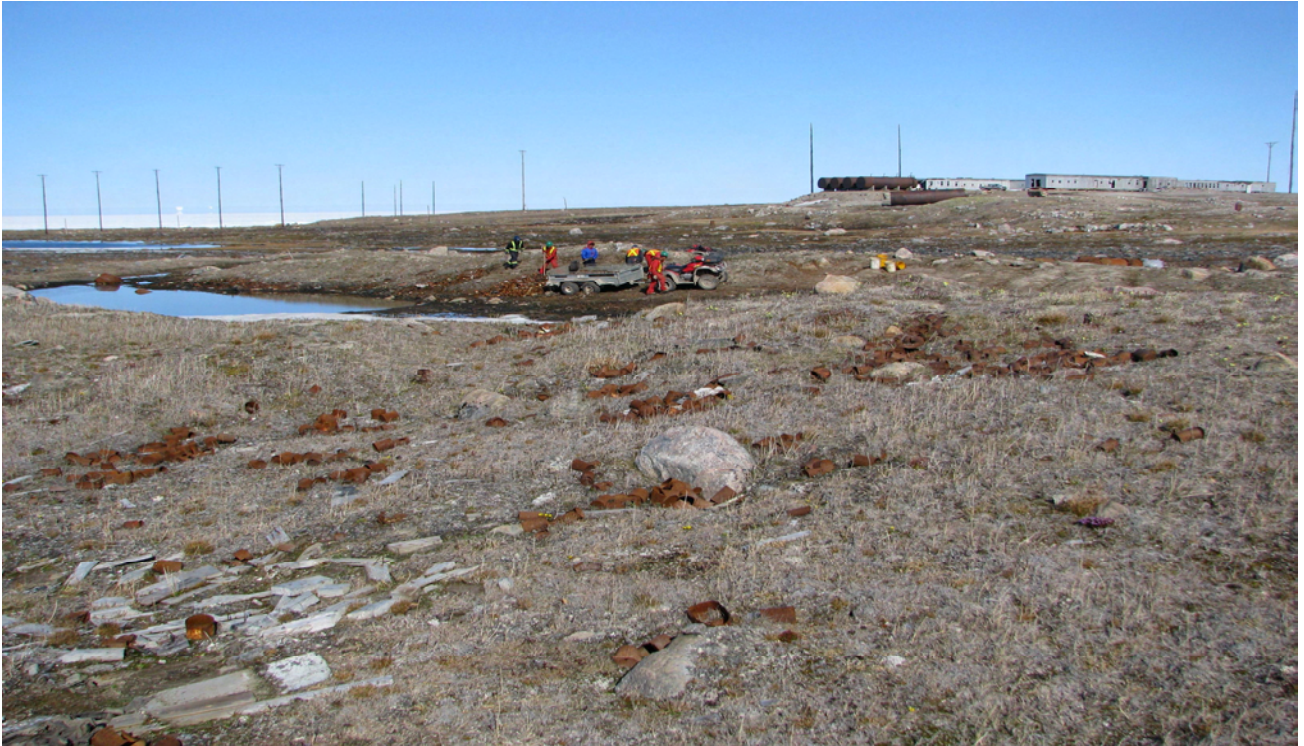
Worked Area # 1 (after Remediation)

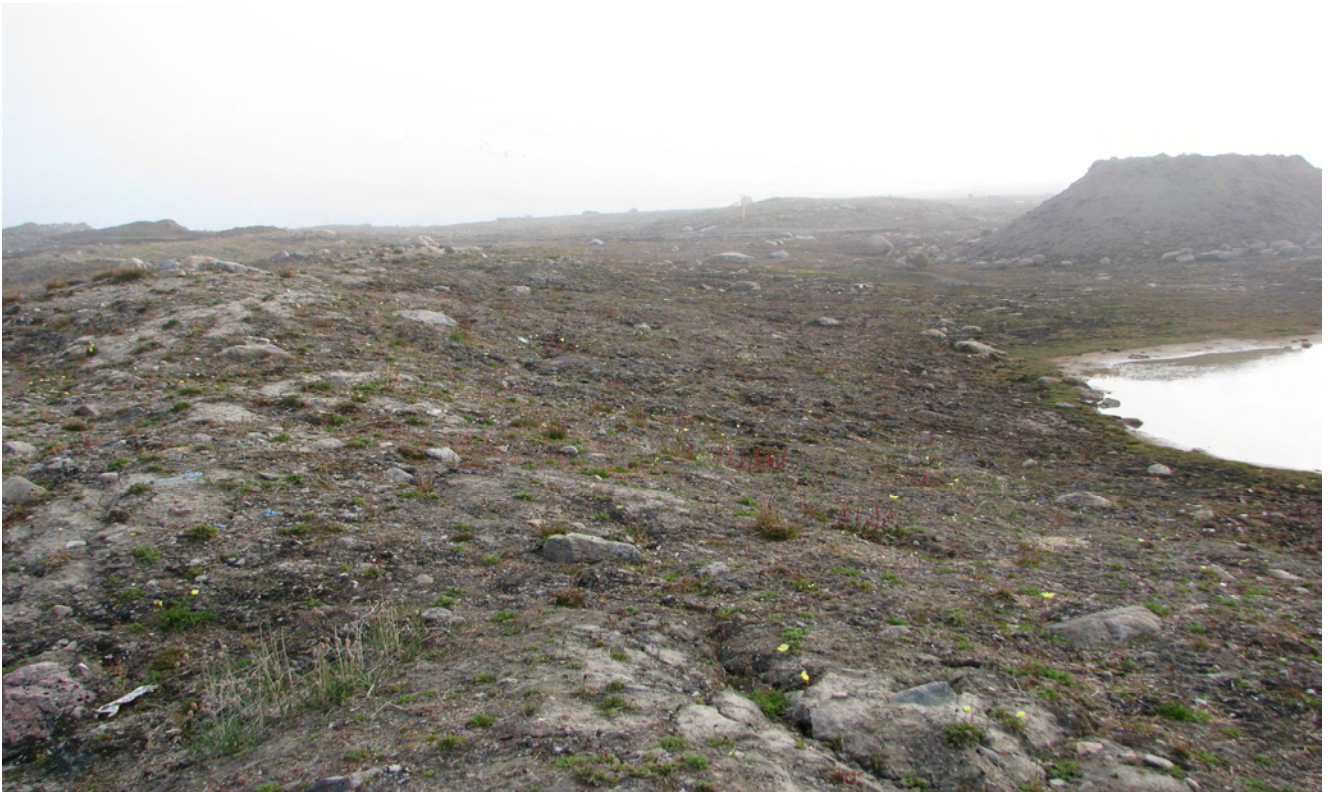
Debris Area # 6 (before/during remediation)
