**Project No: Water Use License 1BR-MAC0712**

**Regarding: Mackar Inlet DEW Line Site**

NWB Annual Report

Project Name: CAM-5, Mackar Inlet DEW Line Site

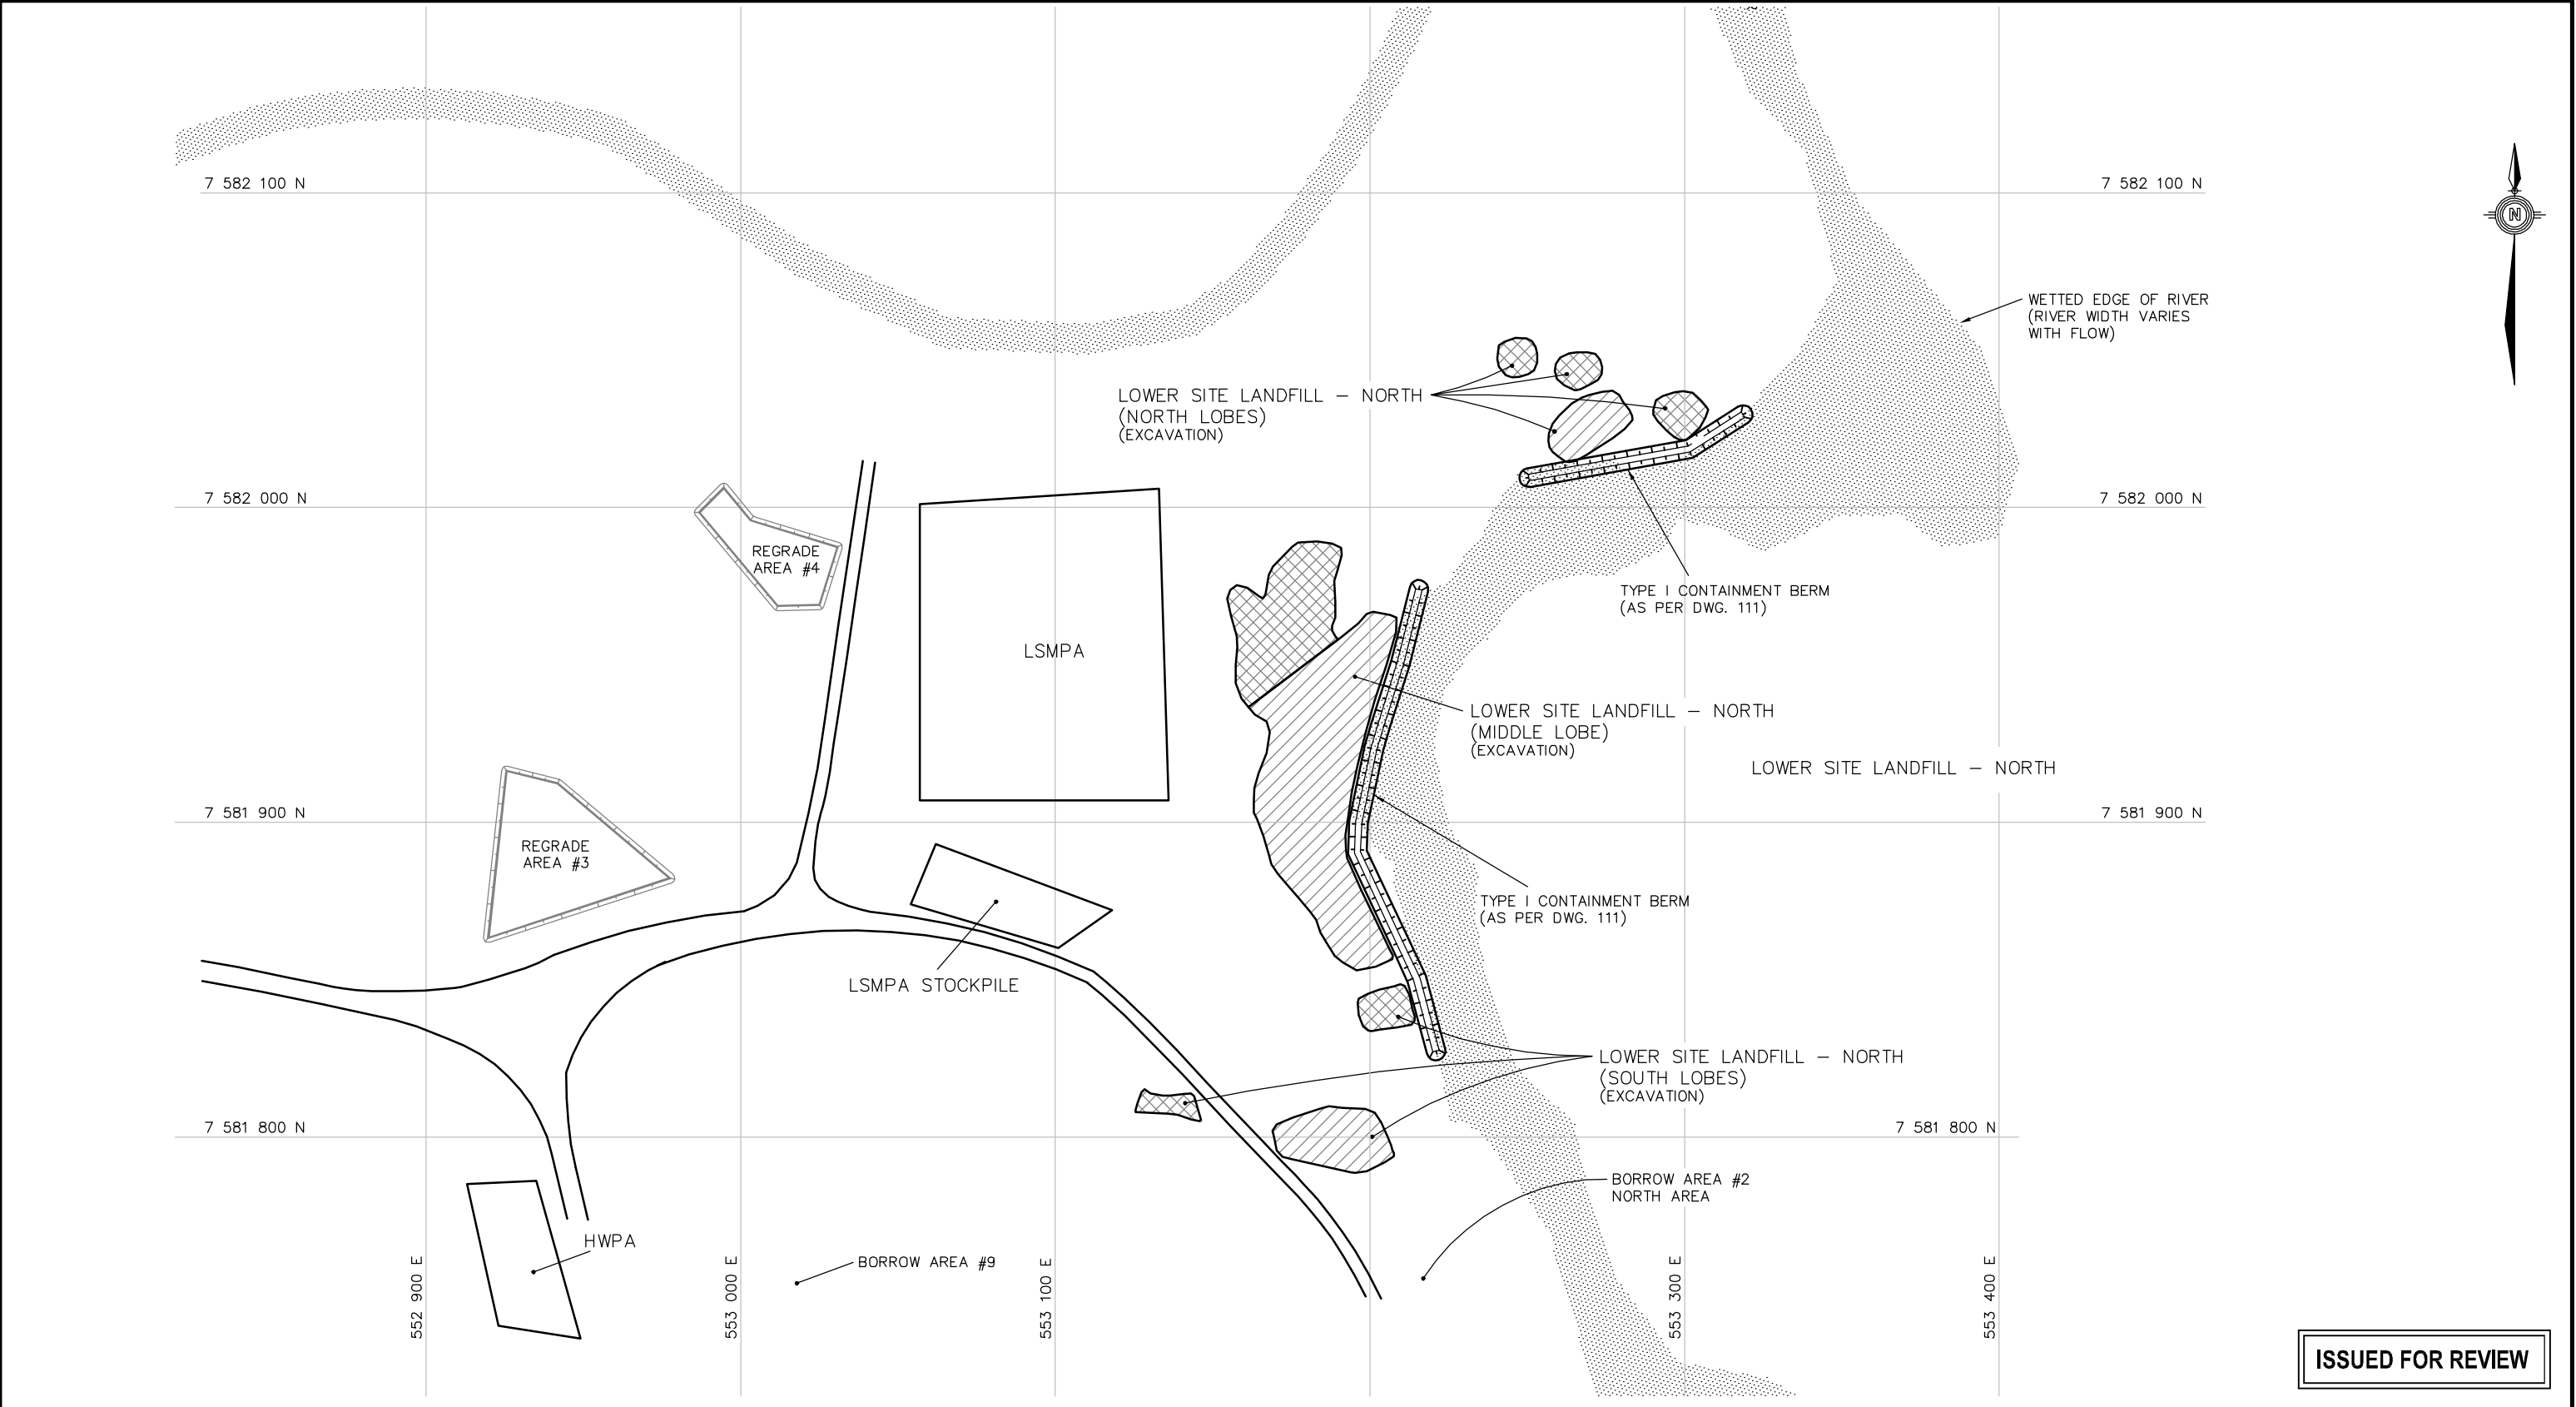
Figure 4

- COMPLETE

- INCOMPLETE

| | | Lower Site | | | | |

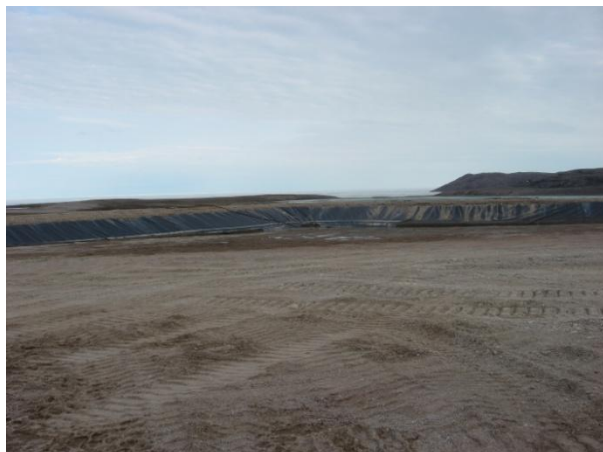
**Landfarm:** Construction of the landfarm was completed in June 2009. Following completion, approximately 9,600 m<sup>3</sup> of Type B hydrocarbon impacted soil was placed in the facility for treatment. Treatment is expected to continue in 2010.

**Photograph 1 ↑**  
Landfarm

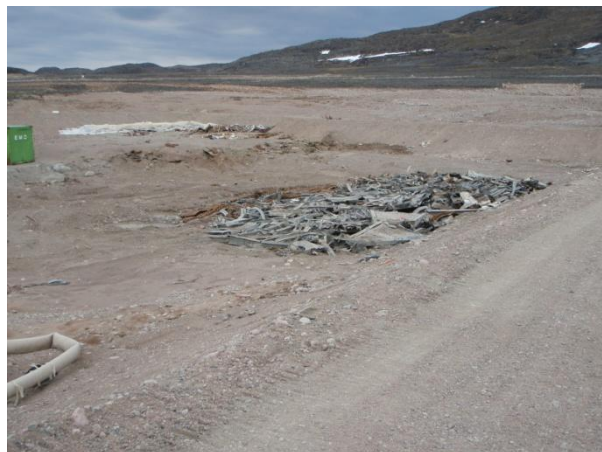
**Non-Hazardous Waste Landfill:** Construction was completed in 2008 and non-hazardous waste materials were placed in the facility in 2009. The facility was winterized at the end of the 2009 season by placing a layer of intermediate fill over the debris. It is anticipated that all non-hazardous wastes will be collected from the site and placed in the landfill in 2010, followed by closure of the landfill at the end of the 2010 season.

**Photograph 2 ↑**  
Non-Hazardous Waste Landfill

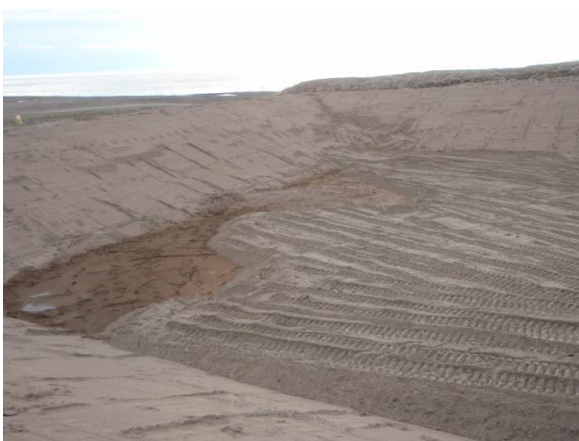
**Tier II Disposal Facility:** Construction of the Tier II Facility was completed in July. Approximately 1200 m<sup>3</sup> of Tier II contaminated soils were disposed of in the facility by the end of the 2009 season. The facility was winterized by placing a later of intermediate fill over the contaminated soil.

**Photograph 3 ↑**  
Tier II Disposal Facility

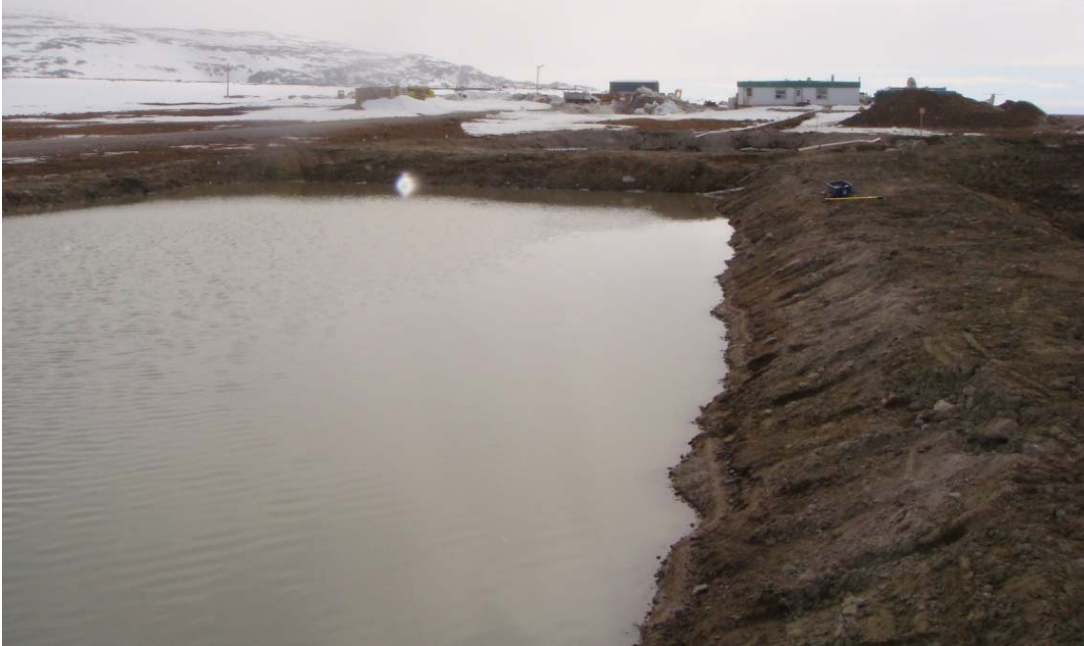
**Photo 1 (DSC00274):** Sample 09-16007 collected from Cell 2 of the camp sewage lagoon on June 11, 2009. Sample was collected using swing sampler. This photo was taken facing southwest.

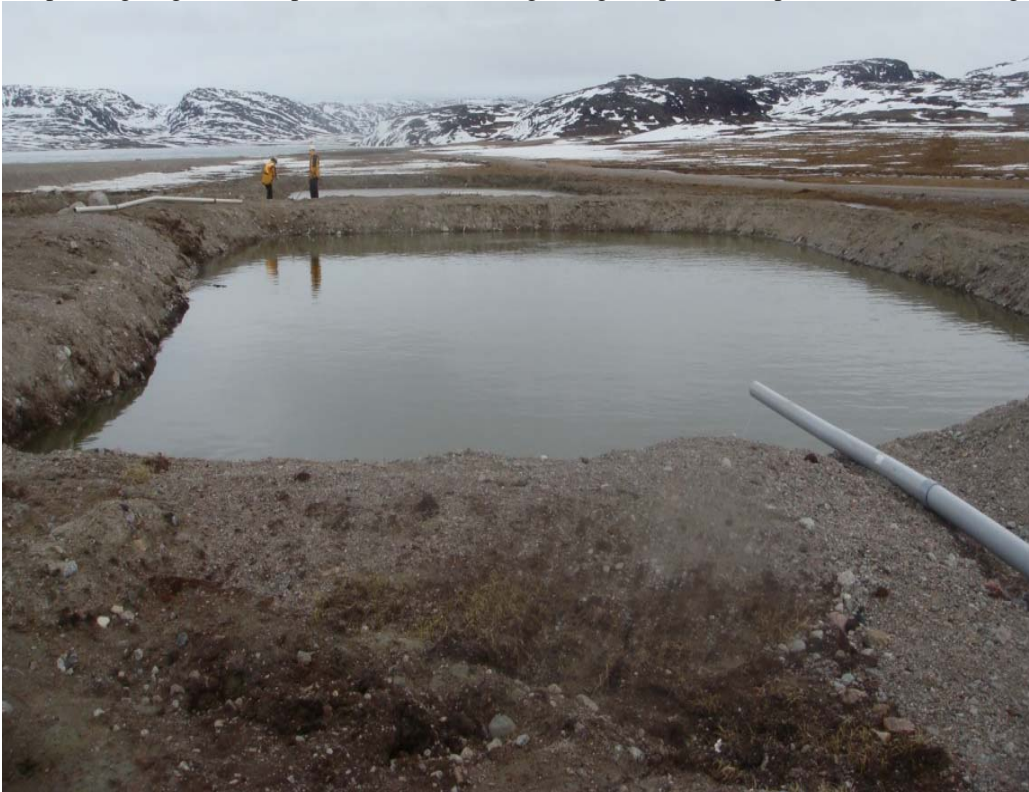
**Photo 2 (DSC01256):** Sample 09-16046, 09-16108, 09-16226 and 09-16266 collected from Cell 2 of the camp sewage lagoon. Sample was collected using swing sampler. This photo was taken facing east.

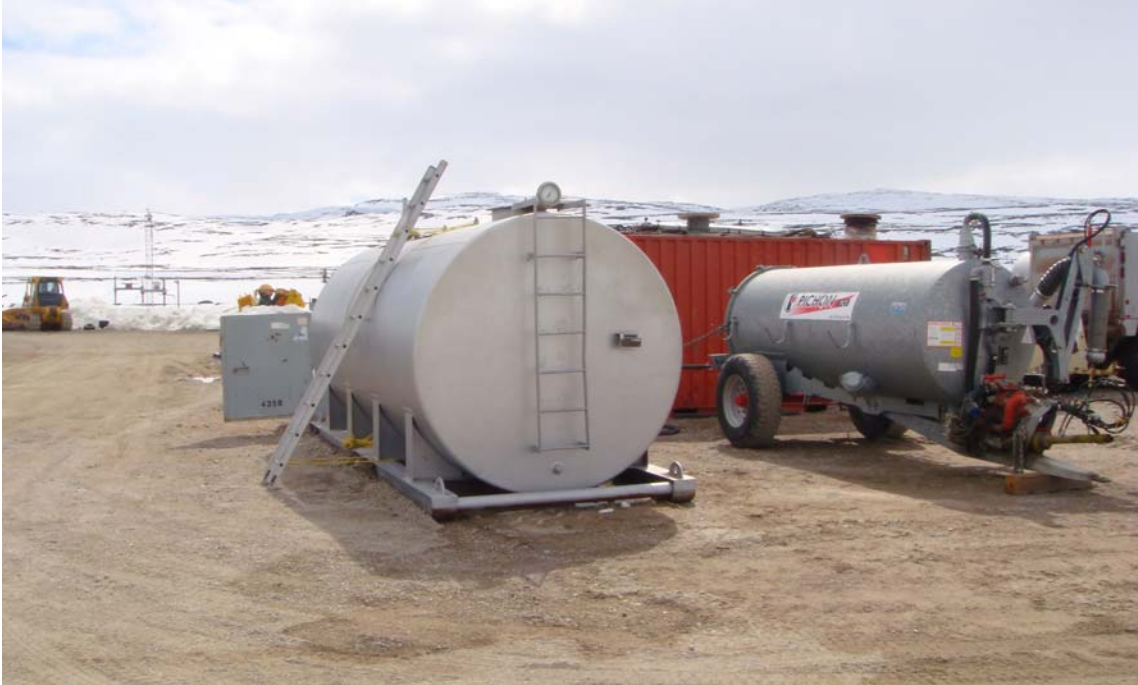
**Photo 1 (DSC 00254):** Sample 09-16008 and 09-16225 collected from the ladder through the opening on top of 6000 gallon tank. The Tank Farm is on the other side of the red maritime container in the background. Picture was taken facing south.

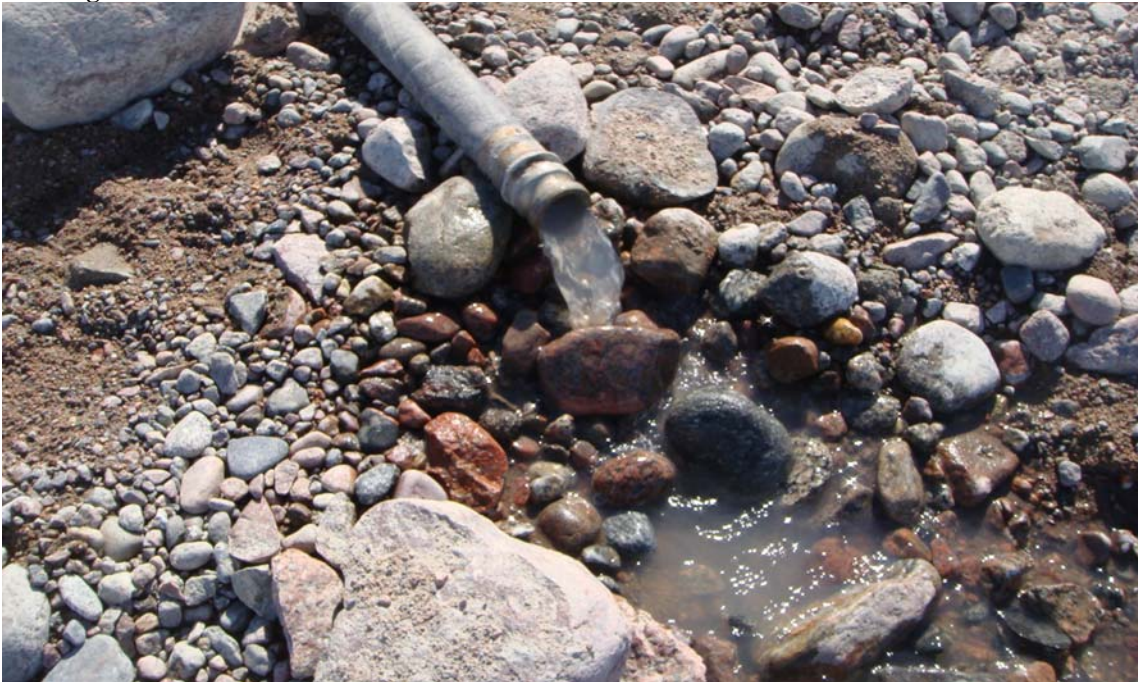
**Photo 2 (DSC 00445):** Sample was collected from the end of the discharge hose which was being discharged to outside the west of the land farm.

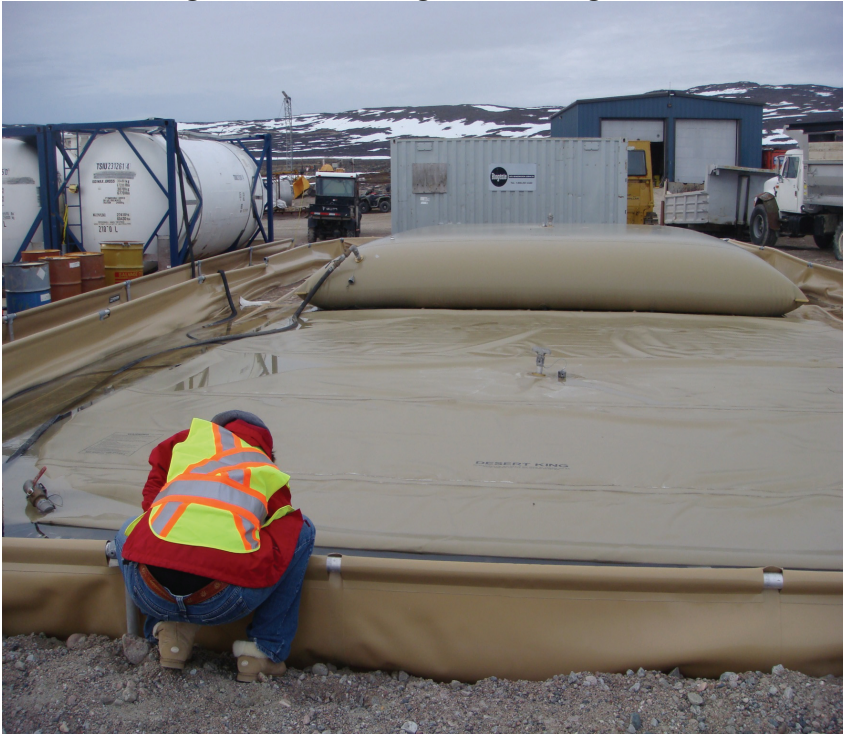
**Photo 1 (DSC 00461):** Sample 09-16292 water sampling from the west insta berm at the contractor tank farm, facing south UVS building is in the background.

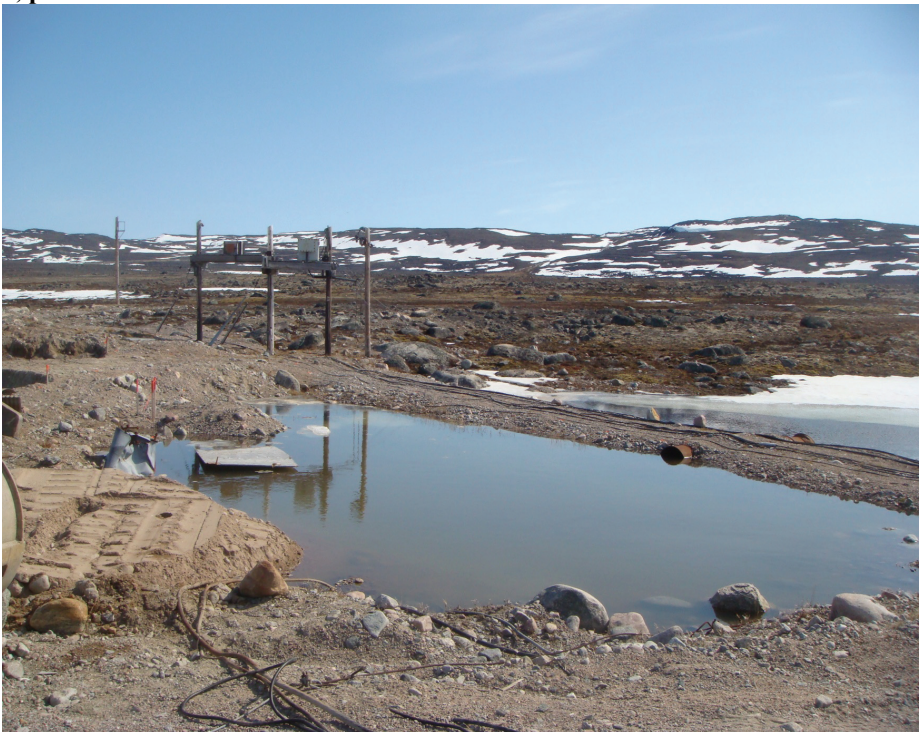
**Photo 2 (DSC01397):** Sample 09-16390 and 09-16391 water pooling over contaminated soil area AA-1, photo faces south west.

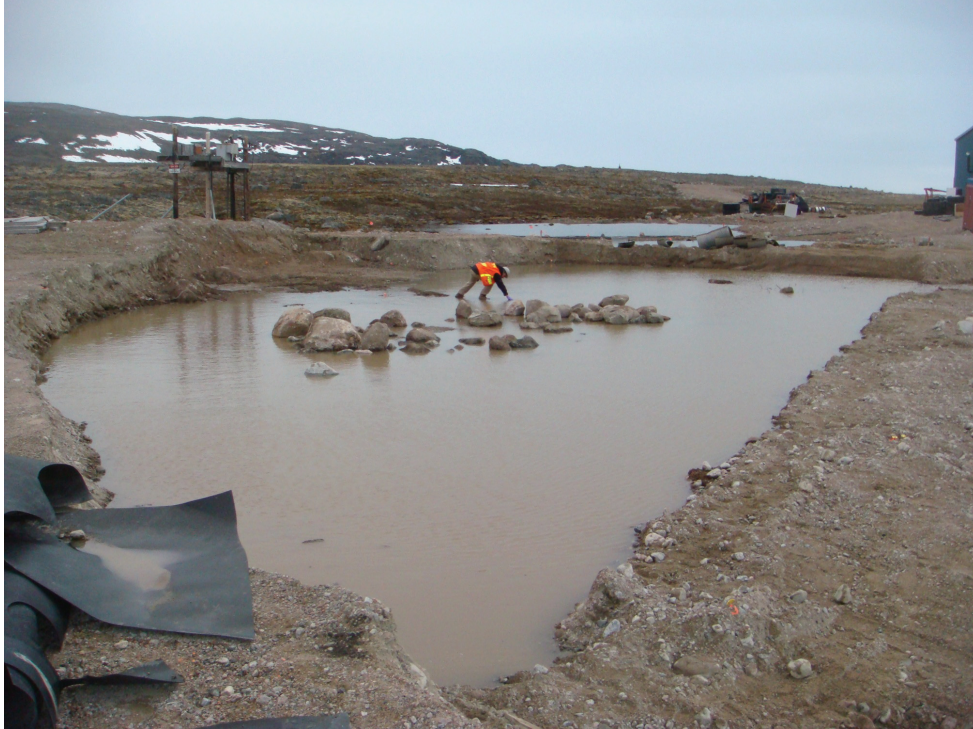
**Photo 3 (DSC01477):** Sample 09-16782 facing southwest. Sample was collected from the middle of the AT-South excavation. Corner of the UVS building is visible in the far right corner.

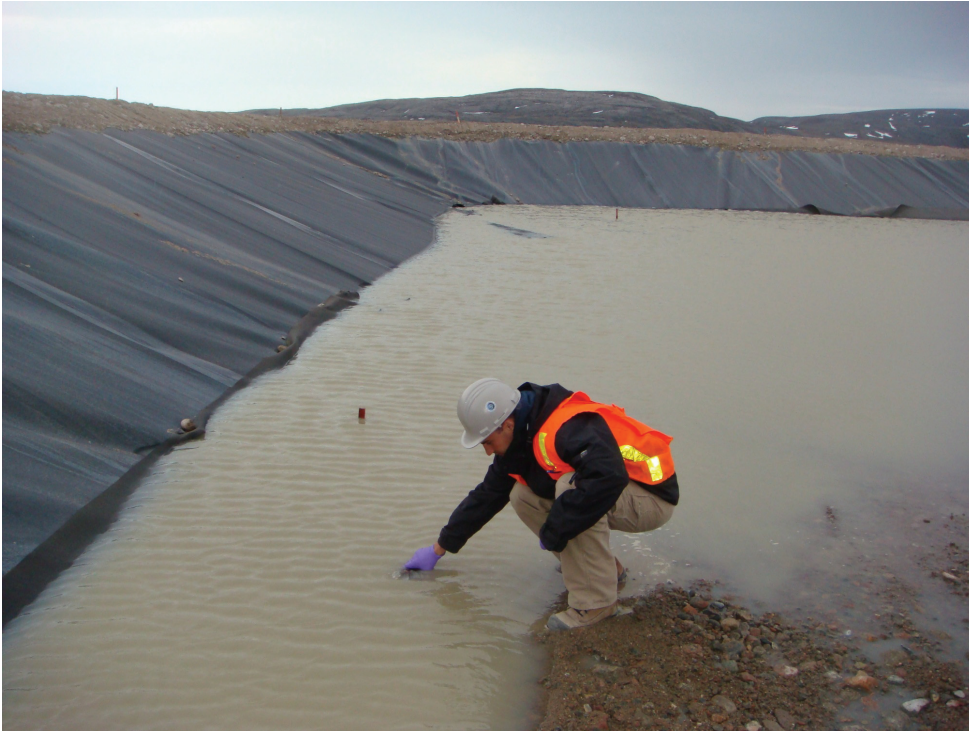
**Photo 4 (DSC01446):** Sample 09-16319 facing north. Sample was collected from the edge of pooling water in the NW corner of the land farm.

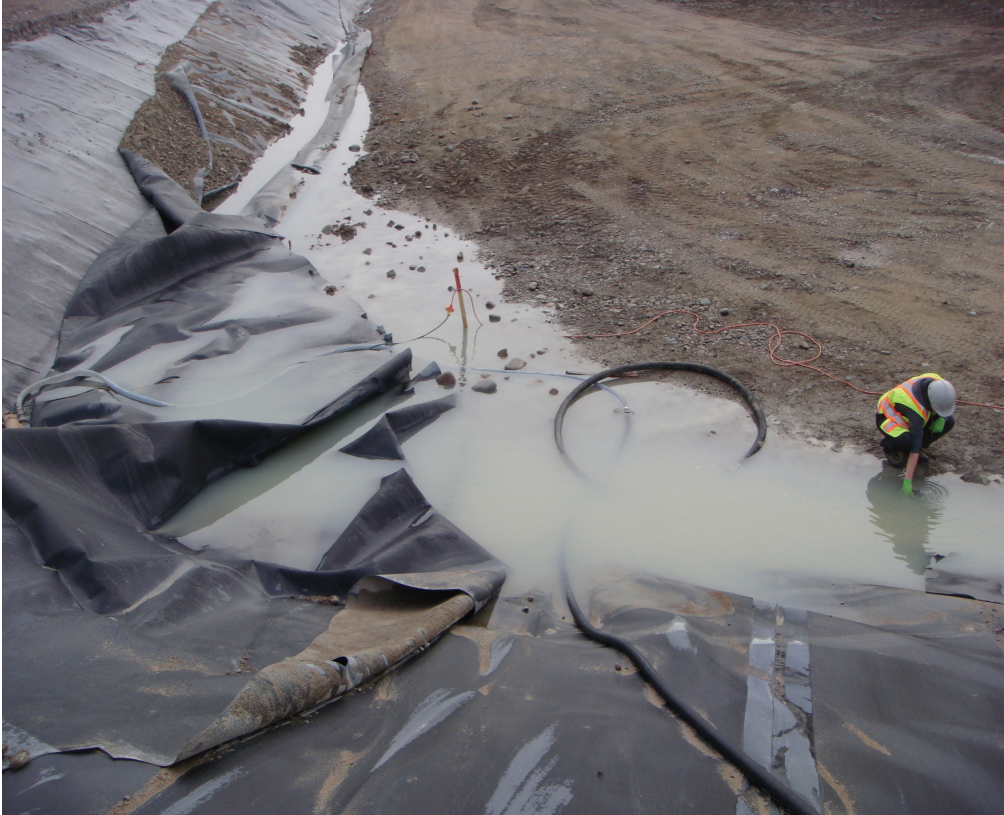
**Photo 6 (DSC00734):** Sample 09-17876 landfarm water sample, lower site. Sample was collected from the pooling water in the NW corner of the land farm.

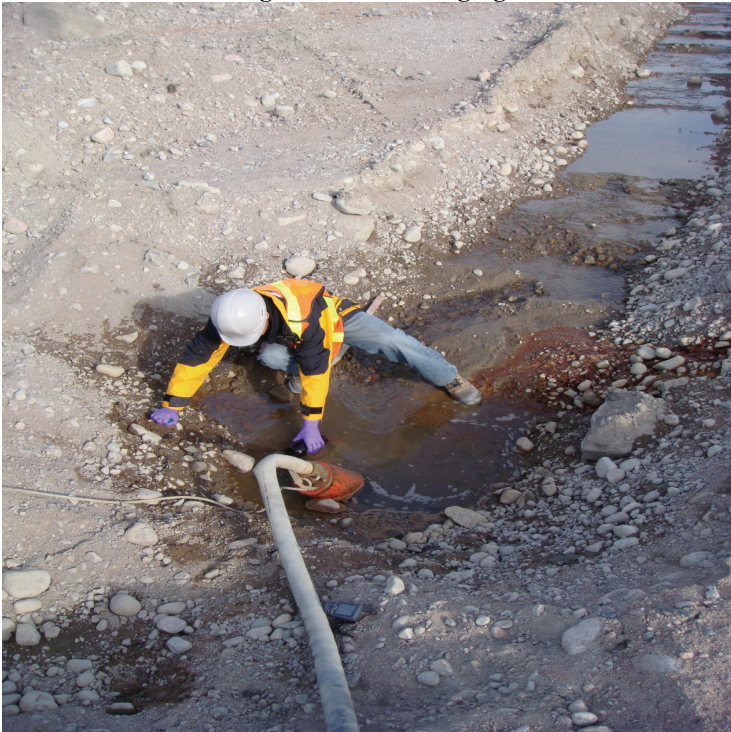
**Photo 5 (DSC00746):** Sample 09-17599 east along the trench dug for removing upwelling groundwater in the landfarm. The area is also bermed off to prevent any surface water from the landfarm from entering into the discharging water.

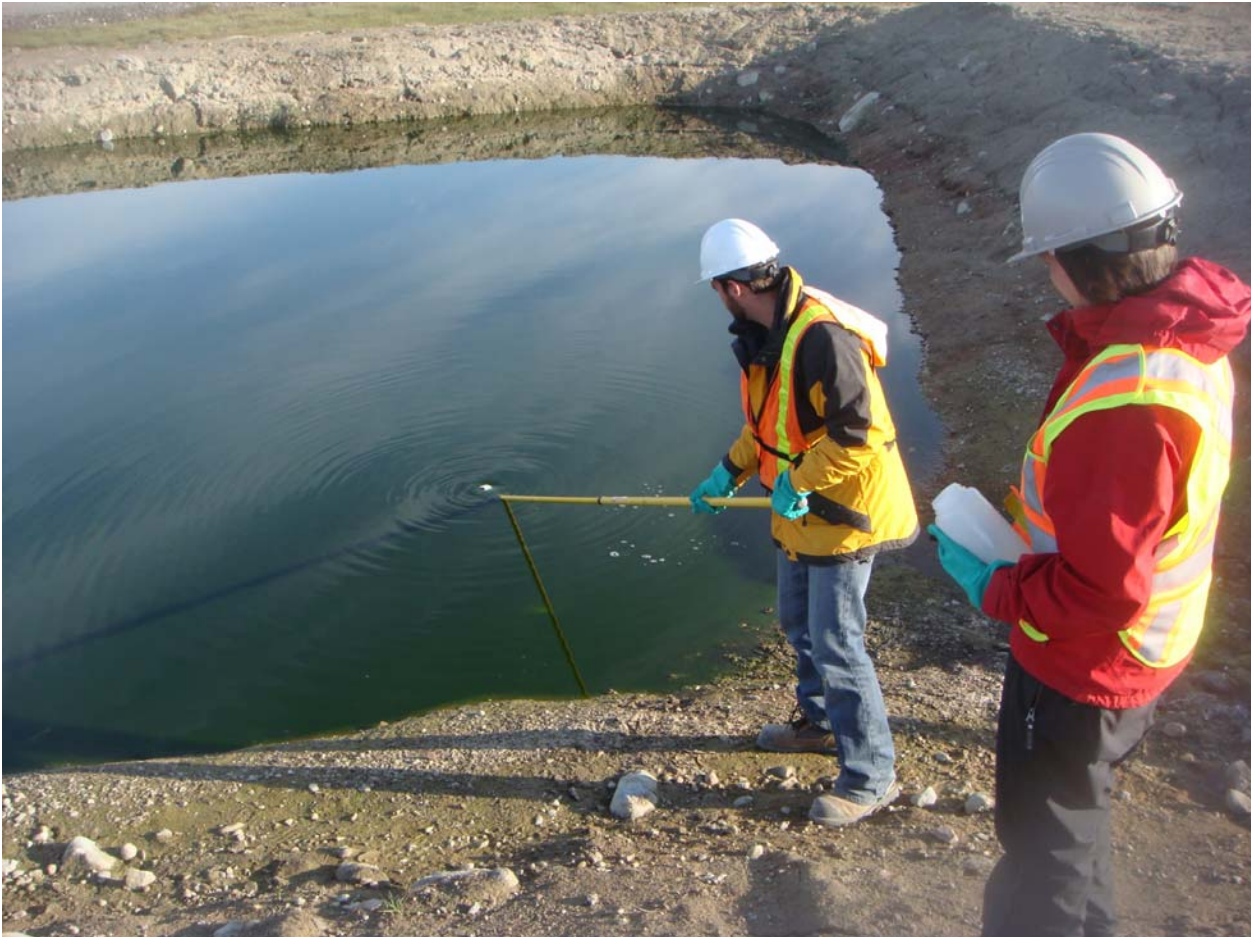
**Photo 1 (DSC01666):** Sample 09-22802 collected from Cell 2 of the camp sewage lagoon from the Northwest corner. The picture was taken from the south on August 15, 2009.

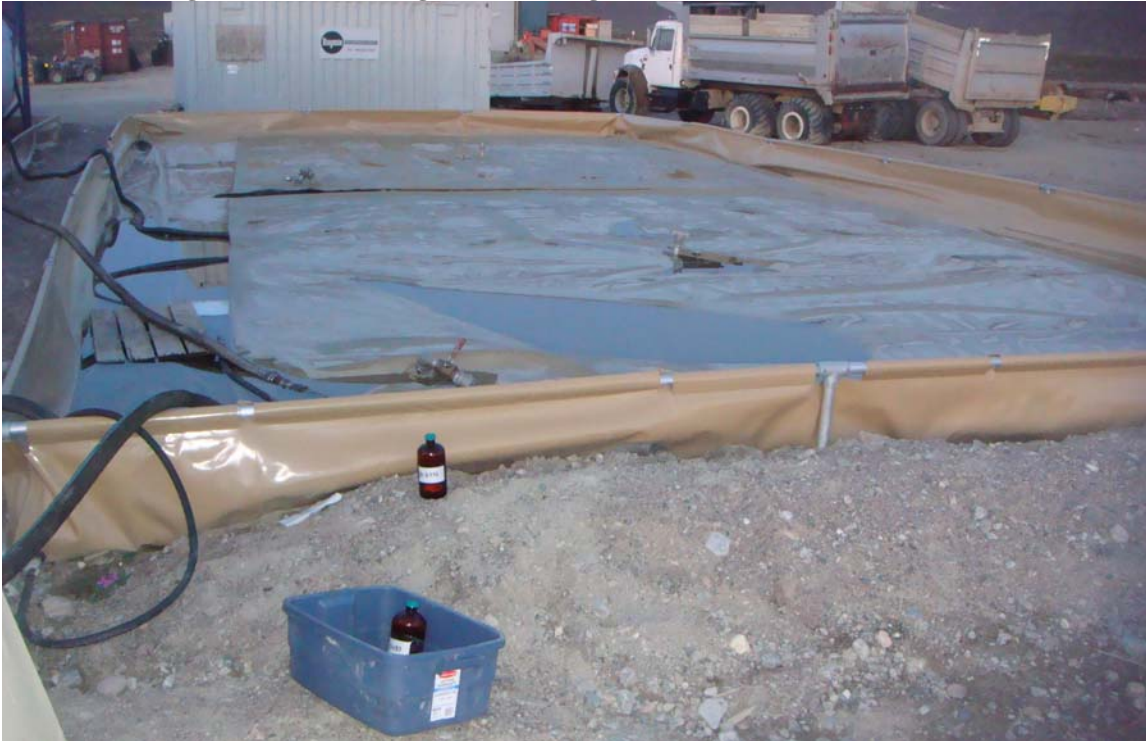
**Photo 1 (DSC01952):** Sample 09-16792 water sampling from the west insta berm at the contractor tank farm, facing south UVS building is in the background.

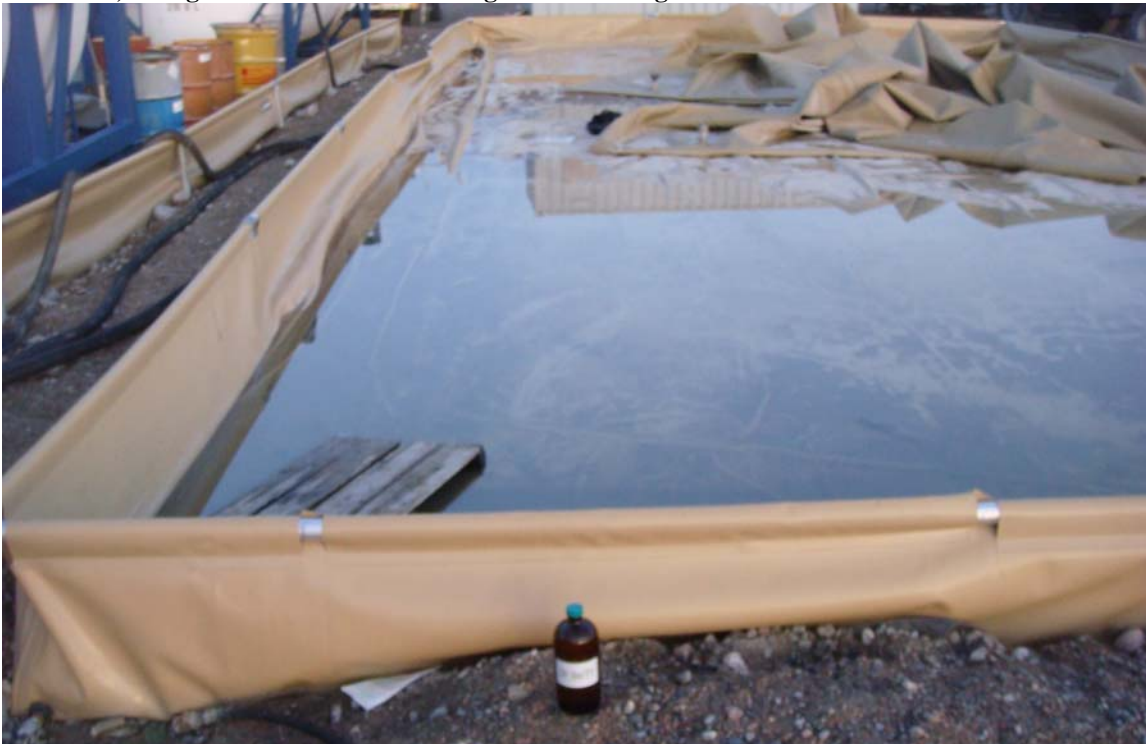
**Photo 2 (DSC00900):** Sample 09-23177 water sampling from the east insta berm at the contractor tank farm, facing south. The UVS Building is in the background.

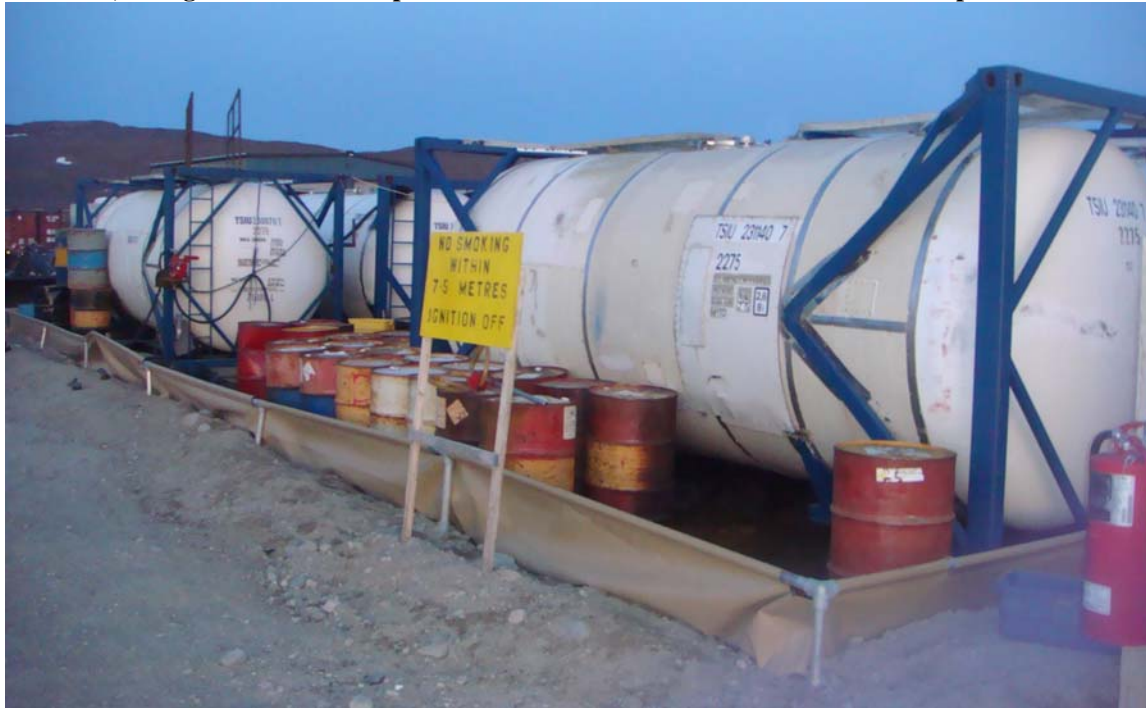
**Photo 3 (DSC01951):** Sample 09-17689 water sampling from the east insta berm at the contractor tank farm, facing south west. Sample was taken from the front corner shown in the photo.

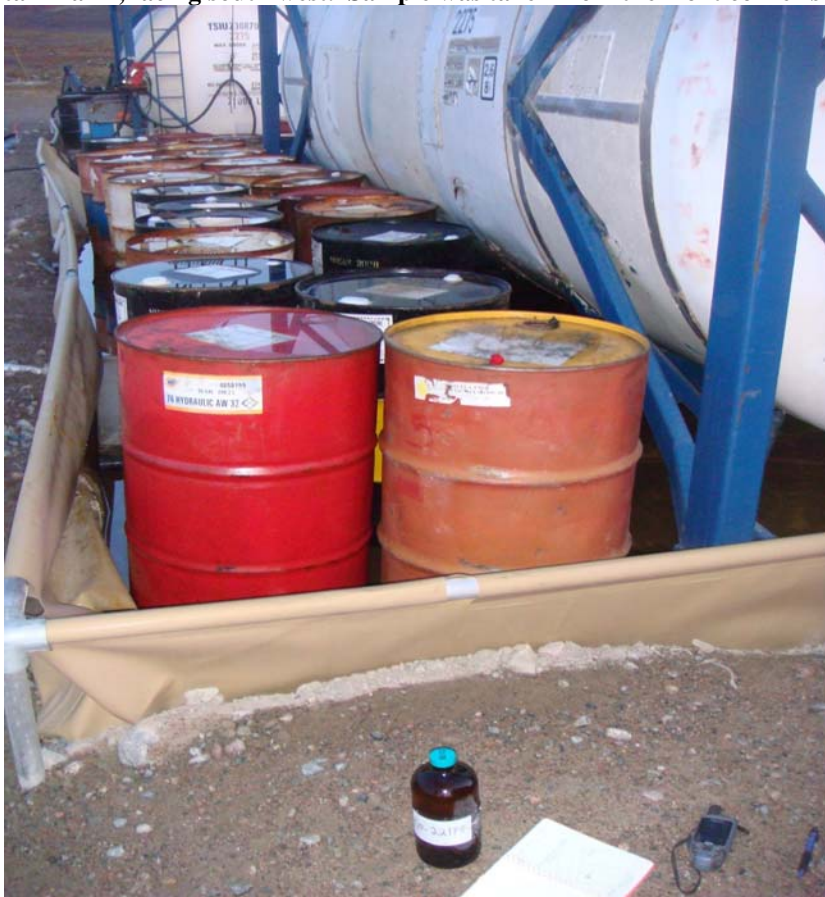
**Photo 4 (DSC00901):** Sample 09-23178 water sampling from the east insta berm at the contractor tank farm, facing south west. Sample was taken from the front corner shown in the photo.

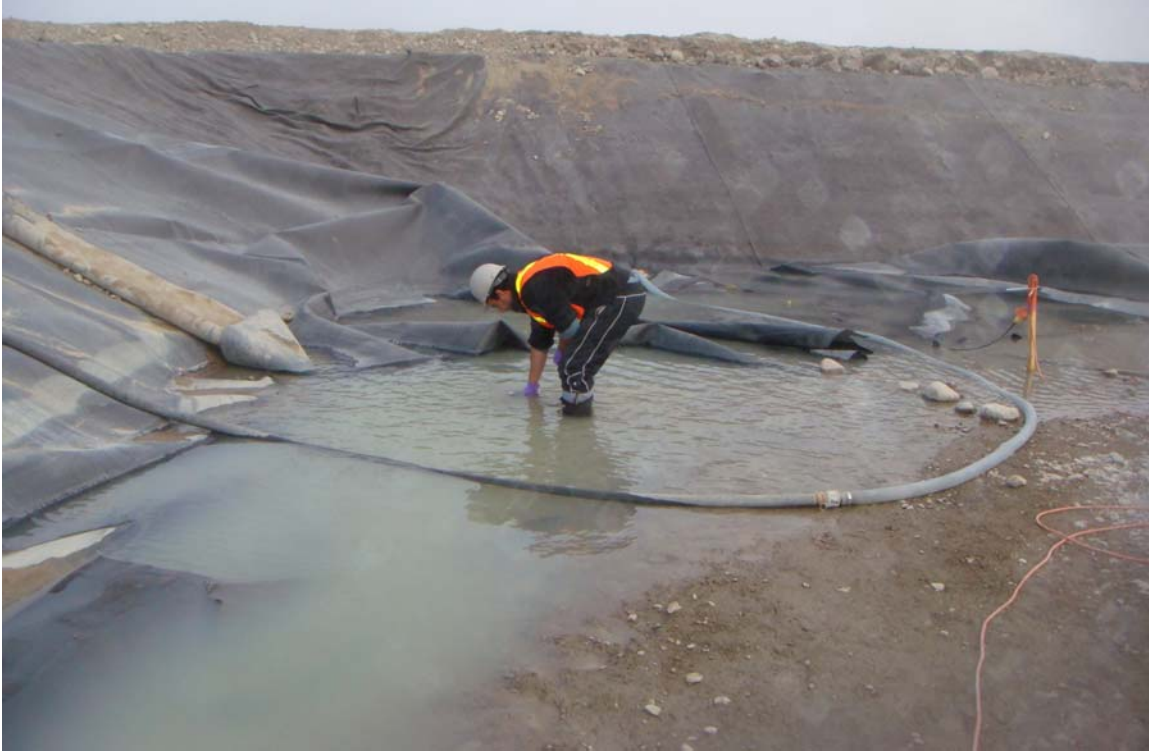
**Photo 5 (DSC01618):** Sample 09-17792 and 09-23817 where water has pooled. Sample was taken from the Key Trench in the northwest corner of the landfarm. Photo is taken facing north.

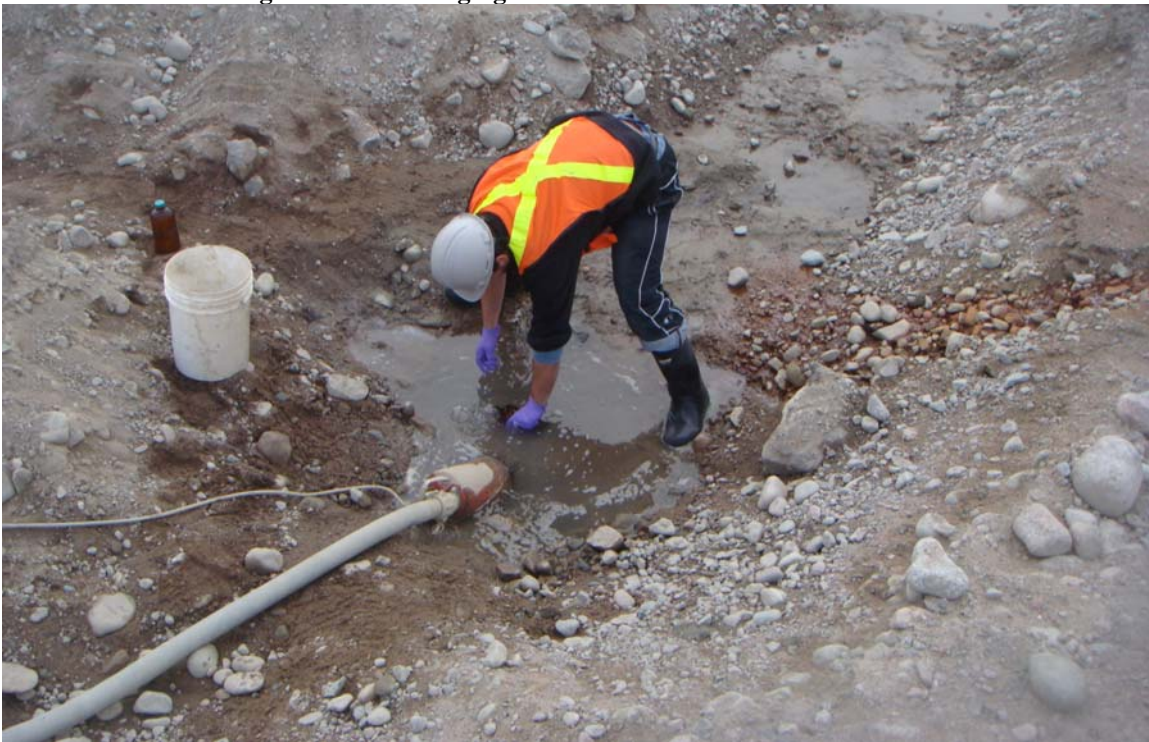
**Photo 6 (DSC01620):** Sample 09-22271 and 09-23816 photo is taken from the top of the western berm of the land farm looking east along the trench dug for removing upwelling groundwater in the landfarm from entering into the discharging water.

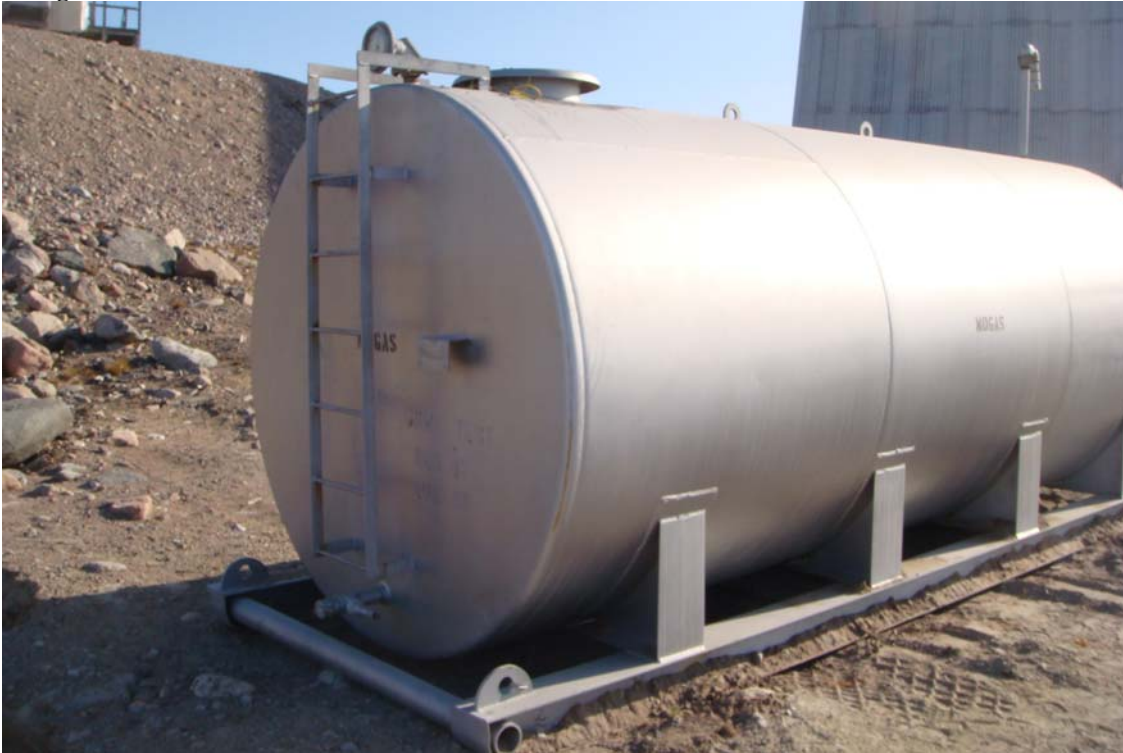
**Photo 7 (DSC00799):** Sample 09-22314 water from MT West excavation was pumped into a 6000 gallon holding tank. Sample was taken from the tank shown in the picture below. In the background is the billboard.

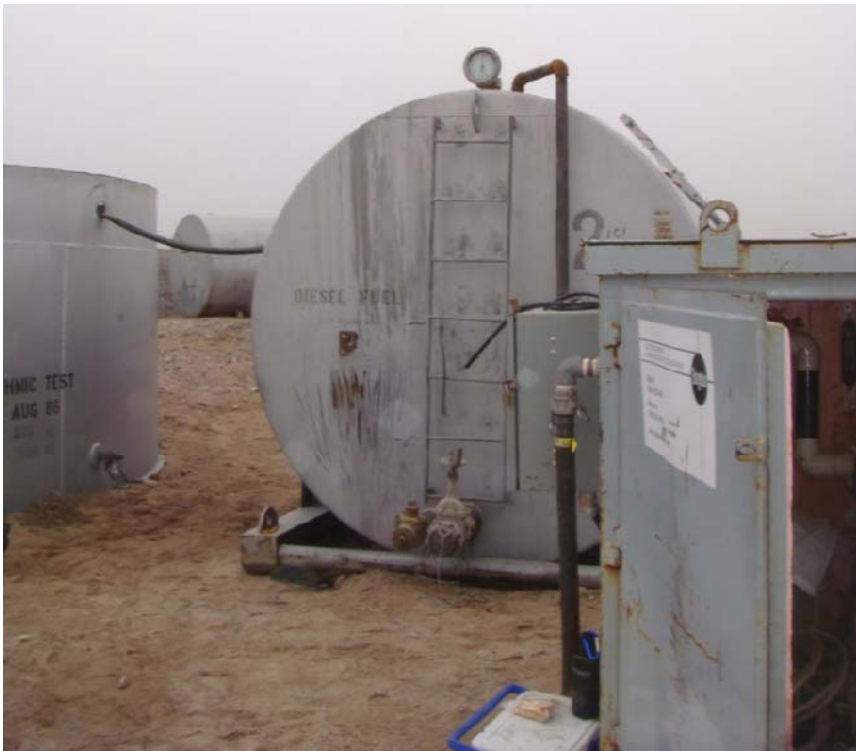
As of August 27, 2009 the analytical results for the water contained in the hazardous waste processing area did meet most of the wastewater discharge criteria however, the bottle for oil and grease broke upon arrival at the lab. The tank was not discharged, and the water was resampled in September. Results will be documented in the September report.

As of August 29, 2009 the analytical results for the water contained in the hazardous waste processing area did not meet the wastewater discharge criteria. The water was not discharged to land in accordance to the water use license. Water samples were collected again in September and results will be documented in the September report.

**Photo 8 (DSC00906):** Samples 09-23886 and 09-23978. Photo was taken looking west towards the Hazardous Waste Processing area water tank where lower site POL Pad South was located prior to deconstruction and excavation.

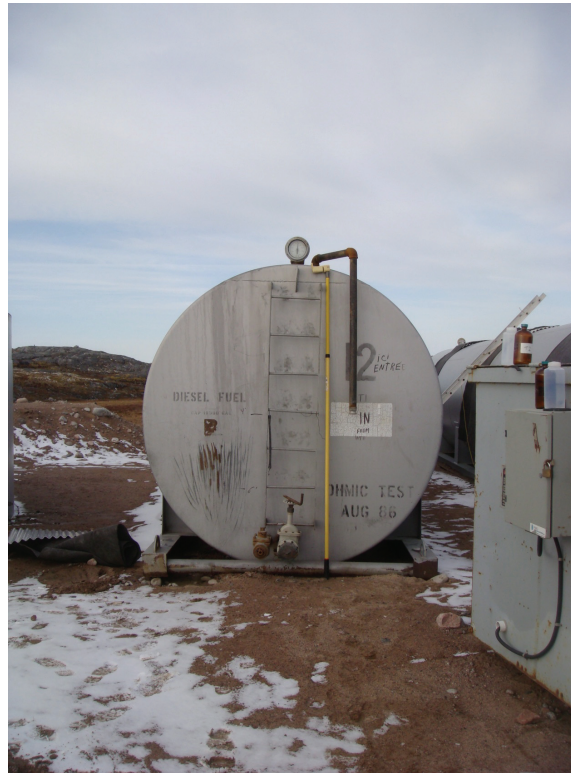
**Photo 1 (DSC00932): Sample 09-24068**  
Photo is taken looking west towards the Hazardous Waste Processing area water tank, where the lower site POL Pad South was located prior to deconstruction and excavation.

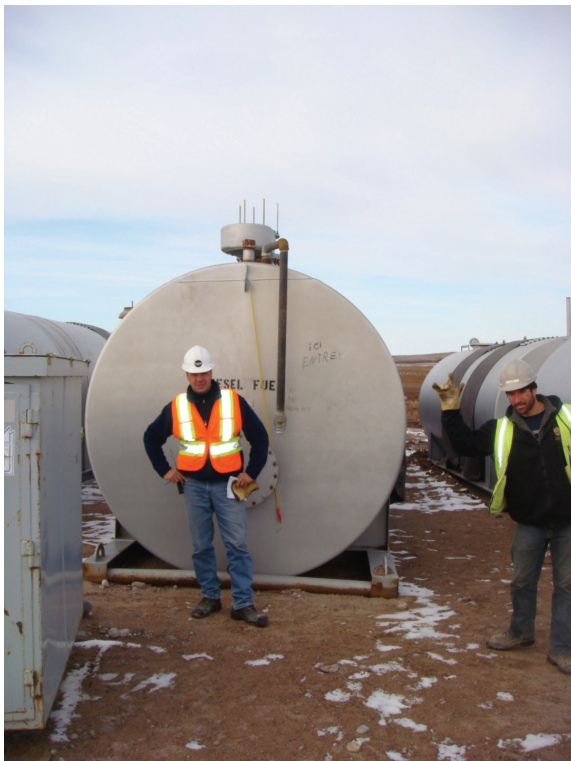
**Photo 2 (DSC00933): Sample 09-24069** Photo is taken looking west towards the Hazardous Waste Processing area water tank, where the lower site POL Pad South was located prior to deconstruction and excavation.

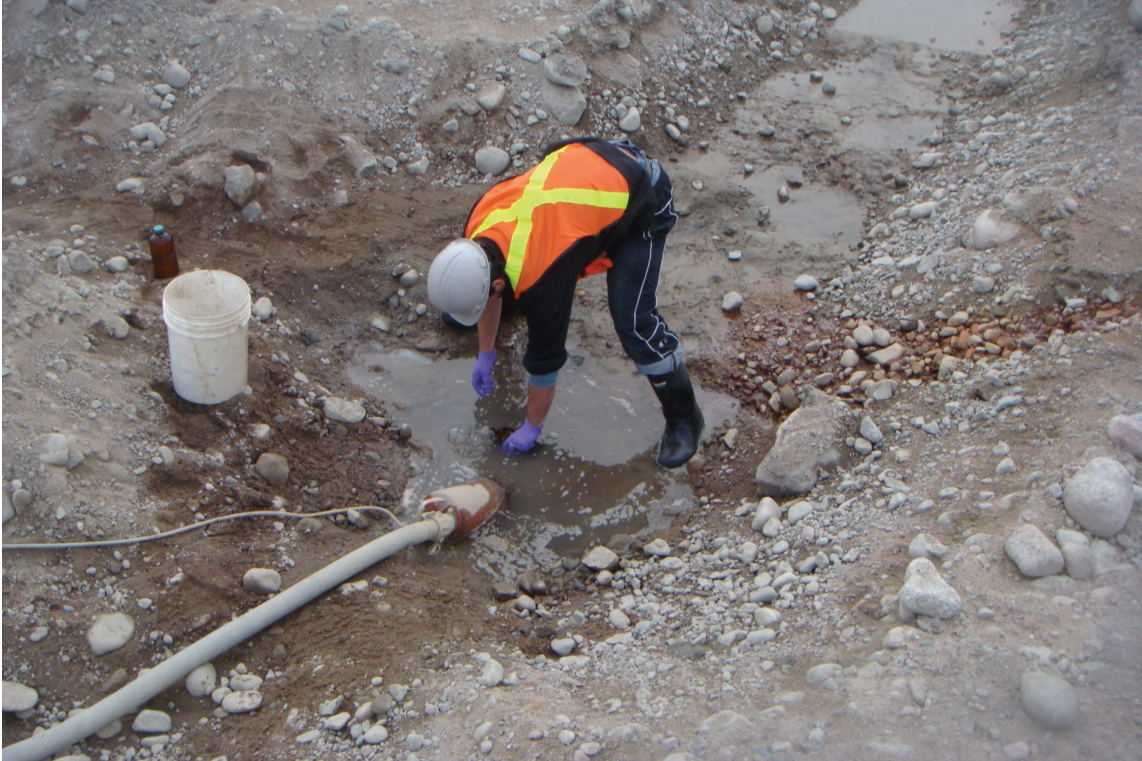
**Photo 3 (DSC01620): Sample 09-24070/71** Photo is taken from the top of the western berm of the Landfarm looking east along the trench dug for removing upwelling groundwater in the landfarm, the area is also bermed off to prevent any surface water from the landfarm from entering into the discharging water. CAM-5, August 5, 2009.
