**Project No: Water Use License 1BR-MAC0712**

**Regarding: Mackar Inlet DEW Line Site**

NWB Annual Report

Project Name: CAM-5, Mackar Inlet DEW Line Site

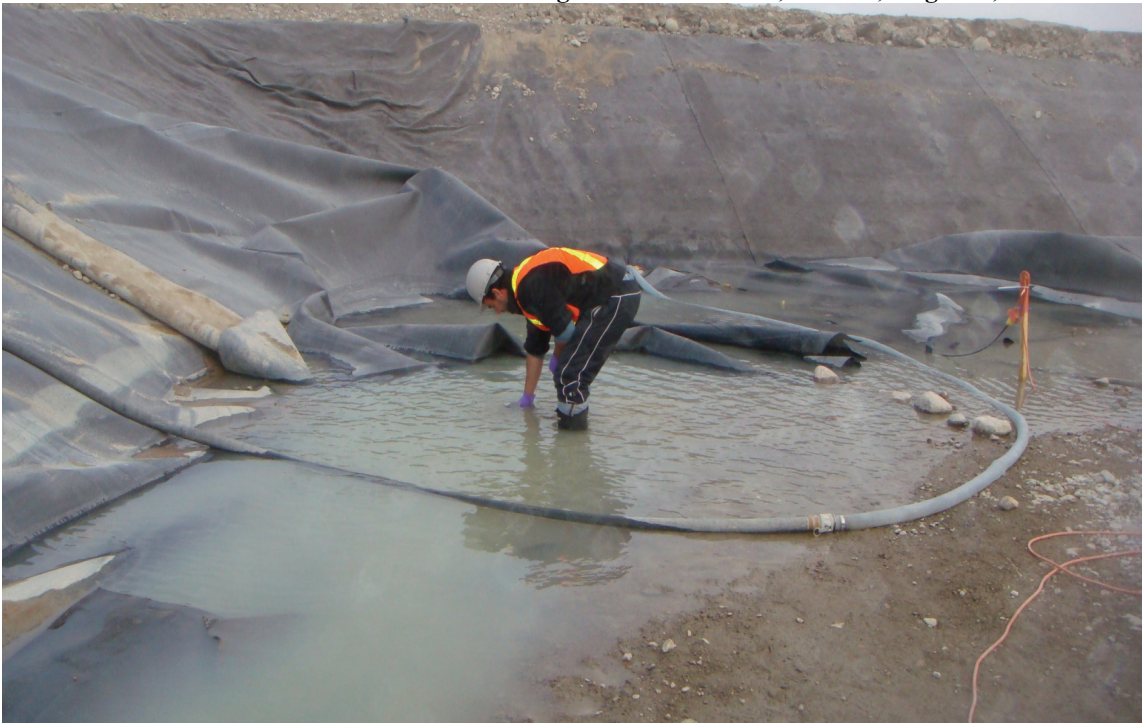
**Photo 4 (DSC01618): Sample 09-24072** Sample taken from the Key Trench in the North-West corner of the landfarm. Photo here is taken facing north. Lower Site, CAM-5, August 5, 2009.

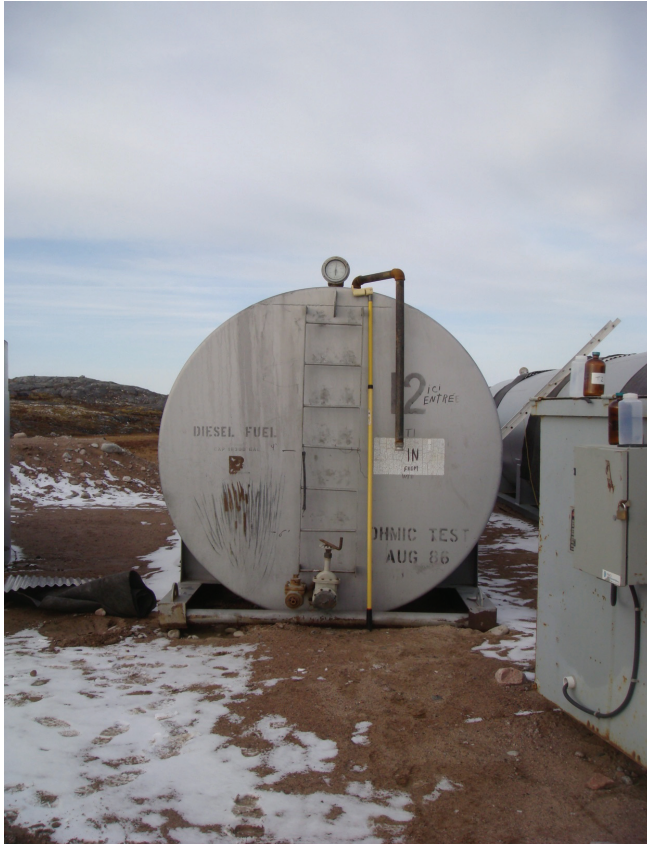
As of September 8<sup>th</sup>, the samples from the Hazardous Waste Processing Area (09-22868, 09-22869, 09-22878) did not meet the waste water discharge criteria for oil and grease and therefore the water was not discharged to land. These samples will be treated and re-sampled in 2010.

**Photo 5 (DSC00932): Sample 09-24078** Photo is taken looking west towards the Hazardous Waste Processing area water tank, where the lower site POL Pad South was located prior to deconstruction and excavation.
