DESIGN DRAWINGS AND CELL CONSTRUCTION

**Hydrocarbon-Impacted Soil Landfarm Facility
1575 Federal Road.
City of Iqaluit, Nunavut**

Water Licence Number - NWB4NUN0511-Type “B”

Dated: October, 2011

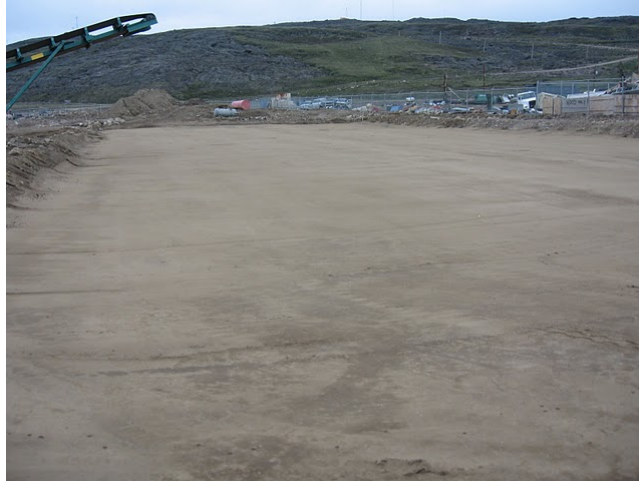
Site levelled stones packed and sand layer in place and packed.

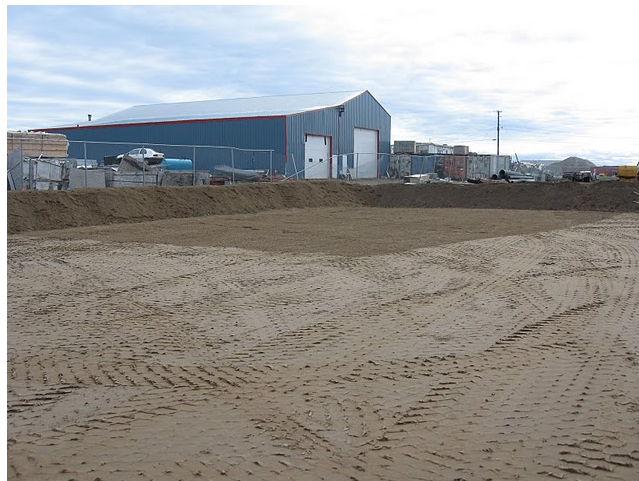
**Prior to putting down liner floor of cell was hand raked to remove sharp stones
and to smooth out the transition from walls to floor**

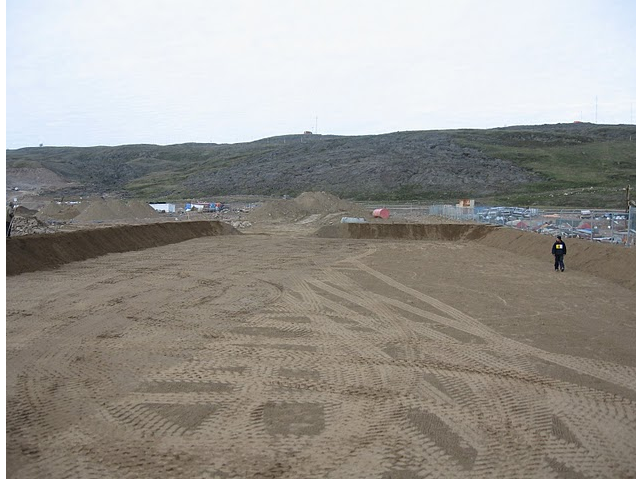
**During construction an opening was left in end wall to permit access.
This opening was filled in once liner was installed.
Soft sand put on berm walls restricted foot traffic.**

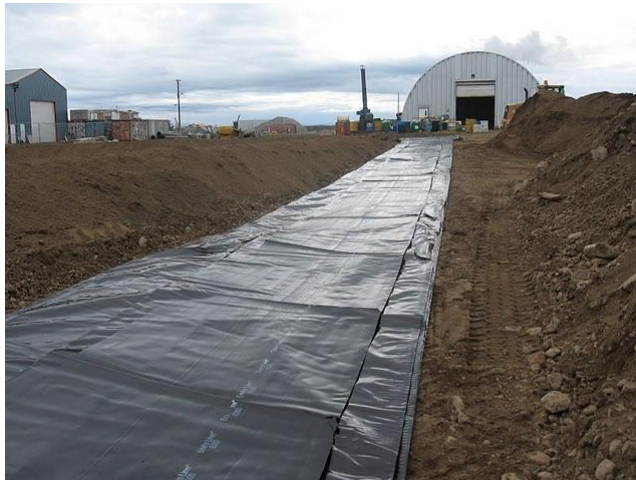
New liner rolled out waiting to be unfolded and pulled into position.

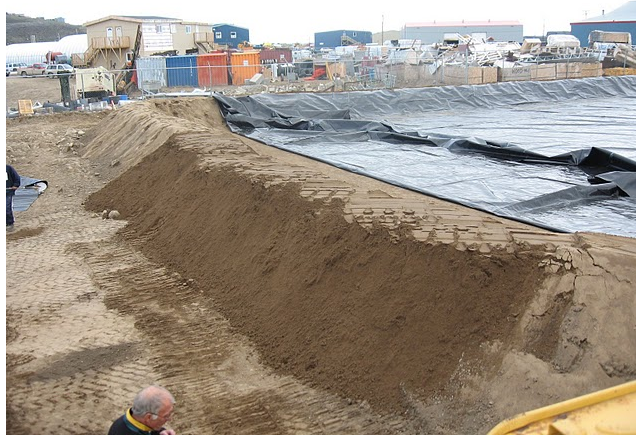
Liner flipped back to allow opening to be closed. Soil was packed and liner returned to position.

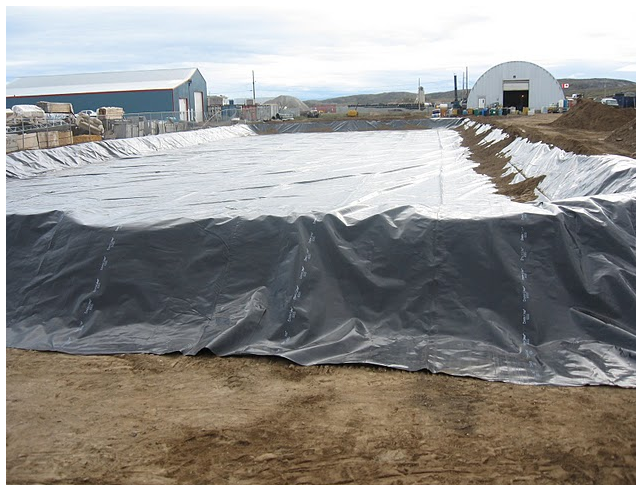
**Liner in position and sand being put on walls to keep secure.
Ramp was later installed on both sides of berm at this location to allow
equipment into and out of cell.**

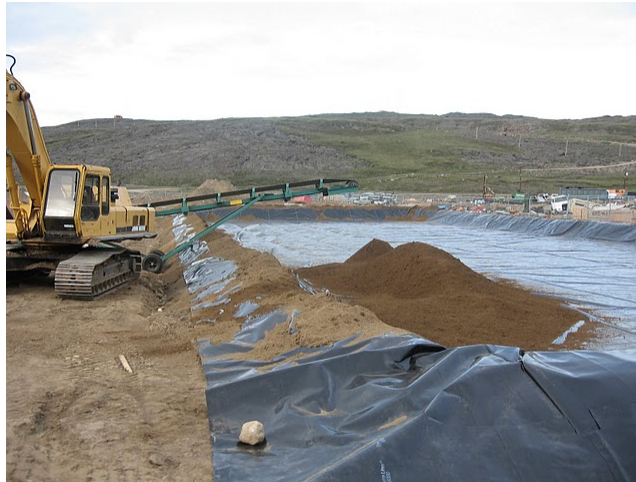
Screened sand is used to cover liner. This sand is hand shovelled to form a packed layer which allowed equipment to deliver the full 20 inches of sand into cell bottom.

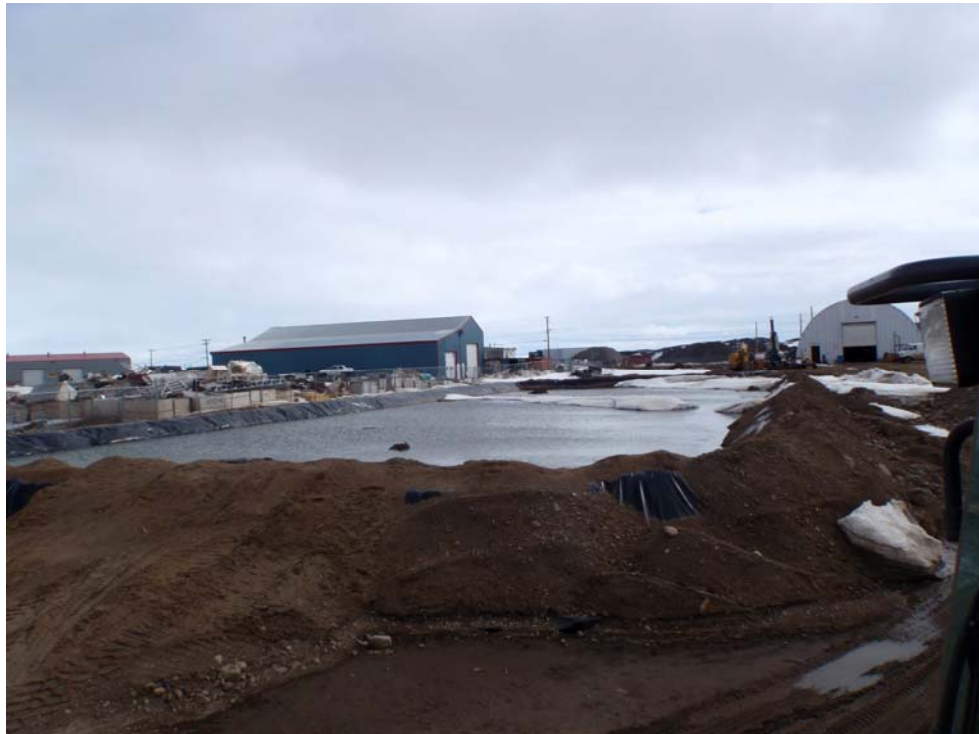
**Cell #4 in summer of 2010.
It contains in excess of 600 cubic metres (130,000 gallons) of water
collected from the other three cells and melt waters.**
