## **Installation and Construction Details of Monitoring Wells**

**Hydrocarbon-Impacted Soil Landfarm Facility  
1575 Federal Road.  
City of Iqaluit, Nunavut**

**Water Licence Number - NWB4NUN0511-Type “B”**

Dated: October, 2011

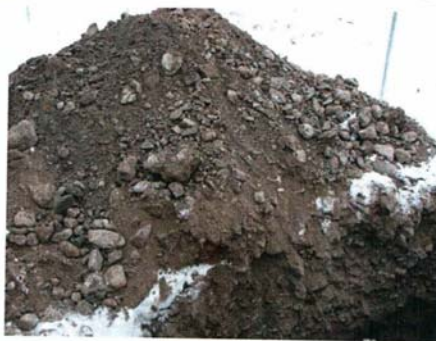
Description: Showing  
soil type

of 1.8 mbgs to permafrost. Based on field observations, all soils encountered on site are classified as coarse grained (See Photo 1 in Appendix B).

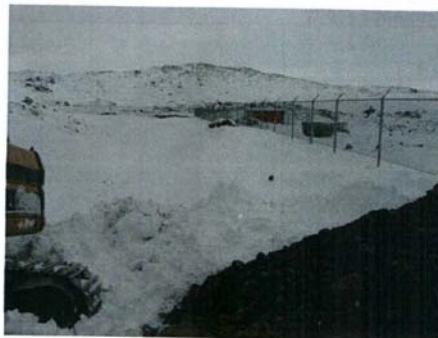
Photo ID: 2

Description: Showing  
landfarm and fence

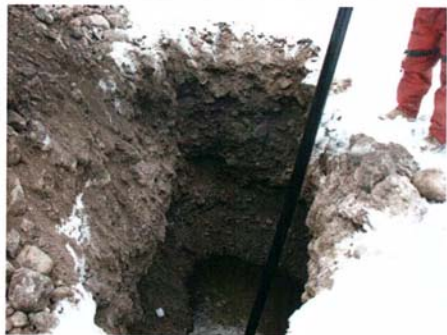
Nunatta Environmental Services Land Treatment Facility	
Photo ID: 3

Date: November 4, 2008	
Direction: NA	
Description: Showing stratigraphy and groundwater

Groundwater in the active layer was encountered at the site during the test pitting program, which took place during thaw conditions. Groundwater levels were measured 1.7 mbgs, with average depth of the water table was approximately from 1.7 mbgs.

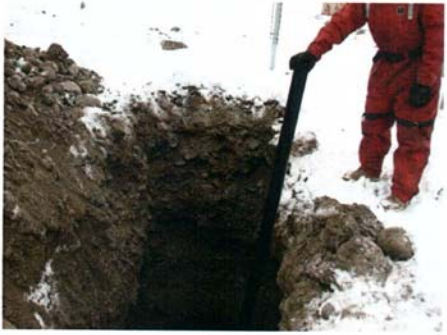
Nunatta Environmental Services Land Treatment Facility	
Photo ID: 4

Date: November 4, 2008	
Direction: NA	
Description: Showing stratigraphy
