## NWB Annual Report

License No: NWB4NUN0511 - Type "B" Issued Date: September 13, 2005  
 Expiry Date: December 13, 2011

Project Name: Nunatta Environmental Services "Landfarm"

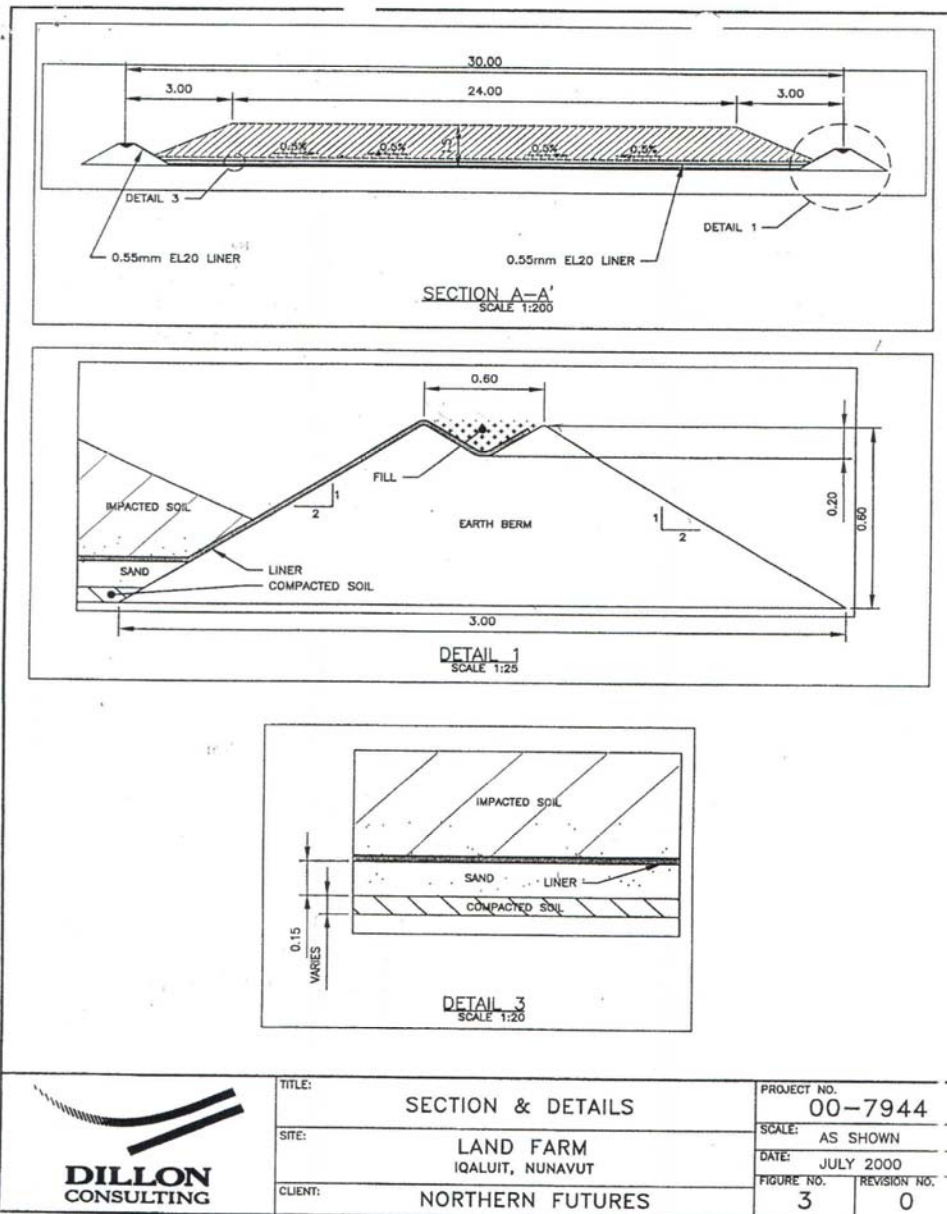
This is a scanned copy of the original engineers drawings used  
 In the construction of the new Cell #4  
 This design has proven to work very well here In the North  
 with the soil types we have to work with.  
 All the Cells at Nunatta were constructed using this design and have  
 proven very strong and stable.

Approved Cell construction drawings were Engineered by Dillon and have been the model used in constructing of all cells on Nunatta Landfarm as it has proven to be a good design for this northern location and soils we have to work with.

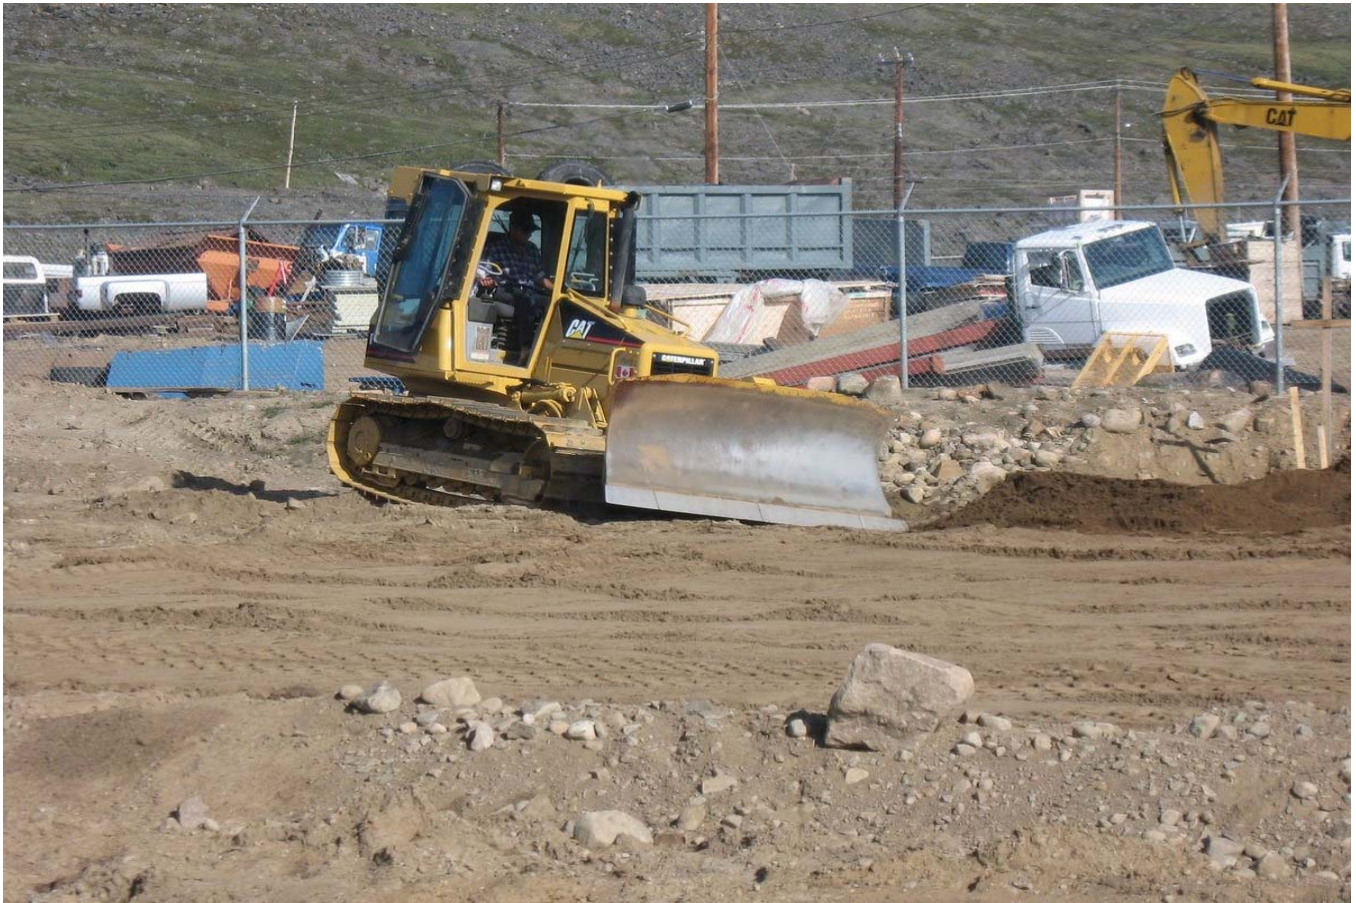
During the warm months of 2009 we began the construction of an overflow cell. This was in response to an unusual number of fuel tank ruptures in Iqaluit. We began by digging out large rocks and putting down a layer of screened out material.

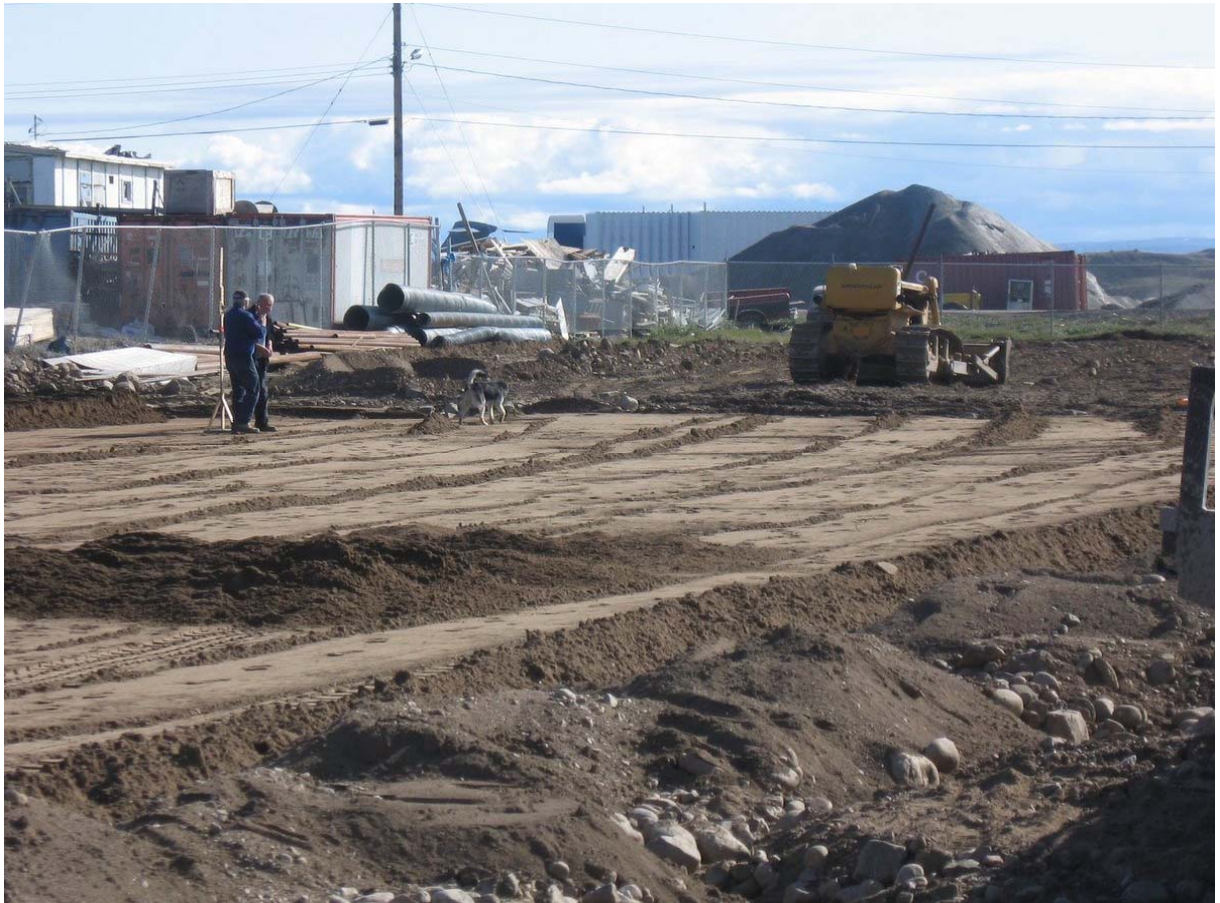
All work was monitored by Axel Have (P.eng)

Length, Width and Grade was checked with the use of transit

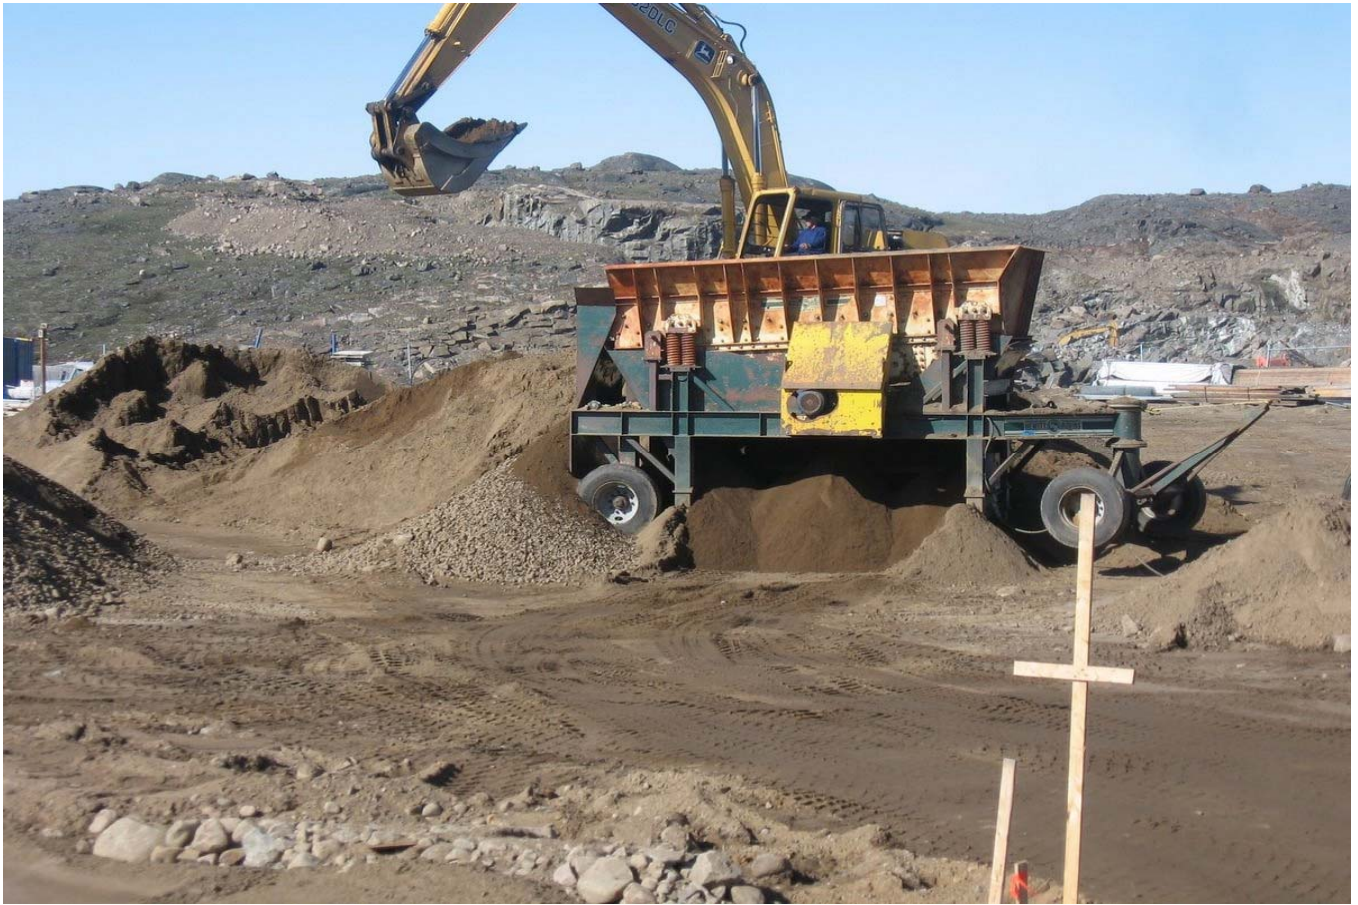
Sand was brought in and put through a shaker to remove all rocks down to less than  $\frac{1}{2}$  inch

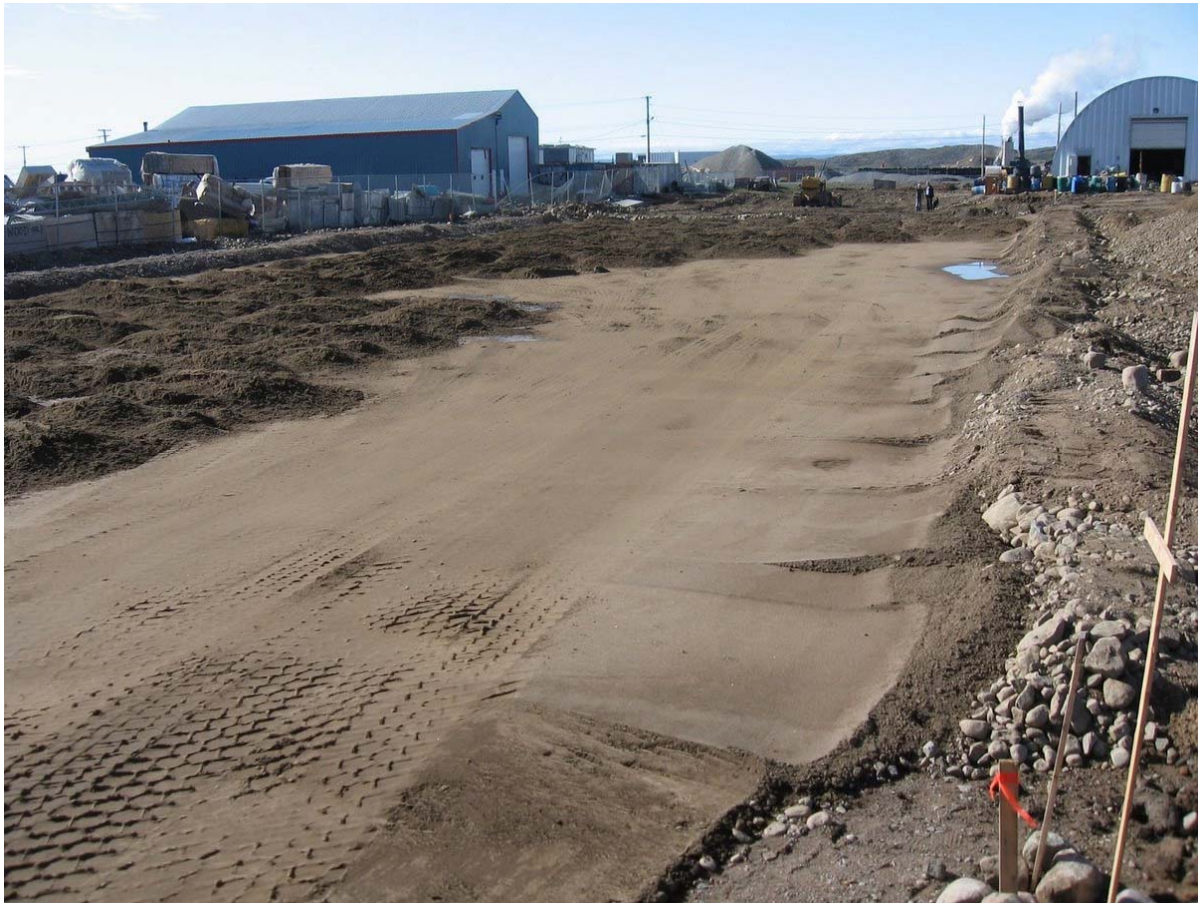
This was placed on an already smooth base and compacted, then another layer added and compacted again. Grade was corrected throughout this process.

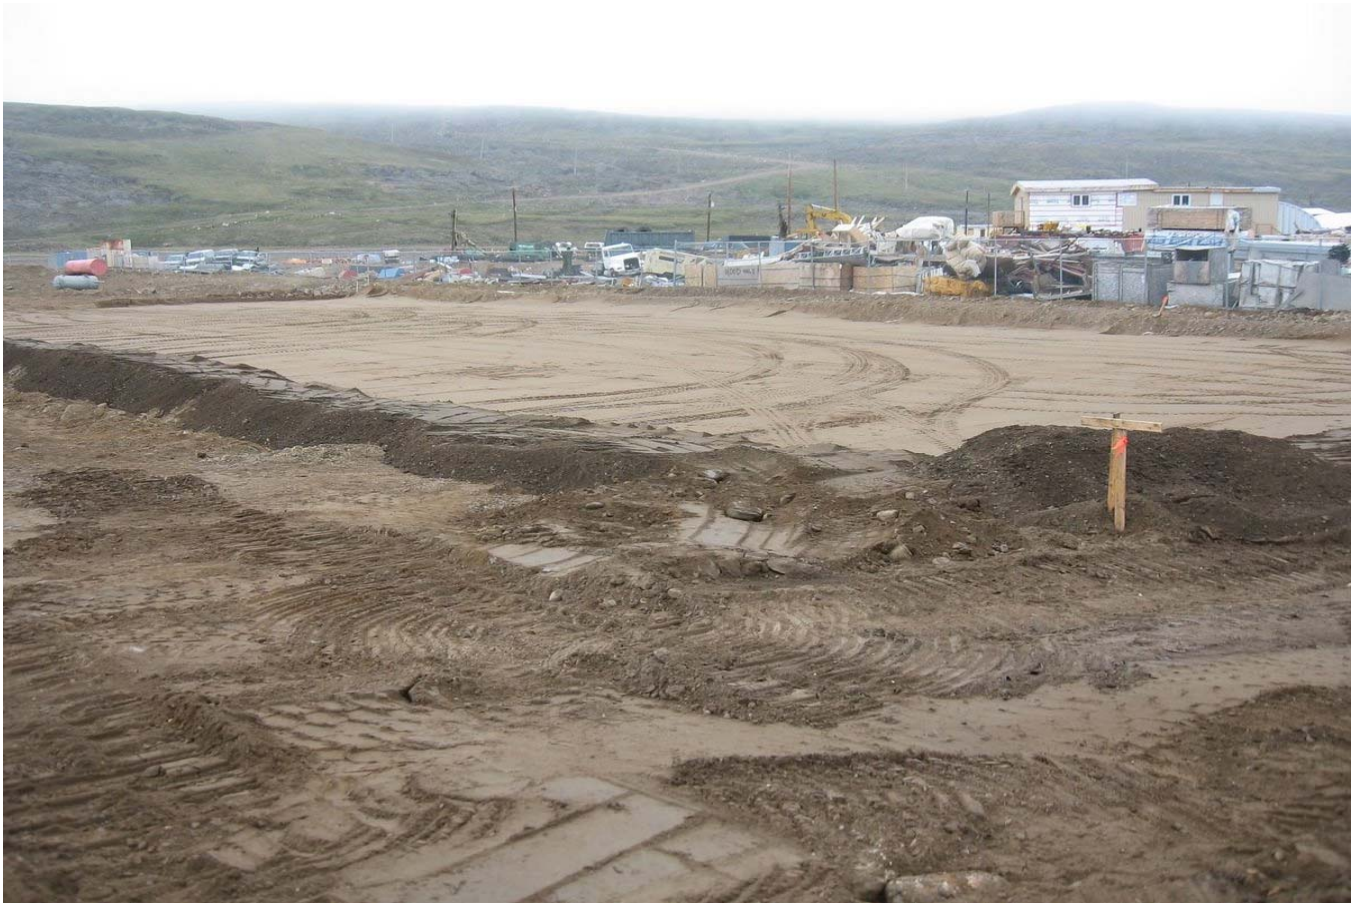
Walls were constructed of waste rocks in bottom and soils that pack on top to make for firm walls

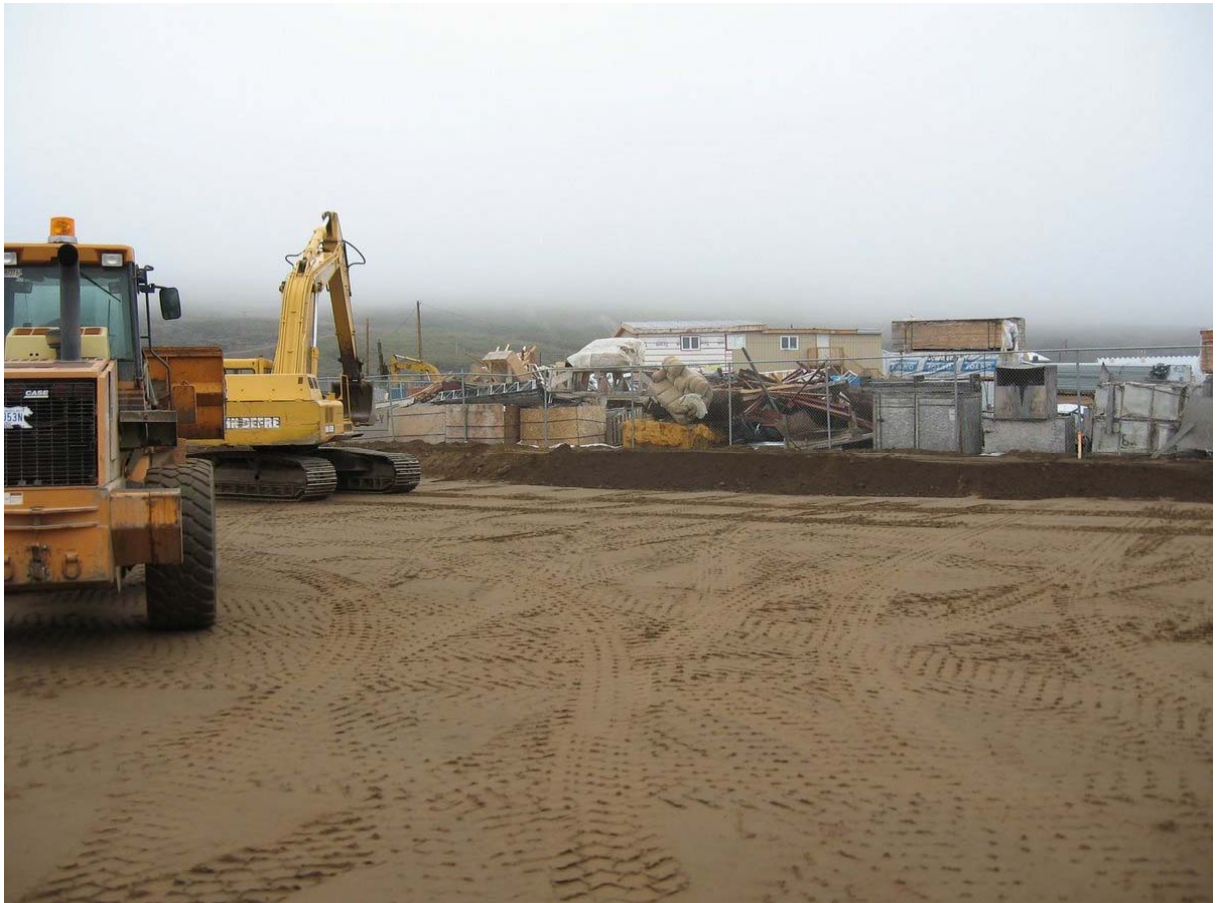
Excavator and loader used to carry materials and to pack walls tight

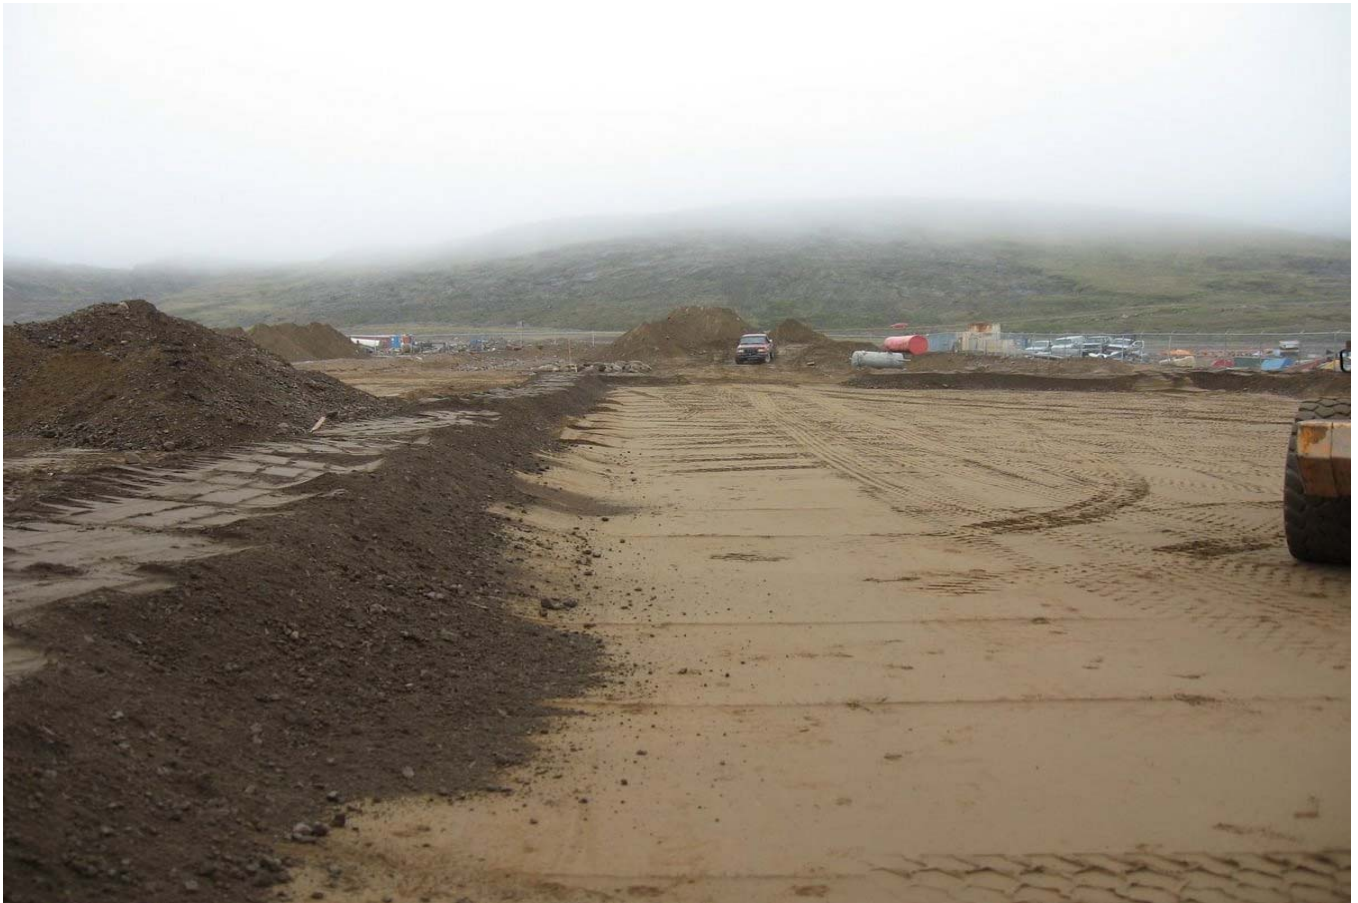
Small stones were raked out of inside cells and walls were covered with screened sand.  
To complete the formation of cell containment area.

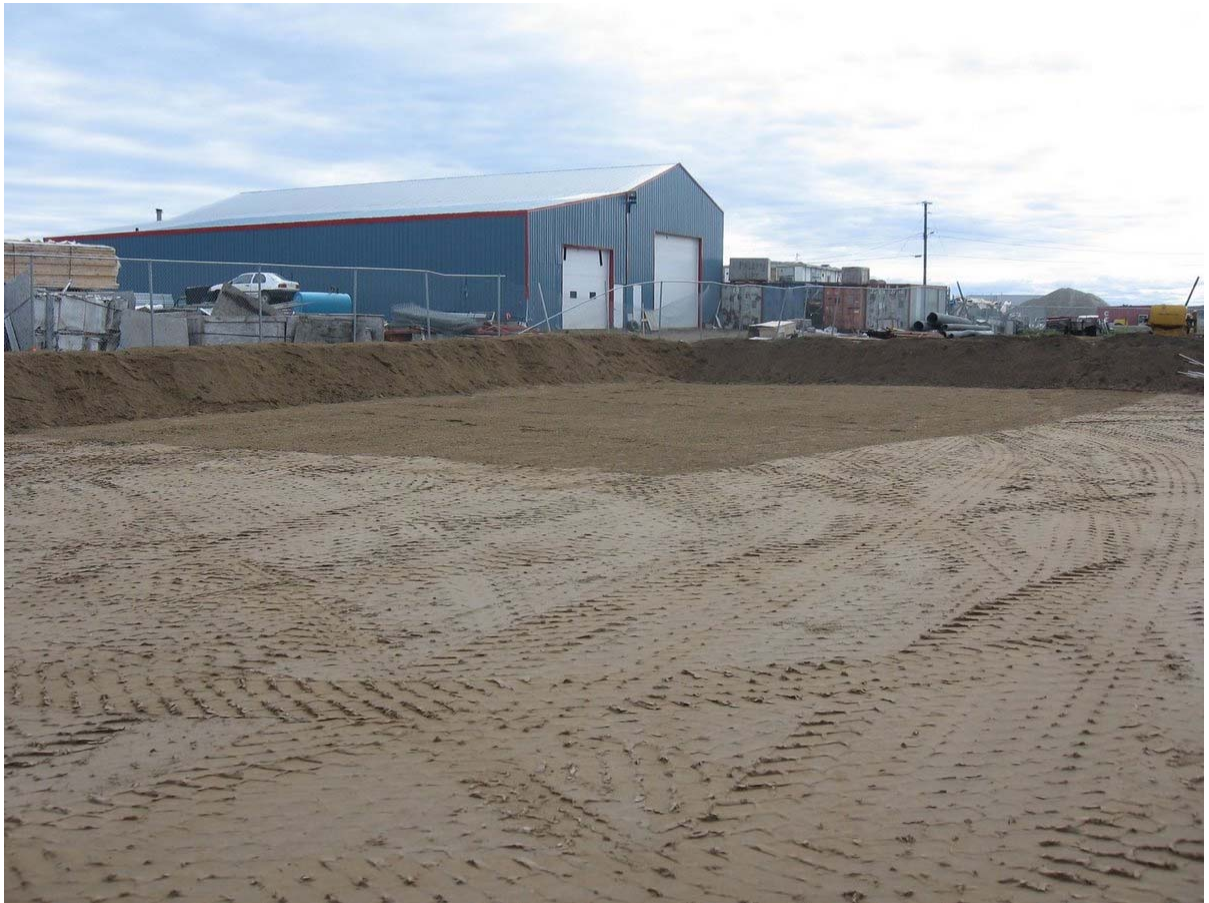
The whole area was raked and picked clean of any small debris that could puncture the liner.  
The transition from floor to wall was shaped so as not to have sharp angle which could cause a rip

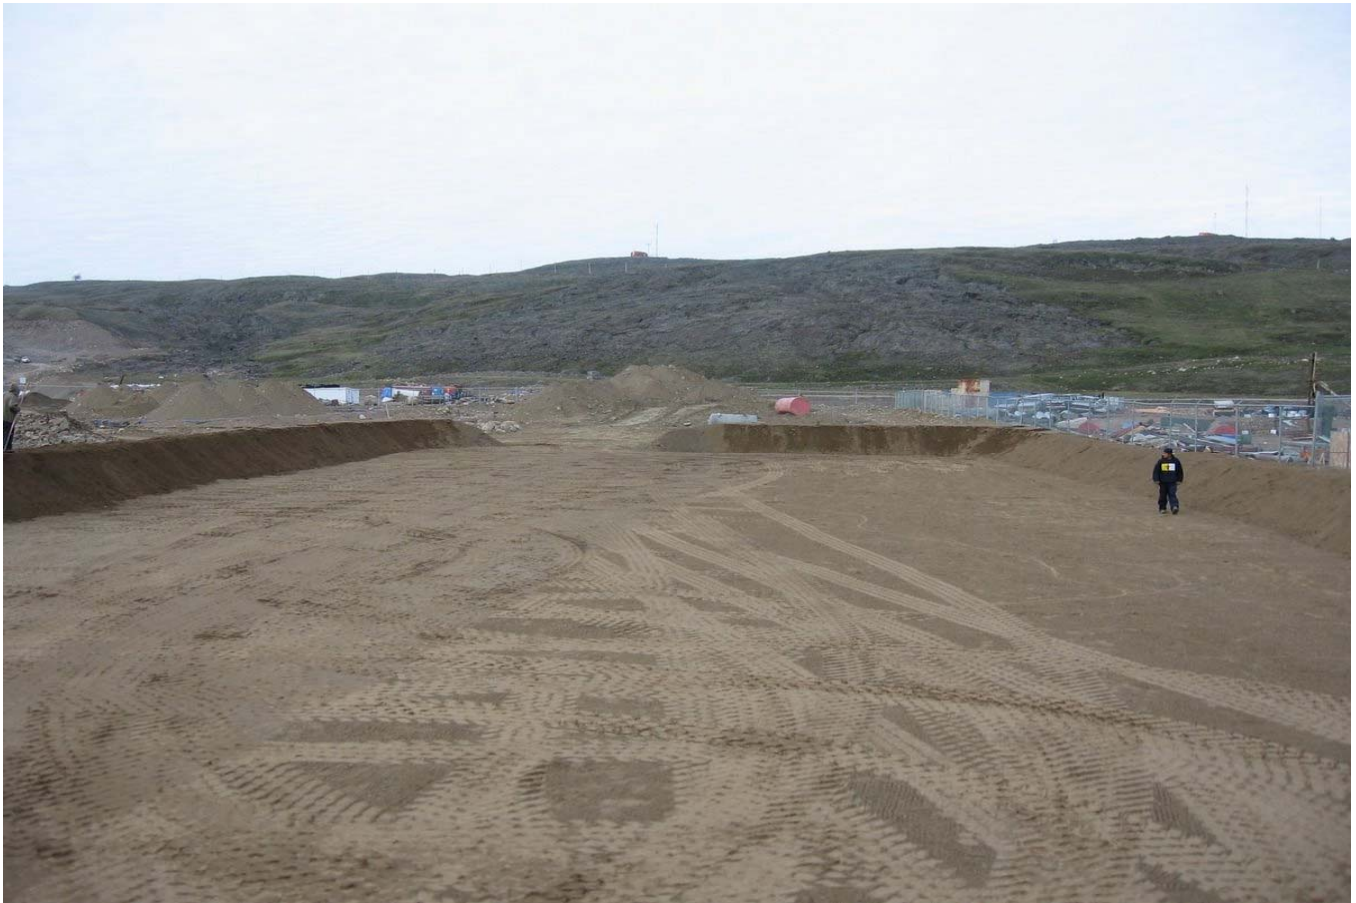
The opening in the end wall was to allow passage of man and machine.  
We thought it best to keep access until liner was installed then fill in hole.  
This position later became a ramp to allow access into cell.  
One of two access points into cell #4

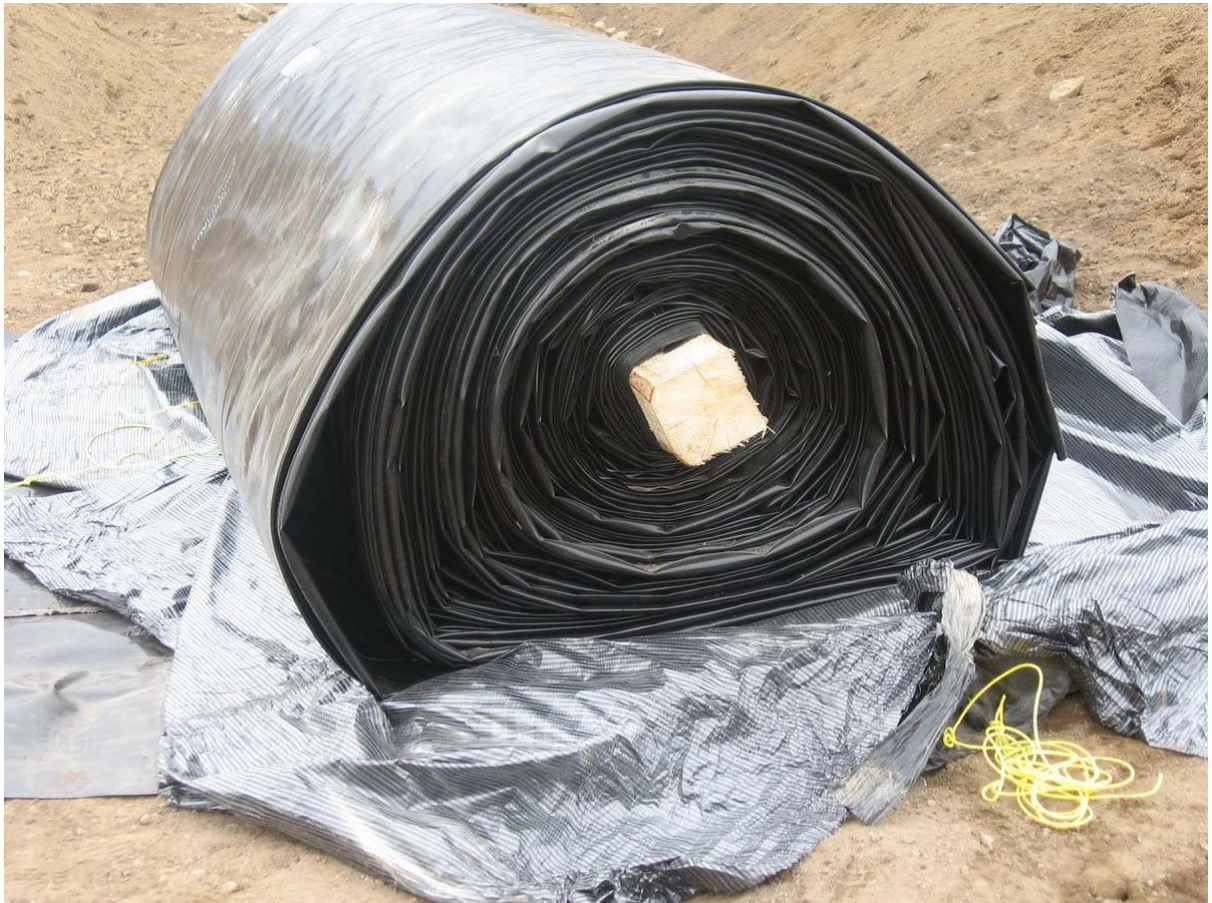
This is the new liner uncrated.  
Total weight 2200 pounds or 1000Kg

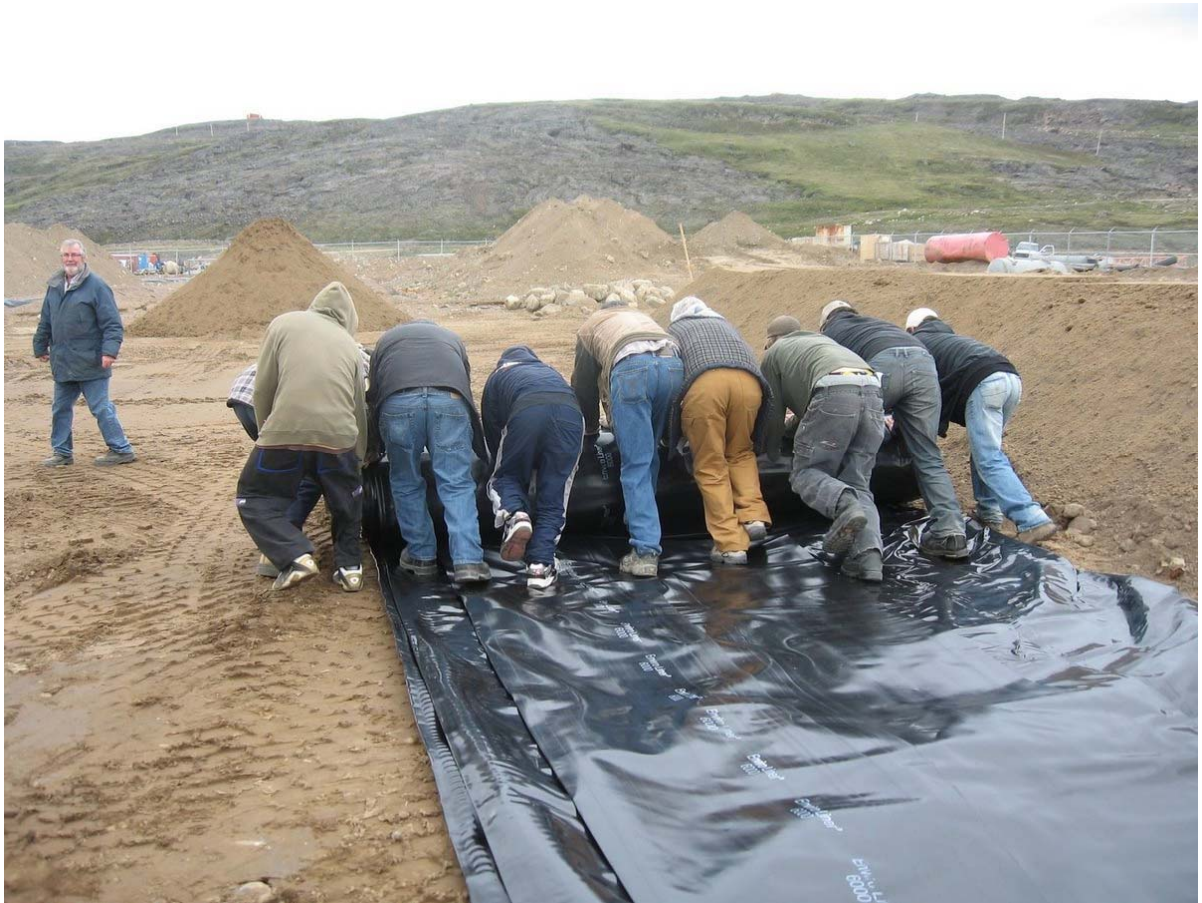
Unrolling of liner prior to unfolding across the width of the cell area

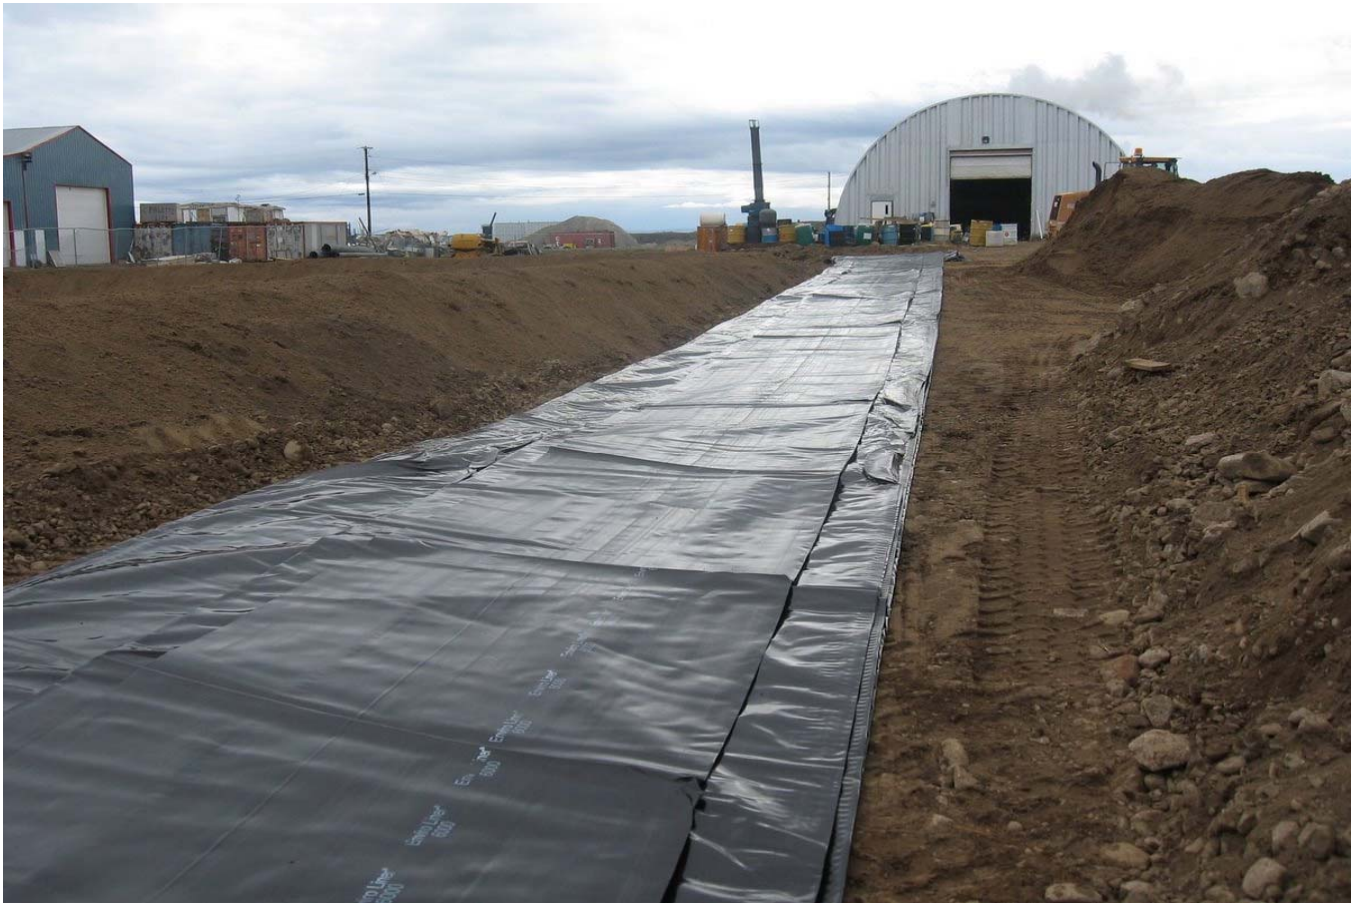
Shows length of cell area, liner unrolled and ready to unfold across the cell wall (left on photo)

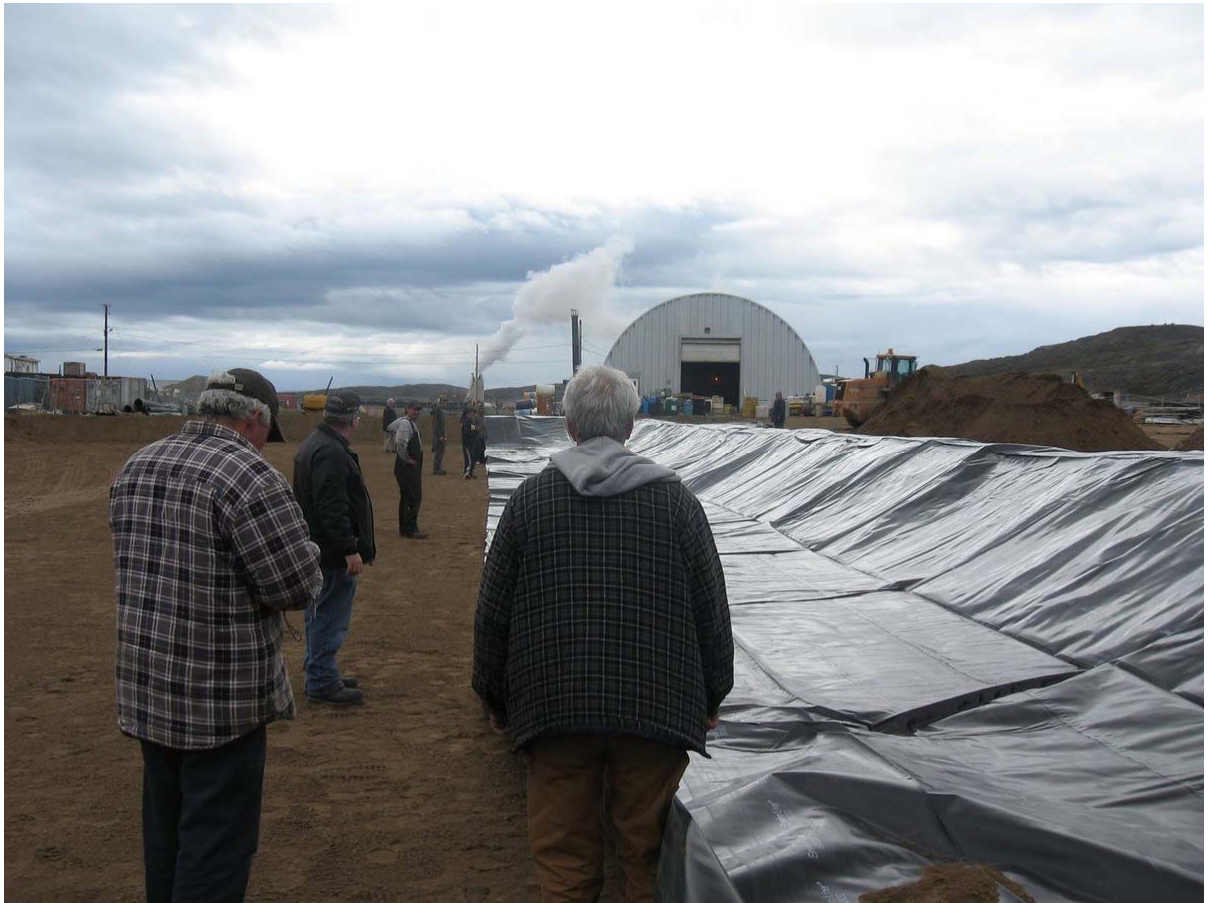
First couple folds out.  
Takes many hands to pull liner evenly into position.

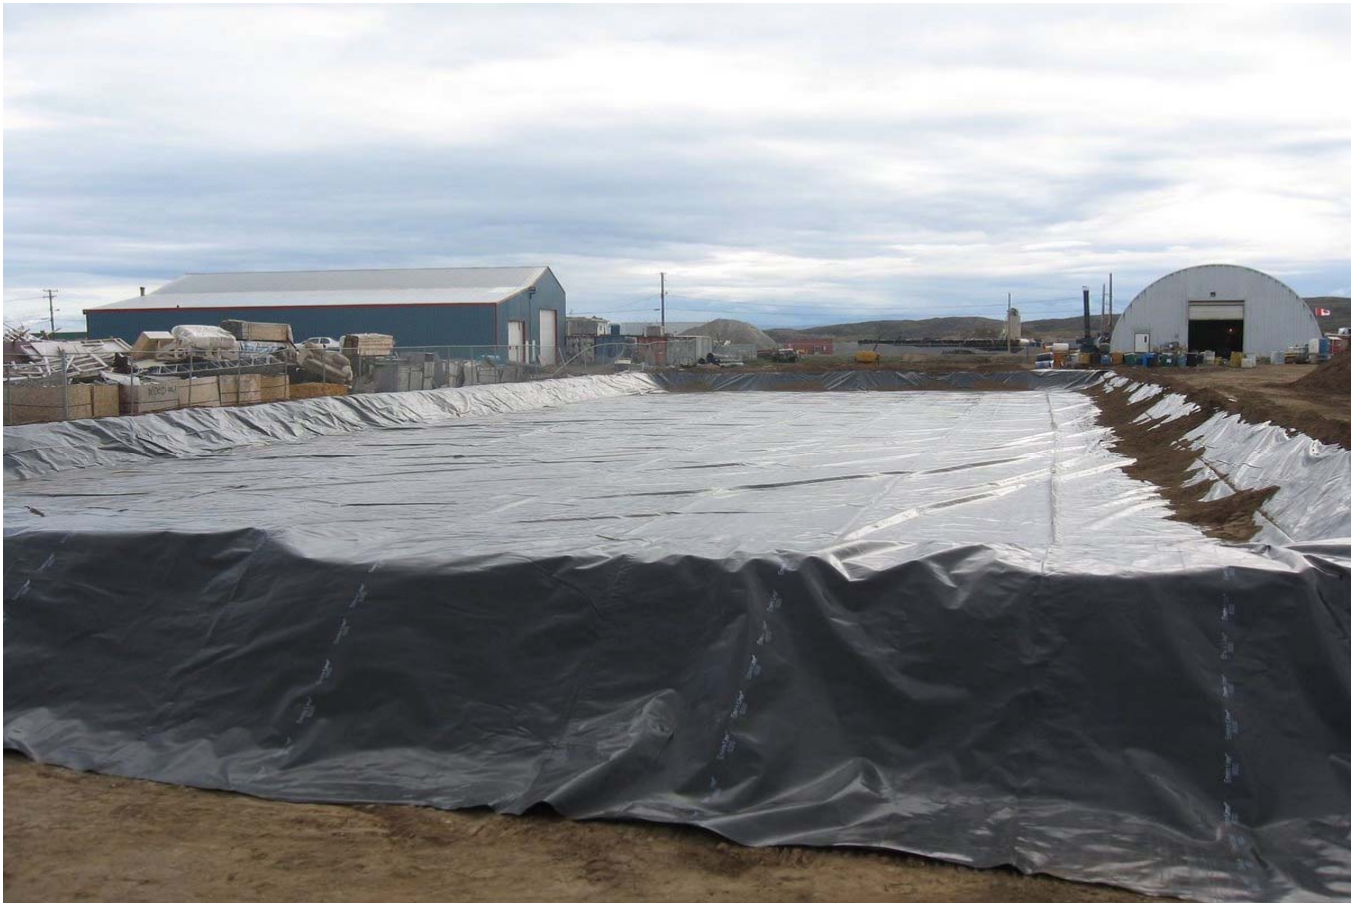
Liner in position and placing of sand on top of walls underway to keep the wind from getting under liner  
Equipment cannot drive on liner with out sand to aid in spreading out weight over larger area.  
Plans call for 6 inches of compacted sand over liner.  
We feel more than this is required and will add 16-18 inches.

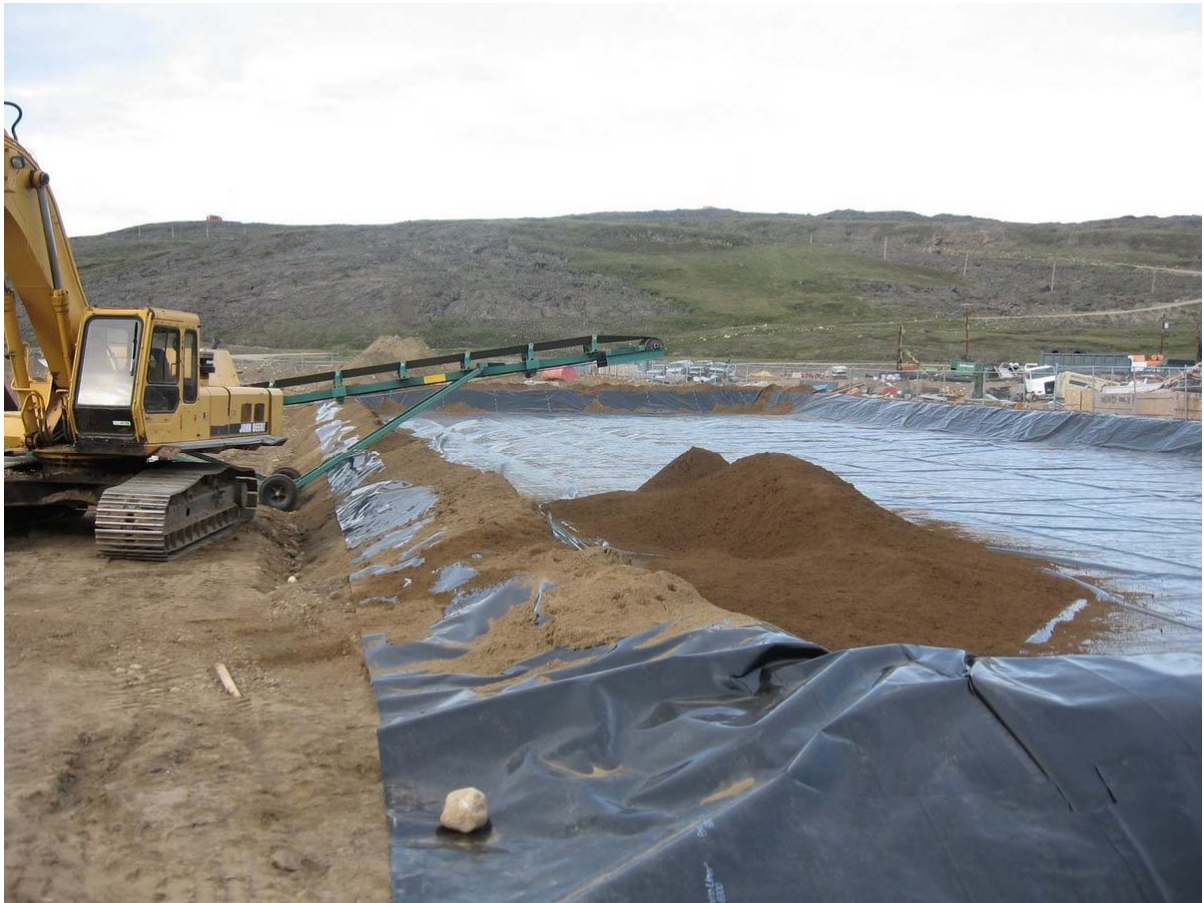
Screening plant and stacker used to get sand into new cell without damaging the liner. Sand was shoveled out until no more sand was available. Completion of cell will continue Summer of 2010 when city will allow removal of more sand from pit.

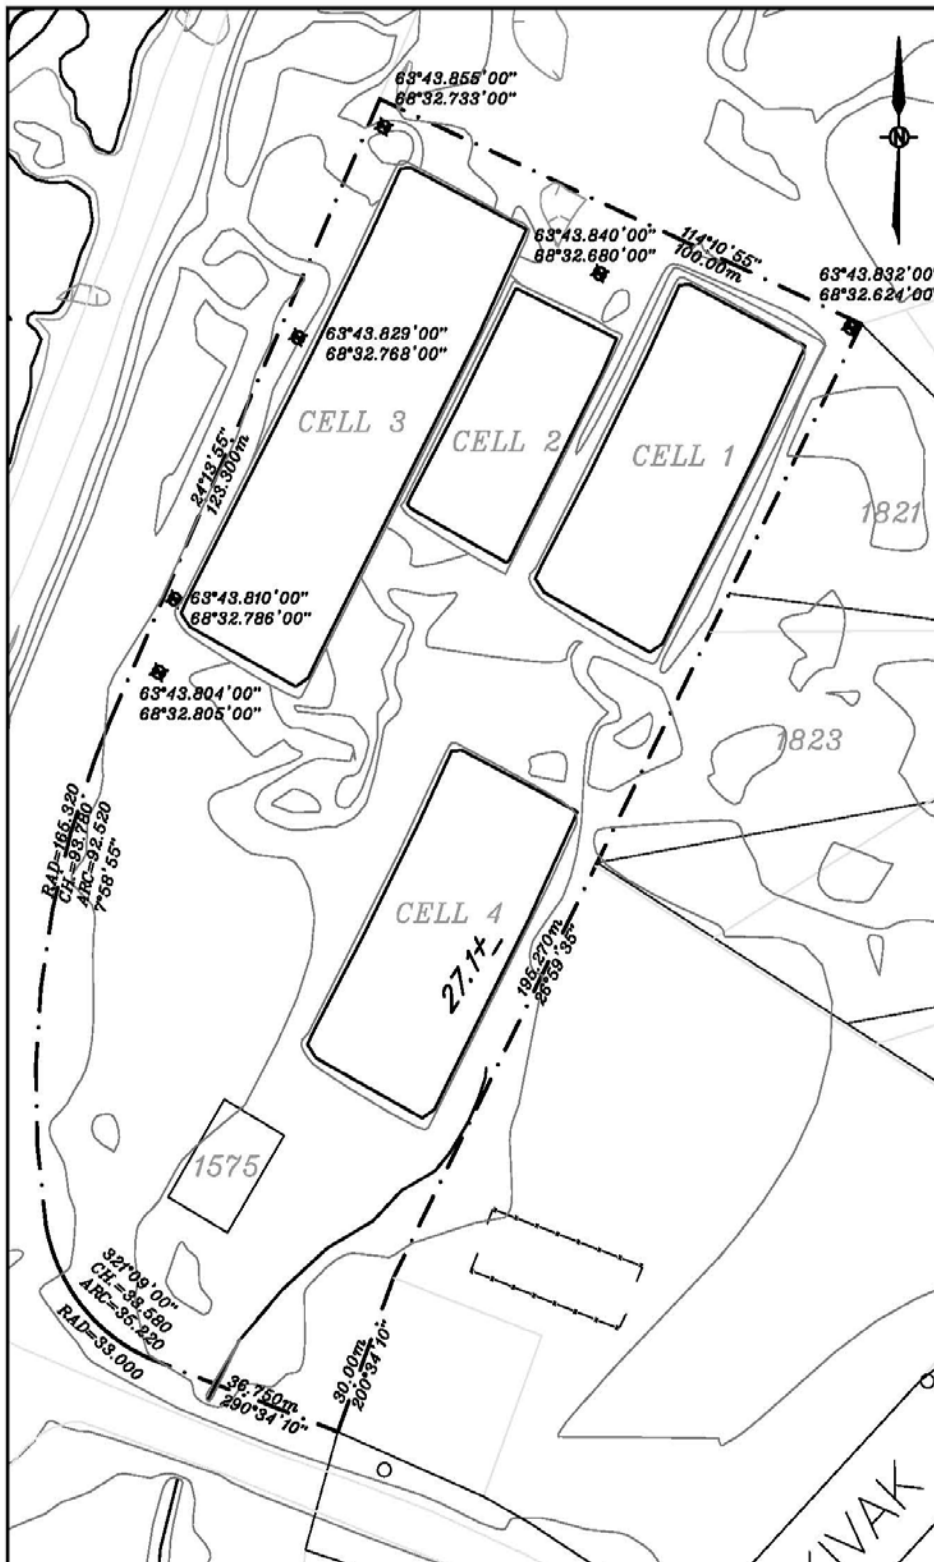
**SPG.3**

This is an over view of the land farm with  
Overflow cell #4 in place.

Water Monitoring well #MW 6  
( previously refered to asMW 08-4)

Land farm elevations shown in meters

November of 2008 after a change in Management, Franz Environmental was contracted to install 4 new Monitoring wells around the perimeter of the landfarm. In order to fit the new overflow cell we removed one of the test wells. This well was installed as MW08-4. New mapping referred to as WM6.

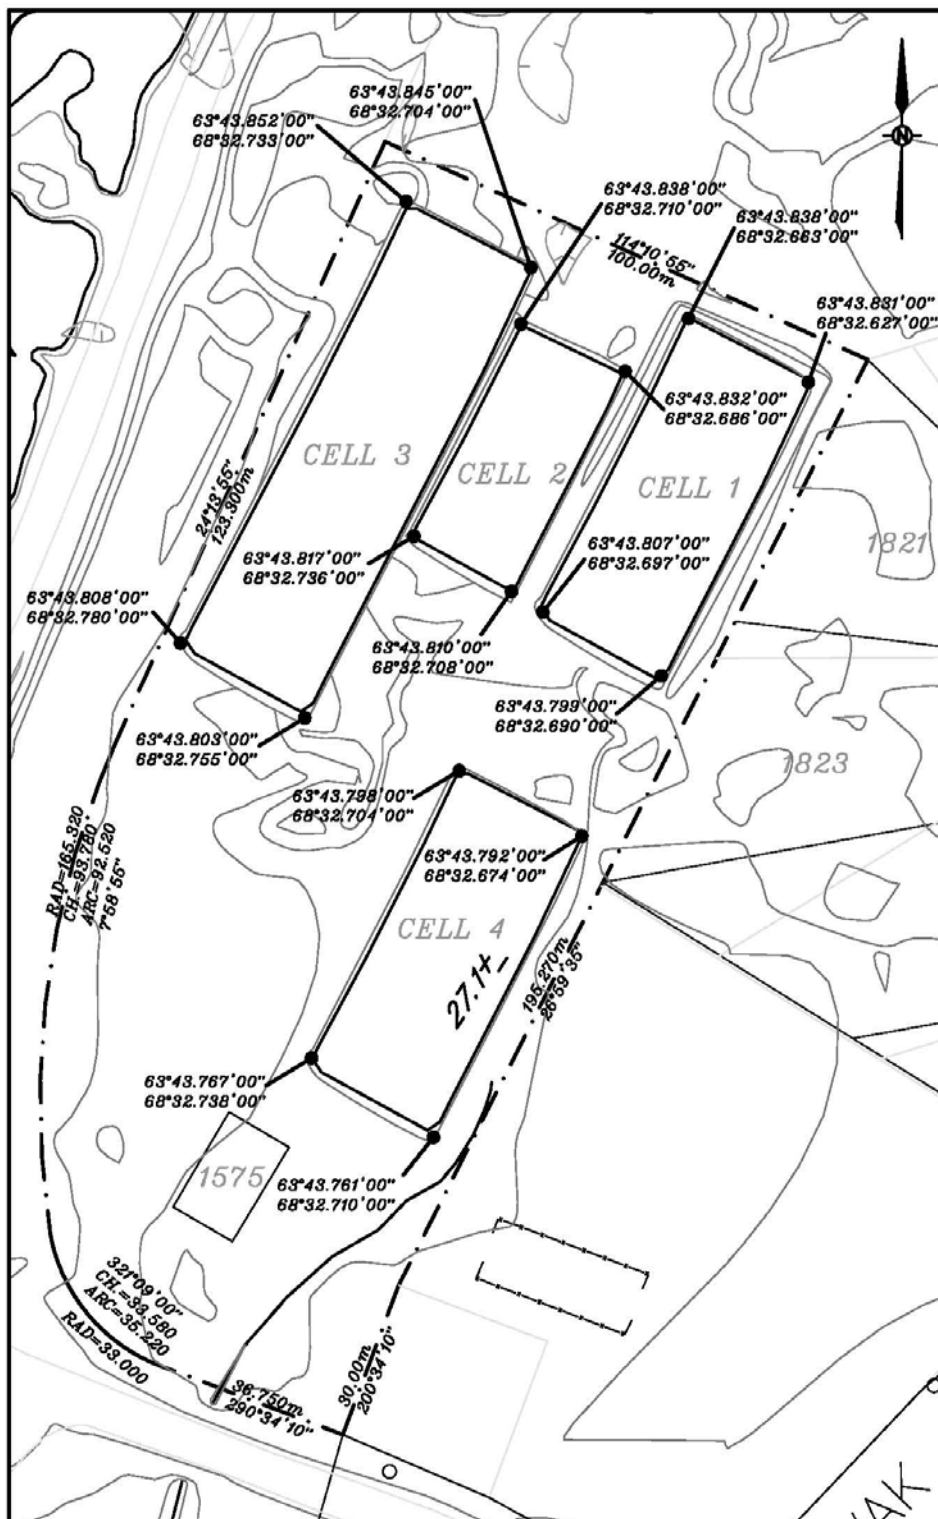
GPS coordinates of cell corners

These coordinates are to center of cells  
Corner locations are included in attachment.
