Nunavut Water Board

Standard Form for Annual Reporting Requirements of NWB2 Exploration Water Licenses

NWB Annual R	Report	Year being reported: 2009 ▼								
License No: N	IWB4NUN0511 - Typ									
		Expiry Date: December 13, 2011								
P	Project Name:	Nunatta Environmental Services "Landfarm"								
Li	Licensee: Nunatta Environmental Services									
М	Mailing Address: Box 267, Iqaluit, Nunavut X0A 0H0

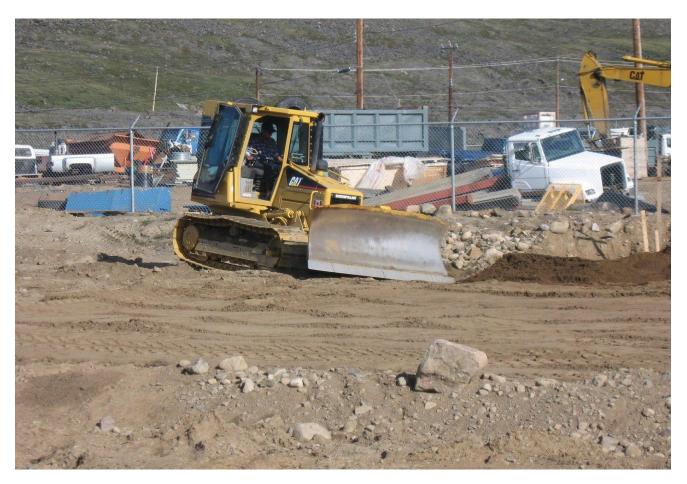
During the warm months of 2009 we began the construction of an overflow cell. This was in response to an unusual number of fuel tank ruptures in Iqaluit. We began by digging out large rocks and putting down a layer of screened out material.

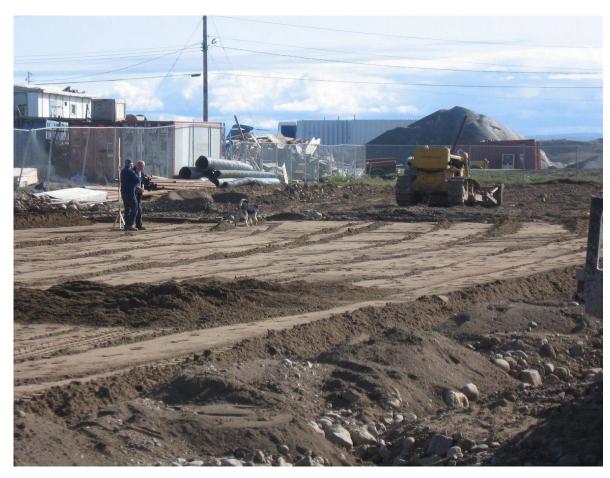
All work was monitored by Axel Have (P.eng)
Approved Cell construction drawings were Engineered by Dillon and have been the model used in constructing of all cells on Nunatta Landfarm as it has proven to be a good design for this northern location and soils we have to work with.

Length, Width and Grade was checked with the use of transit

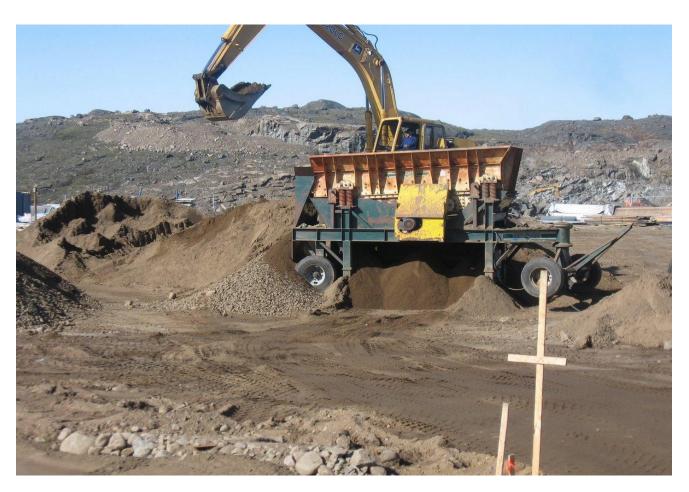
Sand was brought in and put through a shaker to remove all rocks down to less than $\frac{1}{2}$ inch

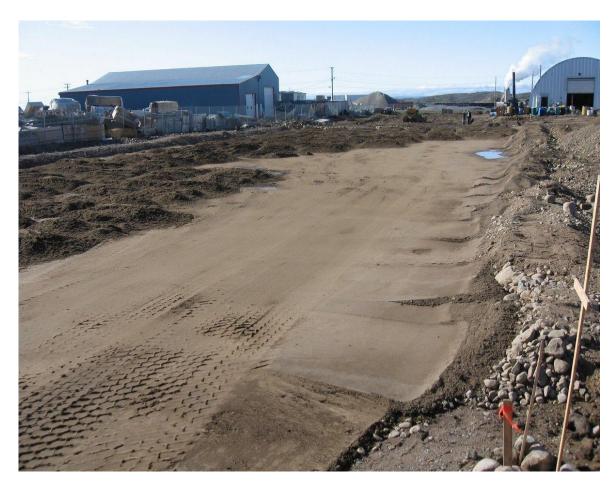
This was placed on an already smooth base and compacted, then another layer added and compacted again.
Grade was corrected throughout this process.

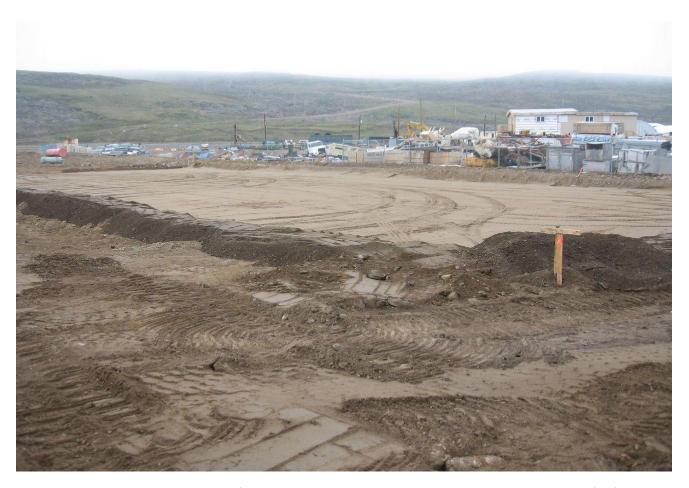
Walls were constructed of waste rocks in bottom and soils that pack on top to make for firm walls

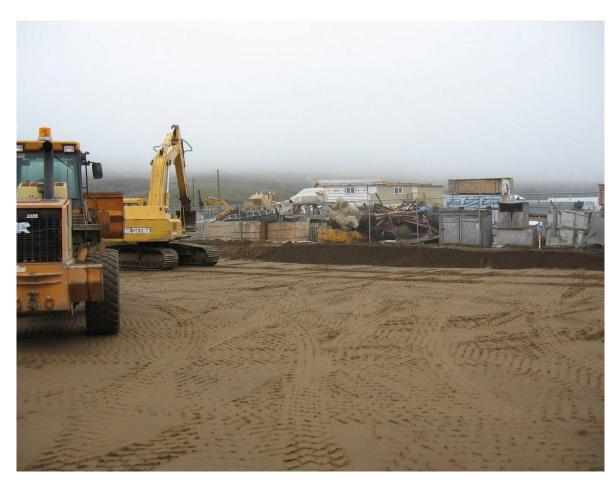
Excavator and loader used to carry materials and to pack walls tight

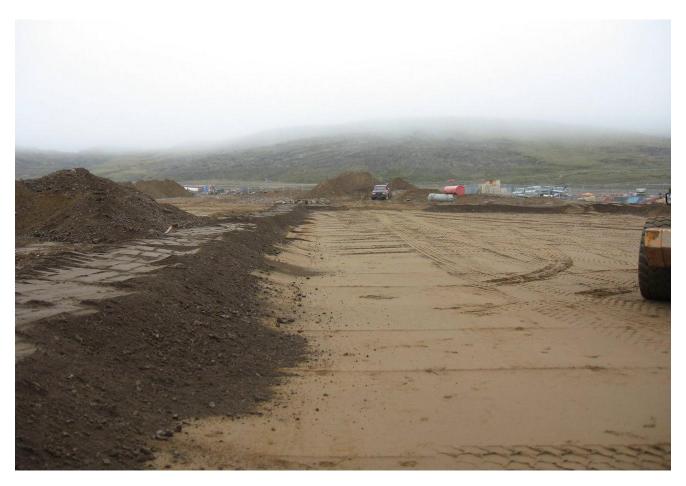
Small stones were raked out of inside cells and walls were covered with screened sand. To complete the formation of cell containment area.

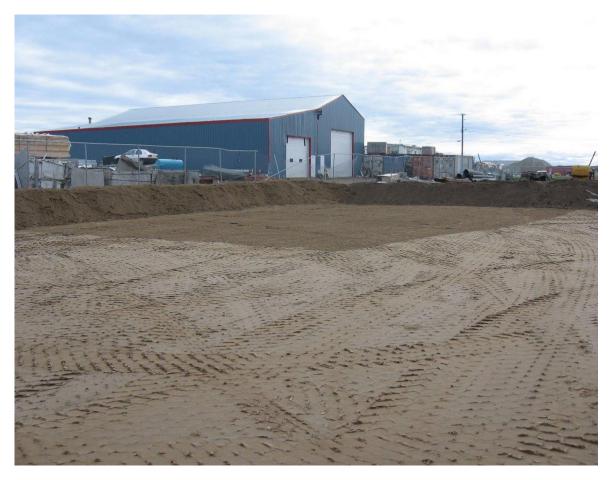
The whole area was raked and picked clean of any small debris that could puncture the liner. The transition from floor to wall was shaped so as not to have sharp angle which could cause a rip

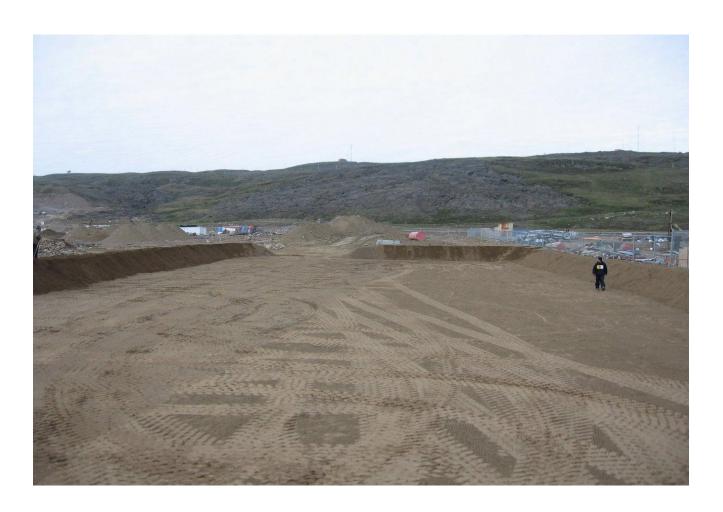
The opening in the end wall was to allow passage of man and machine. We thought it best to keep access until liner was installed then fill in hole. This position later became a ramp to allow access into cell. One of two access points into cell #4

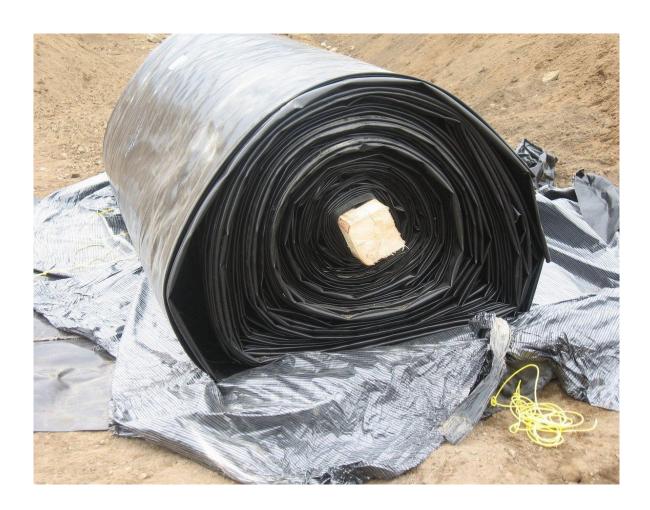
This is the new liner uncrated.

Total weight 2200 pounds or 1000Kg

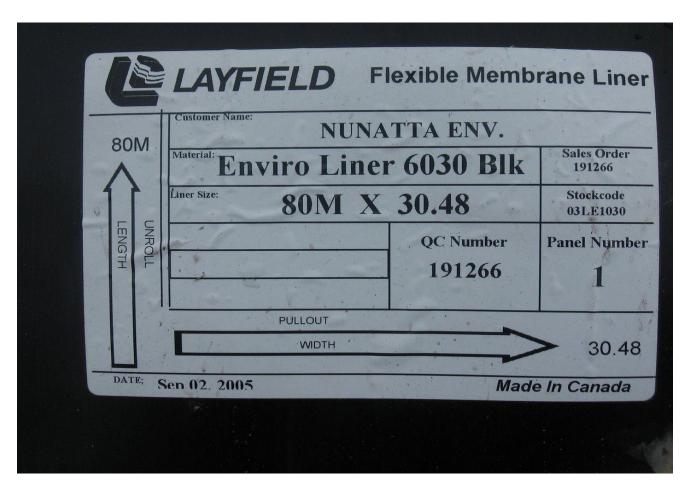
Showing liner label. This was adhered to side of roll. Kept in file as proof of purchase

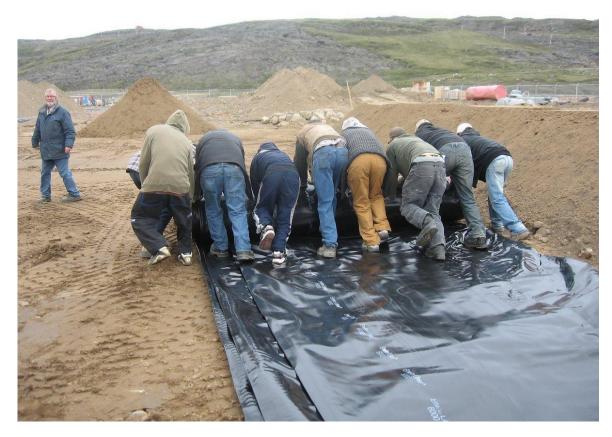
Unrolling of liner prior to unfolding across the width of the cell area

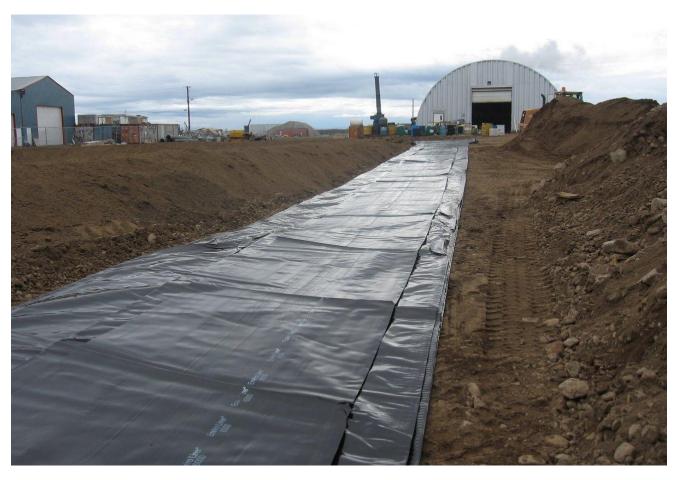
Shows length of cell area, liner unrolled and ready to unfold across the cell wall (left on photo)

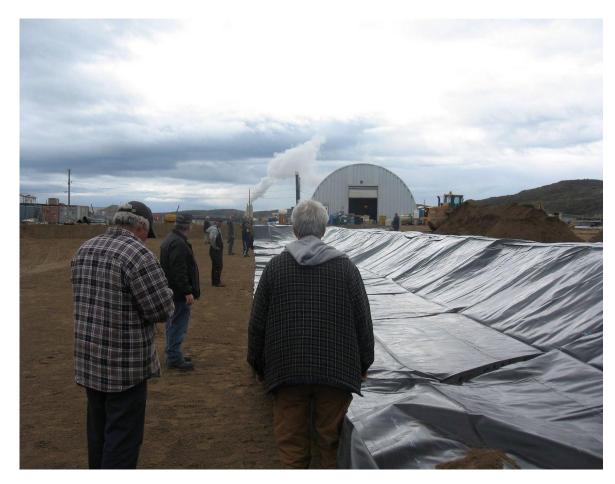
First couple folds out. Takes many hands to pull liner evenly into position.

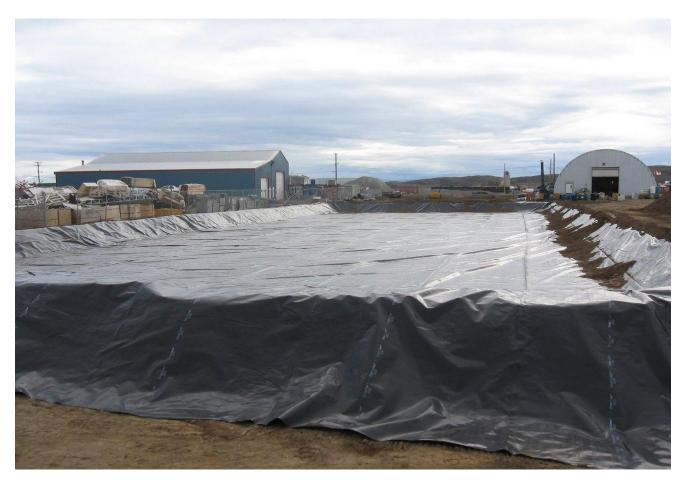
Liner in position and placing of sand on top of walls underway to keep the wind from getting under liner Equipment cannot drive on liner with out sand to aid in spreading out weight over larger area. Plans call for 6 inches of compacted sand over liner.

We feel more than this is required and will add 16-18 inches.

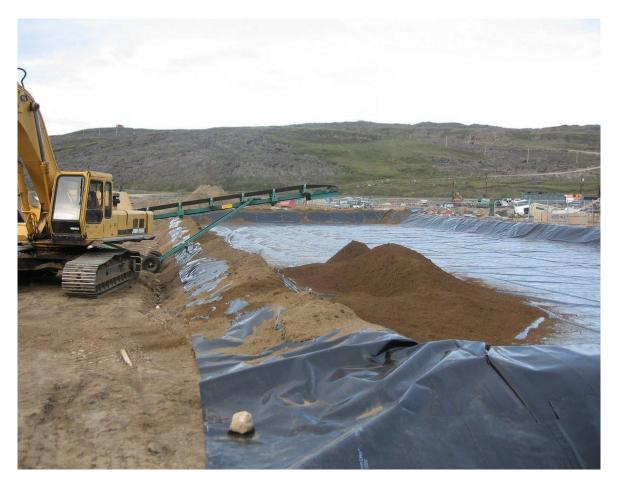
Screening plant and stacker used to get sand into new cell without damaging the liner. Sand was shoveled out until no more sand was available. Completion of cell will continue Summer of 2010 when city will allow removal of more sand from pit.
