PIN-E CAPE PEEL INTERMEDIATE
DISTANT EARLY WARNING (DEW)
LINE SITE REMEDIATION PROJECT

ARCHAEOLOGICAL IMPACT ASSESSMENT

FINAL REPORT

ARCHAEOLOGICAL IMPACT ASSESSMENT (AIA) OF THE PIN-E INTERMEDIATE DEW LINE SITE, CAPE PEEL, NUNAVUT

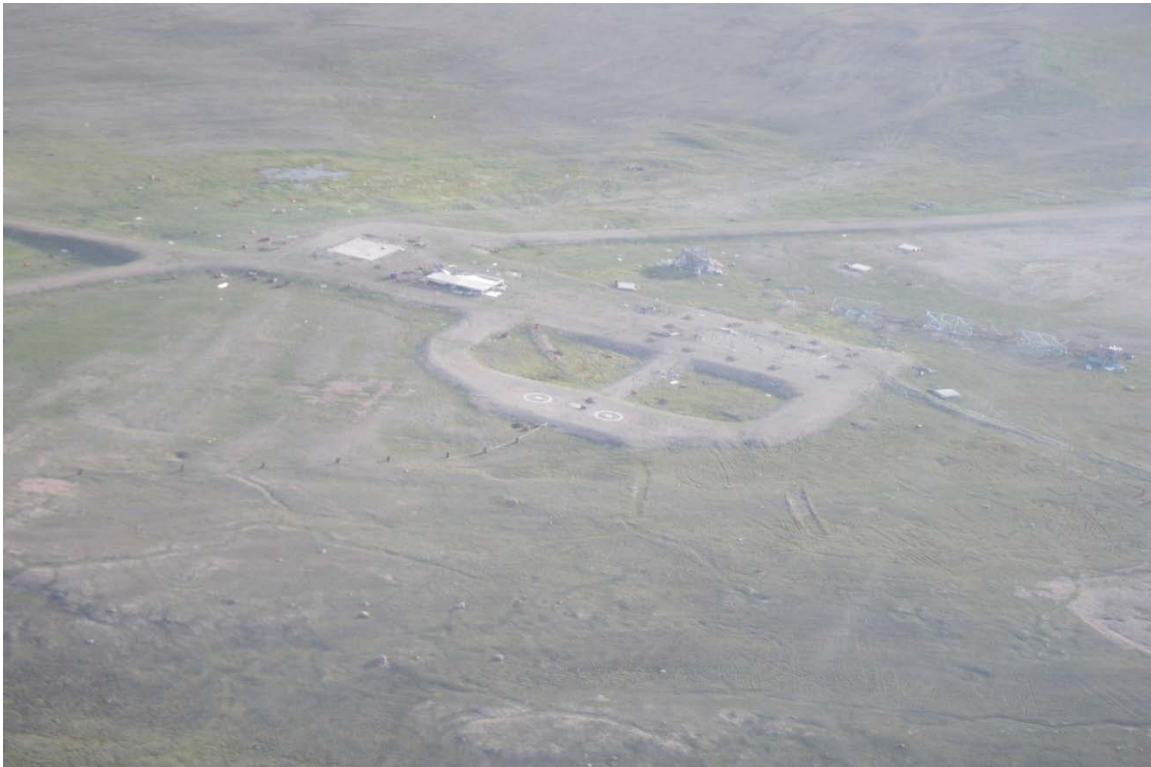
Plate 1 Aerial photo of the PIN-E Intermediate DEW Line site facilities.

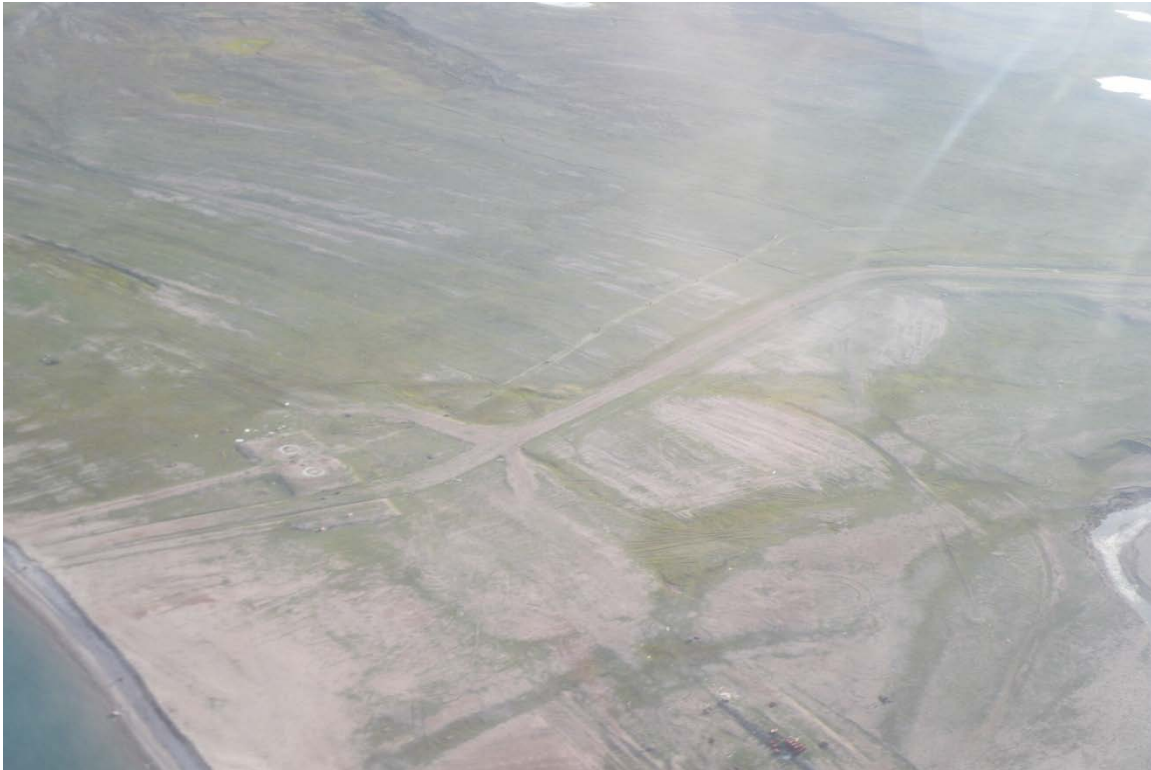
Plate 2 Aerial photo of the beach landing area showing roads, barrels and former location of POL tanks.

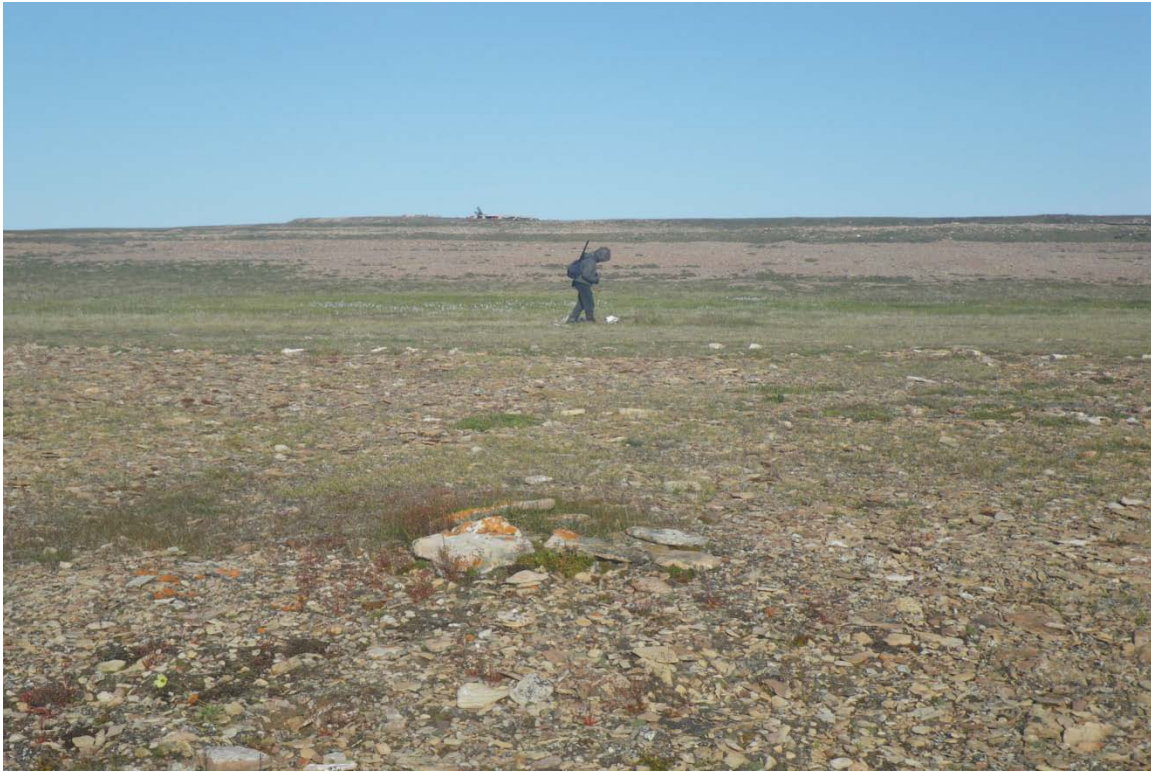
The PIN-E site area is characterized by hummocks, rolling hills and raised beaches compost of coarse grained gravel. The station facilities were constructed on a raised beach (Plate 3) sloping toward Dease Strait. During the study the only wildlife that was observed were a small heard of musk-oxen, very little vegetation was observed at this location.

Plate 3 View north of PIN-E sites, in the background, from an intermediate beach ridge showing typical topography of the study area.

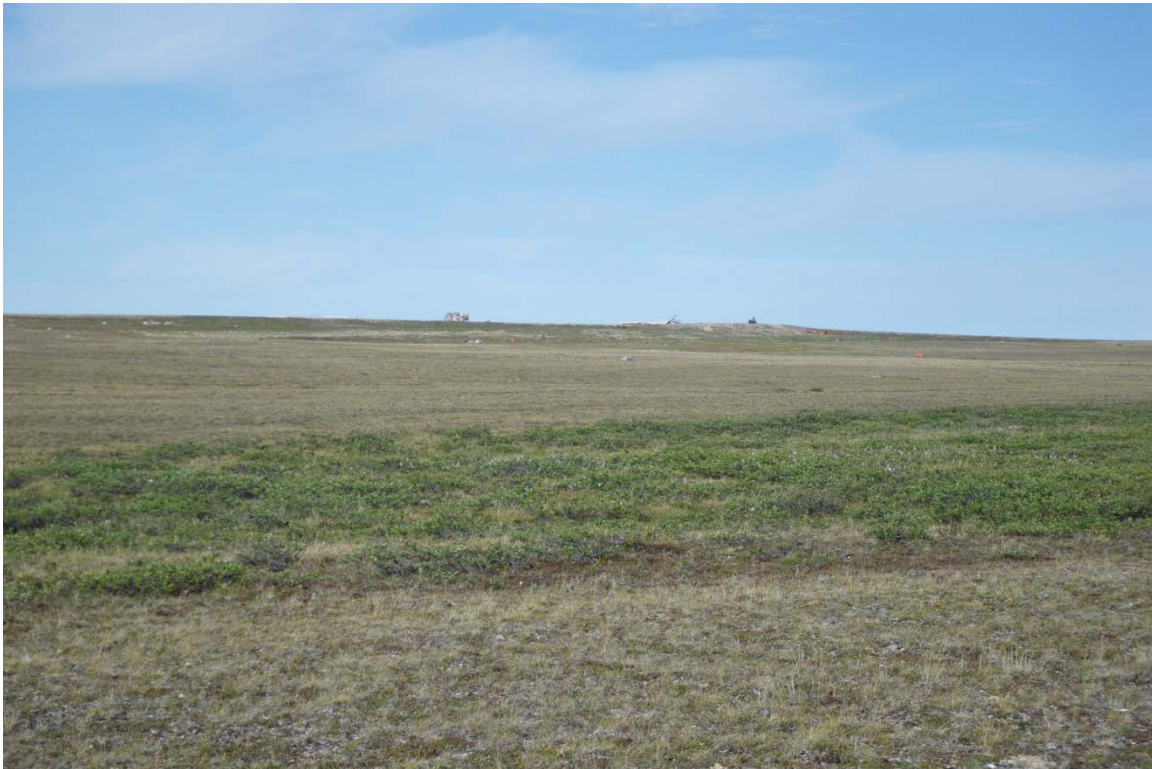
The AIA assessment included all of the areas of moderate to high archaeological potential that has been disturbed by the PIN-E DEW Line site as well as areas identified as having potential for future borrow sources or dumps. The disturbed areas that were surveyed included the Station Area (Plate 4), airstrip, beach (Plate 5), barrel dumps, landfills (Plate 6) and all the existing roads and anywhere there was evidence of a bulldozer push or any other disturbance. Previously undisturbed areas that were examined included the periphery of all the impacted areas as well as several areas that were identified as potential borrow areas, landfills and landfarms for remediation activities (Plates 7 and 8).

Plate 7 View north of PIN-E site with potential borrow area in the foreground.

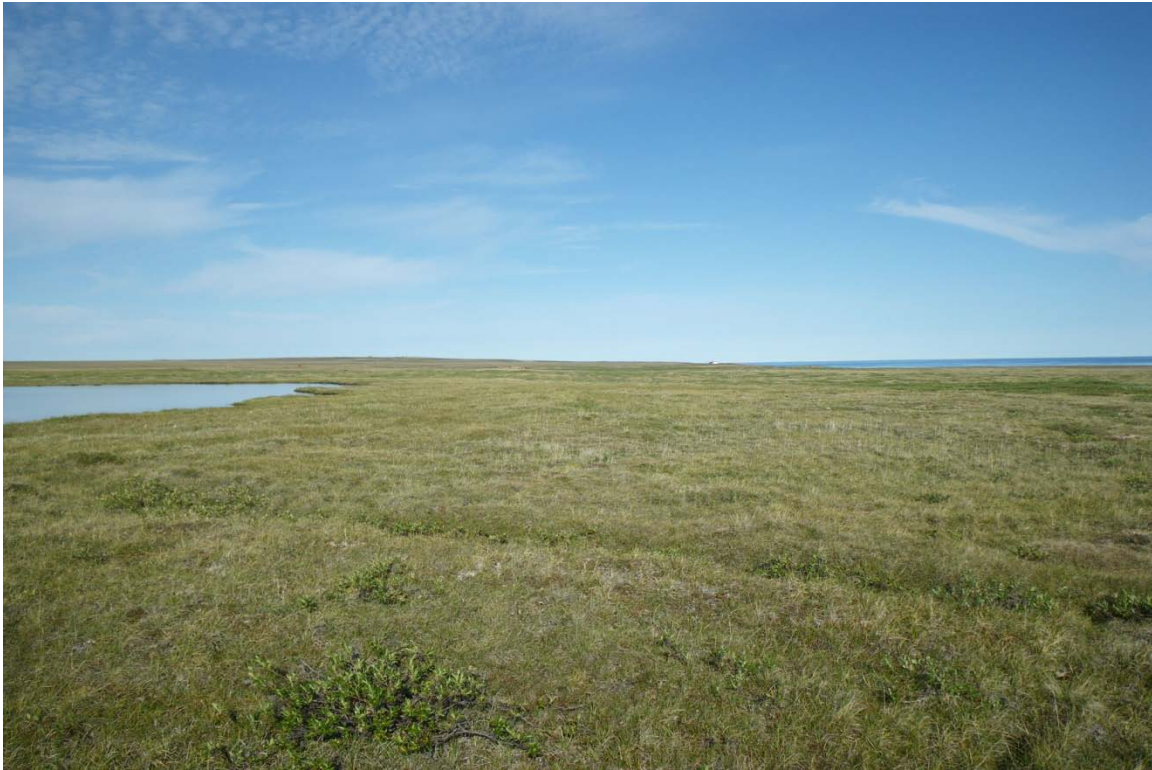
Plate 8 View east of potential borrow area off the west end of the runway.

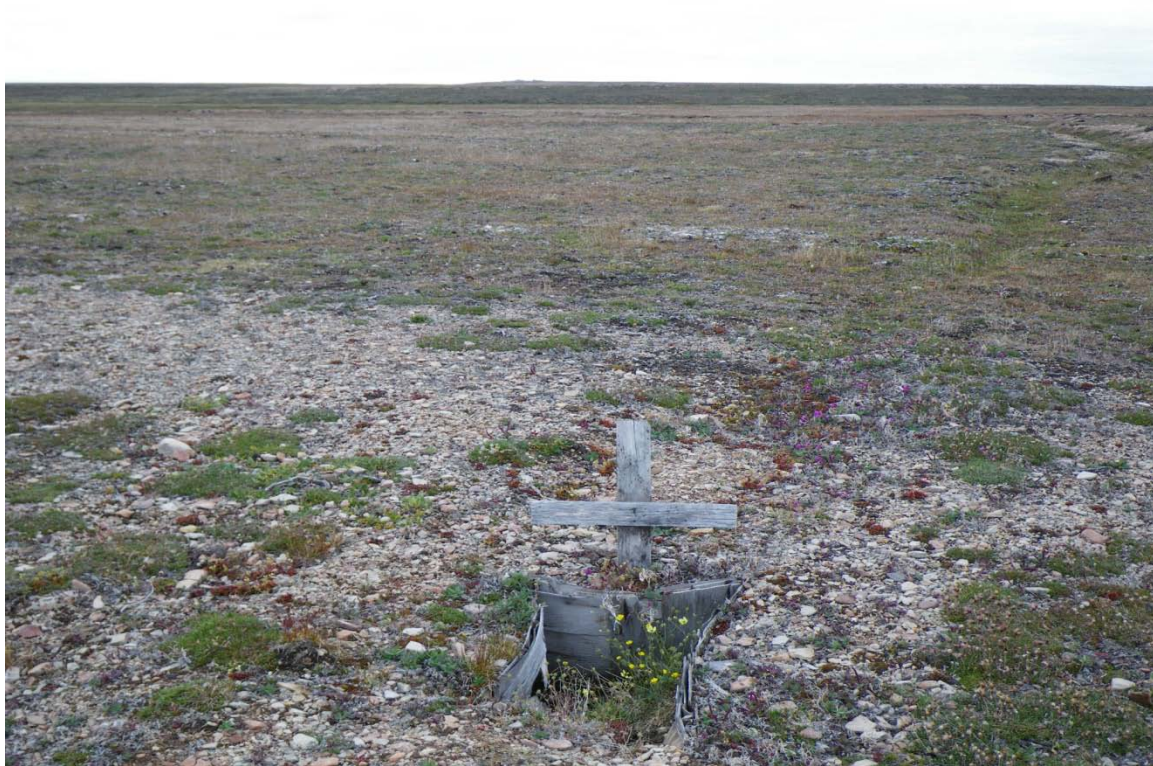
The grave is located approximately 450 m southwest of the Inuit house remains on a beach ridge (Plate 12). The grave is marked with a wooden cross made of dimensional lumber and the coffin is partially exposed as the lid has collapsed and is only shallowly buried. The coffin is small, approximately 2 feet by 4 feet, and is made of plywood. Remains can be seen under the collapsed lid that appears to be immature rib bones. After recording the grave site Gary Avalak, who assisted in recording the grave, asked his mother Mary Avalak about the grave and she thought it might have been the grave of Alice Kaotalok who had lived in the area with her husband David and her parents. According to Mary, Alice has died of cancer and was buried around the same time as the operation of the DEW Line Site. Although this is a possibility, the grave appears quite small for an adult and may possibly contain the remains of a child.

Plate 12 View northwest of grave and surrounding terrain.

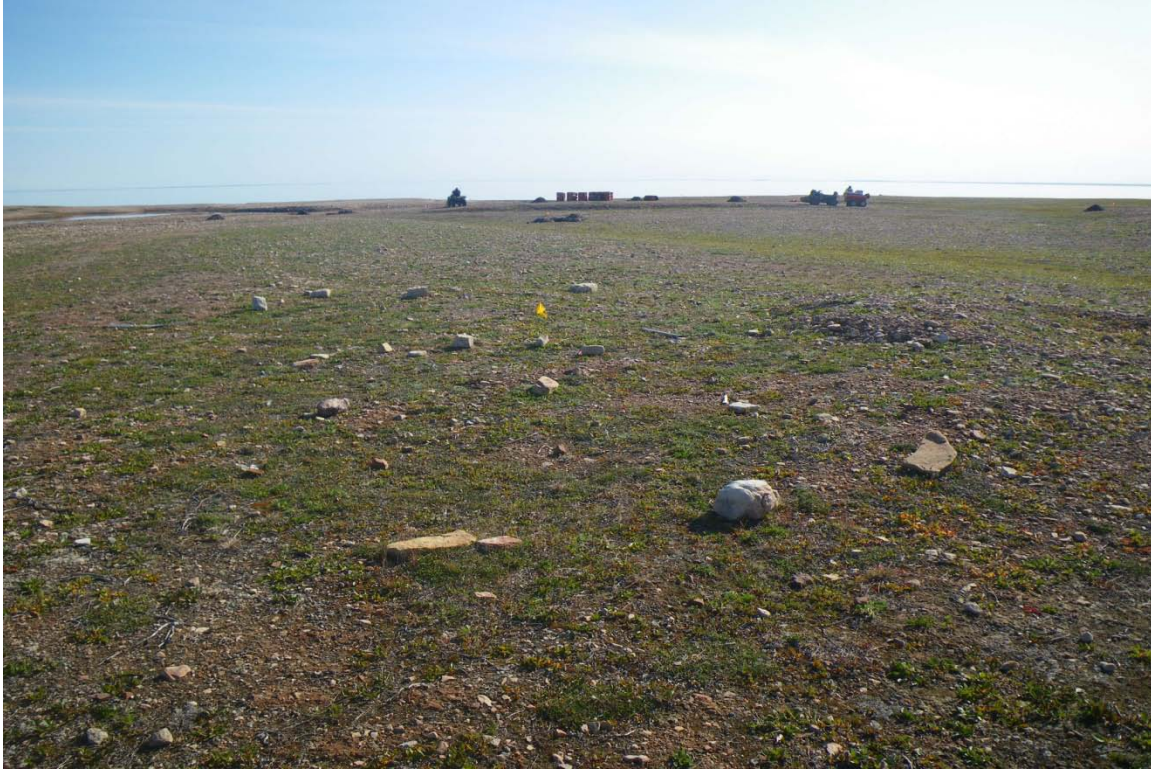
The two modern stone tent rings were located on the beach beside the river along the northeastern edge of the study area. The two tent rings are 3 and 5 m in diameter and are

made of seven and eight large stones respectively (Plate 13). Material culture around the two stone rings includes shotgun shells, plastic oil containers and food cans.

Plate 13 View east of modern tent ring.

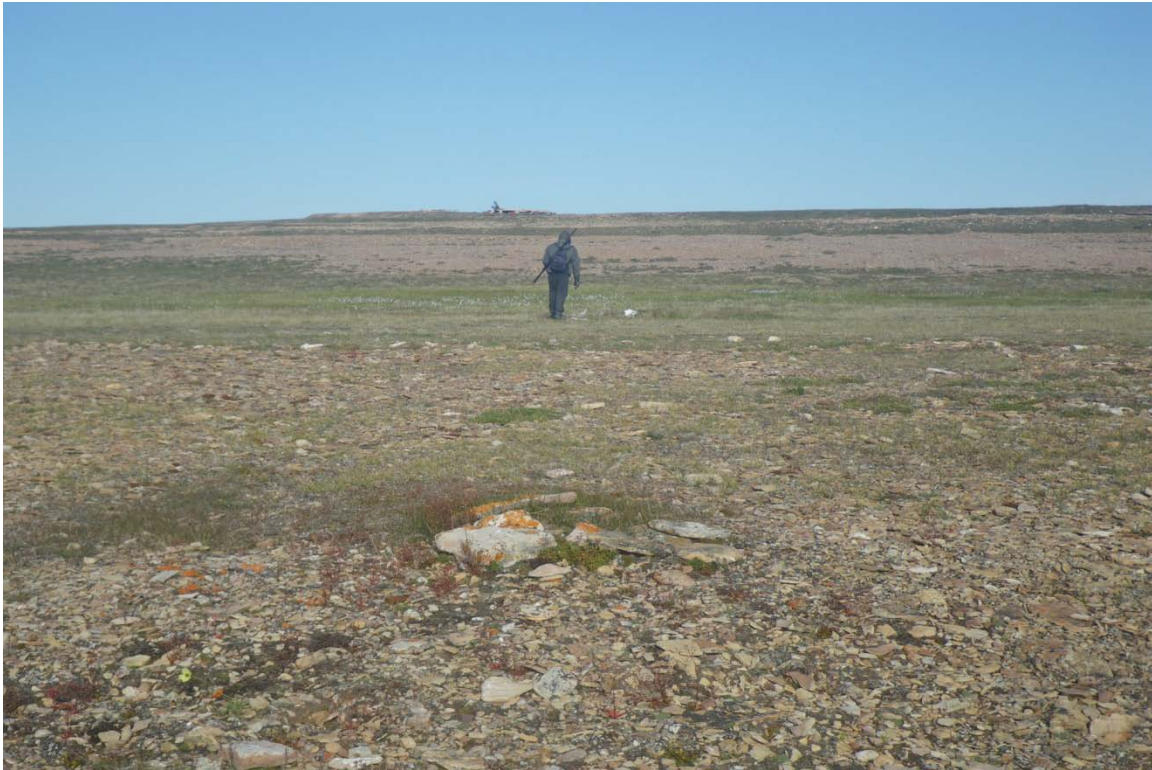
NgNj 1 is a stone feature site that is made up of a single stone cairn that was recorded on an intermediate ridge line (Plate 14). The cairn was recorded on the fourth beach ridge just below the location of the PIN-E DEW Line site. The cairn is made up of at least 14 flat stones with a diameter of 1 m (Plate 15). There was no additional cultural material observed around the stone feature. Although the area just north of the site has been previously disturbed by a bulldozer the site area has not. The stones also exhibit a lichen patterning that would indicate prolonged exposure and therefore is thought to predate the DEW Line Site. NgNj 1 is considered to be of moderate potential and it is

Plate 14 View north of NgNj 1 with PIN-E Site in the background.

recommended that any impacts to the site be avoided. At this time there are no plans to disturb NgNj 1 during the remediation activities.

The AIA identified two heritage resource sites, NgNj 1 and NgNj 2. The site NgNj 1 is considered to be of moderate significance and it is recommended that this site be avoided during remediation activities. NgNj 2, however, is considered to be of limited significance and no further work is recommended.

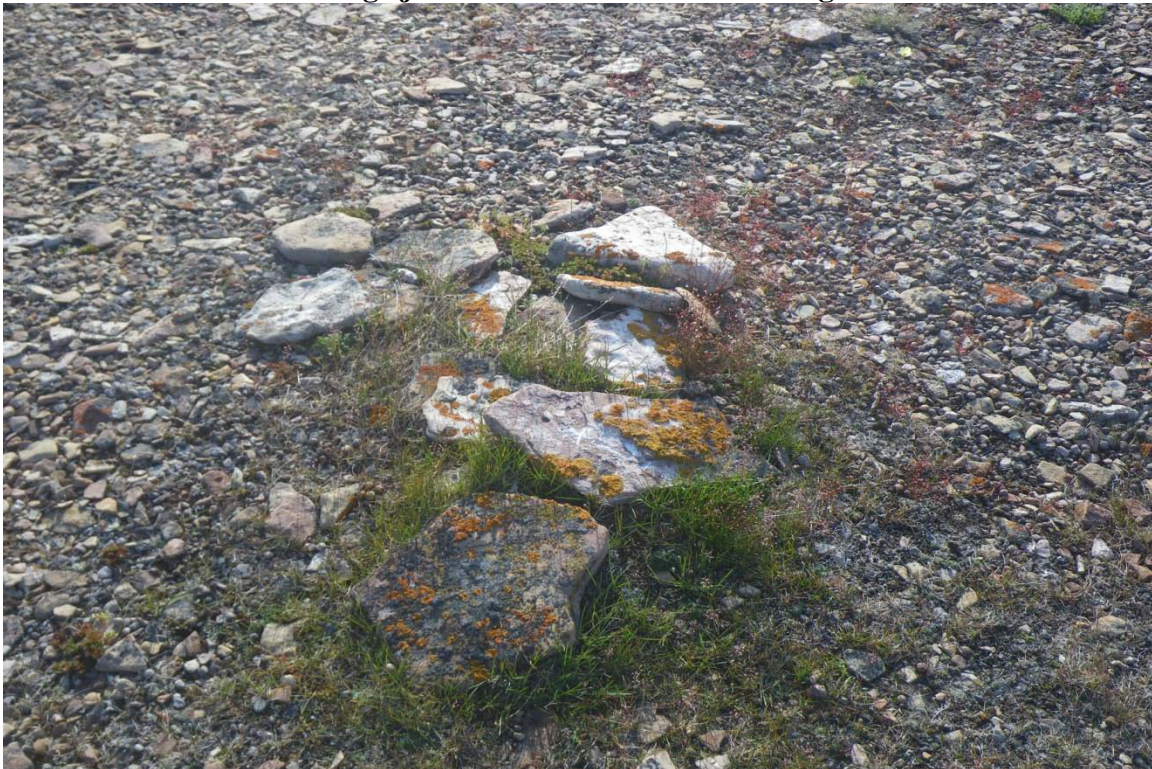
Plate 15 Detail of stone cairn, NgNj 1.

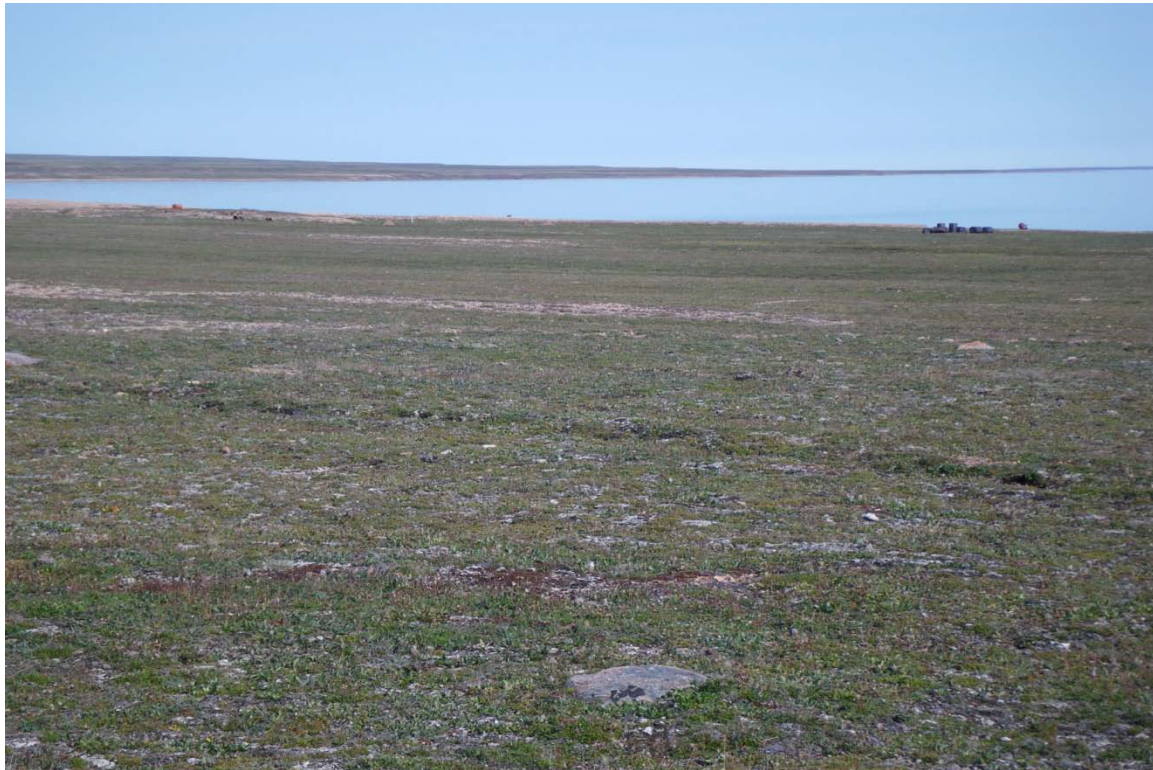
NgNj 2 is an isolated find site consisting of a single modified flake. The flake was surface collected on the second beach ridge approximately 230 m from the water (Plate 16). The flake is made of red quartzite and is relatively large (55 x 68 x 16 mm) with three flake scars on the dorsal side. The flake appears to be broken, missing the platform, and has been bifacially modified along both lateral edges and distal edge. The distal edge also appears to show signs of having been utilized. No additional cultural material was observed around the site area and four shovel tests were negative for cultural material. Due to the limited cultural assemblage, NgNj 2 is thought to be of limited significance and no further work is recommended.

Plate 16 View northeast of NgNj 2 site area.
