Appendix A

Station Area Non-hazardous Waste Landfill

SITE NAME:	CAM-4 - Pelly Bay
LANDFILL/AREA DESIGNATION:	Station Area Non-Hazardous Waste Landfill
DATE OF INSPECTION:	August 14, 2008
DATE OF PREVIOUS INSPECTION:	August 24 - 26, 2007
INSPECTED BY:	Darrin Johnson, P.Eng.
REPORT PREPARED BY:	Darrin Johnson, P.Eng.

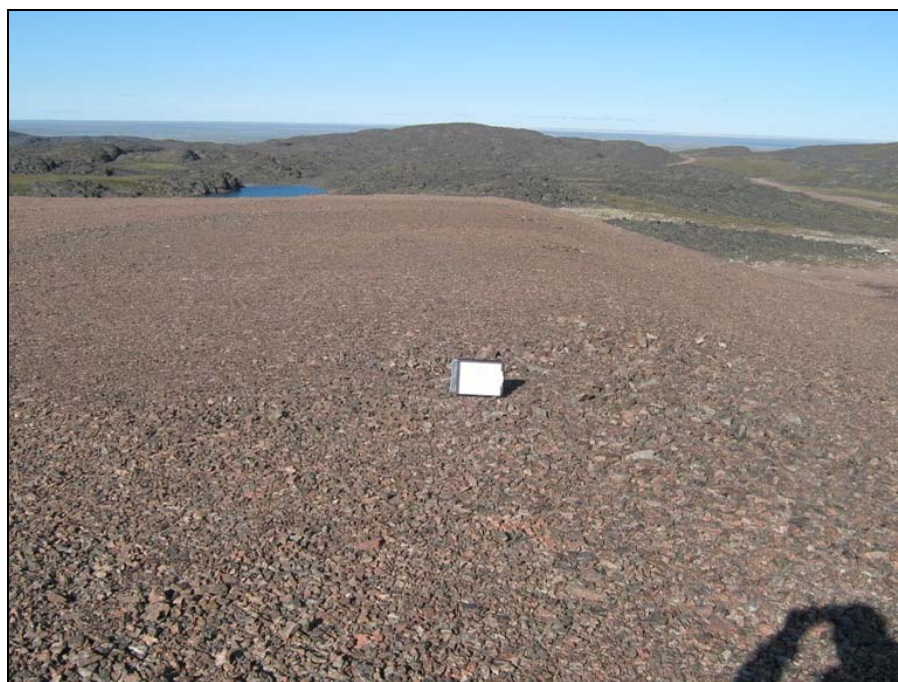
Photograph SNH-2A. Southwest corner at the crest facing northeast. Some tire tracks from a vehicle that tried to drive up onto the landfill near clipboard. ↑

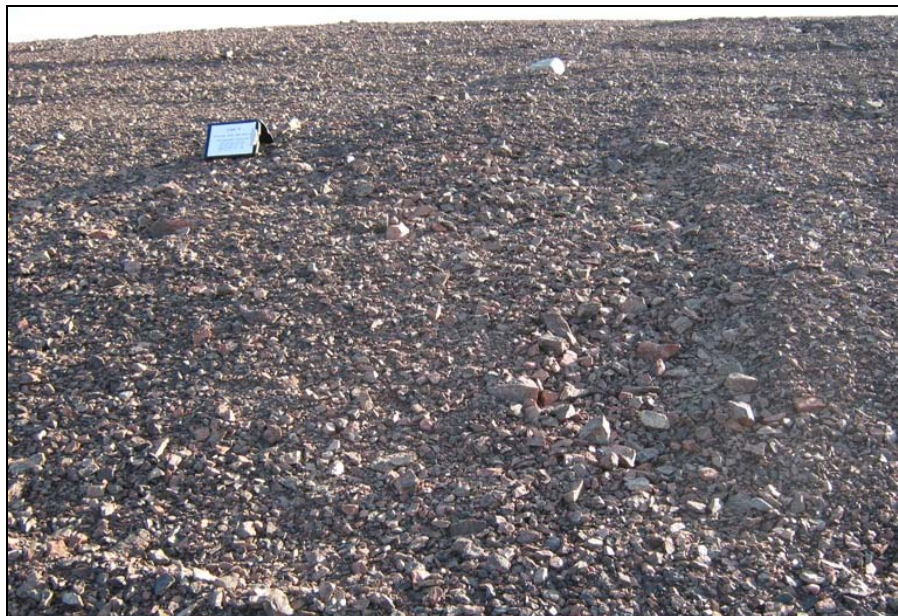
Minor erosion gullies were observed on the east slope that appear to be self-armouring (Photo SNH-8 in Appendix A2). An area of minor seepage and orange staining was observed on the lower half of the northeast slope (Photos SNH-7A and 7B in Appendix A2). Some minor drainage was observed along the road at the south toe (Photo SNH-10 in Appendix A2). No issues of concern that require immediate attention were identified.

Photograph SNH-8. East slope. Area of possible minor erosion with gullies about 0.5m wide and less than 0.1m deep that appear to be self healing with larger rock in cover fill. ↑

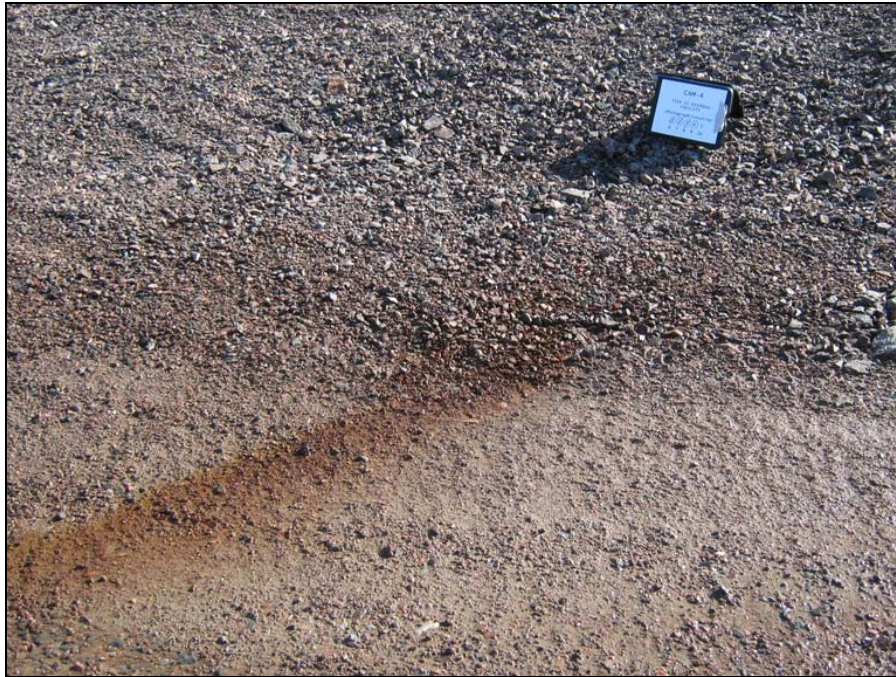
An area of minor orange staining was observed at the toe of the northeast slope (TII-4A in Appendix B2). Seepage was observed from the lower half of the northeast and southeast slopes (TII-6 and 7 in Appendix B2). No staining was observed on the slopes. Minor ponding of water and drainage was observed along the toes of the northwest, southeast and southwest slopes (TII-3, 9A and 10 in Appendix B2). No issues of concern that require immediate attention were identified.

Photograph TII-4A. At the northeast toe. Some seepage with orange staining. Some water drainage along the road at the toe. ↑

- SOME SEEPAGE AT TOE
WITH SOME ORANGE STAINING
