**Defence Construction Canada**

## **The Collection of Landfill Monitoring Data at the CAM-4 Kugaaruk Site – 2008 FINAL Report**

**Gartner Lee Limited doing business as AECOM**

November, 2008

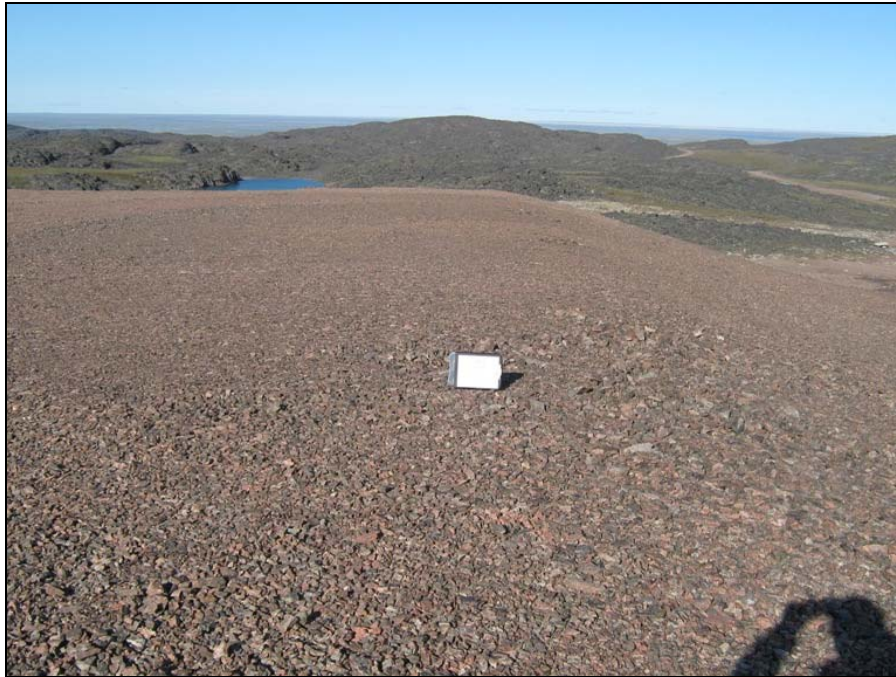
**Photograph SNH-2A.** Southwest corner at the crest facing northeast. Some tire tracks from a vehicle that tried to drive up onto the landfill near clipboard. ↑

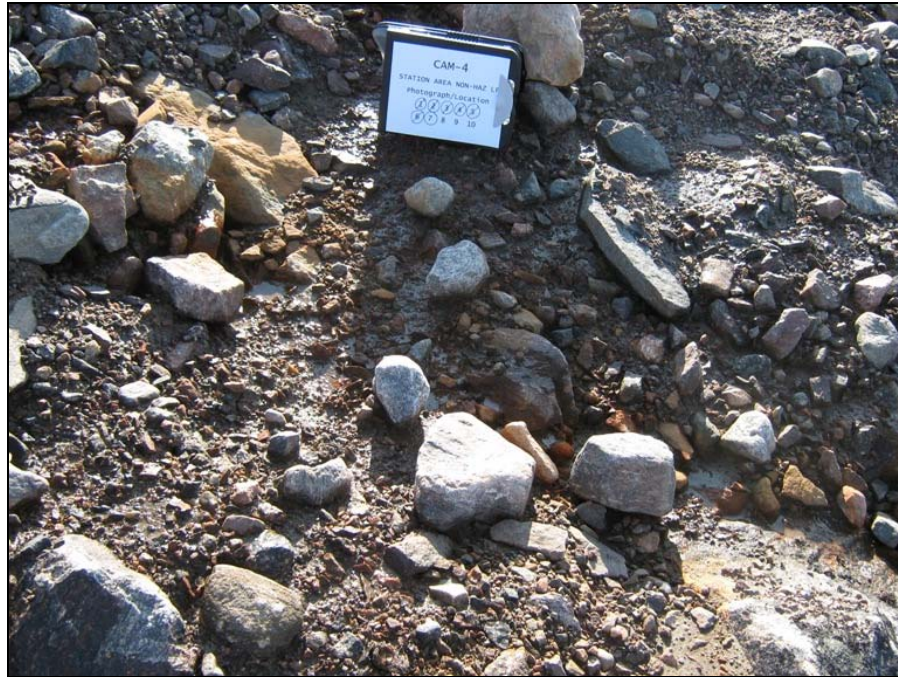
**Photograph SNH-7B.** Toe of slope near northeast corner. Orange staining and seepage discharging onto rocks at toe of landfill. Down-slope of photo SNH-12. ↑

- PHOTO 61 (TOE OF SLOPE NEAR NE CORNER)
  - ORANGE STAINING AND SEEPAGE DISCHARGING ONTO ROCKS AT TOE OF LANDFILL
  - DOWNSLOPE OF PHOTO 60

Minor erosion gullies were observed on the east slope that appear to be self-armouring (Photo SNH-8 in Appendix A2). An area of minor seepage and orange staining was observed on the lower half of the northeast slope (Photos SNH-7A and 7B in Appendix A2). Some minor drainage was observed along the road at the south toe (Photo SNH-10 in Appendix A2). No issues of concern that require immediate attention were identified.

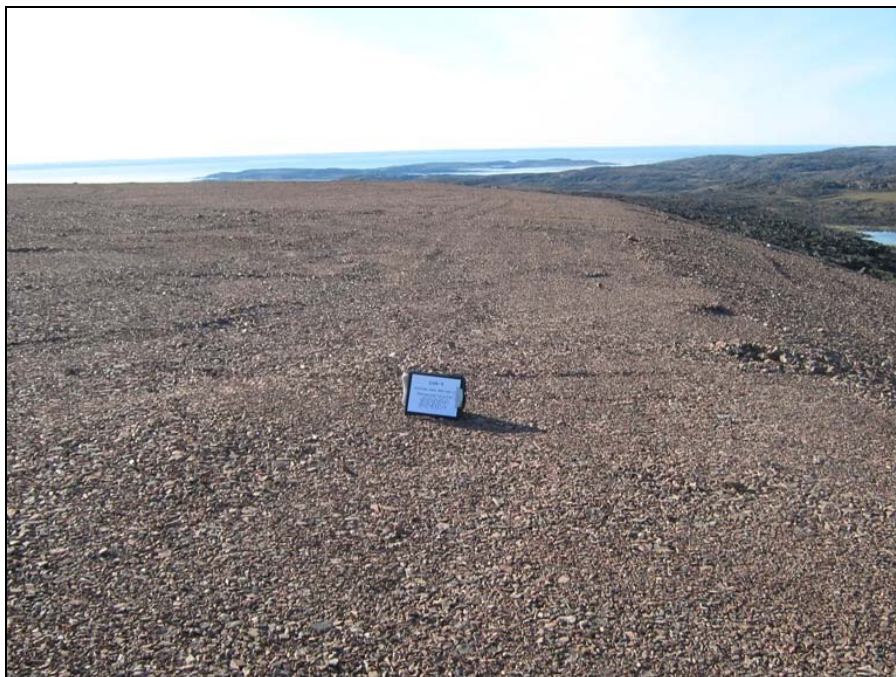
**Photograph SNH-9B.** Facing north along east crest. Some tire tracks but no damage. ↑

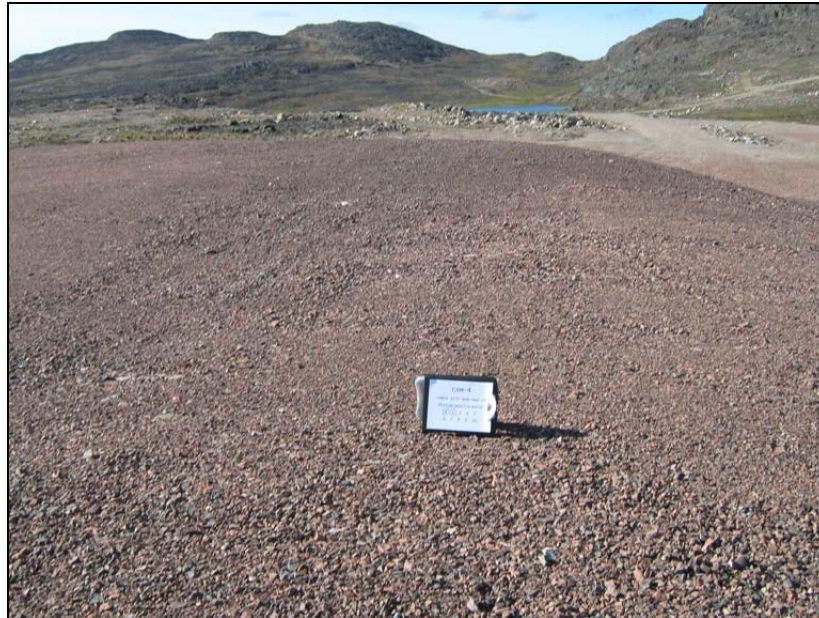
**Photograph LNH-2B.** Facing west along the crest from the centre of the north crest. Some tire tracks visible but no damage or rutting. ↑

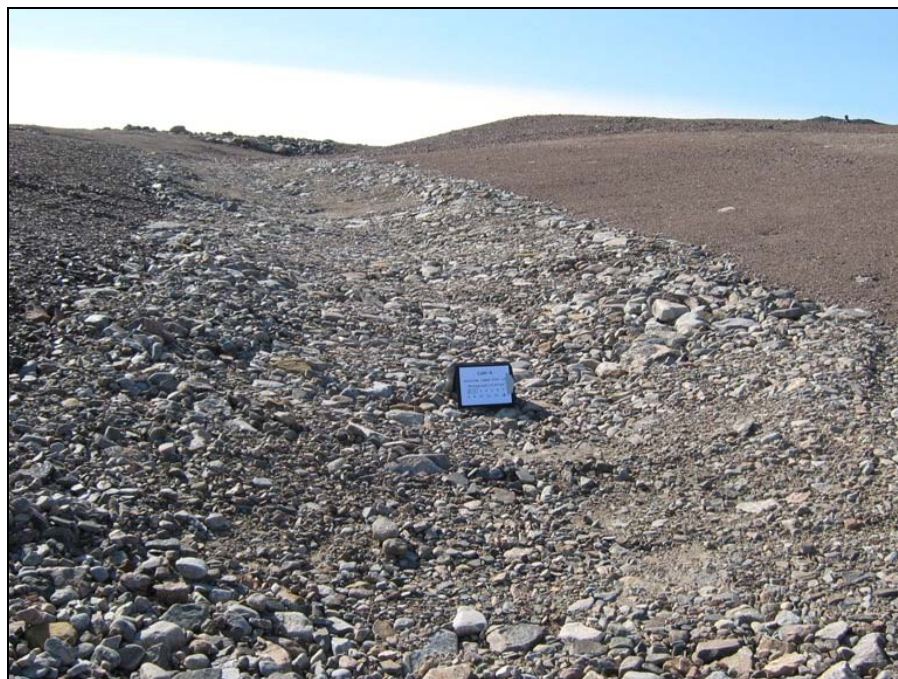
**Photograph LSL-2A.** Looking west, upstream, along the rip-rap lined drainage channel. ↑
