# FOX-5 DEW Line Site

## Pre-construction Delineation Phase:

NTI Technical Representative Report to NTI

August, 1998

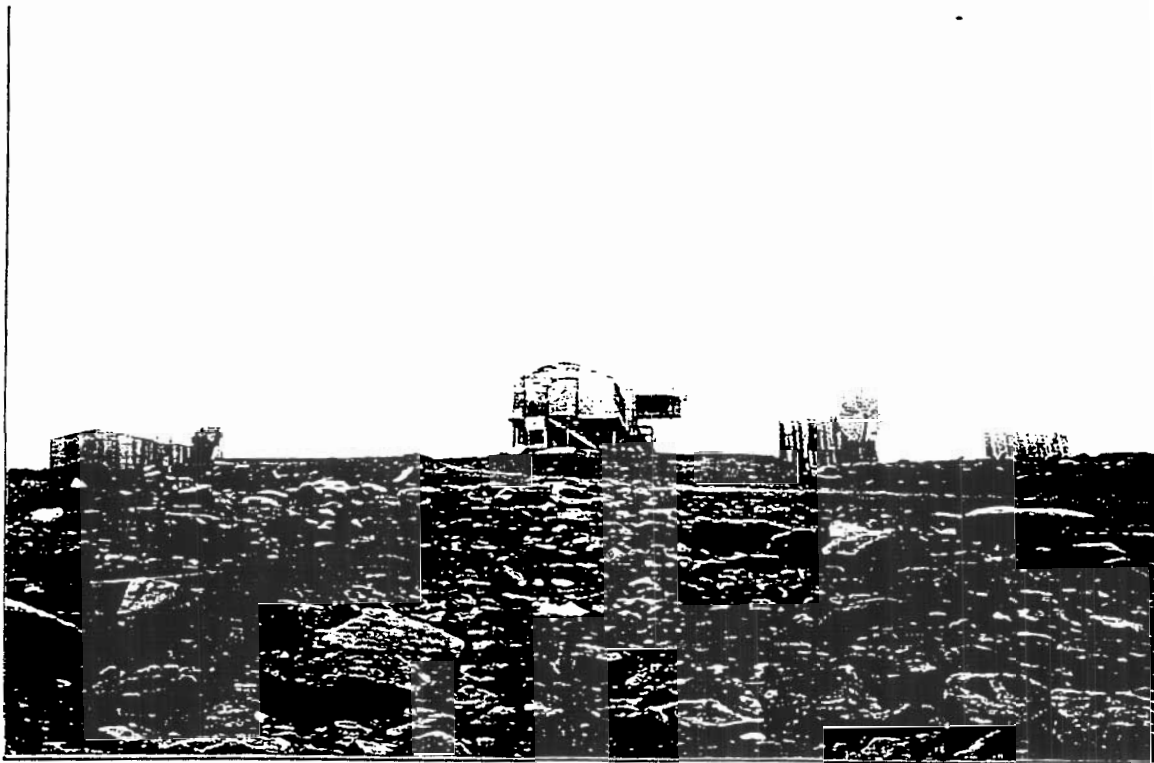
1. FOX - 5 upper site. View from access road.

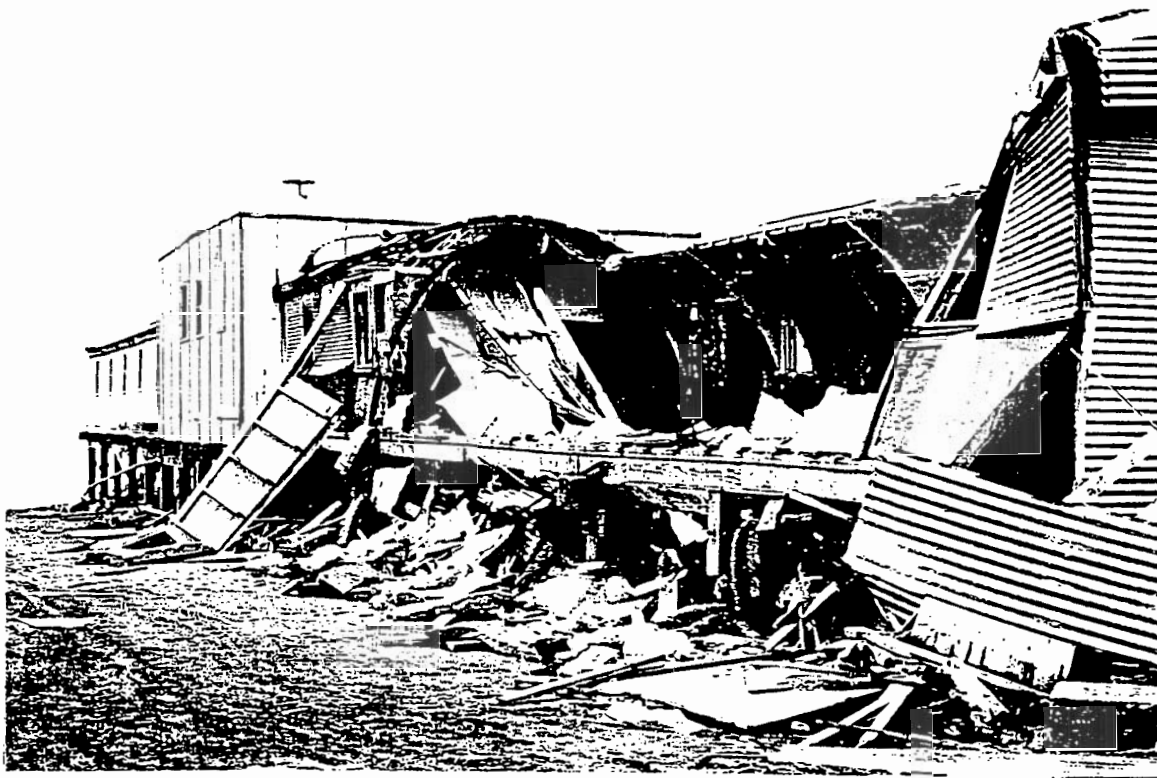
2. Dormitory showing extensive destruction.

2. Concerns and findings of the Local Representative were noted and will be included in the final cleanup design.
3. The upper site buildings are extensively damaged. Paint flakes as large as 15 cm in diameter are scattered throughout the site due to wind erosion. This problem should be addressed as soon as possible to reduce the scatter of PCB paint. The physical breakdown of the paint is the main concern with regard to PCB contamination from paint.
4. The main landfill does not appear to be physically stable. It is on an incline that receives runoff that is causing erosion and is exposing the buried contents of the dump. At least two of the runoff channels that flow through the dump were flowing during the site visit.
5. ESG noted the drum dump located down-gradient of the MOGAS tanks and had intended on investigating the area before leaving the site.

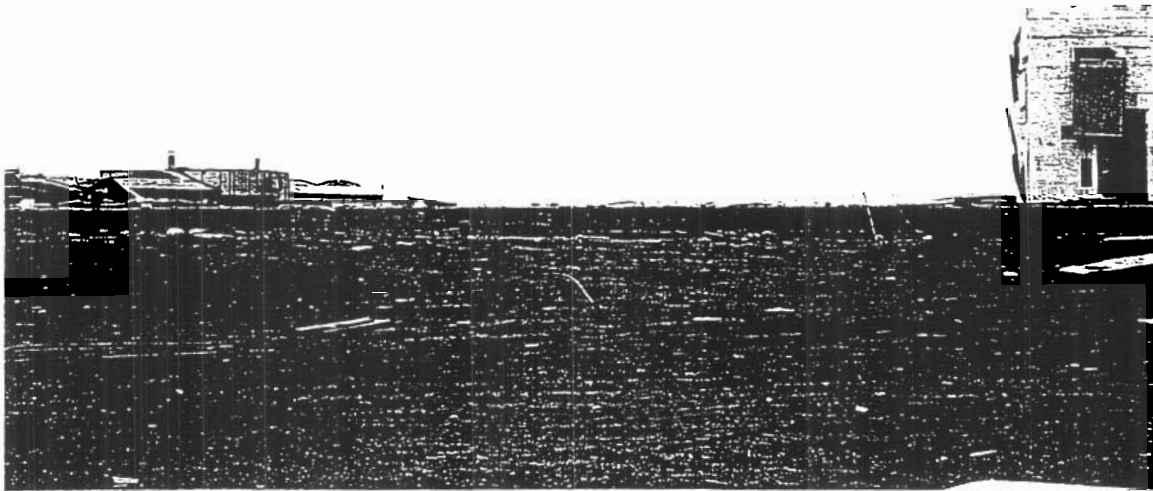
3. Concrete foundation of the warehouse now relocated to the Hamlet.

7. The vehicle storage garage was dismantled in 1997 and relocated to the community for use by the Hunters and Trappers Association. The garage had not been reassembled at the time of the site visit.

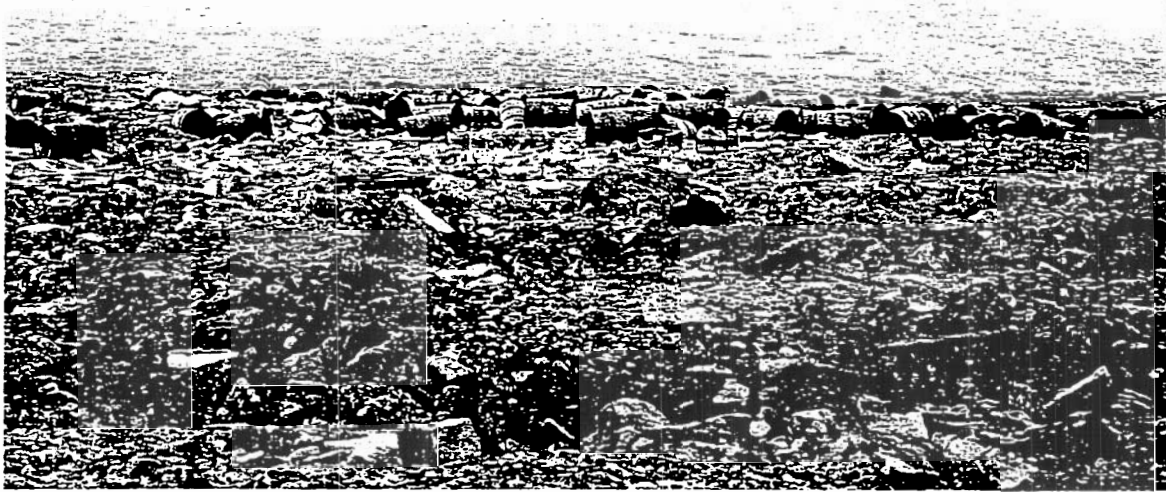
5. Undocumented barrel dump area down-gradient of the MOGAS Tank

4. The locals report that the landfill is eroding, exposing more debris every year.
5. The horizontal POL tanks were used as a refilling station.
6. A barrel dump is located half way between the horizontal POL tanks and the landfill. There are approximately 50 drums in this area that have not been noted on the cleanup specs to date. ESG was informed of the debris.

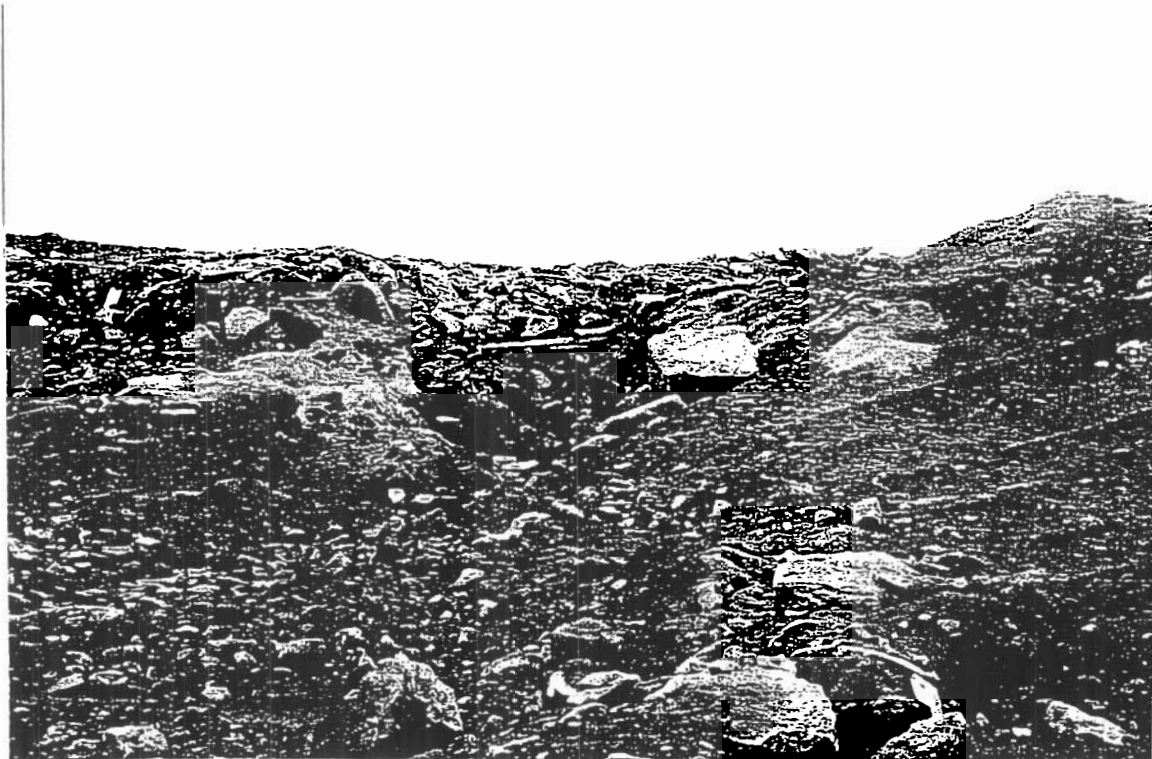
8. View of main landfill showing flowing erosion channel and exposed debris.

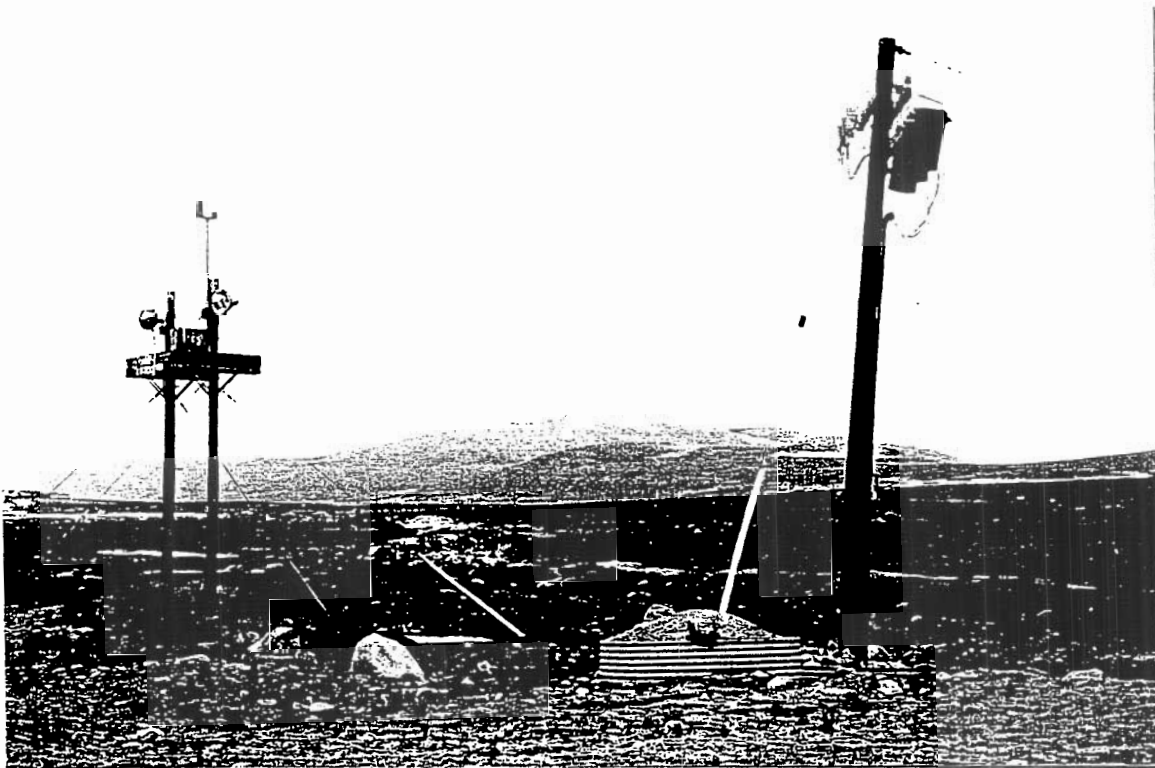
10. Pole-mount transformer and deacon tower located on airstrip apron.

4. Located on the airstrip apron is a power pole with an old pole-mount transformer attached to it. It is very likely that this transformer contains PCB contaminated mineral oil and should be handled prior to dismantling the poles.

5. Also located on the apron is a beacon light stand. The beacon is no longer in tact on the pole and may have been damaged prior to removal. The light ballasts in these beacons commonly contained PCBs and the concern was noted by ESG. Further studies of the soil beneath the stand were to have been completed while the team was on site.

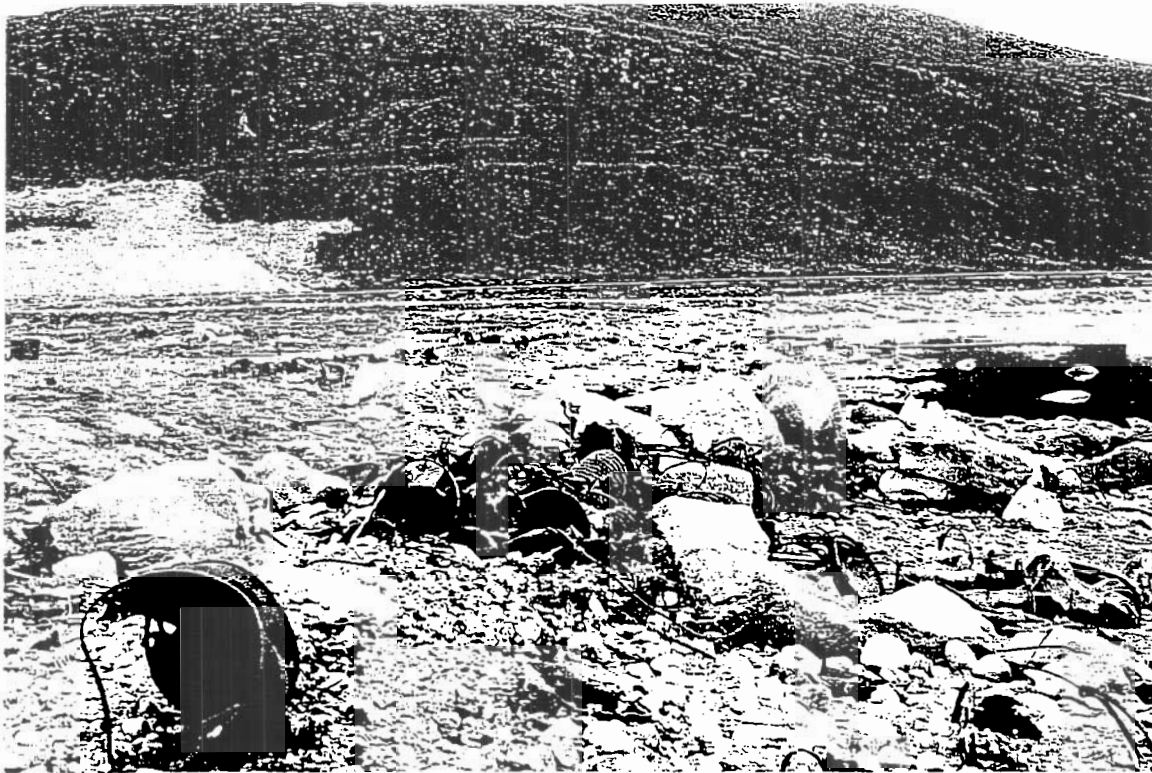
11. View of beach landfill.

7. The airstrip landfill is in a very unstable location and is currently leaching contaminants.

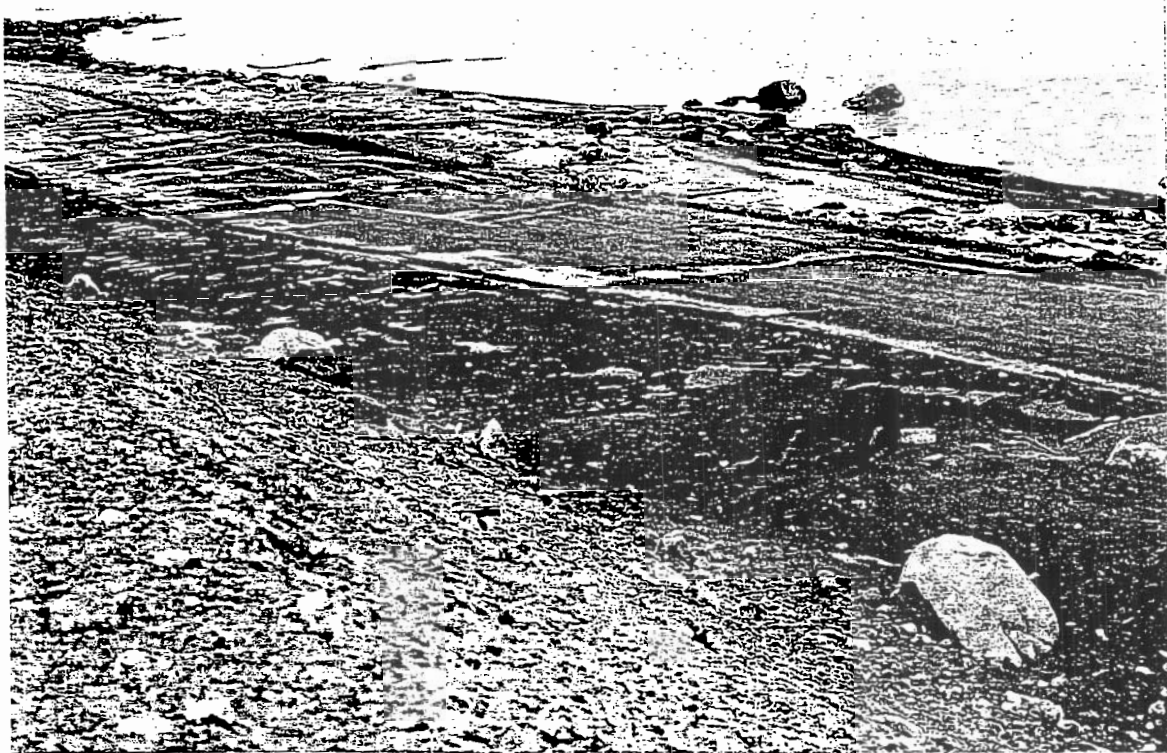
14. Contamination at toe of the berm and proximity to Broughton Channel

6. The beach POL station appears extensively stained. Test results were not available during the site visit. If results of the study show that the soil is in fact contaminated it is recommended that the soil from the berm be relocated away from Broughton Channel.

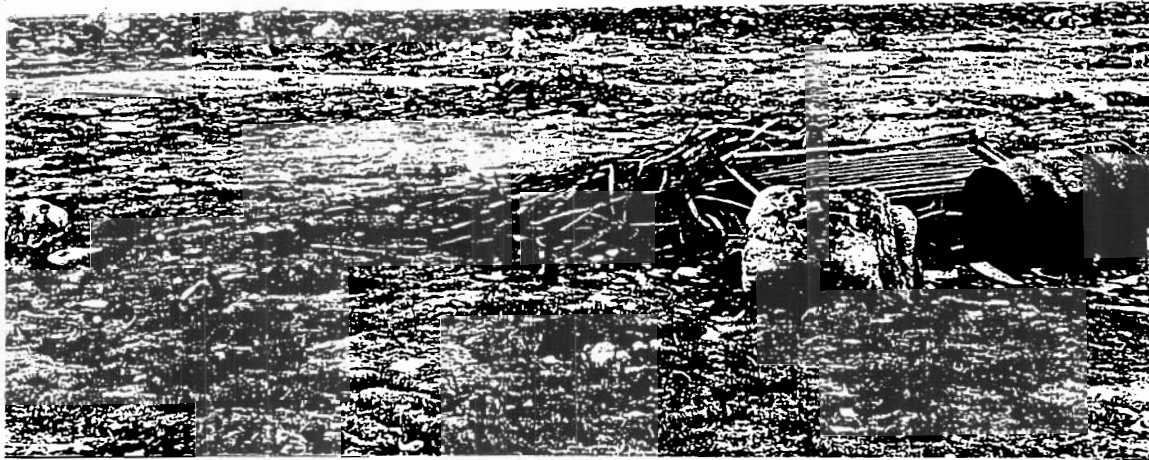
15. View of Old camp located near the current Hamlet landfill.

2. The old camp located near the current Hamlet landfill is a concern because it had not been documented in past DND assessments. The debris is extensive and includes at least 100 drums that are exposed or partially buried. ESG agreed to thoroughly investigate the area prior to leaving the site.

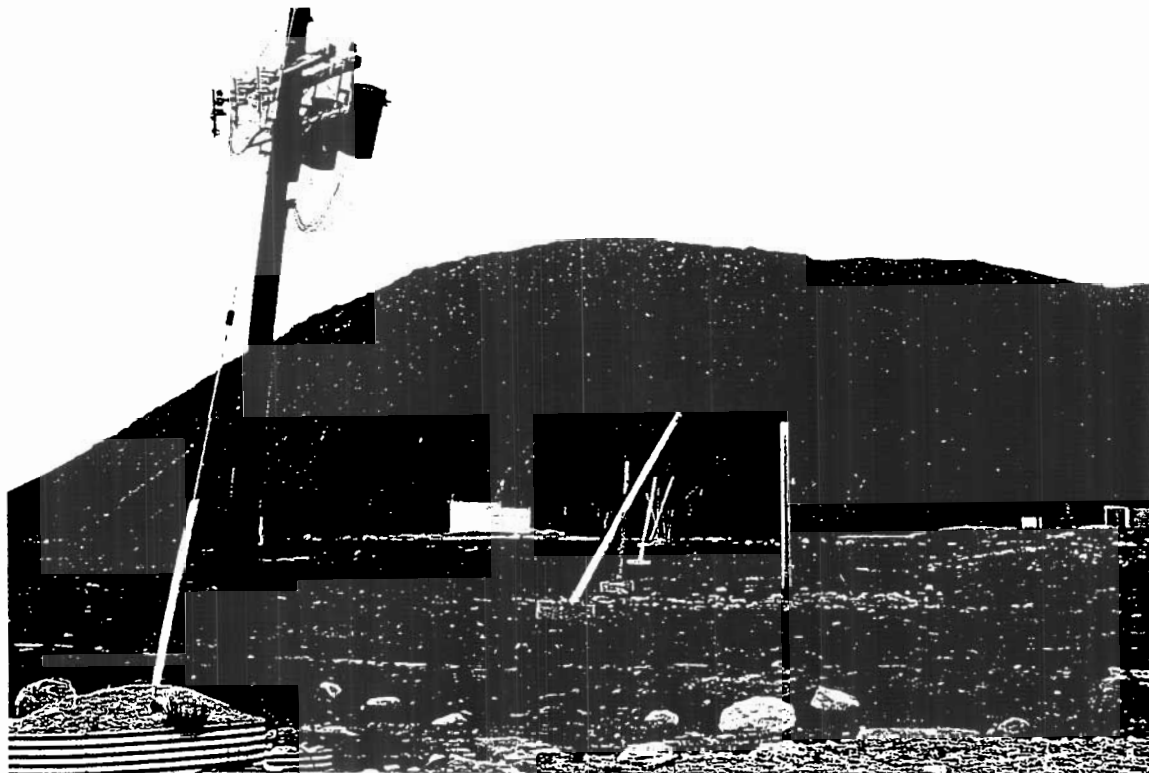
16. View of power line and poles to be dismantled
