# FOX-5 DEW Line Site

## **Pre-construction Delineation Phase:**

NTI Technical Representative Report to NTI

**August, 1998**

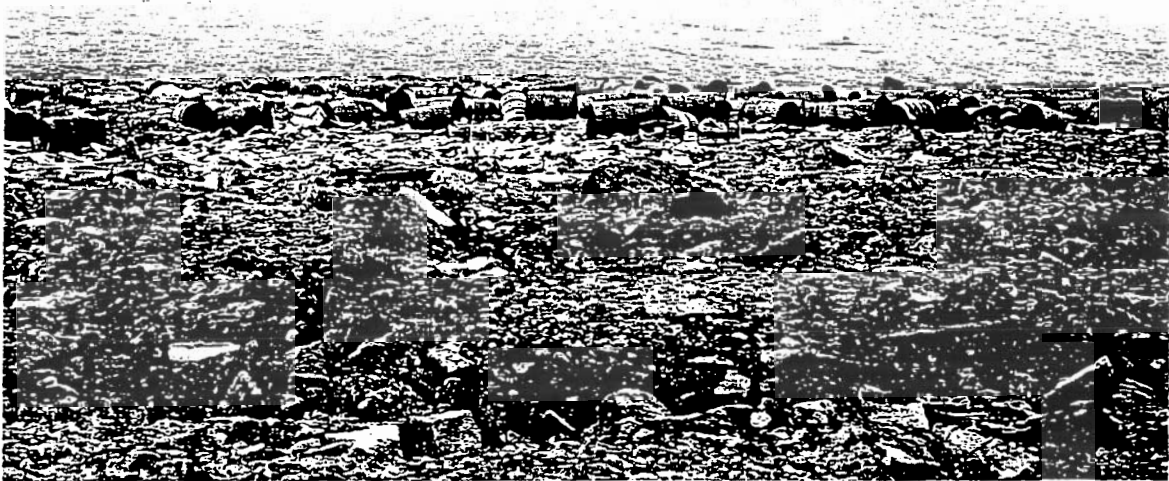
5. Undocumented barrel dump area down-gradient of the MOGAS Tank

4. The locals report that the landfill is eroding, exposing more debris every year.
5. The horizontal POL tanks were used as a refilling station.
6. A barrel dump is located half way between the horizontal POL tanks and the landfill. There are approximately 50 drums in this area that have not been noted on the cleanup specs to date. ESG was informed of the debris.

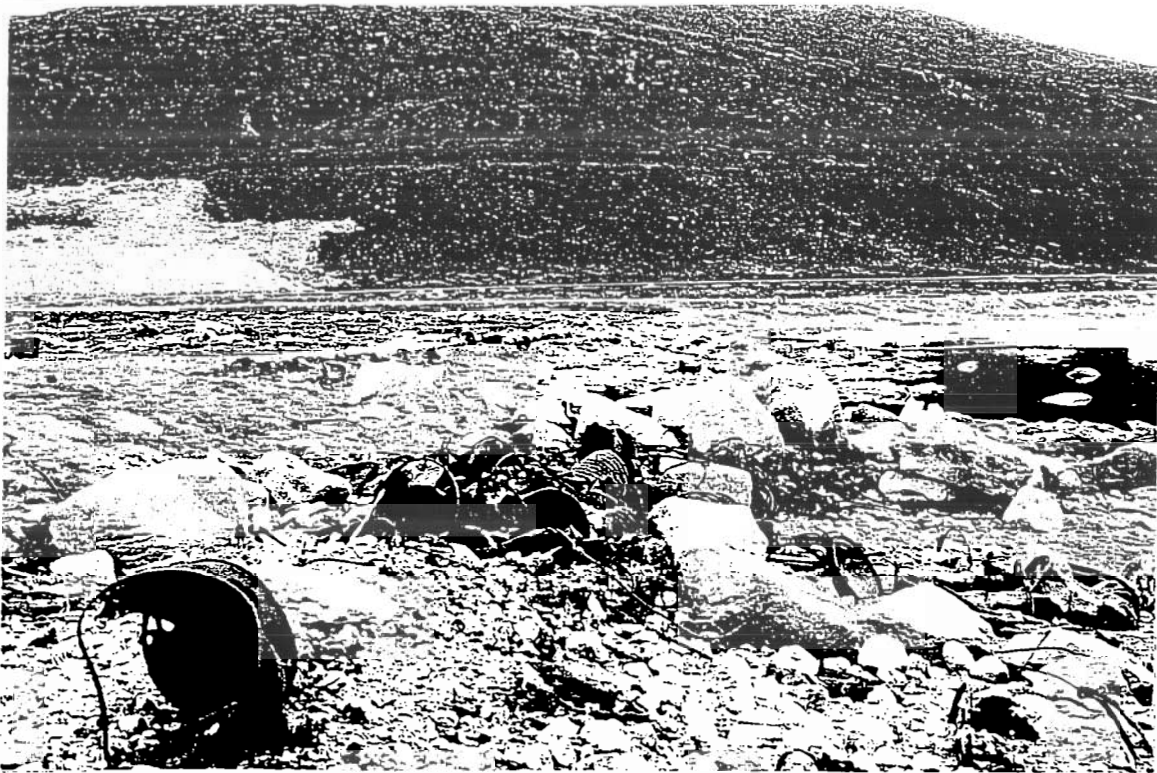
11. View of beach landfill.

7. The airstrip landfill is in a very unstable location and is currently leaching contaminants.

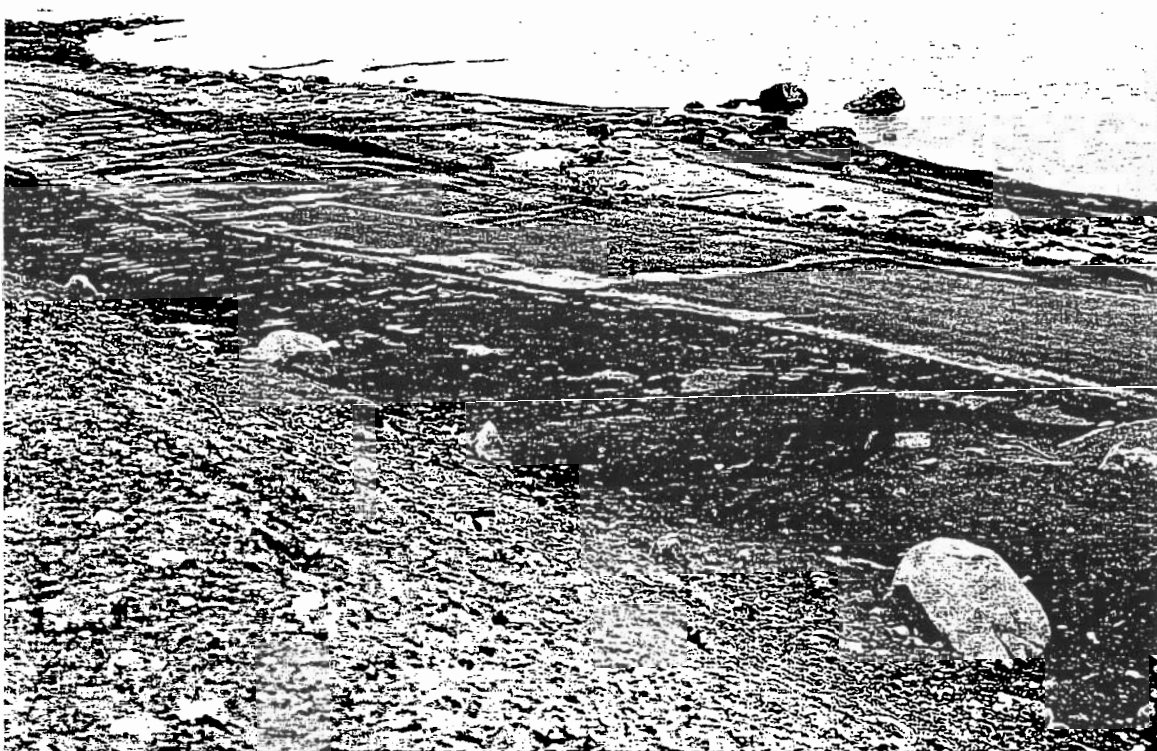
14. Contamination at toe of the berm and proximity to Broughton Channel

6. The beach POL station appears extensively stained. Test results were not available during the site visit. If results of the study show that the soil is in fact contaminated it is recommended that the soil from the berm be relocated away from Broughton Channel.

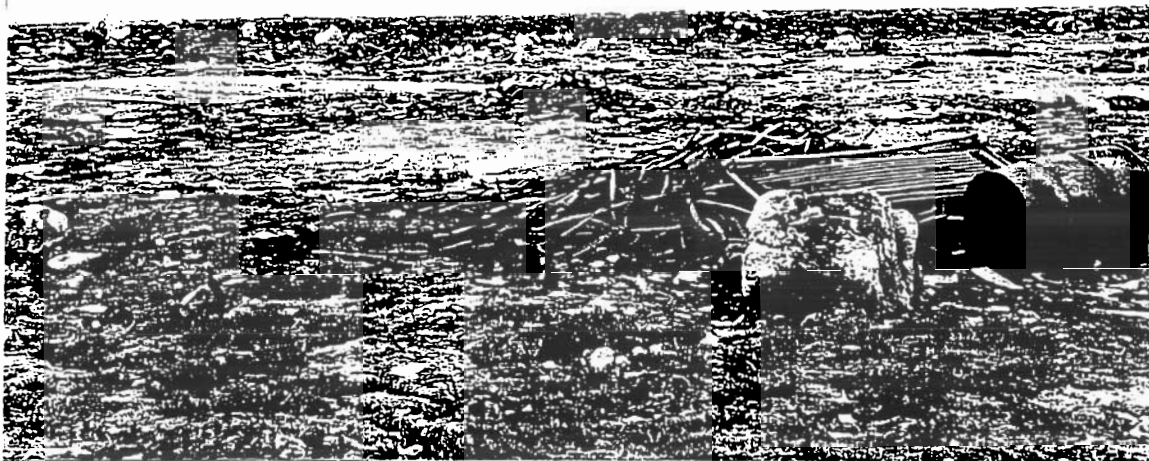
15. View of Old camp located near the current Hamlet landfill.

2. The old camp located near the current Hamlet landfill is a concern because it had not been documented in past DND assessments. The debris is extensive and includes at least 100 drums that are exposed or partially buried. ESG agreed to thoroughly investigate the area prior to leaving the site.
