**Nunavut Baffin Region
2014 DEW Line Landfill Monitoring Program
FOX-5 Broughton Island
Final Monitoring Report**

**RE: Final Monitoring Report
Baffin Region Nunavut DEW LINE Landfill Monitoring Program
Fox-5 Broughton Island, NU
DND Project #: DLCLFMP2 (QIKIQ14)**

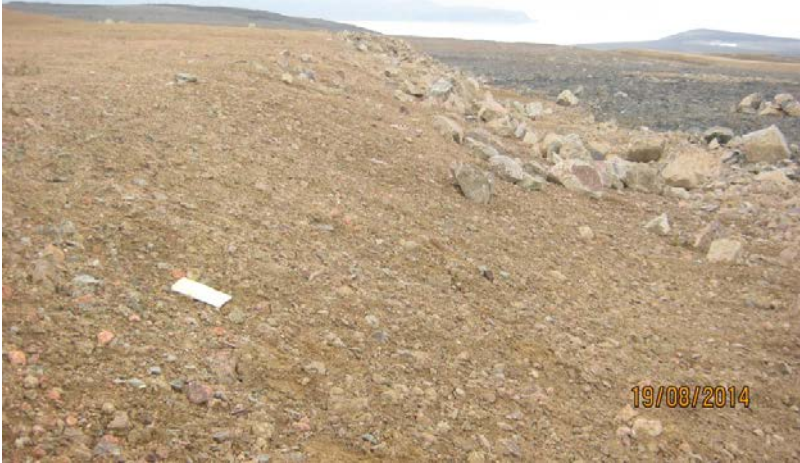
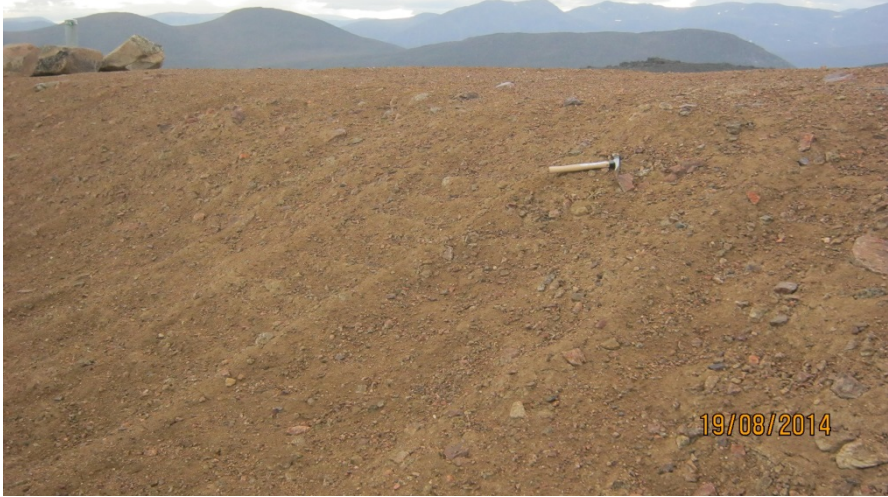
Photo 1 (FOX-5 MID P-1.jpg)	Photo 2 (FOX-5 MID P-2.jpg)
Description: View looking northwest along northeastern slope of landfill. Minor settlement noted at field book location. (FEATURE J)	Description: View looking southwest along southeastern slope of landfill.

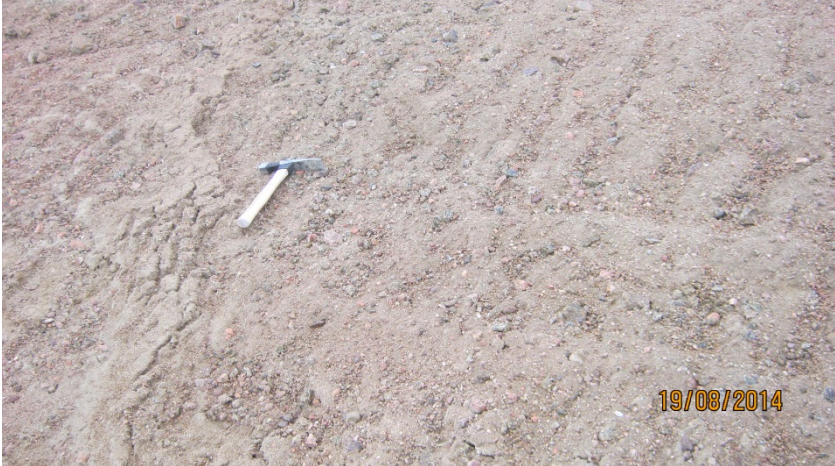
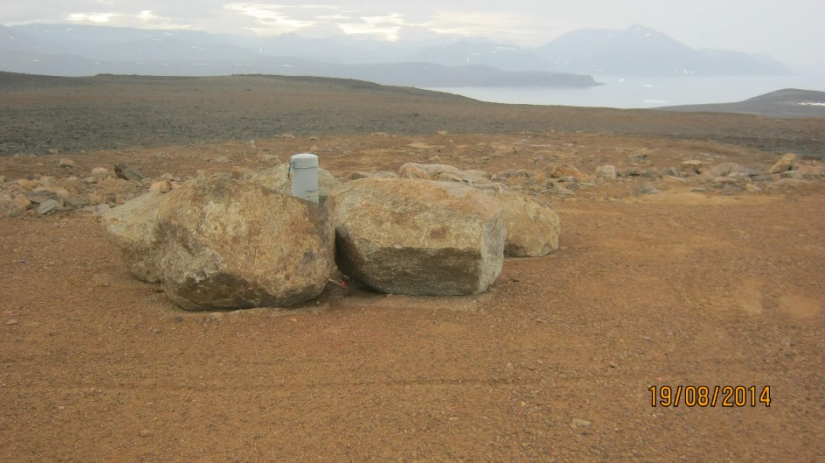
Photo 3 (FOX-5 MID P-3.jpg)	Photo 4 (FOX-5 MID P-4.jpg)
<p>Description: Settlement noted at top of southwestern landfill slope. View looking west partially downhill. (FEATURE N)</p>	<p>Description: View looking west toward VT-12.</p>

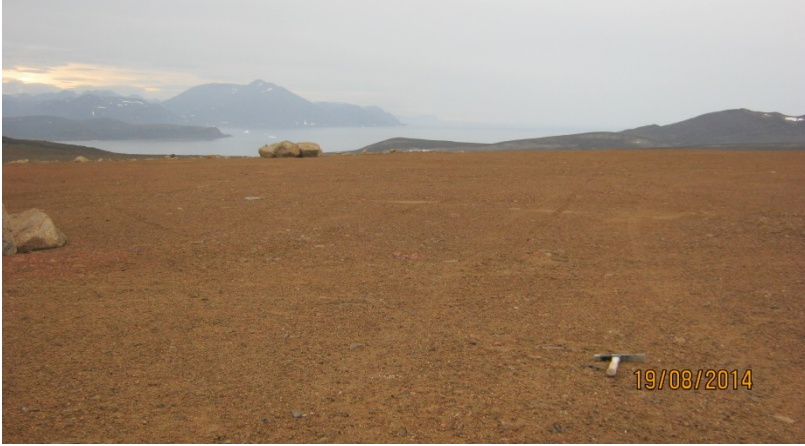
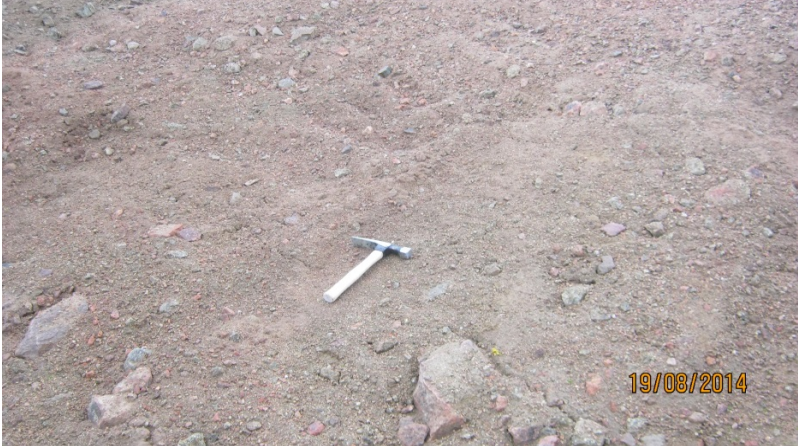
Photo 5 (FOX-5 MID P-5.jpg)	Photo 6 (FOX-5 MID P-6.jpg)
<p>Description: View looking northwest across cap of landfill. Evidence of previously ponded water on cap. VT-11 is adjacent to boulder seen on right hand side of photo. (FEATURE B)</p>	<p>Description: View looking southwest toward southeastern landfill slope. Erosion channel observed at geological hammer location. (FEATURE I)</p>

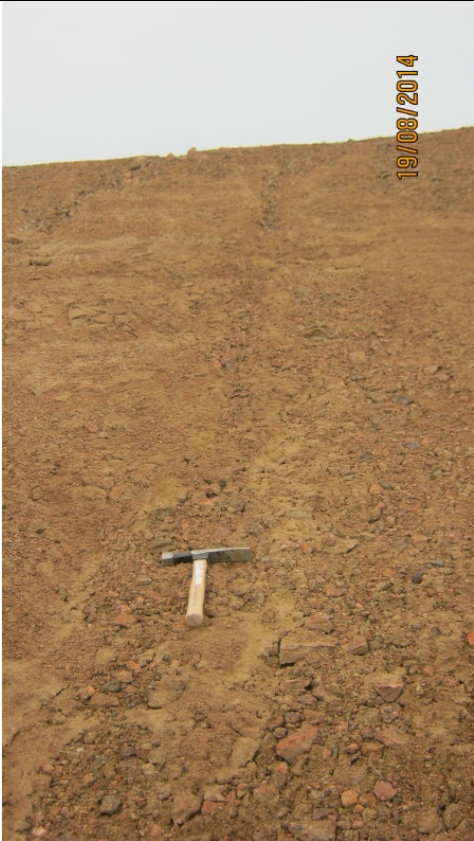
Photo 7 (FOX-5 MID P-7.jpg)	Photo 8 (FOX-5 MID P-8.jpg)
Description: Erosion channel on southwestern slope. View northeast from toe. Note second erosion channel can be seen top left of photo. (FEATURE C)	Description: View northeast looking over minor erosion channels. (FEATURE A)

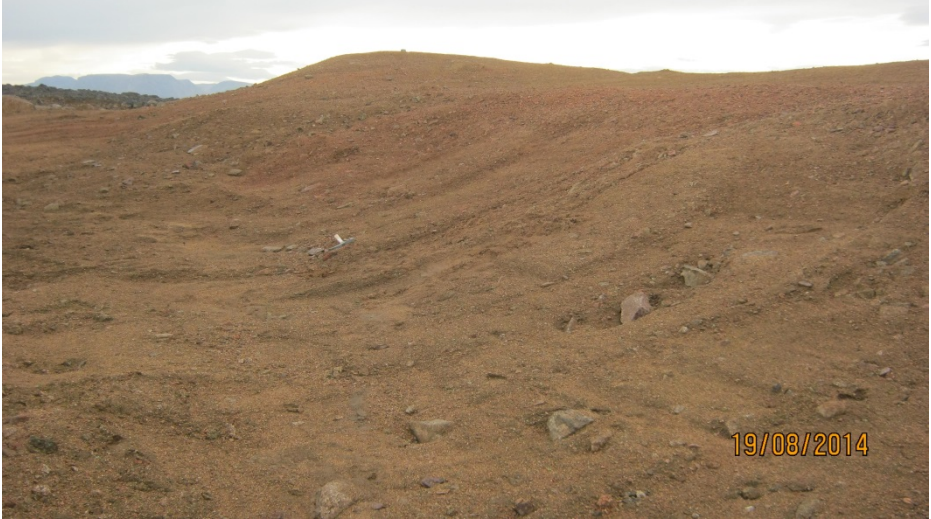
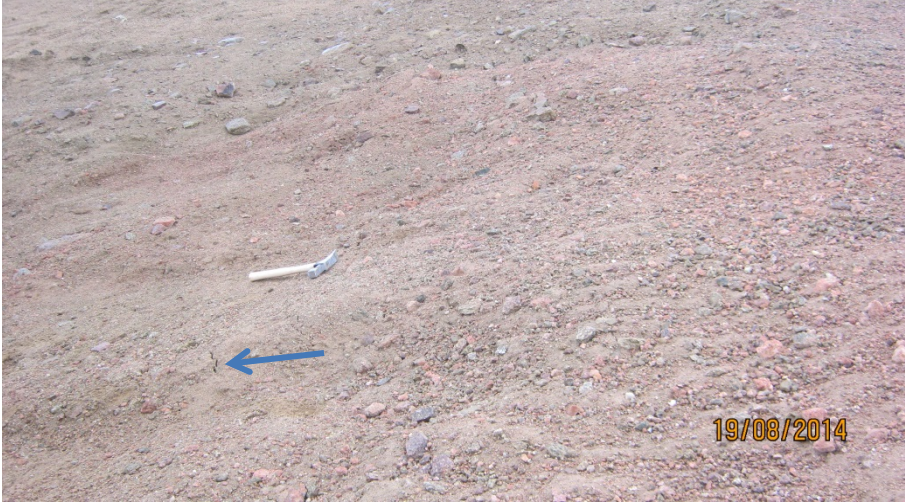
Photo 9 (FOX-5 MID P-9.jpg)	Photo 10 (FOX-5 MID P-10.jpg)
Description: View southwest along southeastern slope of landfill. Erosion channels and natural staining were observed. (FEATURE G, I)	Description: Small tension cracks observed at northern end of southeastern slope. Small crack visible below geological hammer. (FEATURE H)

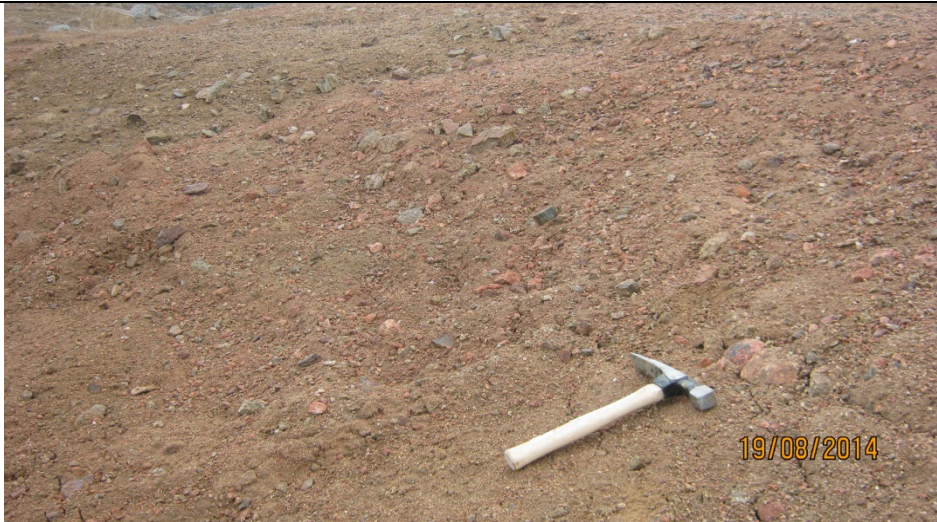
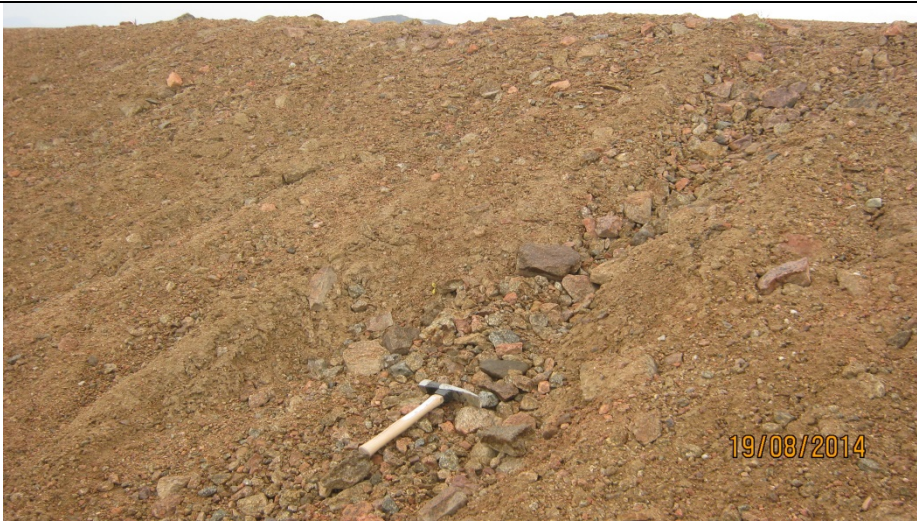
Photo 13 (FOX-5 MID P-13.jpg)	Photo 14 (FOX-5 MID P-14.jpg)
Description: View southwest along southeastern slope. Tension crack noted adjacent to geological hammer. (FEATURE H)	Description: Erosion channel on southwestern slope. (FEATURE C)

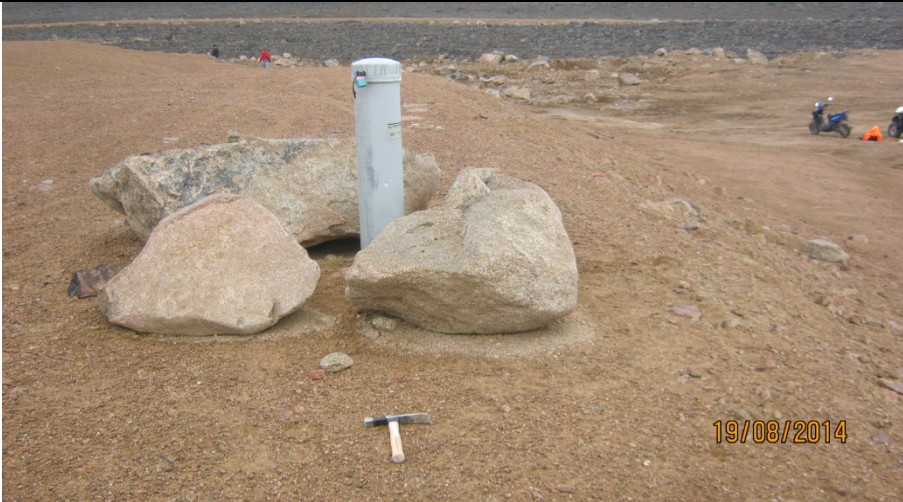
Photo 17 (FOX-5 MID P-17.jpg)	Photo 18 (FOX-5 MID P-18.jpg)
Description: View northeast toward VT-10.	Description: View north toward VT-11.

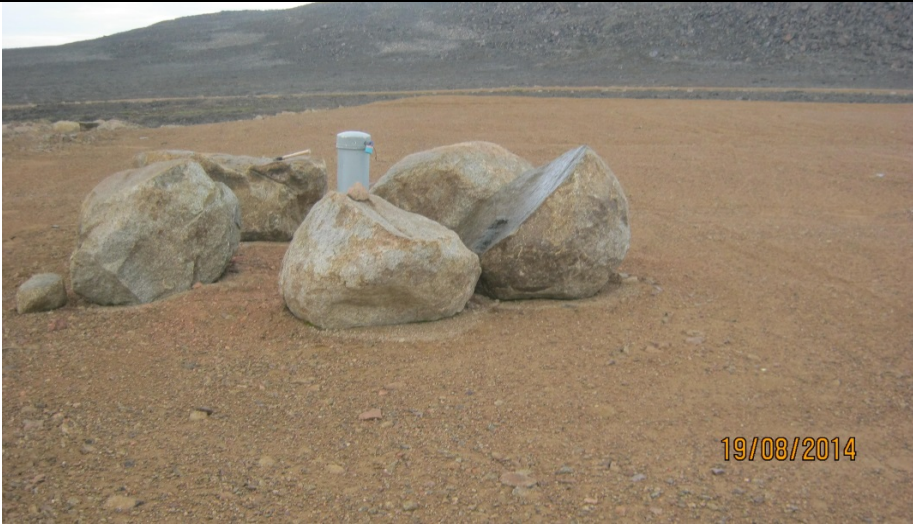
Photo 19 (FOX-5 MID P-19.jpg)	Photo 20 (FOX-5 MID P-20.jpg)
Description: View northeast toward VT-12.	Description: View of previously ponded water near southern corner of cap. (FEATURE B)

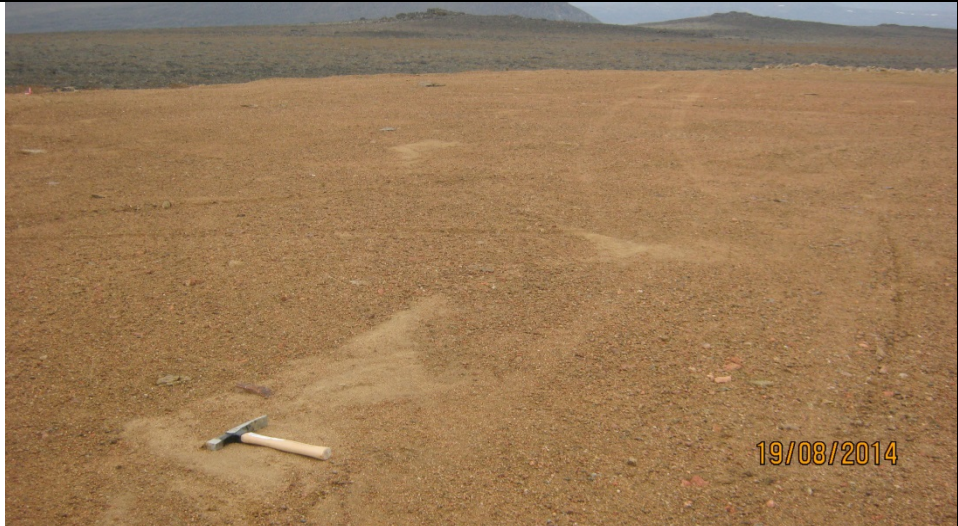
Other Features of Note	There are occasional low areas on the top of the landfill that have allowed ponding of water. These areas have a higher moisture content than the surrounding areas and have allowed the deposition of fine material within them. This fine material retains water making these spots softer.	Vehicle tracks and areas of previously ponded water were observed on the top of the landfill. (Feature B, D)	Areas of previously ponded water on top of the landfill were noted during the previous and current monitoring events. Vehicle tracks were noted on top of the landfill during the current monitoring event but not the previous event.

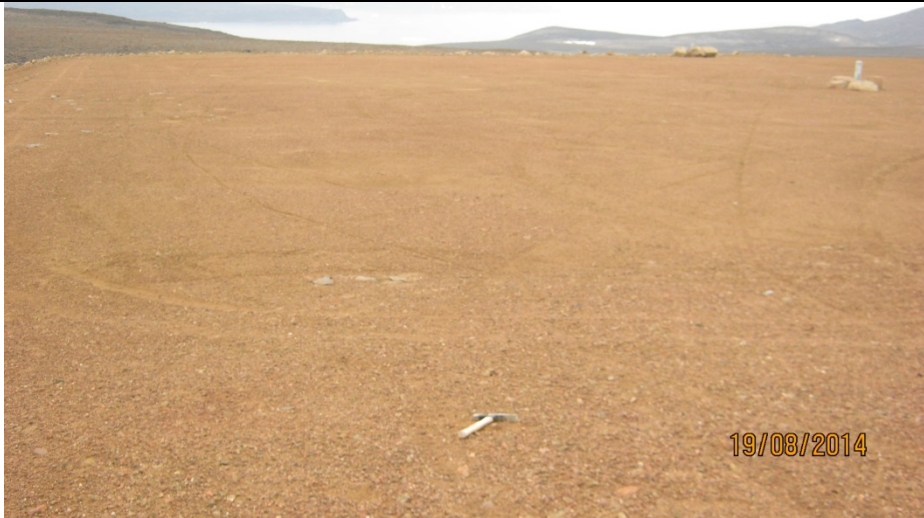
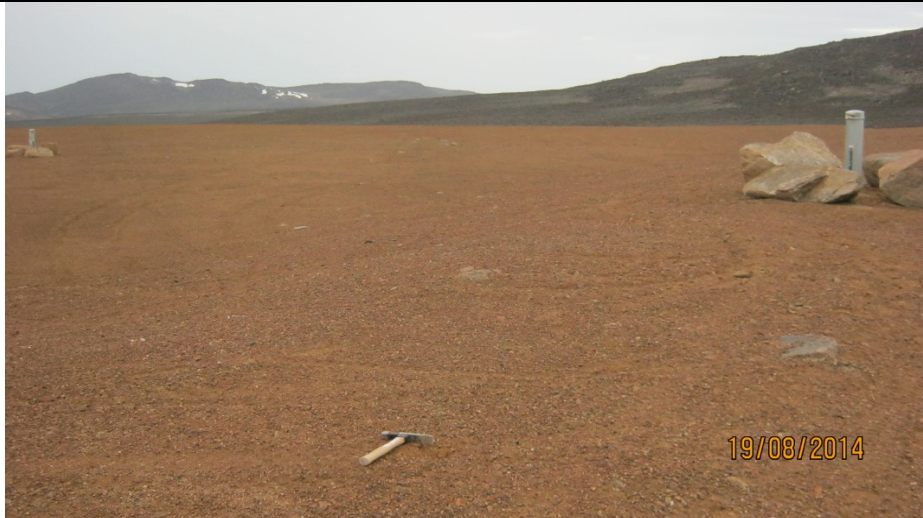
Photo 21 (FOX-5 MID P-21.jpg)	Photo 22 (FOX-5 MID P-22.jpg)
Description: View northwest across landfill cap. Vehicle tracks and ruts observed. (FEATURE D)	Description: View northeast toward VT-9 from southern corner of landfill cap. VT-11 seen in distance. Vehicle and ATV tracks observed. (FEATURE D)

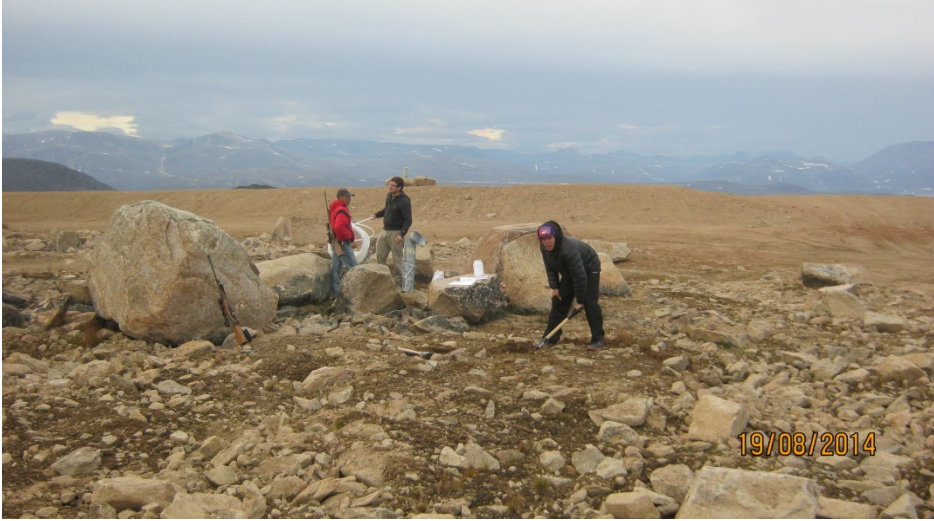
Photo 23 (FOX-5 MID P-23.jpg)	Photo 24 (FOX-5 MID P-24.jpg)
Description: View west toward MW-5.	Description: Sample location F5-MID-MW-5.

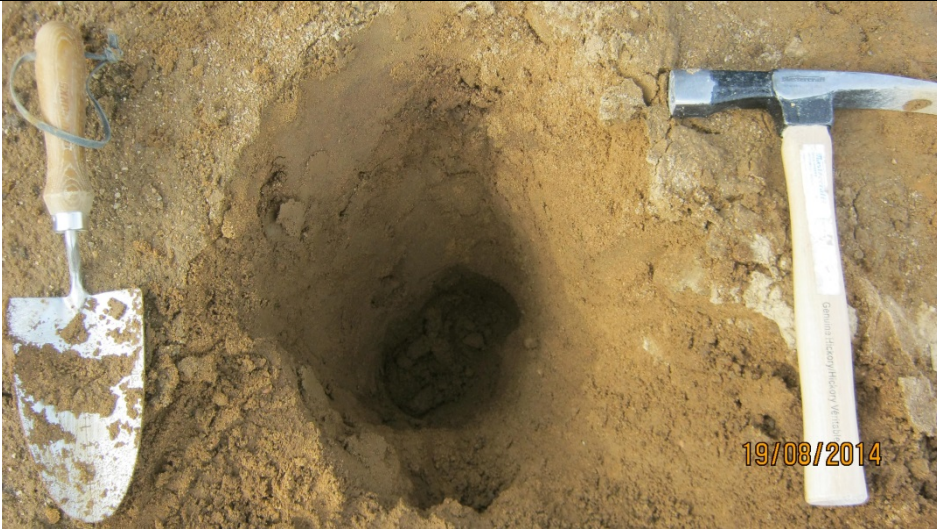
Photo 27 (FOX-5 MID P-27.jpg)	Photo 28 (FOX-5 MID P-28.jpg)
Description: F5-MID-MW-6 during sample collection.	Description: F5-MID-MW-6 after sample collection and backfill.

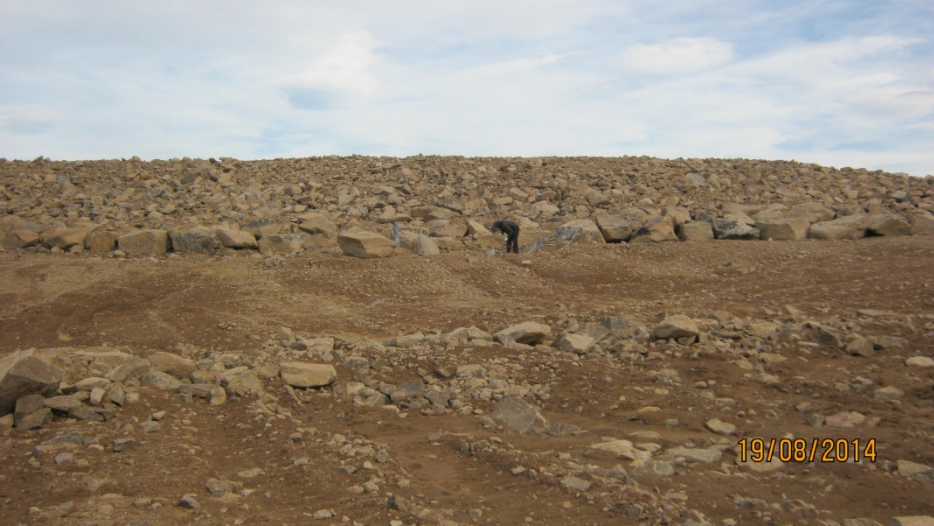
Photo 29 (FOX-5 MID P-29.jpg)	Photo 30 (FOX-5 MID P-30.jpg)
Description: View of northwestern landfill slope from MW-7.	Description: F5-MID-MW-7 during sample collection.

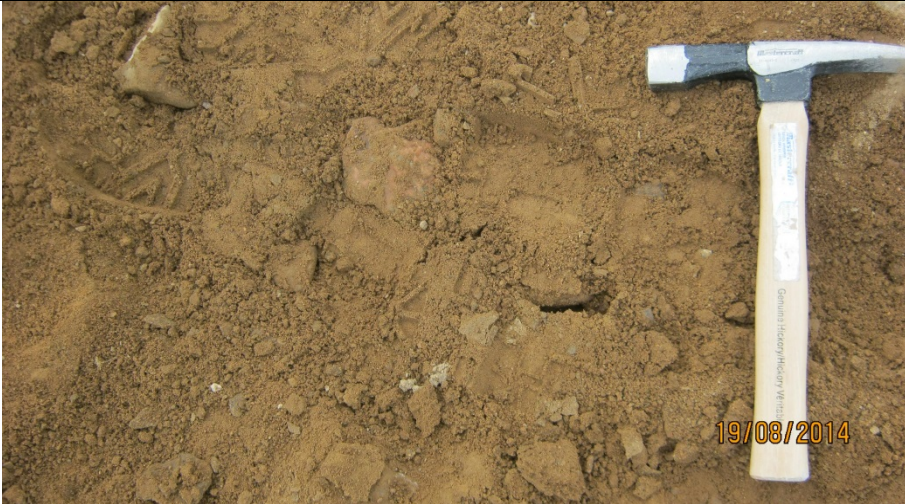
Photo 31 (FOX-5 MID P-31.jpg)	Photo 32 (FOX-5 MID P-32.jpg)
Description: F5-MID-MW-7 after sample collection and backfill.	Description: View south toward MW-8.

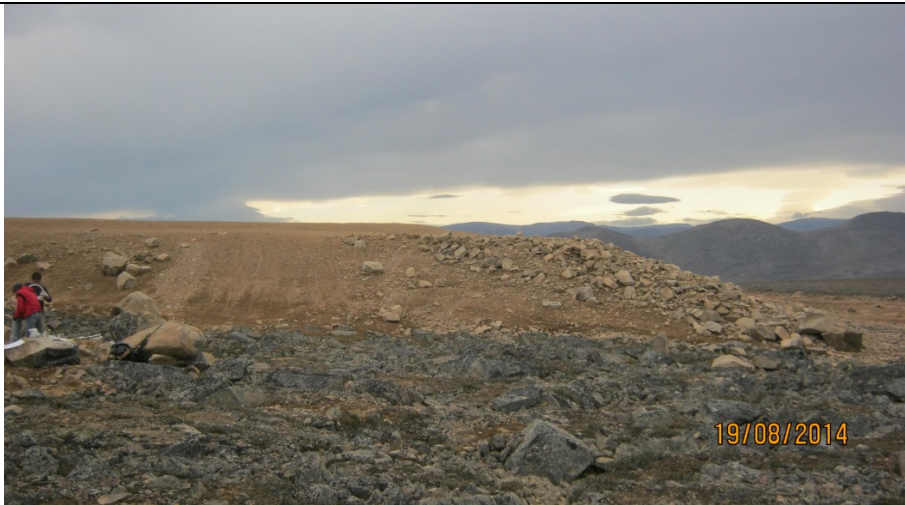
Photo 35 (FOX-5 MID P-35.jpg)	Photo 36 (FOX-5 MID P-36.jpg)
Description: View southeast toward MW-9 and northern corner of landfill.	Description: F5-MID-MW-9 during sample collection.

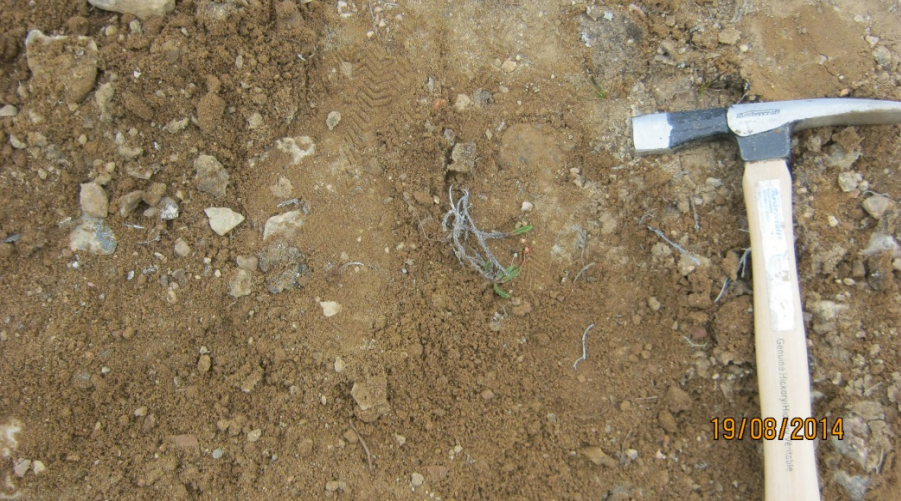
Photo 37 (FOX-5 MID P-37.jpg)	
Description: F5-MID-MID-MW-9 after sample collection and backfill.

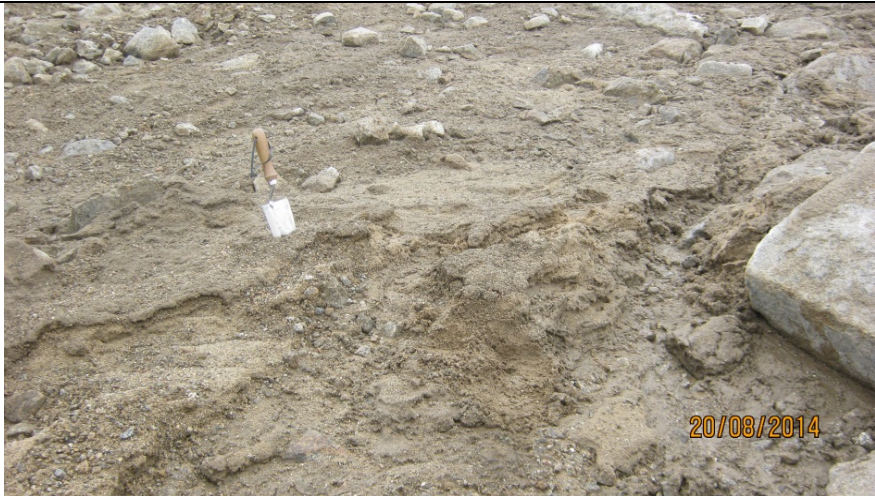
Photo 1 (FOX-5 MN P-1.jpg)	Photo 2 (FOX-5 MN P-2.jpg)
Description: Erosion channel on eastern side of cap, north of MW-14.	Description: Erosion channel on eastern side of cap, south of MW-14. (FEATURE D)

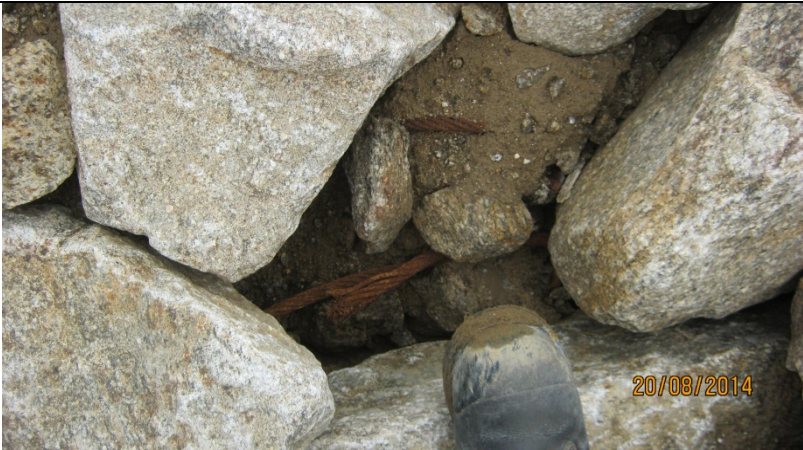
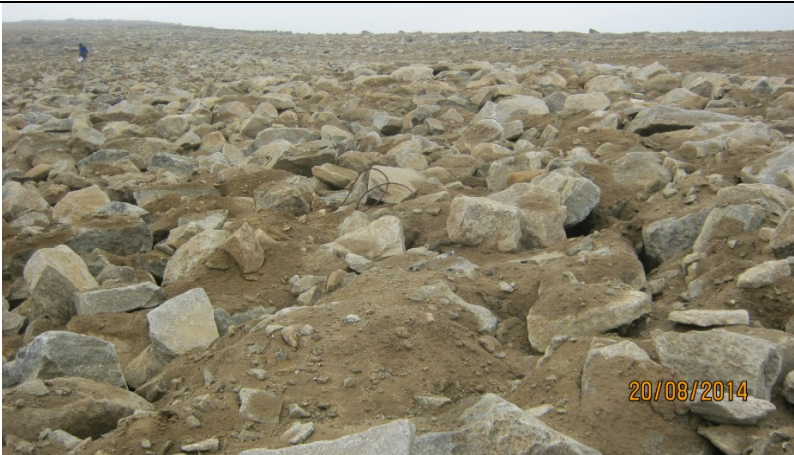
Photo 5 (FOX-5 MN P-5.jpg)	Photo 6 (FOX-5 MN P-6.jpg)
Description: Exposed debris observed near VT-2. (FEATURE C)	Description: View north toward exposed debris (metal wires) from southwest of VT-6. (FEATURE I)

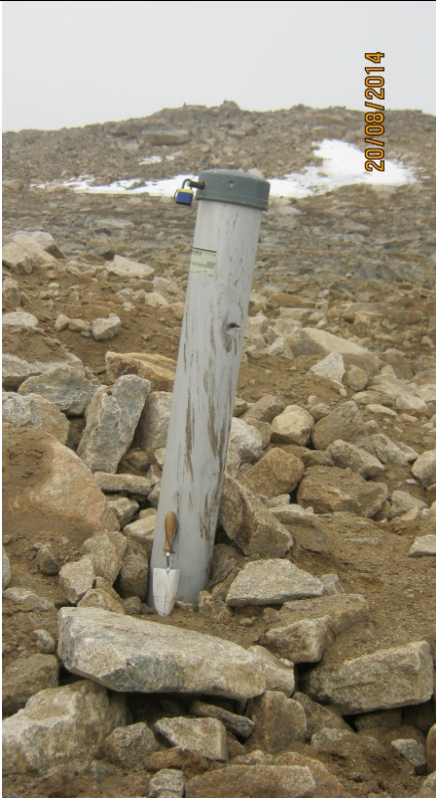
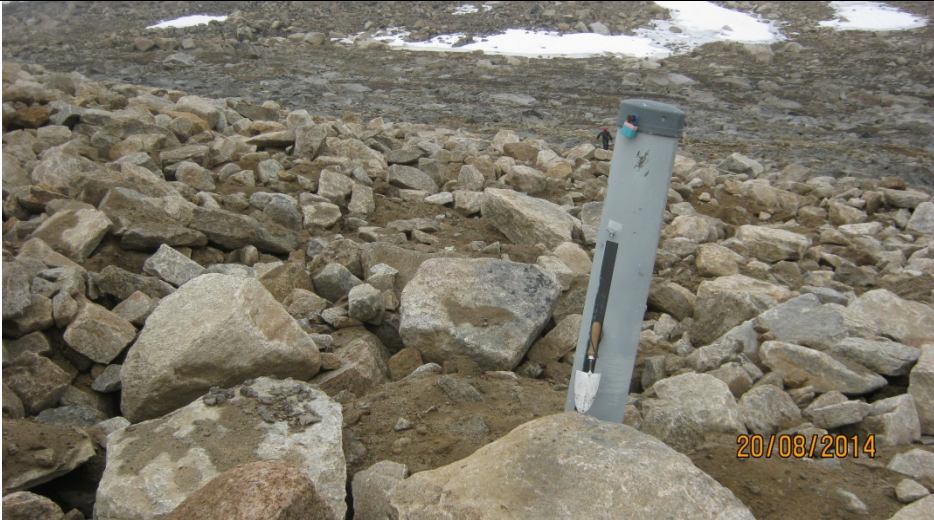
Photo 7 (FOX-5 MN P-7.jpg)	Photo 8 (FOX-5 MN P-8.jpg)
Description: View northwest of VT-1. VT-1 observed to be slightly slanted. (FEATURE A)	Description: View northwest of VT-2. VT-2 observed to be slightly slanted. (FEATURE A)

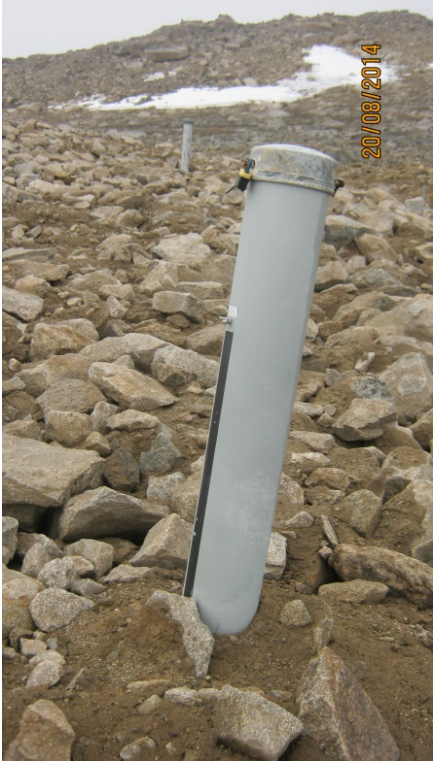
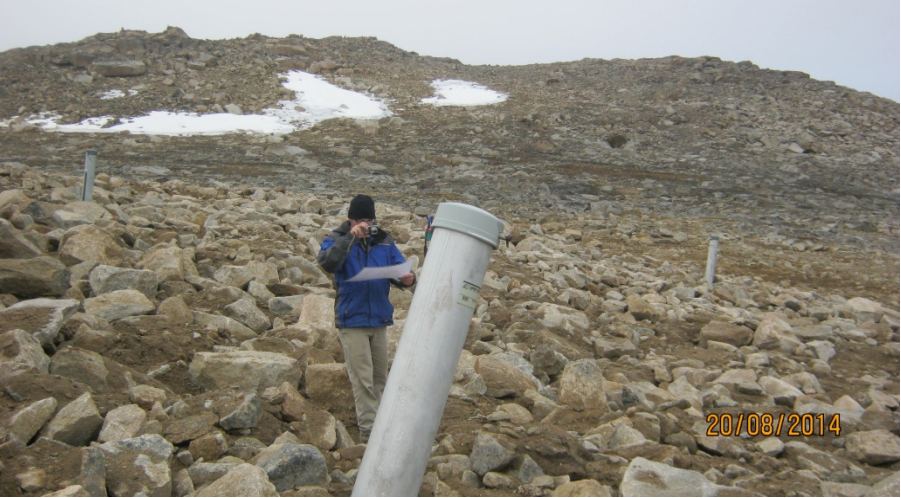
Photo 9 (FOX-5 MN P-9.jpg)	Photo 10 (FOX-5 MN P-10.jpg)
<p>Description: View northwest of VT-3. VT-3 observed to be slightly slanted. (FEATURE A)</p>	<p>Description: View northwest of VT-4. VT-4 observed to be very slanted. (FEATURE A)</p>

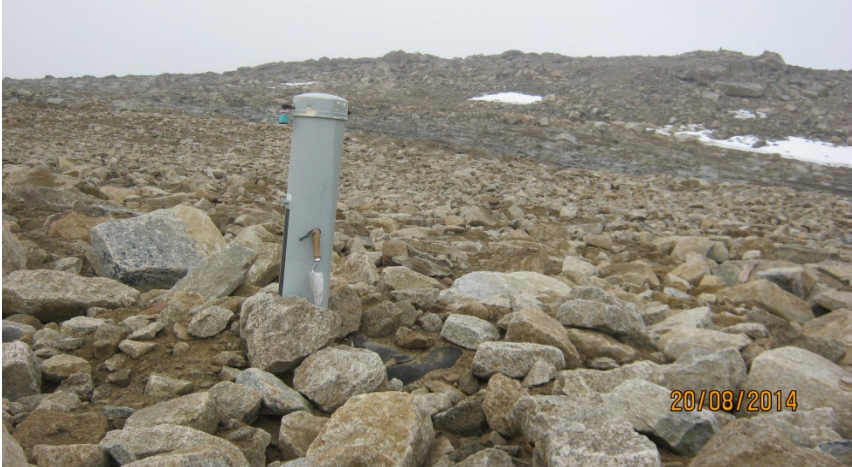
Photo 11 (FOX-5 MN P-11.jpg)	Photo 12 (FOX-5 MN P-12.jpg)
Description: View northwest toward VT-5.	Description: View north toward VT-6.

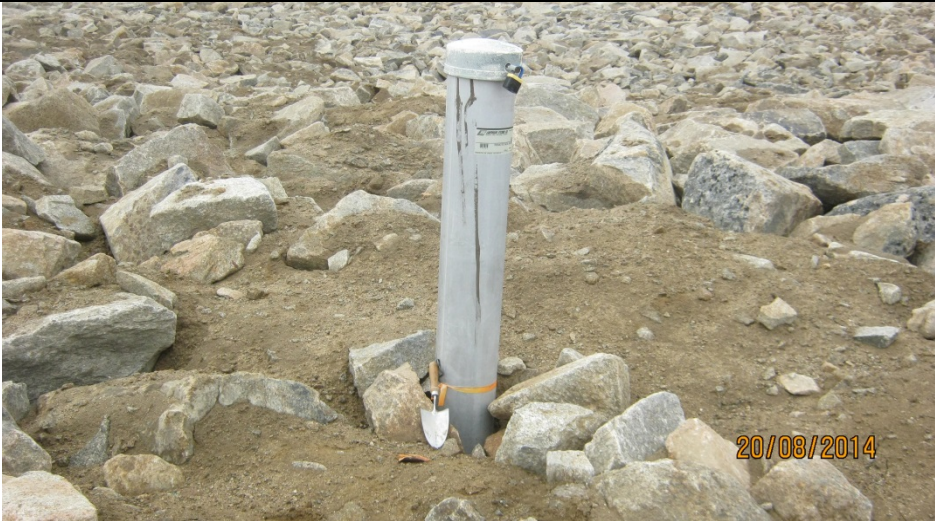
Photo 13 (FOX-5 MN P-13.jpg)	Photo 14 (FOX-5 MN P-14.jpg)
Description: View west toward VT-7.	Description: View of VT-8.

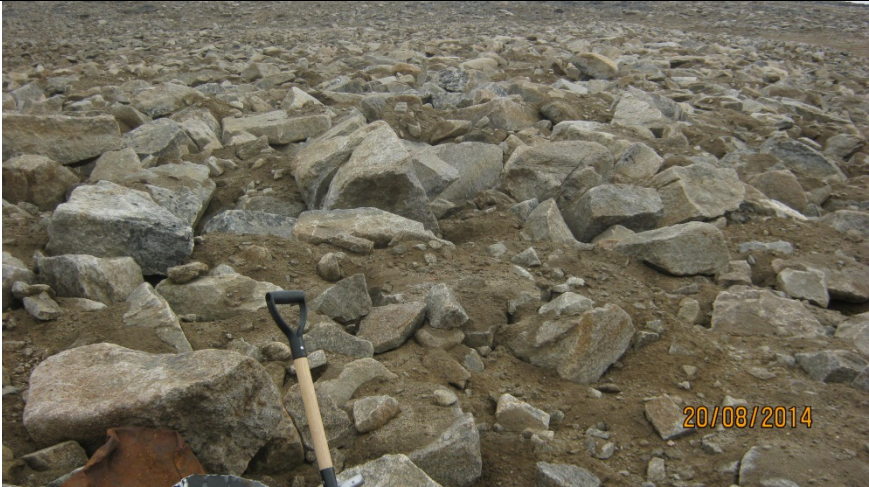
Photo 15 (FOX-5 MN P-15.jpg)	Photo 16 (FOX-5 MN P-16.jpg)
Description: View east across landfill. Exposed debris (corrugated metal) in foreground. (FEATURE J)	Description: View east, downslope, away from the landfill.

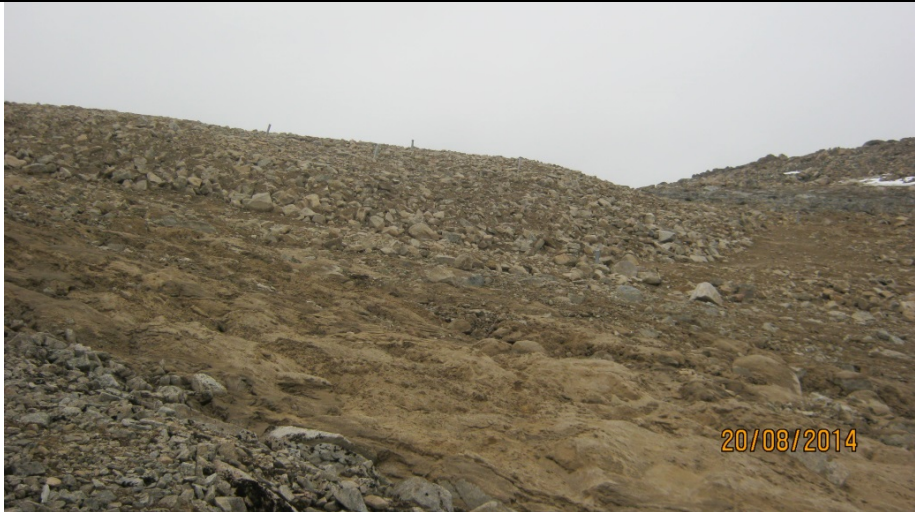
Photo 17 (FOX-5 MN P-17.jpg)	Photo 18 (FOX-5 MN P-18.jpg)
Description: View west over erosion channel, toward northern end of landfill. (FEATURE D)	Description: View south toward northern end of landfill. (FEATURE H)

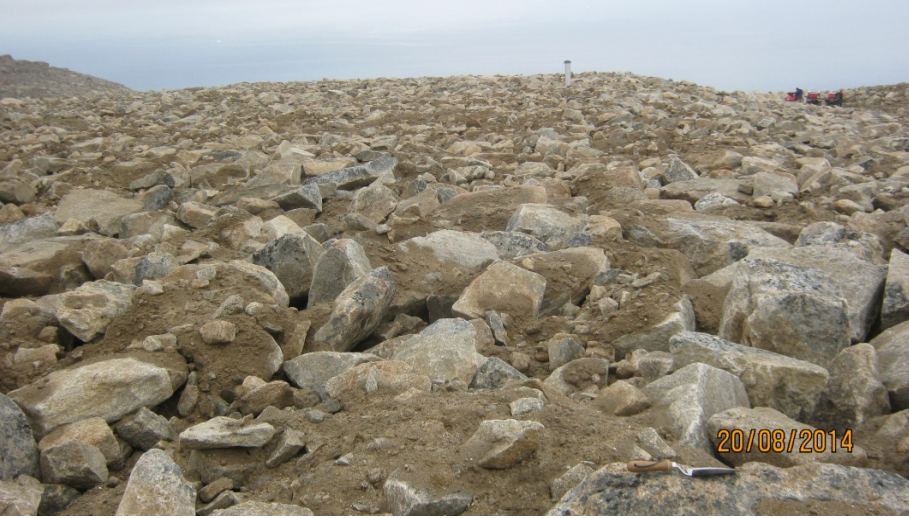
Photo 19 (FOX-5 MN P-19.jpg)	Photo 20 (FOX-5 MN P-20.jpg)
Description: View northeast toward VT-8 from south end of landfill.	Description: View north from south end of landfill.

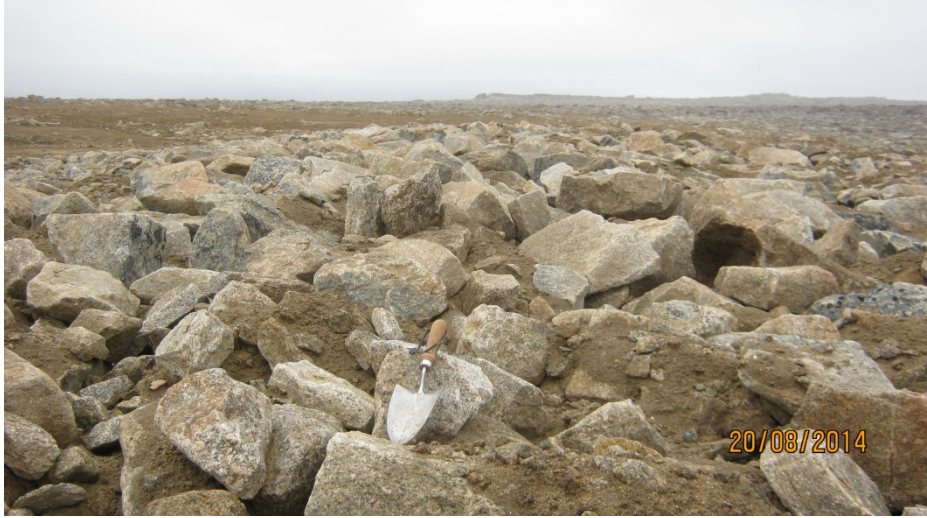
Photo 21 (FOX-5 MN P-21.jpg)	Photo 22 (FOX-5 MN P-22.jpg)
Description: View west from south end of landfill.	Description: View northeast of MW-10, looking toward south end of landfill.

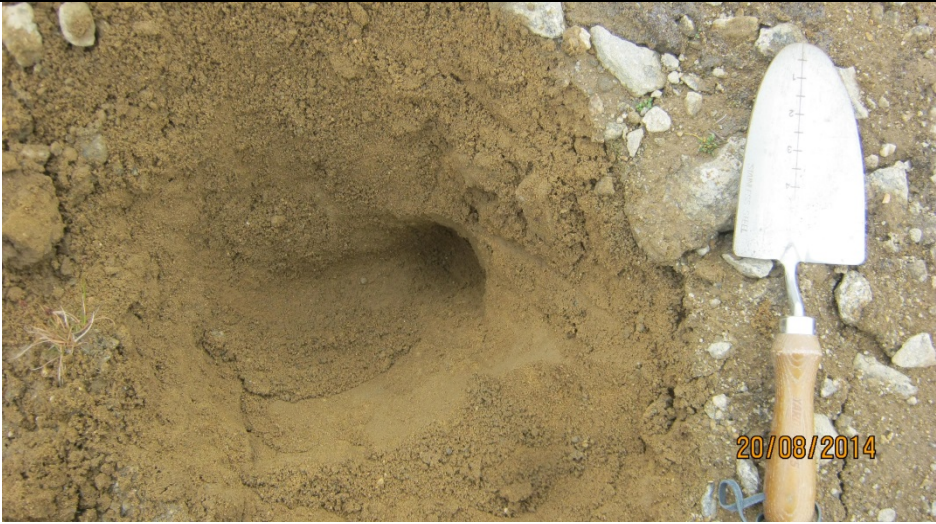
Photo 23 (FOX-5 MN P-23.jpg)	Photo 24 (FOX-5 MN P-24.jpg)
Description: F5-MN-MW-10 during sample collection.	Description: F5-MN-MW-10 after sample collection and backfill.

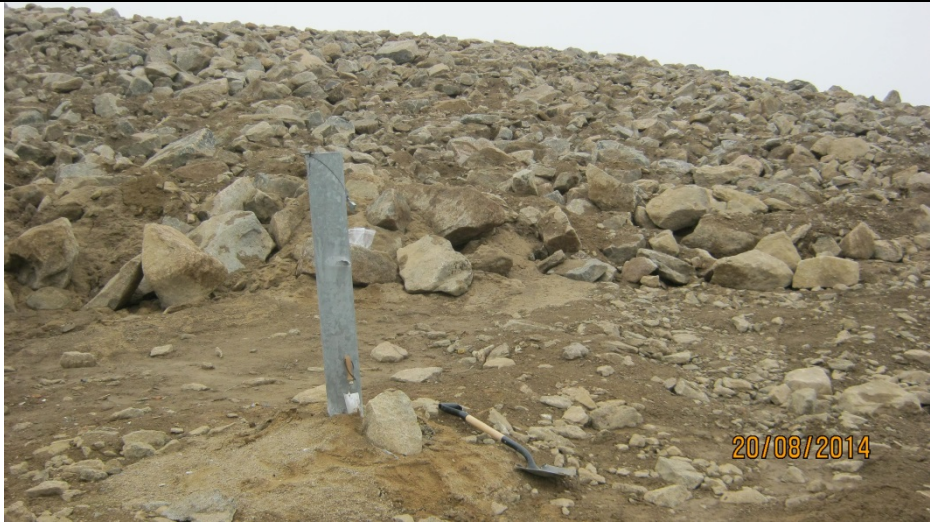
Photo 25 (FOX-5 MN P-25.jpg)	Photo 26 (FOX-5 MN P-26.jpg)
Description: View south toward MW-11 and north end of landfill.	Description: F5-MN-MW-11 during sample collection.

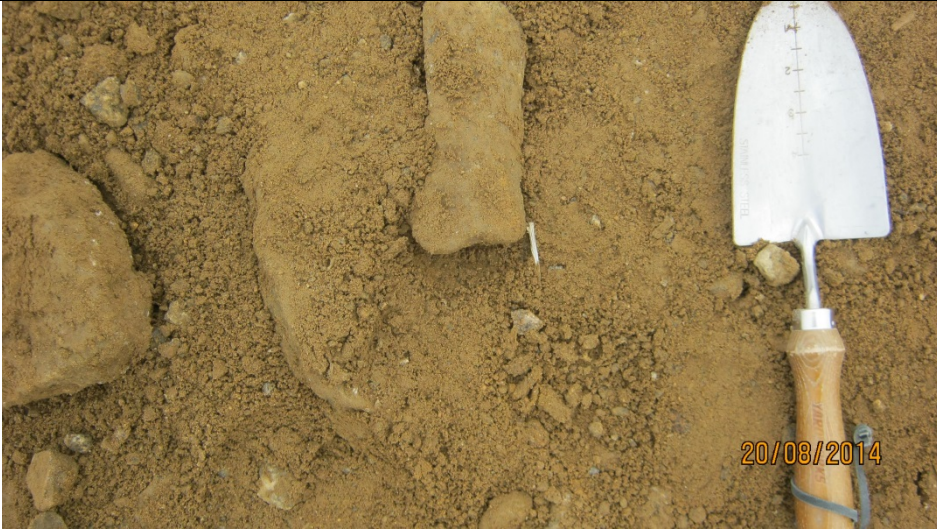
Photo 27 (FOX-5 MN P-27.jpg)	Photo 28 (FOX-5 MN P-28.jpg)
Description: F5-MN-MW-11 after sample collection and backfill.	Description: View southwest toward MW-12 and north end of landfill.

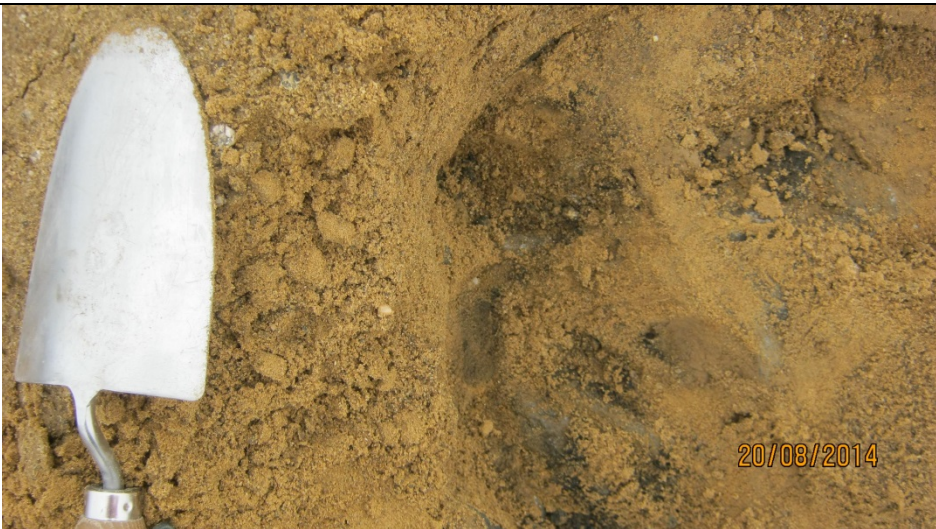
Photo 29 (FOX-5 MN P-29.jpg)	Photo 30 (FOX-5 MN P-30.jpg)
Description: F5-MN-MW-12 during sample collection.	Description: F5-MN-MW-12 after sample collection and backfill.

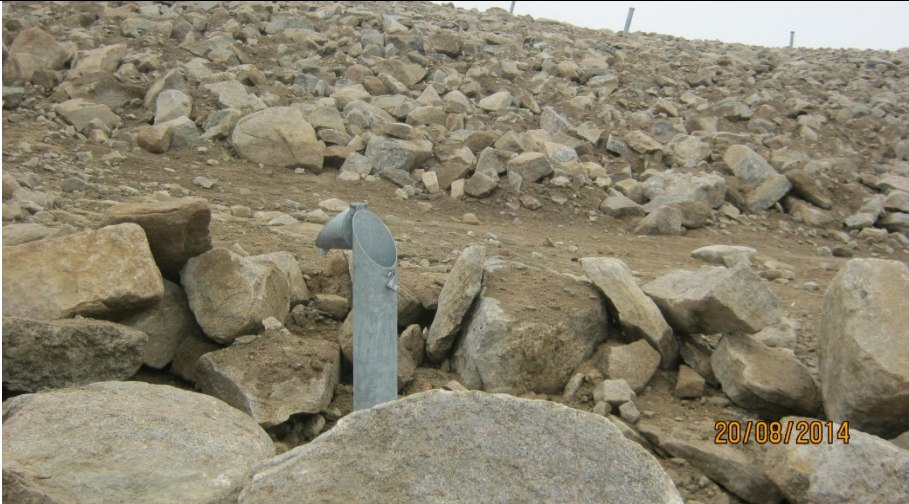
Photo 31 (FOX-5 MN P-31.jpg)	Photo 32 (FOX-5 MN P-32.jpg)
Description: View west toward MW-13 and north end of landfill. Vertical thermistors can be seen in distance.	Description: F5-MN-MW-13 during sample collection.

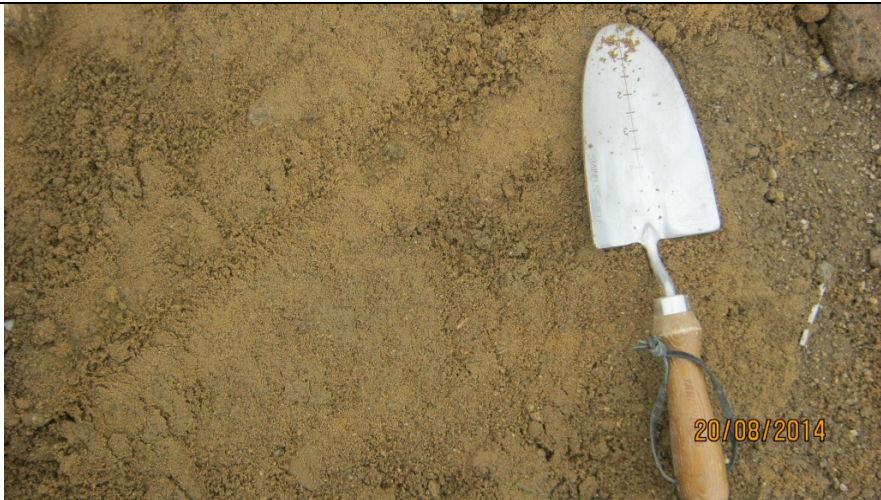
Photo 33 (FOX-5 MN P-33.jpg)	Photo 34 (FOX-5 MN P-34.jpg)
Description: F5-MN-MW-13 after sample collection and backfill.	Description: Exposed debris northeast of MW-13 included pieces of scrap wood. (FEATURE B)

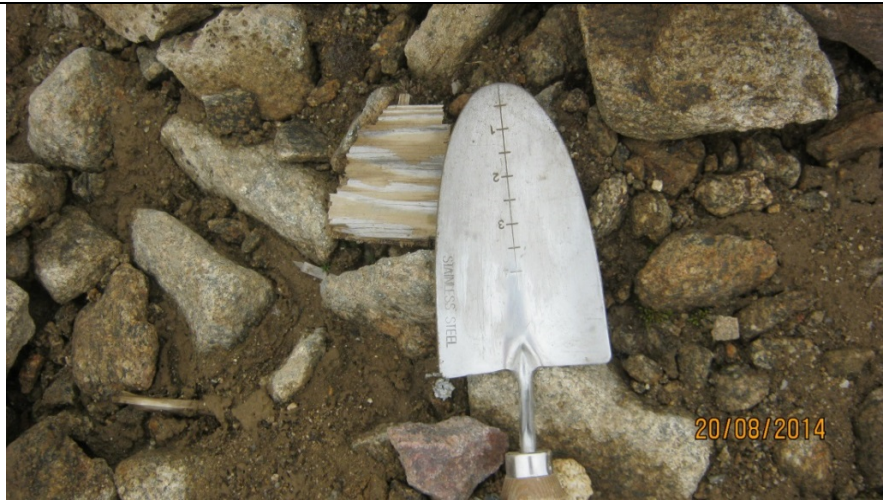
Animal Burrows	Evidence of burrowing animals was not observed.	None observed.	None observed at this landfill.
Vegetation	Indications of vegetation were not observed.	No vegetation was observed at this landfill.	None observed at this landfill.
Staining	Staining was not evident at the landfill.	None observed.	None observed at this landfill.
Vegetation Stress	Indications of vegetation were not observed.	No vegetation was observed at this landfill.	None observed at this landfill.
Seepage Points	Indications of seepage were not observed.	None observed.	None observed at this landfill.
Debris Exposed	Occasional small pieces of metal and wood, and pieces of metal cable or rebar were observed. It does not appear that the debris originated from the landfill.	Occasional small pieces of metal and wood debris were observed around the landfill and within the large boulders placed as cover. It does not appear that this debris originated from within the landfill. (Feature B, C, E, I)	Debris exposure has not originated within the landfill and is relatively minor.

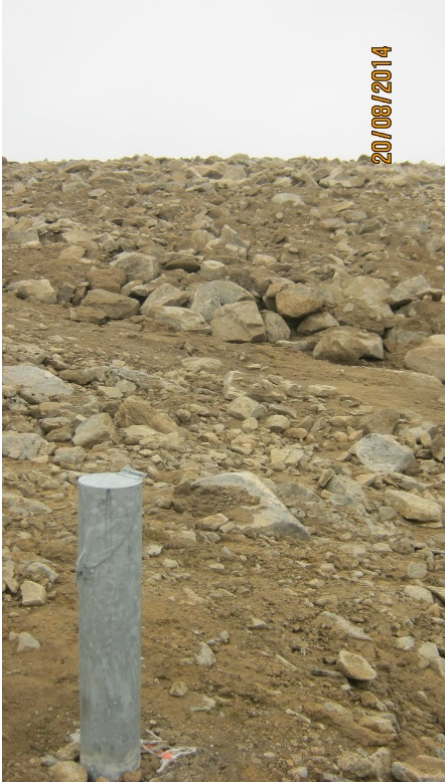
Photo 35 (FOX-5 MN P-35.jpg)	Photo 36 (FOX-5 MN P-36.jpg)
Description: View west toward MW-14 and landfill beyond erosion channel. (FEATURE D)	Description: F5-MN-MW-13 during sample collection.

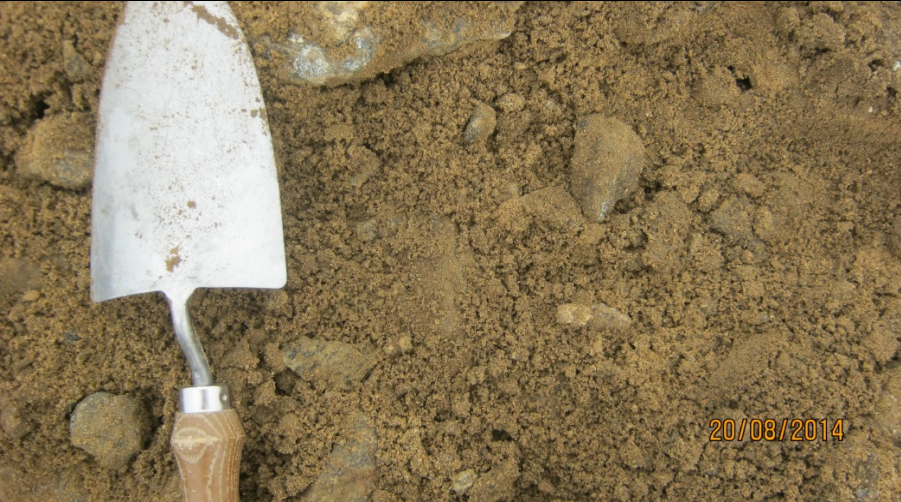
Photo 37 (FOX-5 MN P-37.jpg)	
Description: F5-MN-MW-13 after sample collection and backfill.

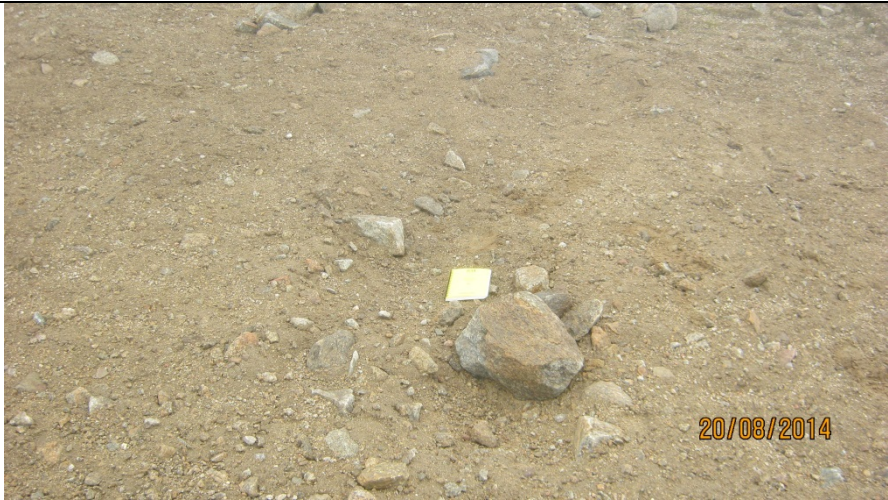
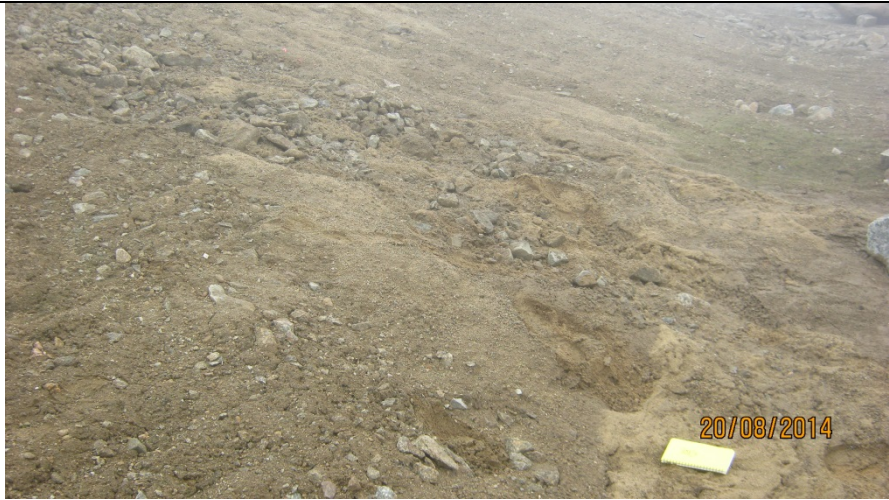
Photo 1 (FOX-5 SA P-1.jpg)	Photo 2 (FOX-5 SA P-2.jpg)
Description: View looking down slope at minor settlement. (FEATURE A)	Description: View looking southwest along toe of landfill. Minor settlement noted at toe. (FEATURE A)
