**Nunavut Baffin Region
2014 DEW Line Landfill Monitoring Program
FOX-5 Broughton Island
Final Monitoring Report**

**RE: Final Monitoring Report
Baffin Region Nunavut DEW LINE Landfill Monitoring Program
Fox-5 Broughton Island, NU
DND Project #: DLCLFMP2 (QIKIQ14)**

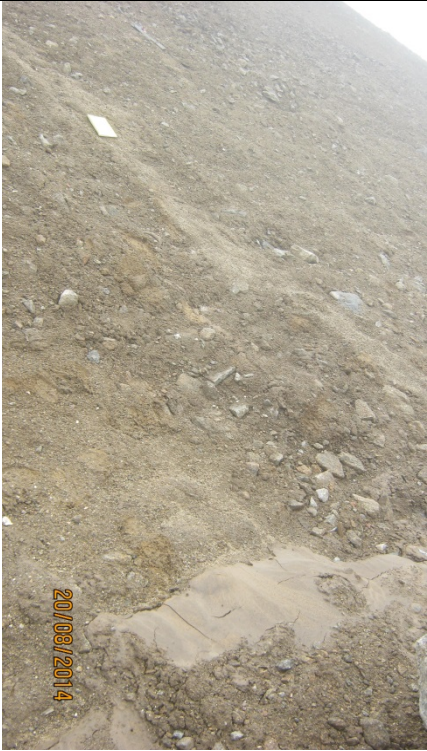
Photo 5 (FOX-5 SA P-5.jpg)	Photo 6 (FOX-5 SA P-6.jpg)
Description: View of erosion channel on northwest wall of landfill. (FEATURE P)	Description: View of minor amounts of debris on southwestern landfill wall. (FEATURE M)

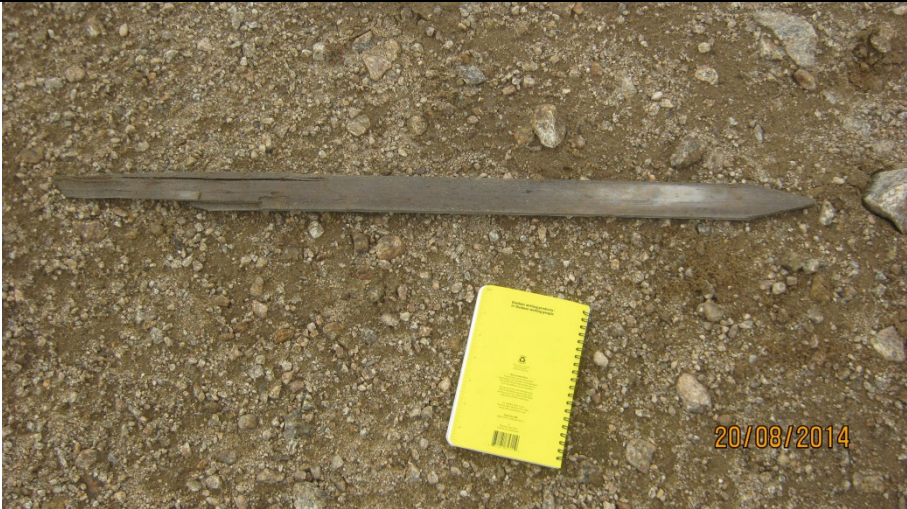
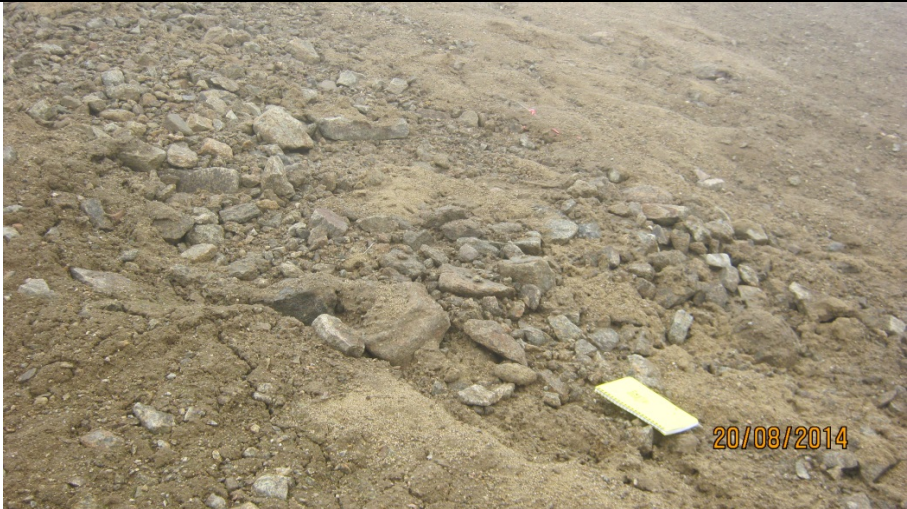
Photo 7 (FOX-5 SA P-7.jpg)	Photo 8 (FOX-5 SA P-8.jpg)
Description: An example of the minor debris on landfill cap.	Description: View southwest along landfill wall. Settlement observed. (FEATURE A)

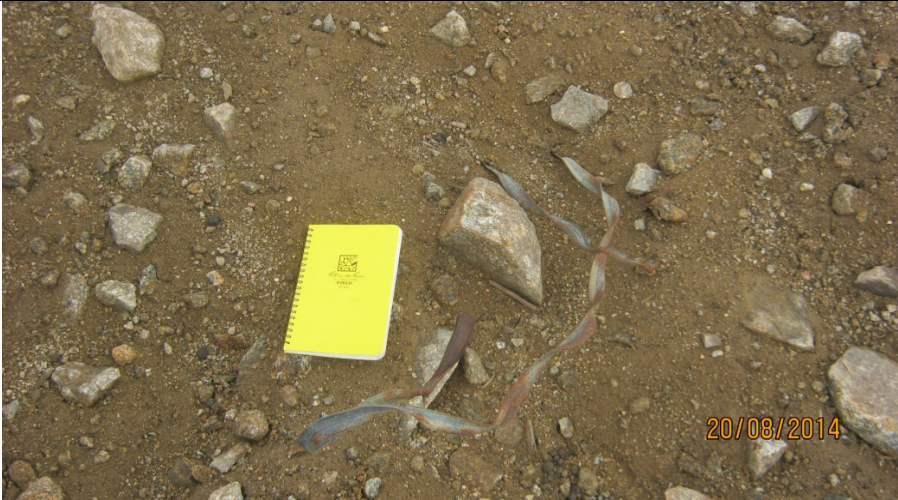
Photo 9 (FOX-5 SA P-9.jpg)	Photo 10 (FOX-5 SA P-10.jpg)
<p>Description: Exposed debris near southern corner of landfill. Debris included metal strapping. (FEATURE J)</p>	<p>Description: Debris adjacent to northeast wall of landfill. Concrete piece with rebar is seen in photo. (FEATURE C)</p>

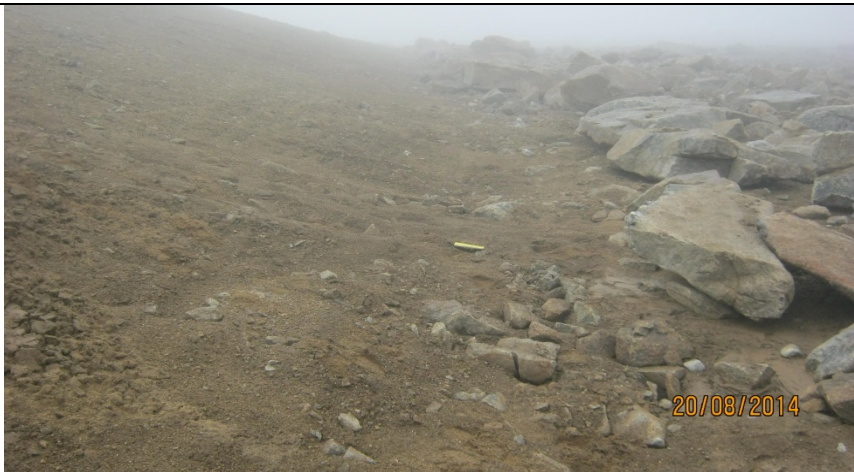
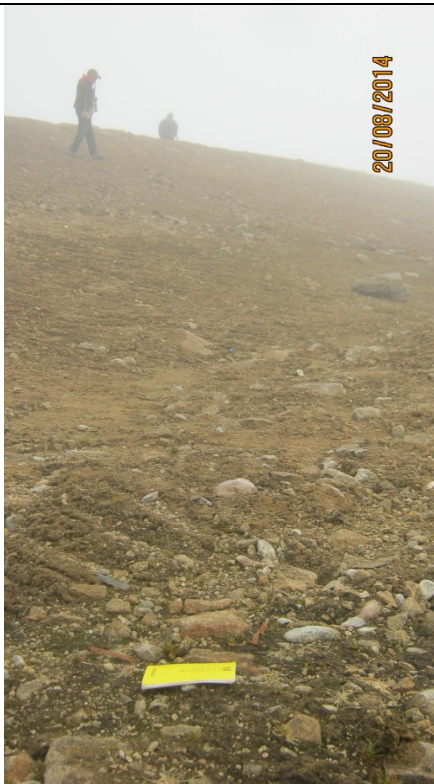
Photo 11 (FOX-5 SA P-11.jpg)	Photo 12 (FOX-5 SA P-12.jpg)
Description: View southwest along northwestern toe of landfill.	Description: View east toward western corner of landfill. Observed debris included metal strapping, seen adjacent to field book. (FEATURE N)

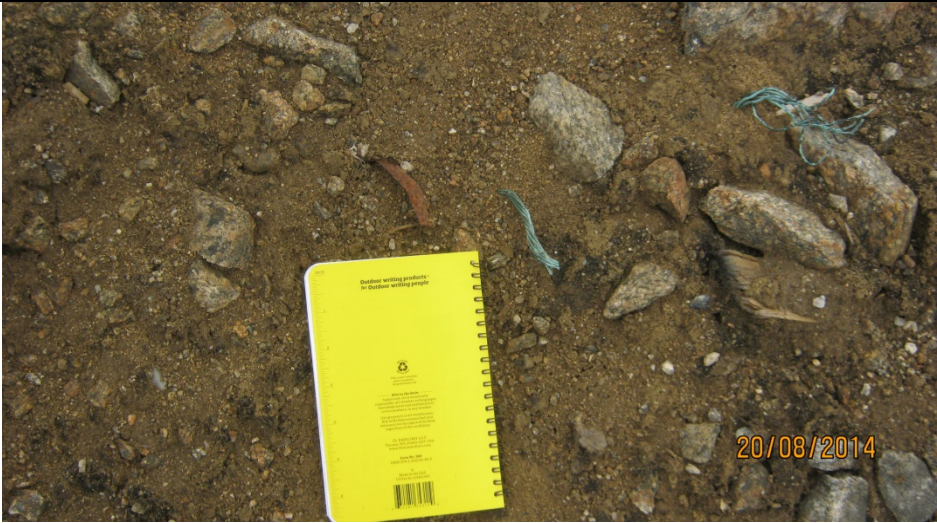
Photo 13 (FOX-5 SA P-13.jpg)	Photo 14 (FOX-5 SA P-14.jpg)
<p>Description: View of debris at eastern toe of landfill. Debris includes metal strapping and rope. (FEATURE N)</p>	<p>Description: View south along eastern edge of cap.</p>

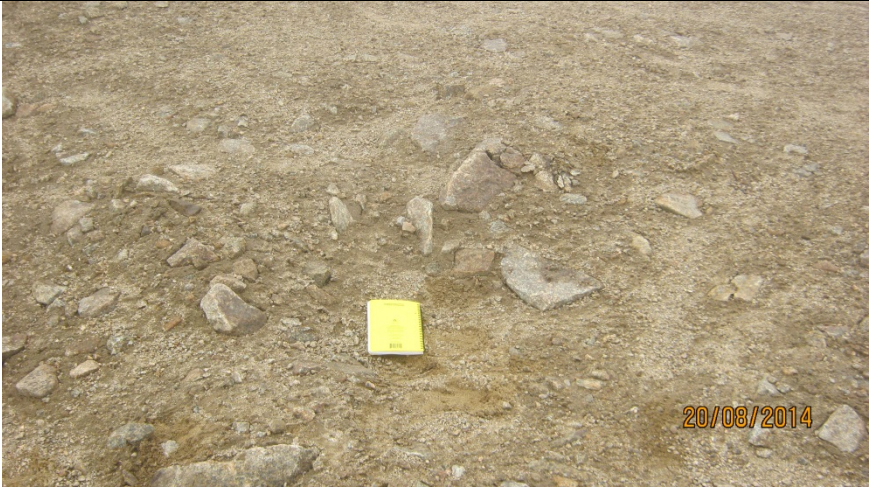
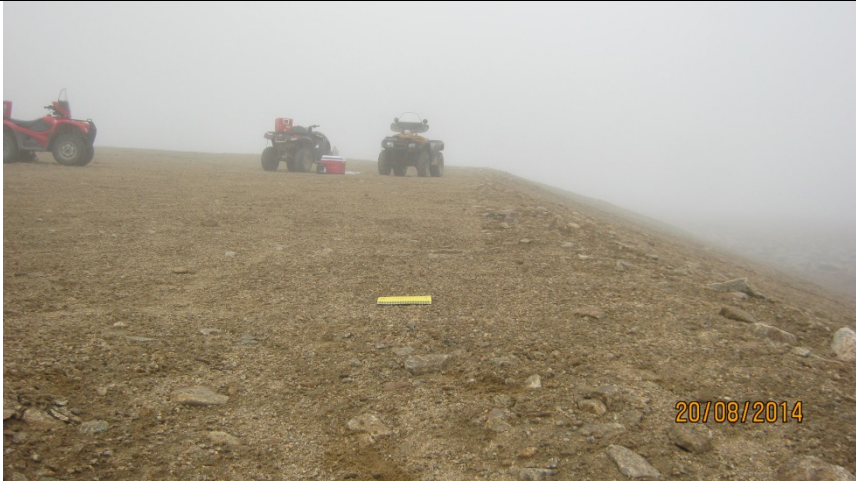
Photo 15 (FOX-5 SA P-15.jpg)	Photo 16 (FOX-5 SA P-16.jpg)
Description: View of minor settlement observed at eastern end of cap. (FEATURE F)	Description: View west along northern end of cap.

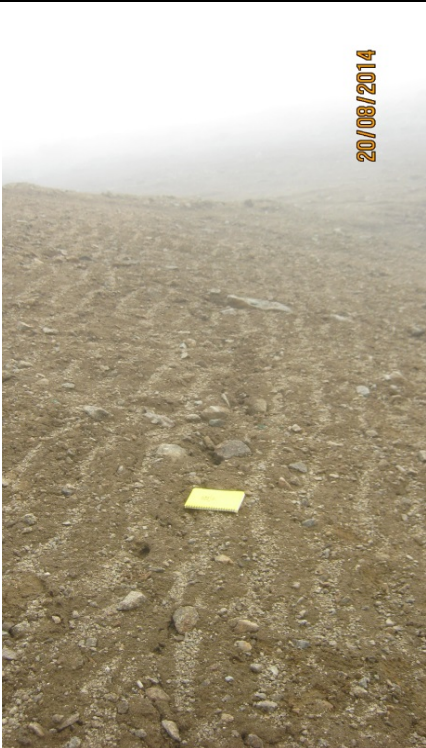
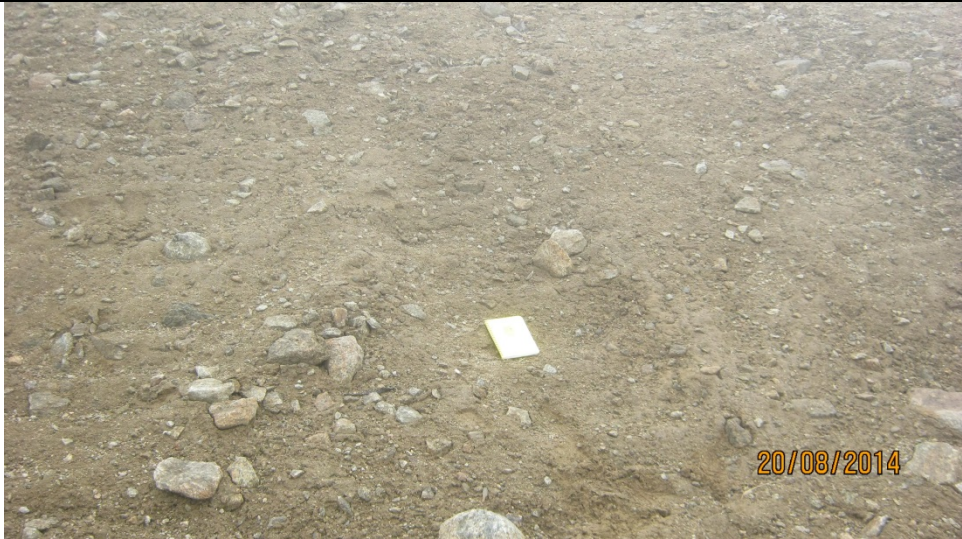
Photo 17 (FOX-5 SA P-17.jpg)	Photo 18 (FOX-5 SA P-18.jpg)
Description: View west along southern toe of landfill.	Description: Minor settlement observed at western toe of landfill. (FEATURE O)

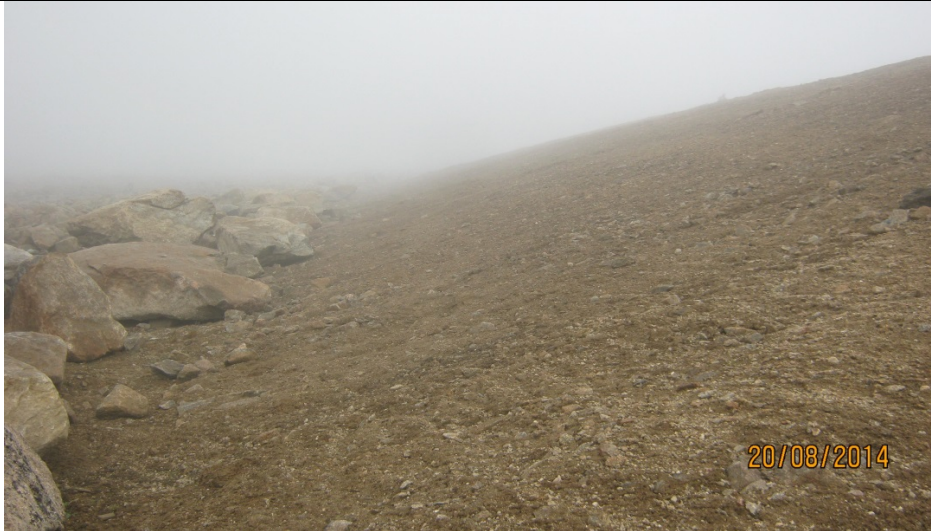
Photo 19 (FOX-5 SA P-19.jpg)	Photo 20 (FOX-5 SA P-20.jpg)
Description: View north along western slope of landfill.	Description: View east along southern slope of landfill.

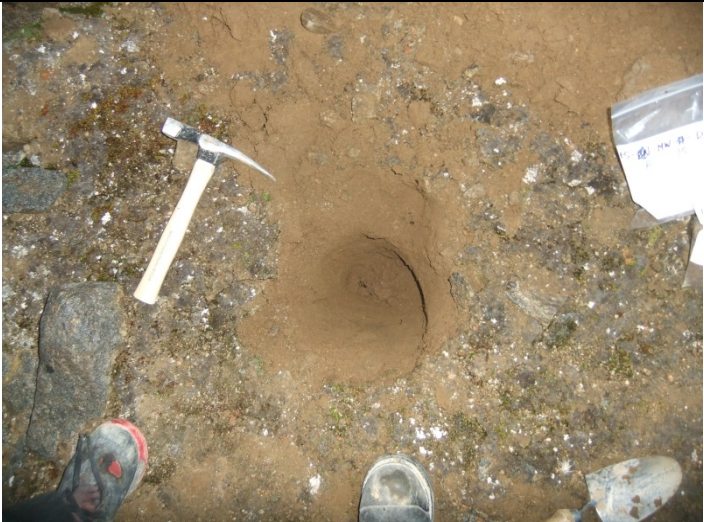
Photo 23 (FOX-5 SA P-23.jpg)	Photo 24 (FOX-5 SA P-24.jpg)
Description: F5-SA-MW-15 during sample collection.	Description: F5-SA-MW-15 after sample collection and backfill.

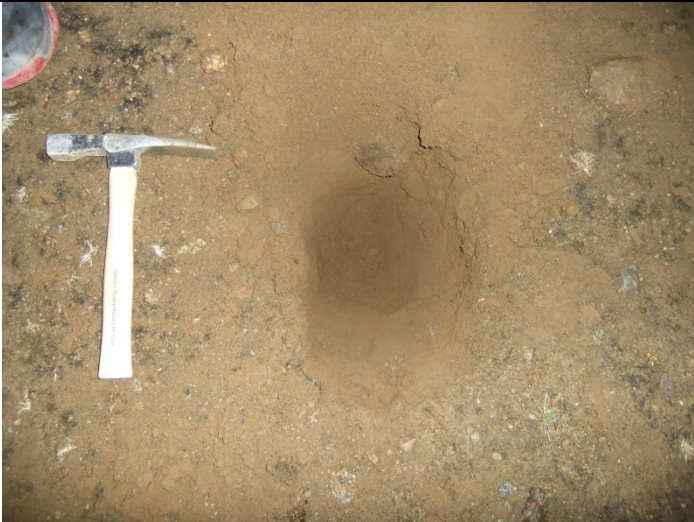
Photo 25 (FOX-5 SA P-25.jpg)	Photo 26 (FOX-5 SA P-26.jpg)
Description: F5-SA-MW-16 during sample collection.	Description: F5-SA-MW-16 after sample collection and backfill.

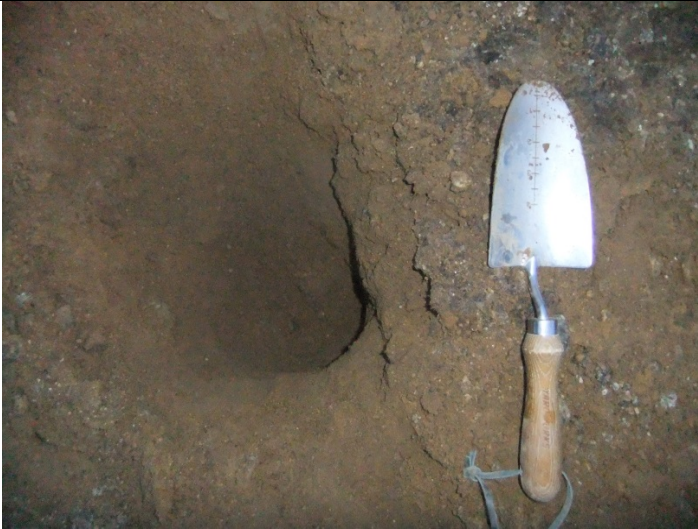
Photo 27 (FOX-5 SA P-27.jpg)	Photo 28 (FOX-5 SA P-28.jpg)
Description: F5-SA-MW-17 during sample collection.	Description: F5-SA-MW-17 after sample collection and backfill.

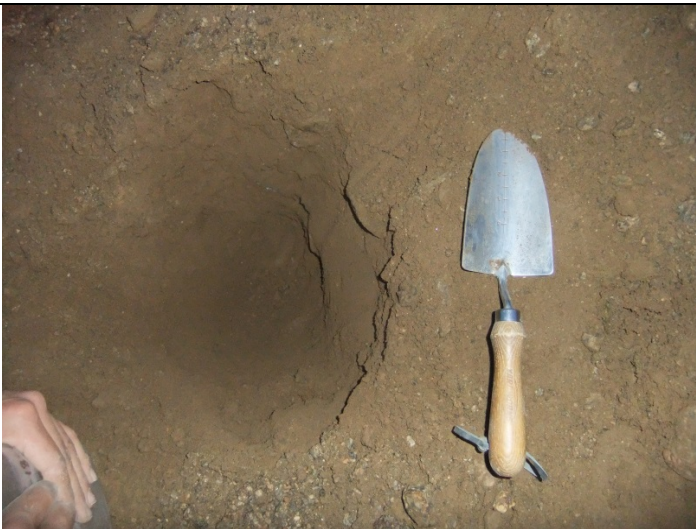
Photo 29 (FOX-5 SA P-29.jpg)	Photo 30 (FOX-5 SA P-30.jpg)
Description: F5-SA-MW-18 during sample collection.	Description: F5-SA-MW-18 after sample collection and backfill.

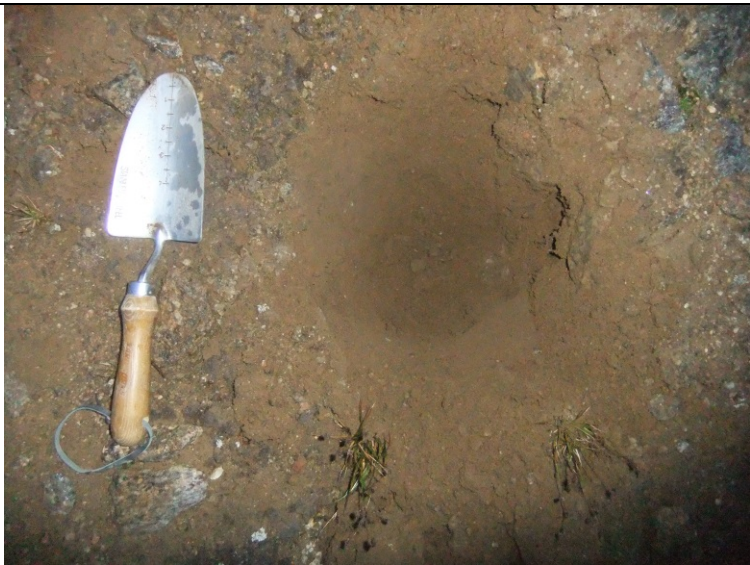
Photo 31 (FOX-5 SA P-31.jpg)	Photo 32 (FOX-5 SA P-32.jpg)
Description: F5-SA-MW-19 during sample collection.	Description: F5-SA-MW-19 after sample collection and backfill.

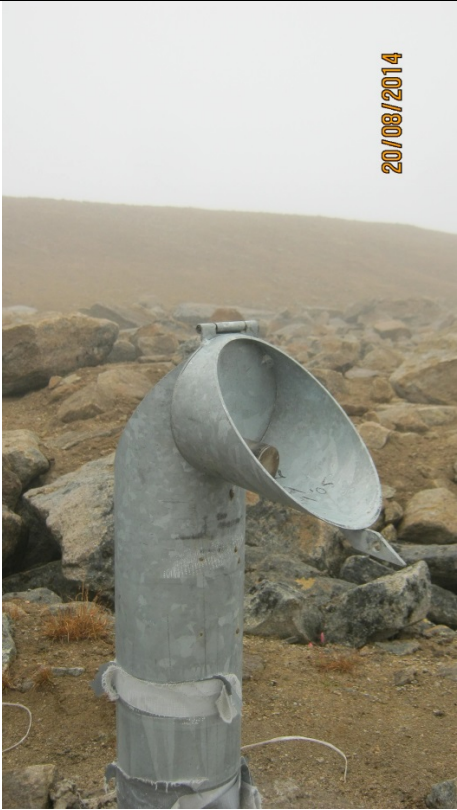
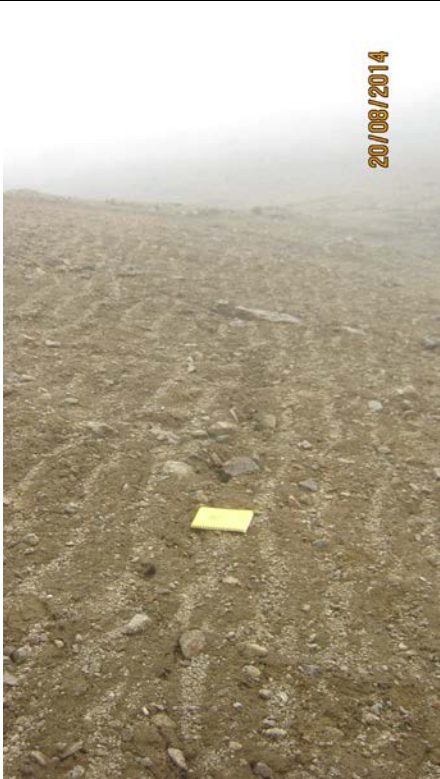
Photo 37 (FOX-5 SA P-37.jpg)	Photo 38 (FOX-5 SA P-38.jpg)
Description: View of MW-19. Northern slope of landfill seen in the background.	Description: View of tension crack on southwestern slope of landfill. (FEATURE L)
