QIKIQ15 BAFFIN REGION DEW LINE SITE MONITORING

2016 FOX-5 Monitoring Report

Report Number: 1530908-2000-R7-V3

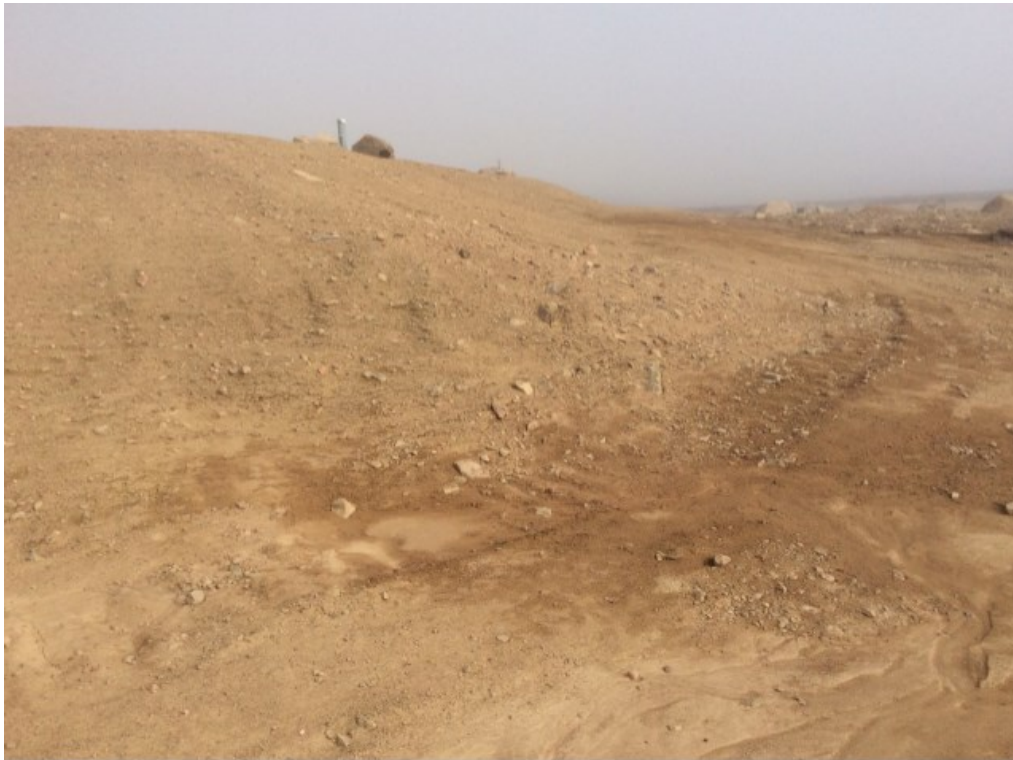
Photo 9: FOX-5 – Middle Site NHWL / Tier II DF - Southeast toe facing north – Previously observed settlement (Feature E) likely just rough grading (ATT11_Photo11.jpg)

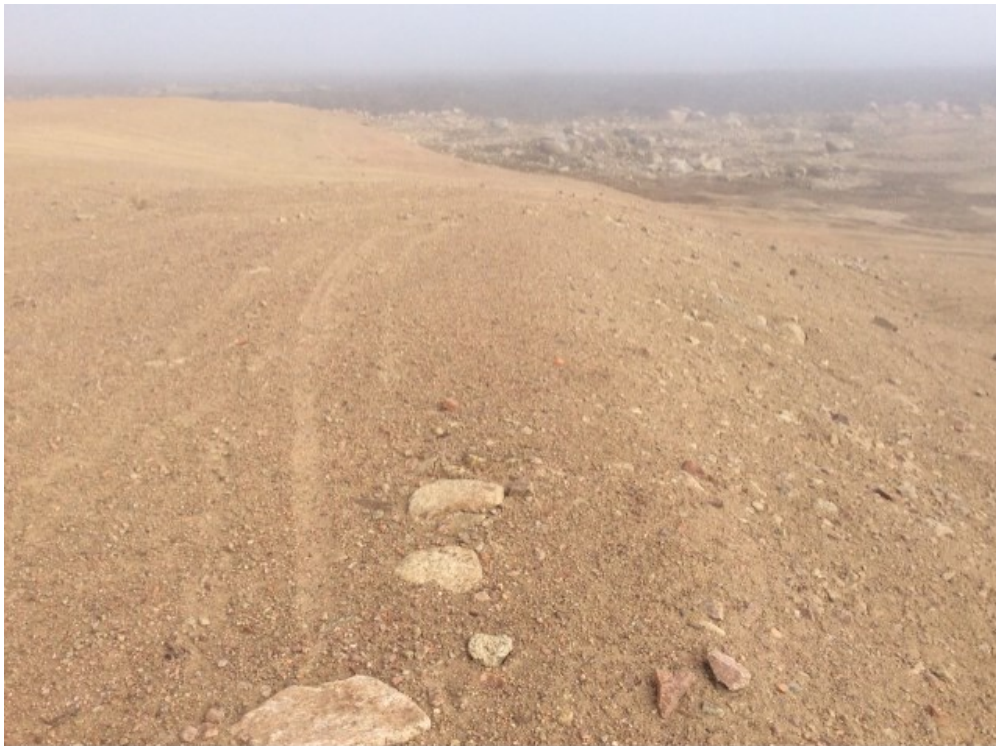
Photo 12: FOX-5 – Middle Site NHWL / Tier II DF - Crest facing northeast – Previously observed erosion channels (Feature F) were not observed in 2016 and could have been early self-armouring, north end of thin minor crack along crest edge (Feature O – not visible in photo) (ATT14_Photo14.jpg)

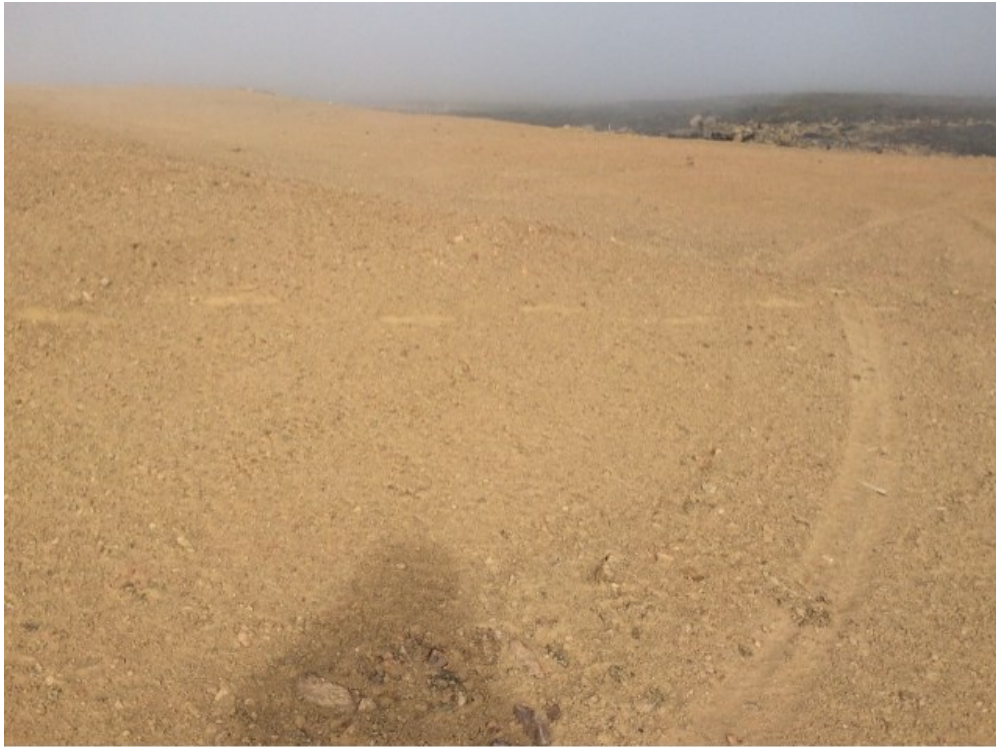
Photo 13: FOX-5 – Middle Site NHWL / Tier II DF - Crest facing north – Previously observed natural staining (Feature G) was not observed in 2016 and could have been moisture (ATT15_Photo15.jpg)

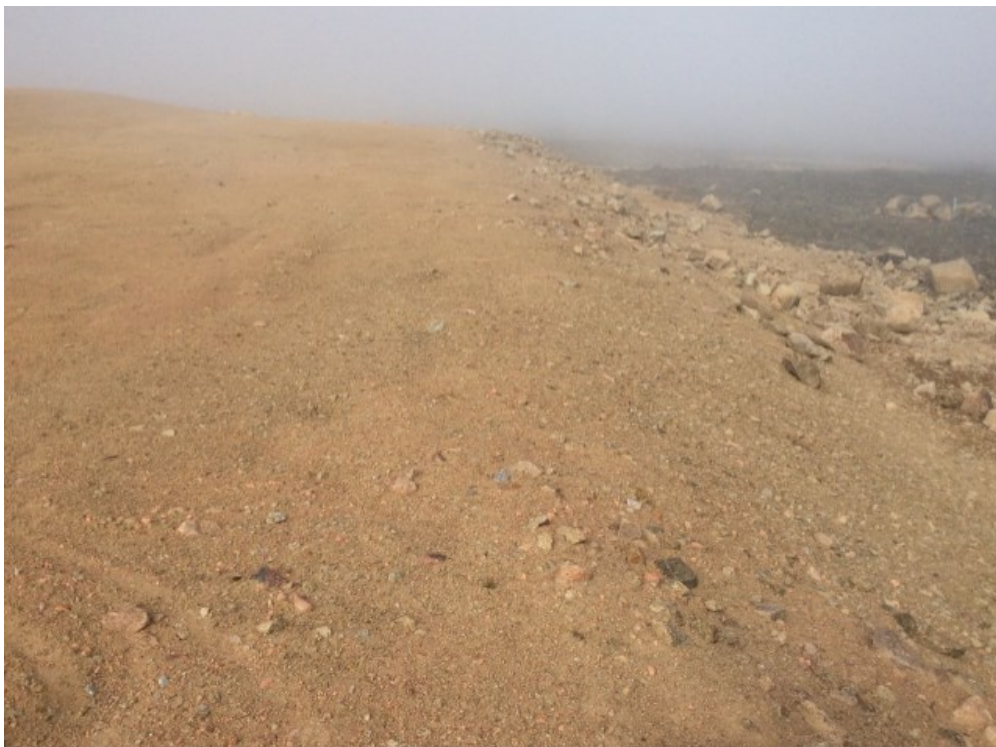
Photo 14: FOX-5 – Middle Site NHWL / Tier II DF - Crest edge facing northwest – Previously observed settlement (Feature J) considered rough grading (Acceptable) (ATT16_Photo16.jpg)

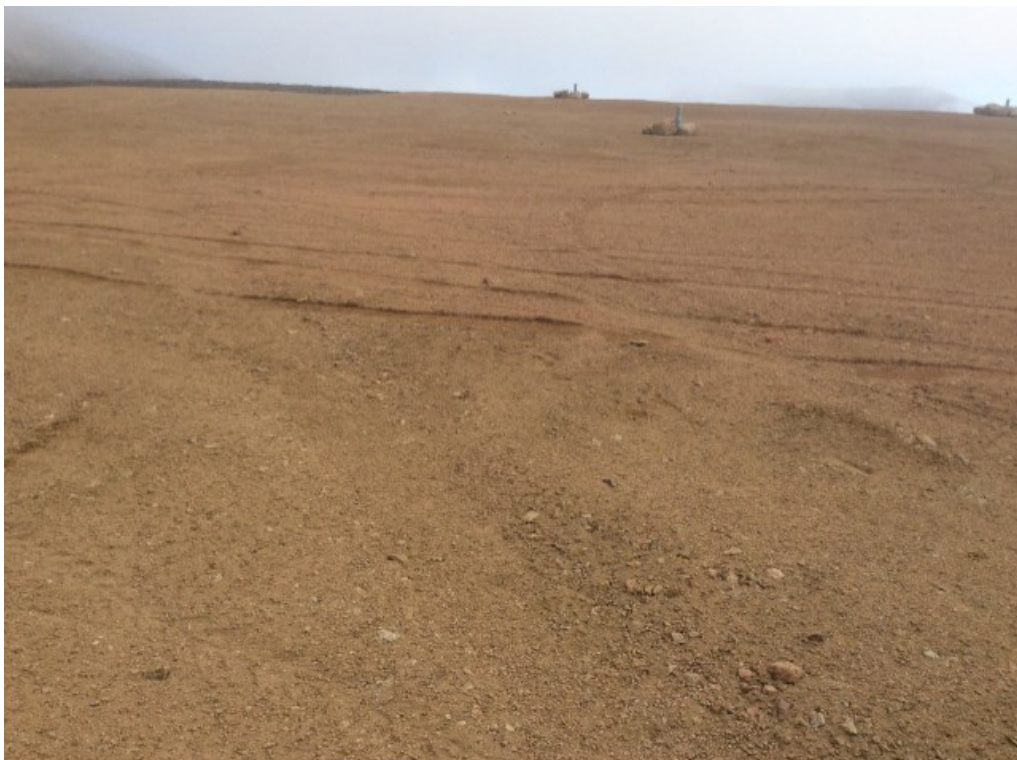
Photo 20: FOX-5 – Middle Site NHWL / Tier II DF - Crest surface facing east towards VT-11 - Previously ponded water (Feature B) not observed in 2016 (ATT21_Photo21.jpg)

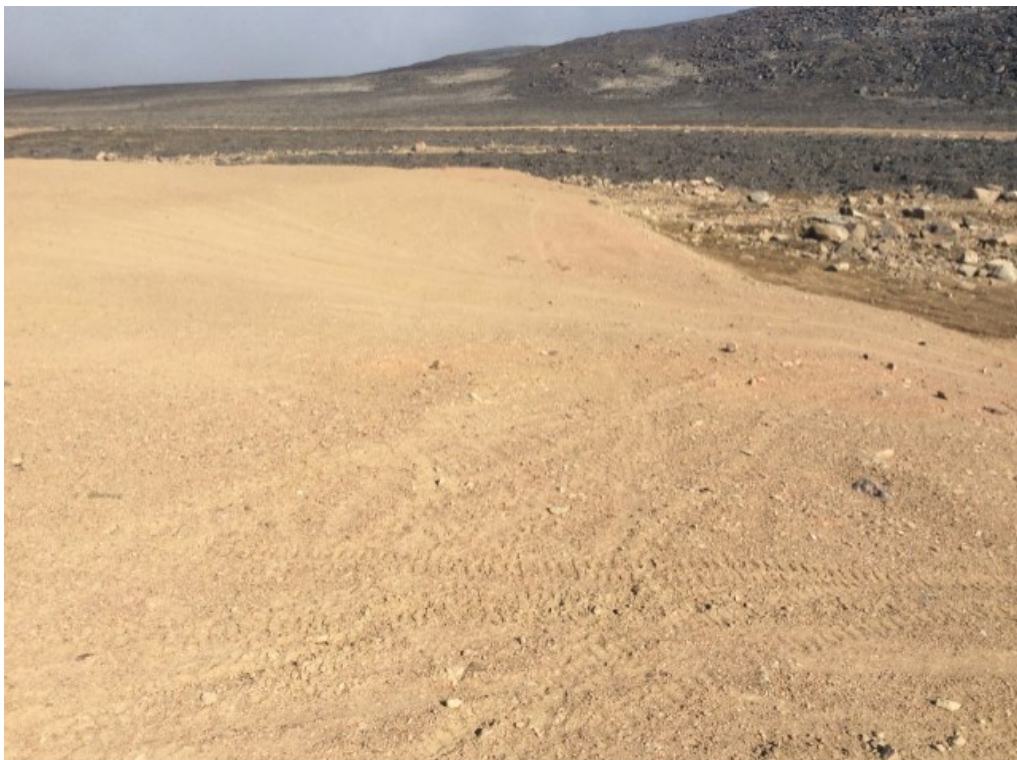
Photo 28: FOX-5 – Middle Site NHWL / Tier II DF – Northeast corner facing north – Previously observed natural staining (Feature G) not observed in 2016 may have been moisture (ATT50_Photo50.jpg)

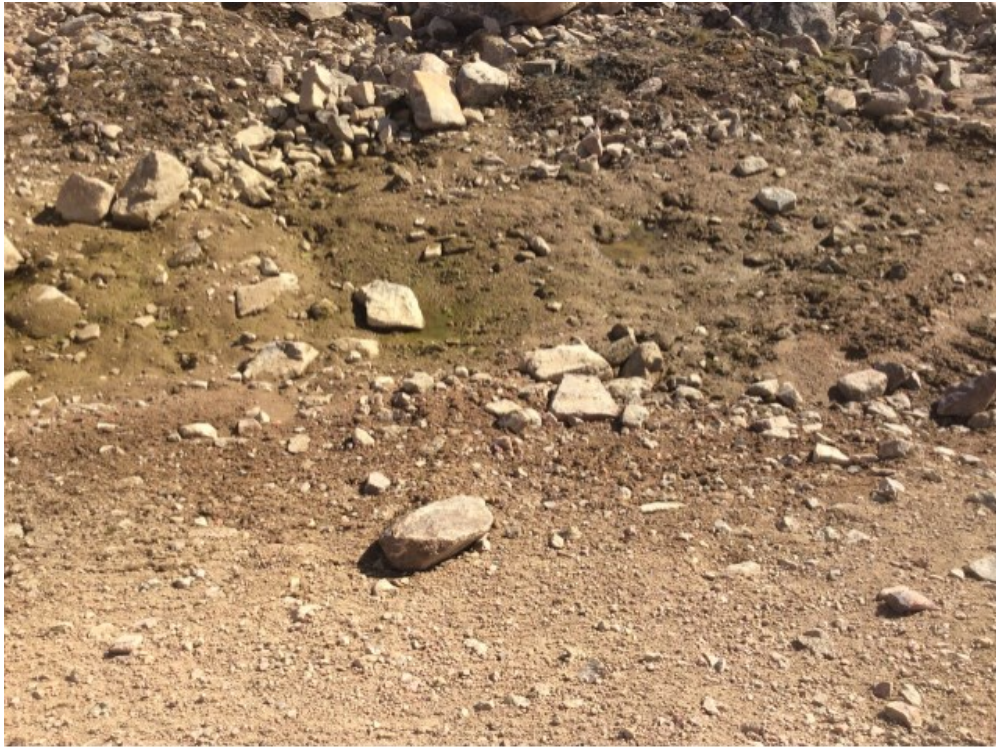
Photo 29: FOX-5 – Middle Site NHWL / Tier II DF – Northeast toe facing northwest – Moist ground but no ponded water at toe (ATT53_Photo53.jpg)

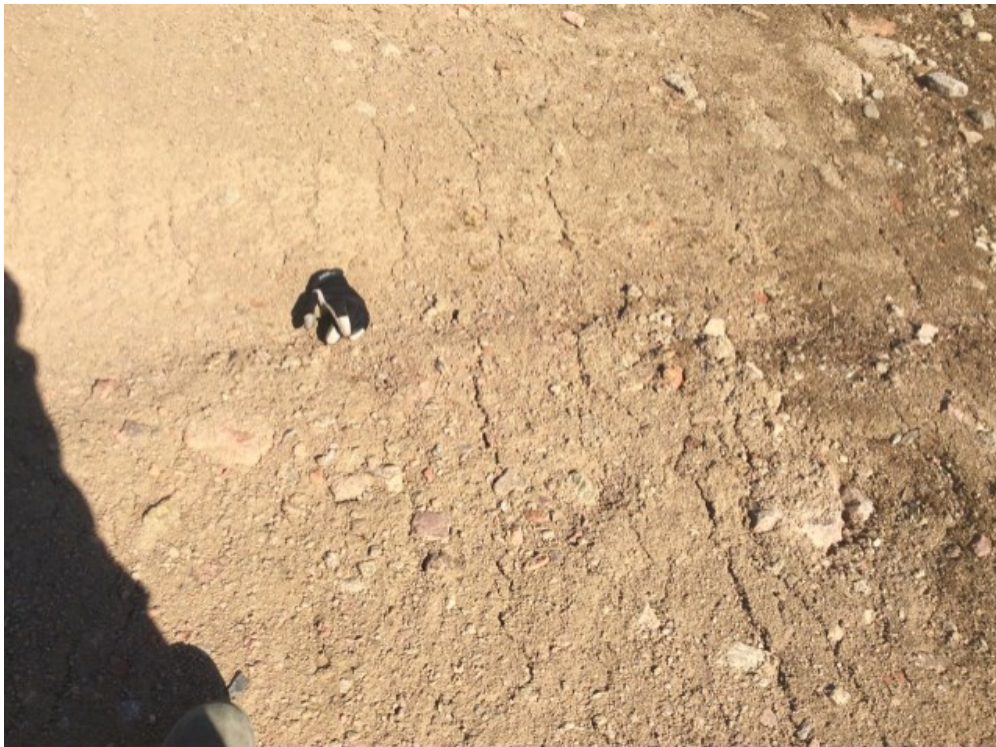
Photo 30: FOX-5 – Middle Site NHWL / Tier II DF – Northeast slope facing north – Feature H – Parallel cracking on slope (Acceptable) (ATT52_Photo52.jpg)

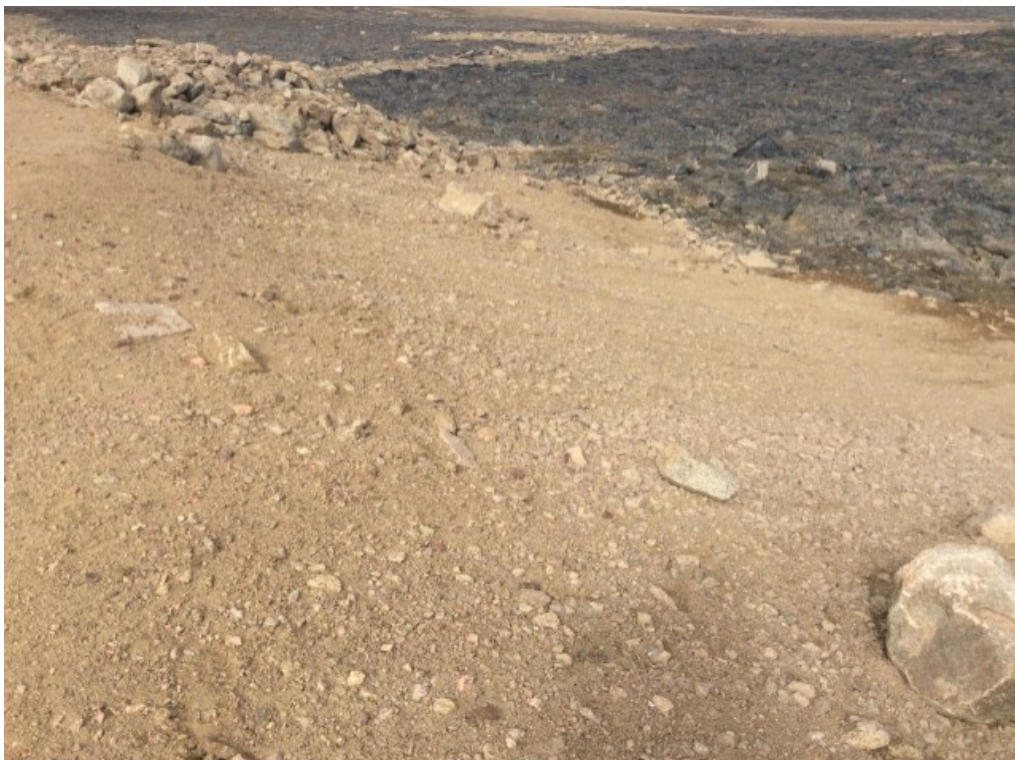
Photo 32: FOX-5 – Middle Site NHWL / Tier II DF – North slope facing northwest – Previously observed Feature M erosion channels have self-armoured (Acceptable) (ATT56_Photo56.jpg)

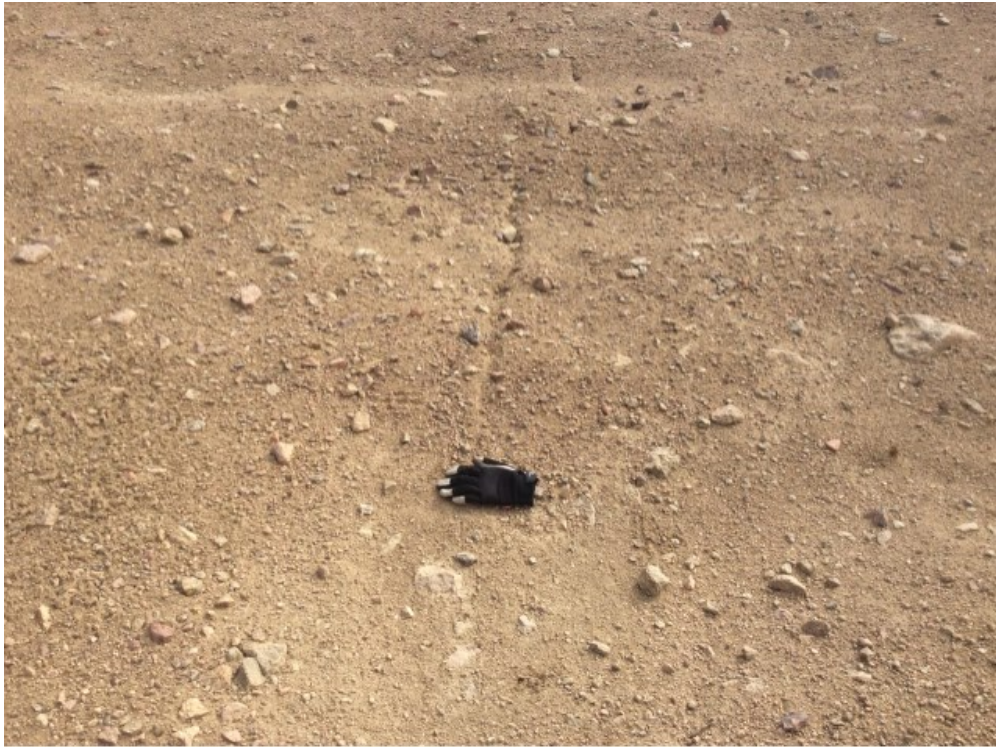
Photo 33: FOX-5 – Middle Site NHWL / Tier II DF – North end crest surface facing northwest – Feature R – weathered tension crack about 5 m from crest edge (Acceptable) (ATT55_Photo55.jpg)

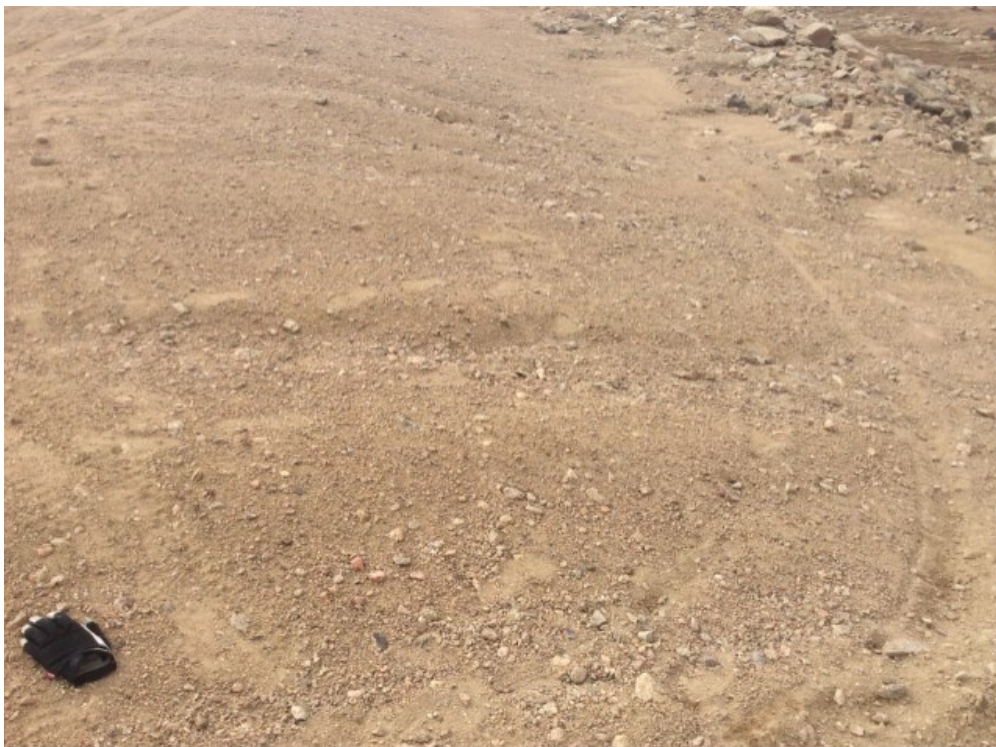
Photo 34: FOX-5 – Middle Site NHWL / Tier II DF – Northwest slope facing south – Feature A - self-armouring erosion channels (Acceptable) (ATT57_Photo57.jpg)

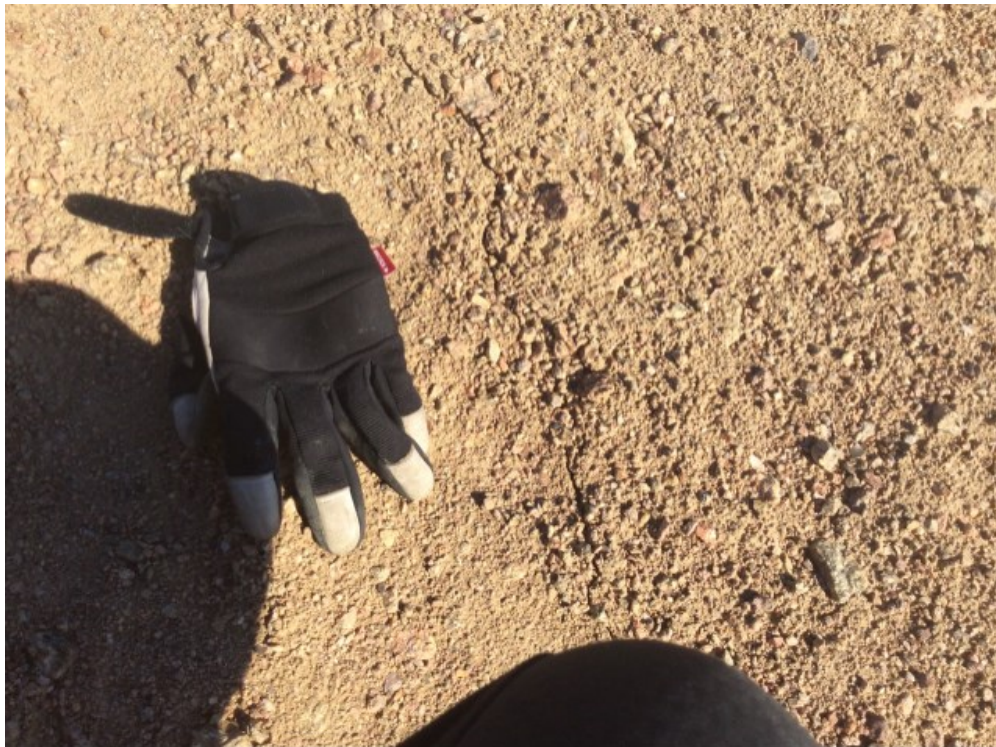
Photo 37: FOX-5 – Middle Site NHWL / Tier II DF – Southeast slope facing northeast – Feature O – tension crack with sharp edges extending from toe to crest at corner of landfill and along crest edge (ATT49_Photo49.jpg)

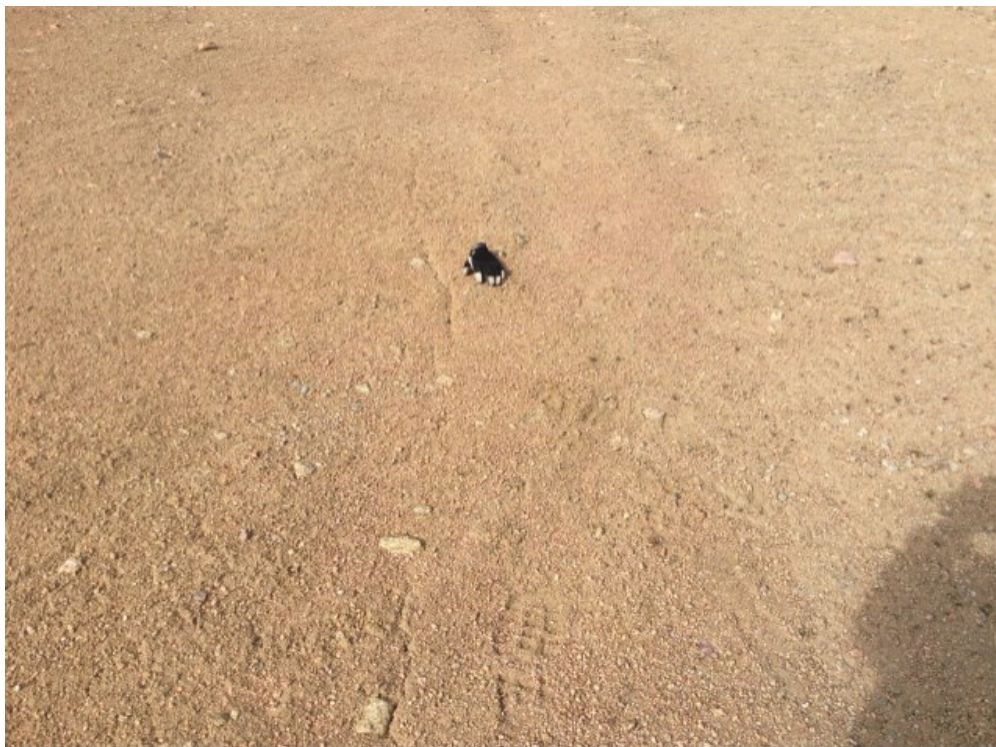
Photo 38: FOX-5 – Middle Site NHWL / Tier II DF – Northeast crest facing northwest – Feature P – weathered tension crack about 4 m from crest edge (Acceptable) (ATT54_Photo54.jpg)

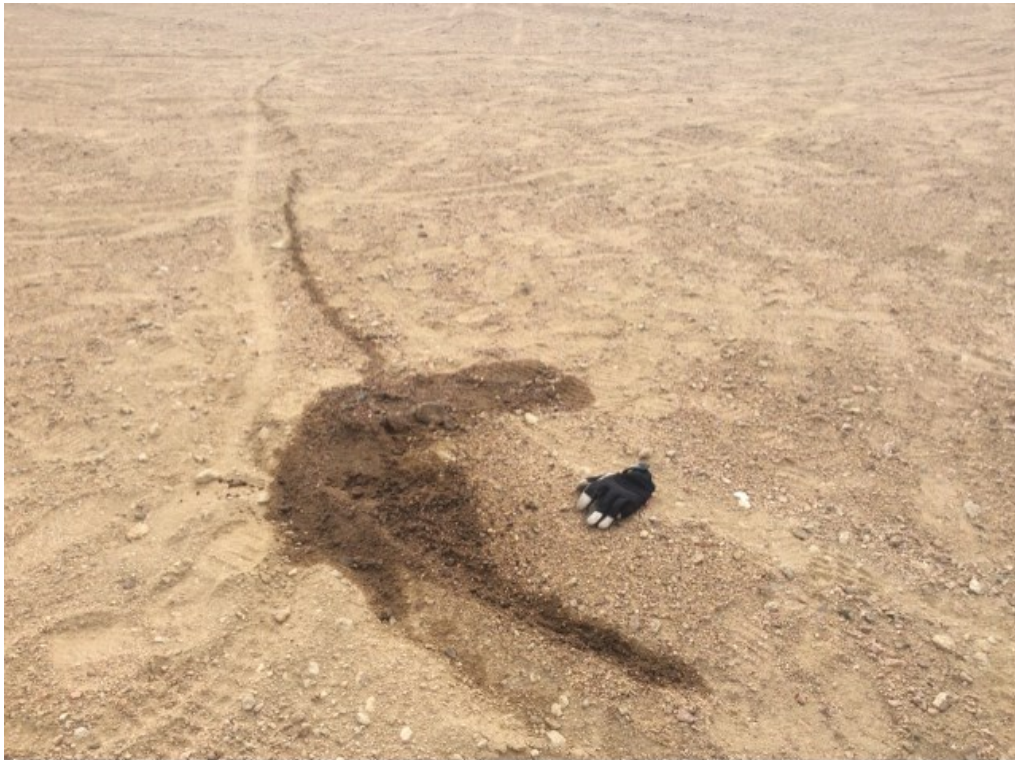
Photo 39: FOX-5 – Middle Site NHWL / Tier II DF – Northwest crest surface facing southeast – Feature Q – hydrocarbon staining not related to landfill performance (Acceptable) (ATT58_Photo58.jpg)

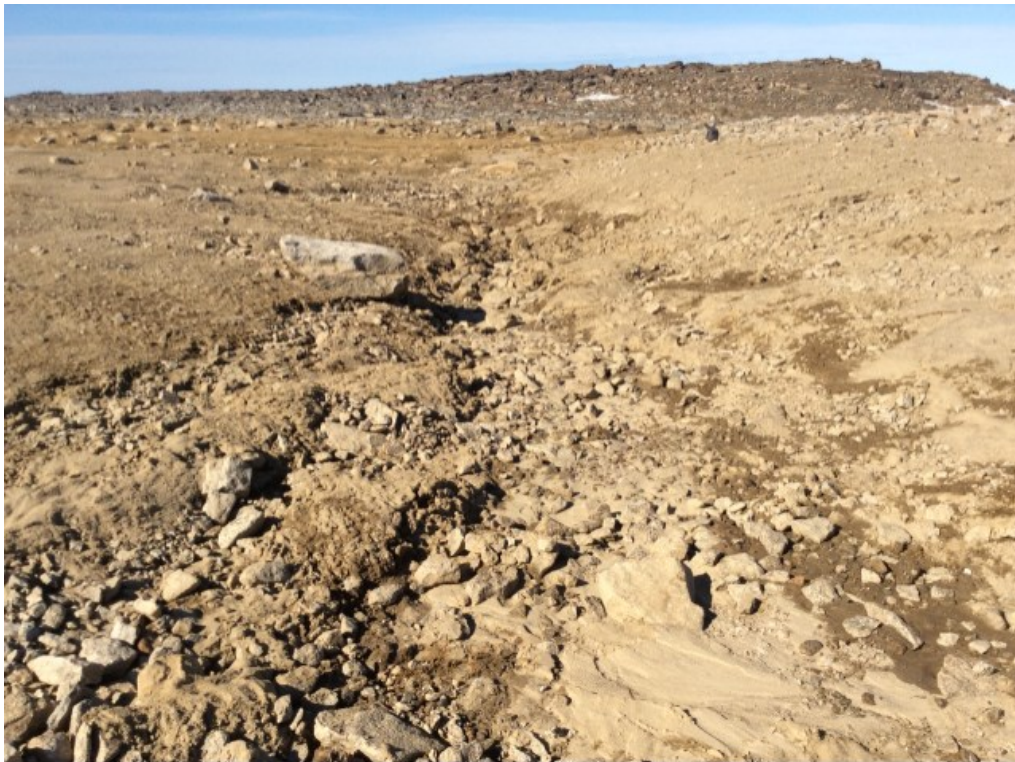
Photo 64: FOX-5 – Main Landfill – Drainage ditch, west of landfill, facing north – Feature H – erosion channel (Acceptable) (ATT34_Photo34.jpg)

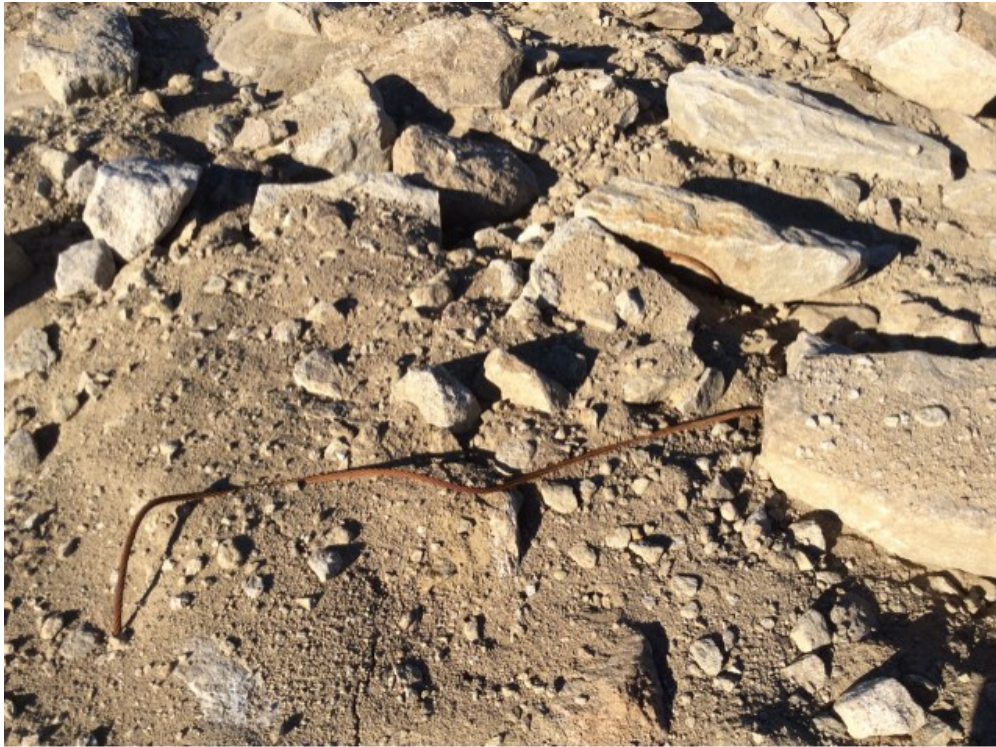
Photo 73: FOX-5 – Main Landfill – Steel rebar at east toe near MW-12 – Previously observed Features B, C and E which are not exposed waste materials but construction debris/remnants (Acceptable) (ATT109_Photo109.jpg)

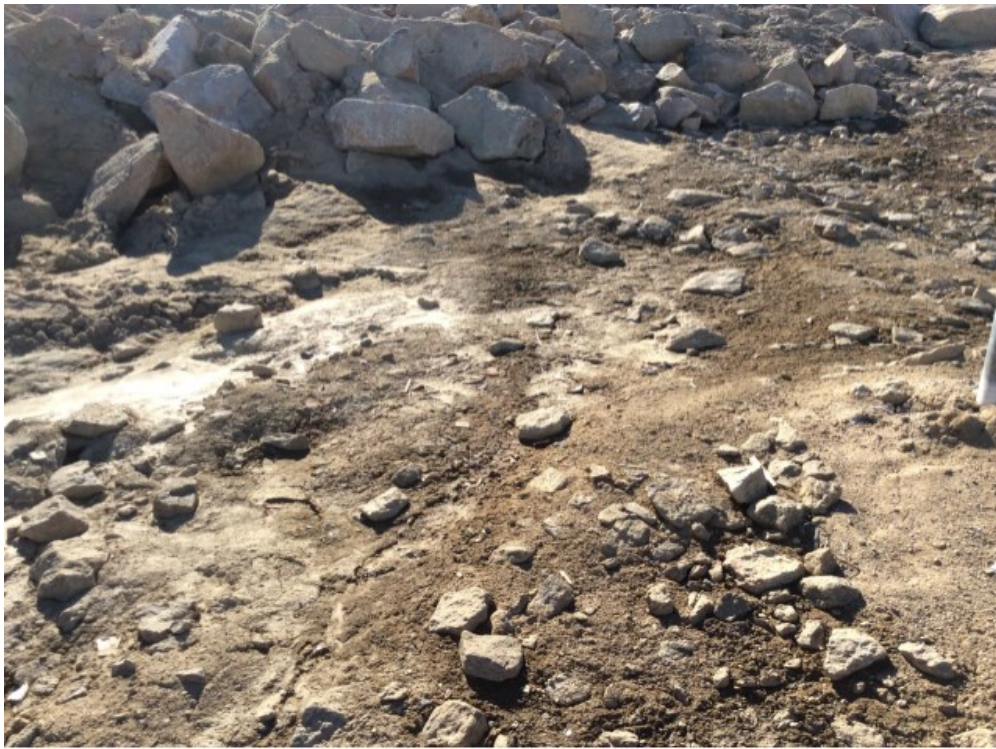
Photo 74: FOX-5 – Main Landfill – Scattered metal debris at northeast toe near MW-11 - Previously observed Features B, C and E which are not exposed waste materials but construction debris/remnants (Acceptable) (ATT106_Photo106.jpg)

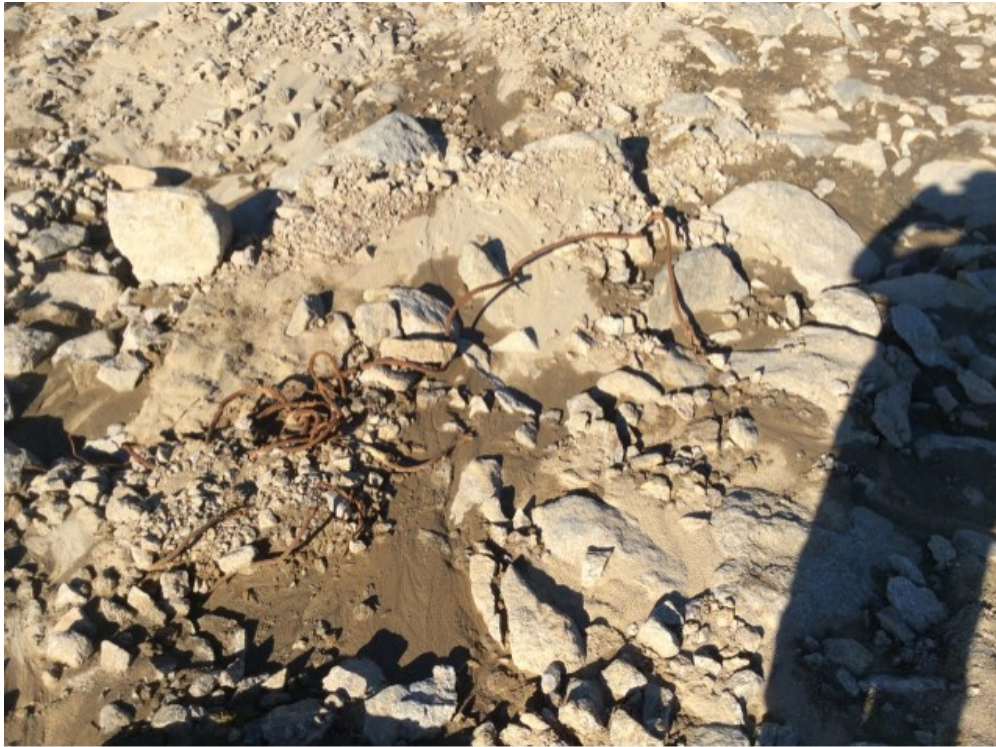
Photo 75: FOX-5 – Main Landfill – Steel cable at east toe - Example of previously observed Features B, C and E which are not exposed waste materials but construction debris/remnants (Acceptable) (ATT111_Photo111.jpg)

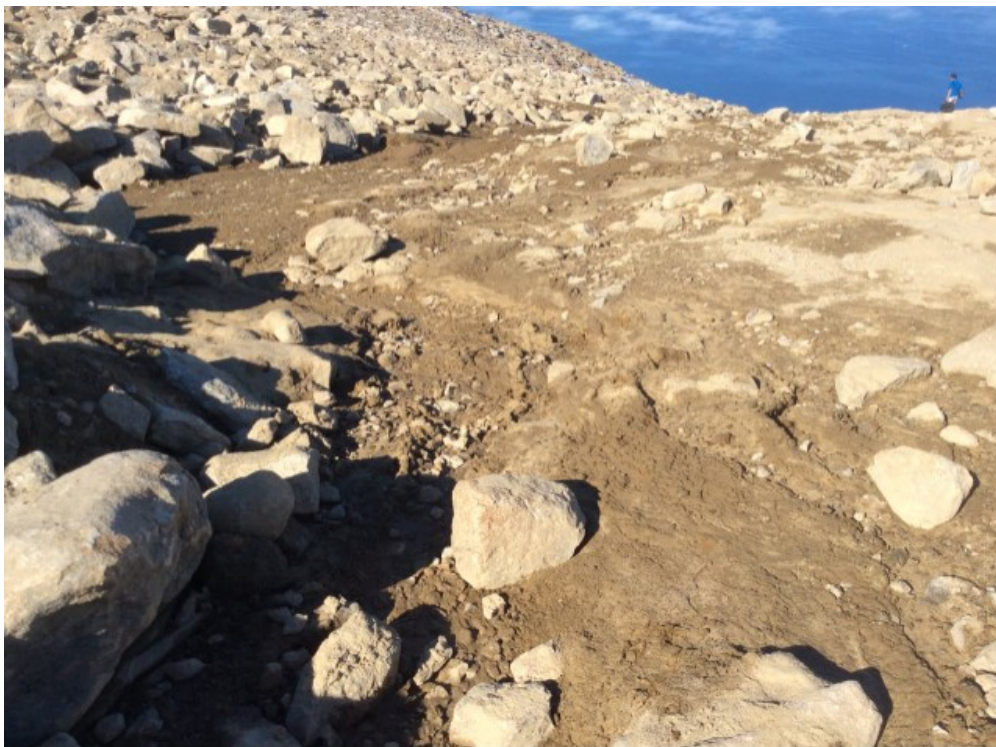
Photo 76: FOX-5 – Main Landfill – East toe facing northeast – Feature D – south end of erosion channel along north east toe (Acceptable) (ATT110_Photo110.jpg)

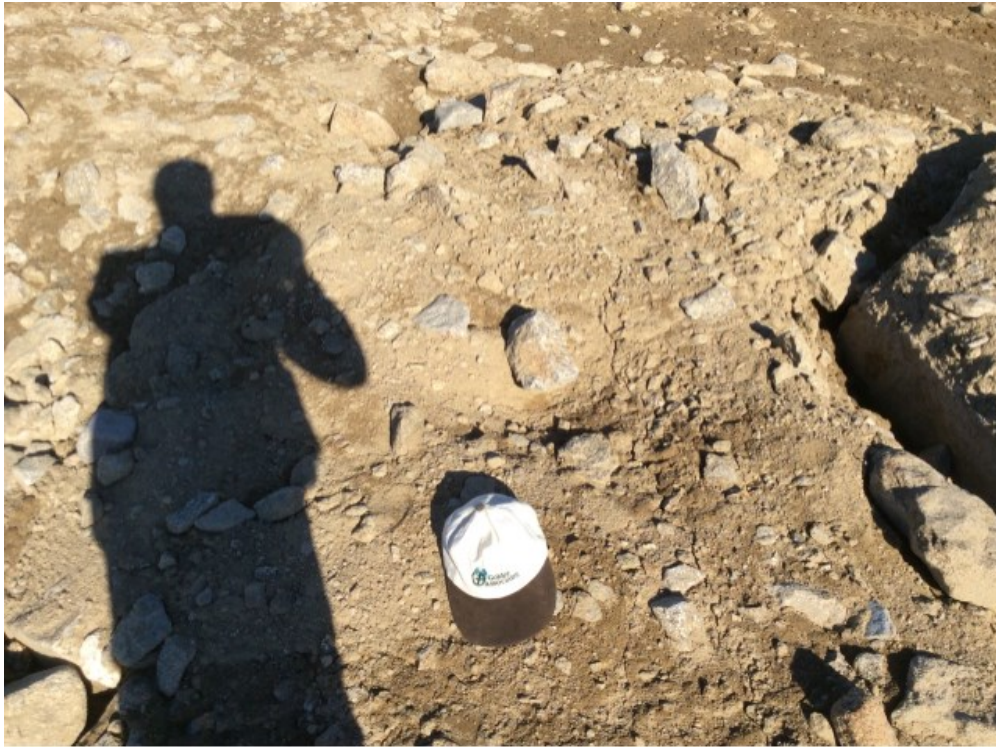
Photo 77: FOX-5 – Main Landfill – South toe facing northeast – Previously observed cracking (Feature G) beyond rip rap at toe is not related to landfill performance (ATT112_Photo112.jpg)

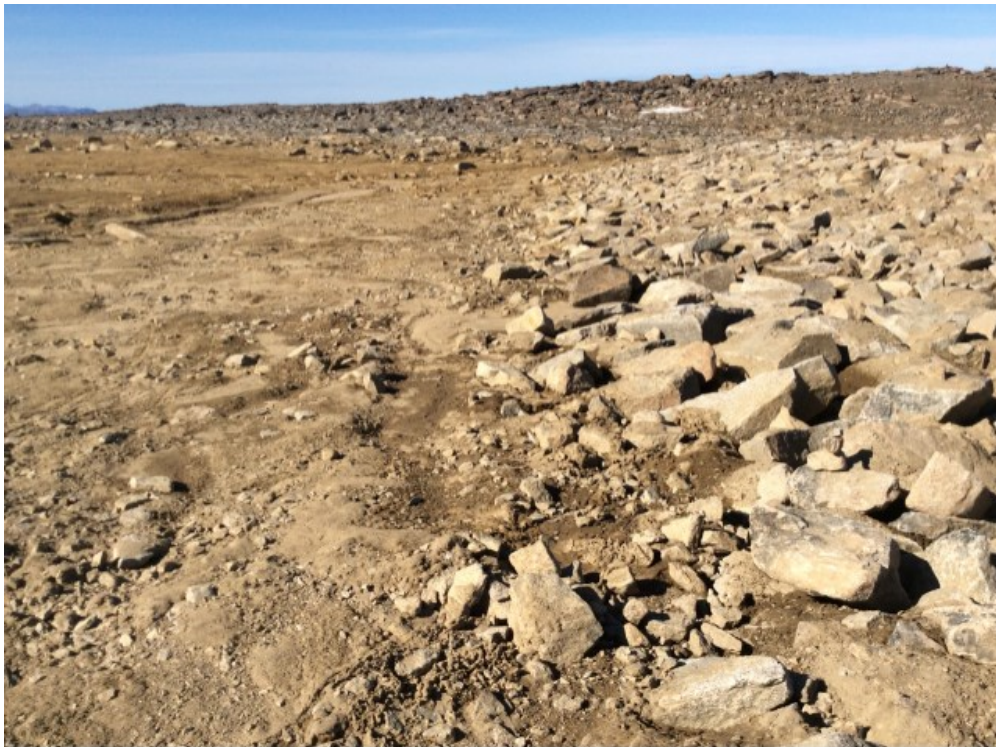
Photo 78: FOX-5 – Main Landfill – Southwest toe facing northwest – Previously observed erosion (Feature H) around toe of landfill (Acceptable) (ATT104_Photo104.jpg)

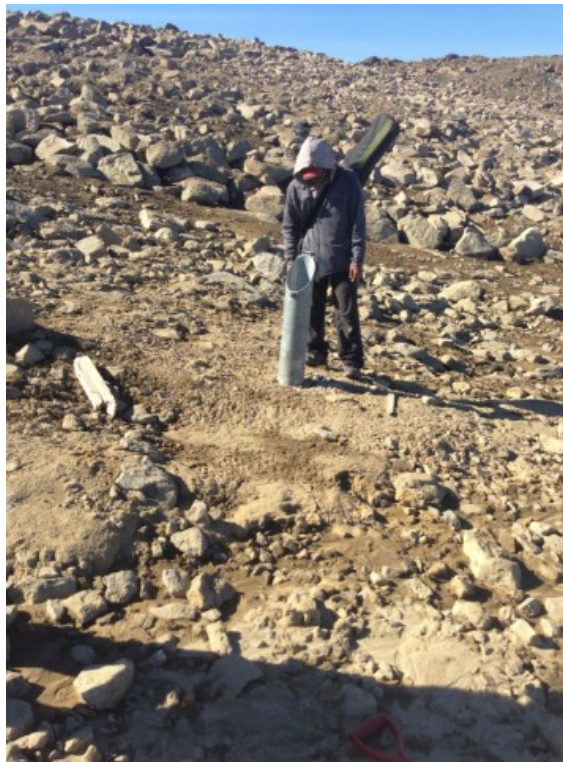
Photo 106: FOX-5 – Main Landfill – MW-14 – monitoring well with previously observed wood debris (Feature E) that is not exposed waste (ATT26_Photo26.jpg)

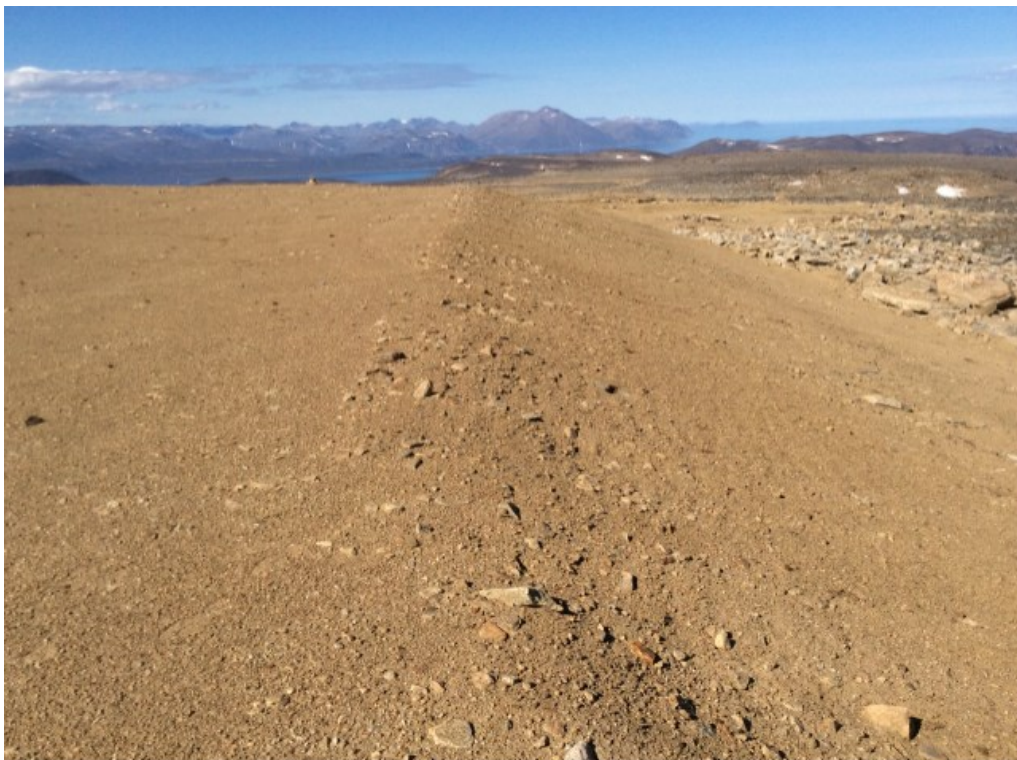
Photo 112: FOX-5 – Station Area NHWL – Crest edge, east corner, facing northwest – previously observed settlement (Feature F) considered rough grading (Acceptable) (ATT26_Photo26.jpg)

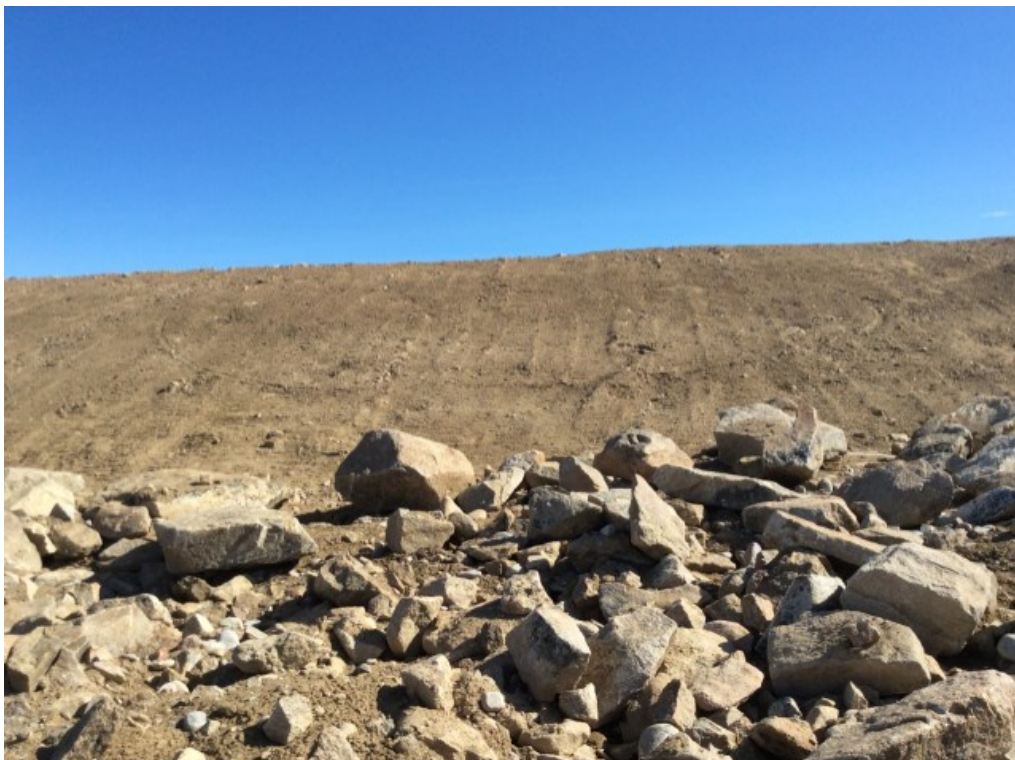
Photo 118: FOX-5 – Station Area NHWL – Northwest slope facing southeast - Motorbike tracks on slope – Previously observed settlement (Feature Q) is likely rough grading and not significant (ATT32_Photo32.jpg)

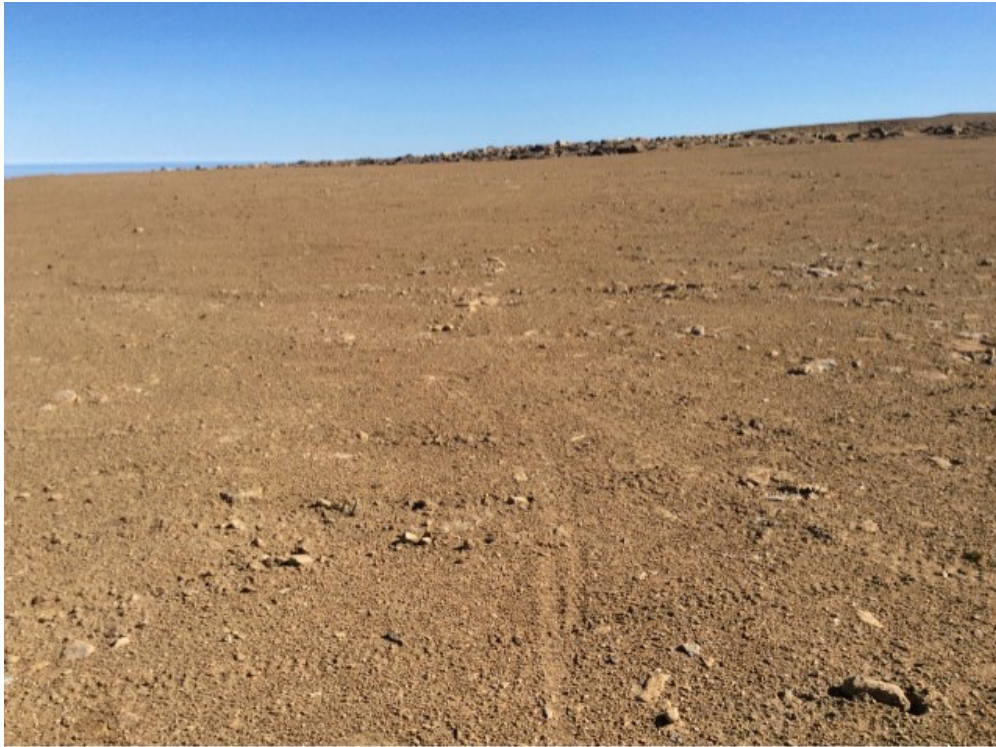
Photo 119: FOX-5 – Station Area NHWL – Crest surface facing southeast – Previously observed vehicle tracks (Feature G) cover most of landfill surface and are not considered significant (ATT33_Photo33.jpg)

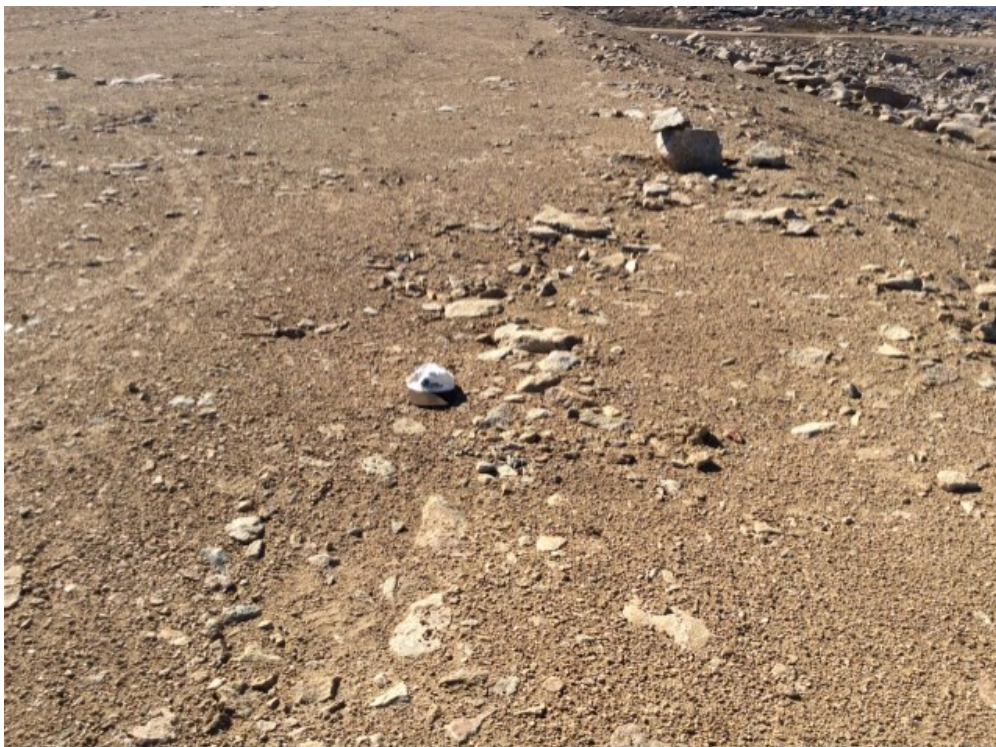
Photo 120: FOX-5 – Station Area NHWL – Crest in north corner facing northwest – Previously observed settlement (Feature A) may just be rough grading (ATT86_Photo86.jpg)

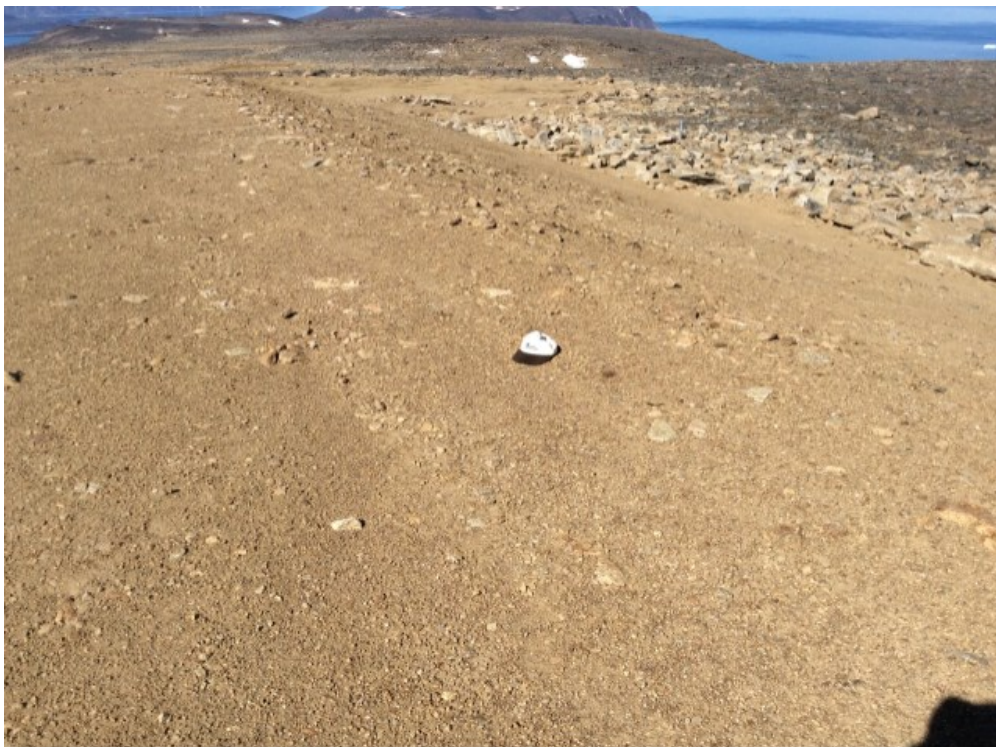
Photo 122: FOX-5 – Station Area NHWL – Northeast crest facing north – Previously observed settlement (Feature D) is very shallow and not considered significant (ATT89_Photo89.jpg)

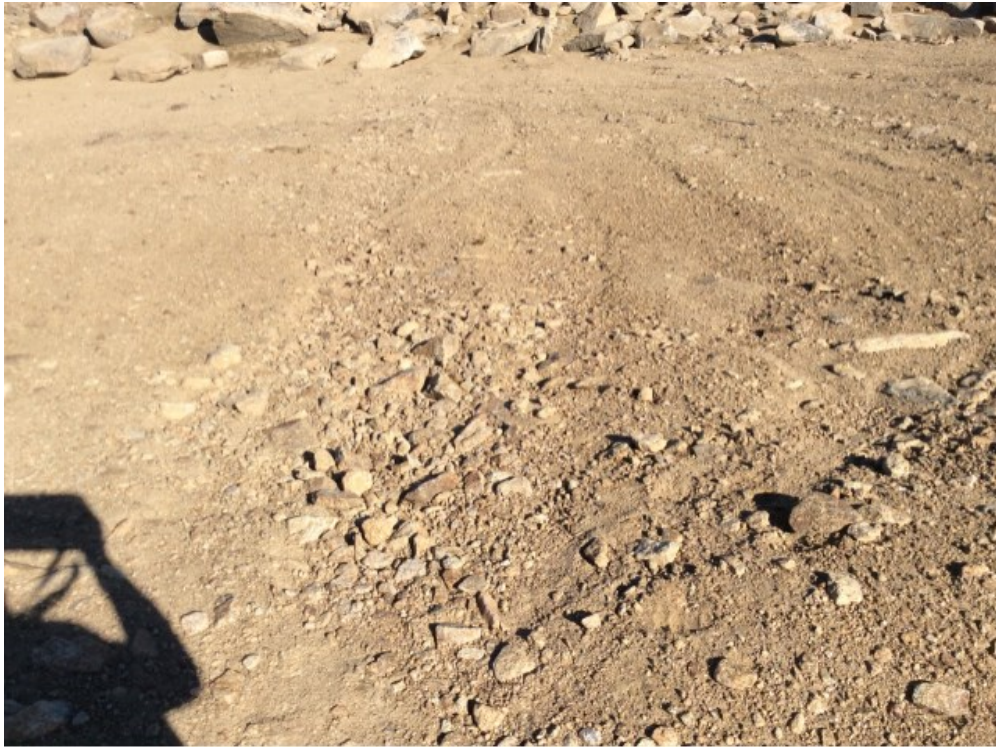
Photo 123: FOX-5 – Station Area NHWL – Northeast slope facing northeast – Feature E – self-armouring erosion (Acceptable) (ATT88_Photo88.jpg)

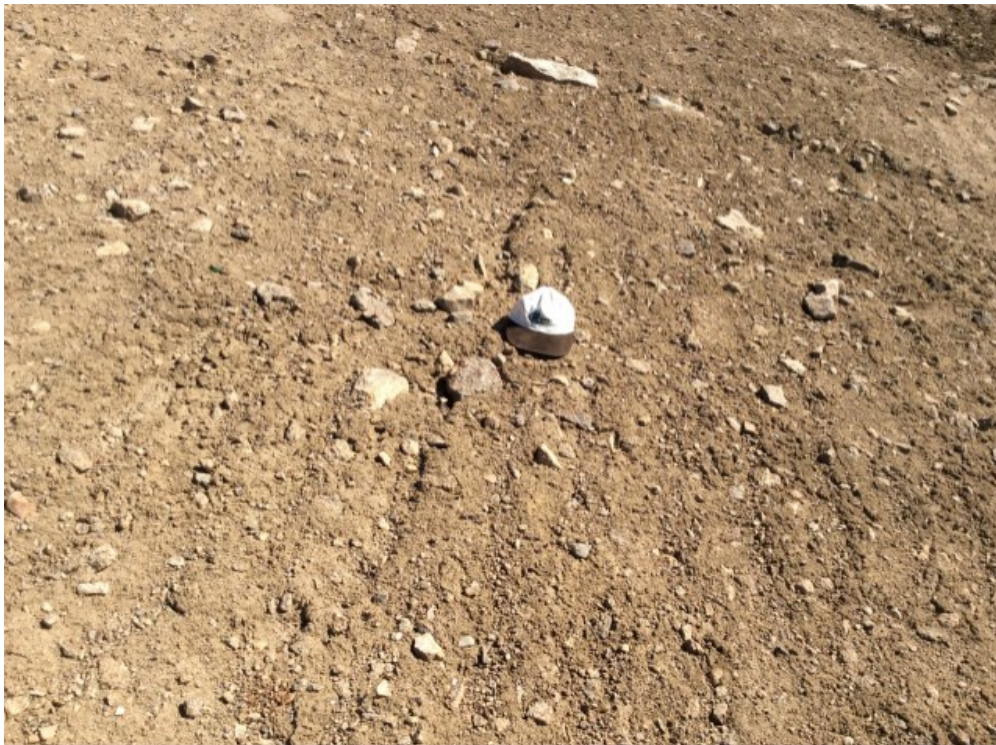
Photo 130: FOX-5 – Station Area NHWL – Southwest slope facing northwest – Feature L – minor weathered cracking (Acceptable) (ATT93_Photo93.jpg)
