QIKIQ15 BAFFIN REGION DEW LINE SITE MONITORING

2016 FOX-5 Monitoring Report

Report Number: 1530908-2000-R7-V3

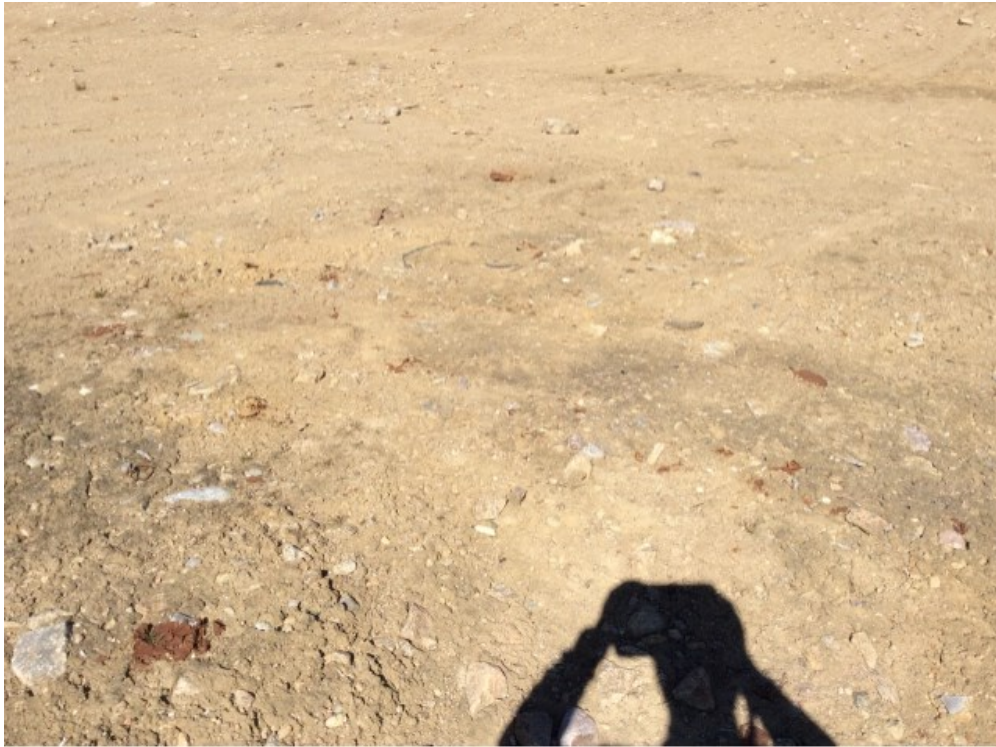
Photo 131: FOX-5 – Station Area NHWL – Southwest toe facing north – Feature M – bits of metal debris (Acceptable) (ATT91_Photo91.jpg)

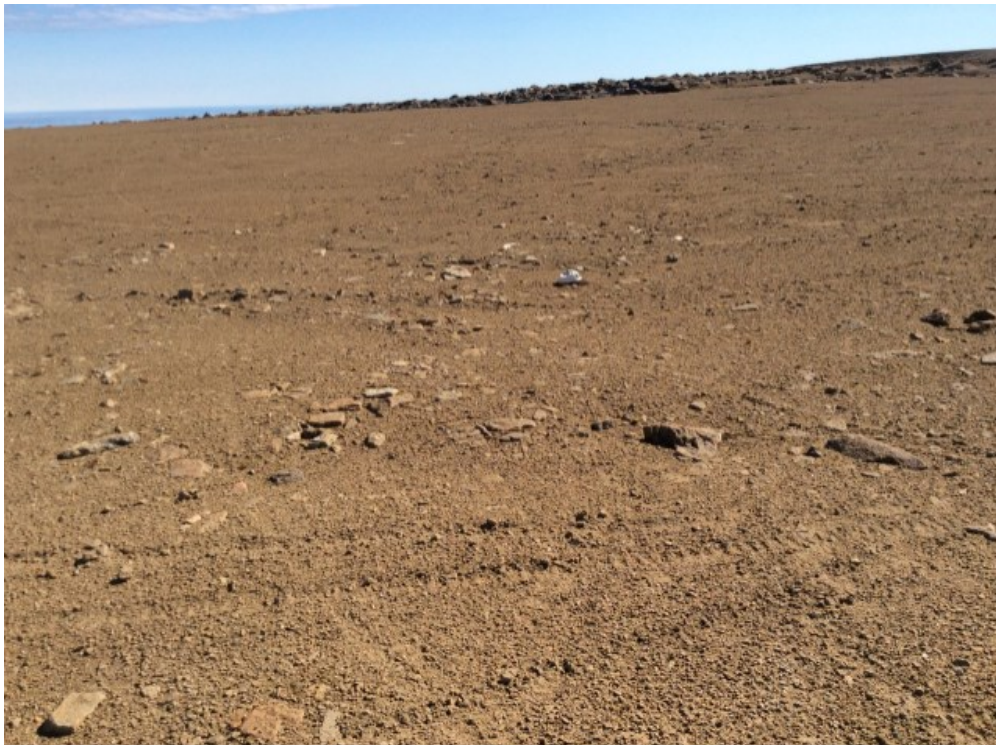
Photo 134: FOX-5 – Station Area NHWL – North crest surface facing northwest – Previously observed settlement (Feature O) on crest are very shallow depressions and not considered significant (ATT85_Photo85.jpg)

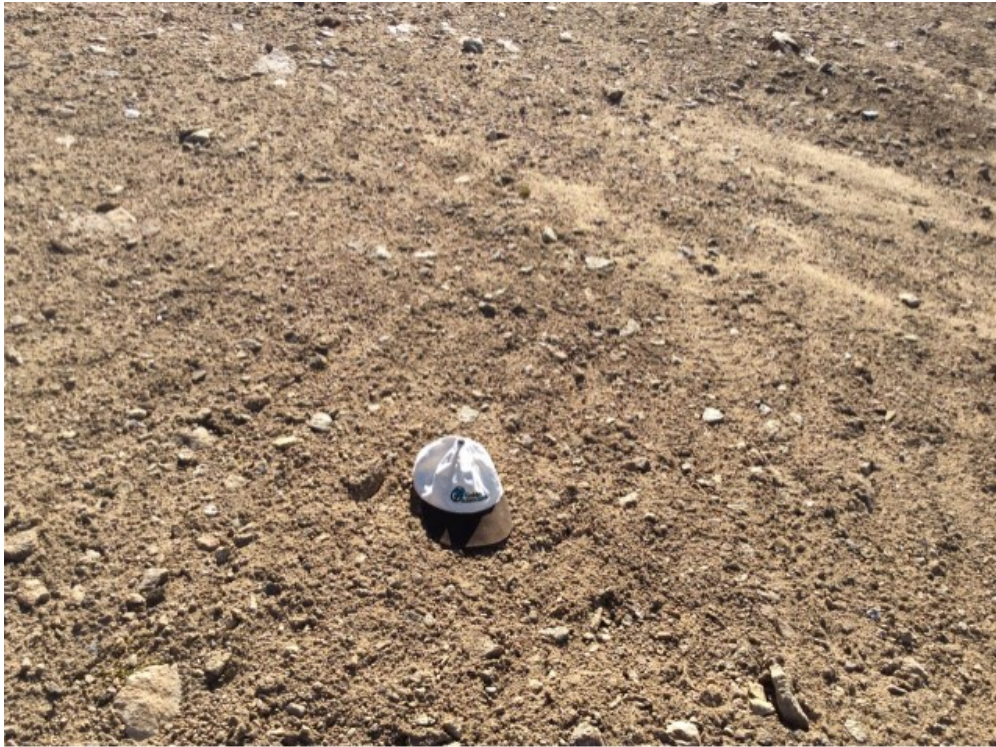
Photo 137: FOX-5 – Station Area NHWL – Northwest slope facing northwest – Feature R – minor weathered cracking (Acceptable) (ATT99_Photo99.jpg)

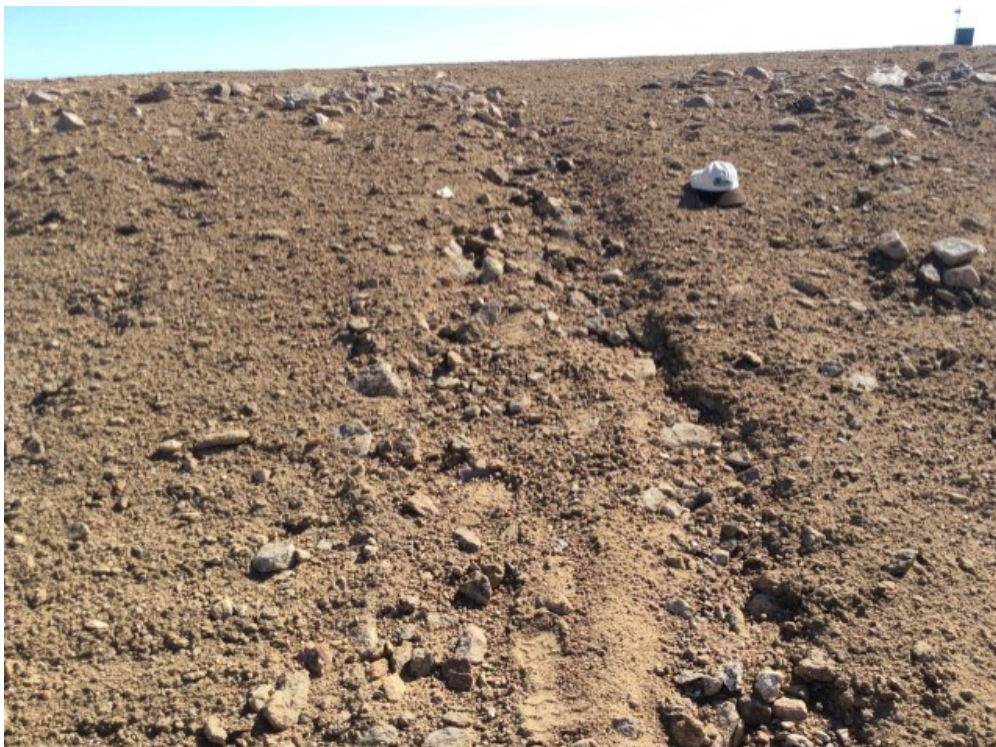
Photo 138: FOX-5 – Station Area NHWL – Northwest slope facing southeast – Feature S – self-armouring erosion channels (Acceptable) (ATT87_Photo87.jpg)
