An Environmental Assessment of Radio Island, NWT

Environmental Sciences Group
Royal Military College
Kingston, Ontario

© Environmental Sciences Group
March 1997
RMC-CCE-ES-97-16

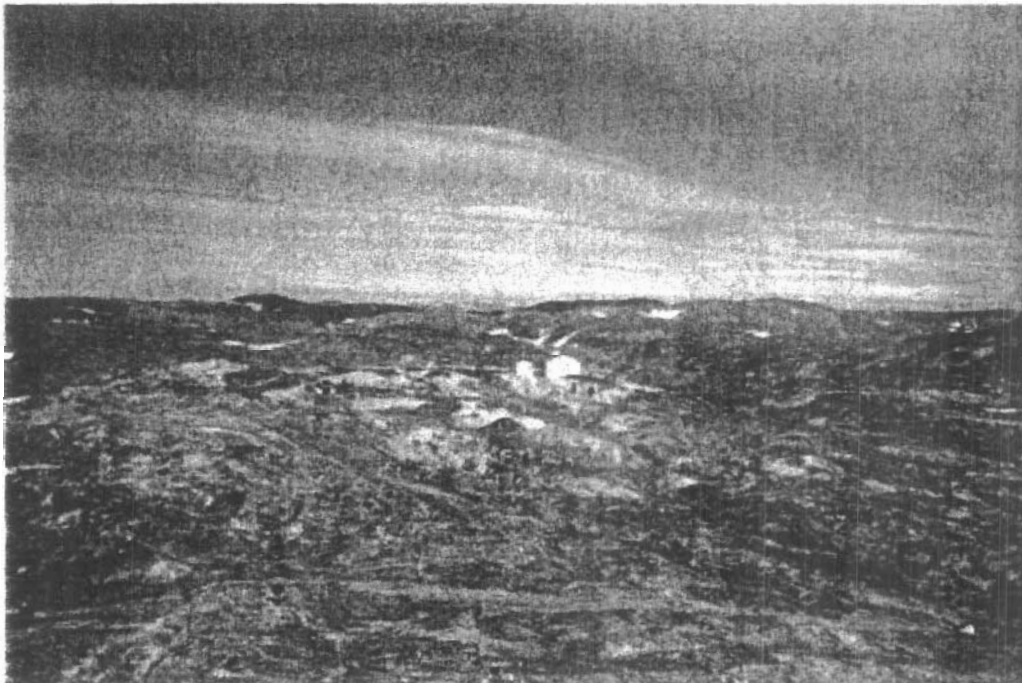
Photograph I-1: The Main Site at Radio Island as seen from the south. The Generator Building Foundation is seen in the foreground.

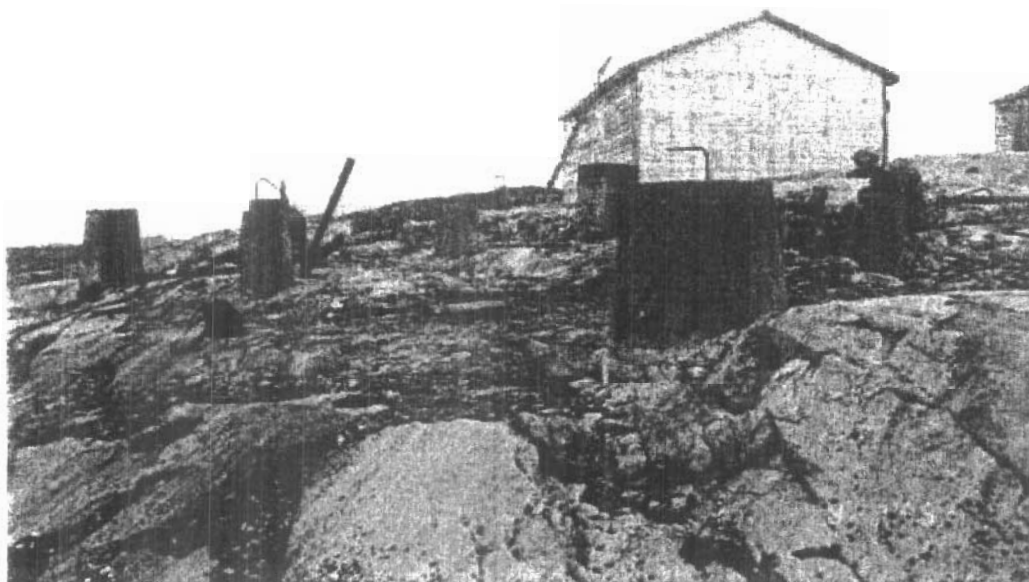
Photograph III-3: The Main House and Concrete Supports as seen from the north. Sampling locations 8411 and 8412 are indicated in the foreground.

Cleanup requirements for the main site therefore involve the excavation of soil around the buildings, foundation and drainage courses, and the cleanup of debris, hazardous and nonhazardous. The estimated volume of DCC II soil is 230 m³. The estimated volume of leachate toxic soil is 10 m³.

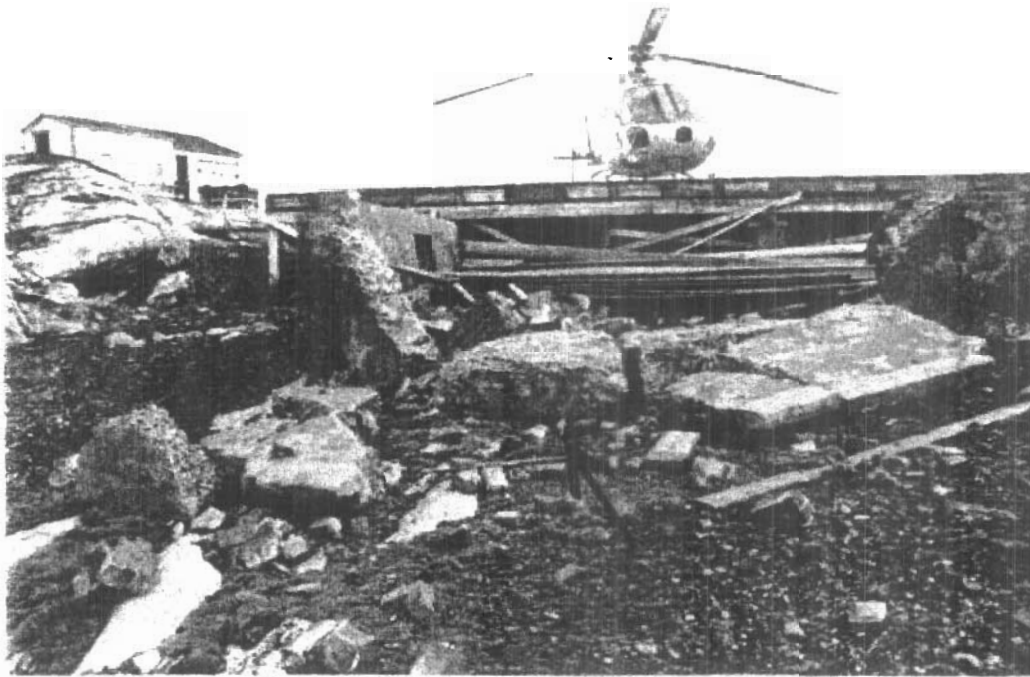
Photograph III-5: The Helipad as seen from the north. Sampling location 8442 is indicated by the arrow. The Winch Shed can be seen to the east.

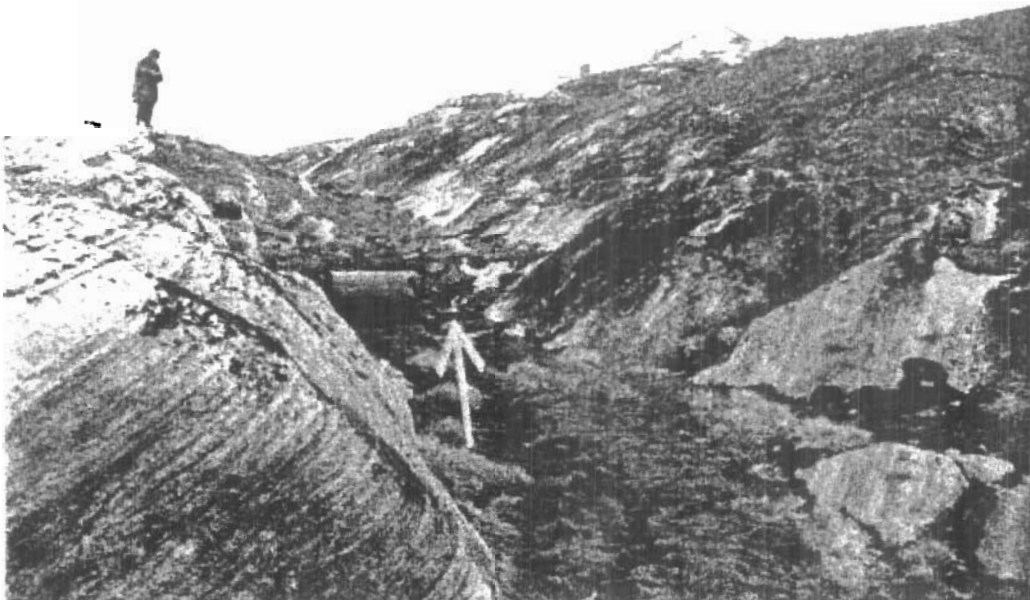
Photograph III-6: A Small Dump Area located to the northeast of the Main House. Sampling location 8417 is indicated by the arrow.

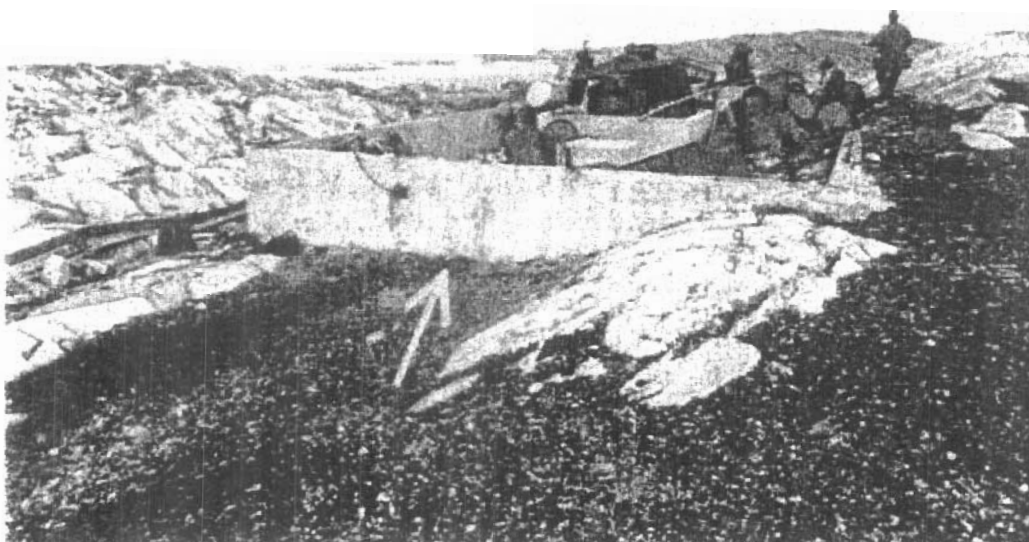
foundation is to the west and south east of the foundation (Photograph III-8 and III-9). The drainage to the west reaches the sea at approximately 30 m while the drainage to the southeast drains to the interior of the island. These features are shown on Map III-2.

Photograph III-8: The Generator Building Foundation as seen from the southeast. Sampling location 8453 is indicated in the foreground.

Cleanup requirements for the generator building foundation therefore involve the excavation of soil from around the foundation, and the cleanup of debris, hazardous and nonhazardous. The estimated volume of DCC II soil is 70 m³. The estimated volume of leachate toxic soil is 10 m³.

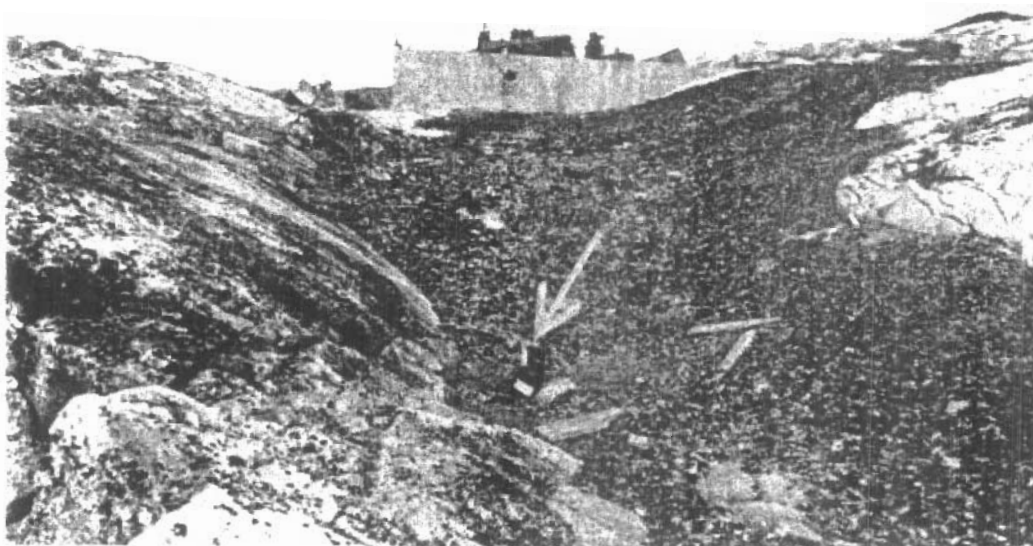
Photograph III-9: The Generator Building Foundation as seen from the southeast. Sampling location 8463 is indicated in the foreground.

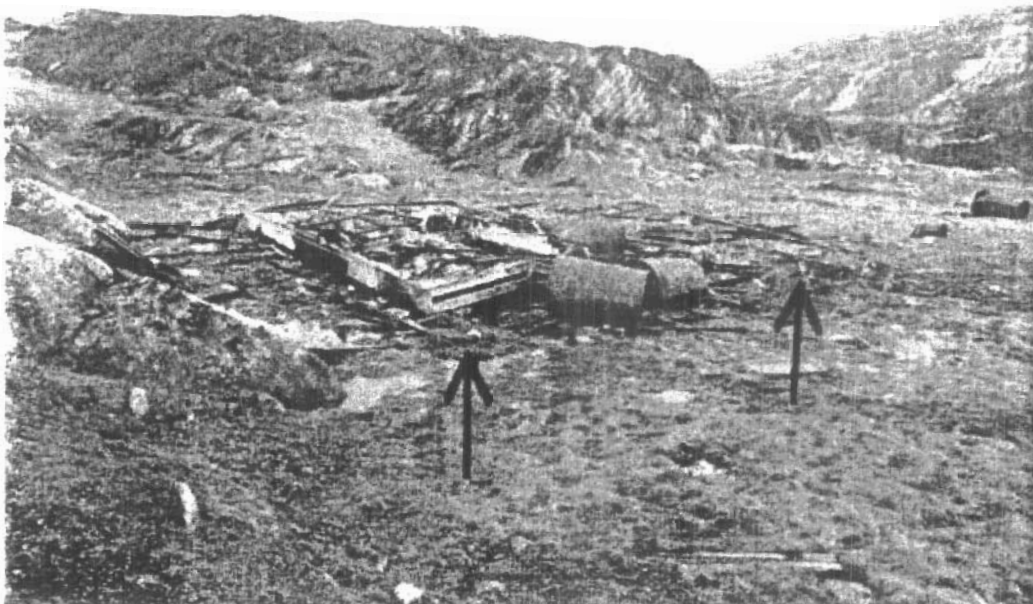
The beach area at Radio Island drains into Acadia Cove to the north. The beach is a fairly small area (1800 m²) receiving drainage from the main site. Located on the east side of the beach are the remains of a burnt out house (Photograph III-10). A large pile of coal (anthracite), a suspected dump, two barrel piles consisting of empty rusted barrels are also present at the beach area. These features are shown on Map III-3.

Photograph III-10: The remains of a structure at the Beach Area. Sampling locations 8427 and 8428 are indicated by the arrows.

requirements for the beach area involve the excavation of soil from the two locations, and the cleanup of debris, hazardous and nonhazardous. The estimated volume of DCC II soil is 10 m³.
