**ENVIRONMENTAL MONITORING PROGRAM  
RESOLUTE BAY AIRPORT LANDFILLS, RESOLUTE BAY, NUNAVUT**

**PSPC PROJECT R125284.001  
CUSTODIAN: TRANSPORT CANADA**

December 13, 2023

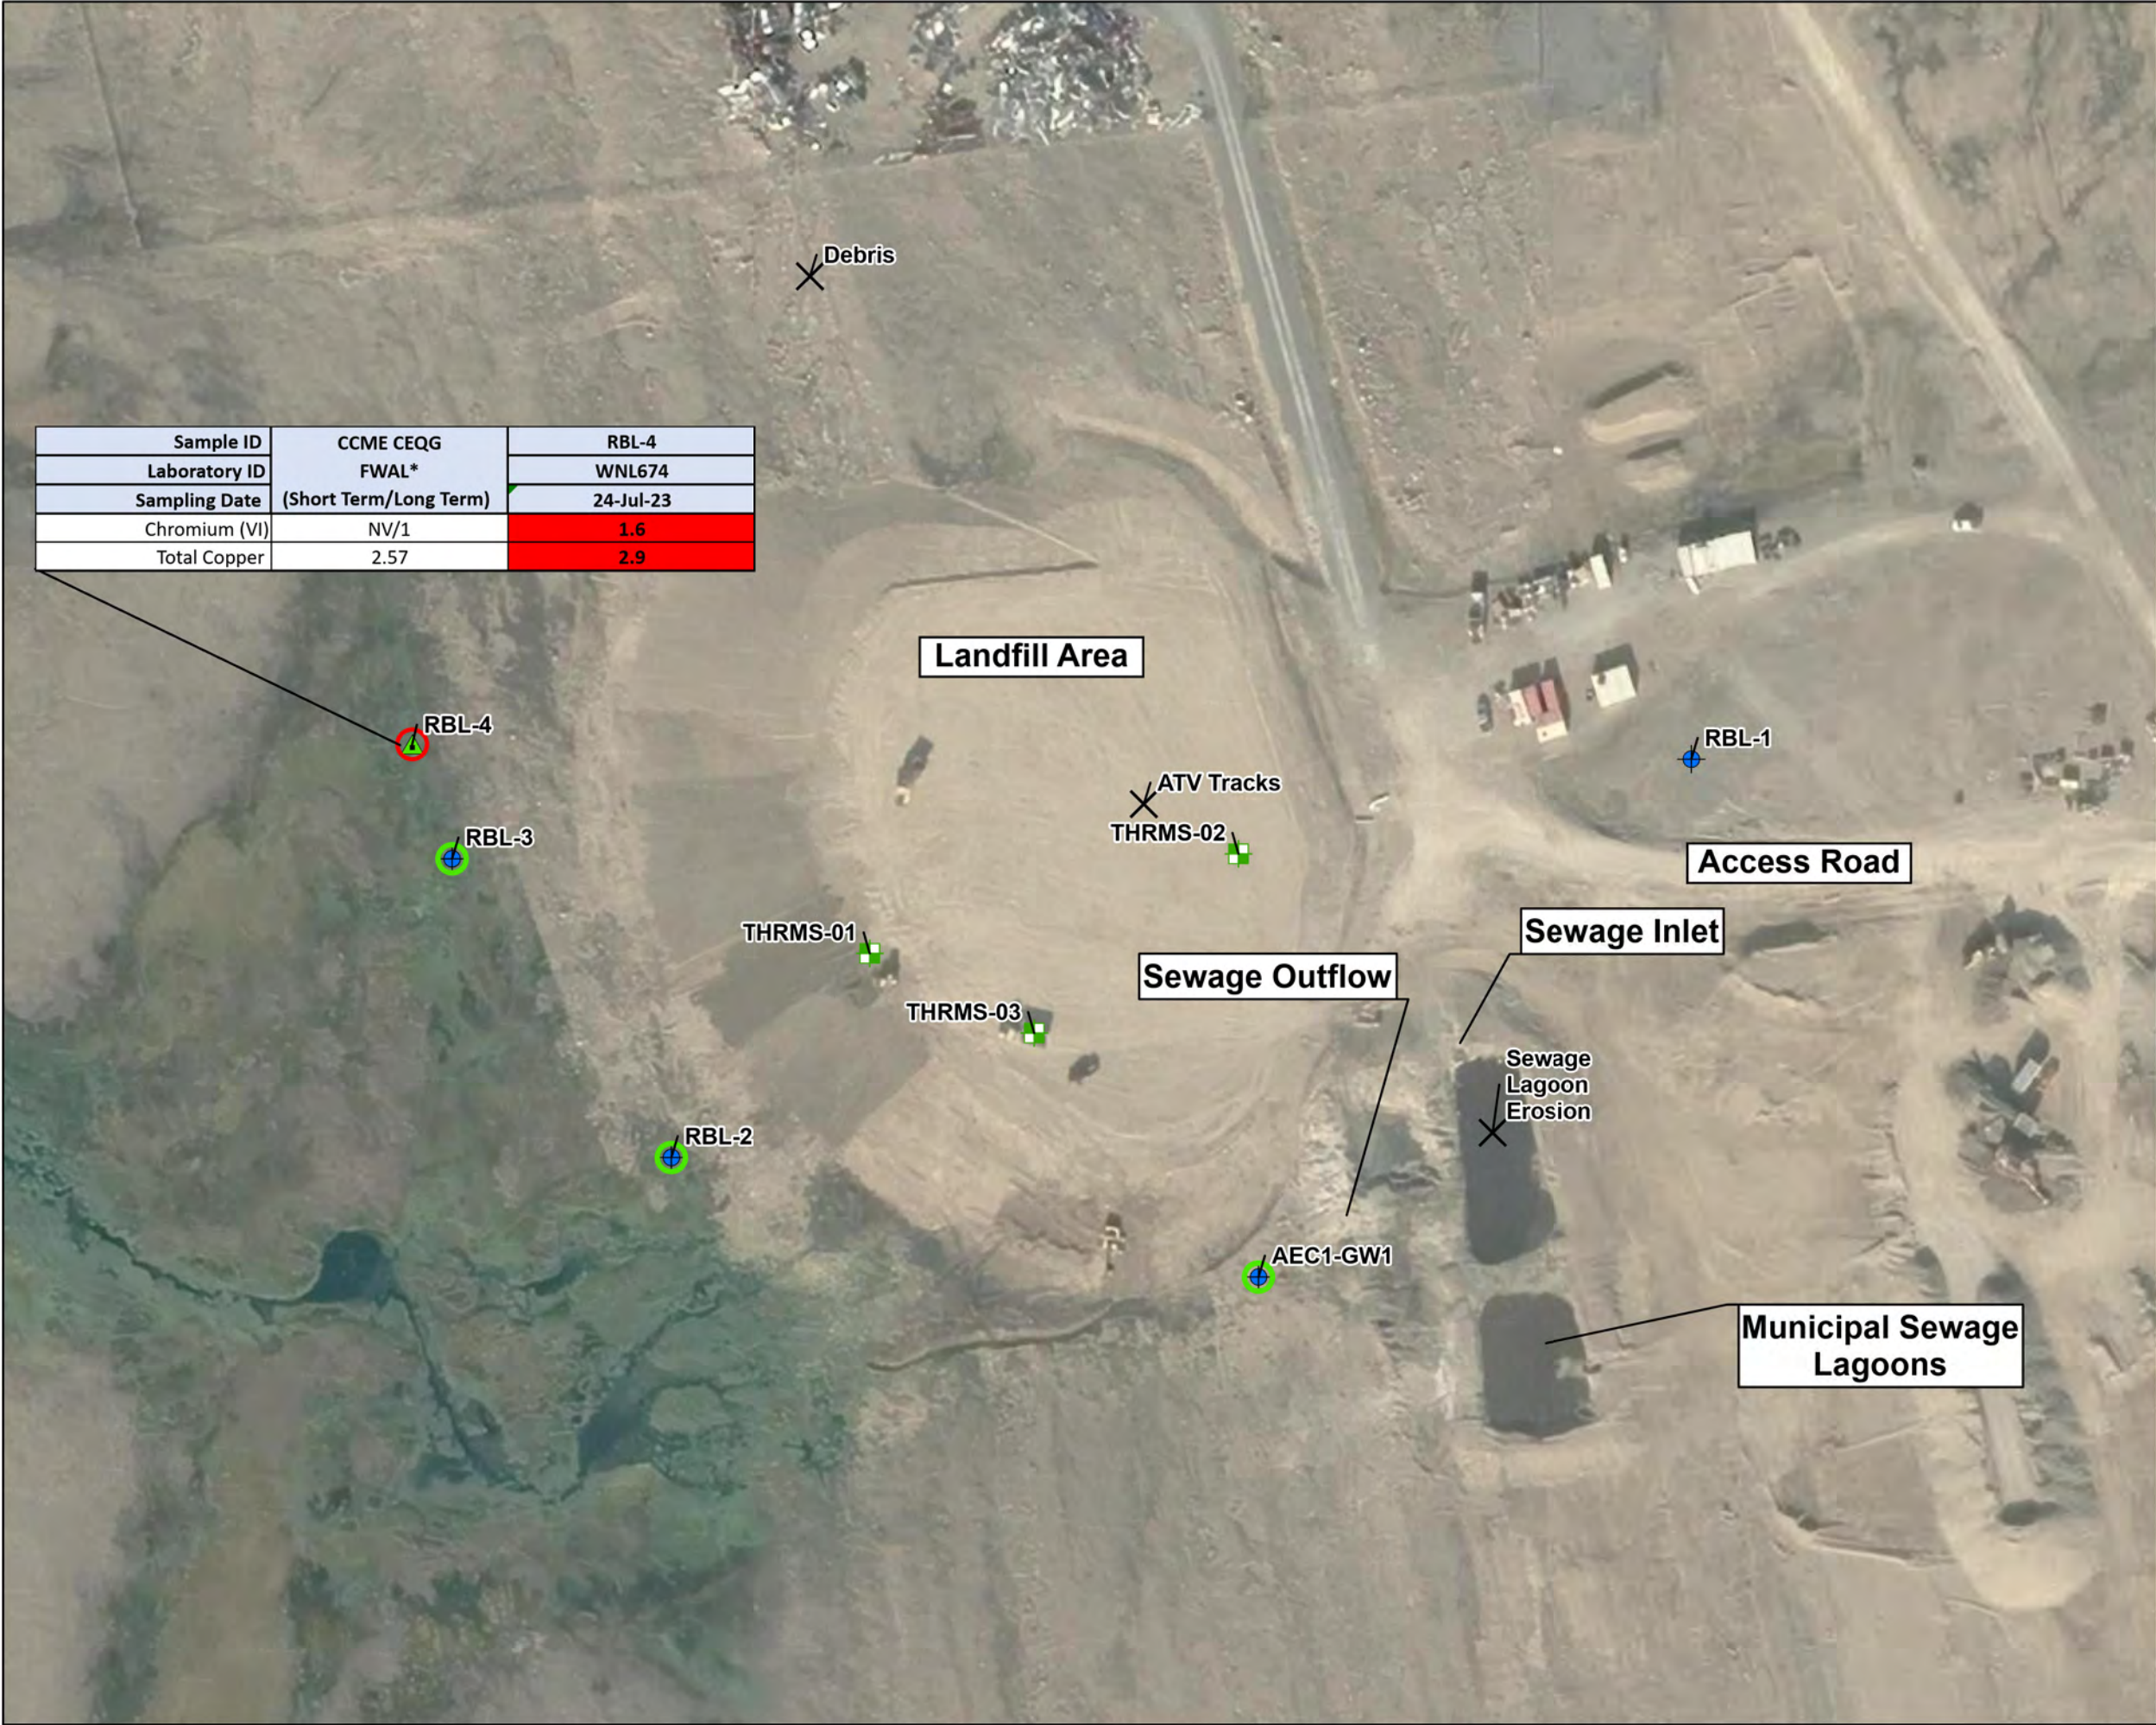
PROJECT # 230427		DATE November 24, 2023	
DRAWN ZS	CHECKED JF	FIG NO. 02	REV 0

Sample ID	CCME CEQG	RBL-4
Laboratory ID	FWAL *	WNL674
Sampling Date	(Short Term/Long Term)	24-Jul-23
Chromium (VI)	NV/1	1.6
Total Copper	2.57	2.9

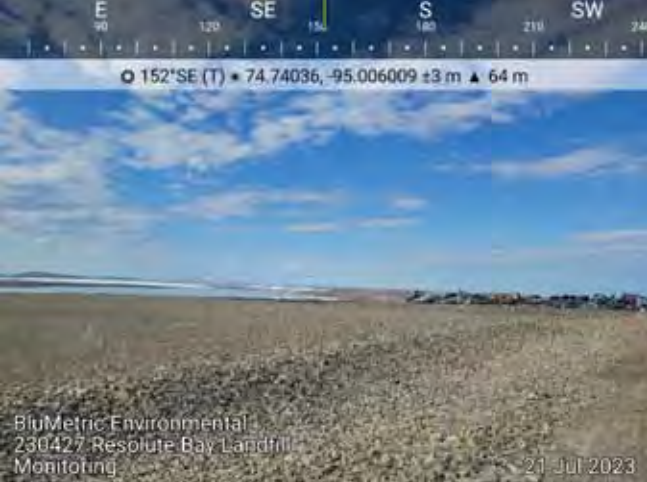
<p>Photo 4</p> <p>Viewing Direction: Facing Northeast</p> <p>Description: View of Drainage swale and landfill plateau.</p>

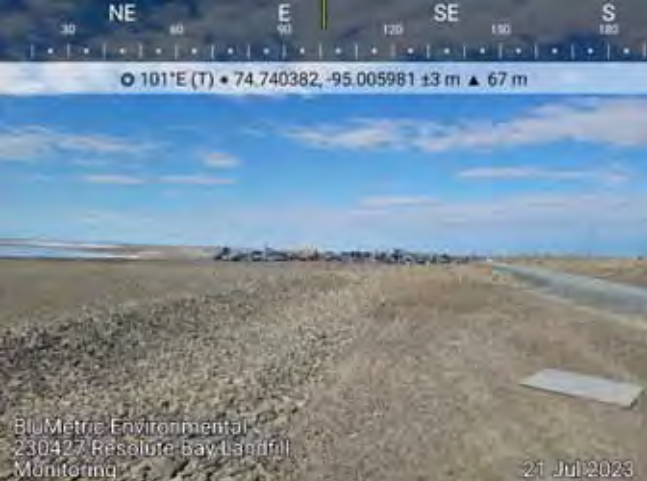
<p>Photo 5</p> <p>Viewing Direction: Facing North</p> <p>Description: View of drainage swale and adjacent Metal waste depot in background.</p>

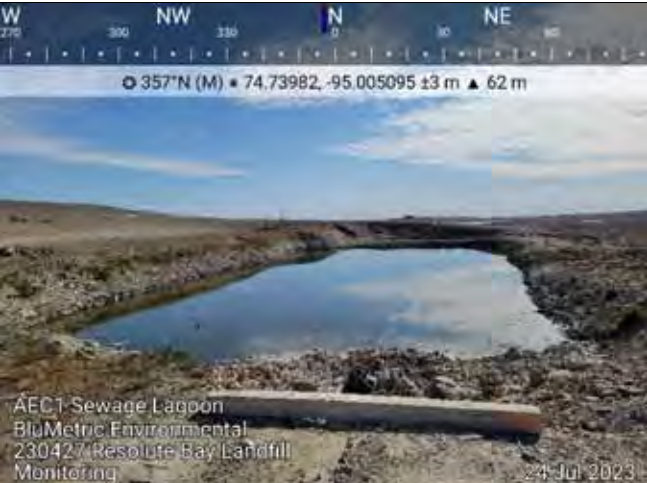
<p>Photo 6</p> <p>Viewing Direction: Facing South</p> <p>Description: View of sewage lagoons. Evidence of overflow along west edge.</p>

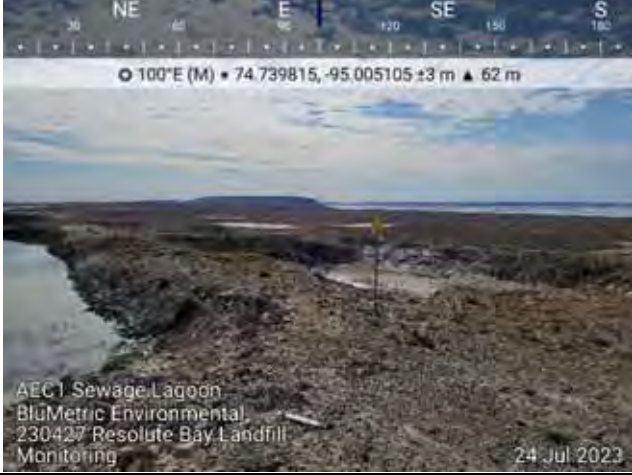
<p>Photo 7</p> <p>Viewing Direction: Facing Southwest</p> <p>Description: View of sewage lagoons. Evidence of overflow along west edge.</p>

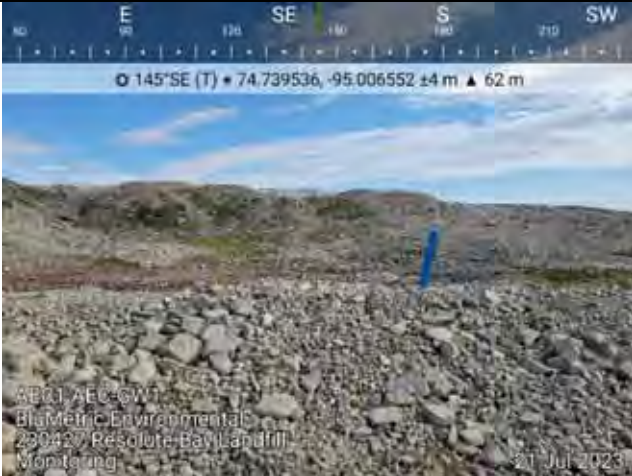
<p>Photo 8</p> <p>Viewing Direction: Facing Southeast</p> <p>Description: View of monitoring well AEC1-GW1 (downgradient from sewage lagoons)</p>

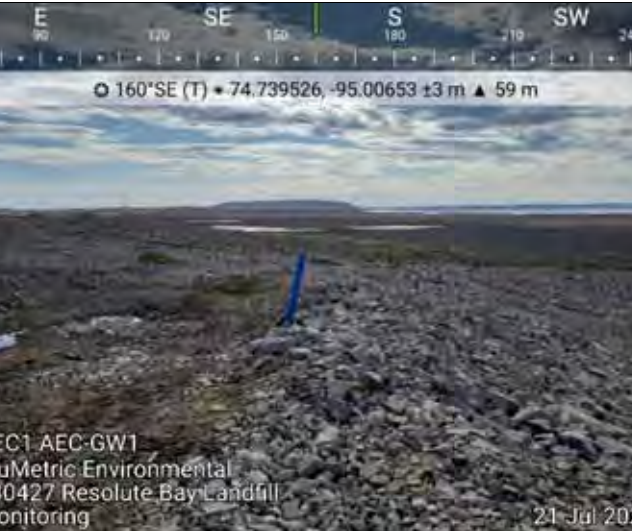
<p>Photo 9</p> <p>Viewing Direction: Facing west</p> <p>Description: View from AEC1-GW1 showing drainage swale and landfill slope</p>

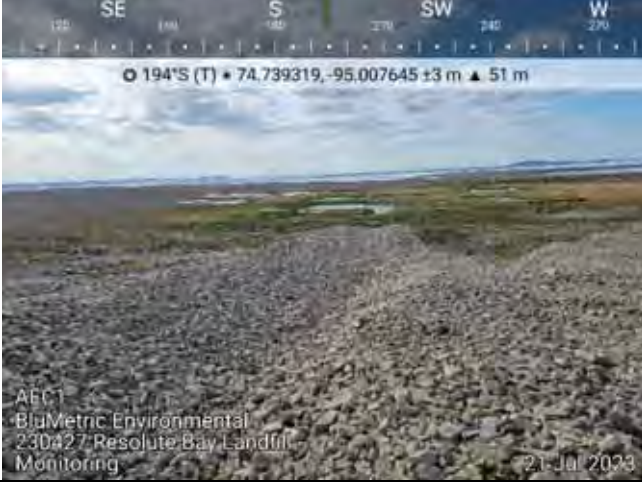
<p>Photo 10</p> <p>Viewing Direction: Facing West</p> <p>Description: Viewing of south drainage swale end point at toe of landfill</p>

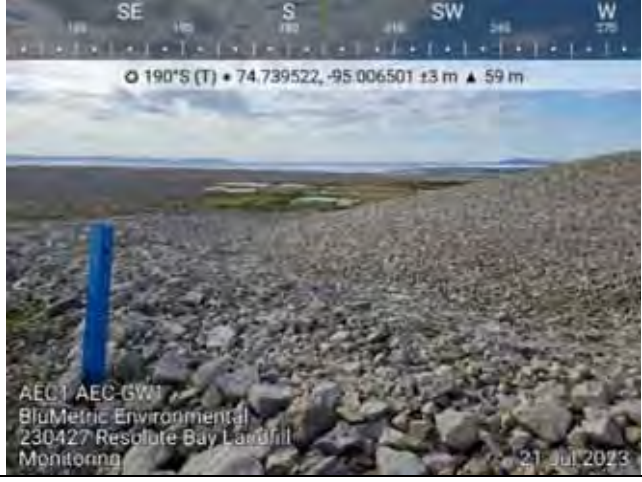
<p>Photo 11</p> <p>Viewing Direction: Facing Northwest</p> <p>Description: View of landfill toe/slope at south drainage swale</p>

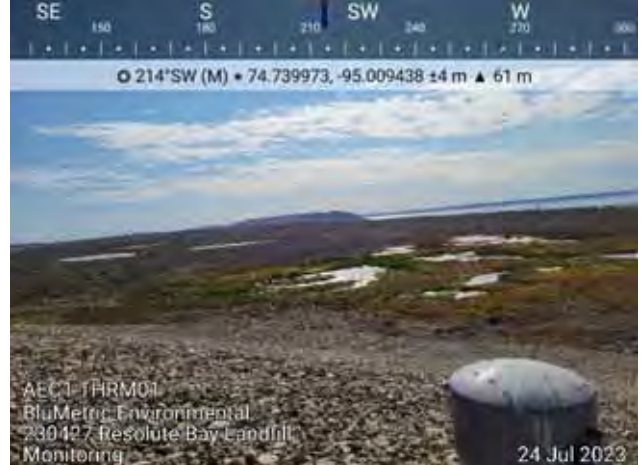
<p>Photo 12</p> <p>Viewing Direction: Facing South</p> <p>Description: View of south drainage swale/landfill toe taken from landfill crest. Thermistor 1 in foreground.</p>

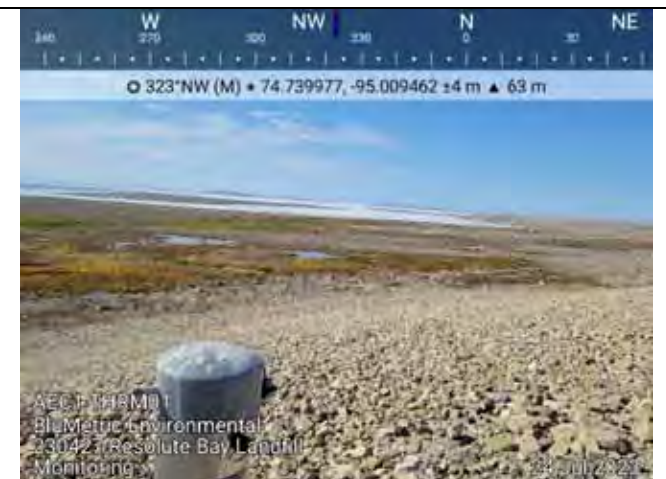
Photo 15
	Viewing Direction: Northwest
	Description: View of wetlands at toe of landfill, taken from landfill crest. Thermistor 1 in foreground.

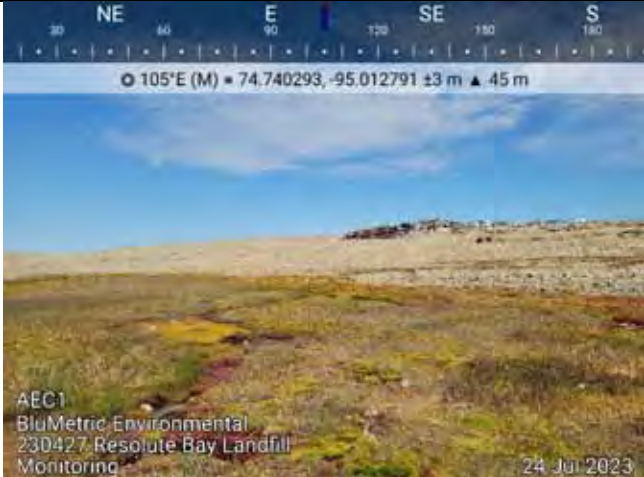
Photo 16
	Viewing Direction: Facing Northeast
	Description: RBL-4 surface water location with Metal Waste depot in background

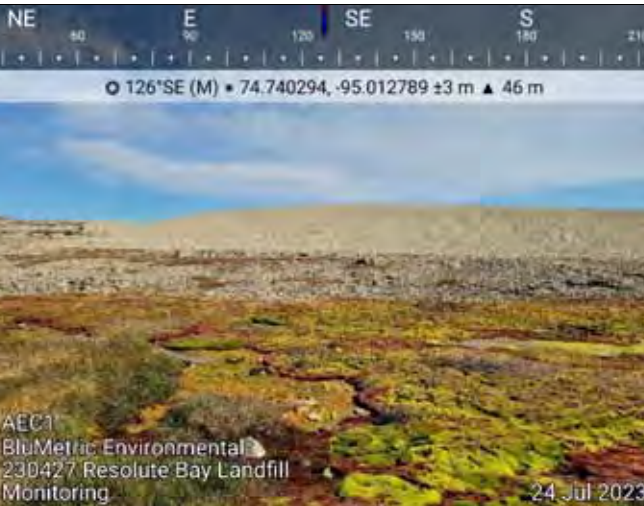
Photo 17
	Viewing Direction: East
	Description: RBL-4 surface water location with landfill in background

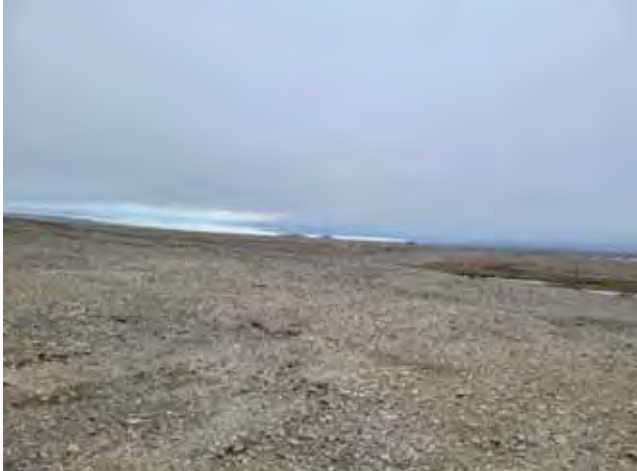
Photo 7
	Viewing Direction: West
	Description: View of drainage swale in North portion of landfill.

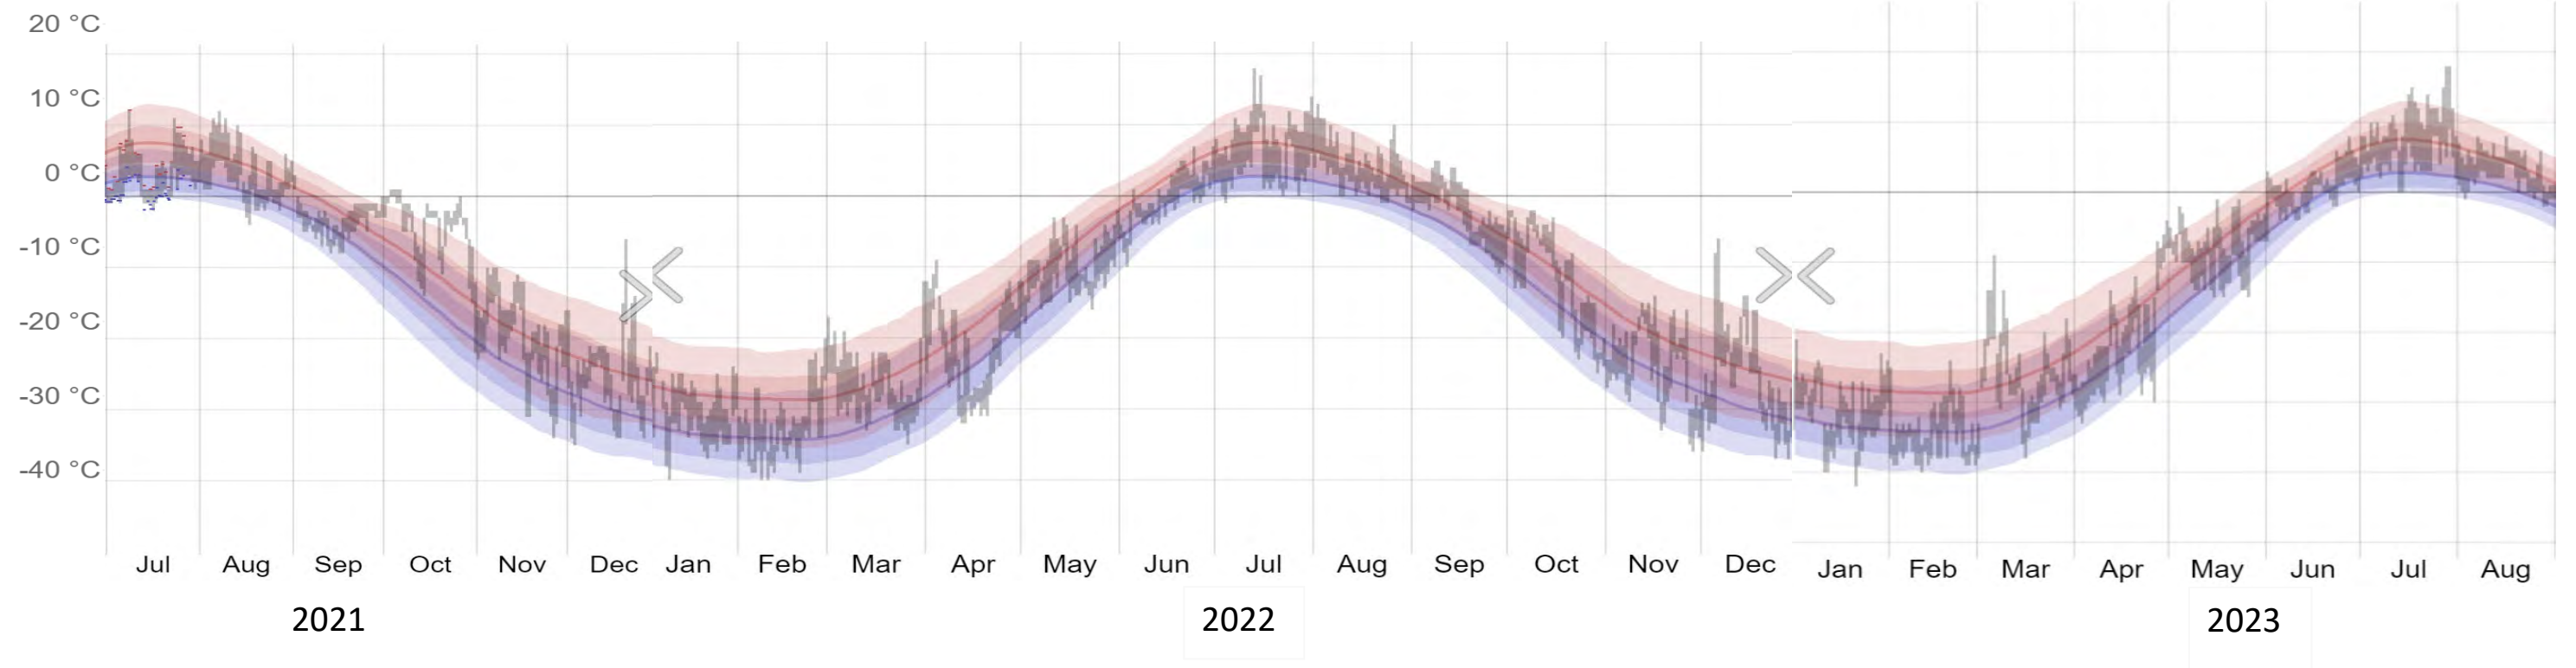
Thermistor data at AEC 1 indicates that the temperatures recorded at depth correlate to the rise and fall of atmospheric temperatures in Resolute, which is similar to previous observations. As expected, and as seen in previous monitoring events (Dillon Outcome Joint Venture [DOJV], 2023), temperatures near surface fluctuate the most as the probe is physically closer to, and therefore more exposed to, atmospheric temperatures, while deeper temperatures vary less annually. Permafrost appears to have aggregated from 1.5 to 2.75 m over the first and second winter after thermistor installation, and the active layer is between 1.25 and 1.50 m, as inferred from plotted thermistor data.

Thermistor 1- Average Temperature at Depth
