# SUMMARY OF 2002 ACTIVITIES

## RESOLUTION ISLAND PROJECT

BAF-5 : ABANDONED POLE VAULT MILITARY RADAR STATION

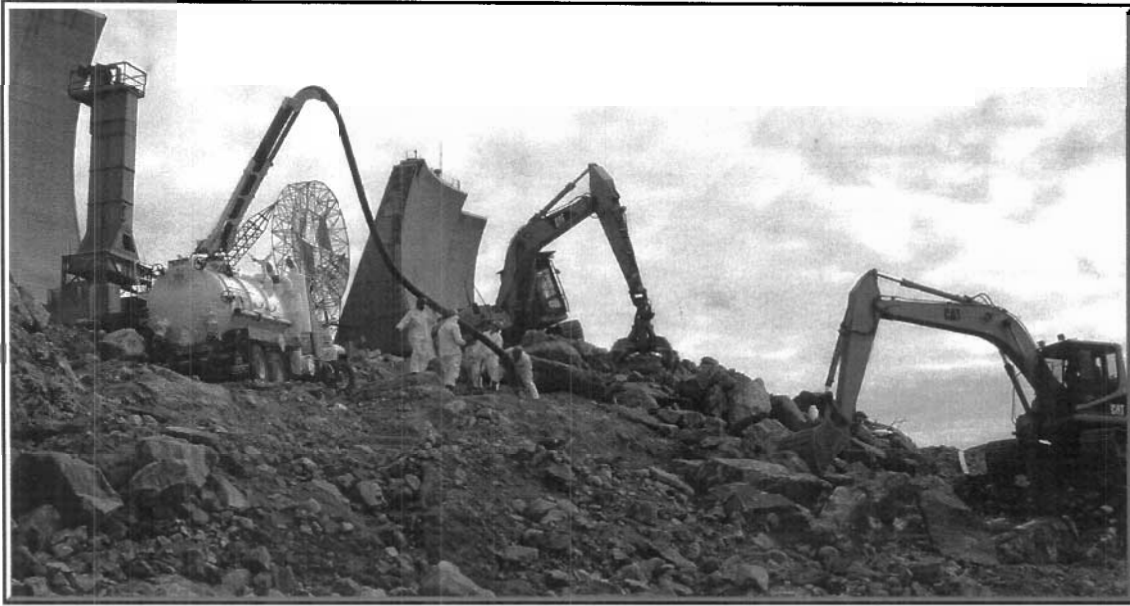
The removal of CEPA soil started on July 23, and continued until August 25. The 315 excavator equipped with the ditch bucket was used to load soil into an International dump truck. The excavation began with the removal of > 2000 soil in the valley below the access road (*i.e.*, quadrants K14, K15). This was followed by the removal of soil slightly down gradient from that area (*i.e.*, quadrants K17 and L17). Excavation work then proceeded back (*i.e.*, up gradient in the valley) towards the screening plant, as well as along the access road, also going back towards the screener. Working on two fronts, alternating soil removal between the valley and the access road minimized down time while waiting for analytical results.

**Photograph 3.1      Excavation and Vacuuming of CEPA Soil in S1/S4 Valley**

The vacuum truck was also used to remove CEPA soil down to bedrock, and in hard to reach areas (*i.e.*, cracks and crevasses). Soil vacuuming was only required in certain areas (*i.e.*, quadrants J13, J15, K13 to K17, L16, and L17). In certain areas, an access road was built over the cleaned surface for the vacuum truck to progress, and reach further areas. These access roads were built using pit run placed, and compacted with a loader.

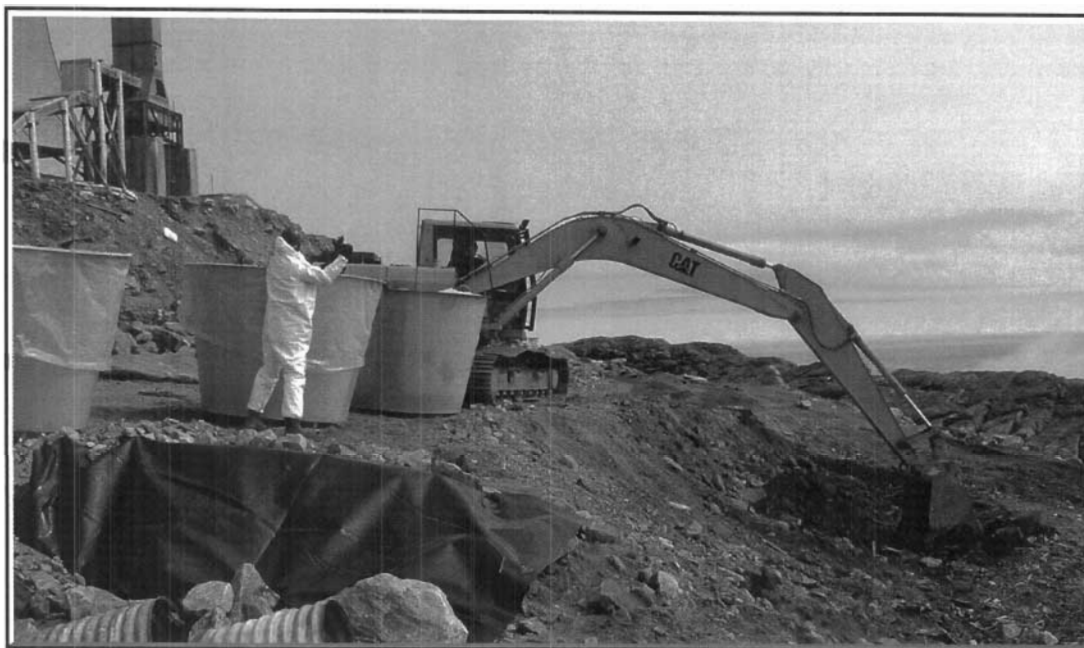
**Photograph 3.2      Excavation of CEPA Soil (> 2000 ppm) in S1/S4 Valley**

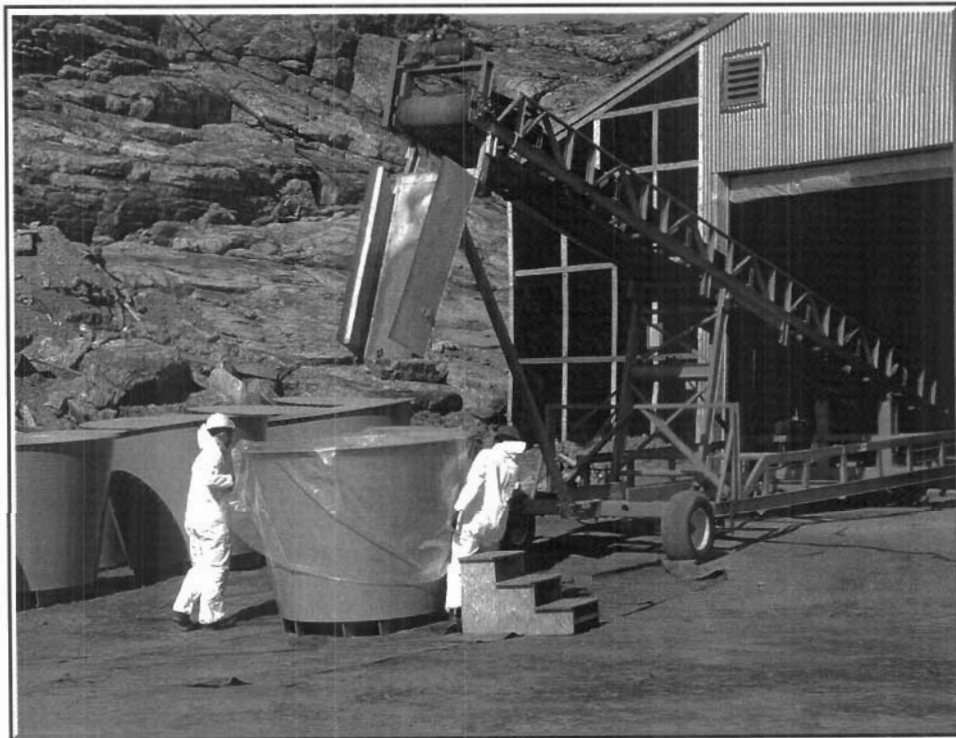
As for the screened CEPA soil stored inside the Main PCB Storage Building, it was transferred into steel containers by using a newly purchased mobile conveyor system. The intake conveyor hopper was placed inside the building while the discharge end was located outside the building. The crew working in the building used a Bobcat mini-loader to feed the conveyor. At the other end of the conveyor belt, the soil was discharged into a container, sitting on a containment pad made of HDPE membrane. An IT38 loader was used to move the containers (empty and full). Once filled, the containers were brought to the lid positioning and bolting platform. A total of 176 containers were filled with CEPA soil ( $> 50$  ppm but  $< 2,000$  ppm).

**Photograph 4.1      Soil Containerization Operations**

Containerization operations began at the east end of the building but quickly ceased when frozen soil was encountered. The conveyor was then moved to the west side of the building where operations resumed, and continued until all available containers were filled. A total of 14 days, including down time (e.g., maintenance, bad weather, crew change, etc.), was required to fill the 176 containers. A maximum of 31 containers were filled, and bolted shut in a single day, but on average, 16 containers were filled daily.

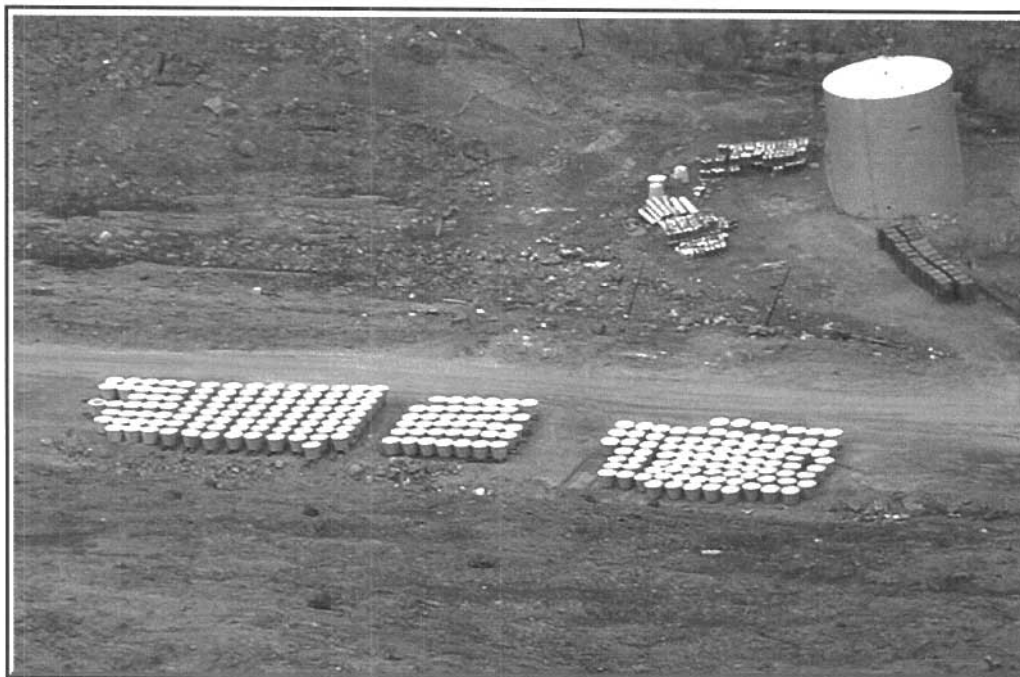
near the NH waste landfill. Initially, pallets of waste fuel, construction materials, and a stockpile of screened sand had to be moved to clear the way. The area was then backfilled with screened sand and leveled. Afterwards, creosote timbers were placed on the level ground, and used as the foundation on which to stage the containers. All of the 234 soil filled containers were placed on this storage pad. The staging area is presented on the Project Drawings as well as on Photograph 4.2.

**Photograph 4.2**      **CEPA Soil Containers (234) at the Beach Staging Area; and, New Location of DND Soil Filled Red Vaults (near POL Tank)**

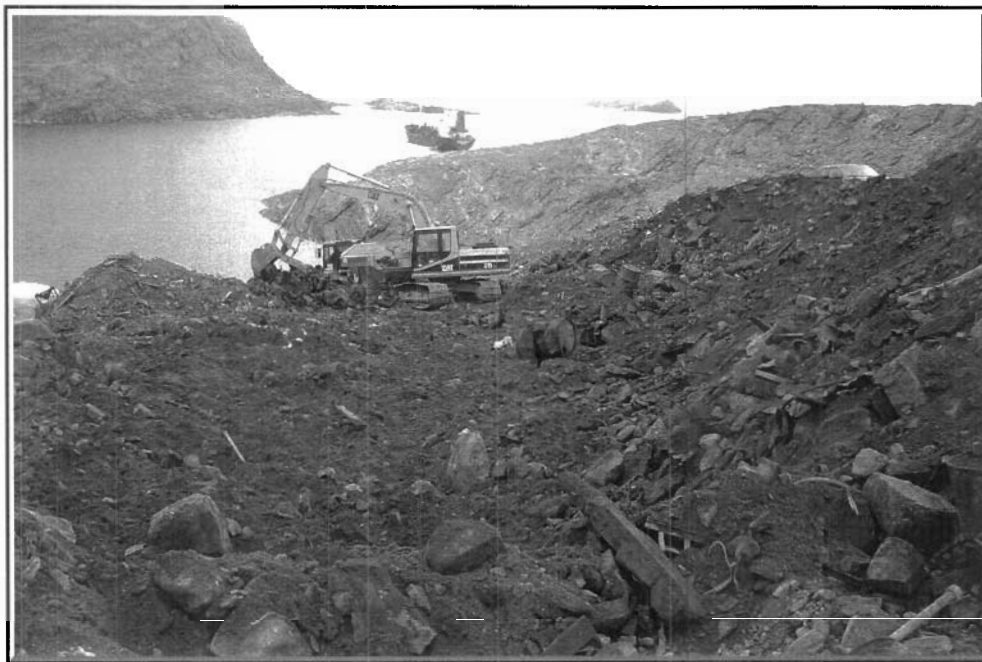
The clean up of the Beach Dumps (*i.e.*, Lead Beach Dump and New Beach Dump) was conducted between July 20, and August 24. Work proceeded slowly due to the presence of permafrost. Excavation of debris was carried out until permafrost was encountered. This was then followed by a period of thawing that lasted a few days. Excavation operations, and thawing periods were carried out alternately during the whole season.

**Photograph 5.1: Excavation of Waste Debris at the Lead Beach Dump**

The 315 excavator with thumb attachment was used to pick debris items out of the dumps. Drums containing liquids were segregated and put aside for further inspection and sampling. Most drums encountered during the clean up were empty, however a few were found to contain some liquid. These liquid containing drums were put aside and temporarily stockpiled on spill pans. They were later sampled and analyzed by the ASU laboratory. Once the liquid was sampled, it was pumped from the old drums, and spill pans into sound drums. The new drums were then managed

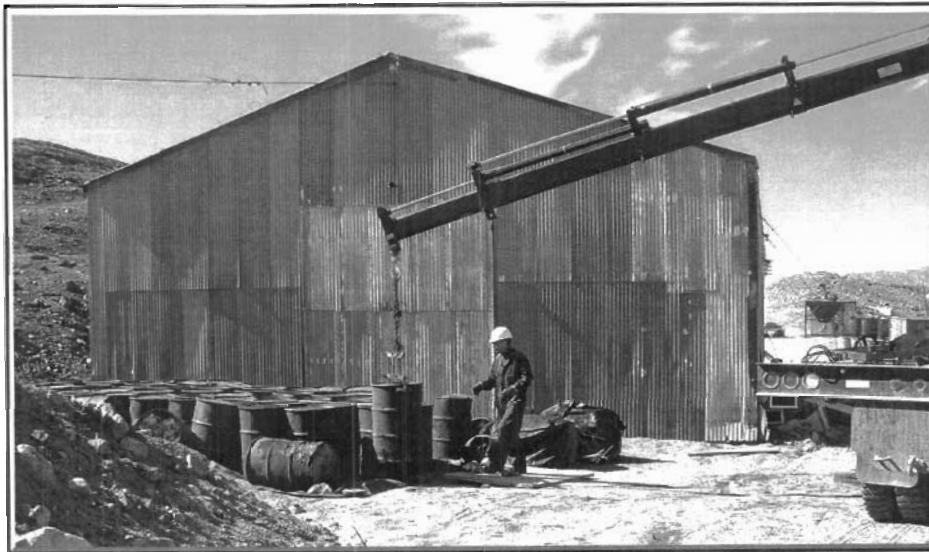
Some of the drums stored inside the warehouse at the end of 2001, awaiting sampling and analysis, leaked on the floor over the winter. These drums were sorted, and transferred into overpack drums, and then placed on pallets and strapped. The oily floor was then cleaned up by spreading sorbent material on the floor. The oily sorbent was recovered, and placed in a waste wrangler which was stored in the warehouse.

**Photograph 5.2: Drums of Waste Grease Removed from Storage Area**

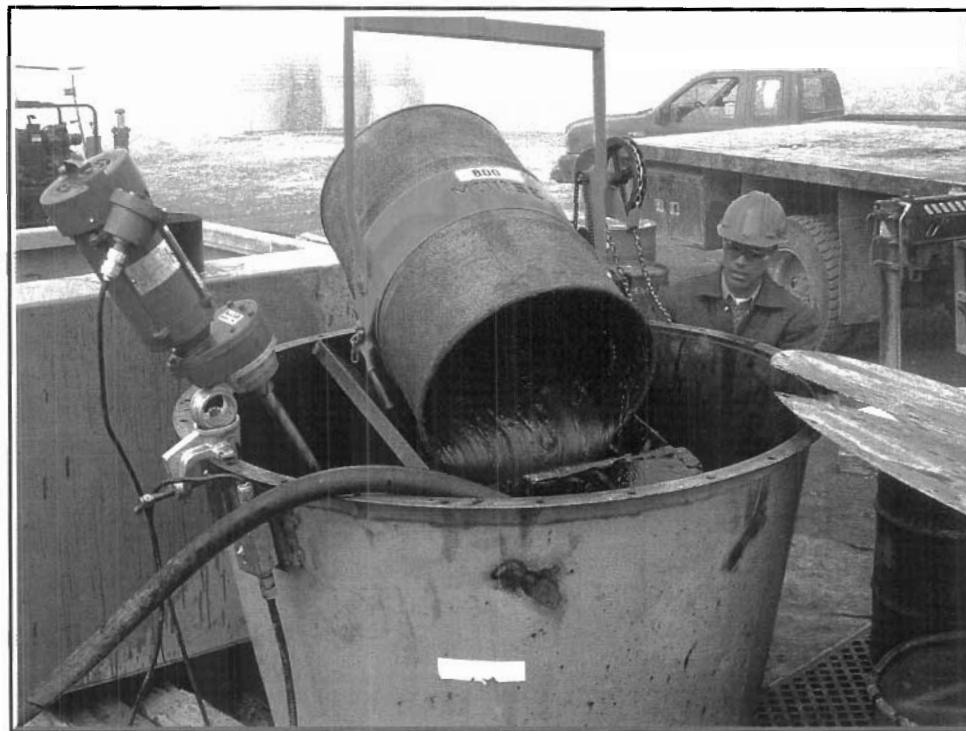
on their sides, and facilitate the draining of their contents. An explosion proof propeller mixer (2 HP) was installed on the mixing tank.

At first, each mixing batch consisted of three (3) drums of fuel and two (2) drums of grease (i.e., 1.5/1 ratio). After a while, the dilution factor was increased in order to improve the burning efficiency. The mixing batches then consisted of four (4) drums of fuel and two (2) drums of grease (i.e., 2/1 ratio). Overall, the average fuel/grease dilution ratio was approximately 1.7/1.

**Photograph 6.1: Grease Drum Being Transferred to Mixing Tank**

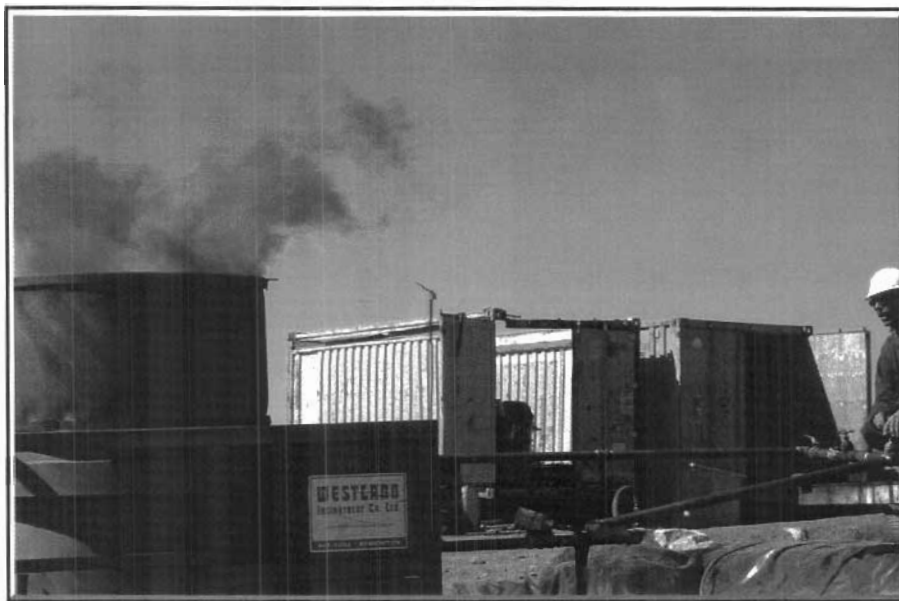
Drums of waste POL products were hauled from various locations (*i.e.*, hazardous waste storage facility, beach POL tank storage area, land, etc.) to the incineration platform by using the 14-tonne HIAB boom truck. Prior to processing, drum identification numbers were logged. Air powered diaphragm pumps were used to transfer the waste oil, and fuel, from drums (staged on a spill pan) to a temporary holding/settling tank (*i.e.*, wheel tank). The POL products were then pumped from the top of this holding tank to the incinerator feeding tank. The diluted grease mixture, as mentioned previously, was pumped from the mixing tank directly into the feeding tank.

**Photograph 6.2: Incineration Operations**

Incineration of the grease mixture proved a little more difficult than the regular waste oil and fuel mixtures. Small pockets of water, often trapped inside grease globules, occasionally caused irregular burning, and sometimes even extinguished the fire. For this reason, the proportion of fuel in the grease mixture was slightly increased in order to improve the calorific value of the mixture as well as the burning efficiency.

Furthermore, grease particles trapped in various restrictions along the piping (*i.e.*, elbows, tees, and valves) caused partial clogging of the lines and reduced flow rate. In order to clear the lines and maintain a constant flow rate, the feeding lines were tapped on a regular basis with a blunt steel object, particularly near restriction points. During the incineration of the grease mixture, constant attention, and frequent manual adjustments were required.

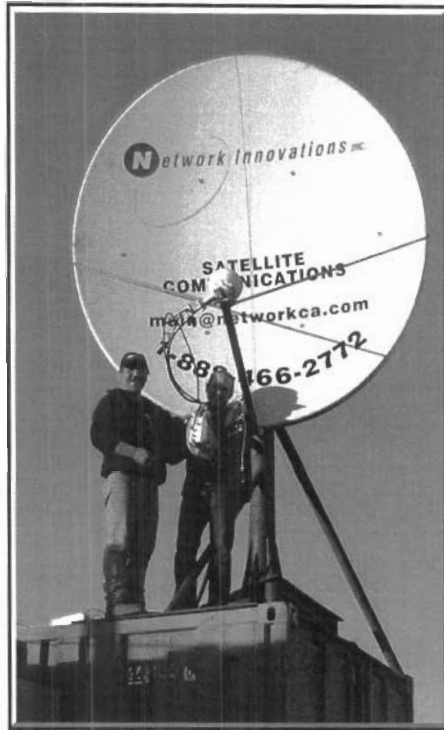
During the 2001 season, a new communication system was installed on site. At the beginning of the 2002 season, the feed-horn on the satellite dish was damaged. The defective part was shipped out and replaced by the service provider (*i.e.*, Vancouver Teleport) who sent a technician on site to install a new feed-horn, and start the system up for the season.

**Photograph 7.1: Replacing Parts on the Communication Dish**

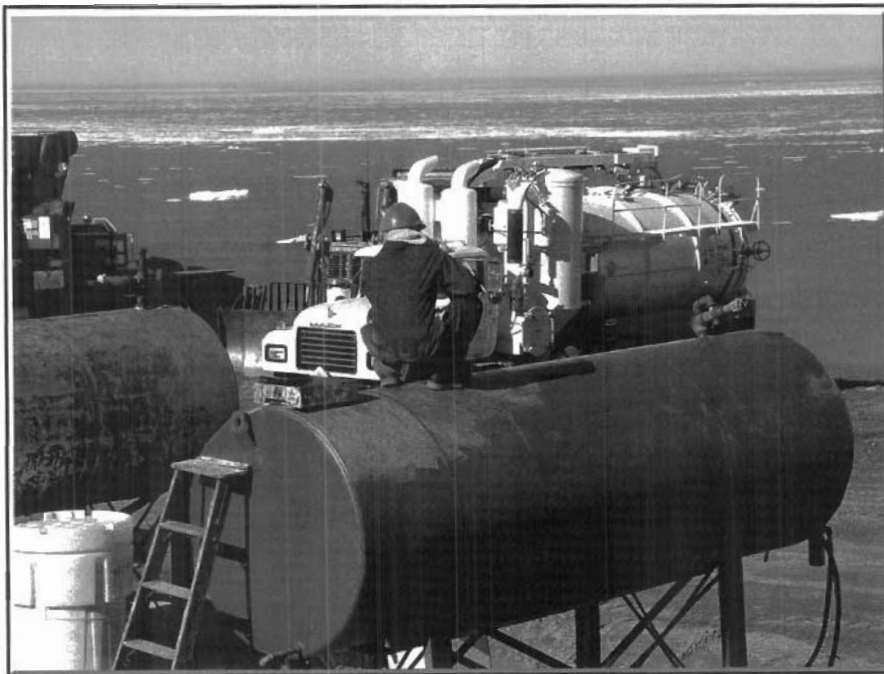
**Photograph 7.2:      Painting the Gasoline Tank Near the Core Camp**

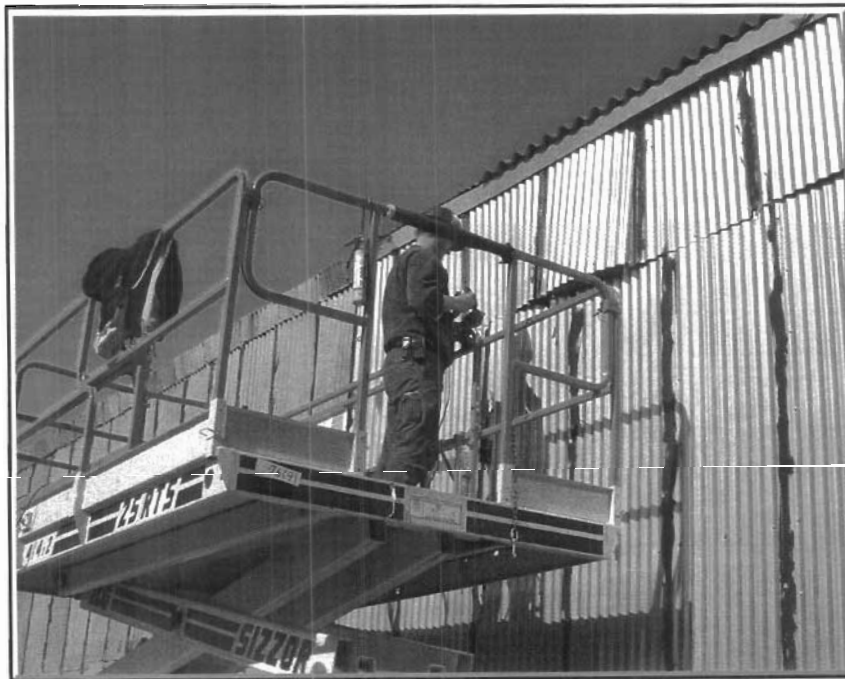
**Photograph 9.1      Repairs to Main PCB Storage Building Cladding**

During the off-season, the two (2) garage doors of the main PCB storage building were damaged by the elements. Once opened, the badly warped doors were taken apart. Each door panel was removed, straightened, and then reinforced before being re-installed. Strong winds also loosened, and detached some pieces of steel cladding on the side of the main PCB storage building. The cladding was repositioned and, screwed in place.

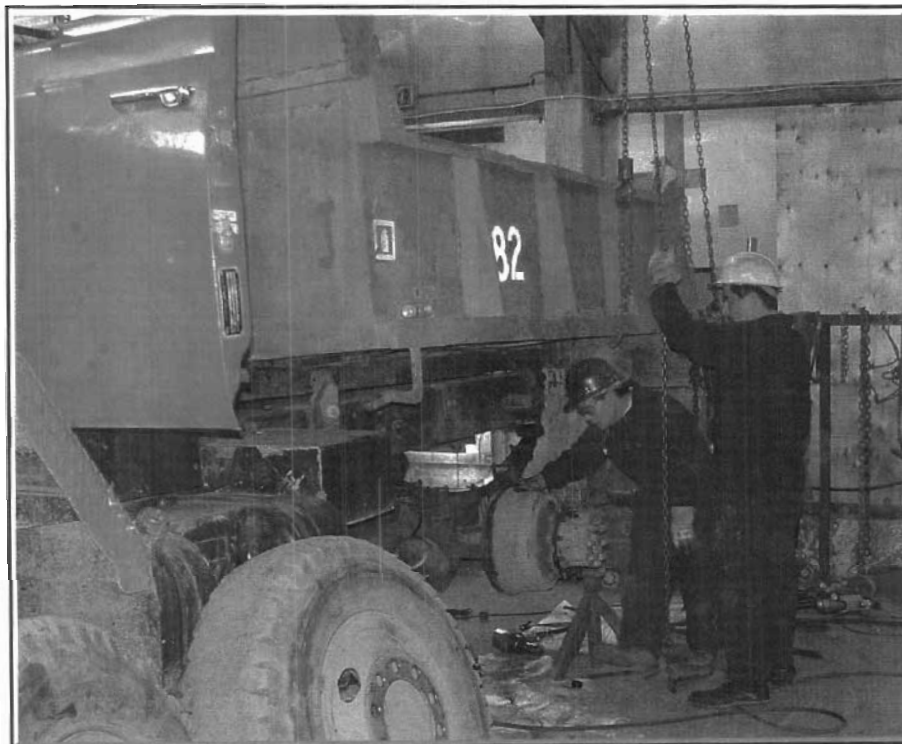
**Photograph 9.2      Repairs to Rear Axle of International Dump Truck**

- ▶ Repaired various pumps;
- ▶ Repaired hydraulic lines and stoppers on grapple attachment of excavator;
- ▶ Set up plasma welder for use as a power generator for the soil conveyor;
- ▶ Replaced the rear axle and differential on the water truck;
- ▶ Repaired the fuel pump on the fuel truck;
- ▶ Built and installed centre bolts on rear axle of International dump truck;
- ▶ Repaired a hydraulic leak on the HIAB boom;
- ▶ Conducted bodywork and paint job on Suburban truck and replaced injection pump;
- ▶ Replaced flat tires on various pieces of equipment;
- ▶ Repaired the muffler on the water truck.
