RE: NWB Permit No. NWB5RES9803 - Annual Report, Supporting Document

Resolution Island 2002 Scientific Investigations

Analytical Services Unit
Queen's University
Kingston, Ontario

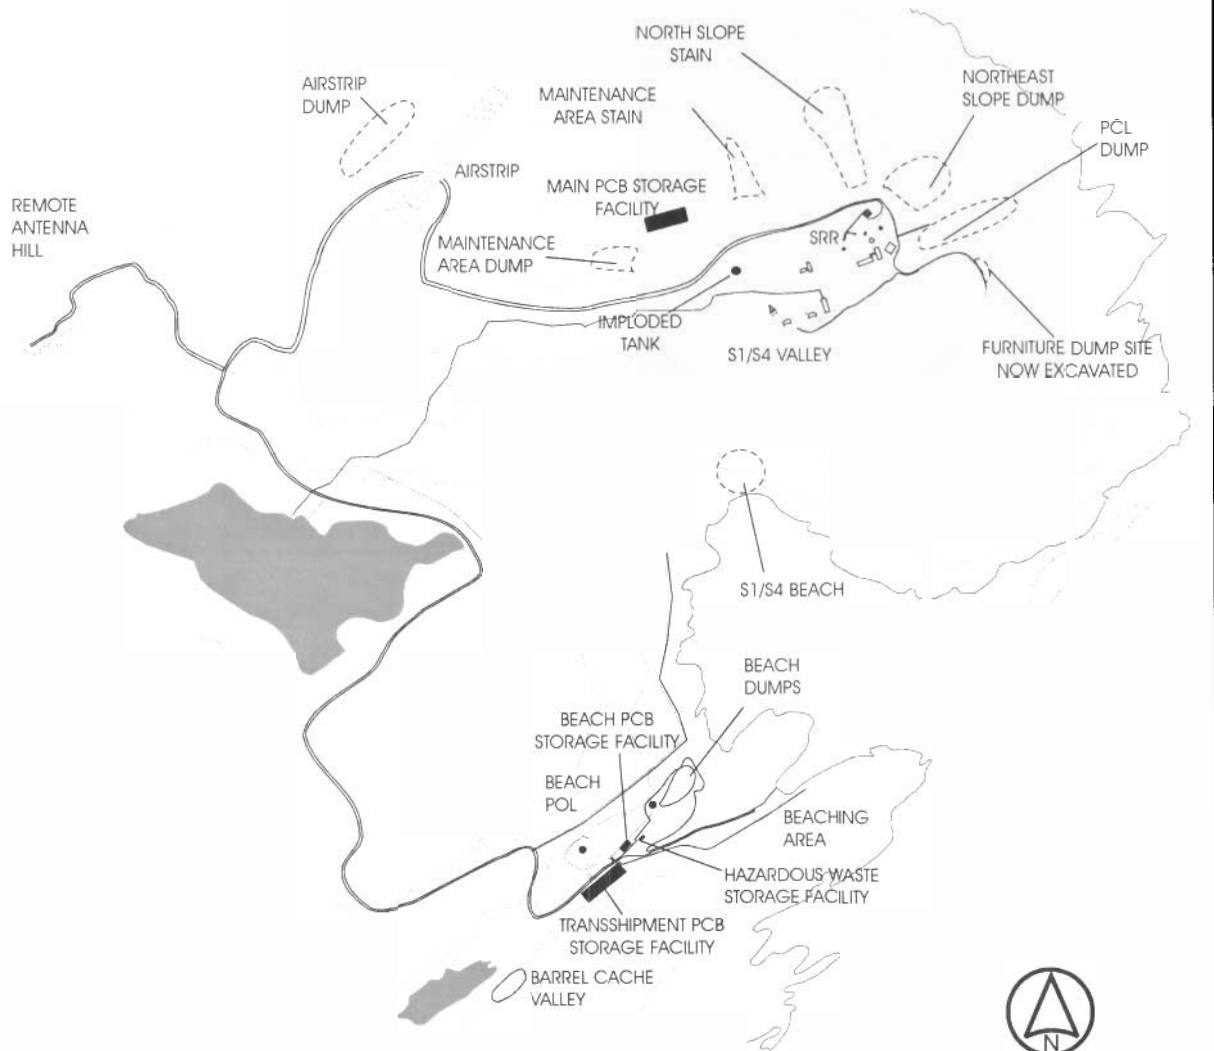
Map I-1: Location and General Layout of the Site at Resolution Island

This is the ninth year that the Analytical Services Unit (ASU) has conducted work at Resolution Island for Indian and Northern Affairs Canada (INAC). Over the period 1993-1996, environmental work at the site was detailed in a set of reports entitled “Environmental Study of a Military Installation at Resolution Island, BAF-5”. These reports¹ fully described items such as site characteristics, history, and previous investigations. Scientific investigations have continued and have been reported annually². From 1997 onwards, work at the site has been managed by the Qikiqtaaluk Corporation (QC) through a contribution agreement with INAC. This work started in 1997 with infrastructure improvements and expanded from 1998 onwards to include remediation activities and training. Map I-1 shows the location and general layout of the site at Resolution Island.

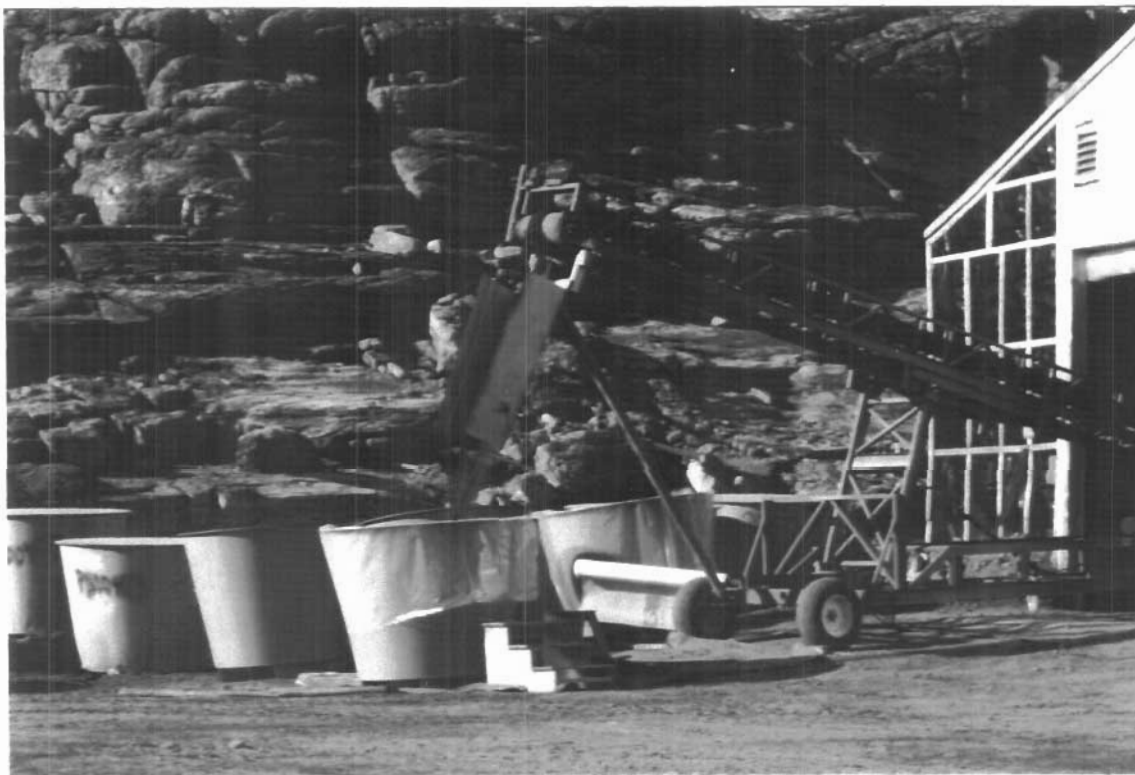
Photograph I-2: Filling the Conical Steel Containers with PCB Contaminated Soils from the Main PCB Storage Facility

Containerization of the soil into 3.1 m³ conical steel containers was commenced this year in preparation for shipment. The newly created transshipment PCB storage facility contains 234 filled containers which are ready to be shipped south. Before the containers can be received by Bennett Environmental a suite of analysis is required. A total of 14 samples were analyzed for particle size distribution, moisture content, pH, PCBs, total petroleum hydrocarbon, chlorobenzenes, dioxins and furans and metals.

The main accomplishments at the site for the year were the excavation of CEPA soil from the S1/S4 buildings and valley area (Photograph I-1) and the containerization of some CEPA soils (Photograph I-2). Excavation was not completed at the S1/S4 buildings and valley area and approximately 400 m³ of PCB contaminated soil remains. On site activities started late again this year and the season also closed early. A contract to send the filled steel containers to Bennett Environmental was not awarded due to contractual difficulties. This together with the decision by QC to close the site early enabled funds to be available for, amongst other things, the design, construction specifications, drawings and cost estimates for a Tier II landfill, the development of a new plan for the complete site remediation and research to support the design of permanent barriers at the site.

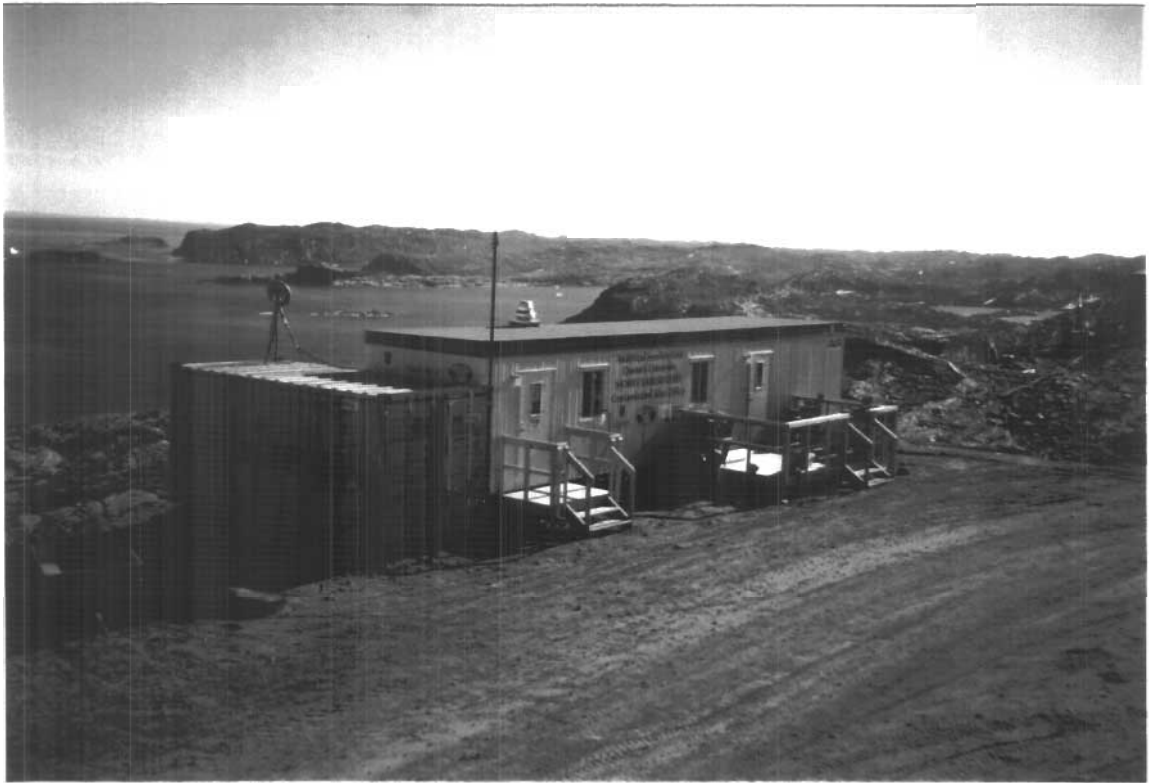
Photograph I-3: The Mobile Analytical Laboratory at the Site

The activities conducted at the site this year by the ASU and described in Chapters II-V of this report are listed below. There were four ASU personnel on site for most of the time this summer. Two people were generally required full time to operate the laboratory. The successful operation of the laboratory (Photograph I-3) ensured the ability to analyze PCBs and other parameters on site; this greatly facilitated the excavation and other activities on site. Equipment and supplies used by the ASU were flown to Iqaluit and transported into the site by helicopter or Twin Otter aircraft. The gas chromatograph was taken back to Kingston at the end of this year's field season for repairs and maintenance.

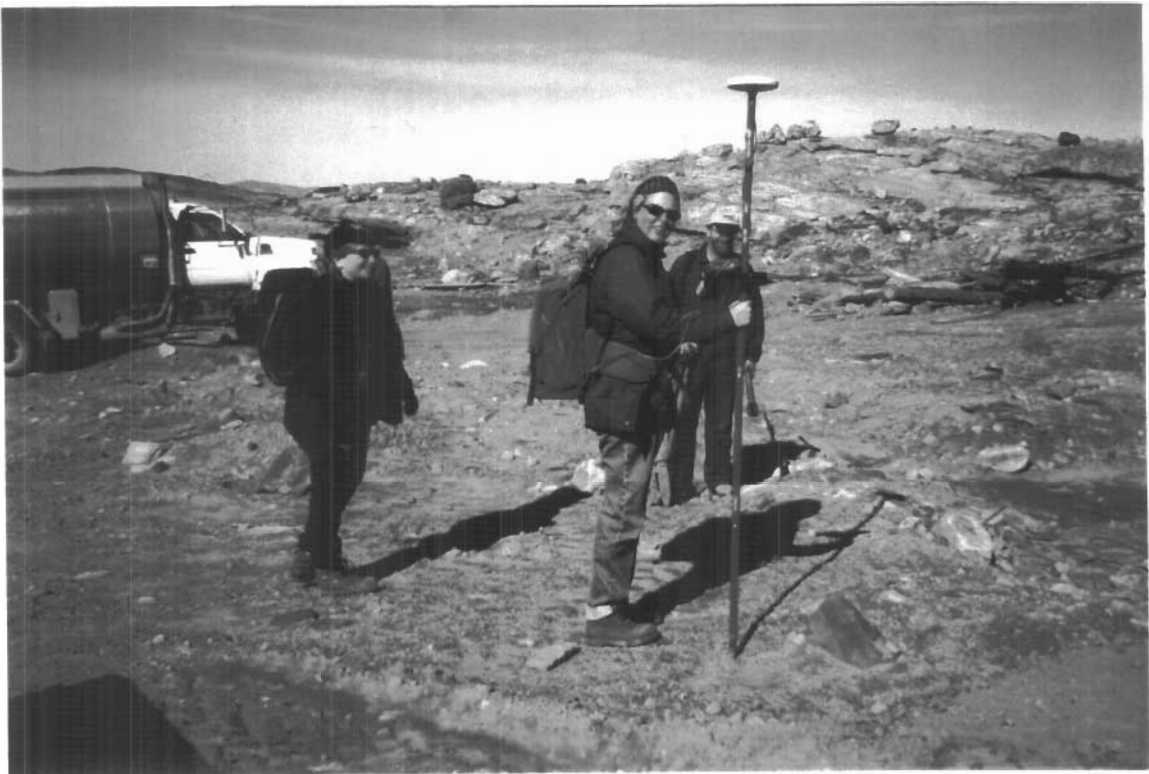
Photograph I-4: Mapping for the NEW Tier II Landfill Using the Ashtech Reliance Decimeter GPS System.

The ASU has also assisted in the design work related to the proposed Tier II landfill. Personnel from EBA Engineering and UMA Engineering visited the site in August in order to ascertain the best location for the landfill and to look at the potential borrow source sites from fill material, gravel and sand. ASU personnel assisted in mapping various areas with GPS and with discussions with EBA and UMA personnel concerning various aspects of their work.

- Confirmation testing, mapping and roping at the S1/S4 Valley area. As remediation of this area was the main task at the Island this year, Queen's assigned a person to overseeing the operation. Conduct GPS work as required (Photograph I-4).
