III. SITE INVESTIGATIONS

A. Airstrip Dump

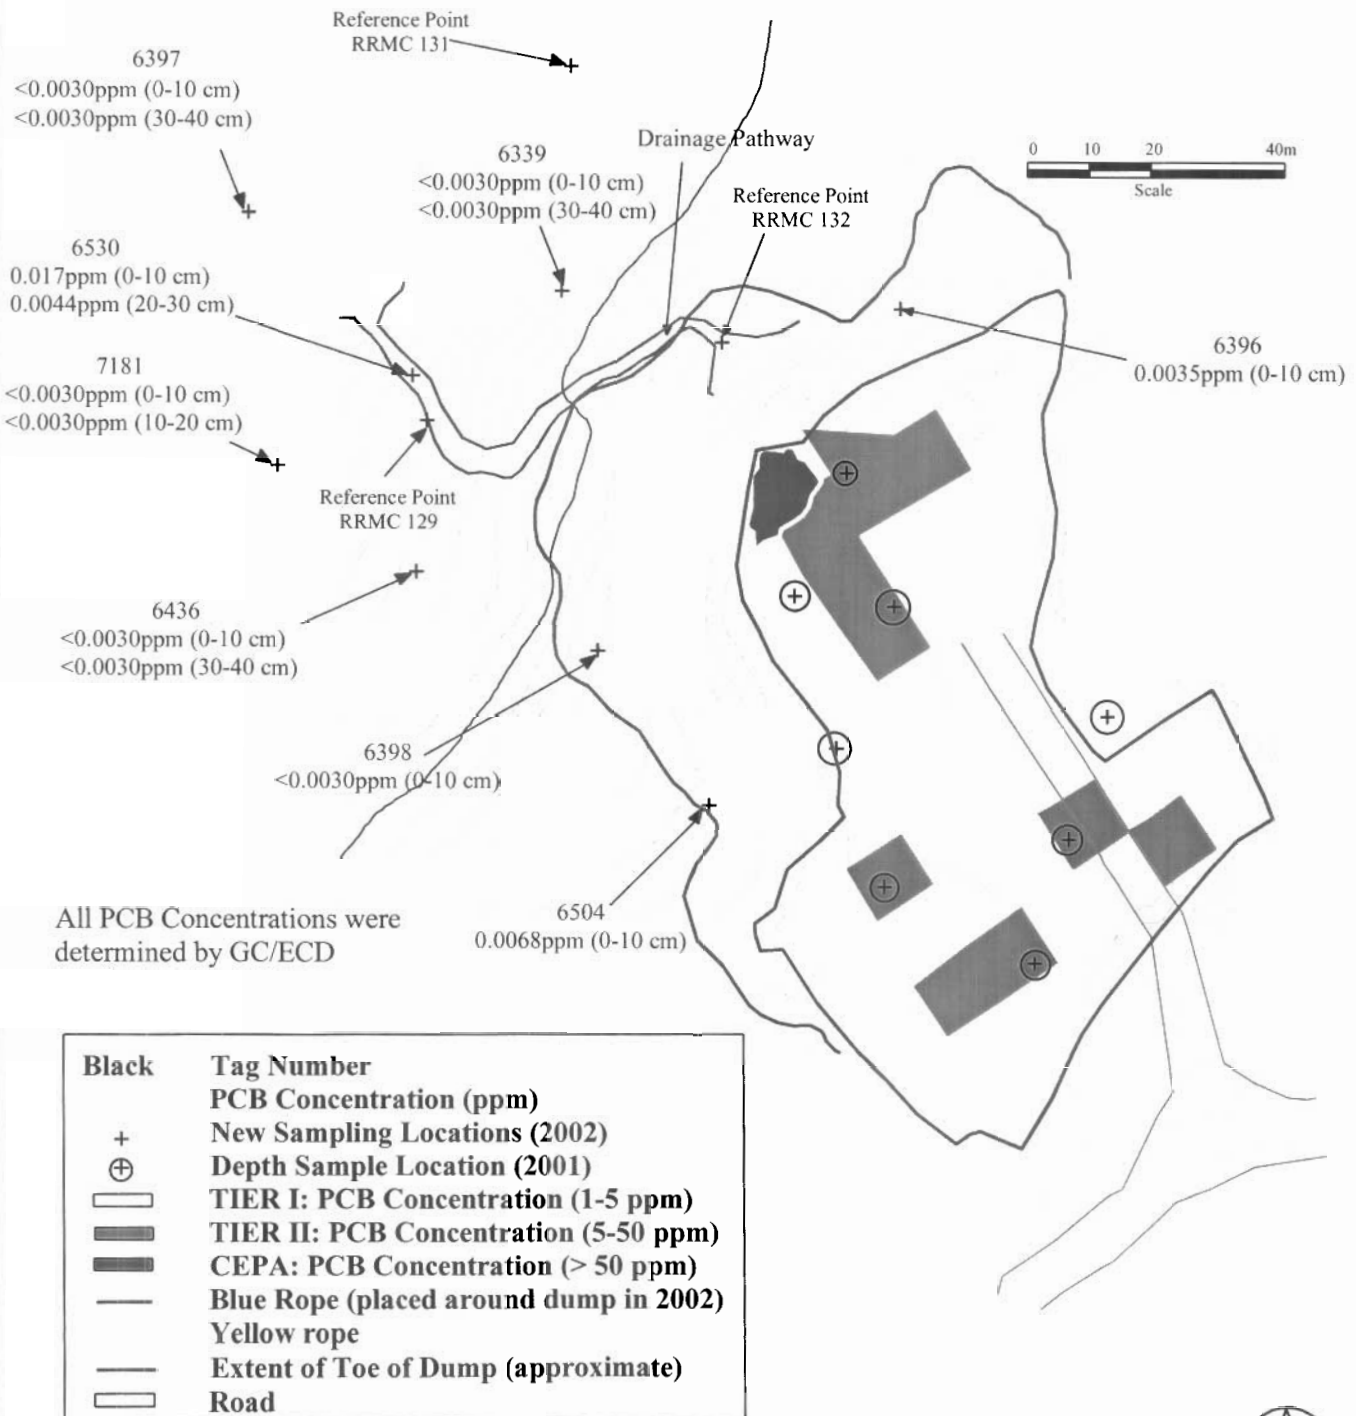
Map III-1: Sampling Locations and PCB Concentrations Below the Toe of the Airstrip Dump in 2002

the path encompassing RRMC 132 (0.200 ppm), 6547 (<0.5 ppm), RRMC 129 and 6530 (0.020 and 0.017; 0.0044 at 20-30 cm) and 6397 (<0.0030; <0.0030 at 30-40 cm). The levels drop and are below the detection limit at 30 m from the dump.

In summary, the results on Map III-1 show that no PCBs (< 0.0030 ppm) have been detected further than 30 meters from the toe of the dump and no PCBs (<0.10 ppm) have been detected at all beyond the dump. Thus a minimal quantity of PCBs have leached from the dump in 30 years. The dump faces north and is therefore generally colder than much of the site. The following actions are therefore proposed in order to remediate the airstrip dump. Firstly the area contaminated at the CEPA level should be excavated and all material screened. The soil would be containerized and shipped off site while the material not passing through the screener will be returned to the hole created by the excavation when it is complete. The whole dump will then be compacted. Any barrels containing free product will initially be removed from the toe of the dump. The dump will then be covered with clean fill. Compaction of the toe of the dump will be done by the dozer but with some intermediate fill as required. Two monitoring wells should be installed beyond the toe of the dump and two soil sampling points identified for long term monitoring.

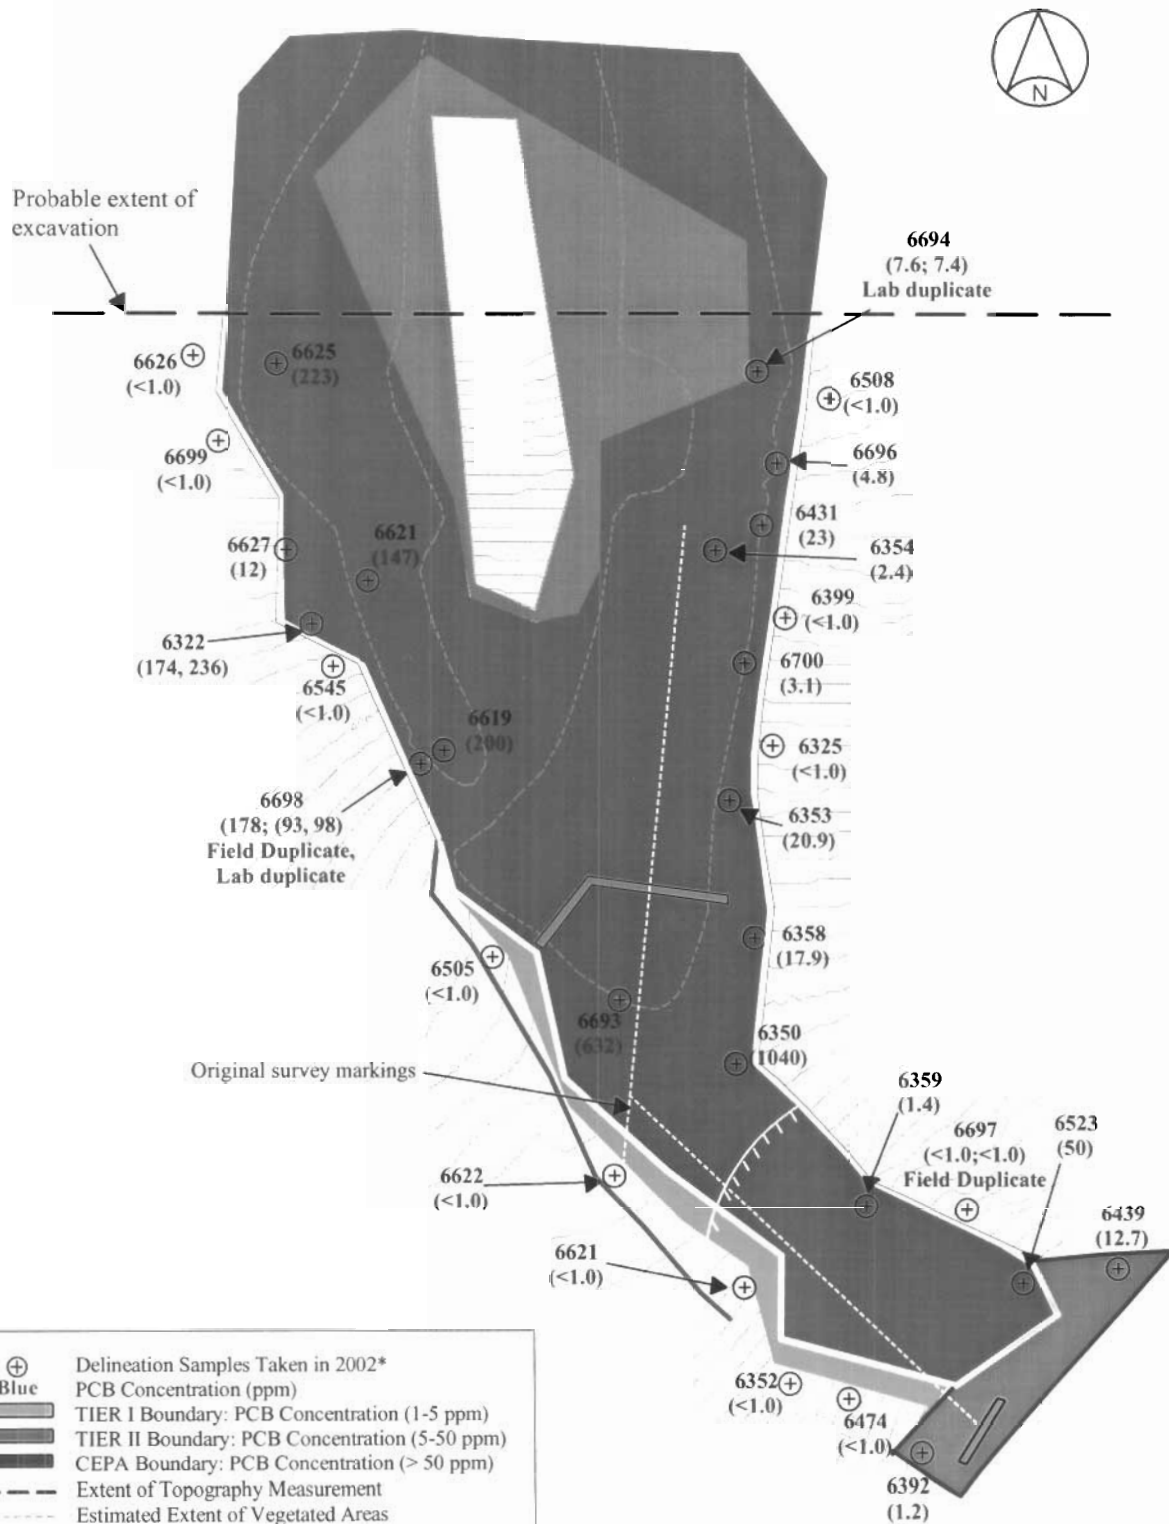
Map III-2: Location of Various Levels of PCB Contamination at the S1/S4 Beach Area, Additional Sample Locations, and the Position of Ropes

This year limited additional sampling was conducted to better define the contaminant boundaries and these boundaries were marked on the ground with rope. The results of the analyses are given in Table III-2 and Map III-2 shows the various levels of PCB contamination, the position of the ropes and the sample locations. Map III-3 again shows the various levels of contamination but with a 20 m by 20 m grid superimposed upon it. This grid is to be used during remediation for demarcation during excavation and confirmatory testing.

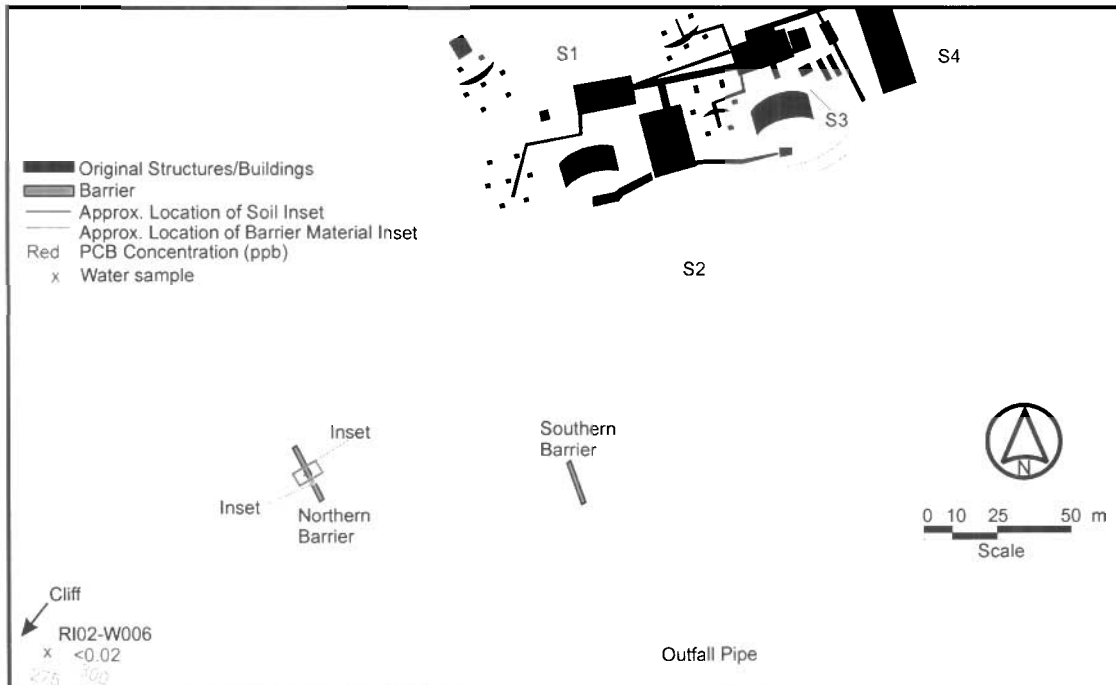
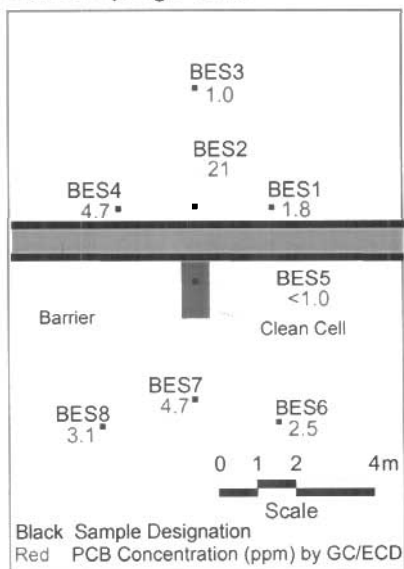
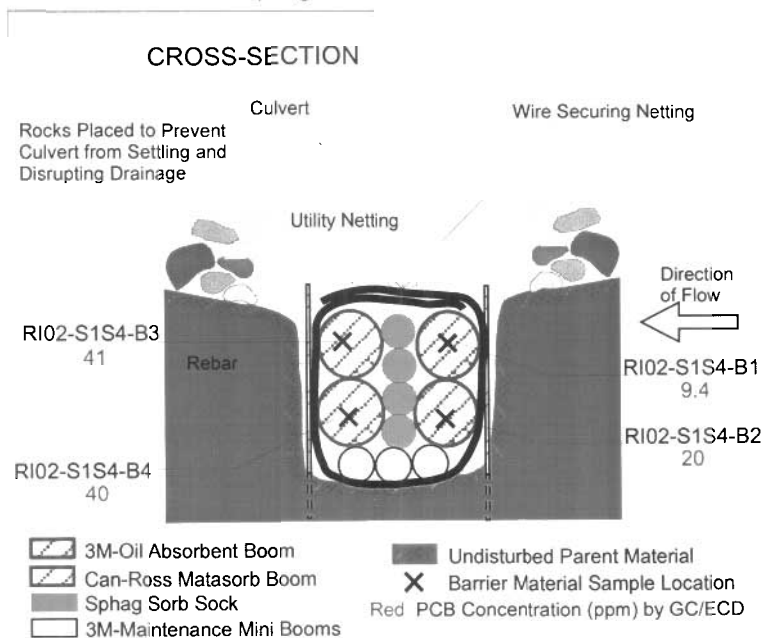
Map III-5: Sampling Points and PCB Concentrations at the Northern Barrier in the S1/S4 Valley

The diagram is a cross-sectional view of a remediation system. At the top, a horizontal line represents the ground surface. Below it, a large, dark, irregular shape represents the 'Undisturbed Parent Material'. A 'Barrier Material Sample Location' is marked with an 'X' on the left side of this material. A 'Red PCB Concentration (ppm) by GC/ECD' scale is shown on the right, with a red line indicating the concentration. A 'Culvert' is shown on the right, with 'Wire Securing Netting' attached to its side. 'Utility Netting' is shown as a dashed line extending from the culvert towards the center. A 'Rebar' is shown as a horizontal line passing through the center. Below the rebar, there are several circular and rectangular objects: '3M-Oil Absorbent Boom' (hatched circles), 'Can-Ross Matasorb Boom' (hatched rectangles), 'Sphag Sorb Sock' (solid circles), and '3M-Maintenance Mini Booms' (small solid circles). A large arrow points from the right towards the center, labeled 'Direction of Flow'. The arrow is labeled 'R102-BB-3' and '11'. To the left of the arrow, there are labels 'R102-BB-1' and '3.8', and 'R102-BB-2' and '24'. A legend at the bottom left identifies the symbols used in the diagram.

Maps III-4 and III-5 show the sampling locations and analytical results which are also given in Tables III-4, III-5 and III-6. QA/QC data is compiled in Section K

The PCB levels in the booms ranged from 3.3 to 41 ppm. The PCB levels in the booms from the beach area were less than those in the S1/S4 valley. Comparison of these results with those from previous years shows that this is a continuing trend indicating that there is more PCB migration in the S1/S4 valley. The results of analyses of soil from the clean cells show that the barriers are still functioning well; the clean cell PCB concentrations found were 2.8 ppm at the beach and <1.0 ppm at the Northern barrier in the S1/S4 valley. Soil samples collected at the same monitoring points as in the previous years continued to show significant variation.

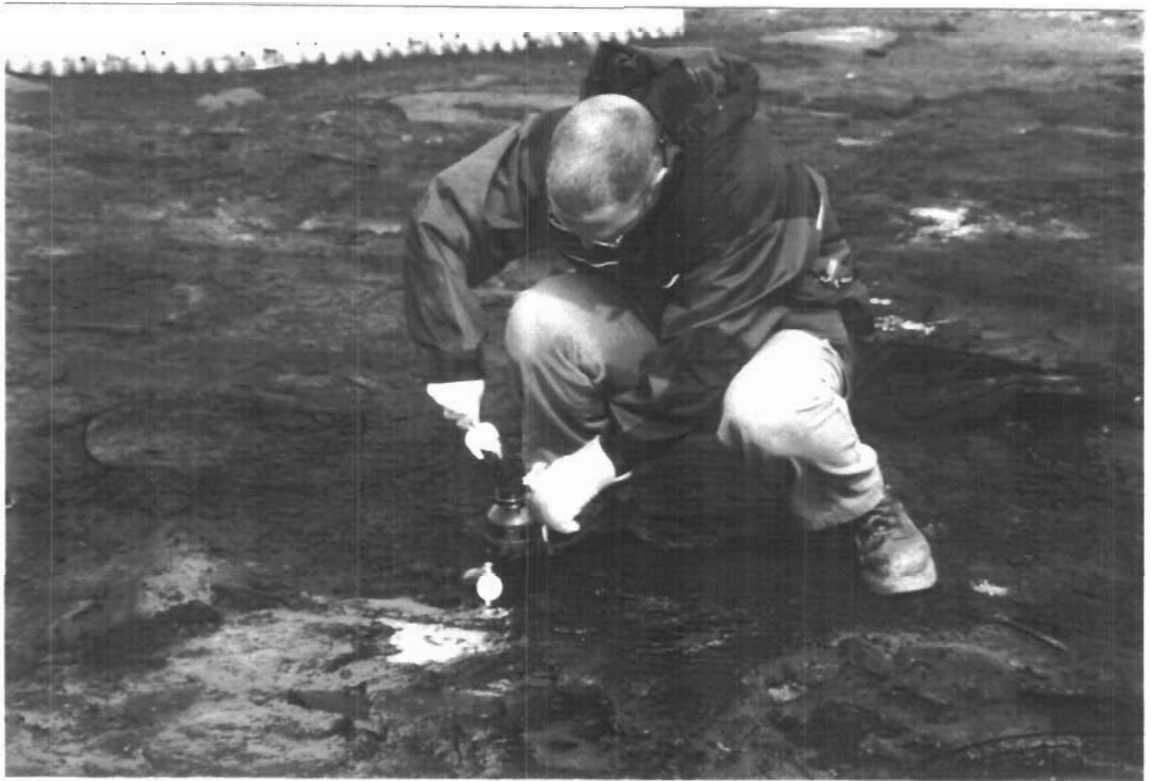
Photograph III-3: Collecting a Soil Sample for the Analysis of Degreasers at the Barrel Cache Valley

Six oily soil samples were collected from three locations at the site: the barrel cache valley, the cotton grass area and the near the imploded tank (Photographs III-3 and III-4). One from each site was analysed for volatile organic compounds which includes chlorinated degreasers such as trichloroethylene and dichloromethane. Results are shown in Table III-7.

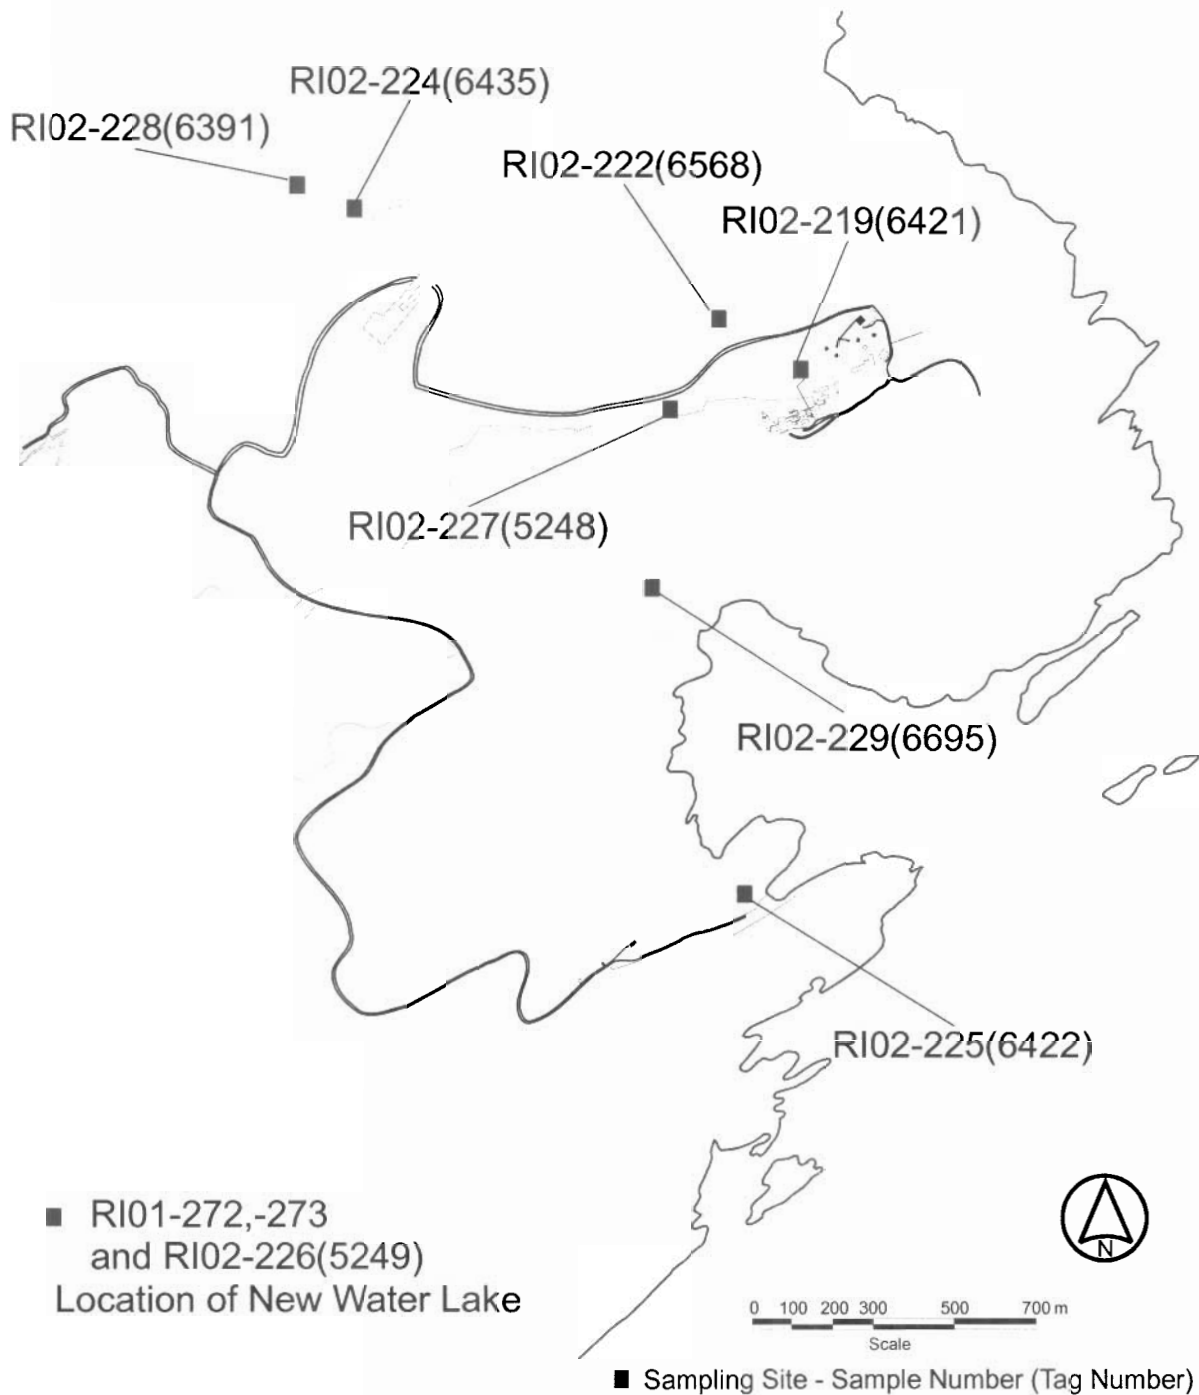
Map III-6: Locations of Background Plant Samples

The results are shown in Table III-15 and the locations on Map III-6. Photographs III-7 and III-8 show the collection of the plants and the recording of locations by GPS. Results indicate that a significant amount of PCBs is present in many of the plants collected. All PCBs showed the Aroclor 1260 pattern. Plants near to PCB contaminated areas contain Tier I and Tier II levels of PCBs. Two areas, which could be considered background were found, the drinking water lake and an area near the S1/S4 beach area. Plants were taken from the drinking water lake area in both 2001 and 2002. Low levels were found in both years. Further background sampling points more distant (> 1 km) from the site need to be established in 2003.
