II. PCB REMEDIATION

C. S1/S4 Beach Area

D. S1/S4 Buildings and Valley Area

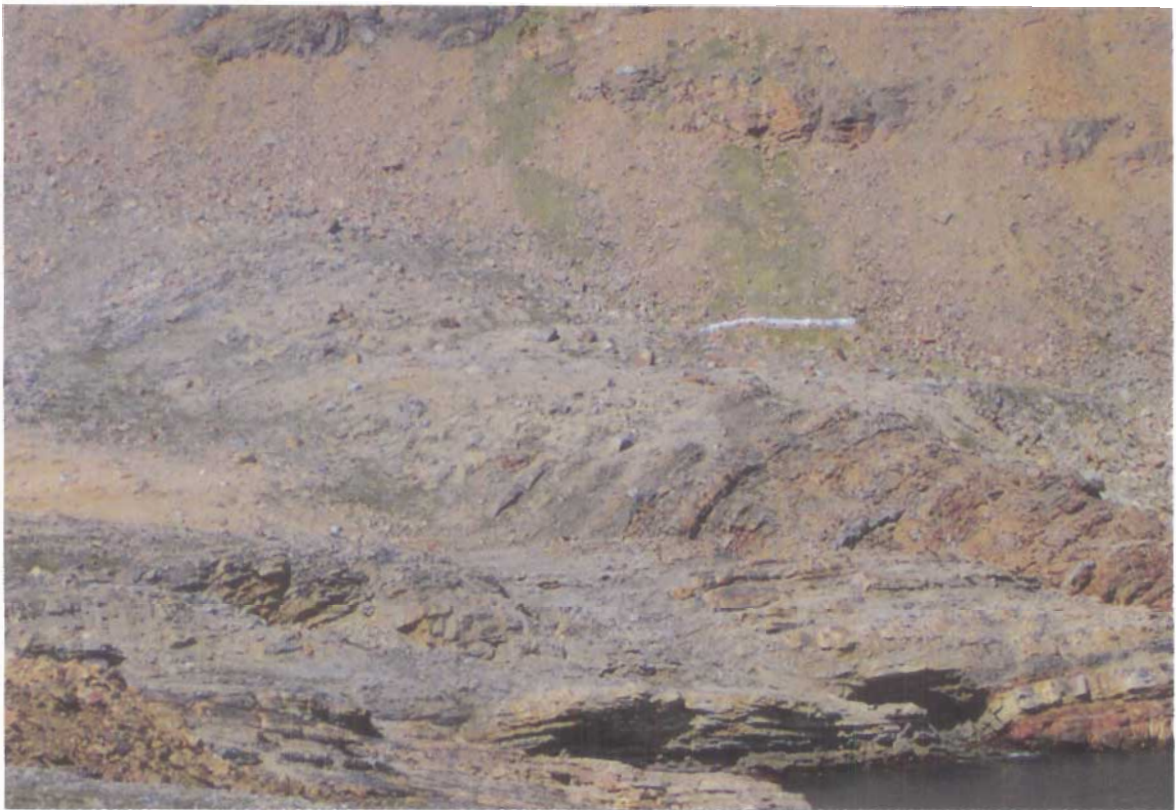
Photograph II-1: The S1/S4 Beach Area at the Start of the Season: Note the Two Grassy Locations Which Mark the Main PCB Contaminated Zones

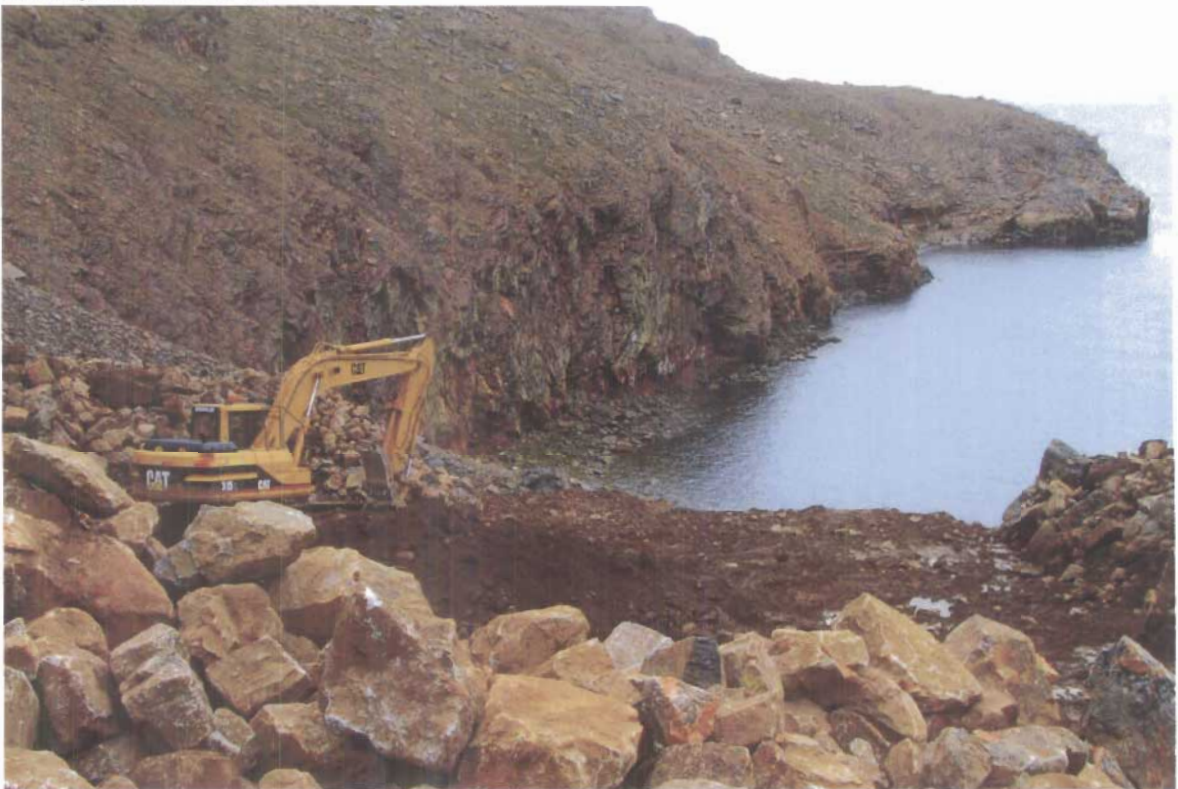
Photograph II-2: During the CEPA Soil Excavation Large Rocks Were Separated: The Excavated Soil Was Then Passed Through a Screener and Containerised

As a compromise between worker safety and project goals, the PMT agreed that only CEPA soil would be removed from the highest part of the area designated for excavation. The area get progressively steeper until it becomes part of the 300 m cliffs (Photograph II-1). In many locations, large rocks had to be moved first so as to access the contaminated soil underneath and to allow the heavy equipment to move unrestricted in the area. As a consequence, large rock piles were created at the edges of excavated areas (Photograph II-2).

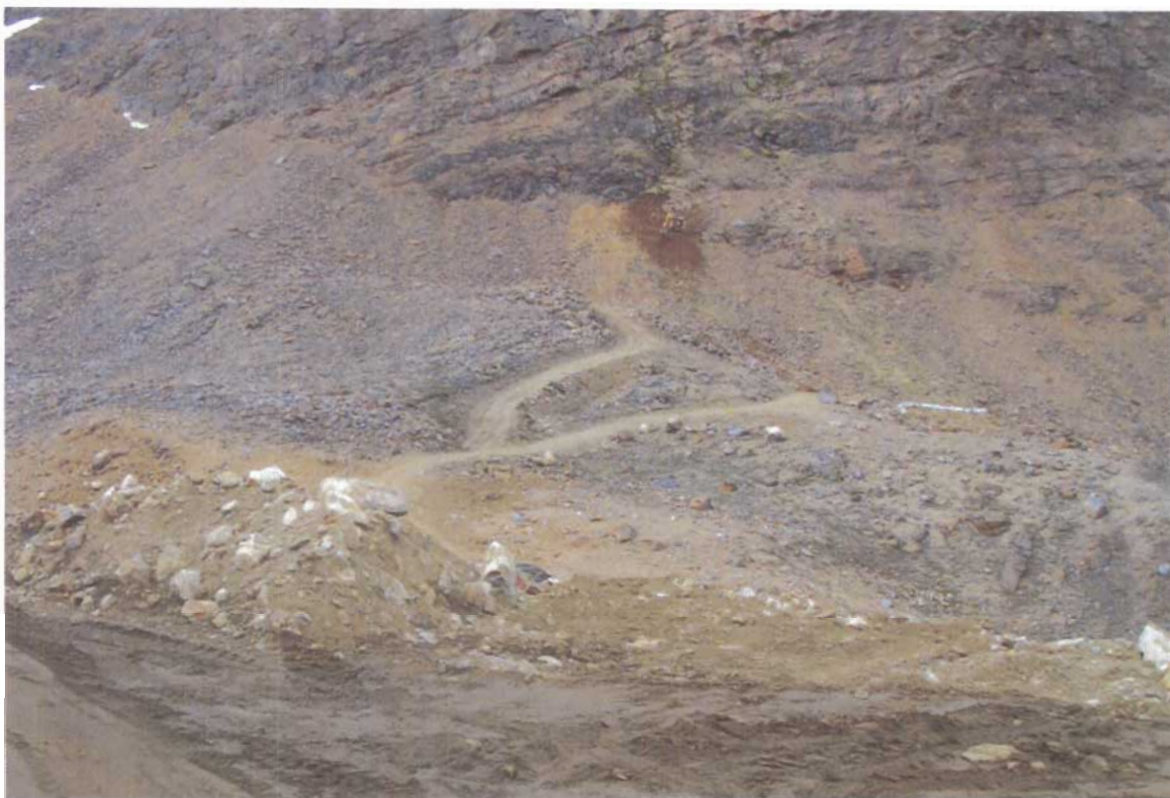
Photograph II-3: The S1/S4 Beach Area at the Start of Excavation of CEPA Soil Showing the Roadways: Excavation Higher Up the Contamination Zone Was Too Dangerous Because of the Steep Slope

Much of the initial excavation took place on steep gradients and access was only possible with the assistance of a skilled heavy equipment operator (Photograph II-3). CEPA soil was first removed from the least accessible grids, (3B, 3C, 4B, 4C, 4D). The CEPA material was pulled down and used as a stable excavation platform and then this pad of soil gradually moved down the slope as excavation progressed. Once the initial excavation of CEPA was made on the steep grade, it was essentially impossible to make it back up the slope, therefore, in these areas, the depth of soil excavated was increased

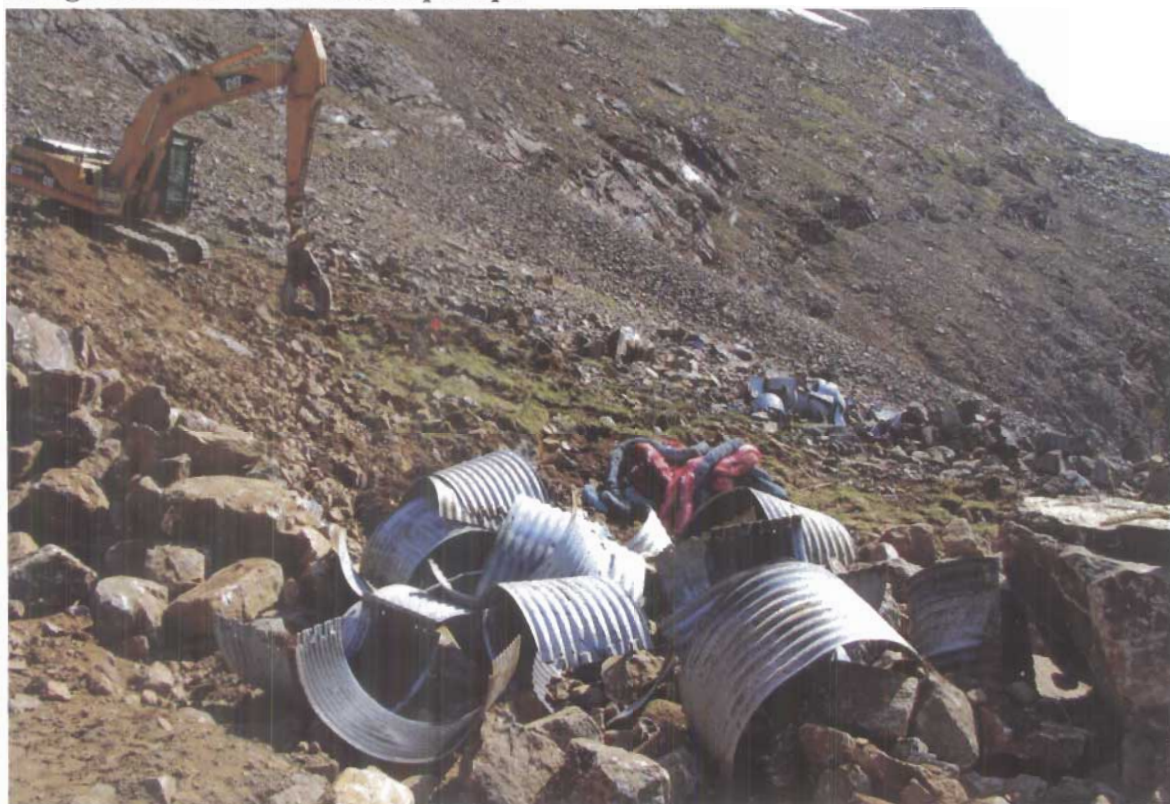
Photograph II-4: The Barrier Placed Across the Drainage Pathway in 1994 Was Removed. Analysis of the Barrier Material Showed That the PCB Level Was Tier II

As the excavation proceeded, it became necessary to remove the large northern barrier installed in 1994. The barrier material was analysed for PCBs in order to determine its fate. Results given in Table II-1 show that the PCB level is Tier II. This result agreed with levels found over the period 1995-2003. The culverts over the barrier were first removed to the edge of the excavation area (Photograph II-4). The barrier materials were then placed into plastic liner bags which were in turn placed into three brown conical steel containers. These were moved adjacent to the 60 wooden boxes of metal contaminated soil and the contents will be placed in the Tier II landfill next year.

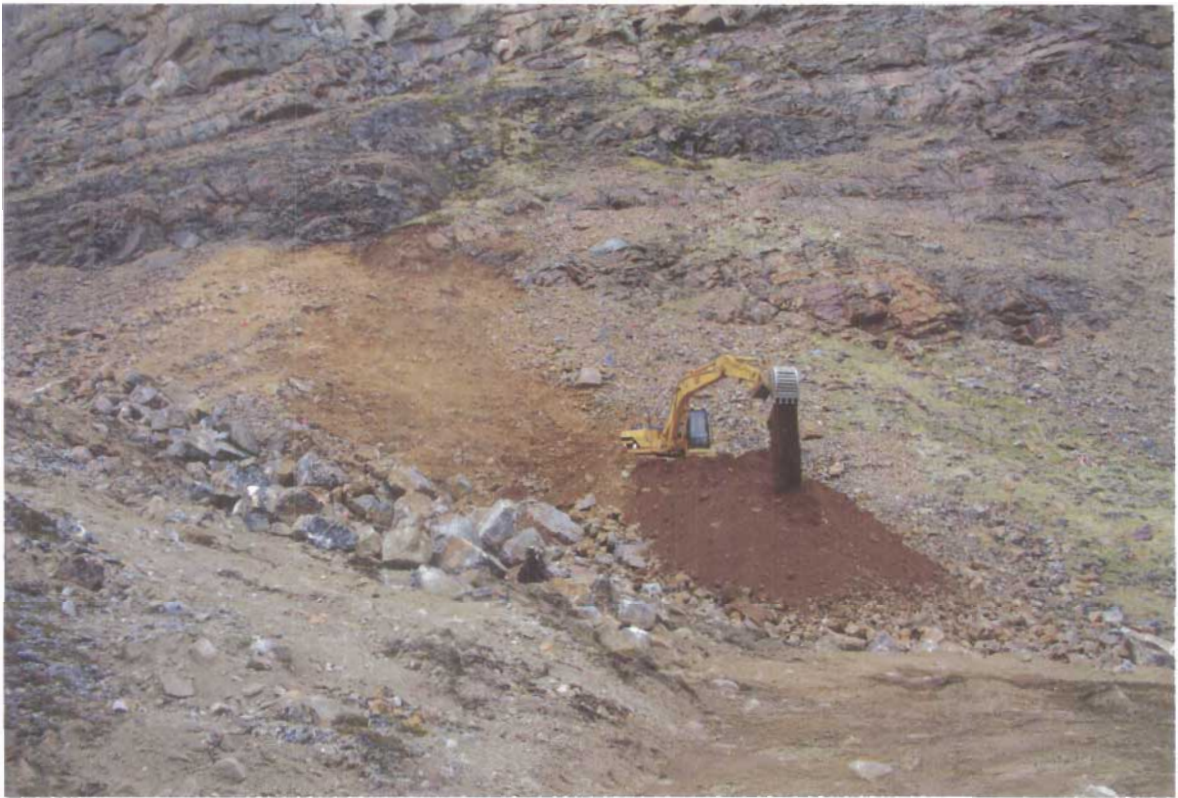
Photograph II-5: Excavation of the CEPA Soil at the S1/S4 Beach Area

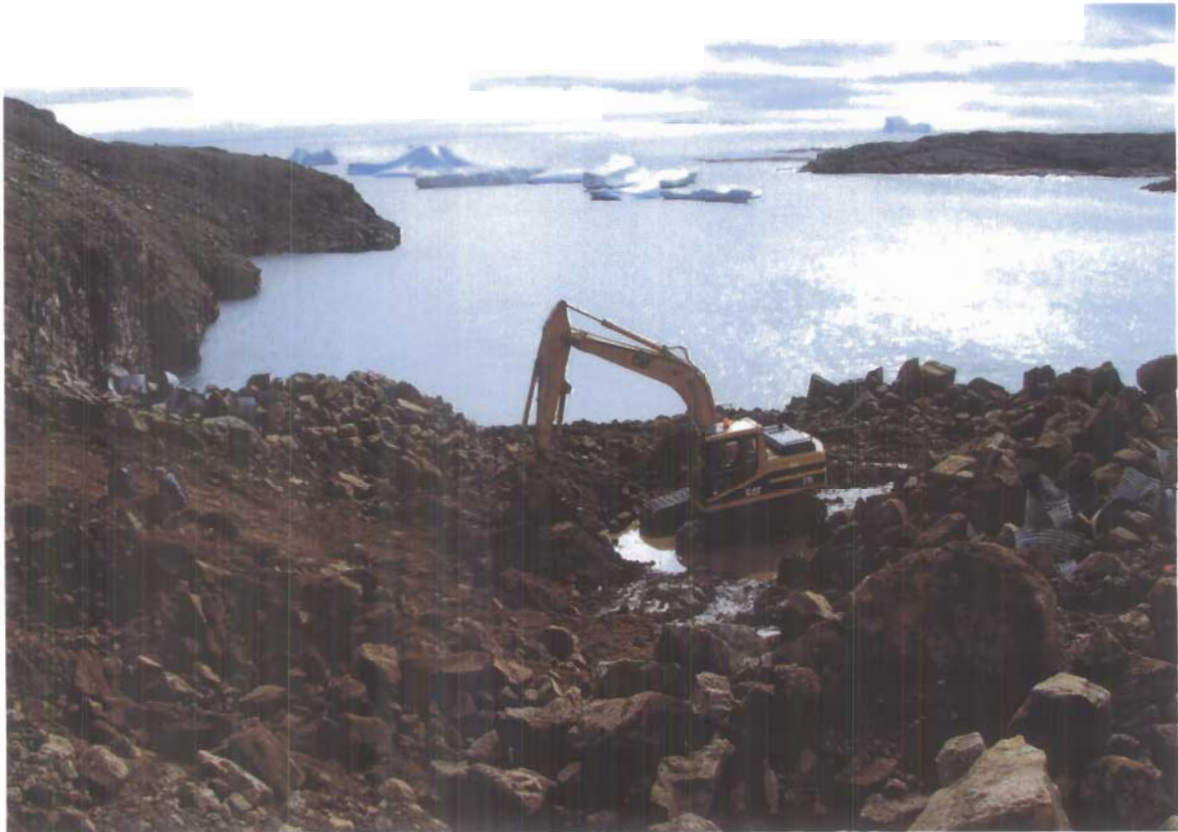
Photograph II-6: Excavation of the S1/S4 Beach Area Near the Base of the Cliff Slope

Excavation on the lower grids at the beach continued until the start of September (Photograph II-6). In total, excavation of 14 out the 18 quadrants was completed (3B, 3C, 4B, 4C, 4D, 4E, 5B, 5C, 5D, 5E, 6C, 6D, 6E and 7D). The summary signoff sheets associated with these 14 quadrants are in Chapter VII: Appendix. Of the remaining 4 grids, 7E and 7F have almost been completed and only 2 grids (8E and 8F) remain untouched. At the end of the season, some work on an access road from the southeast

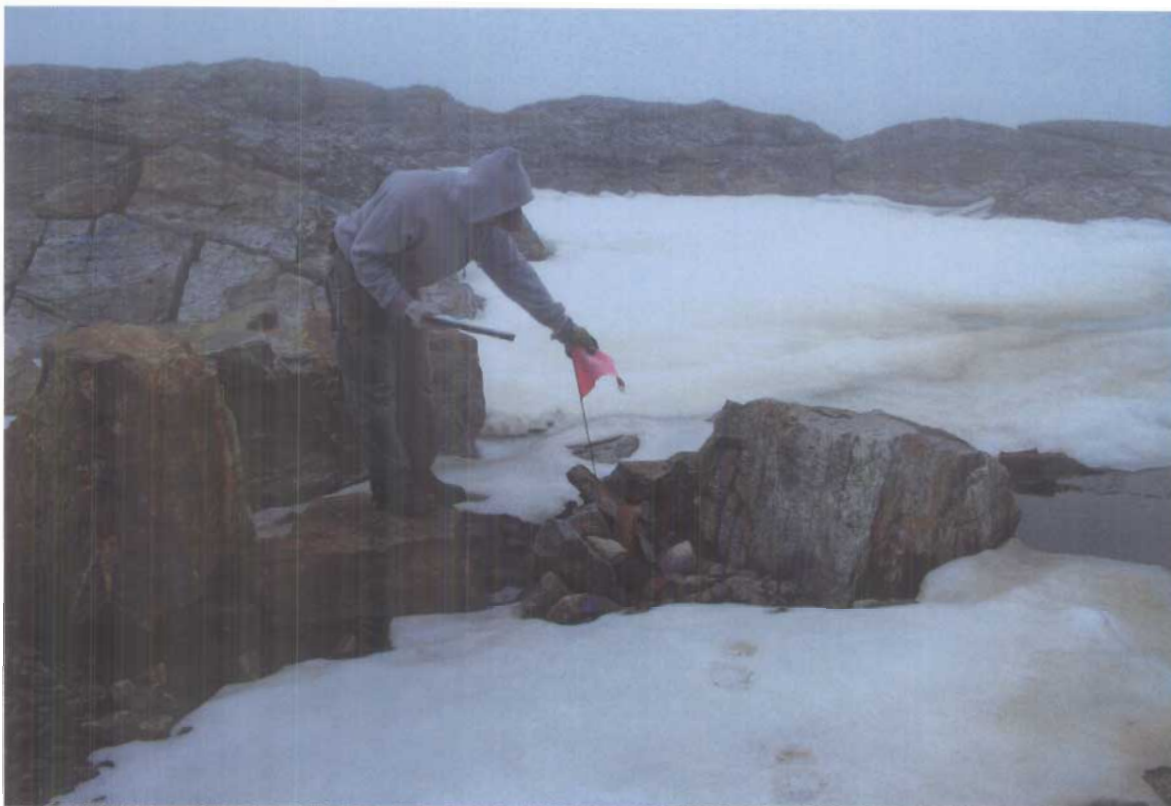
Photograph II-7: The S1/S4 Valley in Late June: Repositioning Quadrant Markers

Following the arrival on site of ASU personnel at the end of June, work began immediately in the S1/S4 valley area. Grid flags, ropes and spray paint markings, were located and re-applied or replaced where necessary (Photograph II-7). Confirmatory samples were taken in and around selected Tier I/II boundary areas to ensure that these contaminated zones had not changed as a result of soil movement during the spring run-off.

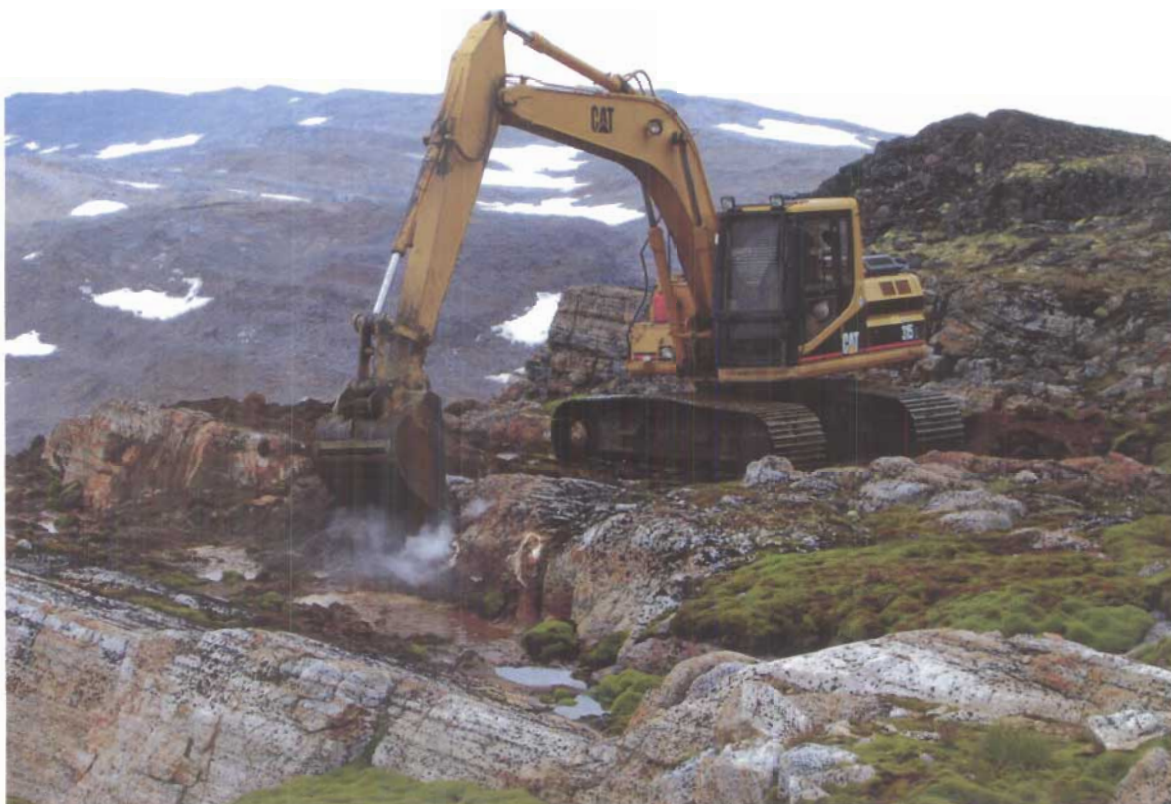
Photograph II-8: Starting the Excavation of Tier II Soil in the S1/S4 Valley at the End of the Valley Where a Lush Cover of Moss Predominates

Excavation of Tier II soil started on 24 July 2004, after most of the snow had melted from the surface. Excavation began in the far south-west corner of the valley (Photograph II-8) and moved in a north east direction. The majority of Tier II soil is located along the valley area and large areas were cleared quickly and stockpiled in convenient areas for transport to the Tier II landfill (Photograph II-9) at a later date. Snow melt from higher elevations in this drainage pathway continued into August and a temporary boom was constructed to prevent PCB migration in the oil stained area (Photograph II-10).

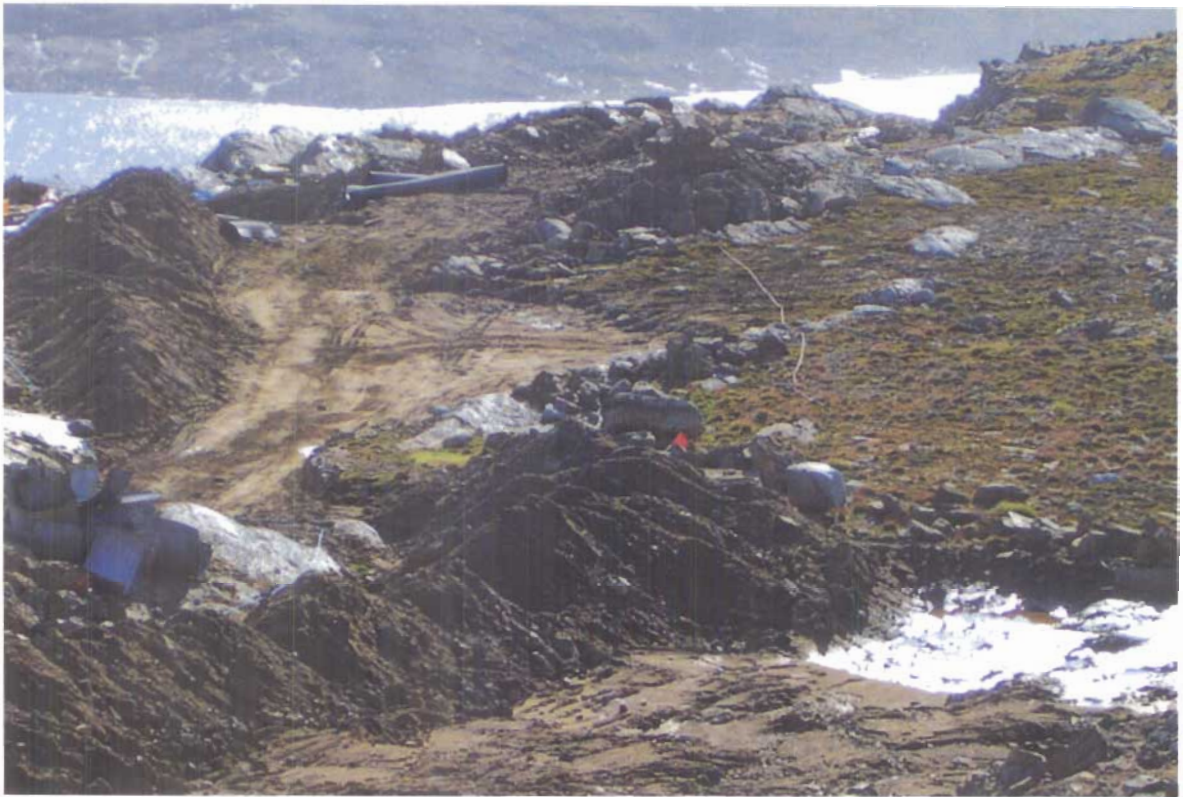
Photograph II-9: The Tier II Soil Excavated in the S1/S4 Valley Was Scraped into Piles

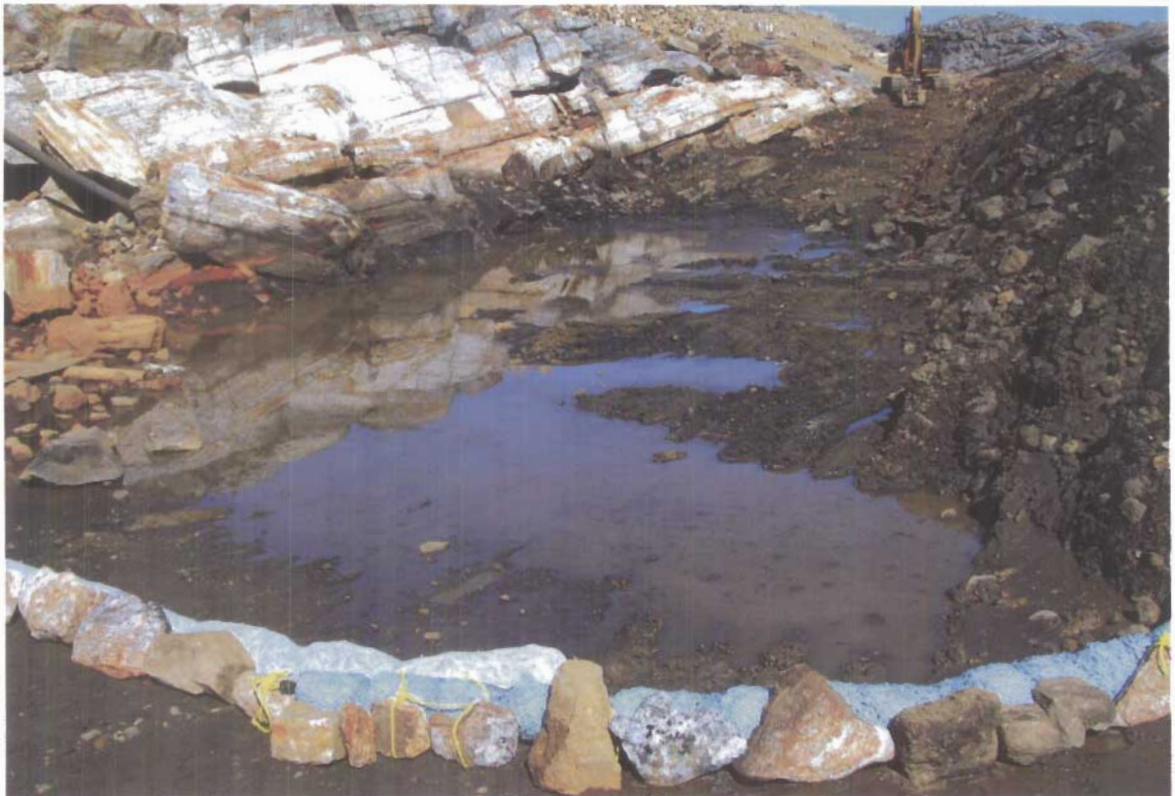
Photograph II-10: The Heavily Oiled Area in the S1/S4 Valley Was Boomed During Excavation of the Tier II Soil

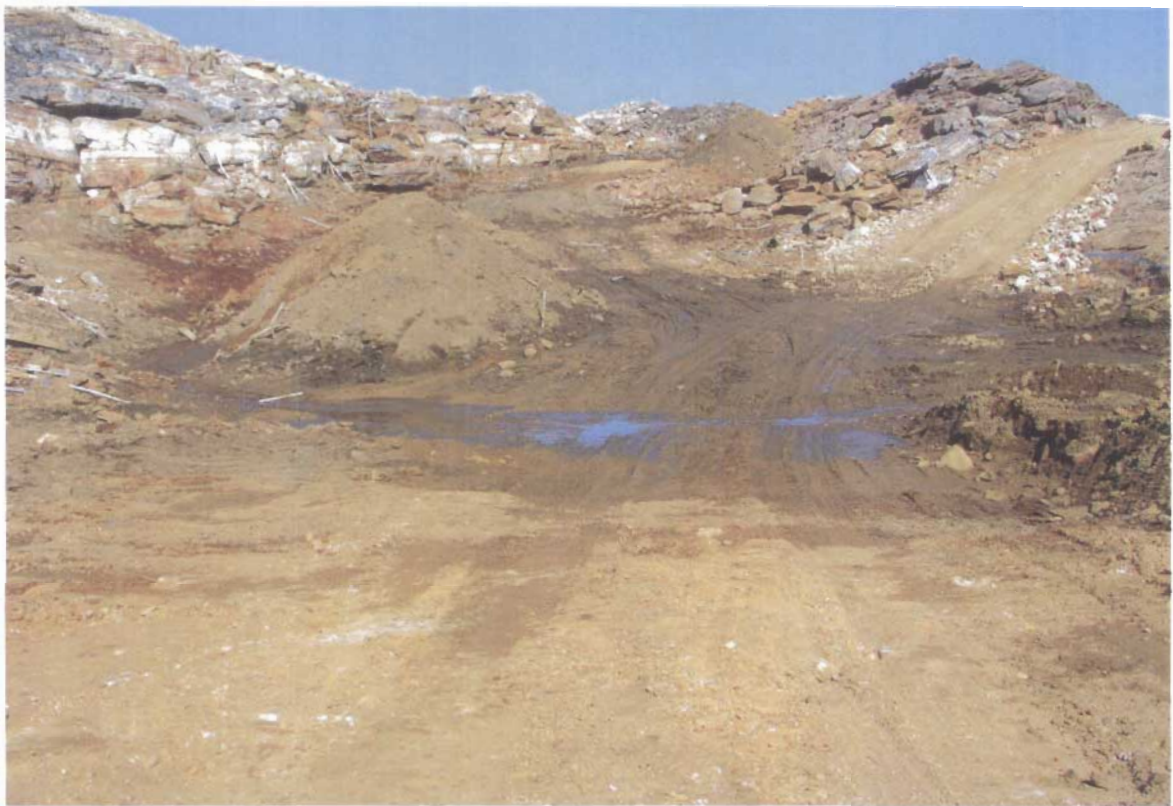
Photograph II-11: The Roadway in the S1/S4 Valley: PCB Contaminated Soil Was Not Excavated from Roadways in 2004

Due to access constraints, Tier II materials were not excavated from several road areas this season, but will be addressed in 2005 (Photograph II-11).

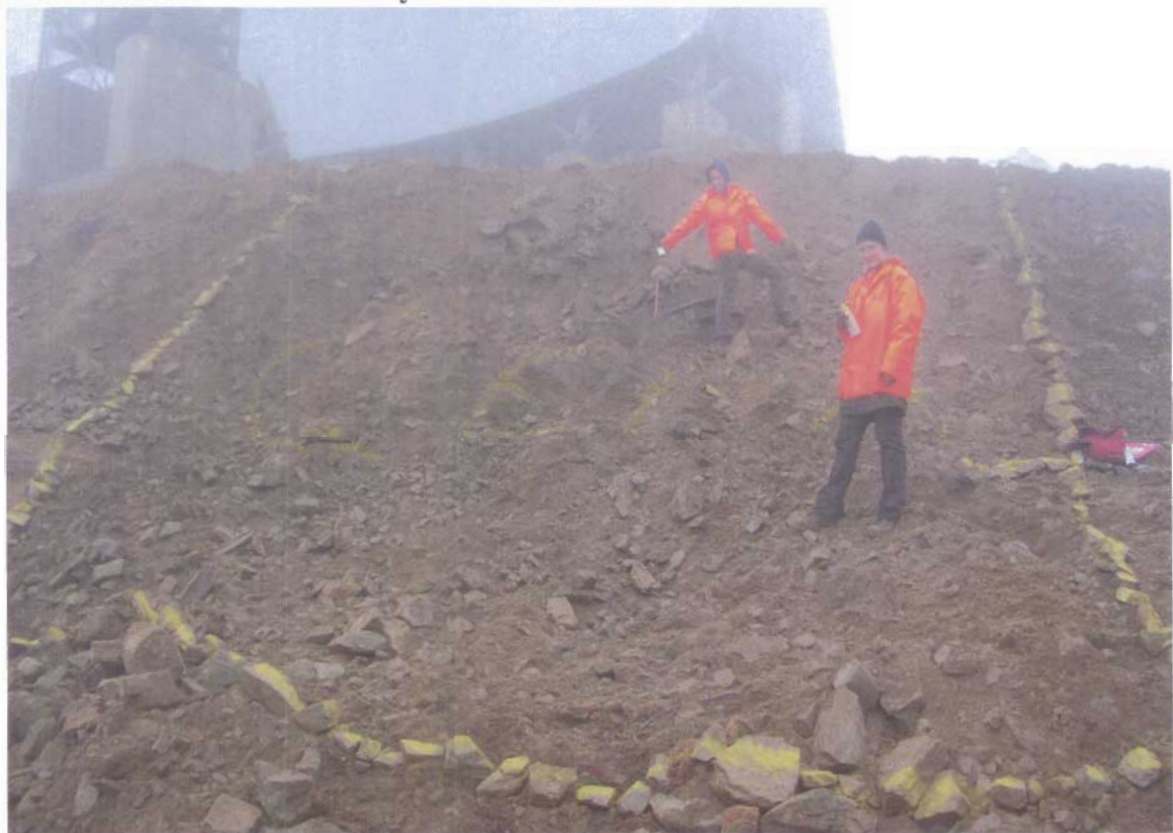
Photograph II-12: The Yellow Spray Paint Marking One of the CEPA Areas Located This Year

As the excavation in the valley progressed, three additional CEPA areas were located (Grids I11, I12, M18). The discovery of small areas of CEPA is not entirely unexpected, given the magnitude and levels of the original PCB contamination and the fractured nature of the bedrock in the area. These were delineated, clearly marked (Photograph II-12), excavated and moved to the stockpile of CEPA behind the B2 building. The area located in M17 was small in size and the concentration of 68 ppm, only slightly over the 50 ppm criteria limit. The patches found at higher elevations (I11 and I12), were larger and higher in concentration (I11: 120 ppm, I12: 200, 220 ppm). The location of CEPA material in these areas was not entirely unexpected. During the original excavation in 2001, due to the instability of the slope after all the surface rocks had been removed, there was a partial collapse at the face (“Resolution Island 2001 Scientific
