III. SITE INVESTIGATIONS

B. Building S4

C. Tier II Landfill

D. Tier II Landfill Monitoring Program

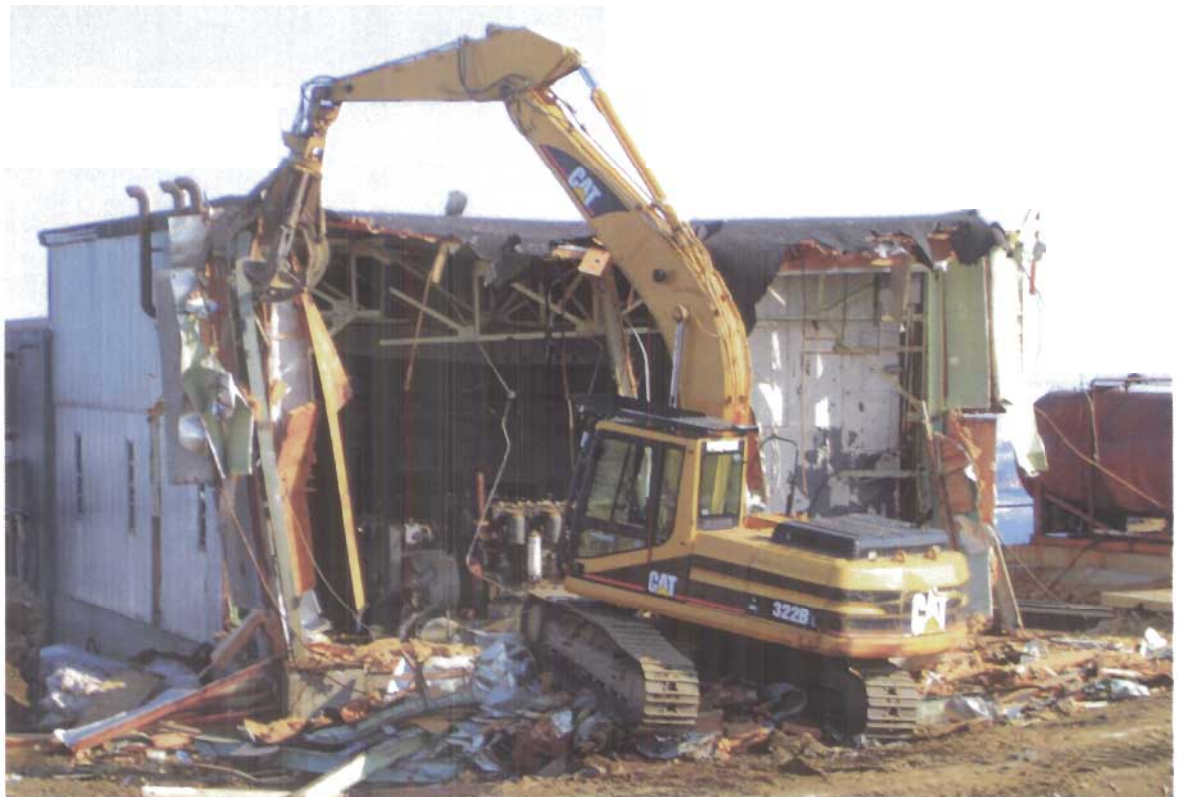
Photograph III-1: Demolishing Building S4. The Concrete Floor of the Building is Contaminated With PCBs and Will be Covered With Clean Fill

It was decided that the whole building should be demolished and all equipment on the floors removed to leave the concrete pads. This was accomplished this year (Photograph III-1). The concrete from the small CEPA area (Photograph III-2) was then removed and transported to the Beach PCB storage facility. The removal of the CEPA concrete was undertaken according to the protocol as written by ASU and set out in Annex A. Two composite samples of concrete powder were obtained after the excavation. Analysis of these sample (RI04-480 and RI04-480D) showed that the level of PCBs in the concrete had been reduced to 0.6 and 1.0 ppm respectively.

The concrete pads will be covered with clean fill once all the surrounding area is free from Tier II and Tier I PCB contaminated soil in 2005. The depth of this fill should be 30 cm for the lower level and 50 cm for the upper level area.

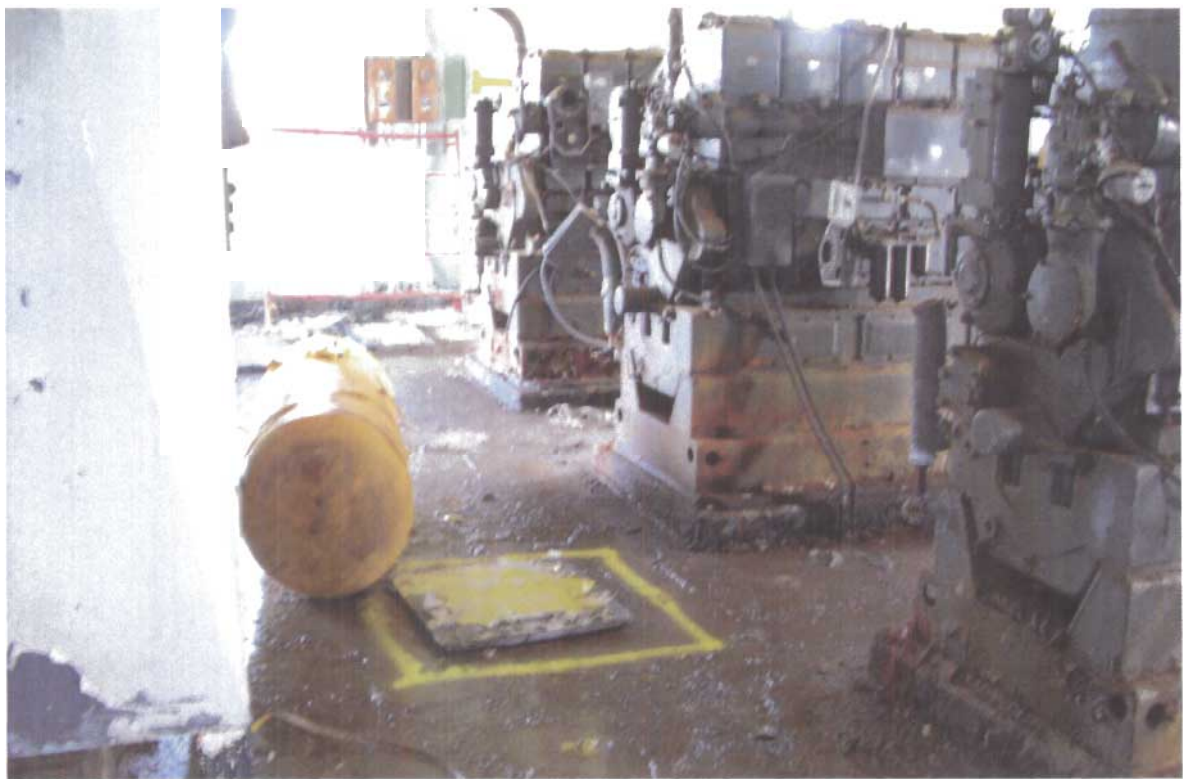
Photograph III-2: The Interior of Building S4 Prior to Demolition: The Area Marked in Yellow was Contaminated Above 50 ppm with PCBs

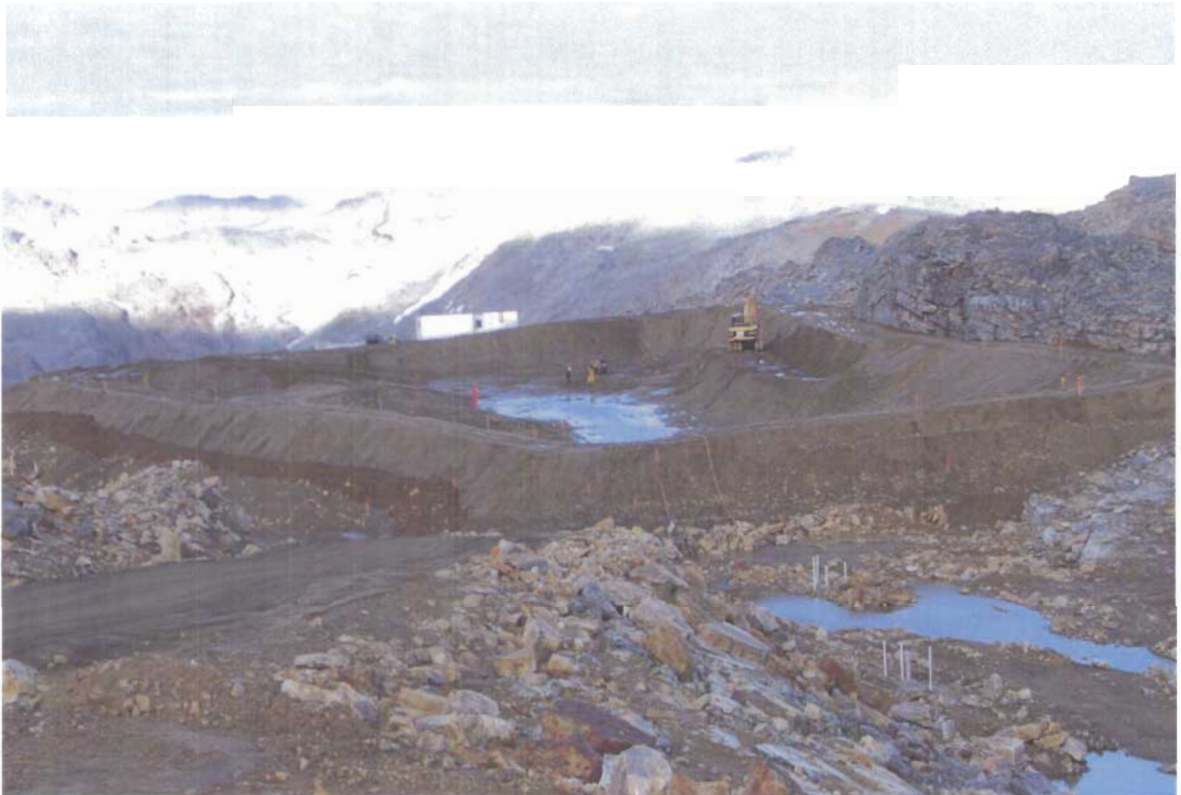
Photograph III-3: Construction of the Berms of the Tier II Landfill

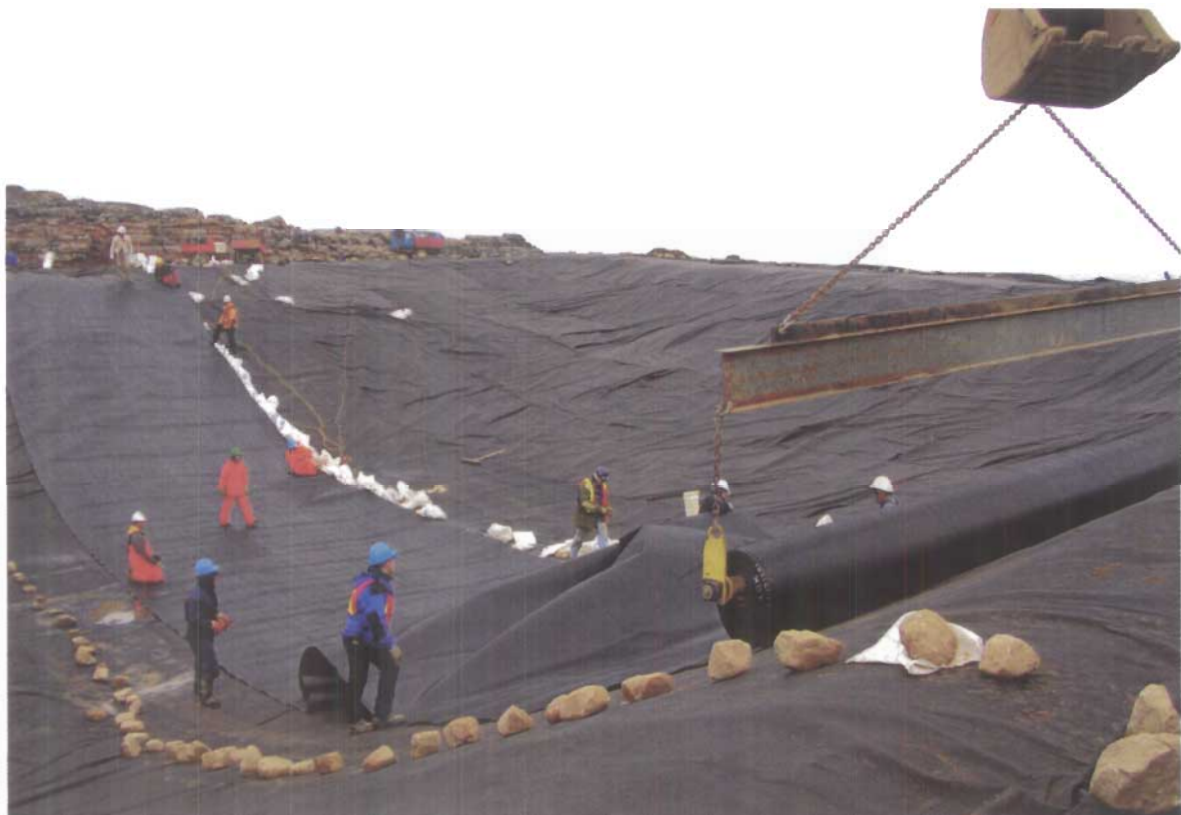
Photograph III-4: Installation of the Tier II Landfill Liner

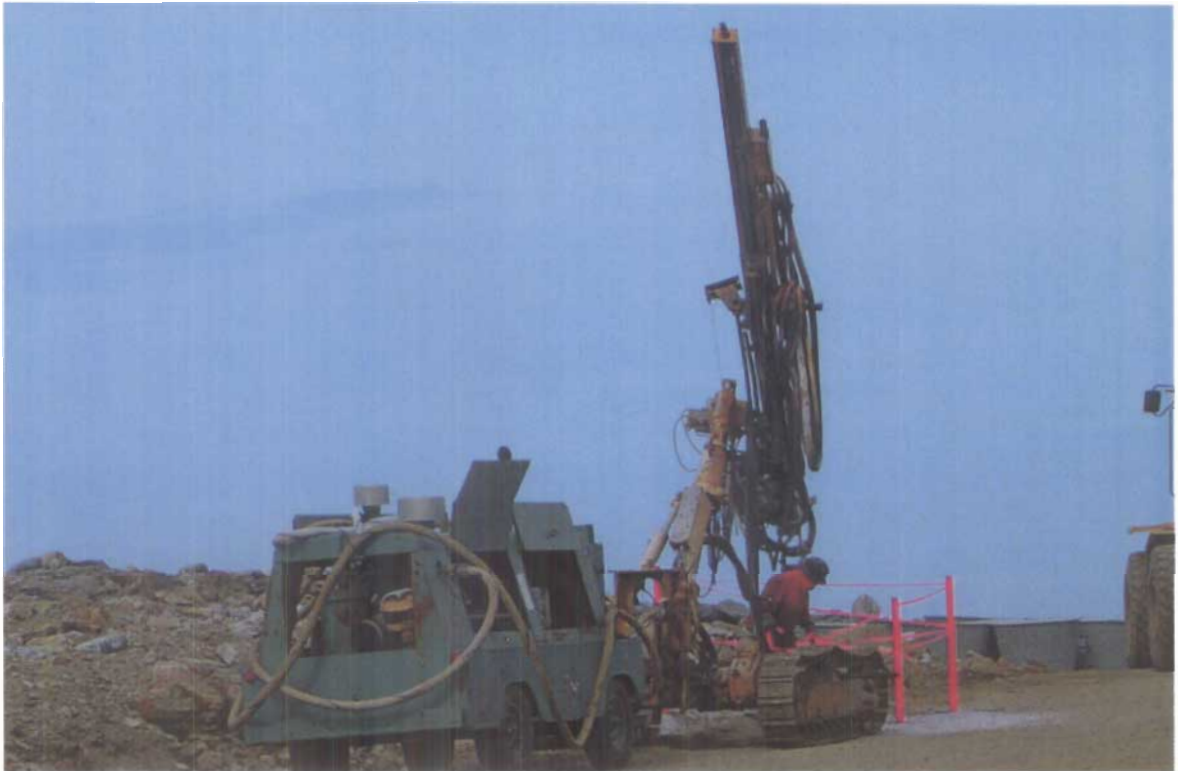
Six more wells were installed around the Tier II landfill site at the beginning of the season (Photograph III-5). Two wells numbered 1A and 1B were established above the landfill. MW 1B remained dry all season whereas MW 1A was sampled on 7 occasions. MW 3B was installed near to MW 3A which was established in 2003. MW 3B was constructed such that the slotted part was sealed below bedrock. This well was however, dry all season. MW 5A and 5B were constructed in a similar manner as MW 3A and MW 3B but about 30 m further away from the landfill berm on the down gradient. There was a distance of 7.7 m between them and both produced water. MW 6 was a further 34 m down gradient from MW 5B.

Photograph III-5: Installation of a Monitoring Well at Resolution Island

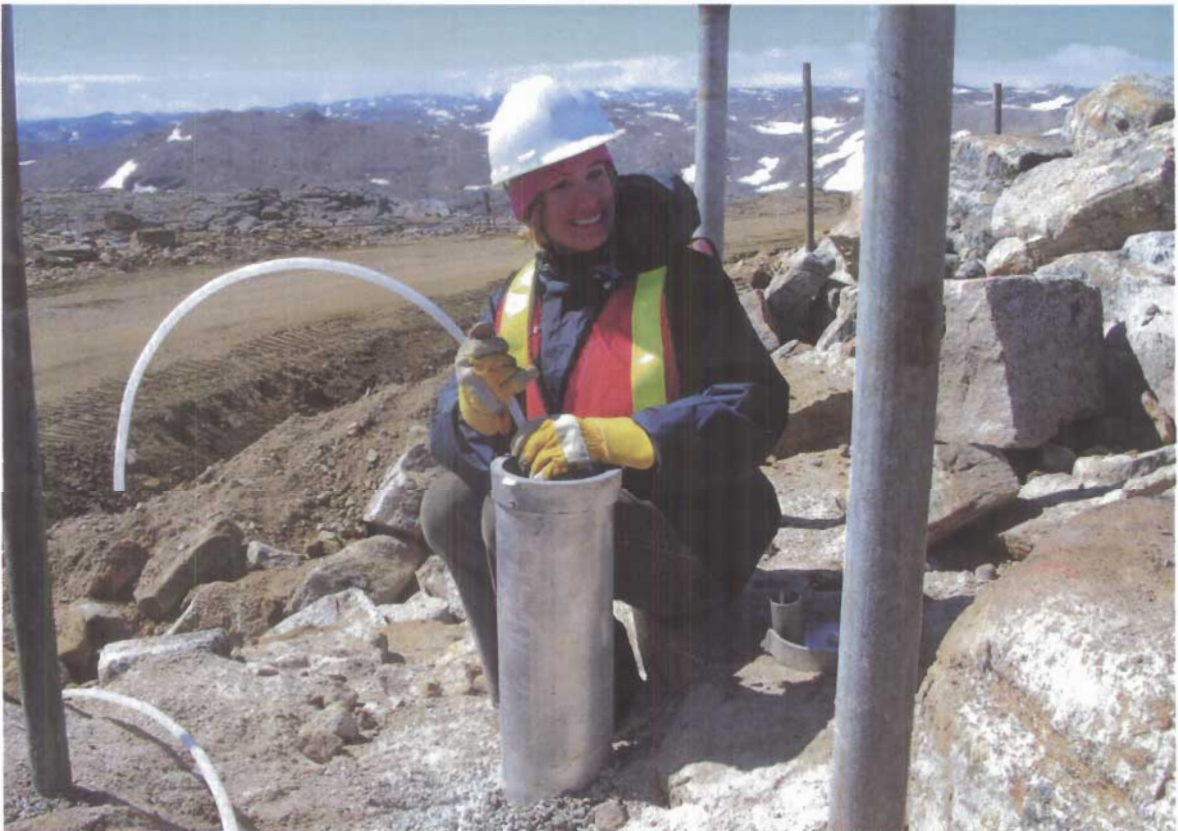
Water was collected from the wells after purging (Photograph III-6) but due to the lack of water in some wells these were sampled less frequently. Results of the analyses are presented in Tables III-5A to III-5G.

Photograph III-6: Paleah Preparing to Purge a Monitoring Well Prior to Collection of Water Samples
