## **V. FUEL CONTAMINATION**

## D. Imploded Tank Area

## *2. Ponding and Barrier Construction*

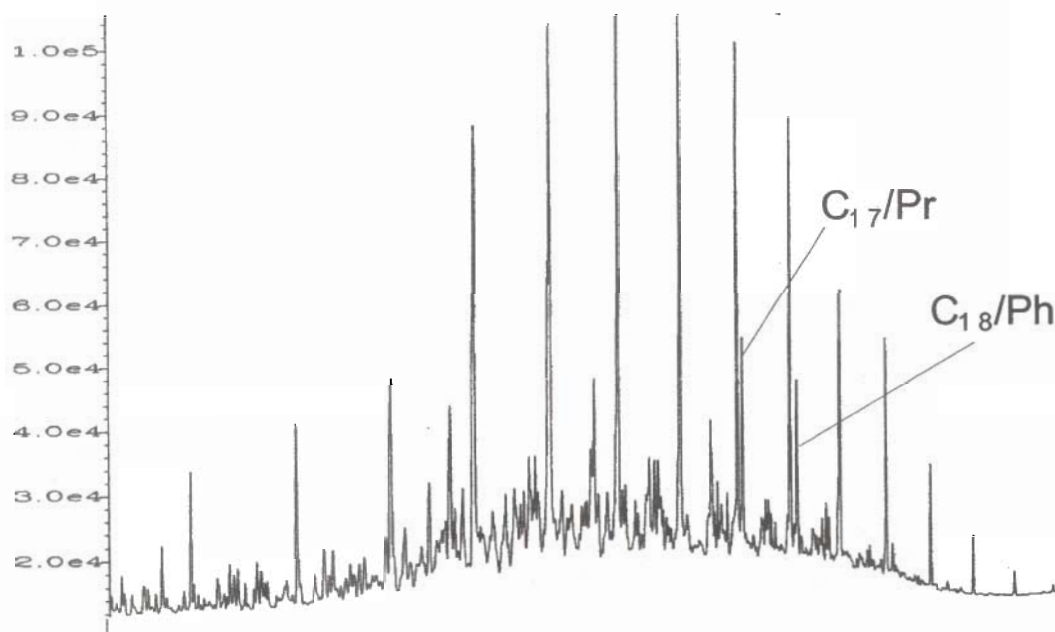
Diesel fuel contains two pairs of compounds with very similar boiling points but for each pair, one is a straight chain alkane while the other is branched. Because the straight chain alkane is volatilized at the same rate as its branched counterpart but the straight chain hydrocarbon is bioremediated faster than the branched counterpart, these two pairs of compounds can be used to discriminate between the two remediation pathways of volatilization and bioremediation. The four compounds are the two straight chain alkanes, heptadecane ( $C_{17}H_{36}$ ;  $C_{17}$ ) and octadecane ( $C_{18}H_{38}$ ;  $C_{18}$ ), and the two branched alkanes 2,6,10,14 tetramethylpentadecane ( $C_{19}H_{40}$ ; pristane Pr) and 2,6,10,14-tetramethylhexadecane ( $C_{20}H_{42}$ ; phytane Ph). These branched alkanes are sometimes referred to as isoprenoids. The ratio of the masses of each pair in the hydrocarbon mixtures (equivalent to the ratio of the peak areas) are given as the mass of the straight chain alkane divided by the mass of the branched alkane; these are abbreviated as  $C_{17}$ /Pr and  $C_{18}$ /Ph in this report. Figure V-1 below shows the two pairs of peaks in a diesel standard.

Figure V-1  
Chromatogram of a Diesel Standard

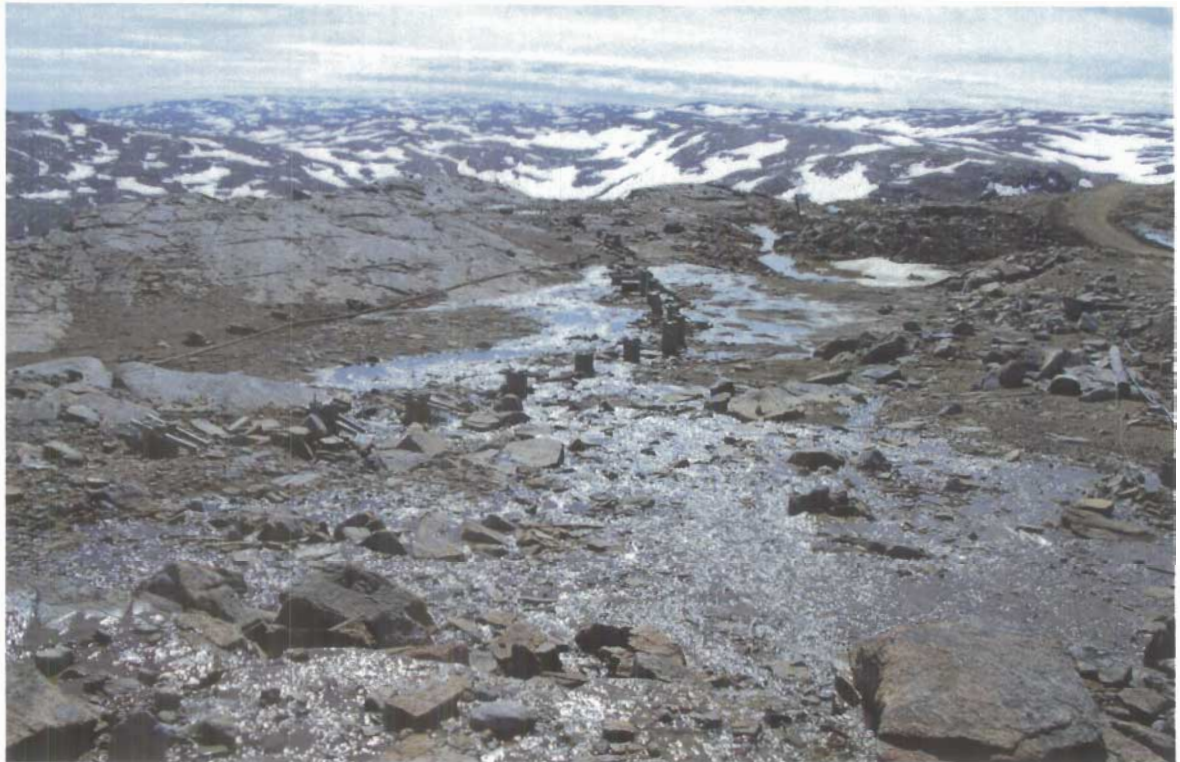
**Photograph V-1: The Initial Part of the Drainage Pathway Leading from the Imploded Tank Area**

Five water samples were collected along the drainage pathway (Photographs V-1 and V-2) at locations shown in Map V-1. Results given in Table V-2 show that all contained less than the detection limit of 1.0 ppm TPH. The reason for collecting these five samples was to confirm that TPH was not being transported in the water along the drainage pathway in measurable quantities. Two soil samples were taken below the cliff at the end of the drainage pathway. This was done in order to extend the assessment area. The 2003 study had shown levels of TPH dropping from values of several thousand ppm near the imploded tank to values of around 300 ppm in the last 100 m of the pathway (actual values 610, 46, 340, 220 ppm). The values obtained from the analysis of two soil samples (one field duplicate) collected from below the cliff were 160 and 90 ppm (field duplicate 97 and 83 ppm). These show that the TPH level has dropped even lower.

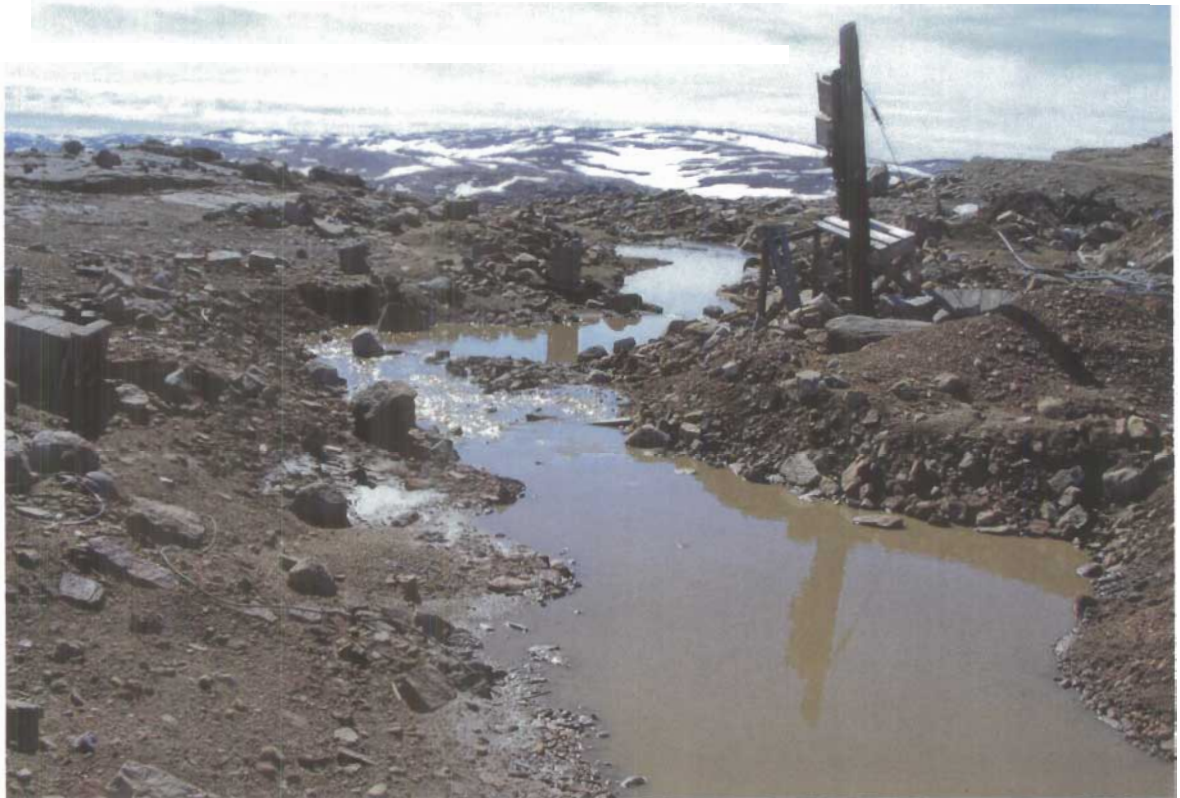
**Photograph V-2: The Mid-Section of the Imploded Tank Drainage Area Where the Ponds and Barrier Were Constructed**

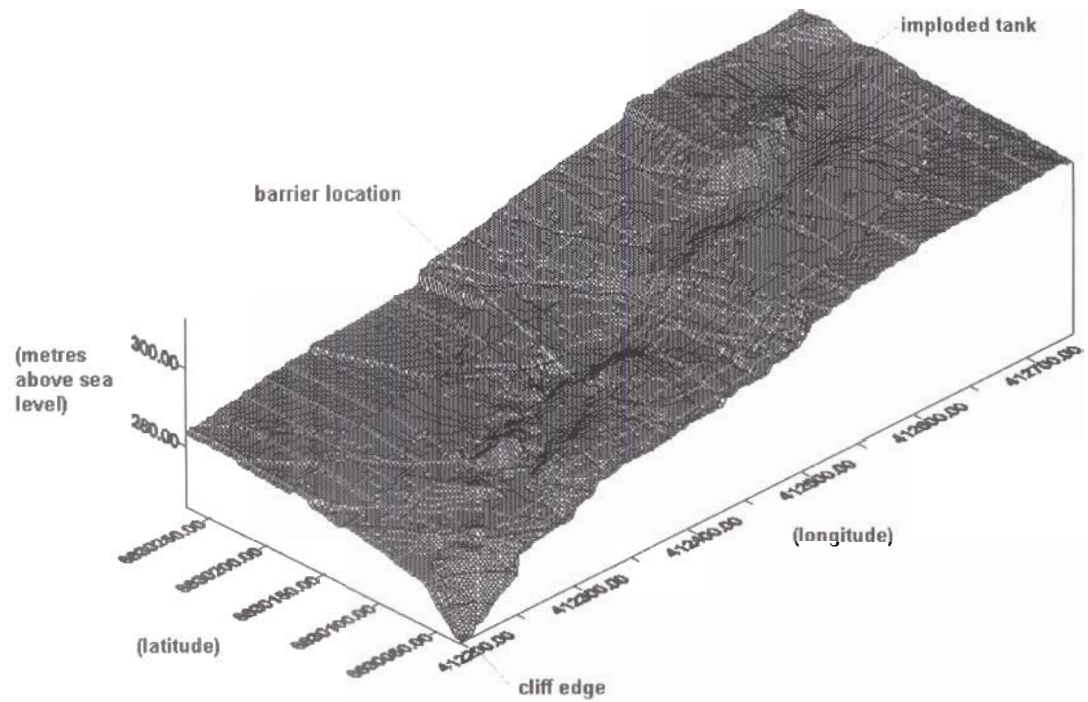
Figure V-2: Topography of Imploded Tank Drainage Pathway

Through chromatographic analysis of soil samples it was determined that as the distance increases from the source of contamination at the imploded tank, there is both a decrease in TPH concentration and an increase in degree of hydrocarbon degradation. The site chosen for the location of the pond and barrier system was such that it served to contain 95% of the hydrocarbons present in the existing drainage course of the imploded tank pathway. Its location was also in an easily accessible area and one that lent itself to the construction of the contouring for the systems with limited movement of materials. The topography and location of the pond and barrier system is shown in Figure V-2.

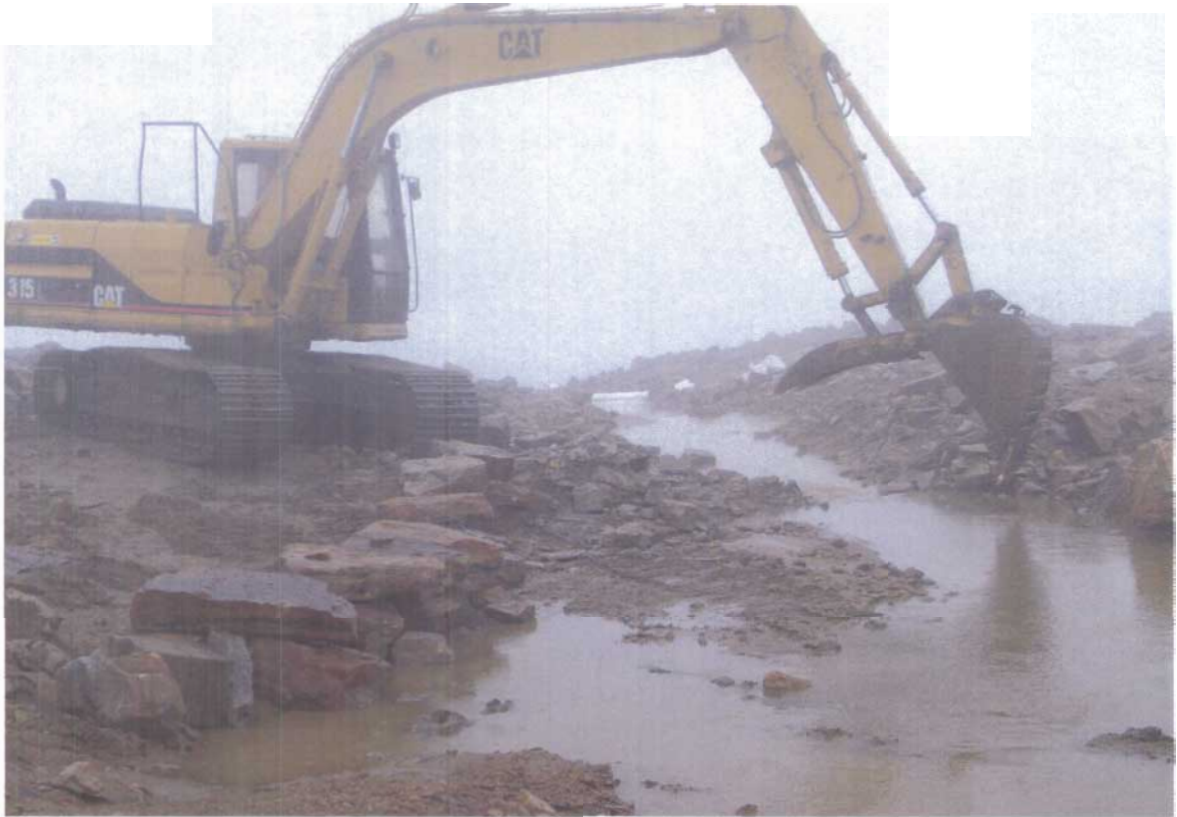
**Photograph V-3: Excavating the Drainage Channel For the Pond and Barrier**

The majority of the berm construction and molding work of the barrier sections was carried out with an excavator (Photograph V-3). Both areas were prepared in typical buttress fashion to ensure stability and longevity of the systems. This process involved gradually decreasing the soil gradation as the berms were constructed starting with large boulders as the berm skeleton and finishing with course-grained soils.

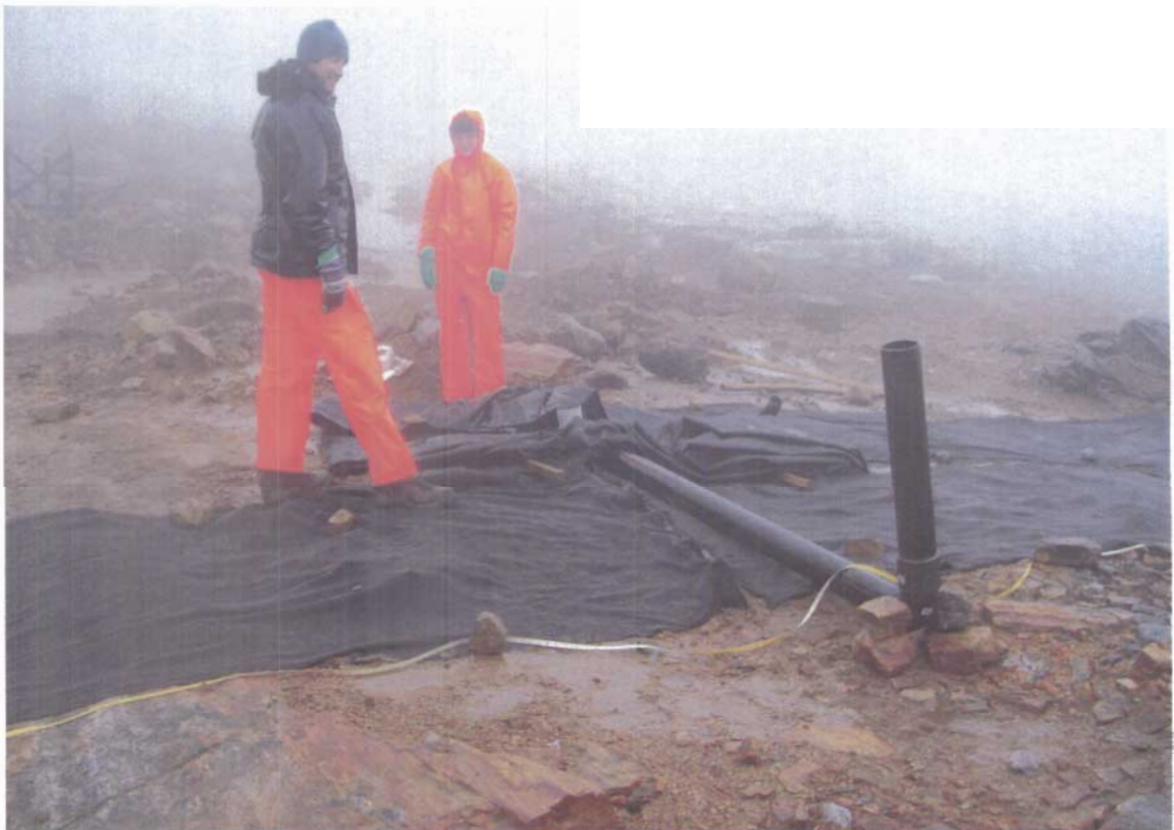
**Photograph V-4: Constructing the Pond: The ABS Pipe Allows Water to be Siphoned Off From the Base of the Pond and Also Controls the Water Level in the Pond**

The drainage and control for the pond was provided by a 4 inch ABS pipe in the form of an outpouring drainage conduit (Photograph V-4). The water is drained from the base of the pond and the water level in the pond is maintained by the height on the outpouring drainage pipe (Figure V-3). The pond was made water tight using a black PVC pond liner and the outpouring ABS drain was secured in place with rocks. The pipe was attached to the liner at the pond bottom using rubber cement pond sealant. The PVC liner was placed over a soft, non-woven geotextile material to mitigate rock punctures in the liner facing. The liner was held in place by toeing the PVC into the outer berms as well as securing the submerged base with sand bags. The face of the main weir was protected and sealed with a manually constructed stonewall. Matasorb absorbent booms were affixed across the mouth of the pond both as a precautionary measure in case of an overpowering spring runoff event, and to provide a second mechanism to remove any TPH. From an experimental point of view, PVC liner was chosen in order to test its durability in the Arctic and because of its low cost. PVC liners are widely available as pond liners in southern Canada but are generally susceptible to UV degradation. The liner in this case is expected to be shielded from direct sunlight by silt.

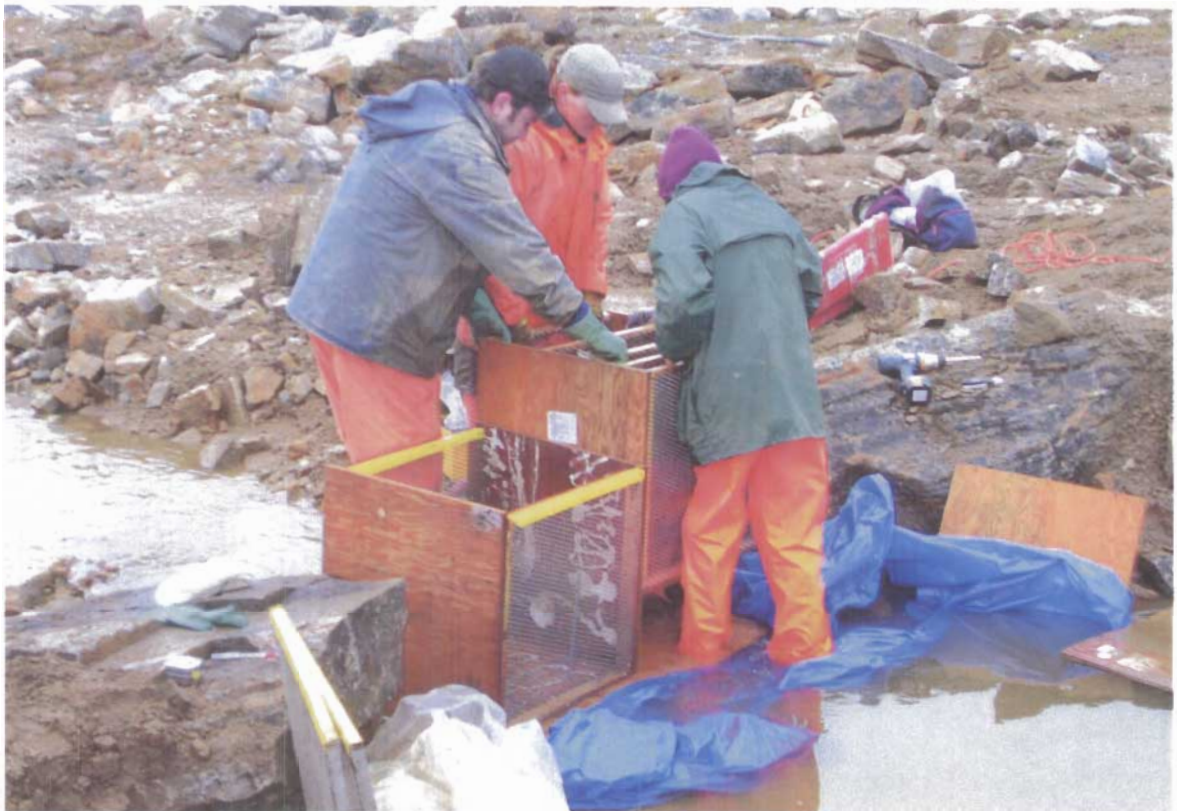
**Photograph V-5: Installing the Filter Boxes in the Barrier**

with rock bolts (Photograph V-5). The base liner was formed first with a layer of GCL (Geo-Composite Liner Bentofix CNSL, Terrafix Geosynthetics Inc.) containing bentonite clay. The GCL was laid on the reservoir floor, up the sides of the berms and to the edges and base of the filter box. An impermeable textured flexible HDPE liner (Terrafix Geosynthetics Inc.) was placed on top of the GCL (Photograph V-6). Both the GCL and HDPE liner were attached to the filter boxes before securing the liner to the berms. This step was modified from the S1/S4 barrier construction protocol where instead the berm-to-liner junction was secured before that of the liner-to-filter box. Each filter box was fitted with 1.5 inch gravel filter followed by a 3 inch GAC filter. The filters were designed similarly to the S1/S4 valley system where in order to maintain flow, the void size was maintained for a  $D_{85}$  pass allowance. For the first filter, gravel was taken from radio hill and sieved to 2-10 mm particle size. The GAC used in the second filter was sieved through a US 6 and 12 standard sieve sizes to achieve a grain distribution of 1.68-3.36 mm. Most HDPE material used as landfill liners are much thicker, generally 60 mil, but these were not flexible enough for this design. The HDPE liner used had a thickness of 20 mil. The material, which was made available to the project by Terrafix Geosynthetics Inc, was a small remnant remaining from a special order project for another client and was ideal for this application. It will be susceptible to UV degradation but, as with the PVC liner, should be shielded from direct sunlight by sediment build up.

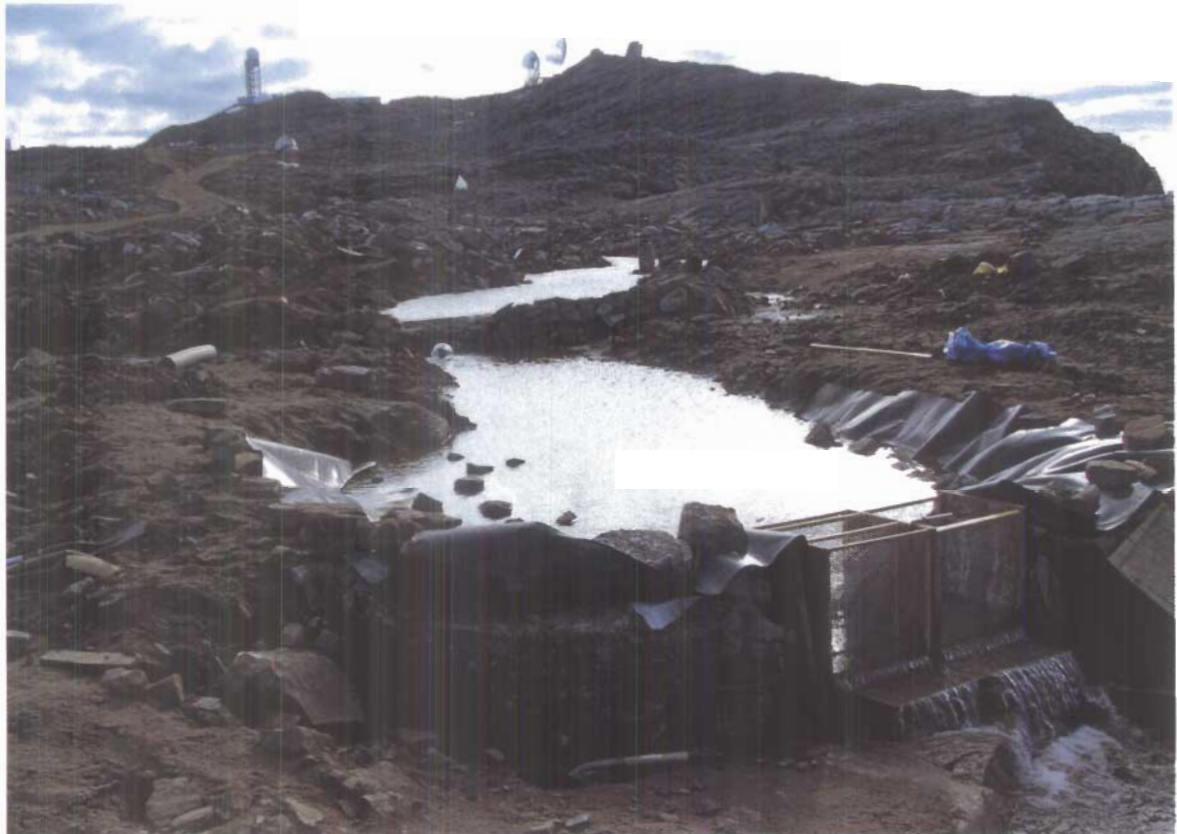
**Photograph V-6: The Barrier in Position but Without Filters: The Pond is Shown in the Background**

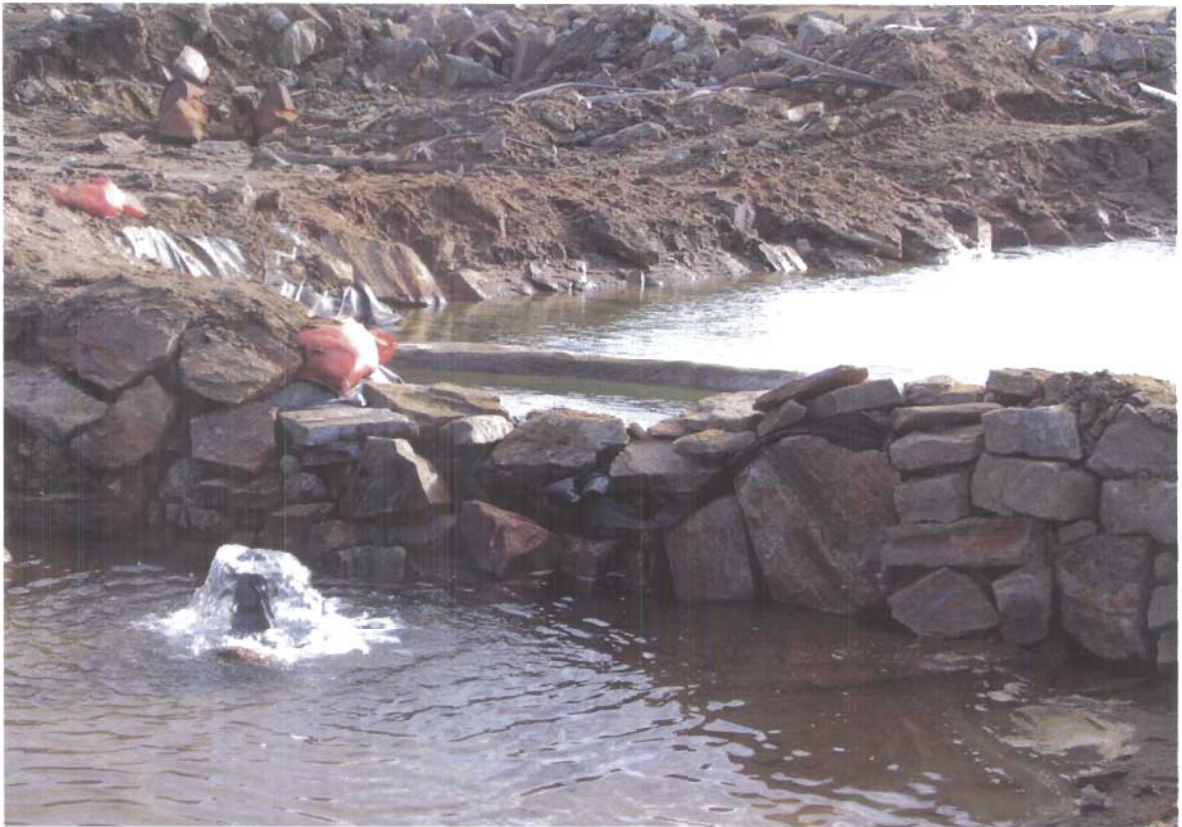
**Photograph V-7: The Division Between the Pond, Which is Draining into a Second Pond Created by the Barrier, with Filters in Place**

Photograph V-7 shows the dam at the end of the pond and the water exiting from the pipe. Construction of the pond and barrier system was completed on 12 August 2004 as shown in Photograph V-8.

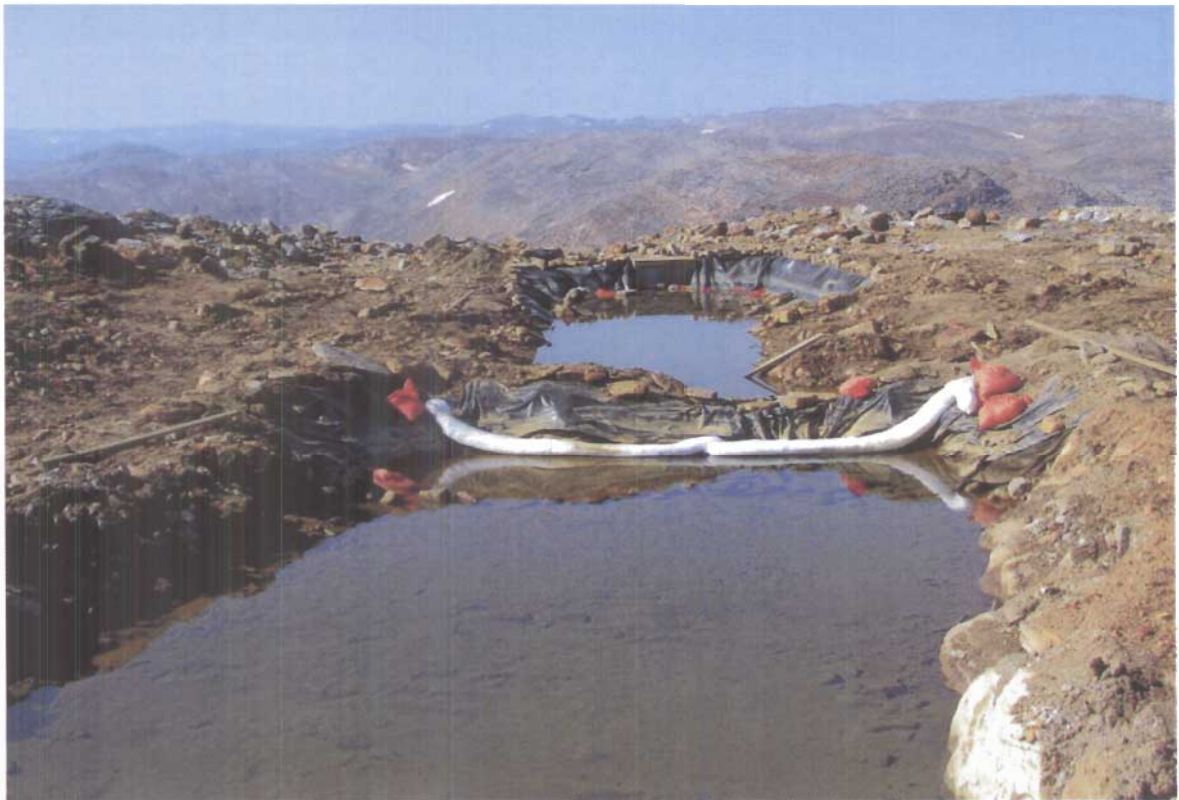
**Photograph V-8: The Completed Trial Remediation System Showing the Pond With Boom in the Foreground and Barrier Filter Box Beyond and Down Stream**
