E. Beach POL Area

F. Landfarming

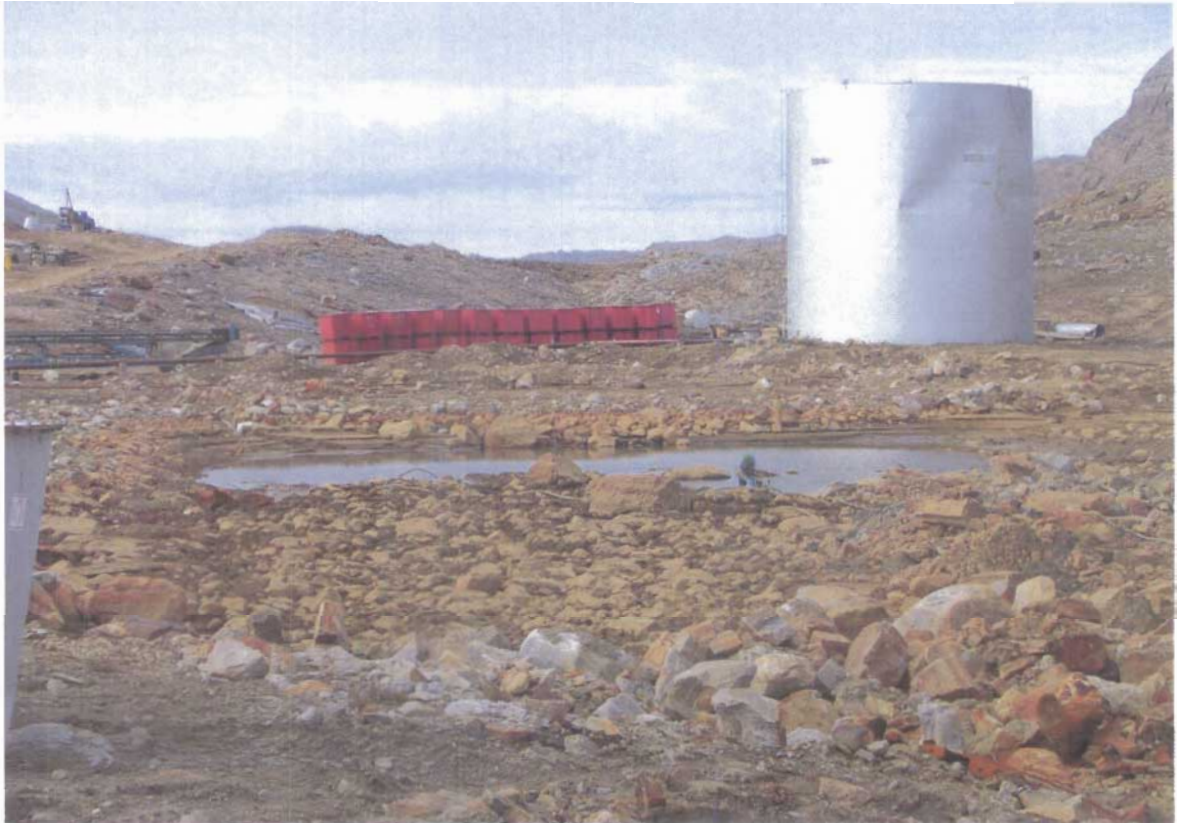
Photograph V-9: The Pond Between the Two POL Tanks After Draining: The Original Boundary of the Pond is Outlined by the Brown Staining

In 2004 the water from the lake below the barrel cache valley was diverted past the pond between the two POL tanks. Water was pumped from the pond to reduce its area as shown in Map V-4. The lake could not be pumped dry due to water infiltration. Twenty samples were collected from various locations mostly in the area previously below the pond. Some of these samples were taken from test pits at various depths (Photograph V-10). Results are given in Table V-4 and on Map V-4. The TPH was shown to be weathered diesel from the shape and position of the peaks on the chromatograms.

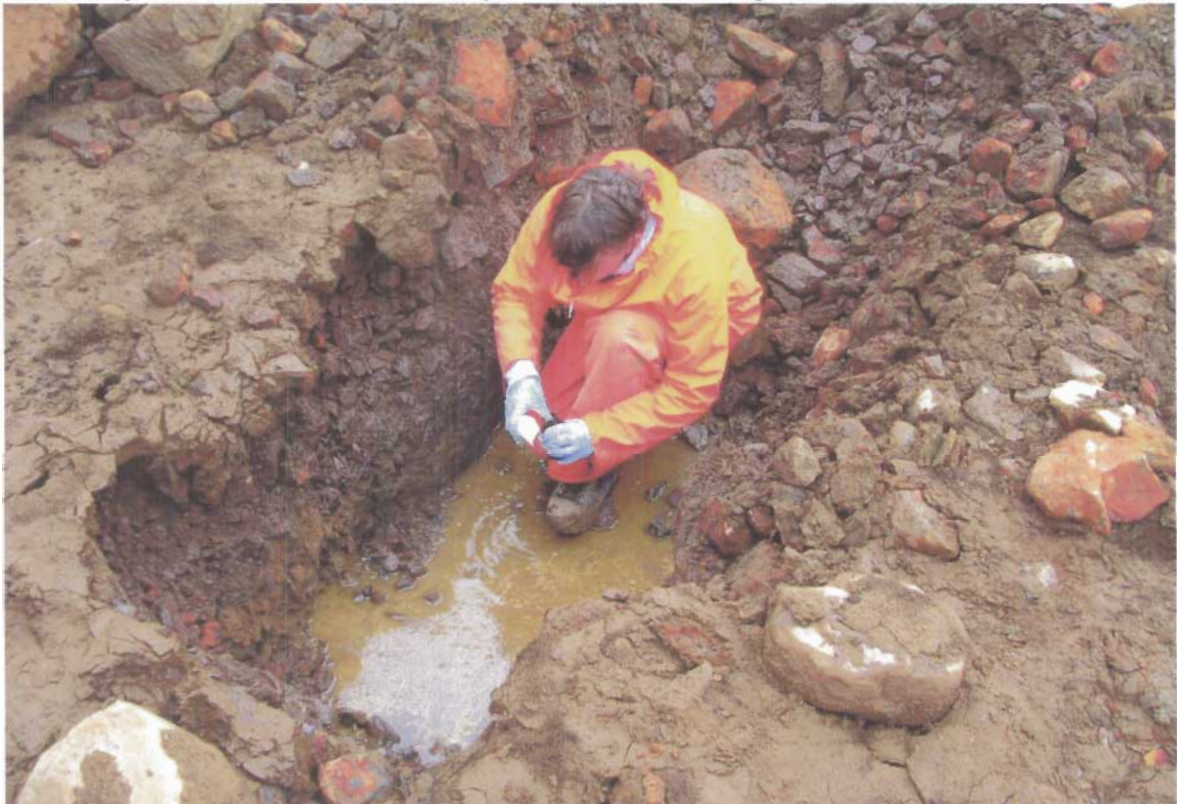
Photograph V-10: Collecting a Soil Sample From a Pit in the Previously Poned Area

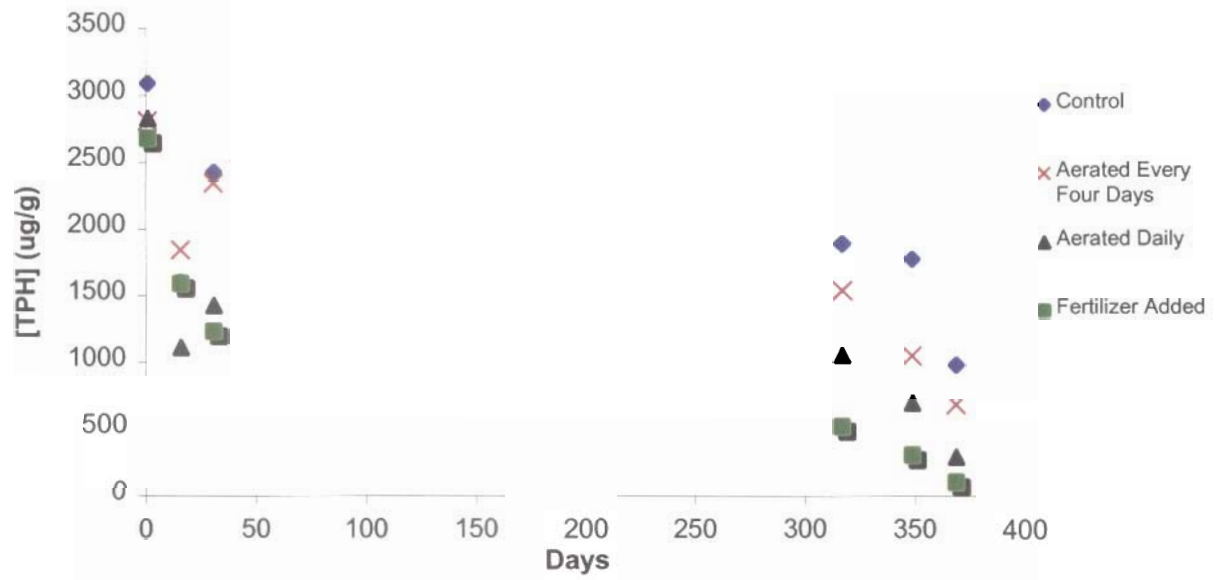
Figure V-5: Change of TPH with Time for the Trial Landfarm

Analytical results obtained from the four plots at three different times in 2003 and 2004. Results are given in Table V-7, summarized in Table V-6 and presented graphically in Figure V-5.

These results show a dramatic decrease in the TPH levels with time. The final results from samples collected on 28 August 2004 were all low for all plots, including the control plot in which TPH level which fell from 1780 to 980 ppm. A similar trend was

seen in second sampling in 2003. The explanation for this is unknown but may relate to weather conditions at the time of sampling. It is also possible that the disturbance of the soil in the construction of the landfarm created conditions that promote TPH loss through aeration or leaching. TPH levels in all plots have decreased over the two year period. The fertilized plot shows a striking decrease in TPH levels by over 90 %. The daily aerated plot similarly shows losses in excess of 80 %, while the aerated every 4 days shows lower reduction in TPH levels.

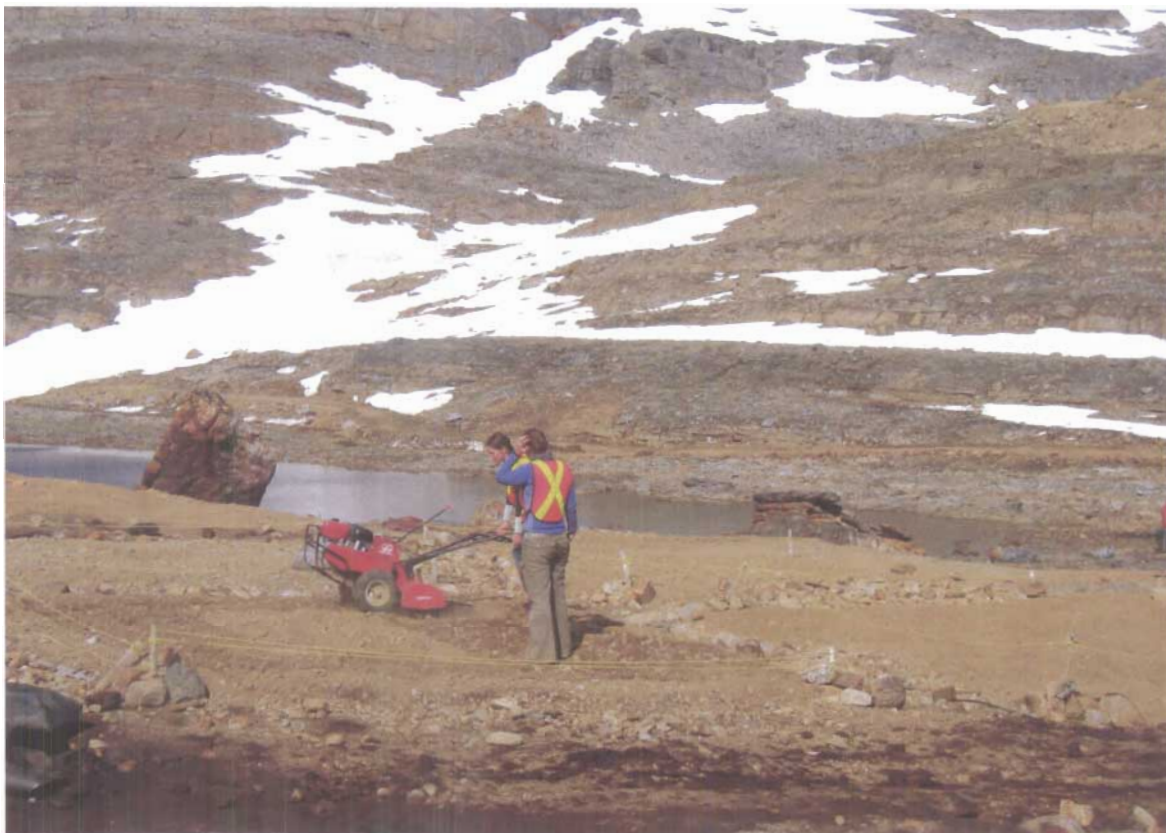
Photograph V-11: Rototilling the Trial Landfarm Plots

In 2004 it was decided to rototill only when the weather was dry as experiences in 2003 had shown that rototilling under very wet conditions was not productive. Fertiliser addition was based on a C:N:P ratio of 100:7.5:0.5 and was not applied until 24 August 2003. Rototilling was carried out (Photograph V-11) to the approximate depth of the plots. Samples were collected periodically for analysis from each plot (Photograph V-12). For each sampling time for each plot, five soil samples were collected. These were from towards the four corners of the plot plus one from the central area. At each location a hole was dug to about 25 cm and a soil profile from the edge of the hole collected with a clean scoopula.

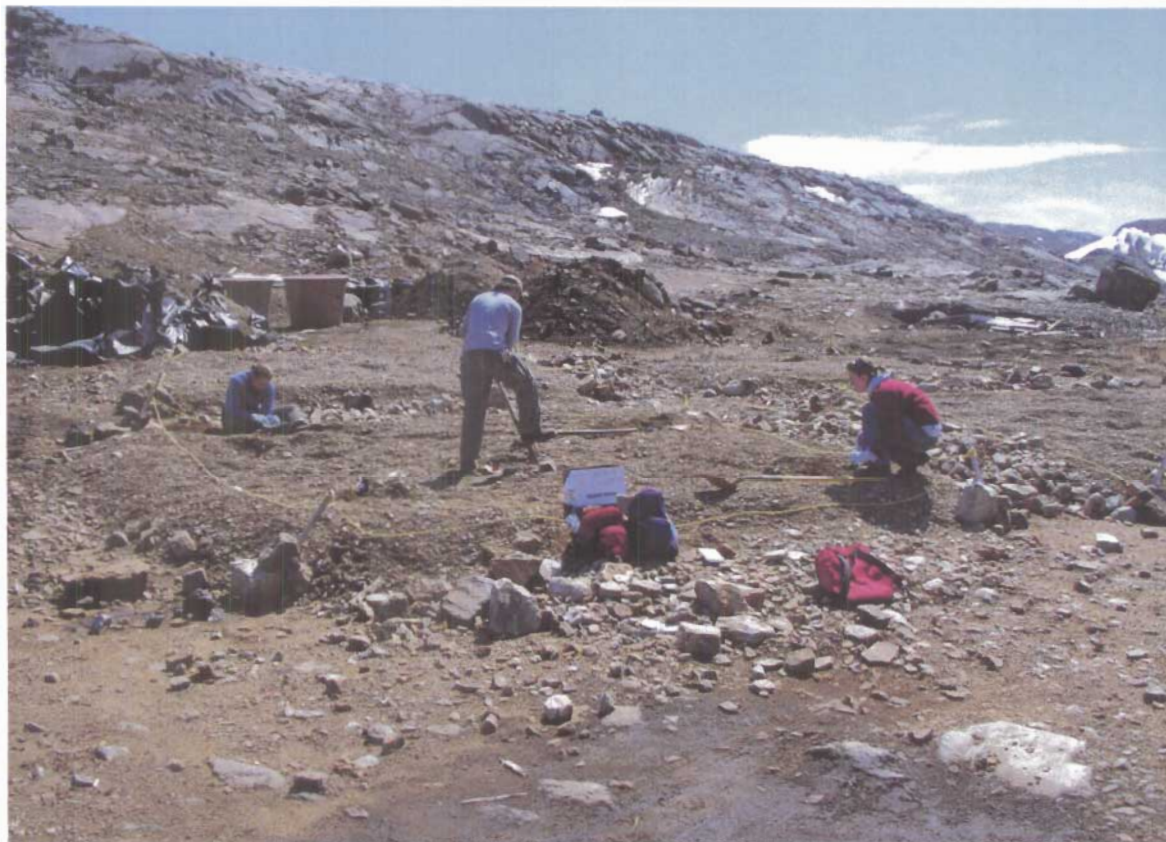
Photograph V-12: Collecting Soil Samples From the Trial Landfarm Plots

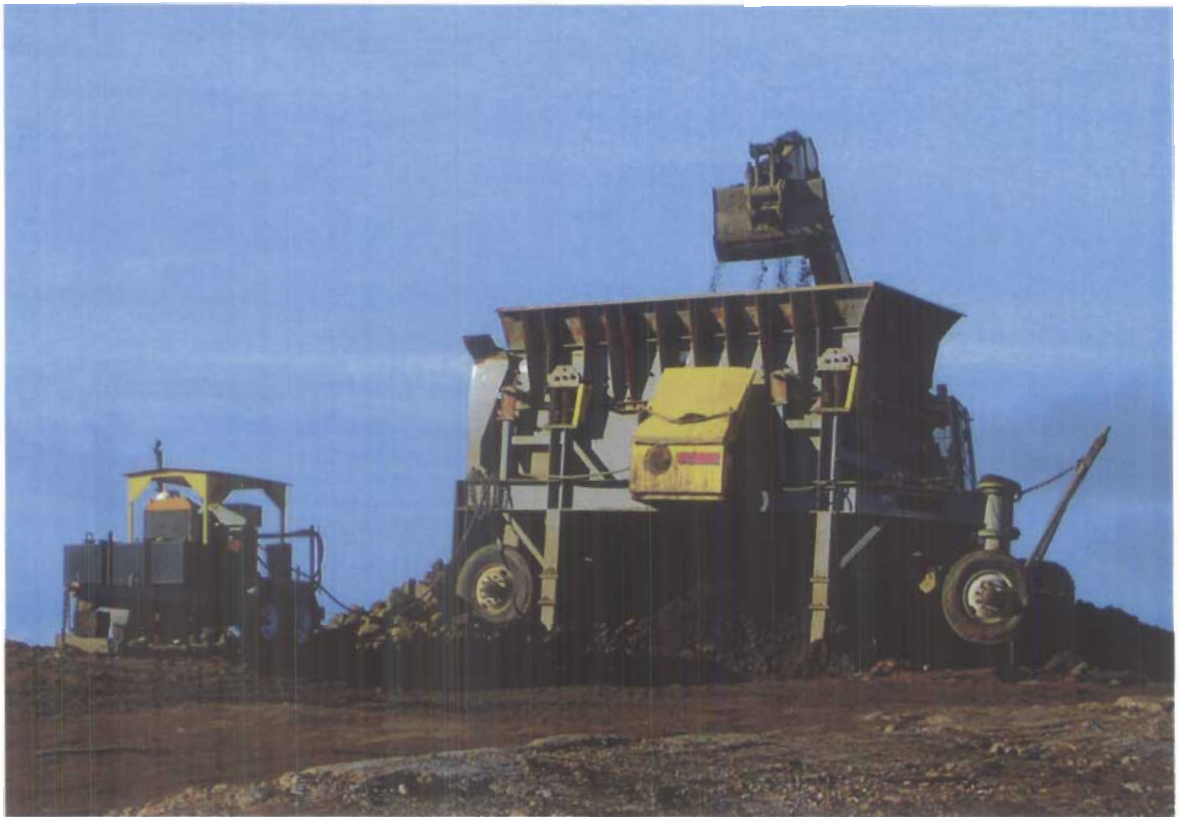
Photograph V-13: The Hydrocarbon Contaminated Soil Was Screened Prior to the Construction of the Main Landfarm

A major landfarm was set up this year in order to remediate the high fuel contaminated soil at the site. This soil came from two sources, the area around the imploded tank and material removed from beneath the Tier II landfill site. The areas identified around the imploded tank and drainage pathway as containing > 8000 ppm diesel fuel as specified in the 2003 ASU report were marked out with rope. These areas were then excavated and the resulting soil, together with that from the Tier II landfill excavation, were passed through a two inch screener (Photograph V-13). The screened soil was then spread out in an area near the imploded tank as shown in Map V-6. The approximate size of the area was 76 m by 21 m with a depth of about 0.5 m. The area was 1390 m² and a volume of 700 m³. Fertilizer was then added at a rate of 117 g urea and 1.8 g diammonium phosphate per m². The whole area was then rototilled (Photograph V-14). A grid was then set up over the landfarm with an approximate quadrant size of 7 m by 7 m as shown in the inset of Map V-6 and Photograph V-15. Soil samples were collected from each quadrant of the grid as in the trial landfarm and analysed for total TPH. Results are shown in Table V-9 and on Map V-6. The concentration of the TPH in the landfarm was 3320 ± 970 ppm. This average is from the 39 samples analysed. Five samples were reserved for further analysis of CCME-TPH, nitrogen, phosphorus and biodegraders. The landfarm as shown in Photograph V-16 was completed on 30 August and soil samples taken on 3 September 2004.

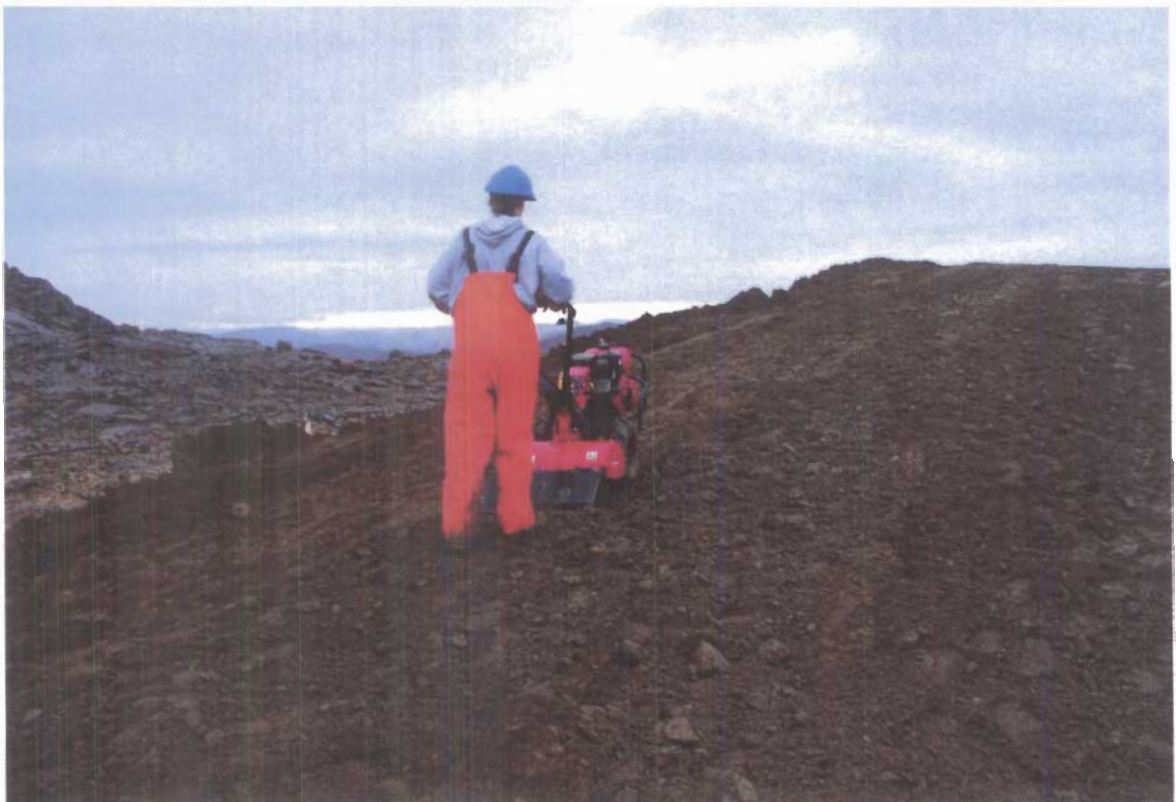
Photograph V-14: Rototilling the Main Landfarm

Urea was added such that the nitrogen level was < 2000 mg/kg soil water. More urea may be added next year depending on the carbon, nitrogen moisture levels. The aeration regime for the landfarm will be based on the results from the laboratory studies currently underway. It is planned that the harrow that was purchased in 2003 will be used to aerate the landfarm as rototilling the large area will take about 5 hours.
