G. Air Sampling for PCBs and Chlorobenzenes

H. Drinking Water

J. Background Water Samples

K. Background Plant Samples

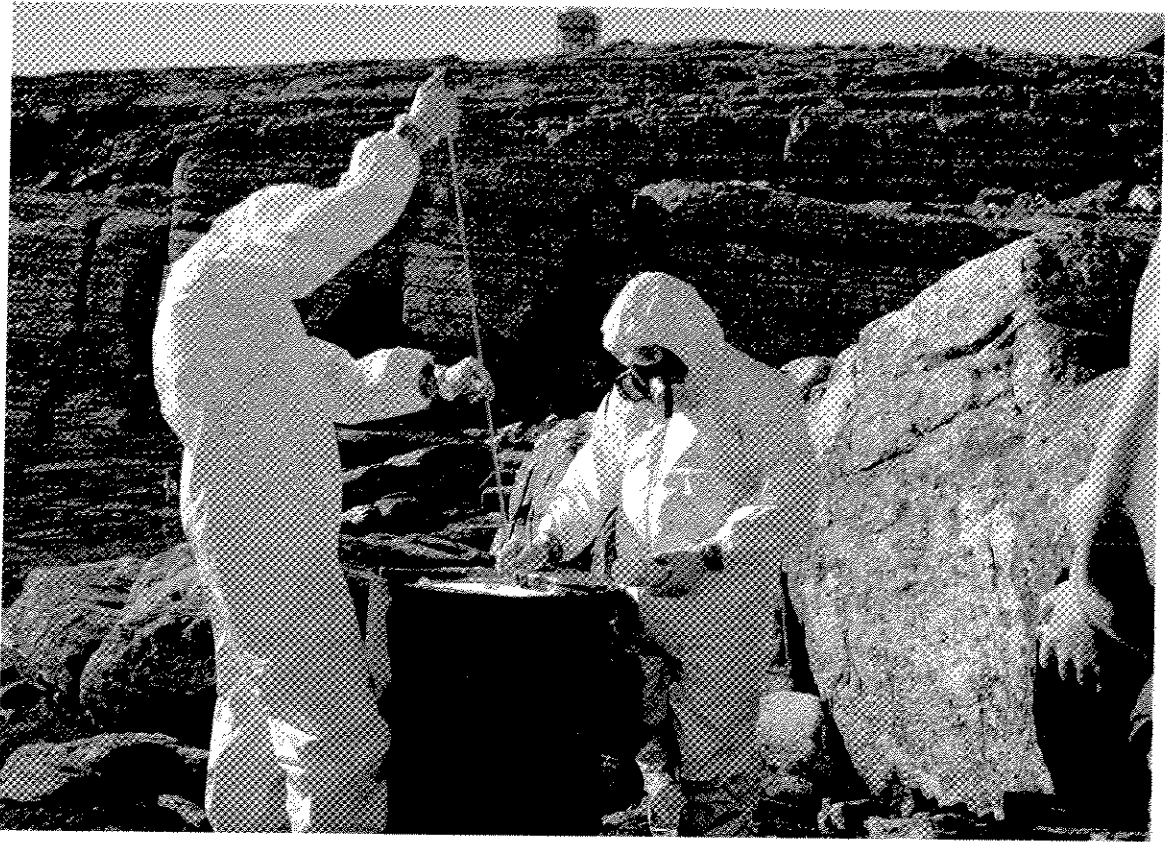
Photograph III-12: David Whitmore and Jared McKay Taking a Sample From a Barrel Containing a Liquid of Unknown Composition

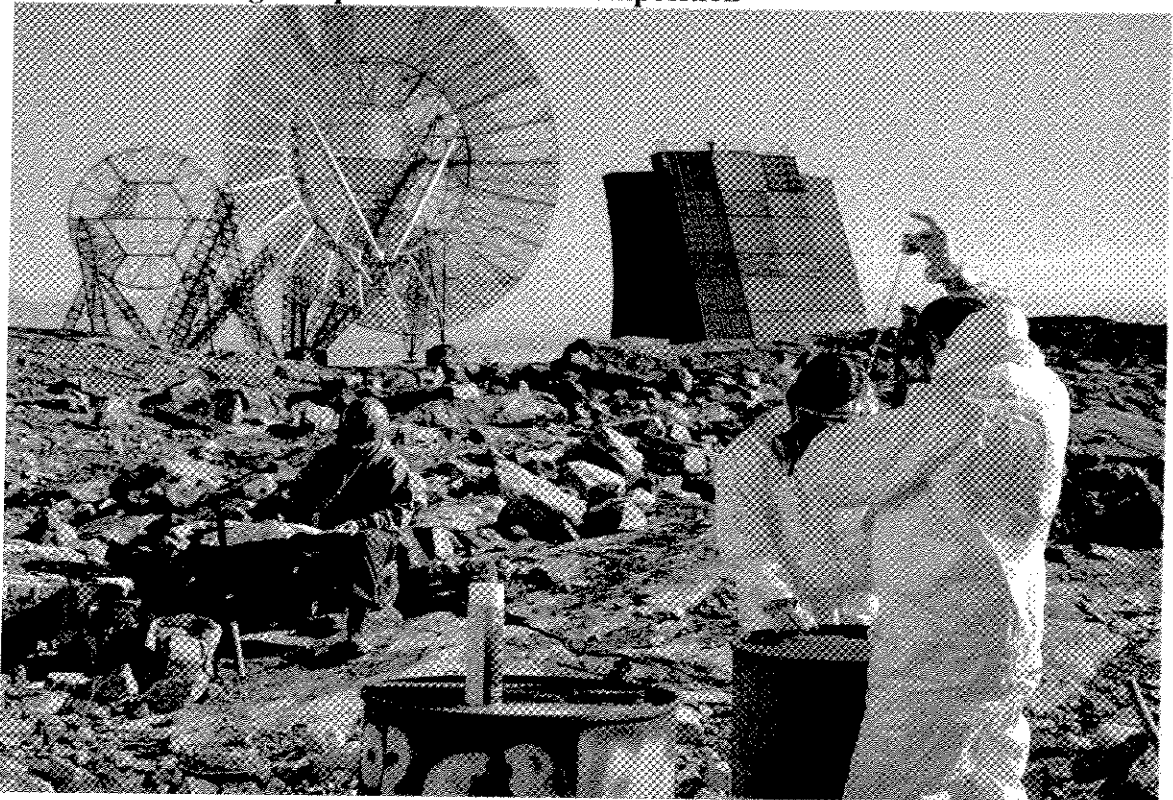
Photograph III-13: Taking Barrel Samples From Behind the Old Officer's Mess

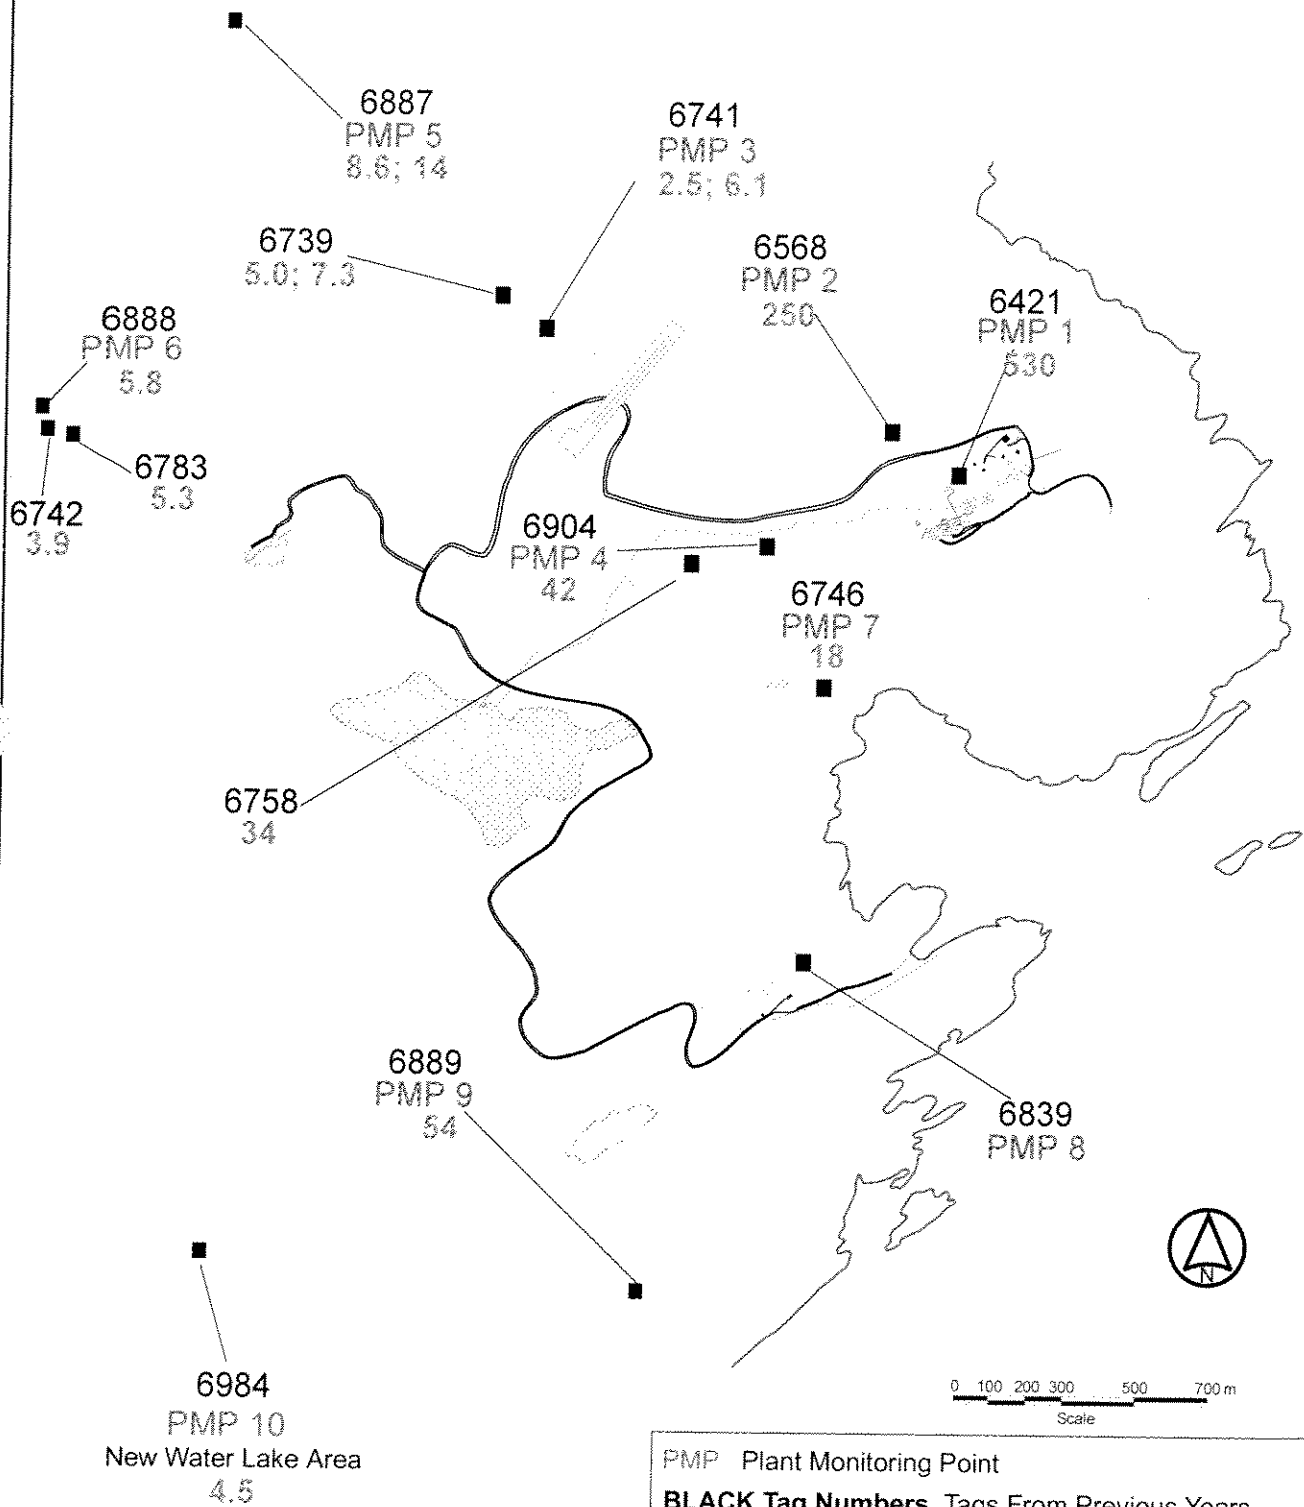
**Map III-4: Locations and PCB Concentrations of Background Plant Samples
Collected in 2005 and Designated Plant Monitoring Points**

The results are presented in Table III-22 and on Map III-4. Map III-4 also shows the ten designated plant sampling points (PMPs) to be monitored in future years as part of the long term monitoring plan. All PCBs showed the Aroclor 1260 pattern. Results indicate that the level of PCBs in the plants in the areas removed from remediation action has already dropped. This is due to the removal of the high level CEPA soil. For instance, at monitoring point PMP3 near the airstrip the level has dropped from 11000 ppb in 2002 to 4.3 ppb (the average of the two results, 2.5 and 6.1 ppb). In contrast the level at PMP2 near the Tier II landfill has increased from <3 ppb in 2004 to 250 this year due to major activity involving Tier II soils nearby. The results are particularly gratifying in that they

indicate that the removal of the PCB contaminated soils has already reduced the airborne transport of PCBs.

Background plant samples were collected and analysed for PCBs again this year. The locations as shown on Map III-4 (RI05 numbers) were sampled this year on 24 July 2005 (P001-P015) and 30 August 2005 (P017-P023). All plants are *Salix Polar* unless otherwise stated in Table III-22.
