V. FUEL CONTAMINATION

E. Imploded Tank Area

1. Ponding and Barrier Research

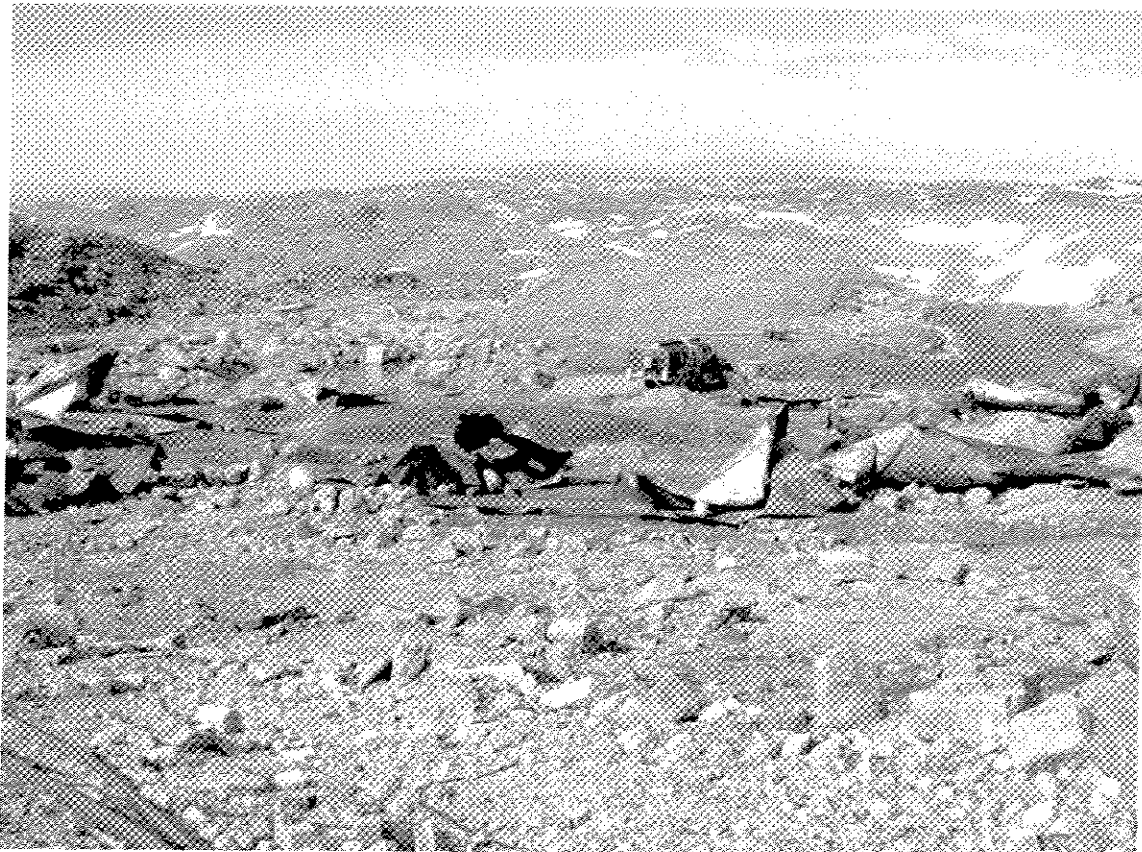
The imploded tank was dismantled this year (Photograph V-1). Stained soil at the resulting footprint was sampled and analyzed. Analysis of the two composite samples taken gave results of 15000 ppm (RI05-1018) and 11000 ppm (RI05-1019) as diesel fuel. Because these results were above the F2 criterion of 8000 pm, the top layer of soil was excavated and added the large landfarm.

Photograph V-1: The Remains of the Imploded Tank After its Demolition: Note the Hydrocarbon Contaminated Pad and the Main Landfarm Beyond

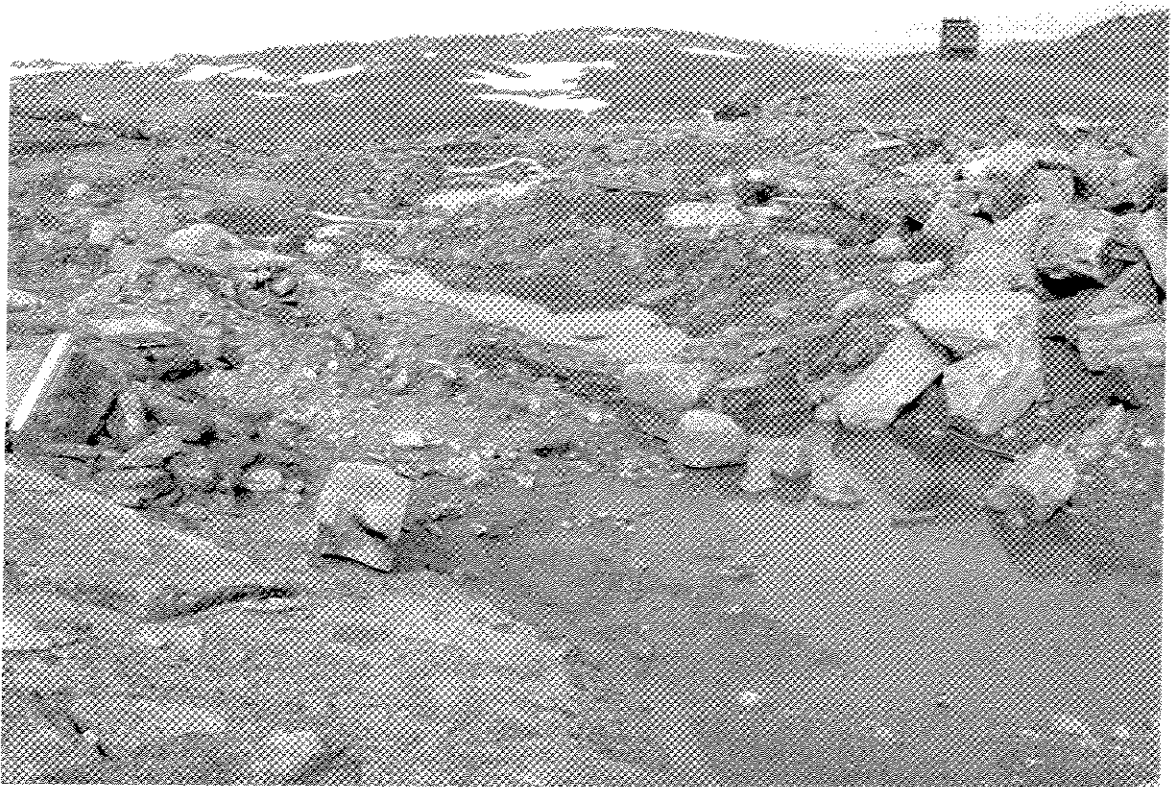
This year the barrier was initially inspected to determine how well it had stood up to the winter and spring run off. As shown in Photograph V-2 the systems were in good condition and required no repair. The boom on the pond was replaced with a new one in early July 2005 and the sand and GAC filters were regenerated and replaced in the filter box.

Photograph V-2: The Drainage Pathway From the Imploded Tank and Main Landfarm With the Pond and Barrier System at the Start of the 2005 Season
