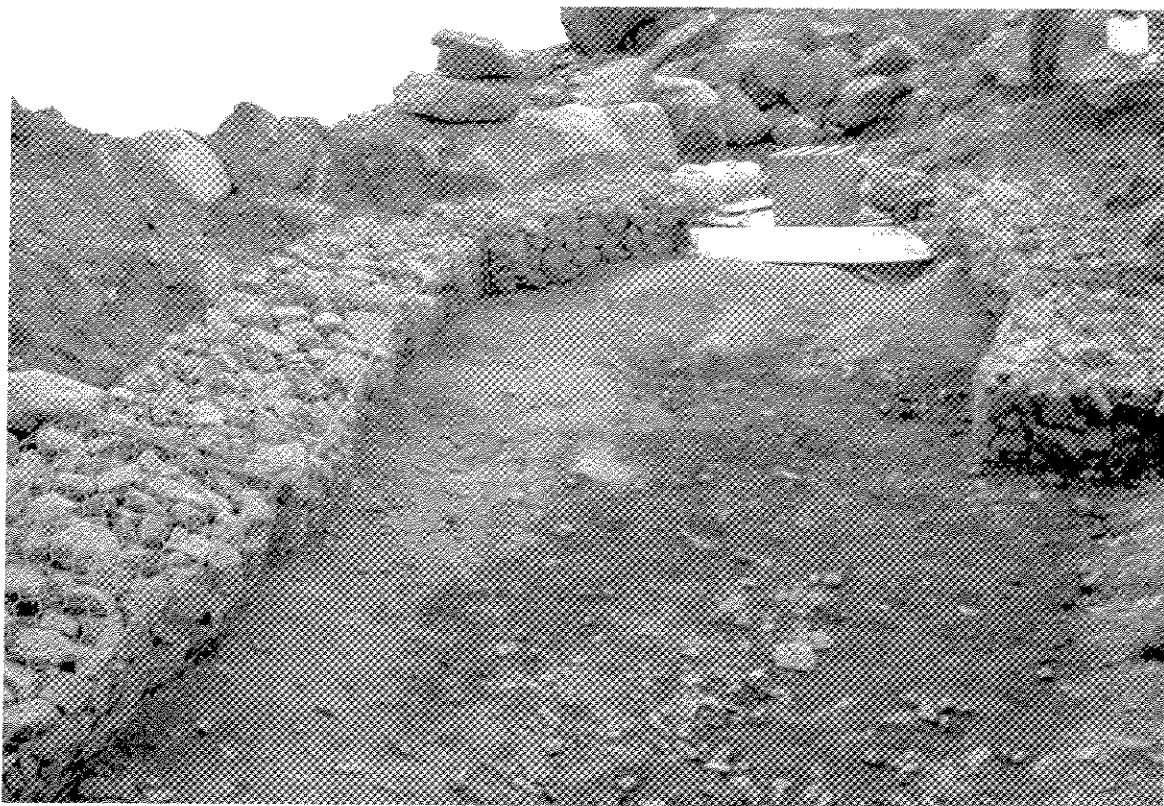
**Photograph VI-9: Gabion Walls Were Constructed to Form the Channel Through Which Water From the S1/S4 Beach Area Then Was Forced to Flow**

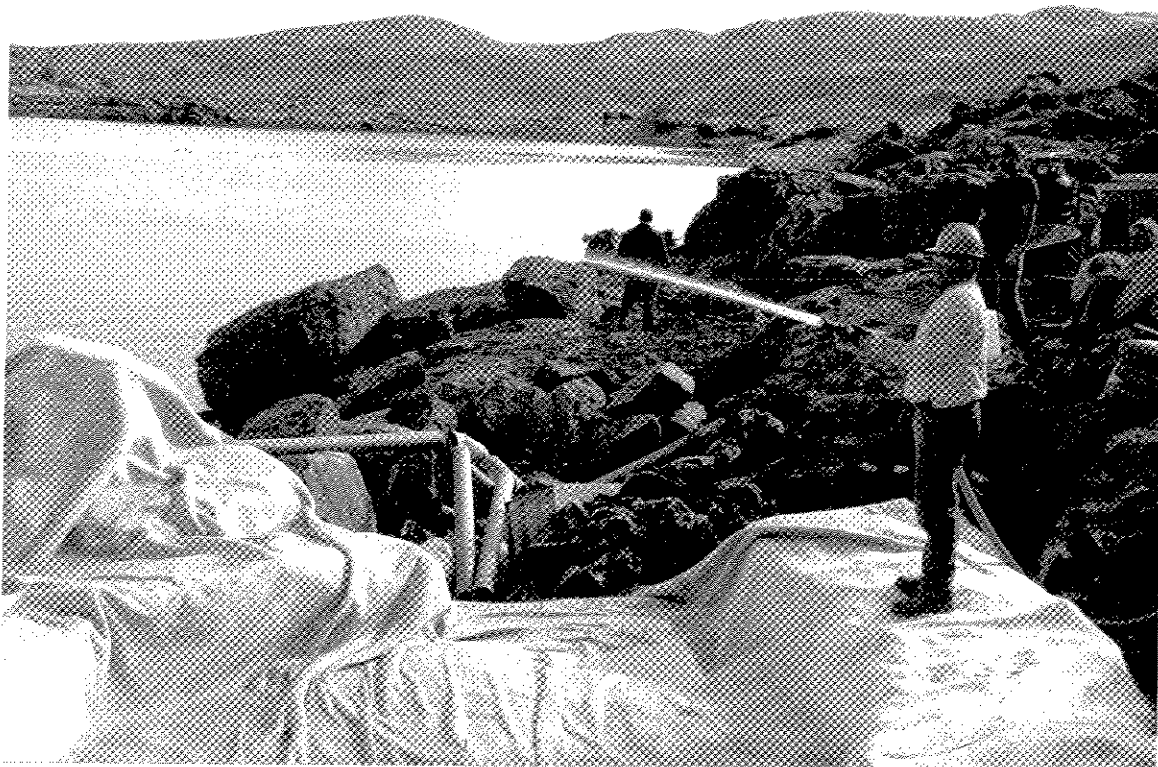
**Photograph VI-10: After the Geocomposite Clay Liner was Placed in Position, It was Wetted to Form a Sealed Channel**

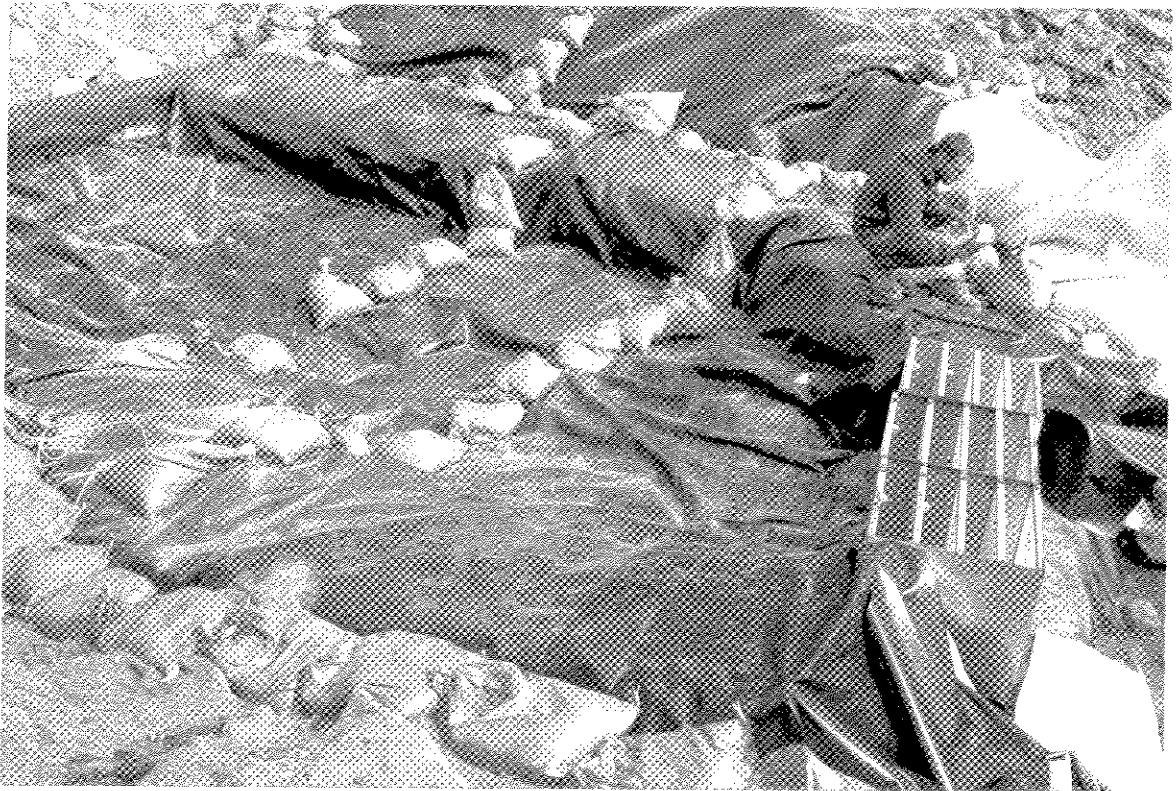
**Photograph VI-11: A Black Liner Was Then Placed on Top of the GCL and Sealed Around the Filter Box. Sandbags Secured the Liner to the Contoured Channel**

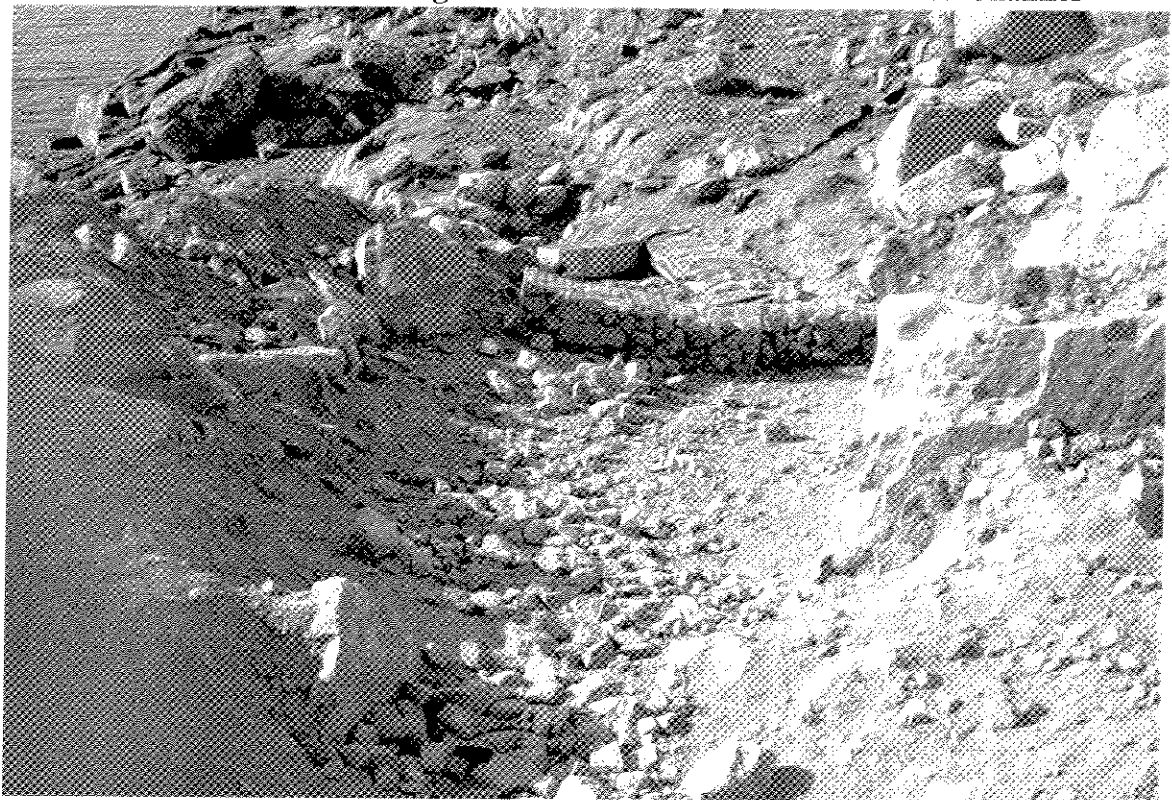
**Photograph VI-12: Gabions Were Placed Across the Drainage Channel Above the Steep Slope Leading to the Barrier as an Additional Sediment Trap**

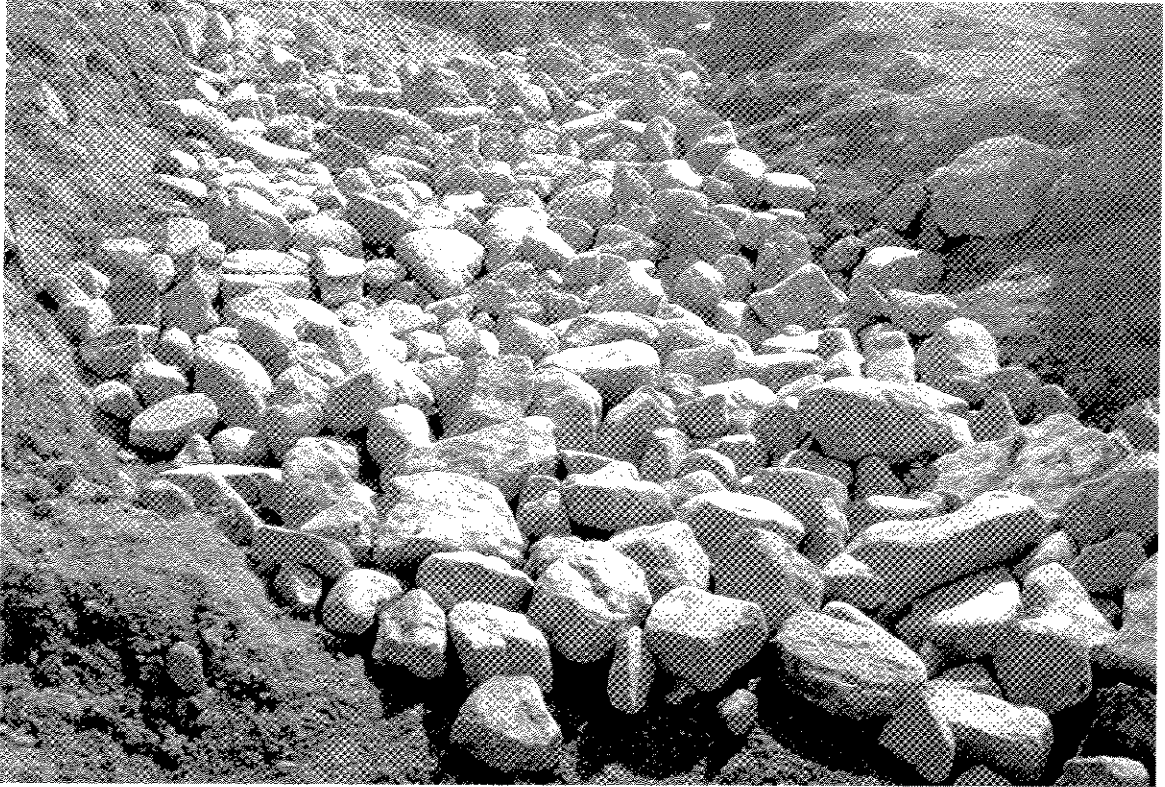
**Photograph VI-13: The Channel Above the Top Gabion Sediment Trap Was Lined With Cobbles To Trap More Sediment**

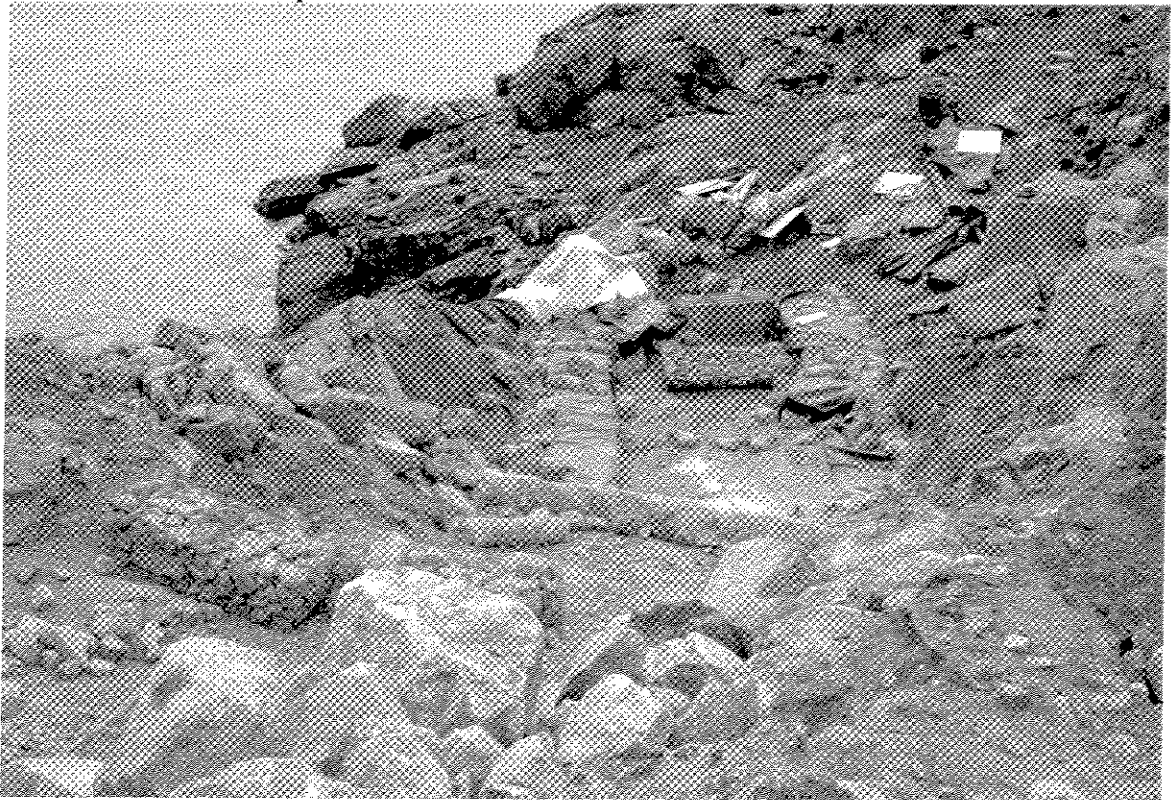
**Photograph VI-14: The S1/S4 Beach Barrier Nearing Completion**
