D. S1/S4 Buildings and Valley Area

2. Soil Excavation

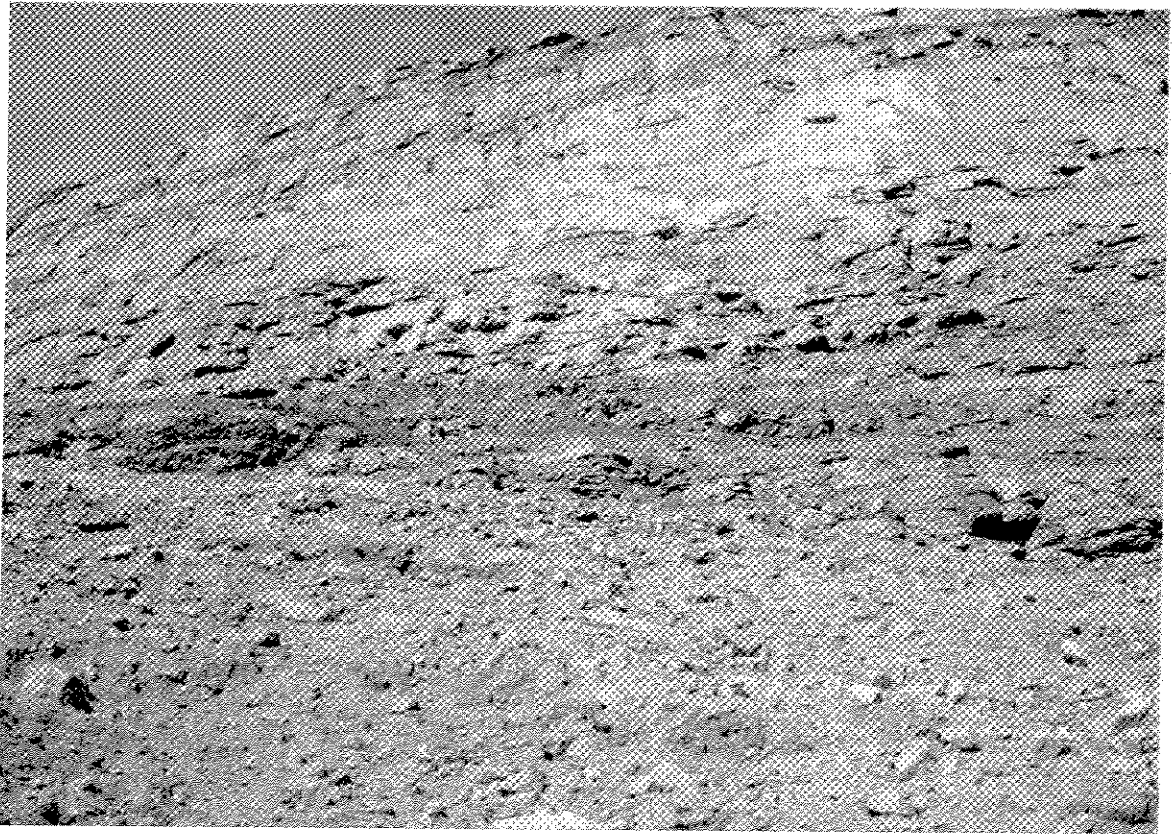
Photograph II-7: The S1/S4 Beach Area After Excavation

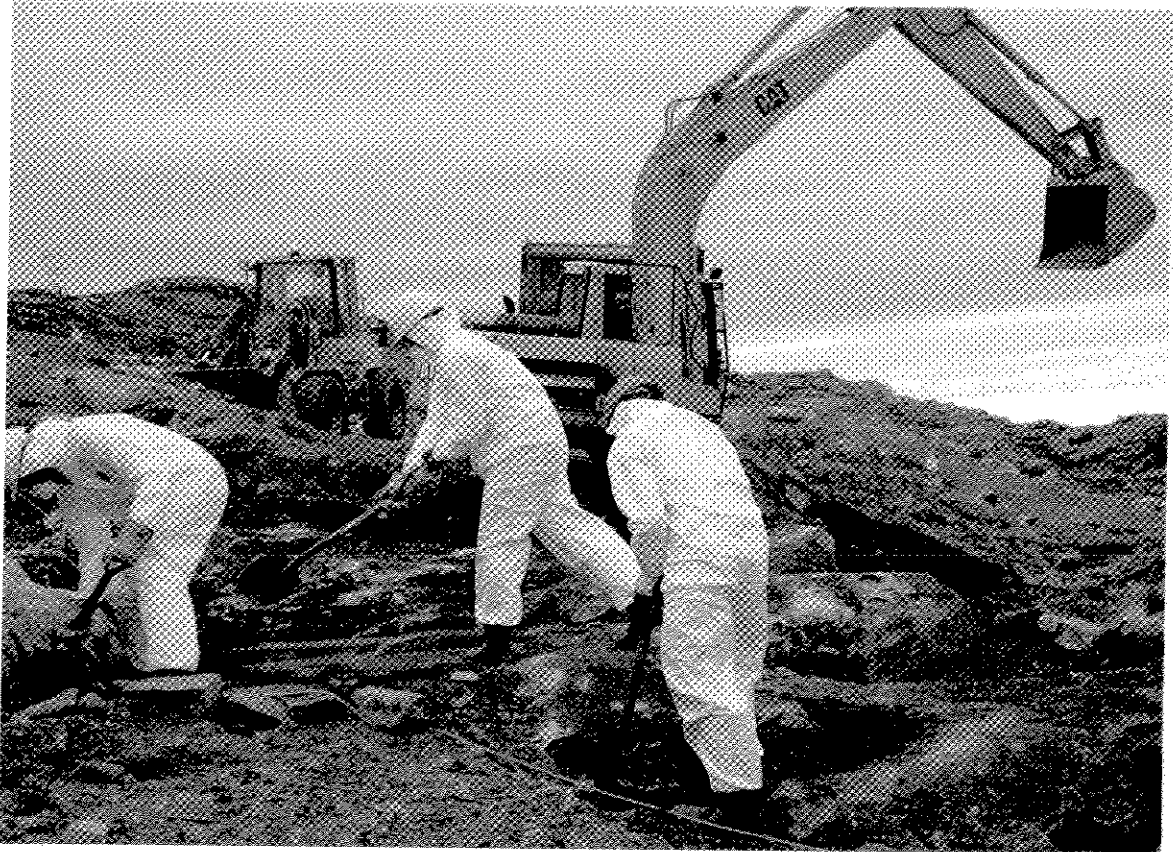
Photograph II-9: Removing the Last of the CEPA Soil by Hand From a Pocket of High Contamination Found Below Dish B

Tier I in these two cases, (grids J17, J18, K17, and K18). Below Dish B in grid I13 there is a small area of frozen Tier II soil (surface area of 5 m²) that was covered with clean fill. Tier I pockets in inaccessible areas near the cliff edge have been left untouched (grids Q25, P24, P23, P22 and O22) due to safety concerns. An area stretching from M20 to L18 contained a very thin layer of Tier I and Tier II soils on a steep terrain that could not be accessed. The small area of Tier I soil in quadrants E7 to D3 was not excavated as the soil was very thin and mostly boulders.
