Resolution Island 2000 Scientific Investigations

Analytical Services Unit
Queen's University
Kingston, Ontario

Contaminated Sites Office

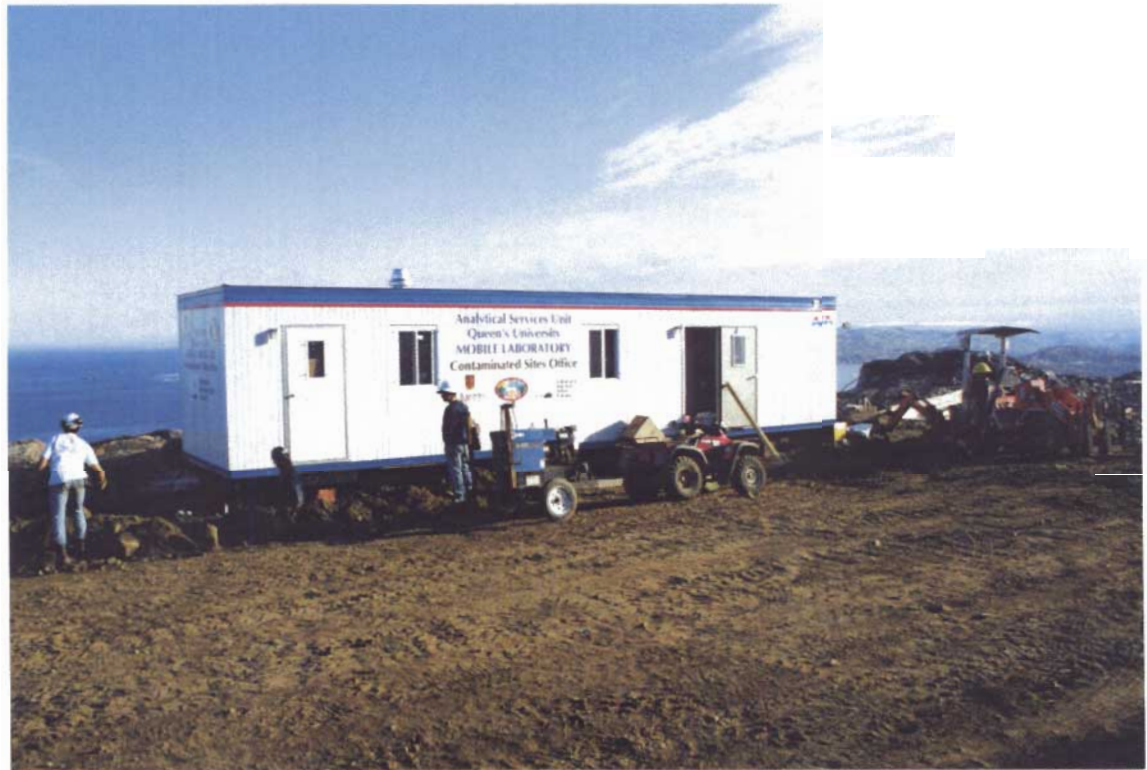
Photograph I-2: The Mobile Laboratory in Position at the Site; The Wheel Assembly was Removed and the Photograph Shows the Trailer Being Secured to the Ground.

Construction of the Mobile Laboratory (44 ft by 10 ft) was tendered to three companies and built by the successful bidder, AFA Structure Inc. (Montreal) for Associated Mobile Technologies (Amtec). The laboratory was delivered to Queen's University on 25 May 2000 where it was fitted out with equipment and modified in various ways. It was then shipped to Montreal on 29 June 2000 (Photograph I-1) and arrived on the sea lift at Resolution Island on 22 August 2000. The wheels were removed from the laboratory which was placed on wooden beams and secured to the ground by

cables (Photograph I-2) attached to rock bolts and “dead men” (large steel pipes buried in the ground to which the cables were welded). The laboratory was positioned opposite the core camp and the sea-can containing additional ASU supplies was placed next to it (Photograph I-3).

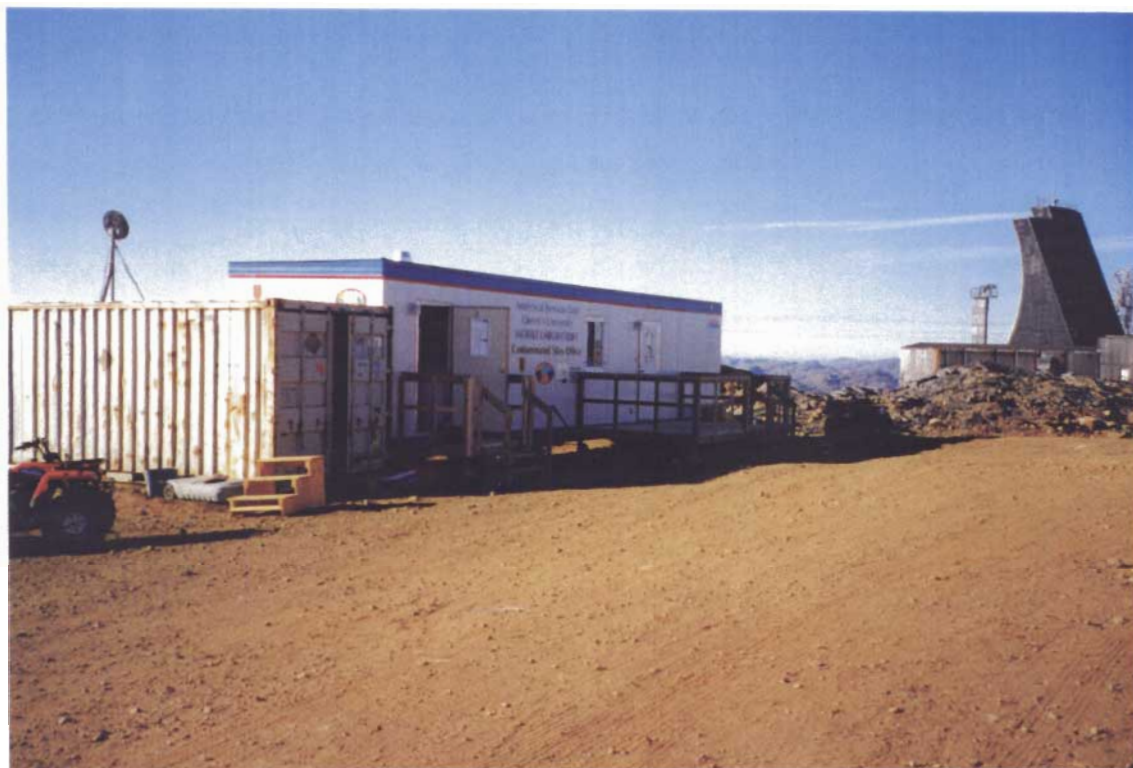
Photograph I-3: The Mobile Laboratory and Sea-Can in September 2000

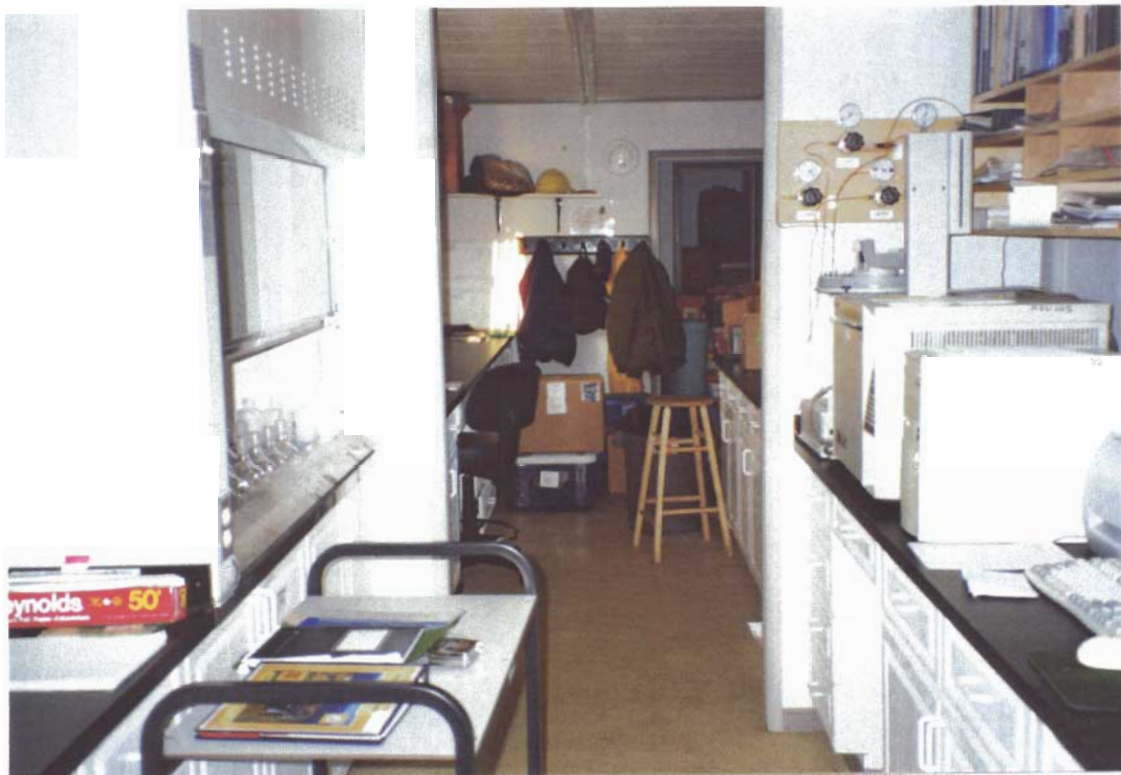
Photograph I-4: The Interior of the Mobile Laboratory Showing the Gas Chromatograph With Gas Controllers and the Fume Hood.

The laboratory was constructed with three separate areas (Photograph I-4). The utilities area contains cold water storage, water pump, hot water tank and electrical panel. In order to operate the GC, gases are required. These gases are normally supplied by cylinders of helium, nitrogen, hydrogen and air. For the laboratory, these cylinders have been replaced by a separate hydrogen generator and an air and a nitrogen system that are jointly connected to an air compressor. Hydrogen is used in place of the helium.

The middle section of the laboratory contains benches, a sink, and an emergency shower and is used for activities relating to sampling. Sampling supplies and containers for soil, water, air and oils are stored in the area as well as equipment for the measurement of air quality, radioactivity, dust etc.

The final section of the laboratory is primarily devoted to the gas chromatograph and the associated equipment needed for the GC/ECD analysis for PCBs; the GC is also equipped with an FID detector for the identification of organic compounds. The analysis of soils by GC/ECD also requires a flask shaker unit, drying oven, rotary evaporator and sets of glassware. The rotary evaporator uses cold water supplied by a refrigerator unit and vacuum provided by a special apparatus. This section also houses a large fume hood since the analysis uses organic solvents - dichloromethane, hexane and acetone.

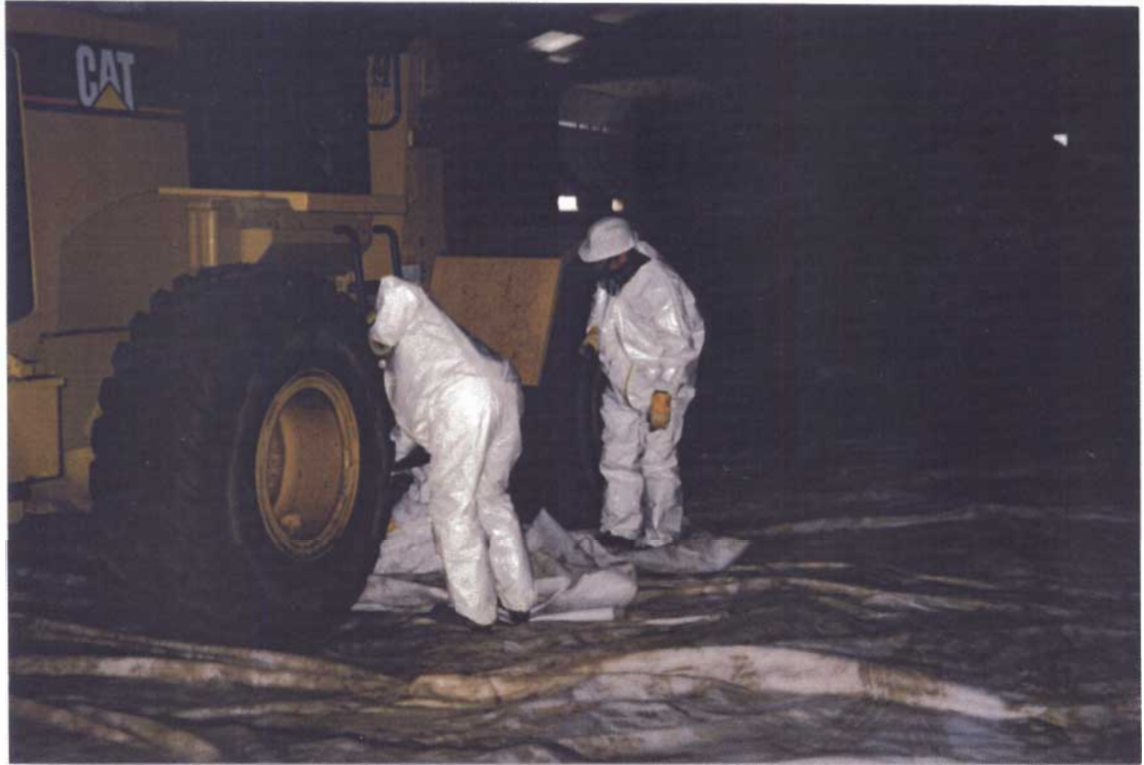
Photograph II-1: Decontaminating the Wheels of a loader in the Main PCB Storage Facility

Decontamination of equipment was carried out with brushes and scrapers. Removed soil was collected on sheets of geotextile fabric. Inside the main PCB storage building an air compressor was successfully employed to complete the work. At outside locations, water was used and this was then picked up with the vacuum truck. CEPA material, both water and soil were emptied from the vacuum truck on to a highly contaminated area that was due to be excavated.

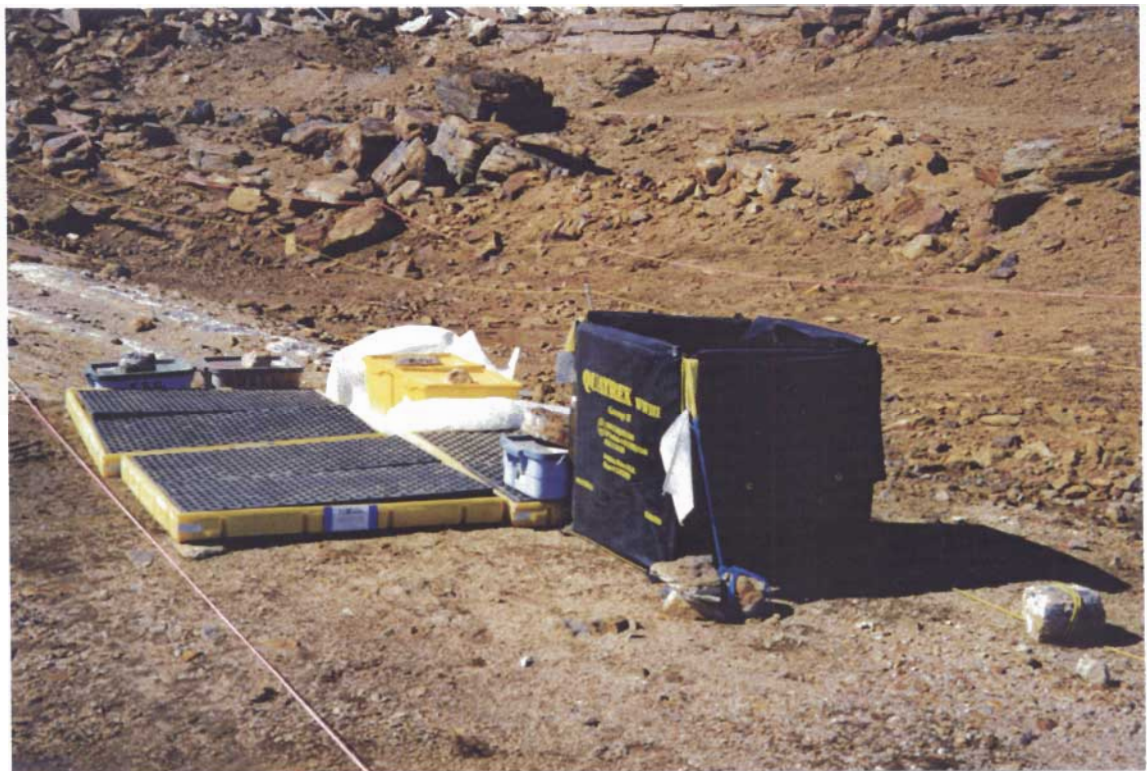
Photograph II-2: Decontamination Unit for Personnel in the Furniture Dump Drainage Pathway

Decontamination centers were set up for personnel at all locations where CEPA soil was being dealt with. The large decontamination trailer was used at the S1/S4 area but smaller units comprised of containers of wash water and supplies of personal protective equipment were used elsewhere. The personal protective equipment used is given in the Health and Safety Plan and was described fully in the 1999 ASU report. Tyvec suits, gloves and rubber boots were always worn in contaminated areas. In general half-faced respirators were used whenever the odour of askarel (PCB mixture) was encountered; dust masks were worn whenever it was dusty. This is further discussed in Chapter III, section E.
