Resolution Island 2001 Scientific Investigations

Analytical Services Unit
Queen's University
Kingston, Ontario

Contaminated Sites Office

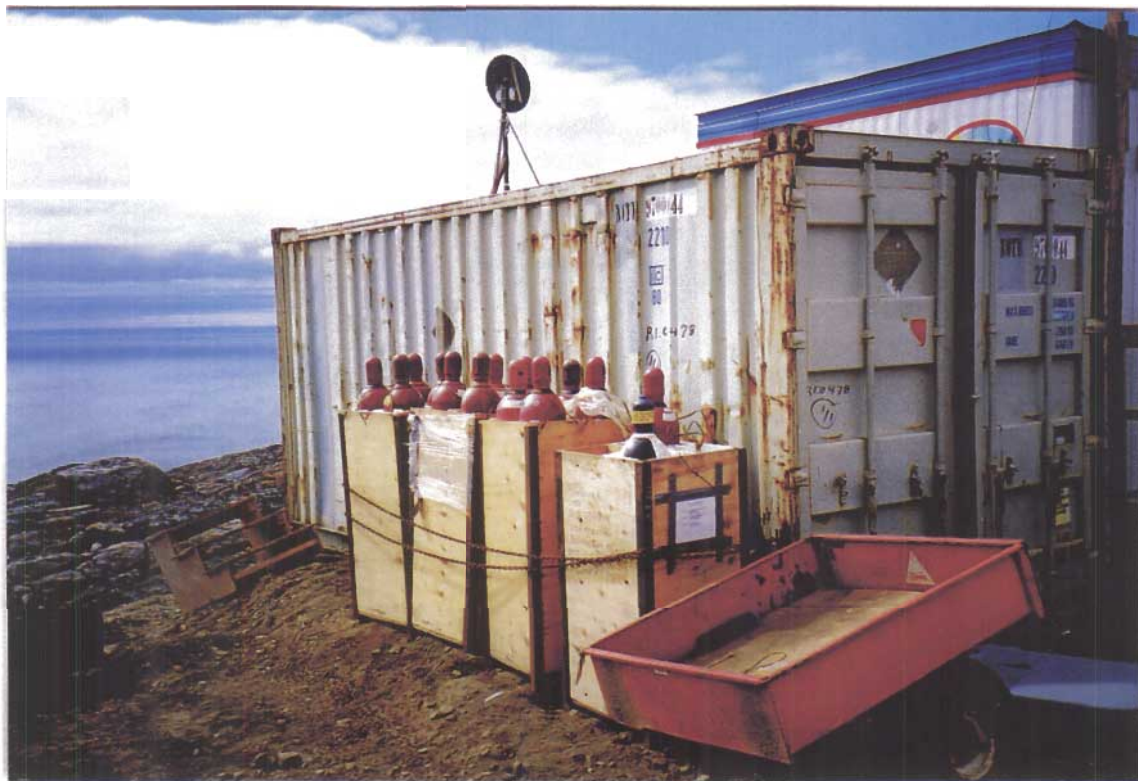
Photograph I-1: Gas Cylinders Beside the Sea-Can Used to Store Supplies Used by the Queen's University Team.

The activities conducted at the site this year by the ASU and described in Chapters II-IV of this report are listed below. There were four ASU personnel on site for most of the time this summer. Two people were generally required full time to operate the laboratory. Equipment and supplies used by the ASU were flown to Iqaluit and transported into the site by helicopter or Twin Otter aircraft. Gas cylinders for the operation of the gas chromatograph were taken to Montreal and sent in by sea-lift.

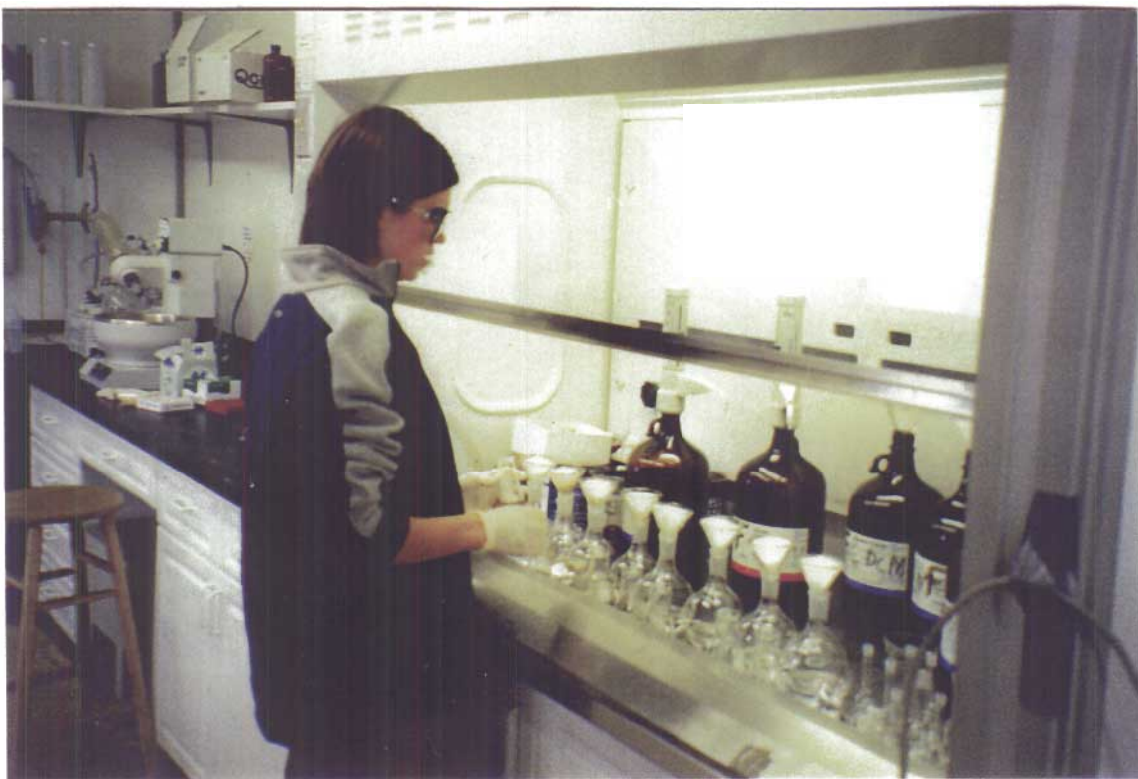
Photograph I-2: Conducting Analyses for PCBs in the Mobile Laboratory.

- Scientific and engineering support at the site.
- Analyses at the mobile laboratory. The analyses were mainly for PCBs using a gas chromatography with an electron capture detector (GC/ECD). Samples analysed included soil, water, oil and wood. The GC/ECD and associated equipment for PCB analysis worked well. The hydrogen generator did not work after a winter at Resolution Island and was replaced by helium and hydrogen gas from cylinders. PCB test kits were also used at the mobile laboratory. Water
