II. REMEDIATION

C. S1/S4 Buildings Area

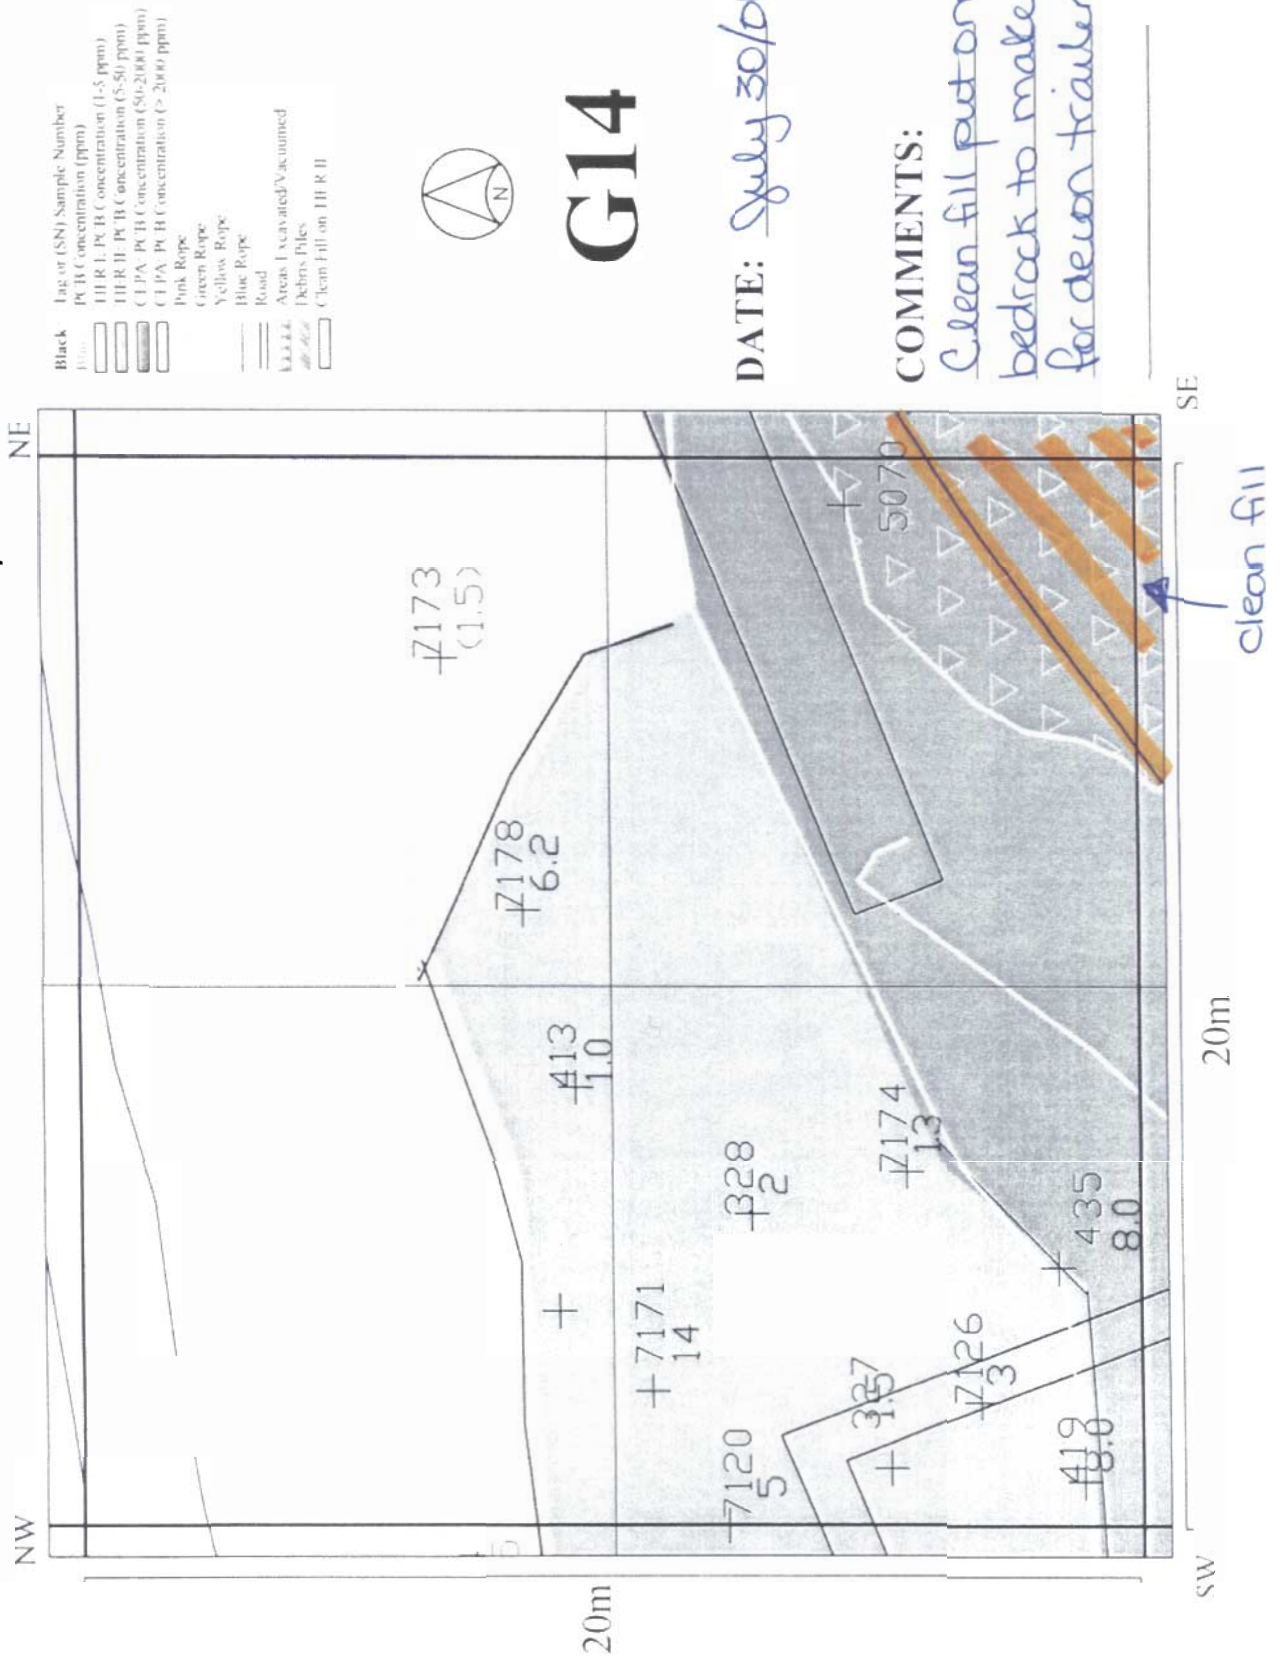
MAP II-3d: Composite Sampling Locations and PCB Concentrations for Quadrant G14 on 30 July 2001

Composite sample

* Note that composite sample extends into grid G13

vacuumed to bedrock

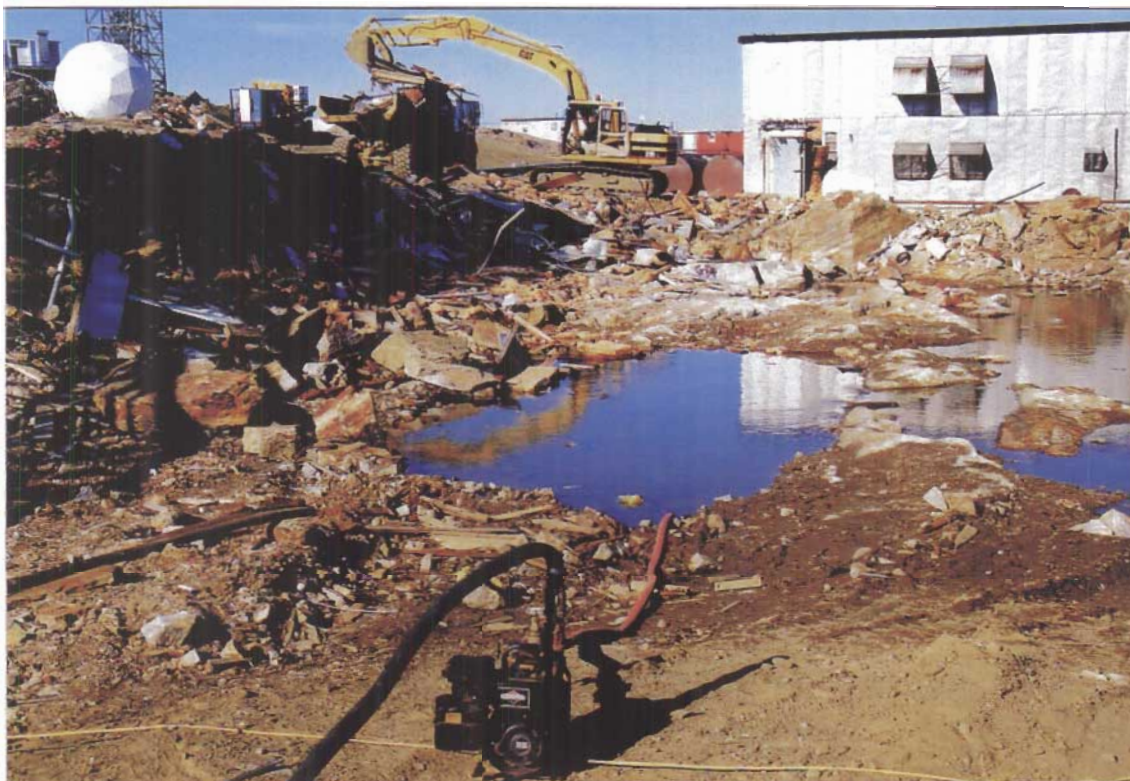
Photograph II-1: Demolition of the Corridor That Links Buildings S3 and S4; and Pumping Water From the S3 Area.

Water pumps were employed to displace water in areas where heavy equipment access or sediment removal was required (Photograph II-1). Water was discharged onto contaminated ground. After the water had been removed from Grids G13-14 and H14-15, the corridor connected to the S4 building was demolished and the debris taken to the non-hazardous landfill. The remaining CEPA contaminated silt and soil in this area was removed using an excavator. Samples were taken to ensure the boundary areas were lower than the CEPA criterion. A team of up to 10 people was used to manually remove rocks greater than 10 cm diameter so as to allow the vacuum truck to work unobstructed (Photograph II-2). Small pieces of insulation debris from the corridor were manually collected and this material was placed in a waste wrangler, and taken to the non-hazardous landfill. Clean fill was added to provide the vacuum truck access over the uneven bedrock and all remaining soil/sediment was removed. Three days of relatively dry weather helped dry the silt and expedite the work. The addition of clean fill provided an access way from the road (F13) and allowed the decontamination trailer to be sited (H14) (Photograph II-3). The trailer was anchored with steel cable and rock bolts. Access by personnel to the S1/S4 area required transit through the trailer.

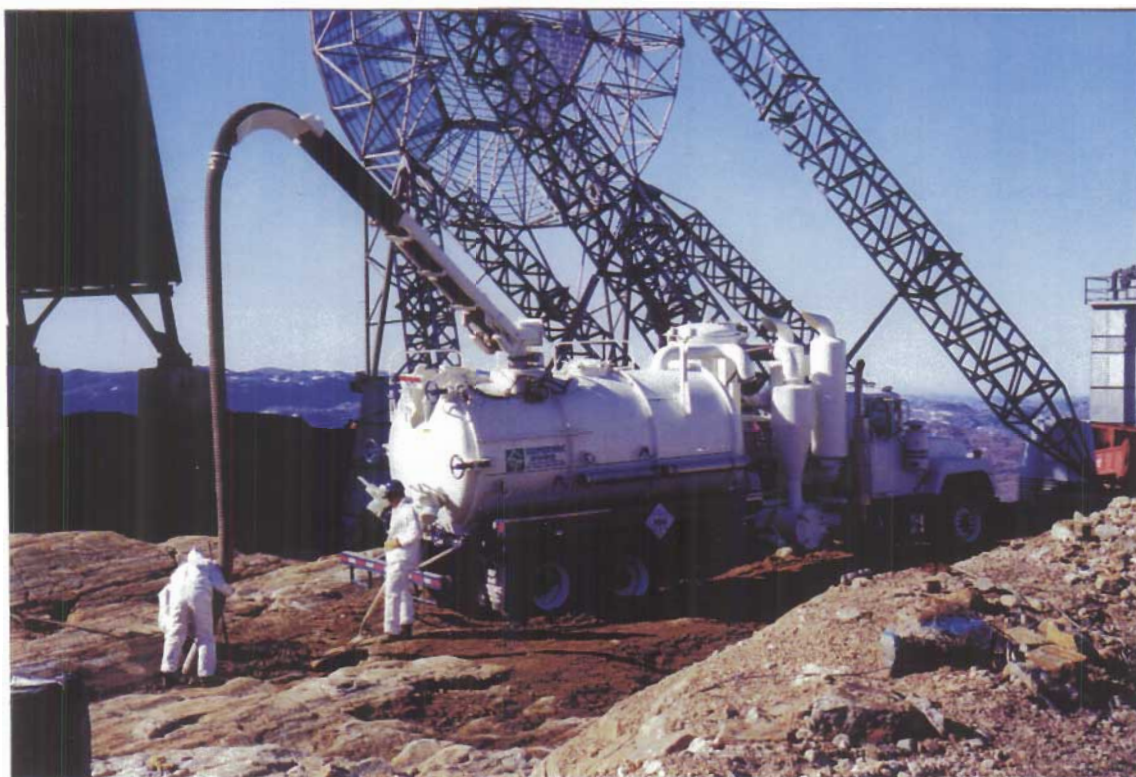
Photograph II-2: The New Vacuum Truck Removing Fine Material From Bedrock.

needed to be further cleared of PCB-contaminated soils which could not be excavated with heavy machinery. This was achieved by shoveling by hand and by using a vacuum truck. This work was slow and arduous, however, the new vacuum truck purchased and brought on site this year did significantly improve the process.

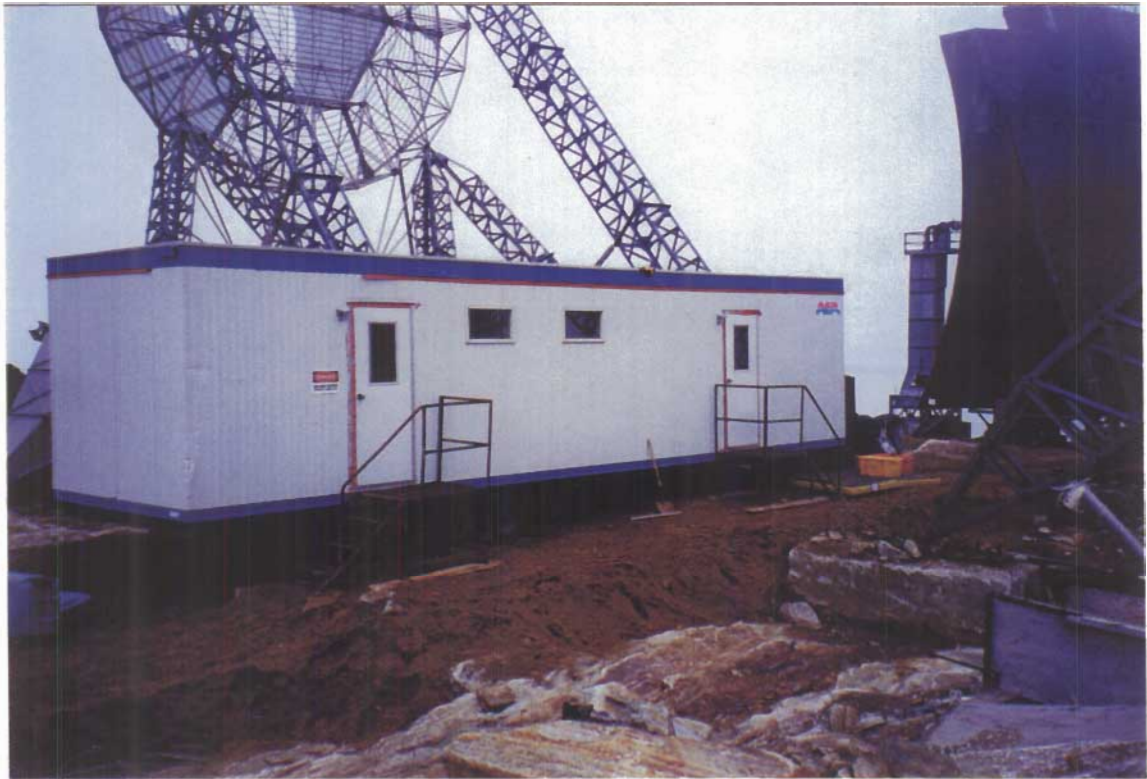
Photograph II-3: The Decontamination Trailer was Placed in the S3 Area After Removal of PCB Contaminated Soils.

Decontamination centers were set up for personnel at all locations where contaminated soil and leaking barrels were being dealt with. The large decontamination trailer was used at the S1/S4 area but smaller units comprised of containers of wash water and supplies of personal protective equipment were used elsewhere. The personal protective equipment used is given in the Health and Safety Plan and was described fully in the 1999 ASU report. Tyvec suits, gloves and rubber boots were always worn when working in contaminated areas. In general, half-faced respirators were used whenever the odour of askarel (PCB mixture) was encountered; dust masks were worn whenever it was dusty.

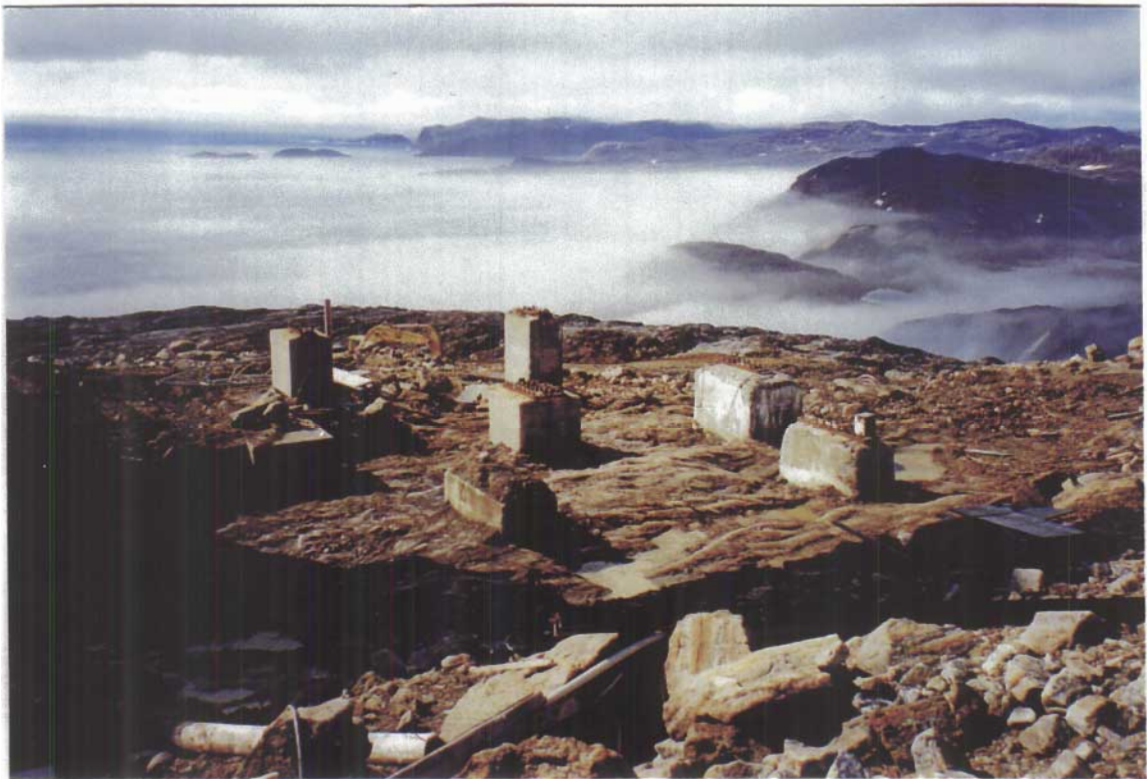
Photograph II-4: All CEPA Soil was Remediated From the Heavily PCB-Contaminated Region which Drained the Area where Building S1 Previously Stood.

Once the CEPA soil in this area (centered on Grid H14) had been addressed, the focus shifted to the S1 drainage area (Photograph II-4). The area leading up to the >2000 ppm zone was excavated, vacuumed and clean fill was added to provide further access. Soil from this area was kept separate from other (lower level) CEPA soil and deposited in a pile besides the screener. Vacuumed soil from this area was likewise deposited here. The CEPA soil surrounding this >2000 ppm area and the soil from an isolated CEPA area (Grids J19-20 and L19-20) was excavated from the same access point. After the >2000 ppm soil was stockpiled, it was containerized. A total of 70 containers were filled. This

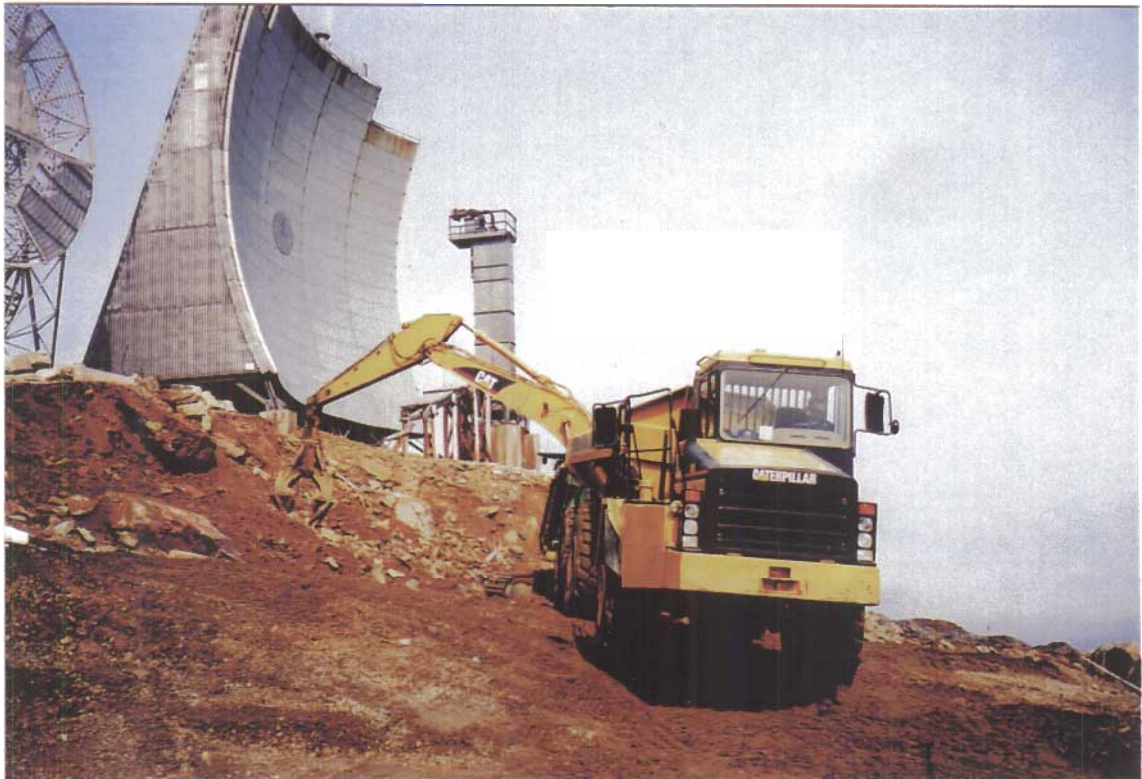
Photograph II-5: Excavating Large Boulders From the Steep Slope Along the Road From the Screening Plant Below the Buildings Area.

When no longer required, the access roads described above were removed. The third front in the S1/S4 area involved CEPA areas on the steep slopes, SSW of Troposcatter Dish B. The surface of these slopes was covered with large boulders, which made access to the soil difficult. An excavator with a clam attachment was used to remove the rocks (Photograph II-5) and these were dumped from the edge of an entry road down a steep slope (Grid G16). The quantities of rock removed, the intensive efforts required and the instability of the slope led to a partial collapse at the face. Samples taken from all along the surface indicated that the collapse had mixed the soil in the area with the net effect being the lowering of PCB concentrations. Results of analyses of soil samples from the area ranged from below 1 ppm to 33 ppm. Four test pits were dug along the collapsed face. Using the clam attachment on an excavator, depths of between 50 cm and 1 m were achieved. The results from samples taken in these areas ranged from 1.1 ppm to 34 ppm indicating that a lowering of PCB levels had resulted from disturbance caused by removing the large boulders. No further excavation was therefore required.

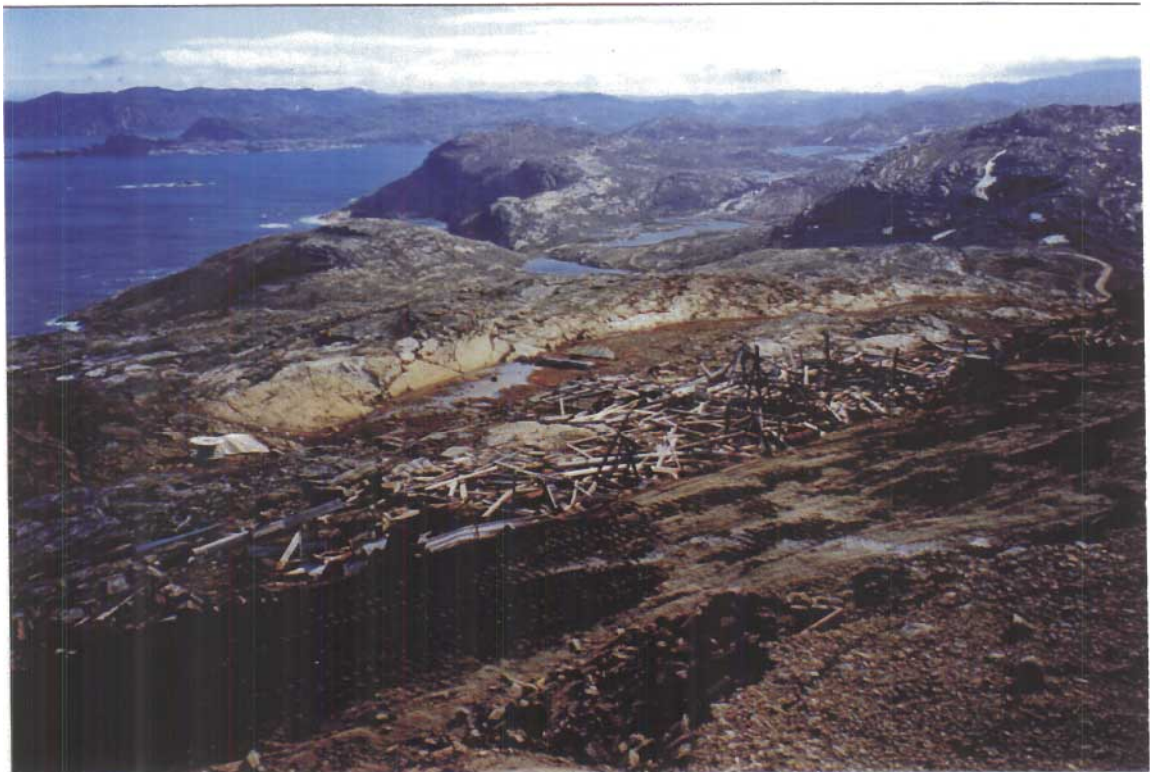
Photograph II-6: Pieces of Wooden Debris Lying on Soil Much of Which is Contaminated with PCB above the 2000 ppm Level.

Wood and debris removal from the areas in and around the >2000 ppm area below the lower road was undertaken (Photograph II-6). There was found to be a direct correlation between levels of PCB soil contamination, and levels of PCB contamination for wood residing in these areas. Several wood samples were taken from lower CEPA areas (50-2000 ppm) and several from higher CEPA areas (>2000 ppm). In both of these areas, samples were taken from wood in direct contact with the soil and from wood slightly elevated above the surface. The samples taken from 6 inches or more above the surface were contaminated at a Tier I level. Samples taken from direct soil contact up to 6 inches above the soil level in the lower CEPA area were found to be Tier II and samples from wood in direct contact with soil up to 6 inches above the soil level contaminated at >2000 ppm were found to be CEPA. A new protocol: 'The Resolution Island Wood Debris Protocol' evolved from this work. It was used to deal with this contaminated wood and is reproduced as Annex A at the end of the chapter.

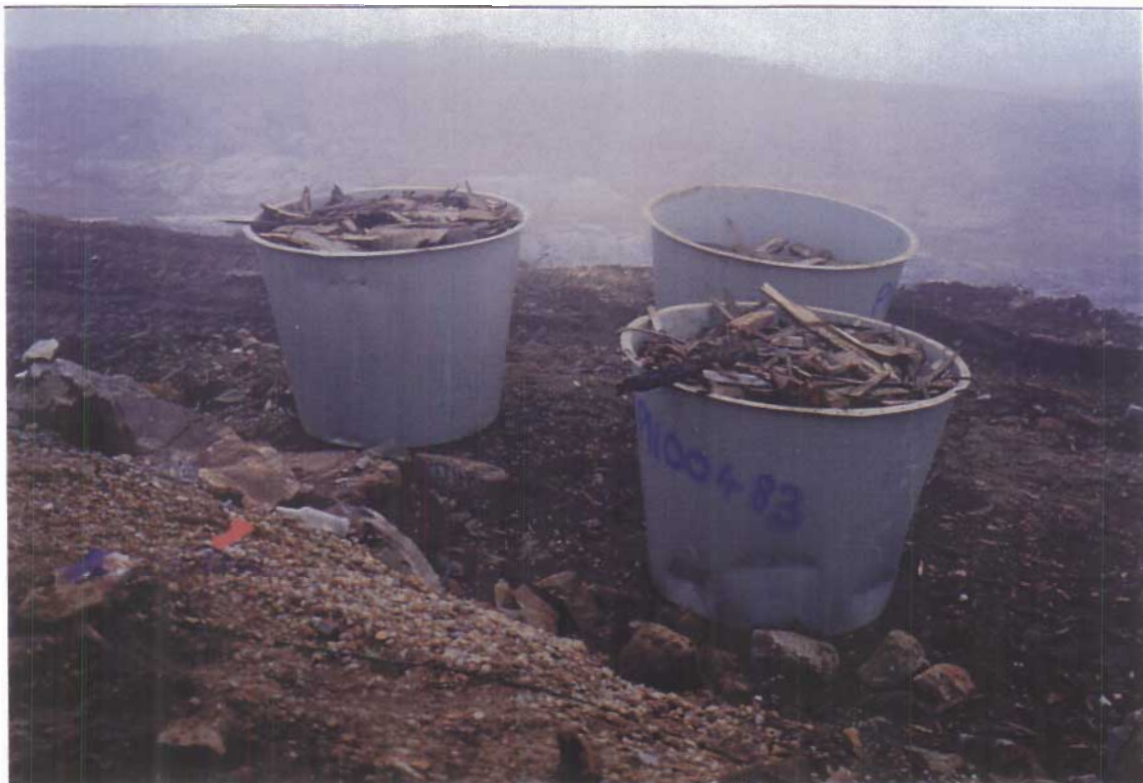
Photograph II-7: Contaminated Wood Lying on Soil Contaminated with PCBs Above the 2000 ppm Level was placed in Steel Containers.

CEPA wood from the >2000 CEPA area was placed directly into 3 large flowerpots (Photograph II-7). These were assigned PN numbers, labeled and then transported to the Beach PCB Storage Facility. The rest of the wood, contaminated to

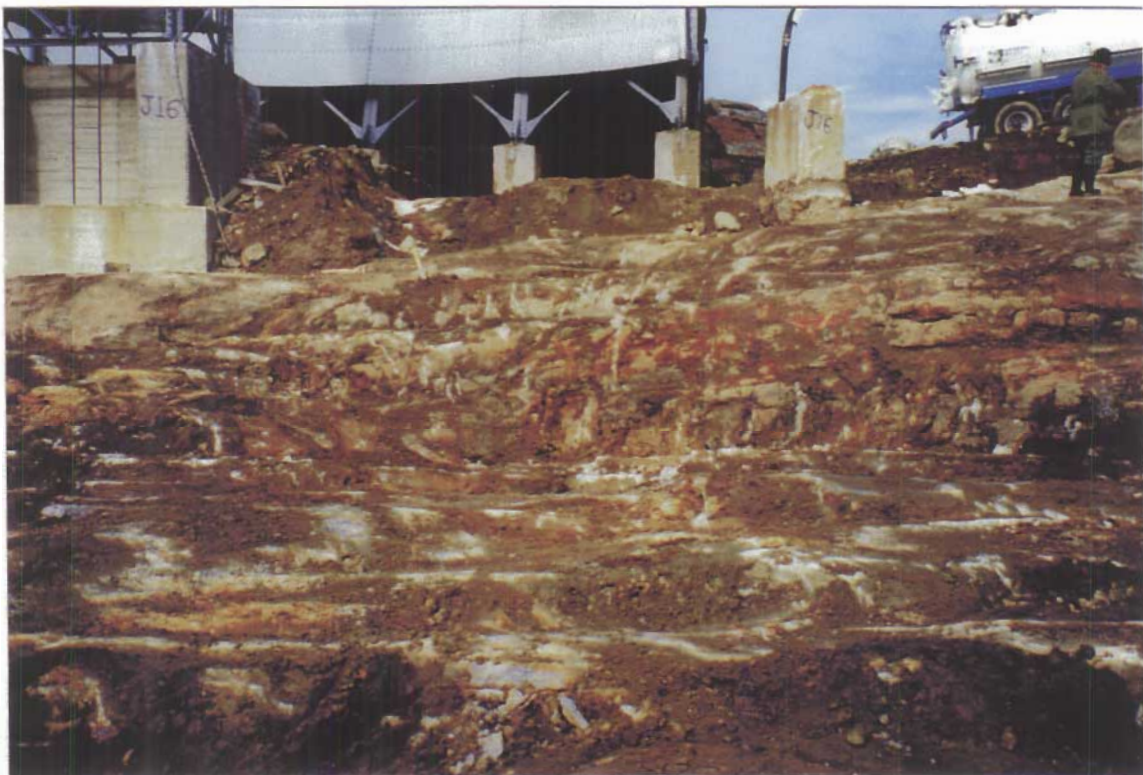
Photograph II-8: Cleaned Area Below the Large Troposcatter Dish Near S1

The final efforts in the S1/S4 area, focused in the immediate vicinity of Troposcatter Dish A. The rock face in front of Dish A was vacuumed to remove the CEPA soil. Due to the architecture of the dish, the use of heavy equipment was restricted to a Kubota and manual excavation was required under the dish itself. To the right of the dish, the former 'archway' was removed. A substantial amount of soil was found on the slope down to the area south of Dish A (J16). In this area, samples were taken after every 30 cm excavation. High contamination levels were found to persist all the way to bedrock, and vacuuming was required (Photograph II-8). Clean fill was used to provide the vacuum truck access to this area. After this area had been cleared, a berm was constructed to prevent the migration of silt in the future (Photograph II-9). A similar berm was constructed beside the screener (Grid location G10-H10).

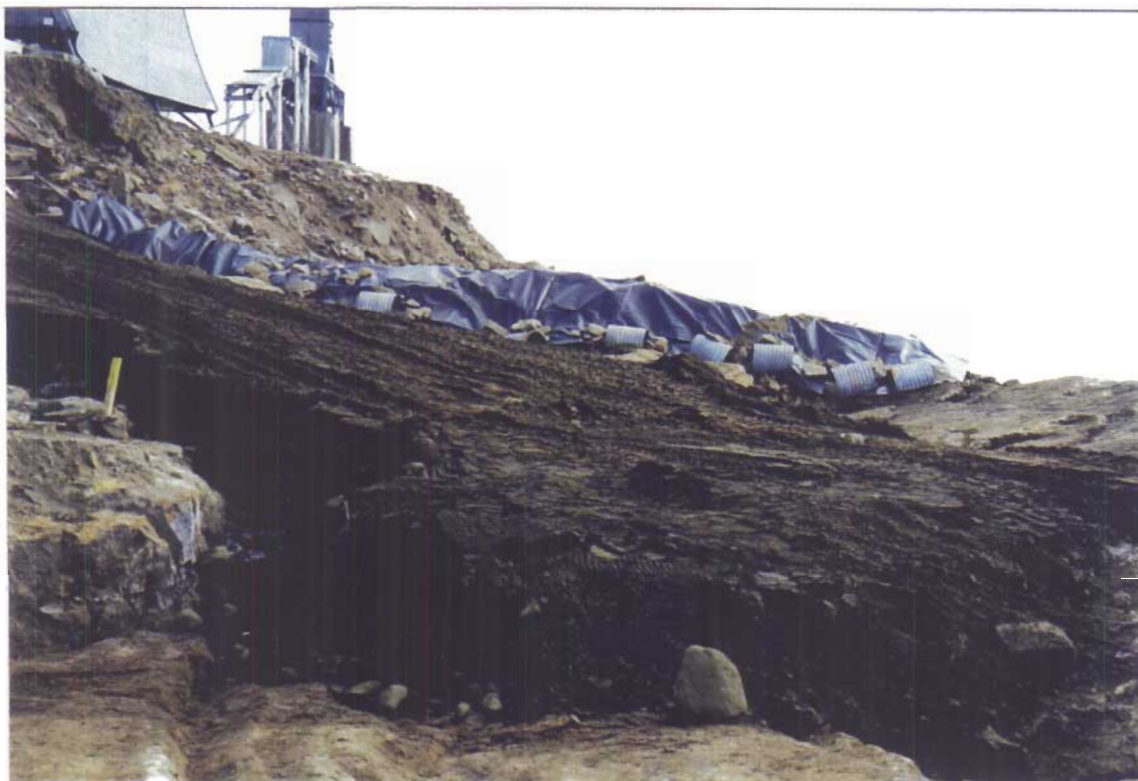
Photograph II-9: Uncontaminated Soil was Placed on Cleaned Ground and a Berm Constructed to Prevent Recontamination of the Area Over Winter.

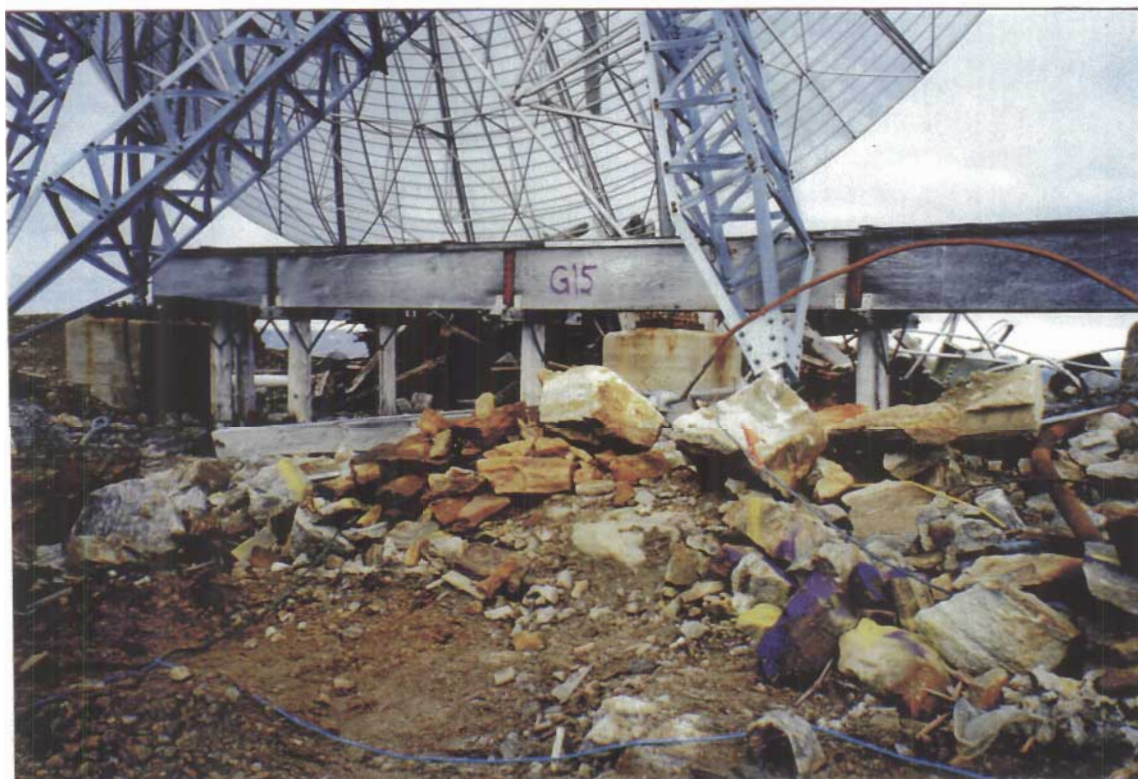
Photograph II-10: The Whole Contaminated Area Was Gridded at 20 Meter Intervals; Grids Where Labels (G15) and Corners Marked With Purple Paint.

A 20 x 20 m grid system was graphically constructed using Autocad Map 2000. The grid was labelled A to S (in a N/S orientation) and 1 to 25 (in a W/E orientation). This grid was graphically constructed to contain all of the contaminated S1/S4 areas of concern in the S1/S4 buildings and S1/S4 valley areas. For the 2001 field season, the working area was encompassed by grid co-ordinates E8 to O21 (Map II-2). Each grid reference relates to the bottom right hand corner of the relevant 20 x 20 square. The 168 co-ordinates required to set-up the grid were exported to a Reliance mapping program and uploaded as a waypoint file to a GPS FS/2 handheld controller unit. On Resolution Island, the Ashtech Reliance differential GPS mobile receiver system was operated in 'rover mode' which allowed navigation to the individual grid points to within 1 m accuracy. Individual grid points were marked with flags and an "X", using purple spray paint. The grid co-ordinates were marked in several locations within the confines of the grid, on available surfaces and rocks (Photograph II-10).
